Property Inspection Report

1234 Channing Way, Exeter, CA, 93221

Date of Inspection: 5/4/2022

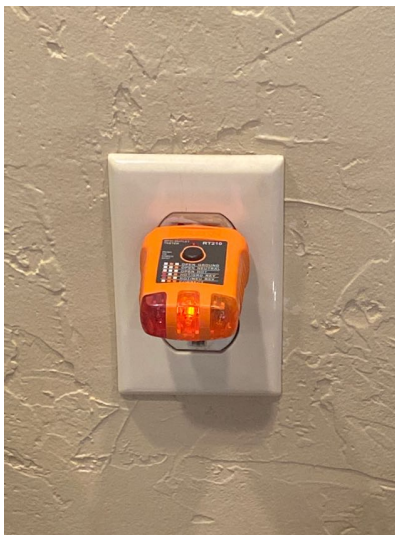
West wall

- A three prong electrical outlet in this room has an open ground. This outlet should be corrected by qualified professional.

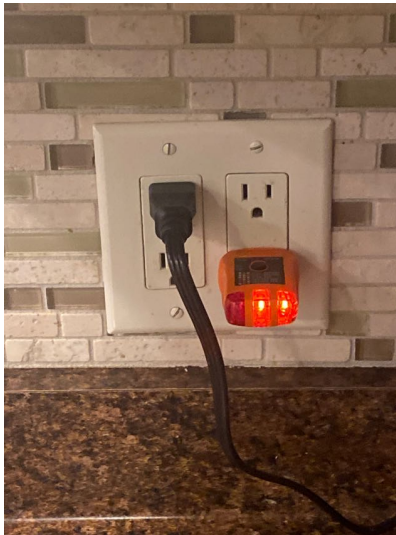
East wall

- No Ground Fault Interrupter (GFI) protection was provided for this rooms electrical outlets located within six feet of a plumbing fixture. Although this may not have been required at the time the home was built, The Inspector recommends installation of ground fault circuit GFI protection as a safety precaution.

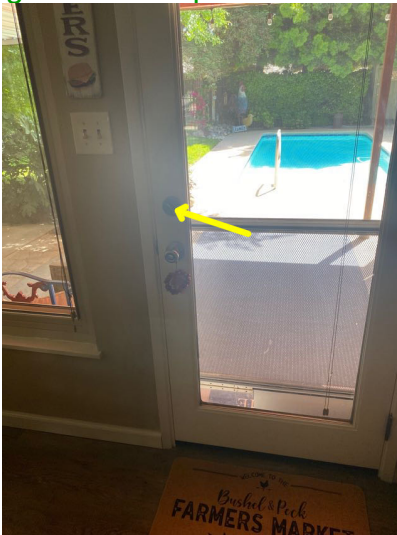
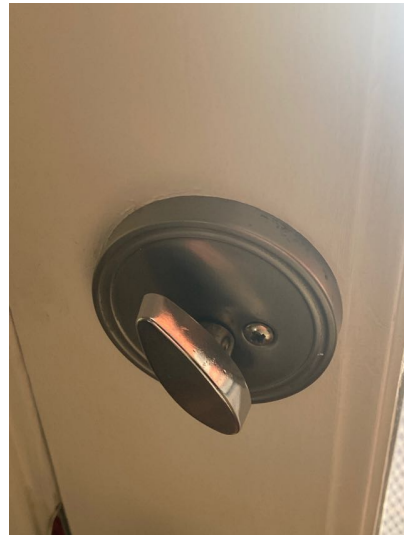
- Deadbolt in the dining room was non-operational at the time of inspection. We suggest further investigation and repairs as needed by a qualified professional.

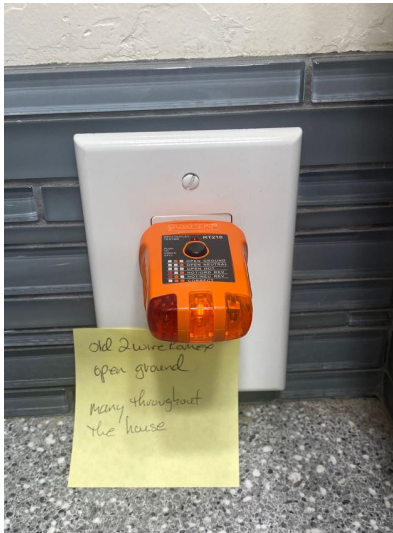
West wall

Page 15 Item: 4	GFI Outlet Condition	<ul style="list-style-type: none"> A Ground Fault Interrupter (GFI) electrical outlet in this room did not respond to the test button. Owner note suggest open ground however wiring tested OK with tester. We suggest further investigation and repairs as needed.
Laundry Room

- A Ground Fault Interrupter (GFI) electrical outlet in this room did not respond to the test button. Owner note suggest open ground however wiring tested OK with tester. We suggest further investigation and repairs as needed.

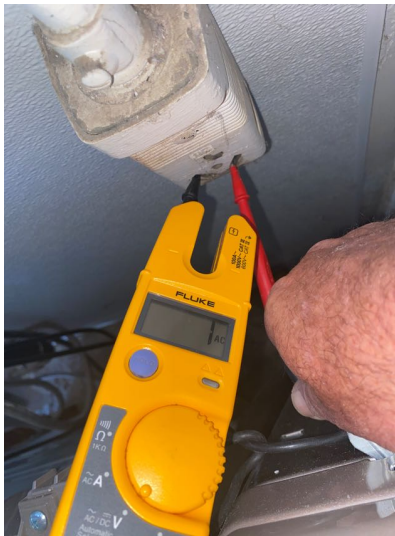
Page 16 Item: 3	Electrical	<ul style="list-style-type: none"> No power was provided for 220 V outlet at the time inspection. We suggest further investigation and repairs as needed.
Water Heater

- No power was provided for 220 V outlet at the time inspection. We suggest further investigation and repairs as needed.

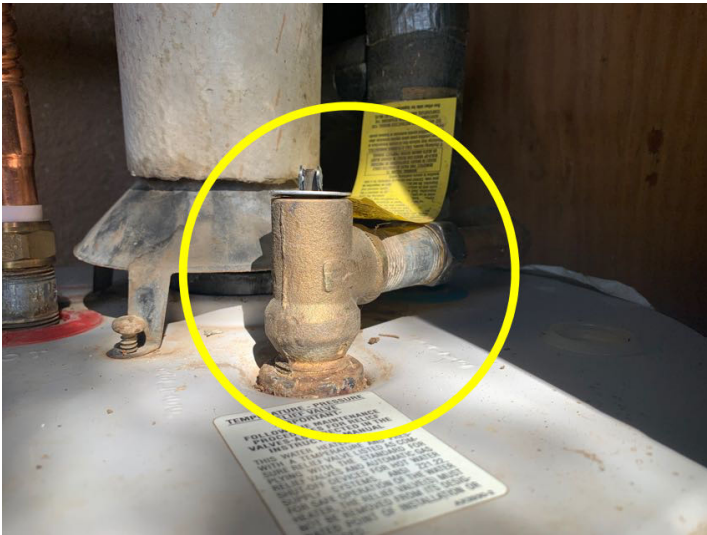
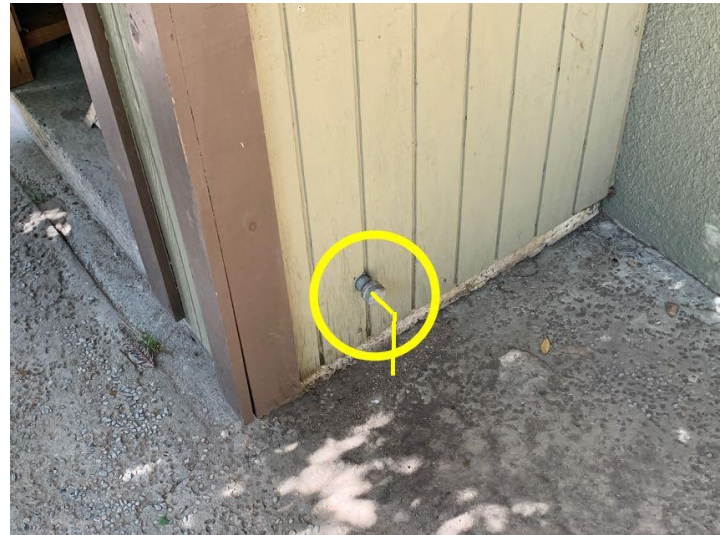
Page 19 Item: 3	TPRV	<ul style="list-style-type: none"> The discharge pipe of the water heater Temperature Pressure Relief Valve (TPRV) had a threaded end that is capped off. The discharge pipe should not be blocked off as it will not allow tank pressure to be released if TPRV opens due to high pressure or overheating. The cap must be removed and pipe elbow installed to direct discharge down. Pipe end must not be threaded to prevent installation of cap as is done here. This is a safety issue. We suggest further investigation and repairs as needed by a qualified professional.

The water heater is equipped with a Temperature Pressure Relief Valve (TPRV).
 - The discharge pipe of the water heater Temperature Pressure Relief Valve (TPRV) had a threaded end that is capped off. The discharge pipe should not be blocked off as it will not allow tank pressure to be released if TPRV opens due to high pressure or overheating. The cap must be removed and pipe elbow installed to direct discharge down. Pipe end must not be threaded to prevent installation of cap as is done here. This is a safety issue. We suggest further investigation and repairs as needed by a qualified professional.

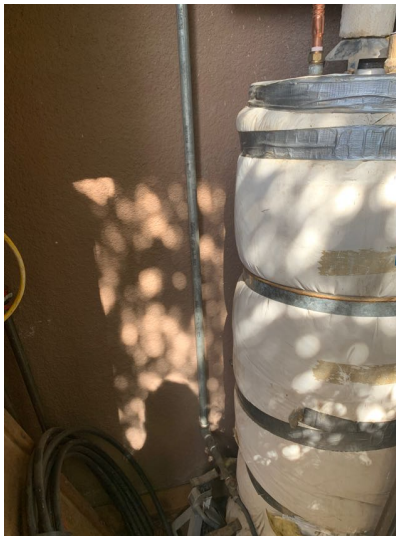
Page 20 Item: 4	Plumbing	<ul style="list-style-type: none"> Gas line piping was unsecured to wall which can lead to damage to gas piping. We suggest further investigation and repairs as needed by a qualified professional.
Exterior Areas

- Gas line piping was unsecured to wall which can lead to damage to gas piping. We suggest further investigation and repairs as needed by a qualified professional.

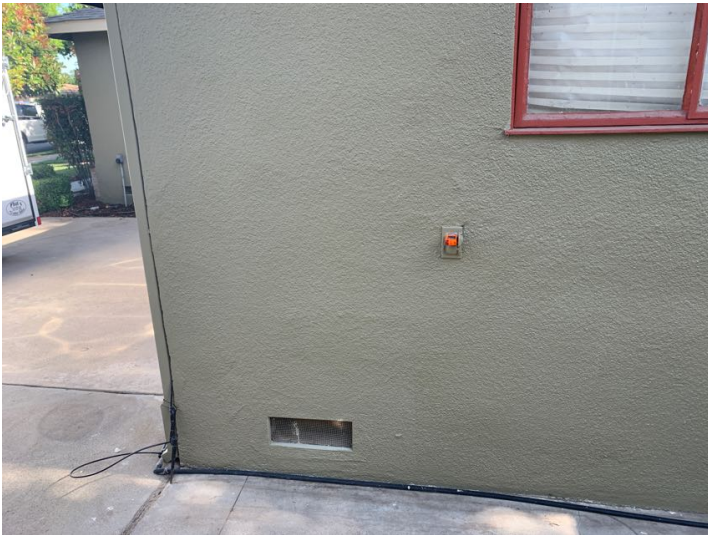
South side of structure

Page 21 Item: 2	Outlet Condition	<ul style="list-style-type: none"> An electrical outlet on south side of structure had hot and neutral wires reversed. We suggest further investigation and repairs as needed by a qualified professional.
Electrical

- Most electrical outlets in back patio area had open grounds. This is likely due to original outlets being ungrounded two prong types and outlets being replaced with three prong type.
- An electrical outlet on south side of structure had hot and neutral wires reversed. We suggest further investigation and repairs as needed by a qualified professional.

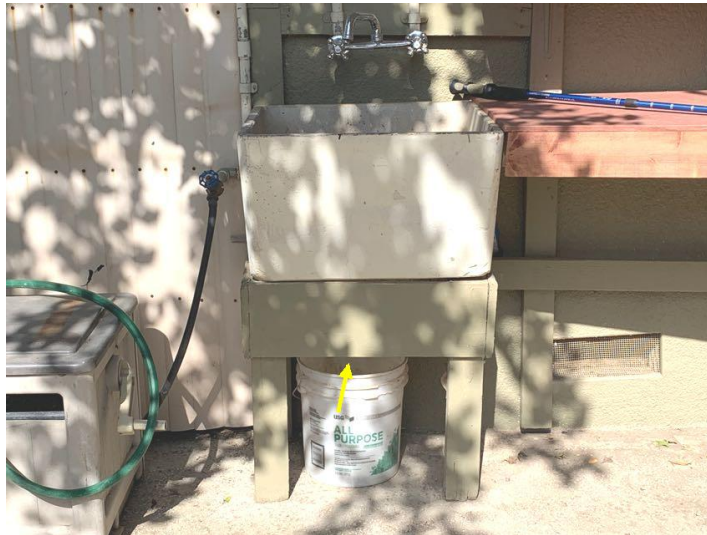
- Outside sink on east side of structure does not have a drain. Sink water is emptied into a bucket.

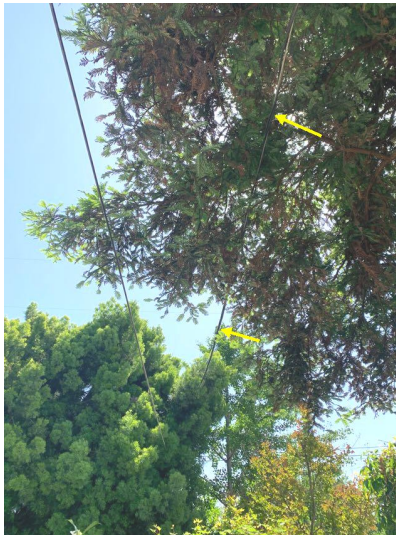
Page 23 Item: 1	Cable Feeds	<ul style="list-style-type: none"> The overhead service drop conductors had inadequate clearance from tree branches. This condition should be corrected by a qualified contractor to avoid abrasion and damage to the conductors. Work around the service conductors should be performed by a qualified professional only. Injury or death may result from attempts at correction by those without proper qualifications.

- The overhead service drop conductors had inadequate clearance from tree branches. This condition should be corrected by a qualified contractor to avoid abrasion and damage to the conductors. Work around the service conductors should be performed by a qualified professional only. Injury or death may result from attempts at correction by those without proper qualifications.

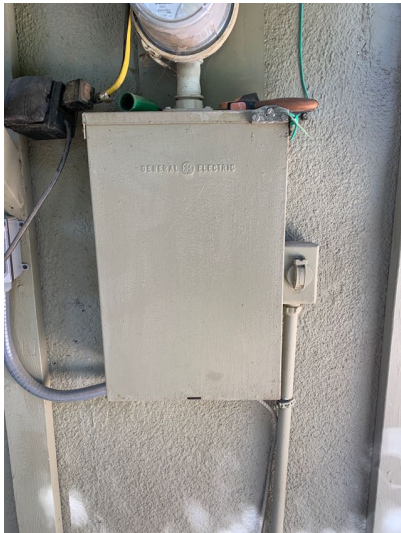
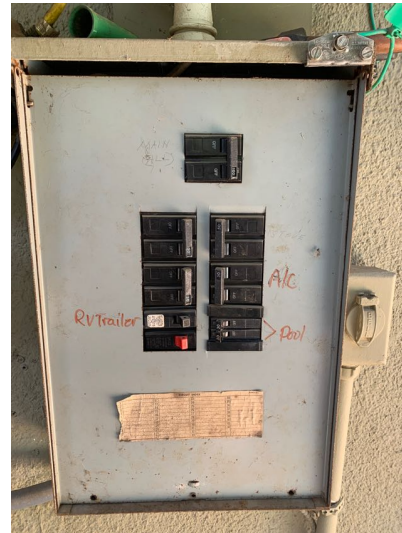
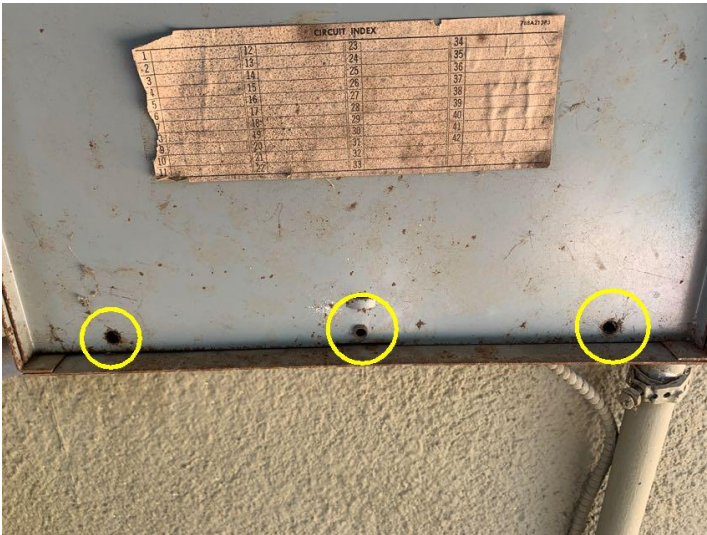
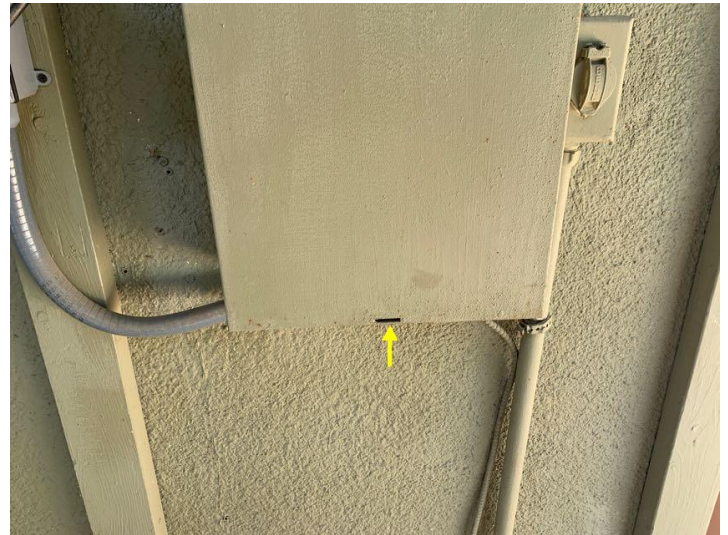
Page 24 Item: 2	Electrical Panel Condition	<ul style="list-style-type: none"> The dead front cover of the main electrical service panel was missing several screws and was not held securely closed. We suggest further investigation and repairs as needed by a qualified professional. Panel cover latch was missing and panel cover would not secure closed. We suggest further investigation and repairs as needed by a qualified professional.

- The dead front cover of the main electrical service panel was missing several screws and was not held securely closed. We suggest further investigation and repairs as needed by a qualified professional.
- Panel cover latch was missing and panel cover would not secure closed. We suggest further investigation and repairs as needed by a qualified professional.

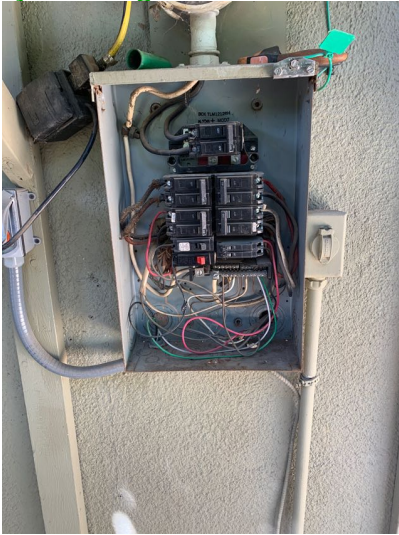
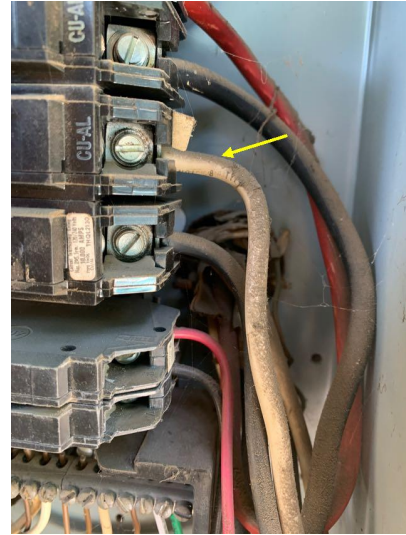
- White wire observed landed on 30 amp breaker at right side of the panel. The white wires normally used in a neutral circuit, not attached to the powered side as installed. We suggest properly marking this wire to avoid possible confusion in the future.

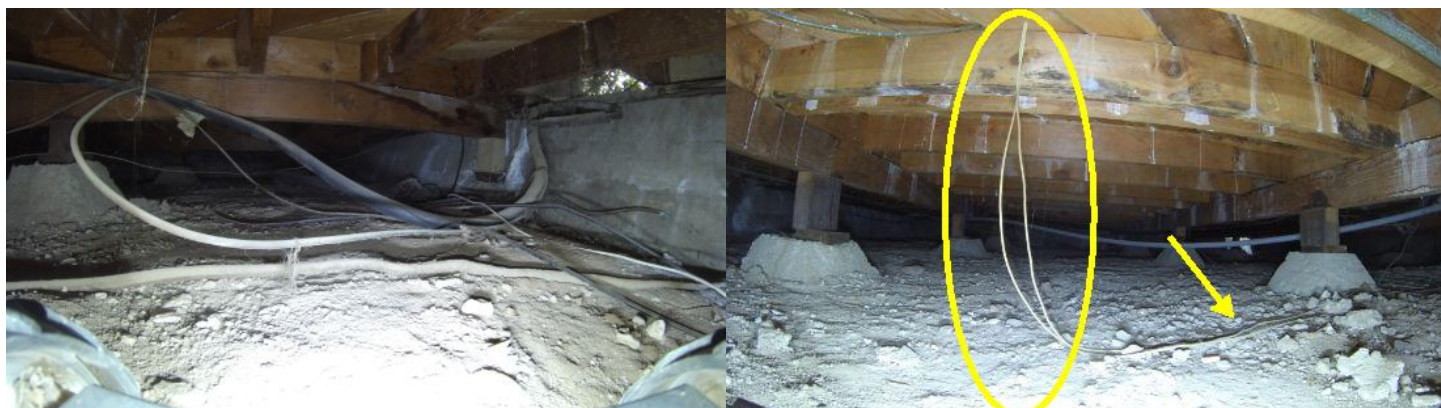
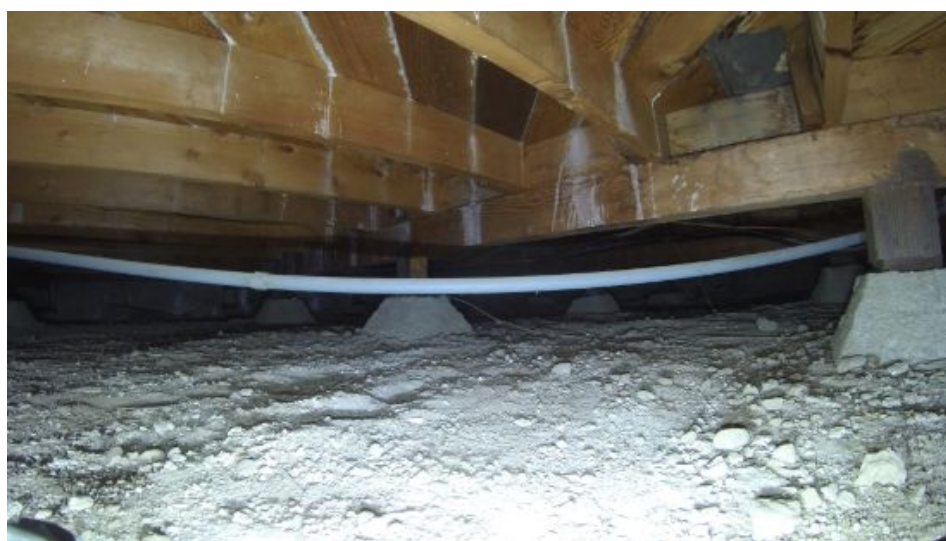
Page 28 Item: 4	Foundation Electrical	Poorly supported wires visible in the crawlspace should be properly fastened. Safe building practices require branch conductors to be supported securely off ground. We suggest further investigation and repairs as needed by a qualified professional.
Grounds

Observations: Poorly supported wires visible in the crawlspace should be properly fastened.

Safe building practices require branch conductors to be supported securely off ground. We suggest further investigation and repairs as needed by a qualified professional.

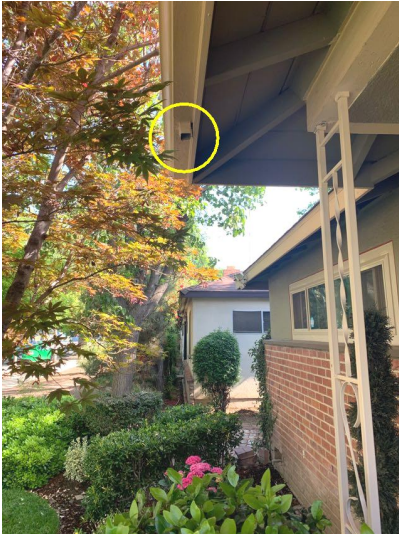
West side of structure

- A downspout on west side of structure was missing at the time of the inspection. This condition may cause problems by introducing excessive amounts of moisture to the soil beneath the foundation. Excessive moisture near the foundation can result in structural failure due to foundation movement or moisture intrusion with the potential to cause structural damage from decay. Moisture intrusion can also cause the development of unhealthy conditions in indoor air related to microbial growth such as mold fungi. The Inspector recommends replacement of any missing downspouts to help protect the home structure and occupants. We suggest further investigation and repairs as needed by a qualified professional.
- Gutter joint at northeast corner of structure was disconnected which will not allow proper drainage. We suggest further investigation and repairs as needed by a qualified professional.

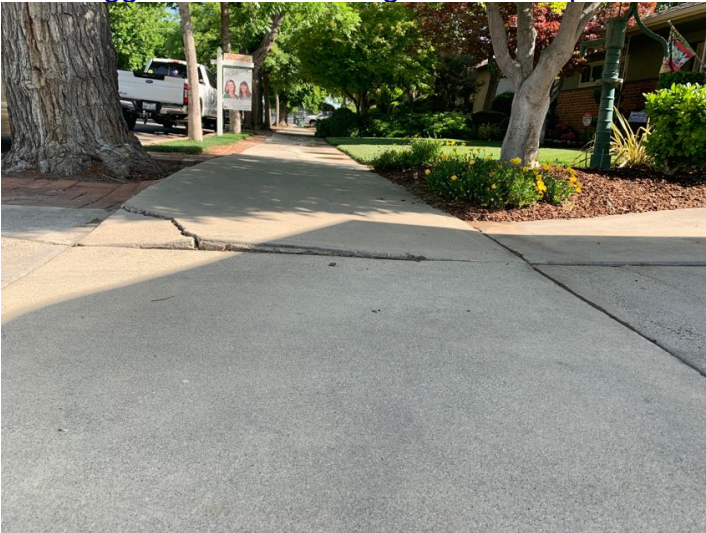
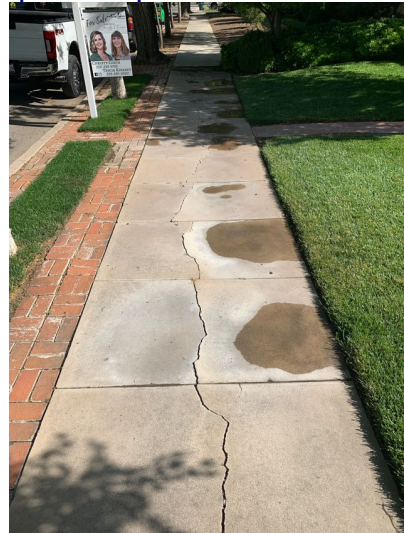
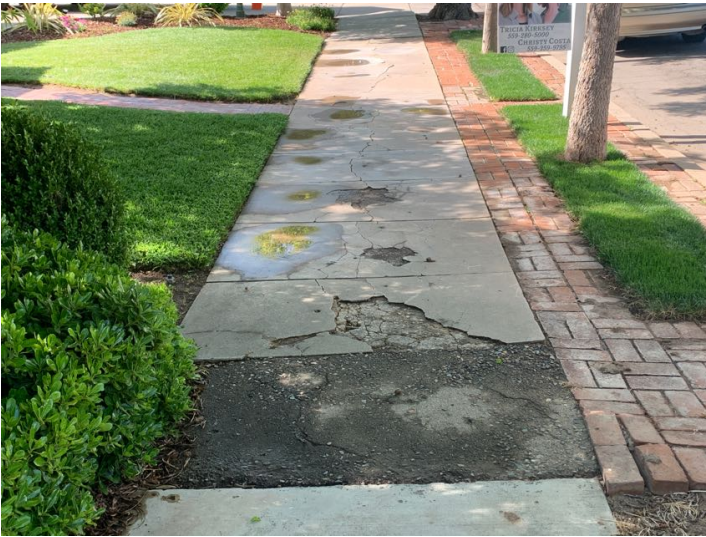
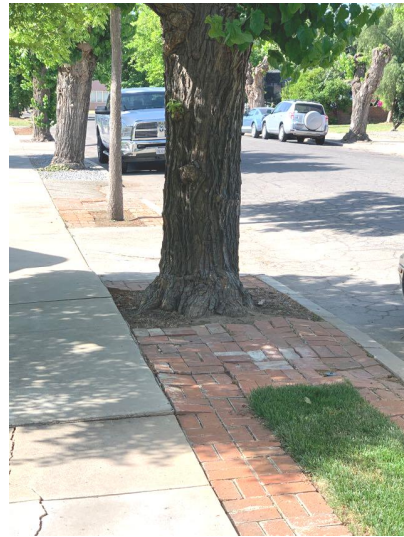
Page 32 Item: 1	Walkway Condition	• Side walk in front of structure has raised concrete slabs due to lifting of adjacent tree root systems. Concrete had areas of deterioration. These conditions constitute trip hazards. We suggest further investigation and repairs as needed by a qualified professional.
Pool And Spa

- Side walk in front of structure has raised concrete slabs due to lifting of adjacent tree root systems. Concrete had areas of deterioration. These conditions constitute trip hazards. We suggest further investigation and repairs as needed by a qualified professional.

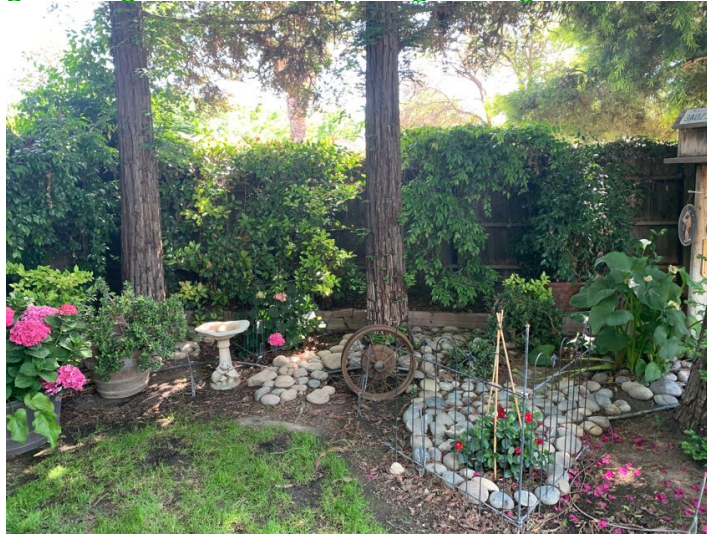
- Vegetation growing on fences will reduce life of materials due to moisture retention causing rot as well as added weight to fencing materials.
We suggest removing the vegetation and repairing damaged fence areas.

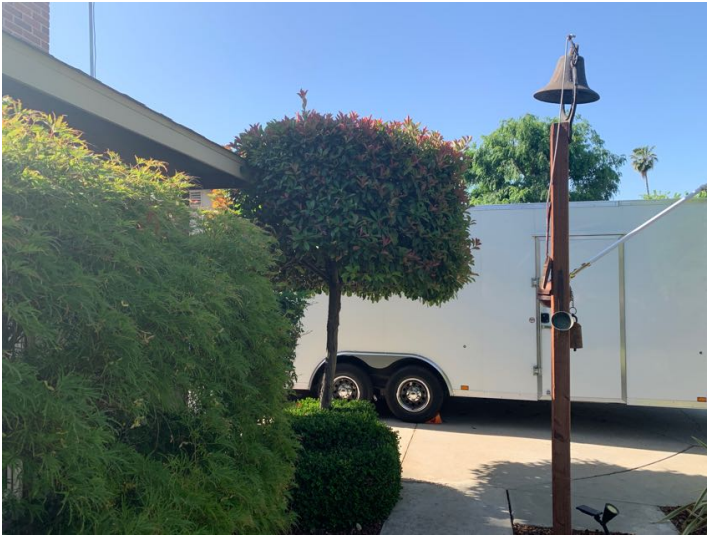
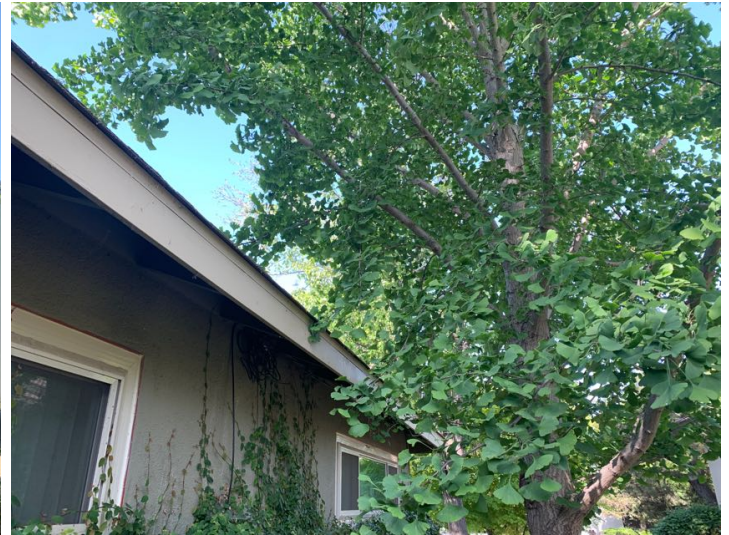
Northside of structure

- Trees at front of and north side of home have branches that are near the home. Falling and rubbing branches may cause damage. We suggest trimming back.

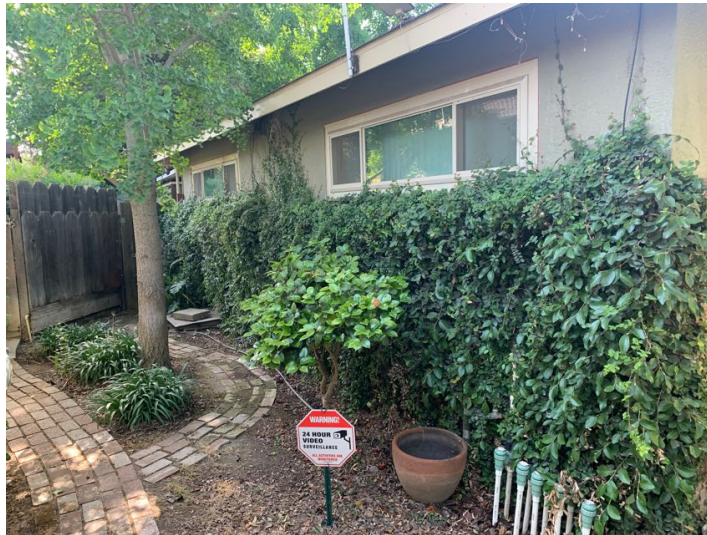
North side of structure

- Vines on north side of structure wall should be removed to prevent damage to stucco.

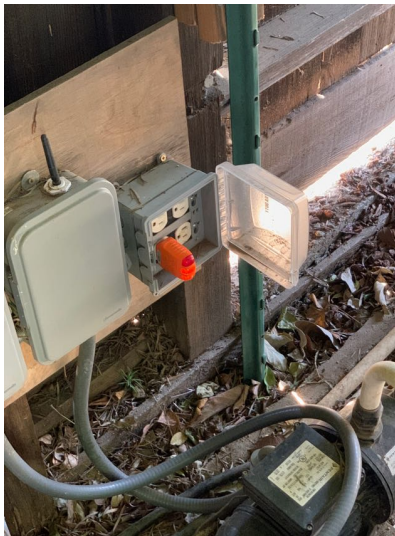
Page 38 Item: 6	Outlet Condition	• An electrical outlet in this area had an open ground. We suggest further investigation and repairs as needed by a qualified professional.

- An electrical outlet in this area had an open ground. We suggest further investigation and repairs as needed by a qualified professional.
