Property Inspection Report

1234 W Fedora Ave, Fresno, CA, 93705

Date of Inspection: 11/22/2022

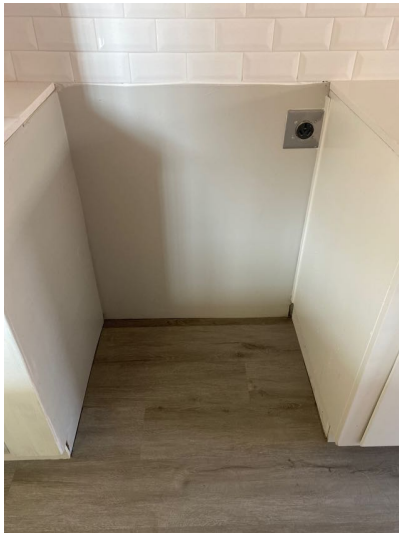
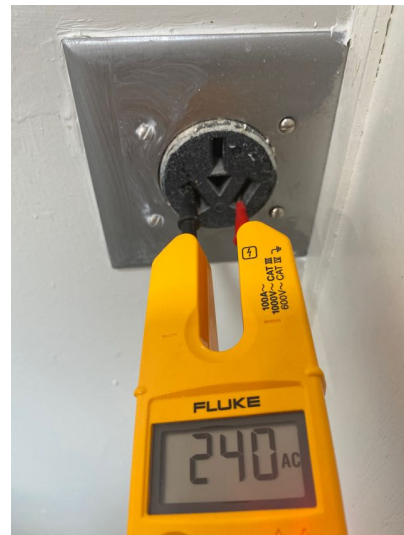
- No gas lines observed for range use at the time of the inspection.
- 110 electrical outlet not visible behind the stove at the time of inspection. 110 volt power energizes control functions. We suggest further investigation and repairs as needed by a qualified professional.

220 volt outlet present

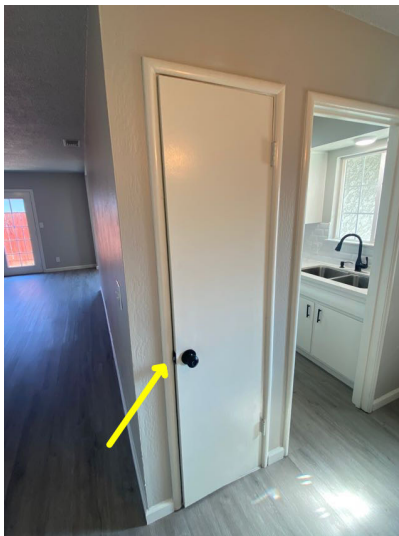
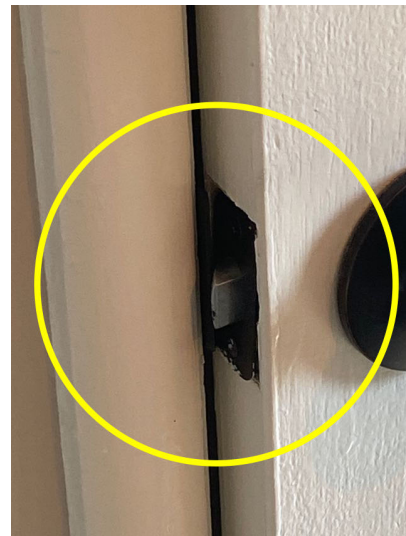
- Entry closet would not stay latched at the time of inspection. We suggest further investigation and repairs as needed by a qualified professional.

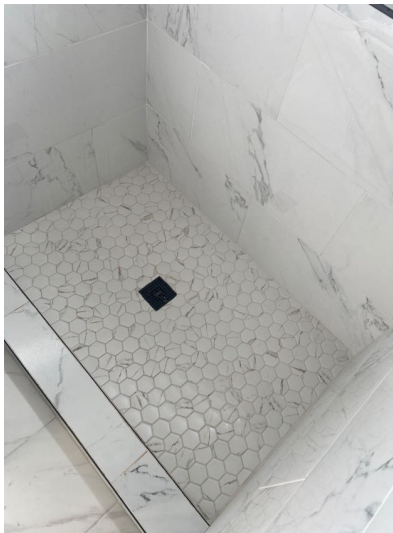
- Shower pan did not hold water and appeared to be leaking. See Hexapod report for further explanation. We suggest further investigation and re[pairs] as needed.

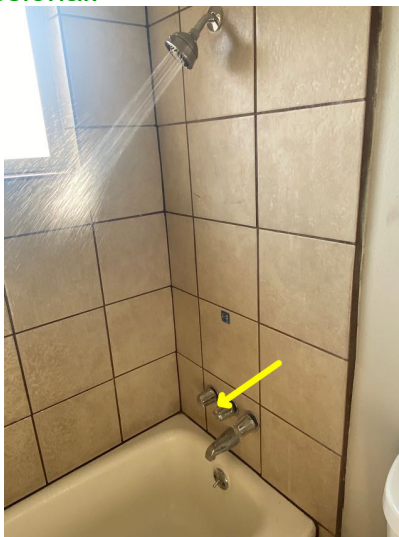
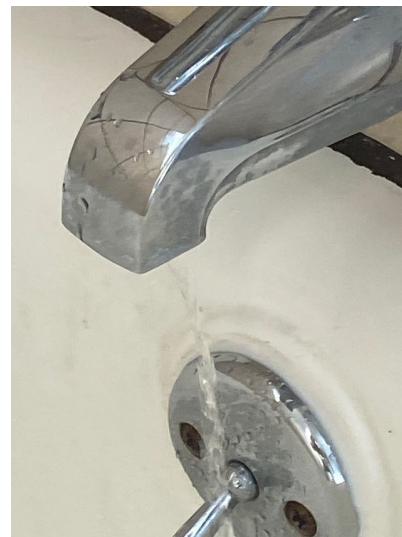
The diverter valve leaking through. (The diverter valve directs the water flow from the tub faucet to the shower head). We suggest further investigation and repairs as needed by qualified professional.

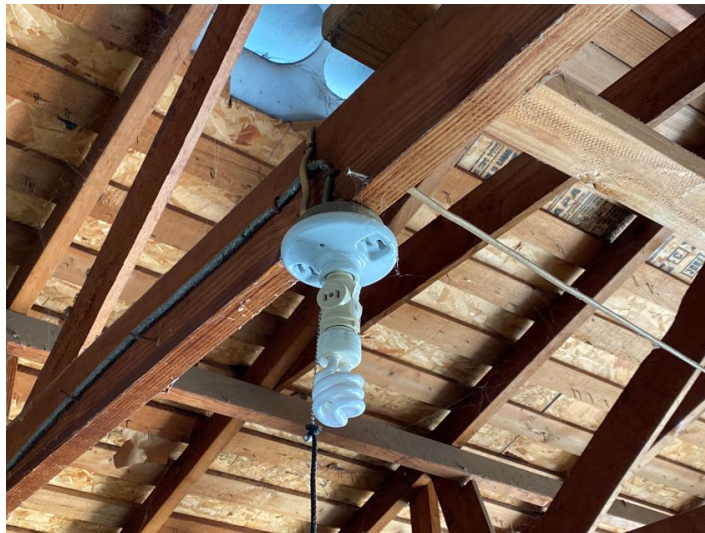
- A ceiling light in this area did not respond to the switch. The bulb may need to be replaced or there may be a problem with the switch, wiring or light fixture. If after the bulb is replaced this light still fails to respond to the switch, this condition may represent a potential fire hazard and the Inspector recommends that an evaluation and any necessary repairs be performed by a qualified electrician.

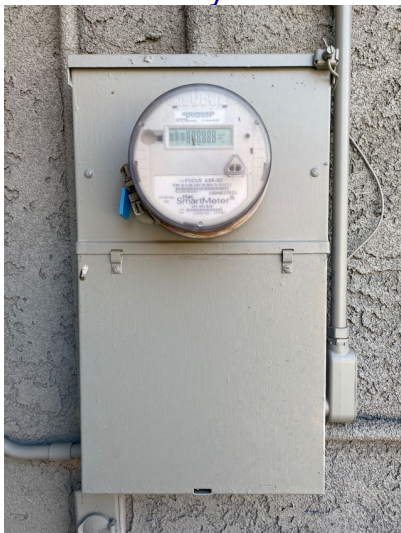
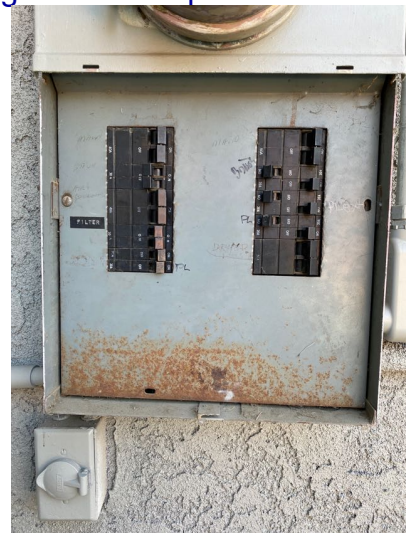
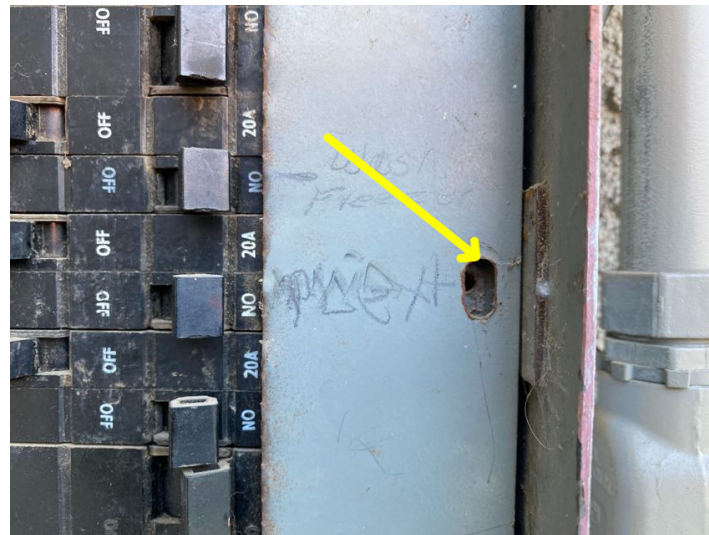
- The dead front cover of the main electrical service panel was missing mounting screw and was not held securely closed. We suggest further investigation and repairs as needed.

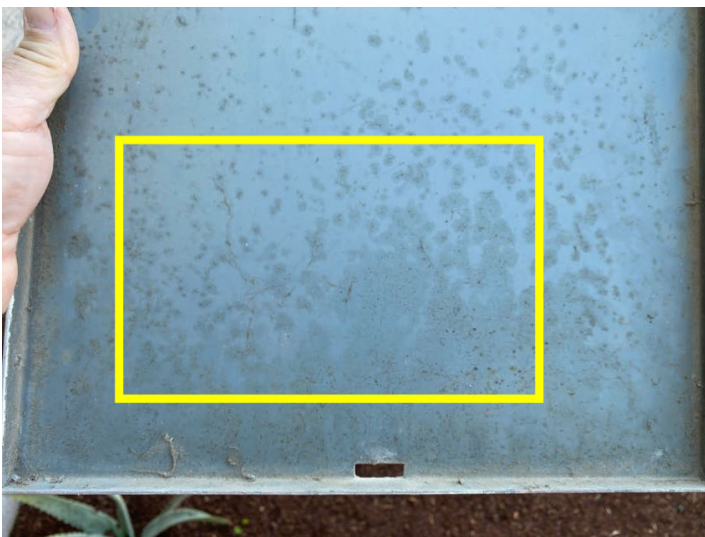
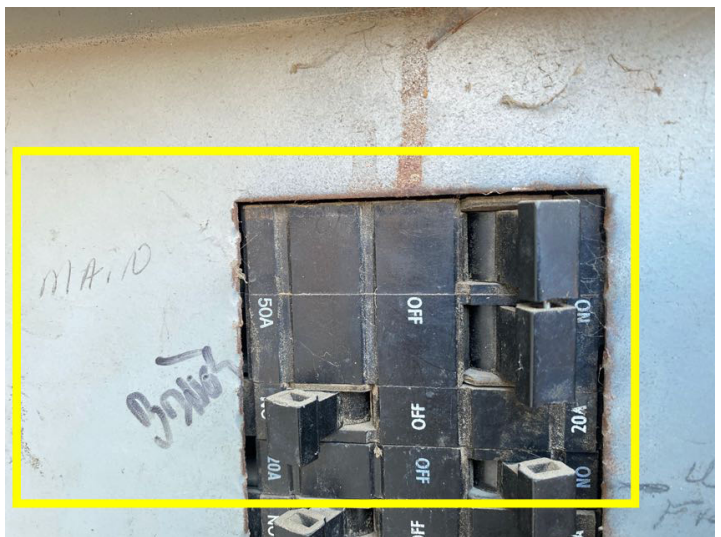
50 amp breaker installed

The manufacturer's label was missing from the main electrical service panel. The manufacturer's label typically provides information describing the main panel such as the name of the panel manufacturer, the panel model number, the panel amperage rating, limitations related to the environment in which the panel was designed to be installed and grounding/bonding information for that particular panel.

- The main electrical service panel label contained a 50 amps. A 50 amp service is considered obsolete by modern standards and for safety reasons the Inspector recommends that you consult with a qualified electrician to discuss options and prices for upgrading the electrical service.

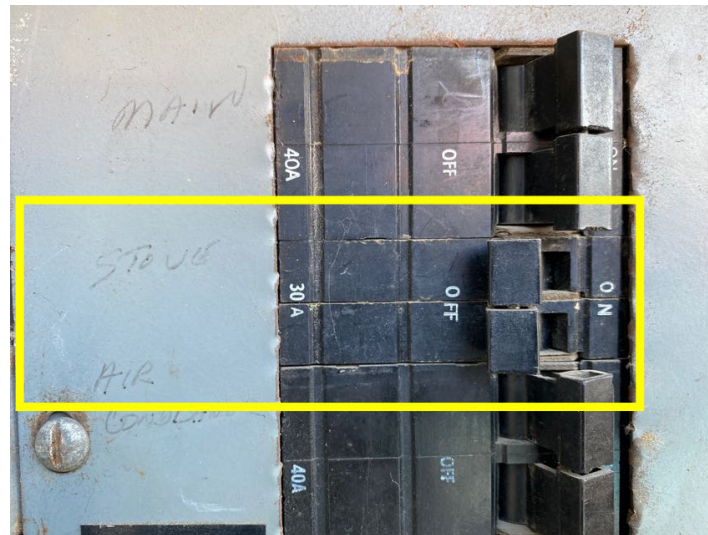
- 30 amp breaker for stove was in the off position at time of inspection.

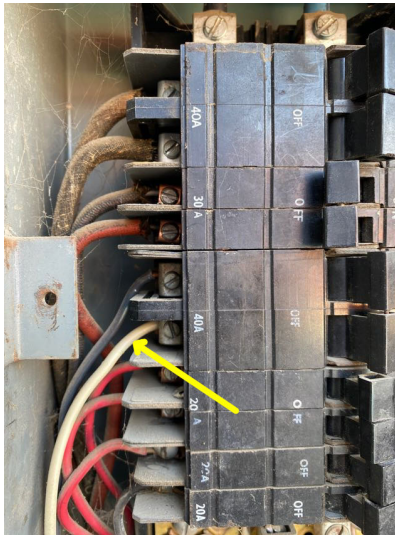
- All branch wiring appeared to be in serviceable condition at time of inspection.
- White wire observe landed on 40 amp breaker at the top of the panel. The white wires normally used in a neutral circuit, not attached to the powered side as installed. We suggest properly mark in this wire to avoid possible confusion in the future.

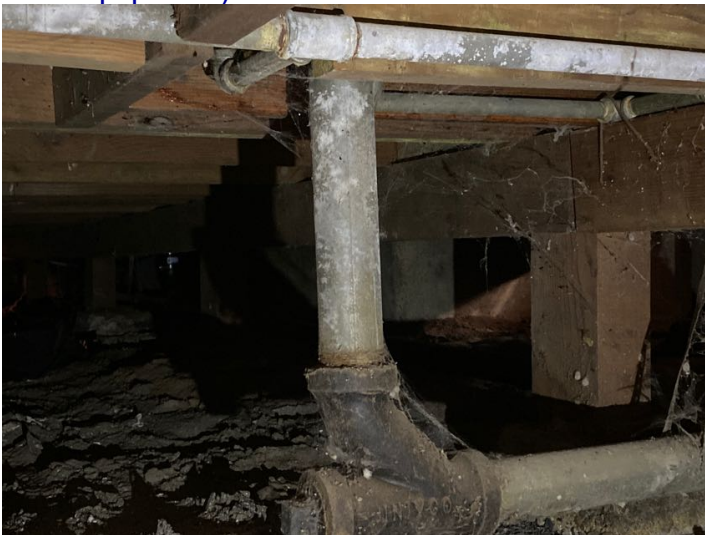
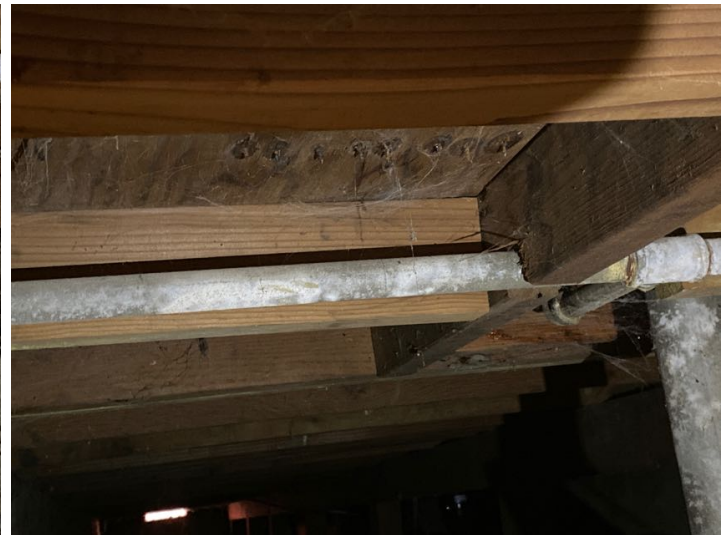
- Discoloration appeared to be a fungi growth due to past water standing in crawl area resulting in growth. We do not know type of fungi without lab tests. 1CallDone is a certified sampler extractor to send to lab for detailed results and recommendations if desired. (photos failed in equipment)

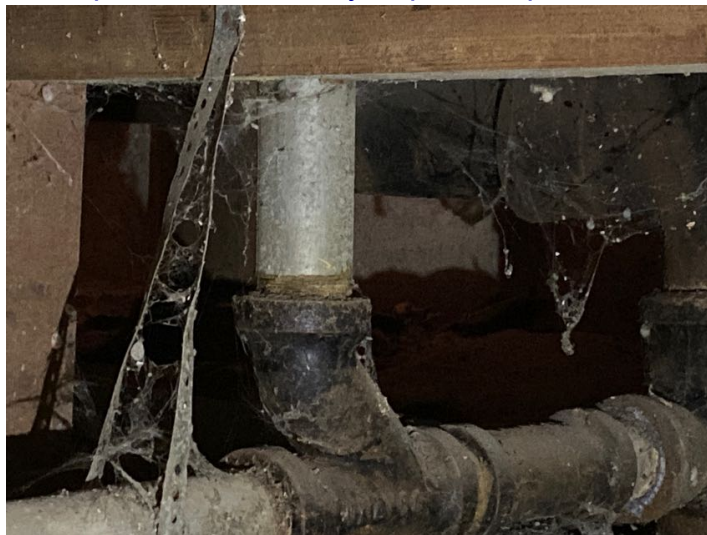
- Drain, waste and/or vent pipes visibly leaking in the crawlspace. Locations are under master bath, hall bathroom and past leakage resulting in damage in kitchen sink area. We suggest further investigation and repairs as needed by a qualified professional.

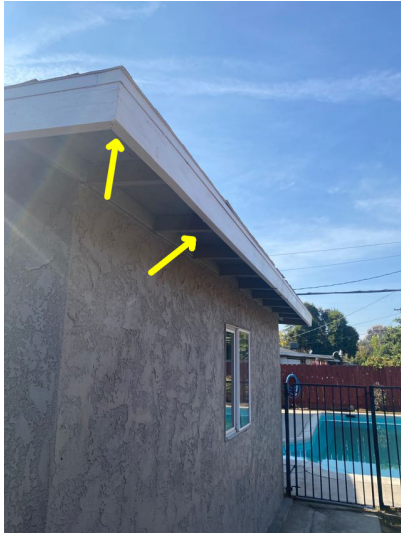
North East corner

- Fascia and sheathing showed moderate deterioration requiring repair or replacement at locations listed by pictures. See Hexpod report for further explanation. We suggest further investigation and repairs as needed.

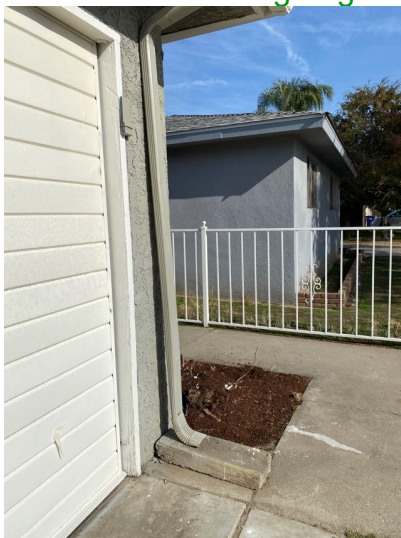
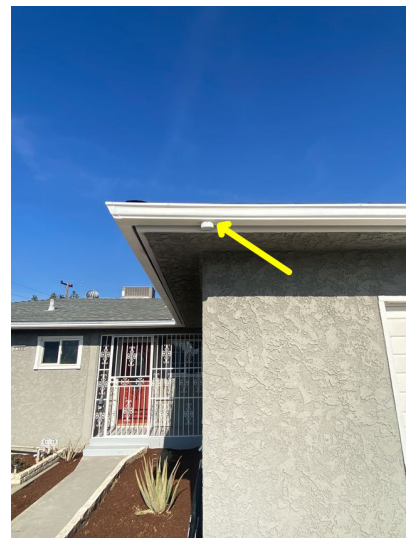
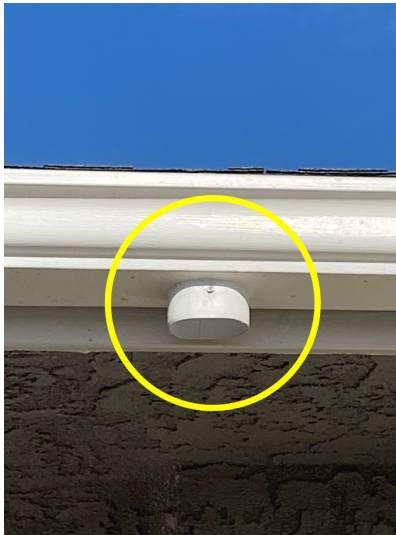
Southeast corner

- A downspout on south west corner of garage was missing at the time of the inspection. We suggest further investigation and repairs as needed by a qualified professional.
- Gutters on east area of garage vehicle door was loose from wall and should be refastened.

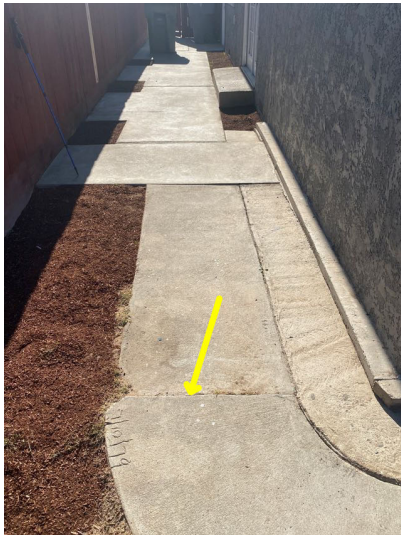
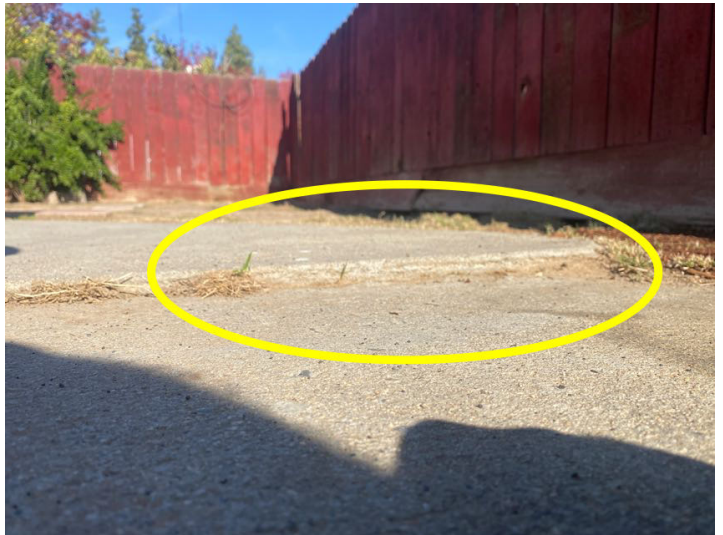
East walkway

- Settled areas and concrete walkway constitutes a trip hazard. We suggest further investigation and repairs needed by a qualified professional.

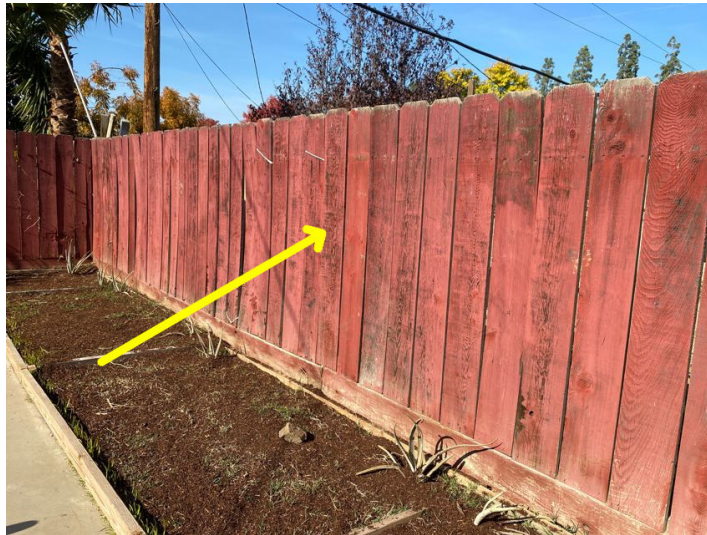
Northwest corner

- Some wood posts on the fence line examined during the inspection and listed by pictures were loose and needed maintenance or replacement.

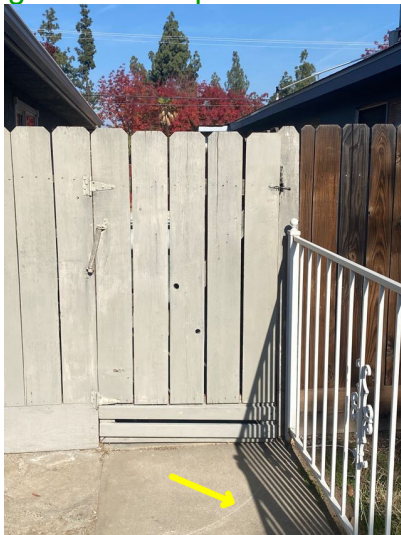
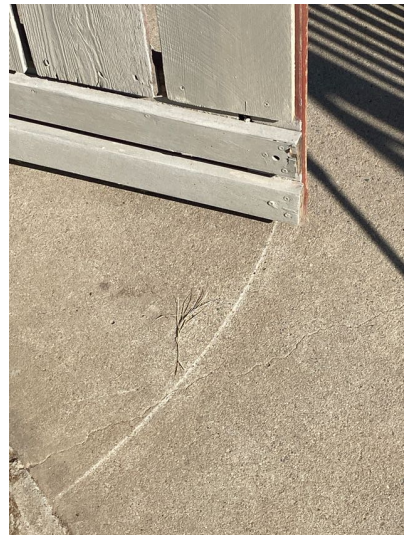
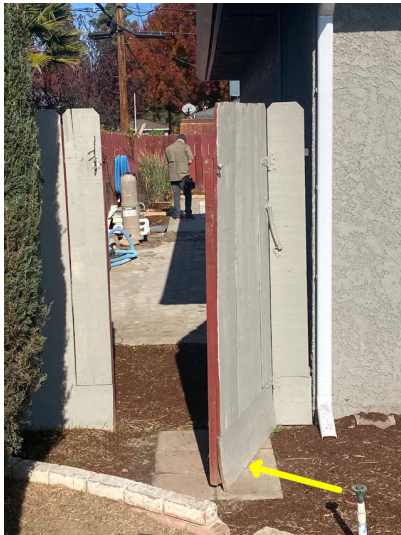
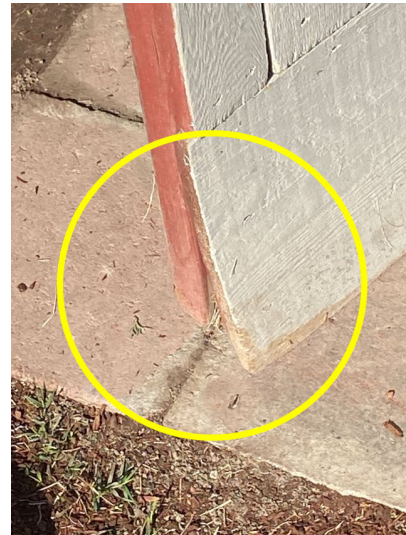
- Gates on east and west corner of property did not operate smoothly. Re-suggest further investigation and repairs as needed by a qualified professional.

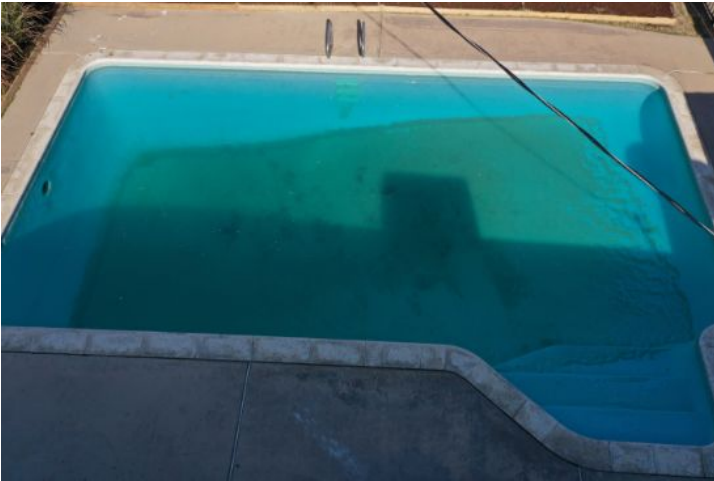
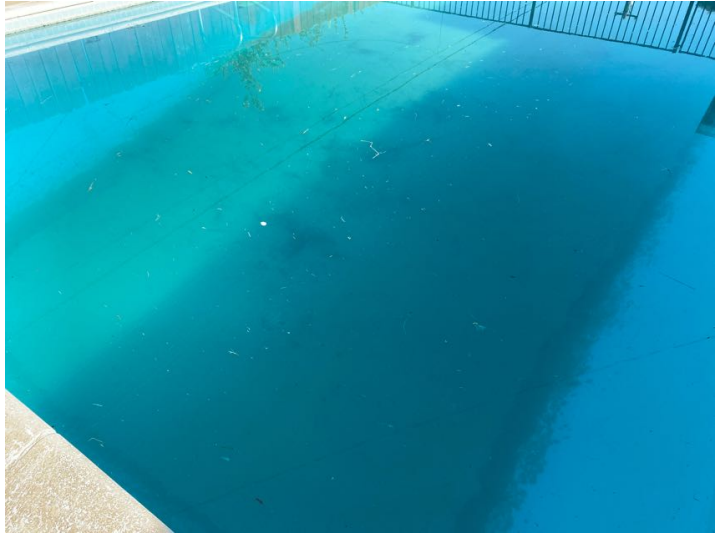
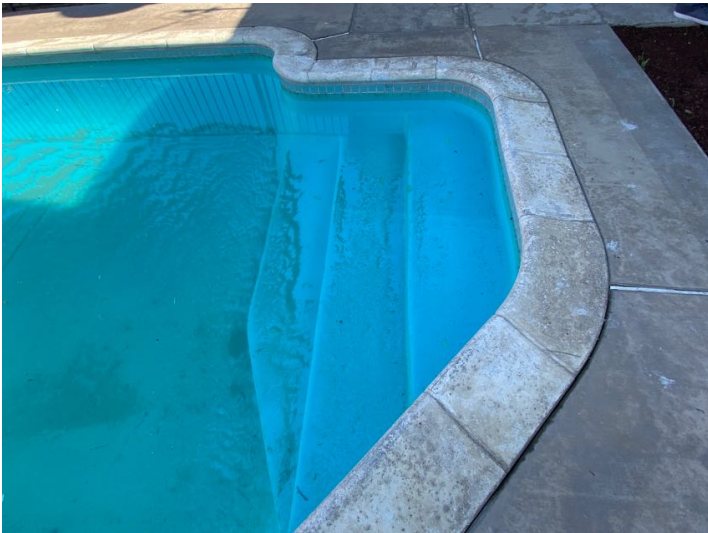
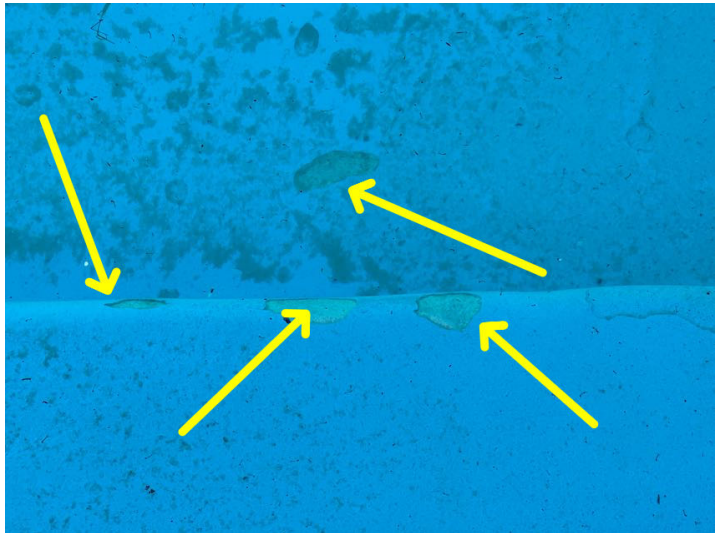
- Structure appeared to be in serviceable condition at time of inspection however, pool was extremely dirty and surface not fully visible. We suggest further observation after cleaning is complete.

- Chips in paint observed on steps, however, limited in other areas due to build up of Reserview, making it not visible. We suggest further investigation with repairs as needed by qualified professionals.

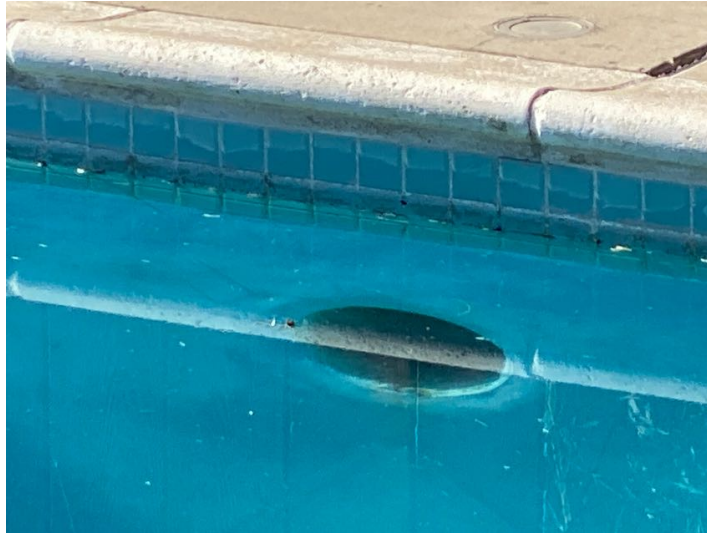
- Lights removed and did not operate at the time of inspection. We suggest consulting a qualified professional.

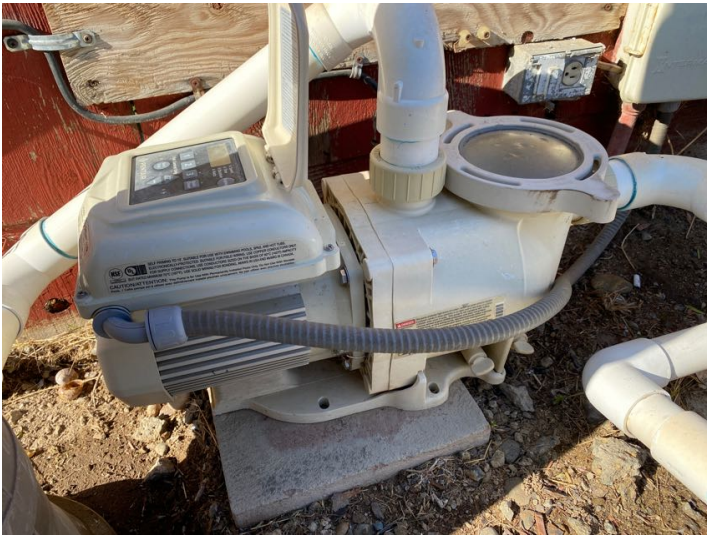
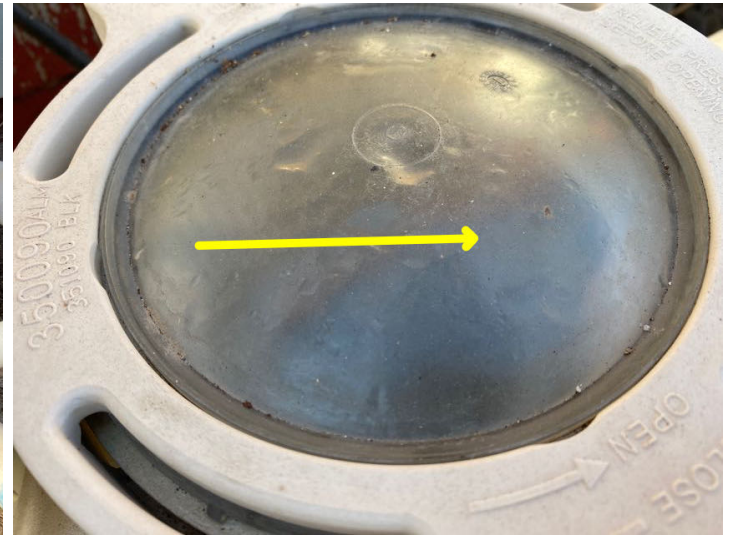
- When we arrived, the pump was on. As we approached the noisy operating pump, it appeared it was not fully priming water. Pool water appeared low. We turned unit off. We suggest further investigation with repairs as needed by a qualified professional.

Less than a quarter capacity of pipe

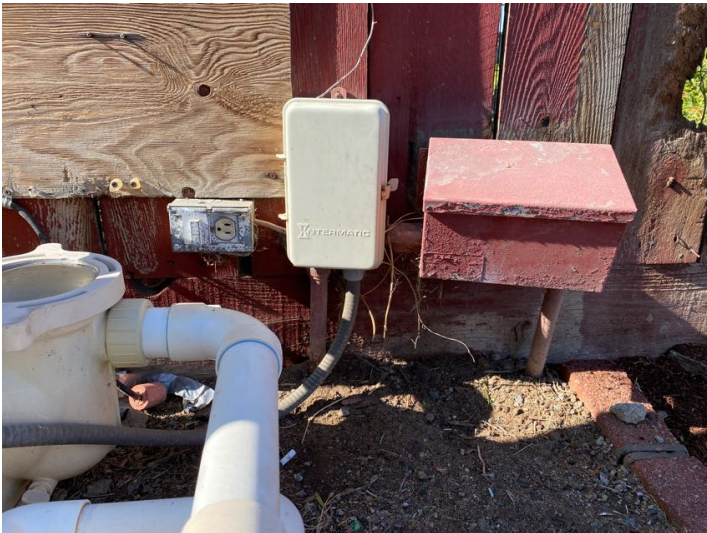
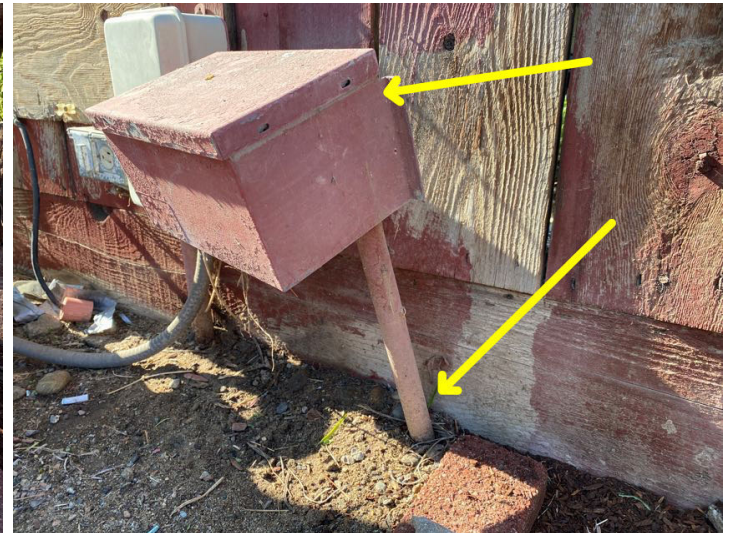
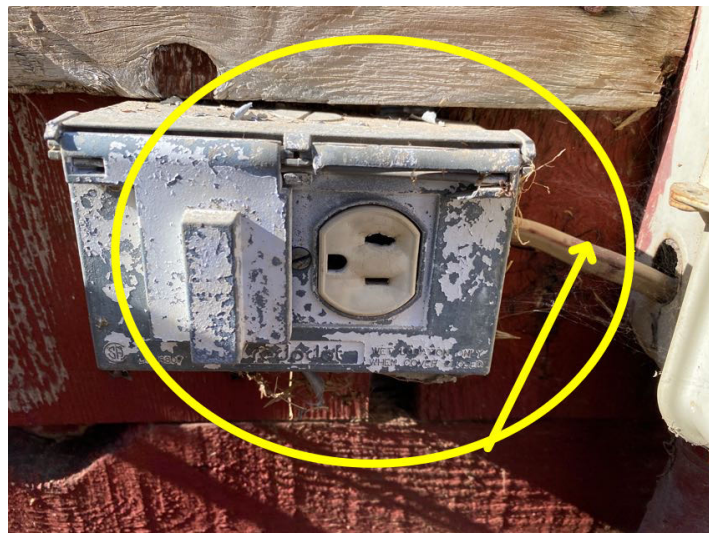
- Electrical system feeding pump area was in poor condition at time of inspection. Loose conduit and open to atmosphere cabling and broken weather resistant cover outlet to name a few. We suggest further investigation with repairs as nearby, qualified professional.

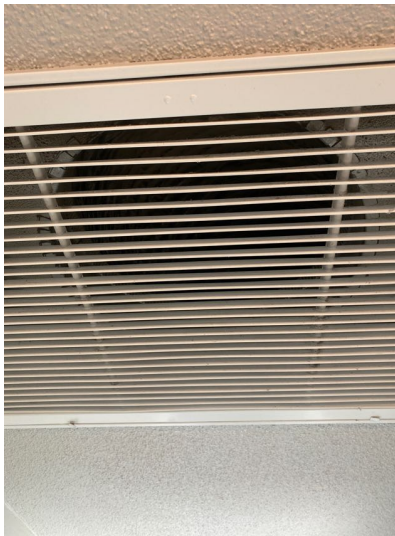
- The air filter was missing and in need of replacement at the time of the inspection. Air filters should be installed changed monthly while the air-conditioning system is in operation to keep efficiencies up and breakdowns minimized.
