Property Inspection Report

1234 W Midvalley Ave, Visalia, CA, 93277

Date of Inspection: 5/12/2022

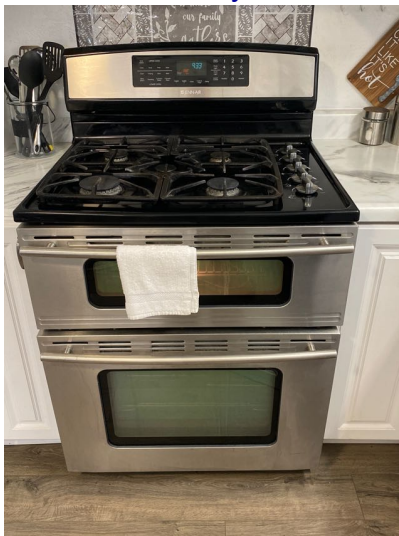
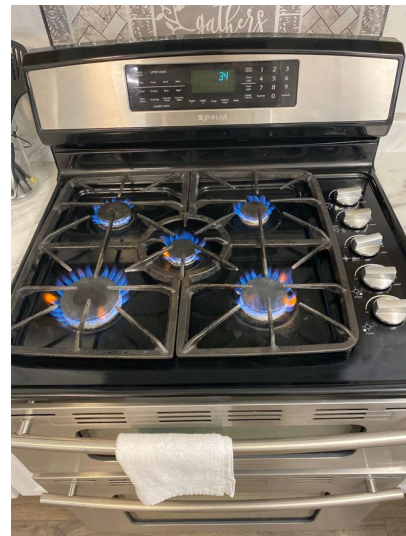
2. Cook Top, Range and Oven Condition

| Kitchen | | | |
|---|---|---|--|
| | Page 6 Item: 2 | Cook Top, Range and Oven Condition | <ul style="list-style-type: none"> • Anti-tip bracket installation is missing from range. See manual or label inside oven door for information. All free-standing, slide-in ranges installation should include an anti-tip device which is essential in the safe operation of the range. It provides protection when excess force or weight is applied to an open oven door. Brackets are carried by home building centers. |

- Anti-tip bracket installation is missing from range. See manual or label inside oven door for information.

All free-standing, slide-in ranges installation should include an anti-tip device which is essential in the safe operation of the range. It provides protection when excess force or weight is applied to an open oven door.

Brackets are carried by home building centers.

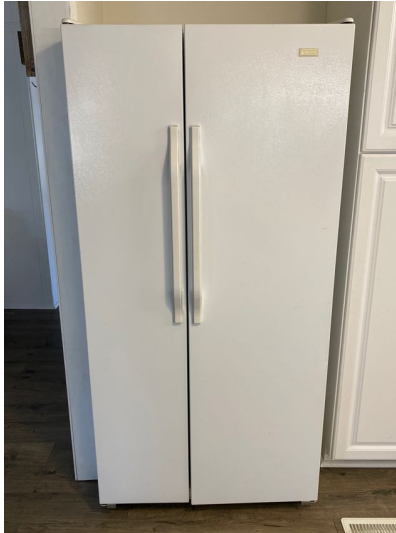
6. Refrigerator Condition

- Refrigerator was not plugged in at the time of inspection. We suggest further investigation and repairs as needed by a qualified professional.

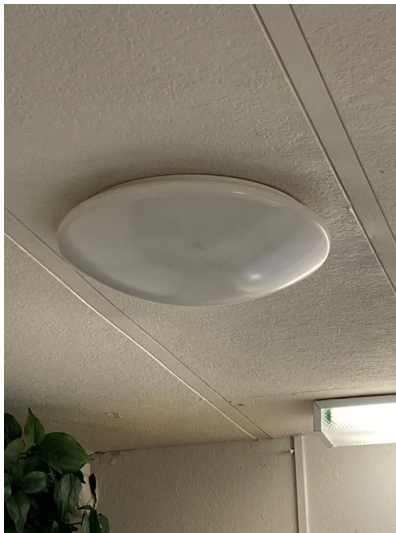
7. Light Fixture Condition

| Kitchen | | | |
|---|---|---|--|
| | Page 8 Item: 7 | Light Fixture Condition | <ul style="list-style-type: none"> • A ceiling light in this room did not operate at time of inspection. The bulb may need to be replaced or there may be a problem with the switch, wiring or light fixture. If after the bulb is replaced this light still fails to respond to the switch, this condition may represent a potential fire hazard and the Inspector recommends that an evaluation and any necessary repairs be performed by a qualified professional. |

- A ceiling light in this room did not operate at time of inspection . The bulb may need to be replaced or there may be a problem with the switch, wiring or light fixture. If after the bulb is replaced this light still fails to respond to the switch, this condition may represent a potential fire hazard and the Inspector recommends that an evaluation and any necessary repairs be performed by a qualified professional.

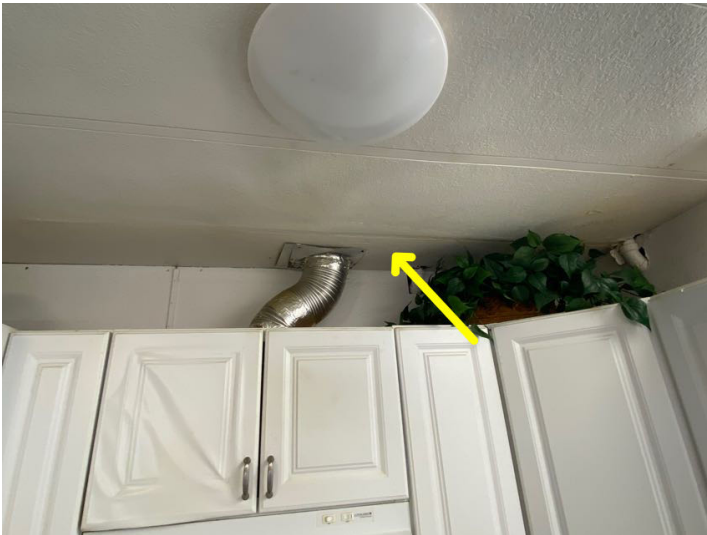
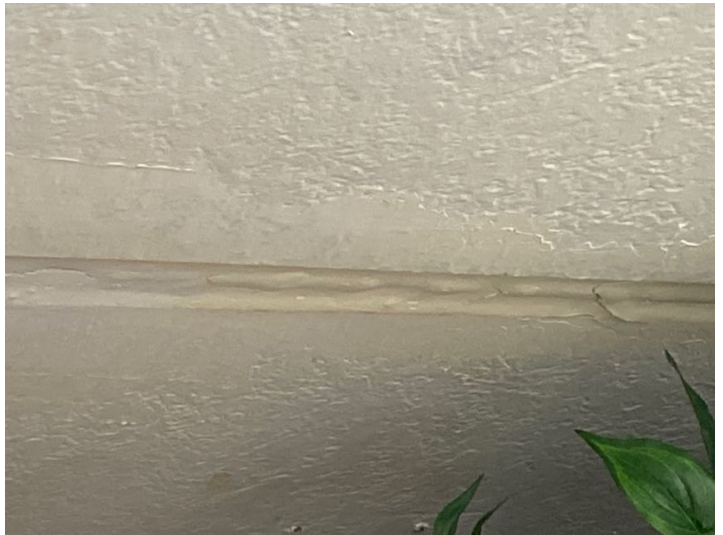
8. Ceiling Damage

- Patching in this room where a ceiling fixture had been removed was poorly executed and easily recognized.

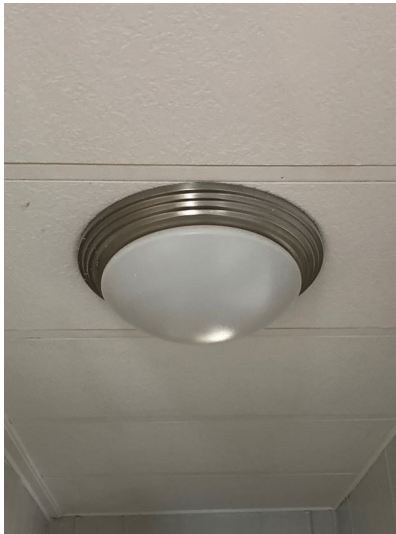
2. Light Fixture Condition

| Kitchen | | | |
|---|---|---|--|
| | Page 11 Item: 2 | Light Fixture Condition | <ul style="list-style-type: none"> • Ceiling light in this area did not respond to the switch. The bulb may need to be replaced or there may be a problem with the switch, wiring or light fixture. If after the bulb is replaced this light still fails to respond to the switch, this condition may represent a potential fire hazard and the Inspector recommends that an evaluation and any necessary repairs be performed by a qualified professional. |

- Ceiling light in this area did not respond to the switch. The bulb may need to be replaced or there may be a problem with the switch, wiring or light fixture. If after the bulb is replaced this light still fails to respond to the switch, this condition may represent a potential fire hazard and the Inspector recommends that an evaluation and any necessary repairs be performed by a qualified professional.

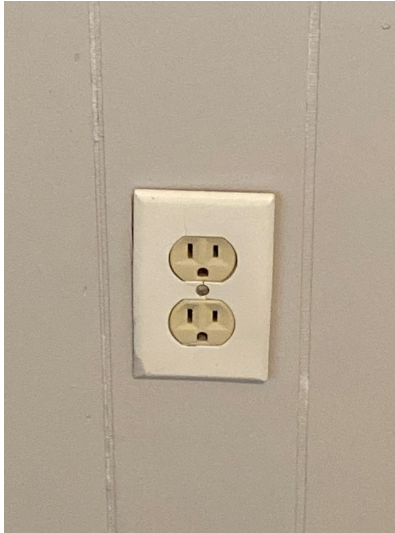
North wall

| Kitchen | | | |
|---|---|---|--|
| | Page 12 Item: 3 | Outlet Condition | <ul style="list-style-type: none"> • Loose outlet on the north wall in this room when tested turn off ceiling fan light. We suggest further investigation and repairs as needed by a qualified professional. |

- Loose outlet on the north wall in this room when tested turn off ceiling fan light. We suggest further investigation and repairs as needed by a qualified professional.

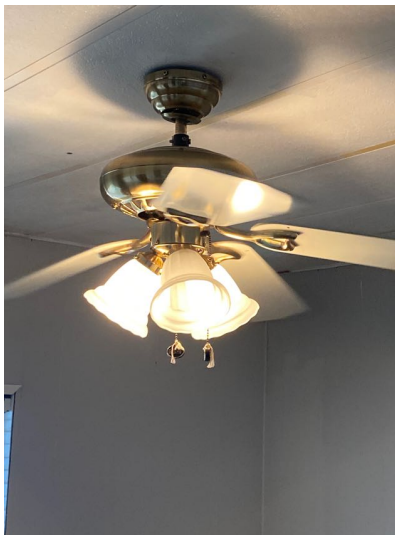
4. Ceiling Fan Condition

| Kitchen | | | |
|---|---|---|--|
| | Page 12 Item: 4 | Ceiling Fan Condition | <ul style="list-style-type: none"> • A ceiling fan in this area wobbled during operation and appeared to be out of balance. This condition may eventually cause the fan to come loose from its mounting device and fall. The inspector recommends correction. |

- A ceiling fan in this area wobbled during operation and appeared to be out of balance. This condition may eventually cause the fan to come loose from its mounting device and fall. The inspector recommends correction.

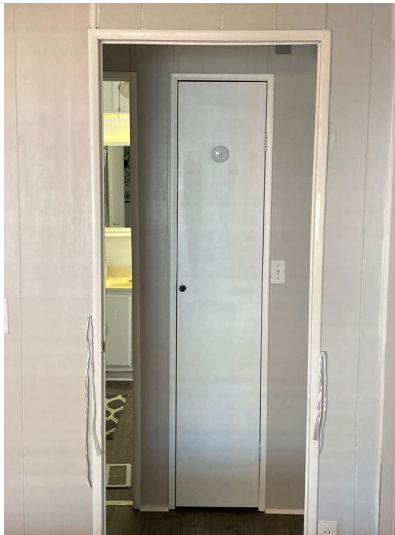
5. Interior Door Condition

- Interior door missing at the time of inspection. We suggest further investigation and repairs as needed by a qualified professional.

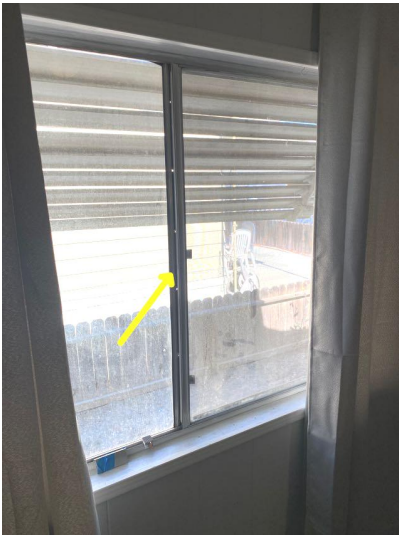
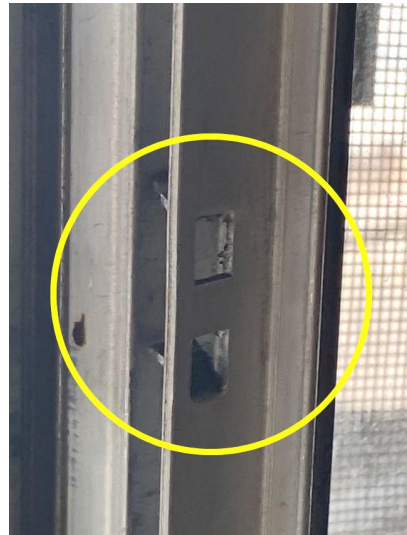
3. Window Condition

- Window latch broken

A window latch missing. The bedroom had inoperable hardware. We suggest further investigation and repairs as needed by a qualified professional.

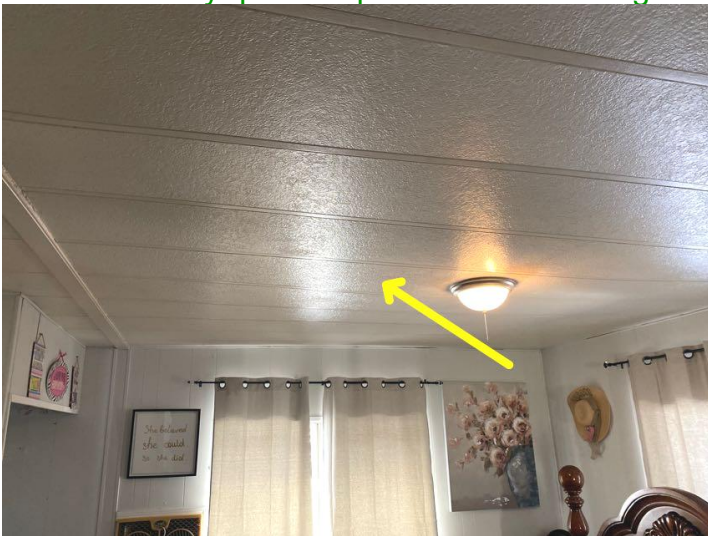
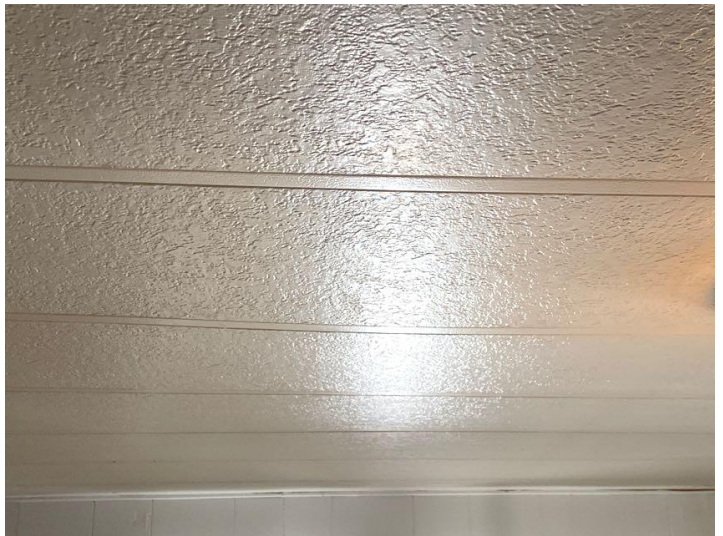
4. Ceiling Damage

- Ceiling is sagging in this room. We suggest monitoring with further investigation and repairs as needed by qualified professional if changes occur.

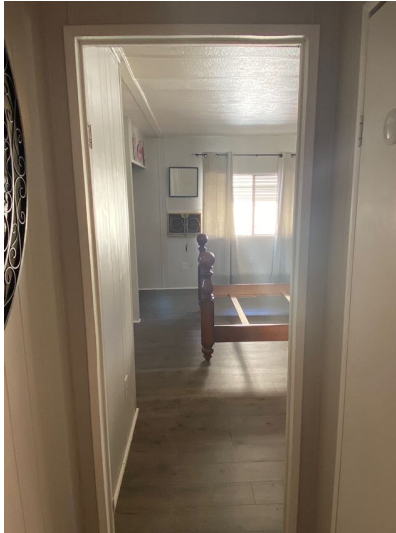
5. Interior Door Condition

- Door missing in this room at the time of inspection. We suggest further investigation and repairs as needed by a qualified professional.

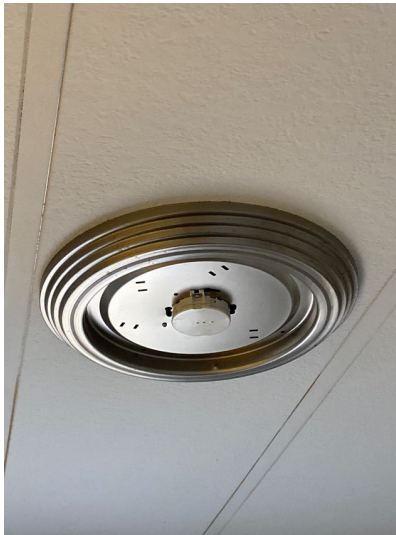
4. Light Fixture Condition

| Kitchen | | | |
|---|---|---|--|
| | Page 15 Item: 4 | Light Fixture Condition | <ul style="list-style-type: none"> • A ceiling light in this did not respond to the switch. The bulb may need to be replaced or there may be a problem with the switch, wiring or light fixture. If after the bulb is replaced this light still fails to respond to the switch, this condition may represent a potential fire hazard and the Inspector recommends that an evaluation and any necessary repairs be performed by a qualified professional. |

- A ceiling light in this did not respond to the switch. The bulb may need to be replaced or there may be a problem with the switch, wiring or light fixture. If after the bulb is replaced this light still fails to respond to the switch, this condition may represent a potential fire hazard and the Inspector recommends that an evaluation and any necessary repairs be performed by a qualified professional.

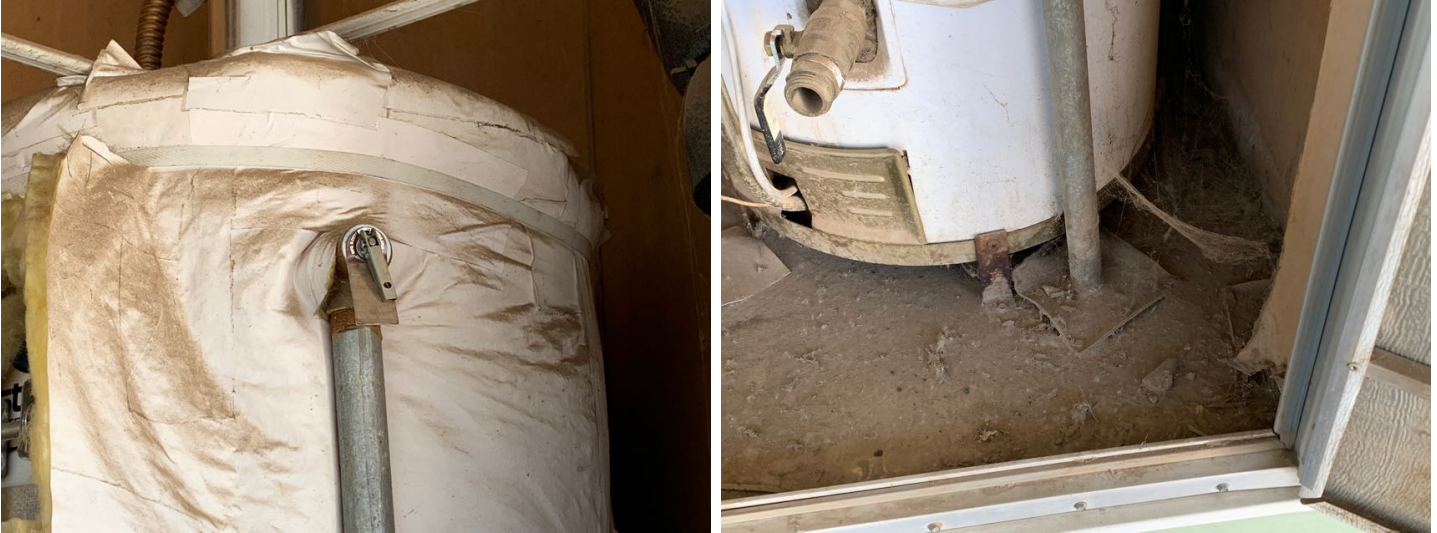
3. TPRV

- The water heater is equipped with a Temperature Pressure Relief Valve (TPRV).
- The termination point of the discharge pipe for the water heater pressure relief valve was not readily observable. The termination should be visible to help ensure that the termination is not discharging and never capped. The termination of the pipe should be an unthreaded end and visible. The 3/4" pipe should route any discharge to an air break on the floor or the home exterior so if the TPRV were to open it would be visible. The Inspector recommends correction by a qualified professional.

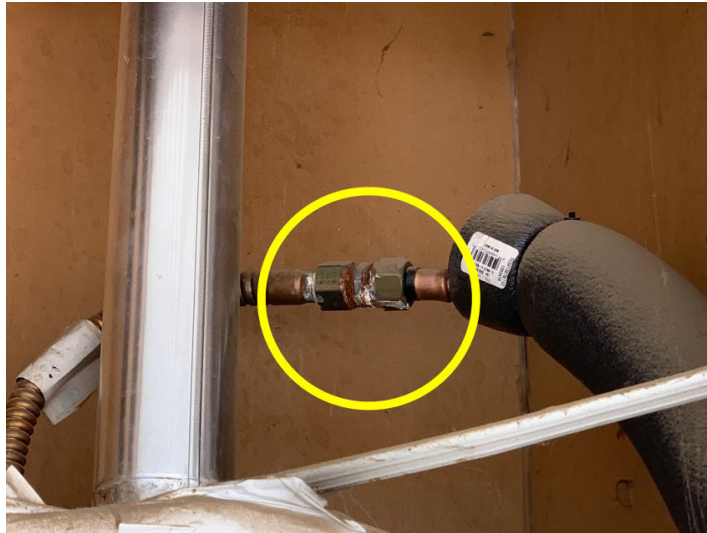
4. Plumbing

- Minor leaks over time, compounded by mixing dissimilar metals without using dielectric couplings between metals. We suggest further investigation and repairs as needed by a qualified professional.

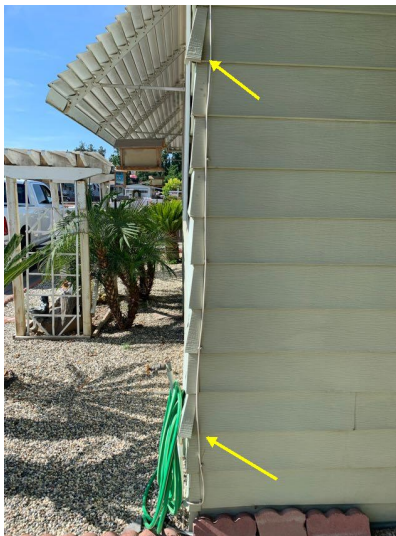
1. Siding Condition

- Corner siding pieces were loose and require reattachment. We suggest further investigation and repairs as needed by a qualified professional.

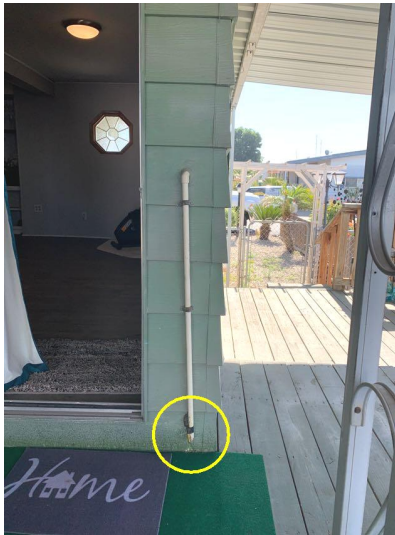
2. Exterior Electrical

| Carbon Monoxide Detector | | | |
|---|---|---|--|
| | Page 21 Item: 2 | Exterior Electrical | <ul style="list-style-type: none"> Unprofessional wiring noted on back patio area. Power was taken from inside light switch and ran through improper conduit. Wiring was capped off at bottom of conduit. We suggest further investigation repairs as needed by a qualified professional. |

- Unprofessional wiring noted on back patio area. Power was taken from inside light switch and ran through improper conduit. Wiring was capped off at bottom of conduit. We suggest further investigation repairs as needed by a qualified professional.

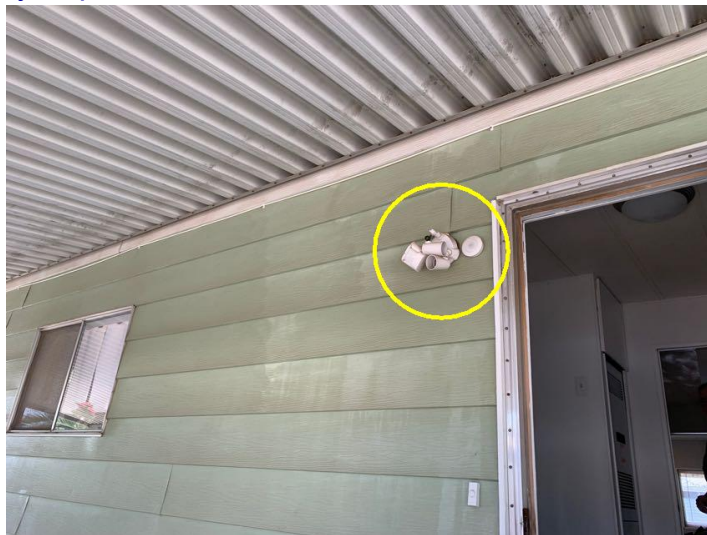
Back entrance door

| Carbon Monoxide Detector | | | |
|---|---|---|--|
| | Page 22 Item: 3 | Lighting | <ul style="list-style-type: none"> Exterior light on locations listed by pictures did not operate. This condition can be caused by daylight sensors, burned out or missing bulbs. You should re-test any inoperable light fixtures after replacing the bulbs. If after bulb replacement the lights still fail to respond to the switch, consider evaluation by a qualified electrician. |

- Exterior light on locations listed by pictures did not operate. This condition can be caused by daylight sensors, burned out or missing bulbs. You should re-test any inoperable light fixtures after replacing the bulbs. If after bulb replacement the lights still fail to respond to the switch, consider evaluation by a qualified electrician.

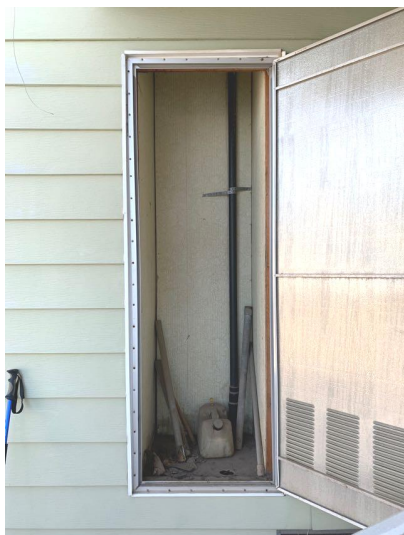
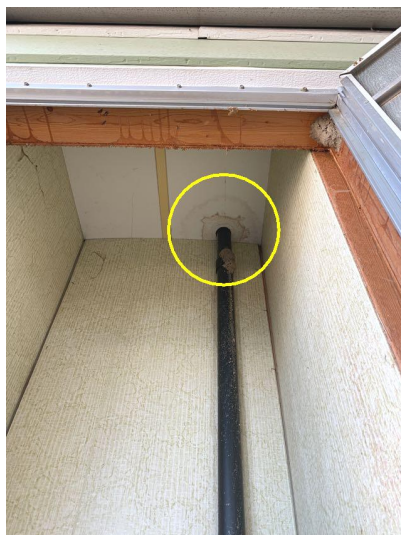
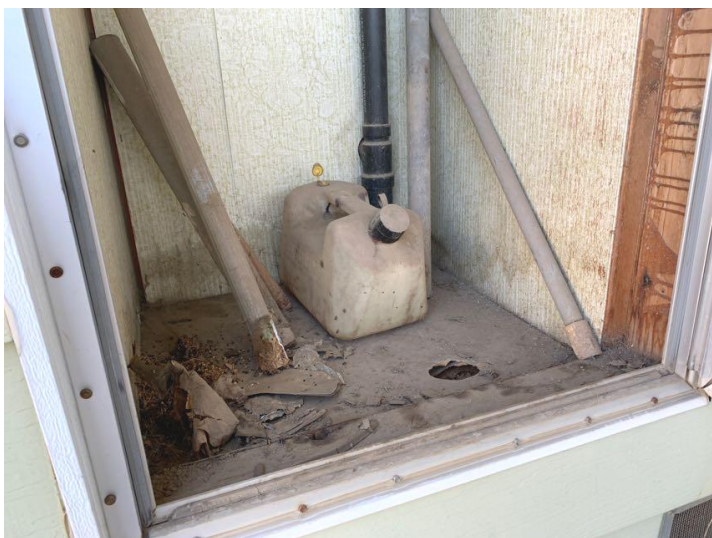
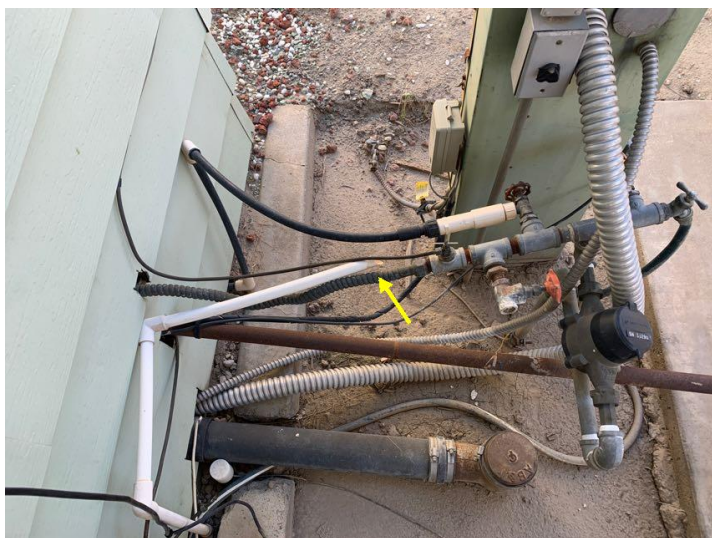
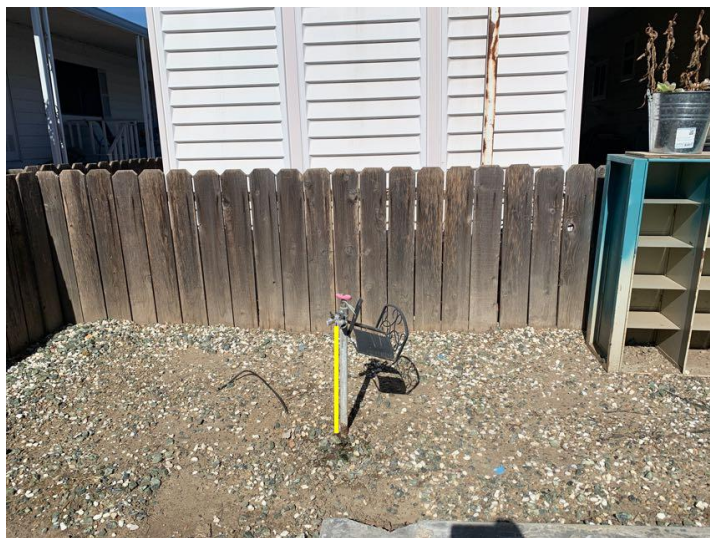
4. Plumbing Observations

- Plumbing utility closet on south side of structure has damaged floor and water staining on lower walls. Staining was also noted around sanitary drain vent going through ceiling. This condition may have been caused by past roof leakage. New roof has been installed.
- Disconnected/broken **PVC** line noted leading from plumbing takeoff.
- Faucet stand pipe at South west corner of yard should be reinforced with a post to prevent damage to piping.

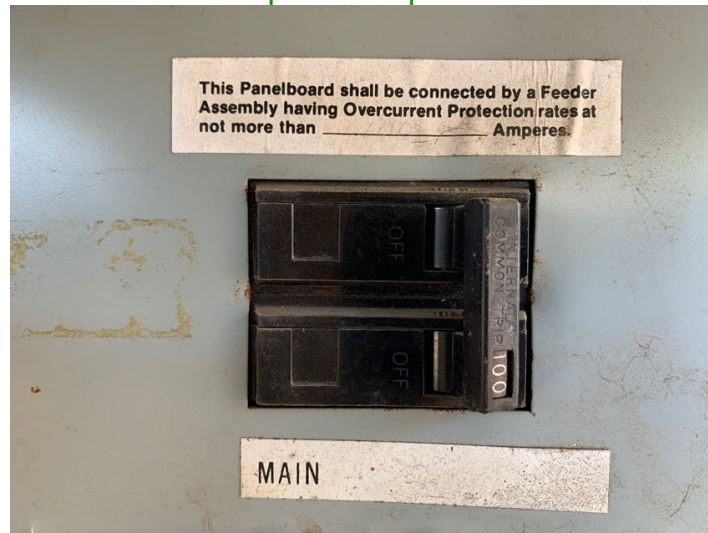
2. Main Amp Breaker

- The manufacturer's label was missing from the main electrical service panel. The manufacturer's label typically provides information describing the main panel such as the name of the panel manufacturer, the panel model number, the panel amperage rating, limitations related to the environment in which the panel was designed to be installed and grounding/bonding information for that particular panel.

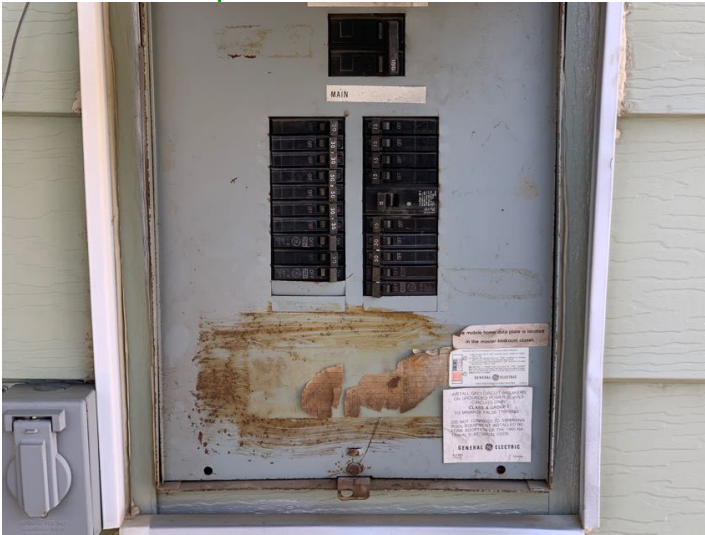
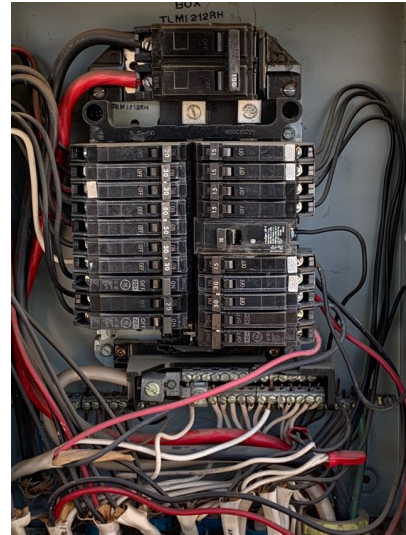
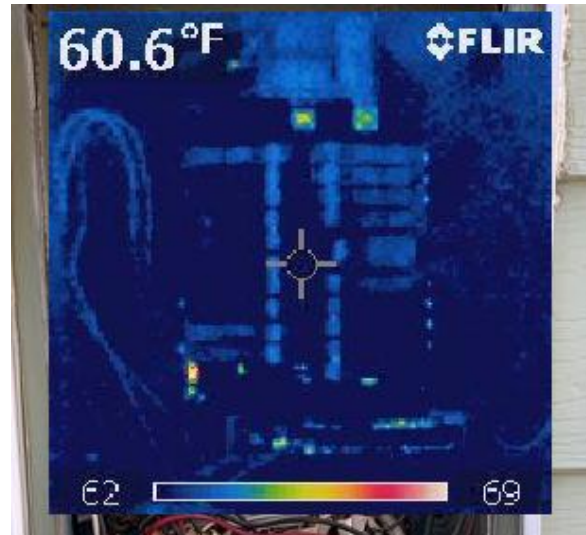
3. Breakers

- The label to identify individual circuits at the main electrical service panel was not fully present. The service panel should contain a clearly marked label identifying individual circuits so that in an emergency, individual circuits can be quickly shut off. The Inspector recommends that a circuit label be installed.

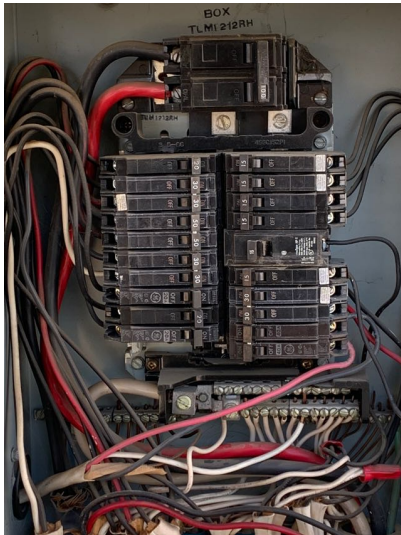
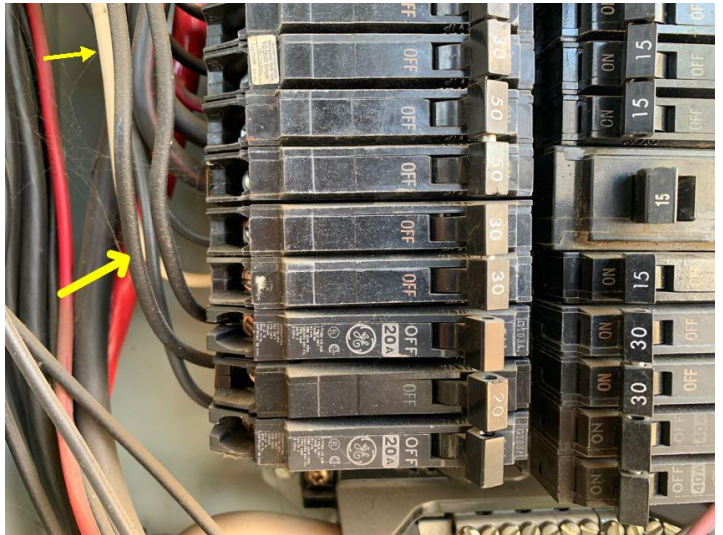
4. Branch Wiring

- All branch wiring appeared to be in serviceable condition at time of inspection.
- Fourth breaker up on the right displayed at a white wire connected. White wires are used as a neutral circuit, not landed on the hot side as installed. We suggest properly marking this wire to avoid confusion in the future.

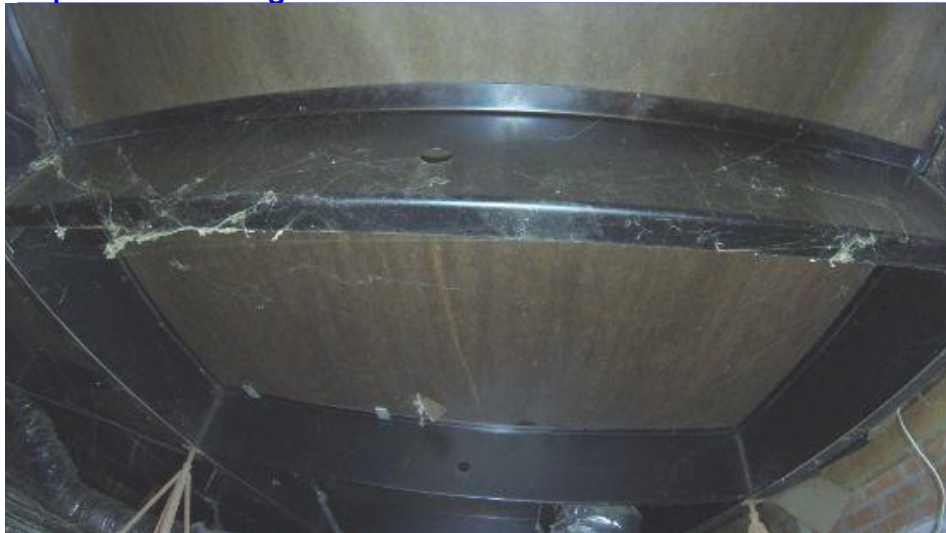
3. Insulation

- No insulation was installed in the crawlspace. The best approach to insulating crawlspaces has recently been the subject of controversy. It is generally agreed that an insulation design which works well in one climate may perform poorly in another. The Inspector recommends that the crawlspace be insulated according to recommendations for the climate zone in which the home is located.

An excellent source for this type of information is the website of the Building Science Corporation: <http://www.buildingscience.com/search?SearchableText=climate+zones>

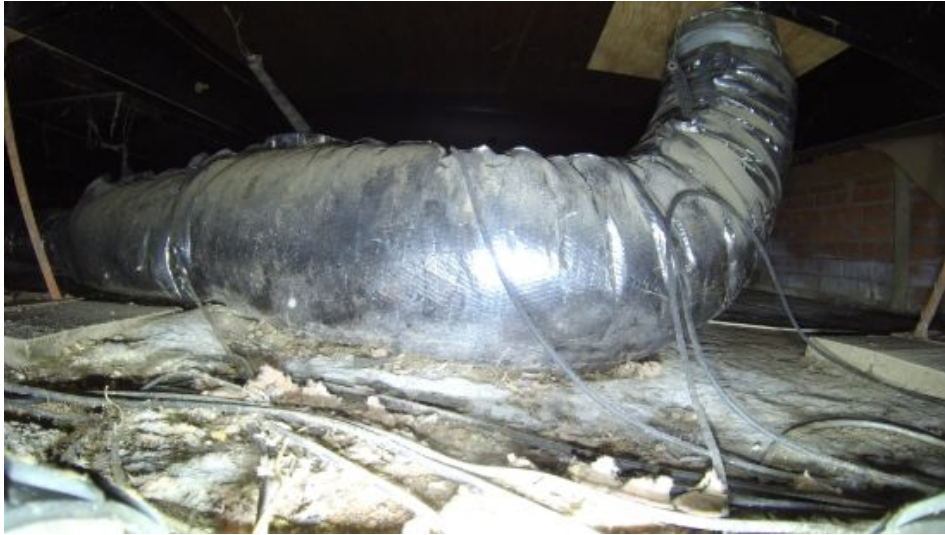
4. Ducting

| Carbon Monoxide Detector | | | |
|---|---|---|--|
| | Page 27 Item: 4 | Ducting | <ul style="list-style-type: none"> Ducts were not properly supported at the time of the inspection. We suggest further investigation and repairs as needed. |

- Ducts were not properly supported at the time of the inspection. We suggest further investigation and repairs as needed.

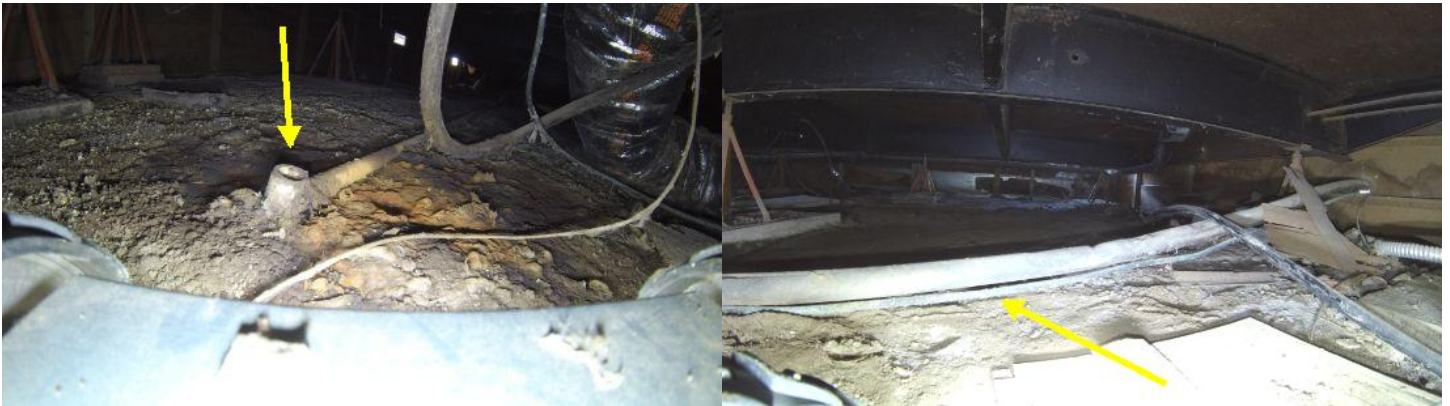
5. Foundation Plumbing

| Carbon Monoxide Detector | | | |
|---|---|---|--|
| | Page 28 Item: 5 | Foundation Plumbing | <ul style="list-style-type: none"> Leaking water pipe was visible in the crawlspace at the time of the inspection. We suggest further investigation and repairs as needed. Poorly supported pipes for A/C visible in the crawlspace were poorly supported. This condition should be corrected to avoid possible future leakage. |

- Leaking water pipe was visible in the crawlspace at the time of the inspection. We suggest further investigation and repairs as needed.
- Poorly supported pipes for A/C visible in the crawlspace were poorly supported. This condition should be corrected to avoid possible future leakage.

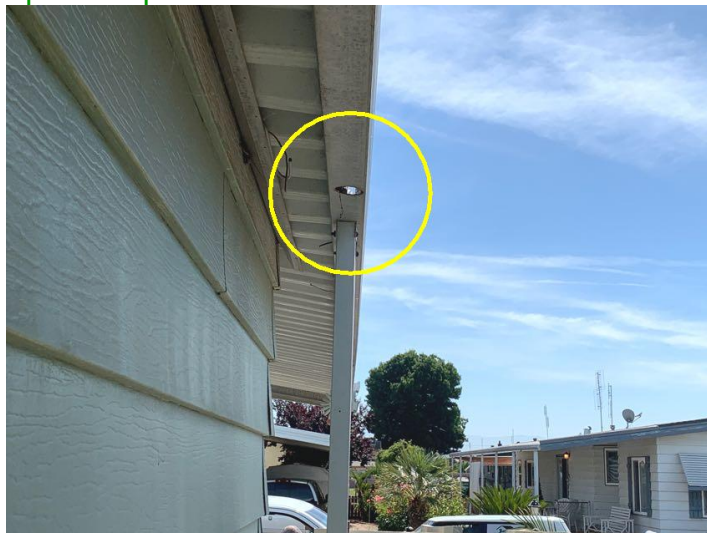
2. Gutter

- A downspout on south side of structure was missing at the time of the inspection. This condition may cause problems by introducing excessive amounts of moisture to the soil beneath the foundation. Excessive moisture near the foundation can result in structural failure due to foundation movement or moisture intrusion with the potential to cause structural damage from decay. Moisture intrusion can also cause the development of unhealthy conditions in indoor air related to microbial growth such as mold fungi. The Inspector recommends replacement of any missing downspouts to help protect the home structure and occupants. We suggest consulting a qualified professional.

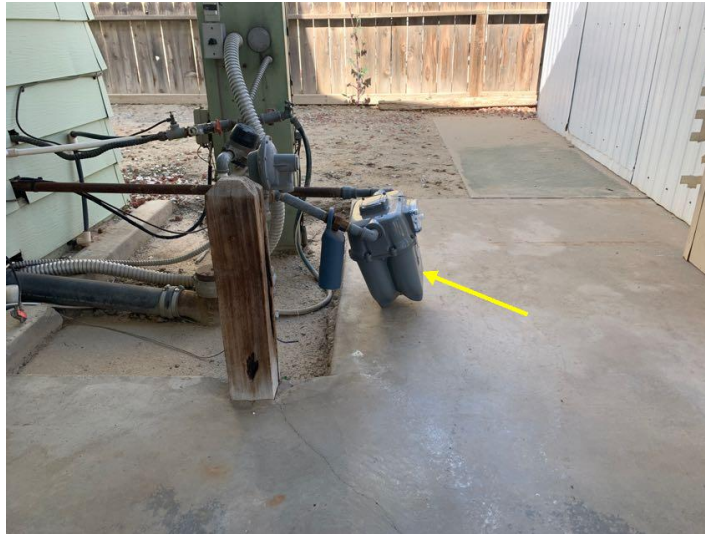
1. Walkway Condition

| Carbon Monoxide Detector | | | |
|---|---|---|--|
| | Page 30 Item: 1 | Walkway Condition | <ul style="list-style-type: none"> Gas meter is situated on walkway area and constitutes a trip hazard. It should be repiped to clear walkway area. We suggest further investigation and repairs as needed by a qualified professional. |

- Gas meter is situated on walkway area and constitutes a trip hazard. It should be repiped to clear walkway area. We suggest further investigation and repairs as needed by a qualified professional.

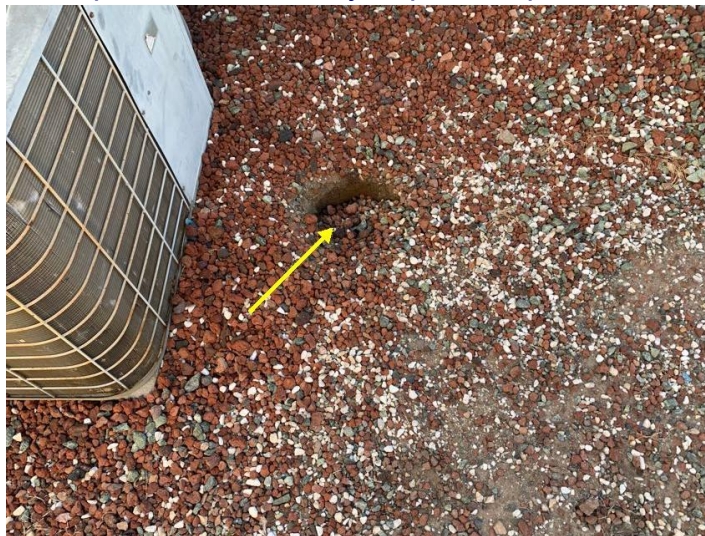
2. Plumbing

| Carbon Monoxide Detector | | | |
|---|---|---|--|
| | Page 30 Item: 2 | Plumbing | <ul style="list-style-type: none"> Sinkhole noted on south side of air conditioning condensing unit. This may be due to leaking underground piping going to hose bib stand pipe in south west corner of yard. We suggest further investigation and repairs as needed by a qualified professional. |

- Sinkhole noted on south side of air conditioning condensing unit. This may be due to leaking underground piping going to hose bib stand pipe in south west corner of yard. We suggest further investigation and repairs as needed by a qualified professional.

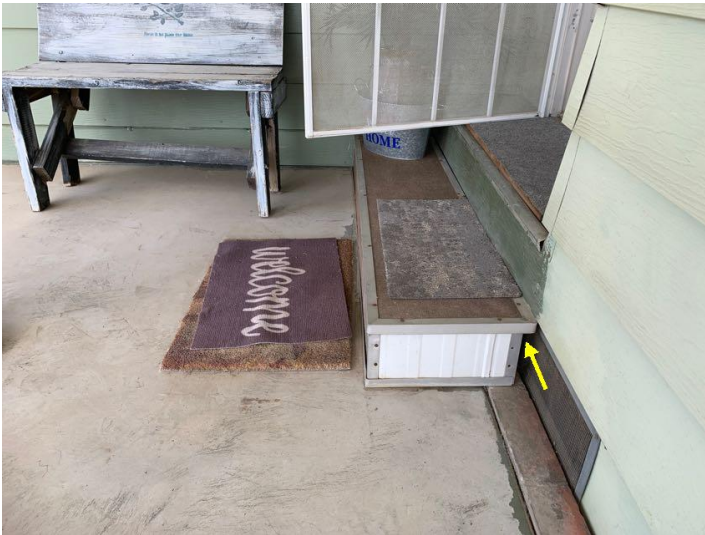
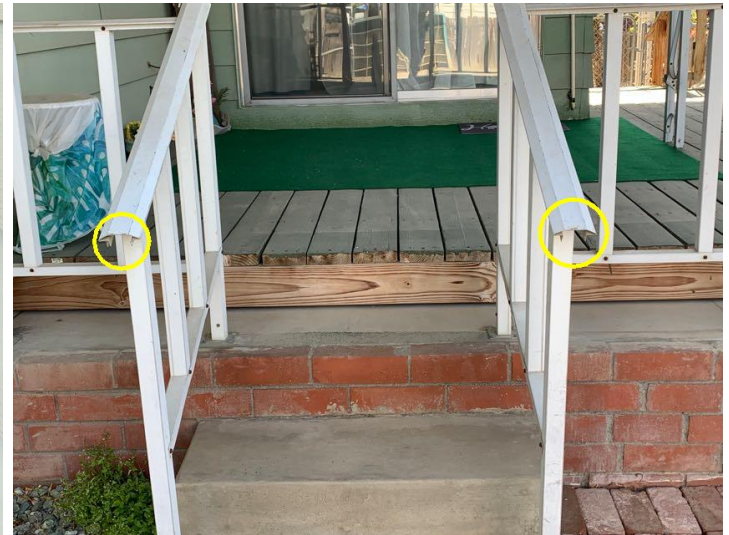
Front porch

| Carbon Monoxide Detector | | | |
|---|---|---|--|
| | Page 30 Item: 3 | Stairs & Handrail Condition | <ul style="list-style-type: none"> Sharp edges noted on front patio aluminum stair railings. We suggest caps be installed to prevent injury. Back entrance step was loose. We suggest further investigation and repairs as needed by a qualified professional. |

- Front patio step is not attached to structure.
- Sharp edges noted on front patio aluminum stair railings. We suggest caps be installed to prevent injury.
- Back entrance step was loose. We suggest further investigation and repairs as needed by a qualified professional.

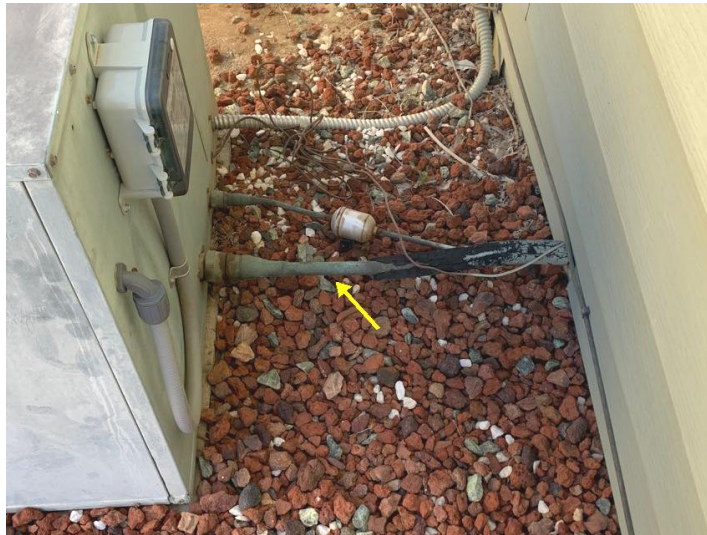
3. AC Refrigerant Lines Condotion

Insulation on the air-conditioning suction (large, insulated) line was damaged or missing at areas and should be replaced to ensure system efficiency.

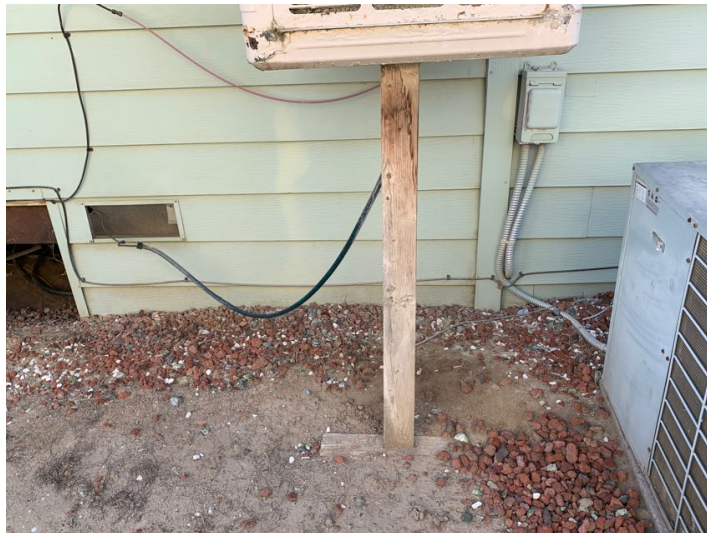
4. Swamp Cooler Condition

| Carbon Monoxide Detector | | | |
|---|---|---|--|
| | Page 33 Item: 4 | Swamp Cooler Condition | <ul style="list-style-type: none"> Wooden post holding swamp cooler chassis is inadequate for proper support. We suggest further investigation and repairs as needed by a qualified professional. |

- Testing of Swamp coolers is not usually done at time of inspection due to system not being set up for proper operation.
- Wooden post holding swamp cooler chassis is inadequate for proper support. We suggest further investigation and repairs as needed by a qualified professional.
