1CallDone Property Inspection Report

A fine street, Tulare, CA 93274 Inspection prepared for: Best Client Real Estate Agent: -

Date of Inspection: 8/16/2019 Time: 12:30 PM Age of Home: 1989 Size: 1624 Weather: Clear

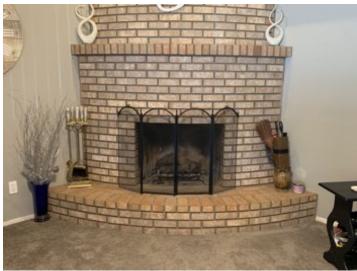
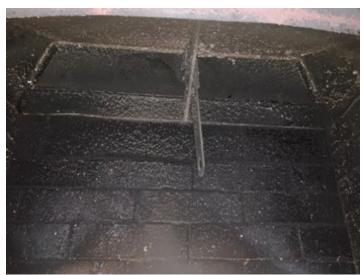
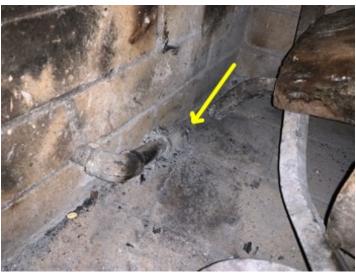
3. Fireplace Condition

- Soot was visible on the exterior of the wood-burning fireplace above the firebox. This condition indicates a possible combustion problem. The Inspector recommends further evaluation and repairs as needed.
- Gas line used to light logs was missing and fittings end was open to the atmosphere. This is a dangerous condition that should be corrected.

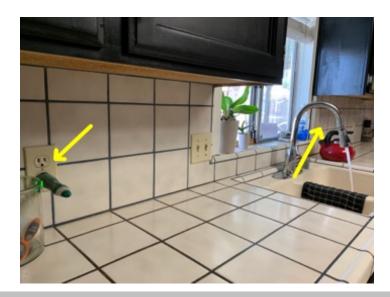
6. GFI Outlet Condition

• No Ground Fault Interrupter (GF) protection was provided for the outlet around sink. Any outlets located within 6 feet of a plumbing fixture must be GF protected. We suggest consulting a qualified electrician.

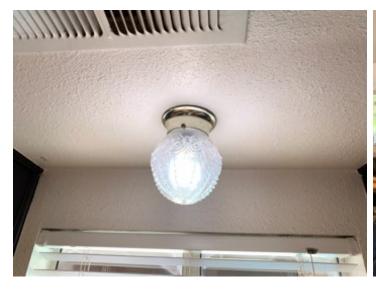
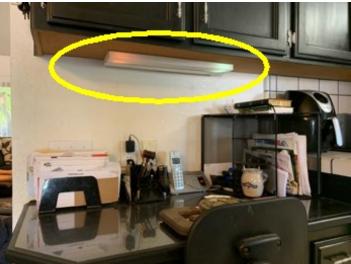
7. Light Fixture Condition

- A ceiling light above sink did not fully operate at time of inspection. The bulb may need to be replaced or there may be a problem with the switch, wiring or light fixture. If after the bulb is replaced this light still fails to respond to the switch, this condition may represent a potential fire hazard and the Inspector recommends that an evaluation and any necessary repairs be performed by a qualified electrician.
- A light near desk area did not fully respond to the switch. The bulb may need to be replaced or there may be a problem with the switch, wiring or light fixture. If after the bulb is replaced this light still fails to respond to the switch, this condition may represent a potential fire hazard and the Inspector recommends that an evaluation and any necessary repairs be performed by a qualified electrician.

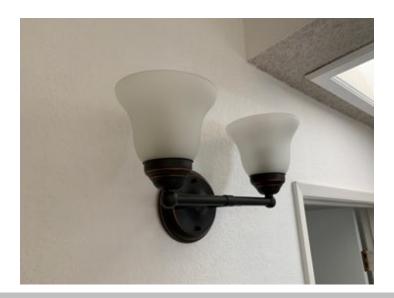
1. Light Fixture Condition

• A wall light in this area did not respond to the switch. The bulb may need to be replaced or there may be a problem with the switch, wiring or light fixture. If after the bulb is replaced this light still fails to respond to the switch, this condition may represent a potential fire hazard and the Inspector recommends that an evaluation and any necessary repairs be performed by a qualified electrician.

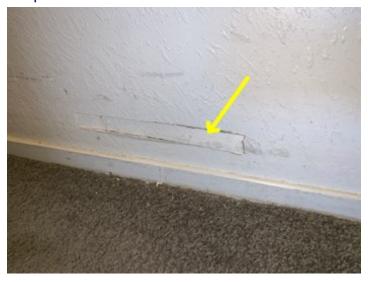
2. Wall Condition

• And opening was cut in the lower section of the north hallway. We suggest further investigation and repairs as needed

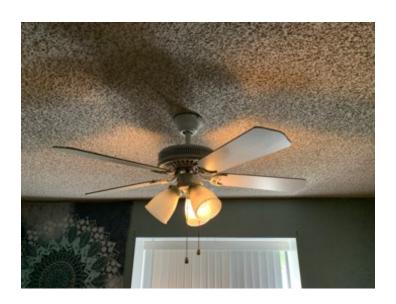
4. Ceiling Fan Condition

• A ceiling fan in this area was inoperable. The Inspector recommends an evaluation and any necessary work be performed.

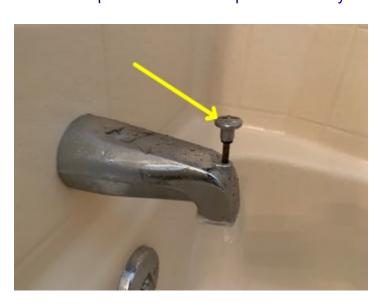
5. Shower Condition

• The diverter valve was inoperable or did not operate correctly. We suggest correction.

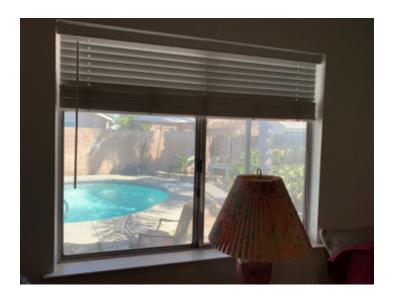
• A window in this bedroom was difficult to operate. We suggest further investigation and repairs as needed.

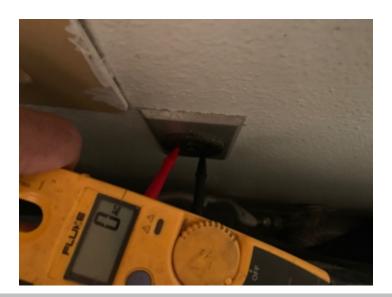
• 220 Volt outlet present however no voltage was supplied at the time of inspection. We suggest further investigation and repairs as needed.

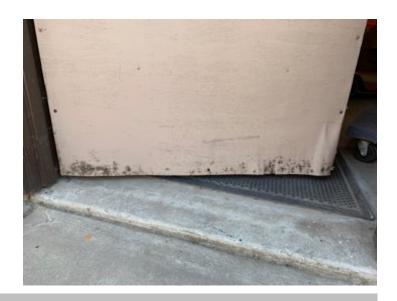
2. Exterior Door

• Lower section of door has been previously patched and is currently weak at the base. We suggest further investigation and repairs as needed.

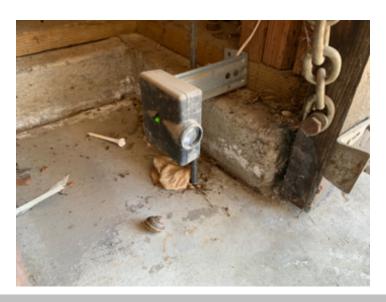
5. Garage Door Reverse Status

- Eye beam system present and operated well for sale opener at time of inspection.
- Eye beam system was not operational on North garage door opener at the time of the time inspection. We suggest repairing and re-testing.

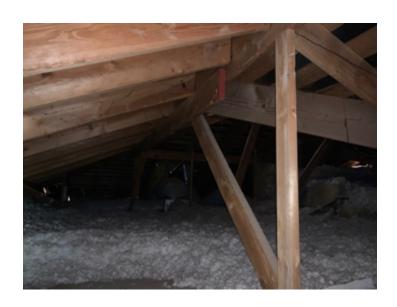
6. Firewall

• Large hole cut into <u>lirewal</u> for ladder to access the attic. This lowers the amount of time that the structure would delay the fire entrance into the house. Screwing drywall or metal onto a pulldown ladder's cover does not provide an air-tight fire barrier as required by modern building standards. The issue becomes moot if a fire-rated assembly (a <u>lirewal</u>) exists between the garage attic and the home's main attic or living space, which there is not. We suggest consulting a qualified professional.

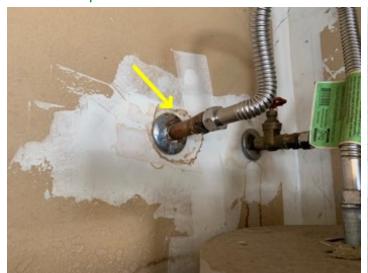
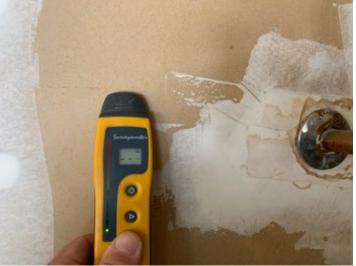
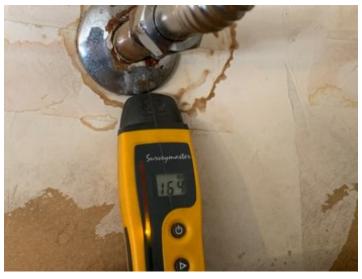
4. Plumbing

• Outfeed hot water line had moisture stains where entering the wall. Or moisture meter detected high levels of moisture within substance. We suggest further investigation and repairs as needed.

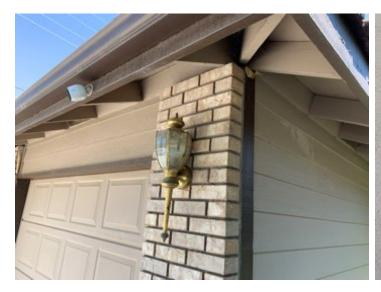
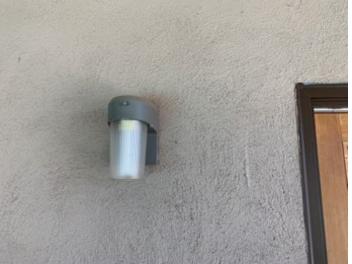
-East wall by the laundry room door and dining room sliding door.

This condition can be caused by daylight sensors, burned out or missing bulbs. You should re-test any inoperable light fixtures after replacing the bulbs. If after bulb replacement the lights still fail to respond to the switch, consider evaluation by a qualified electrician.

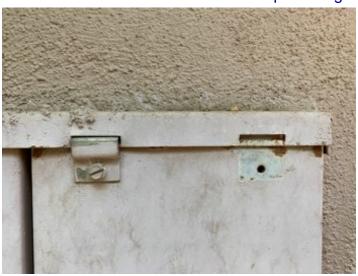
1. Electrical Panel Condition

• The main electrical service panels right hinge was missing at time of inspection.

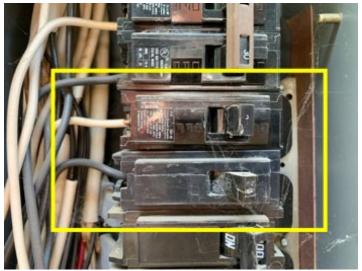
2. Breakers

- Most breakers in the electrical panel appeared to be in serviceable condition at the time of the inspection. Notable exceptions will be listed below.
- Breakers were tested with infrared gun. No unusual hot spots seen with infrared camera at time of inspection.
- The red areas seen in photo are from bright metals reflecting and a normally loaded circuit. These are not abnormal hot spots.
- A breaker with several listings wrote in was not a two pole breaker that would trip both circuits if one fails, such as a breaker above it. We suggest further investigation repairs as needed.

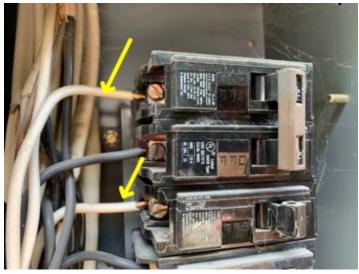
- All branch wiring appeared to be in serviceable condition at time of inspection.
- Wiring in the main service panel appeared to have been performed by persons not familiar with safe electrical practices. White wires normally used for a neutral circuit was attached to two breakers. This condition indicates nonprofessional work. The Inspector recommends that an evaluation and any necessary corrections be performed by a qualified electrician.

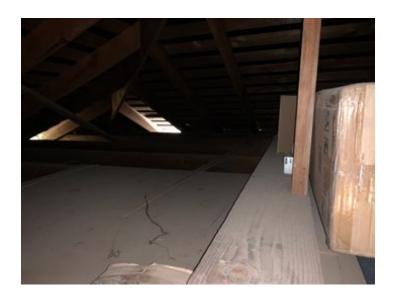
3. Attic Storage area

• Ceiling structure above the garage is not meant for the weight of stored items in the attic. Storing empty boxes, for example, may do little harm however once heavier items are stored, they can stress and/or damage the ceiling framing (rafters or trusses). It may also cause additional openings in the ceiling firewall due to the flexed ceiling covering.

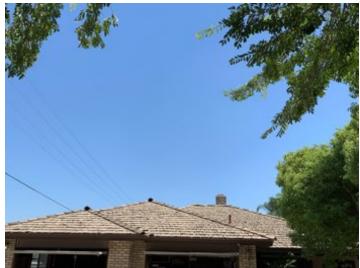
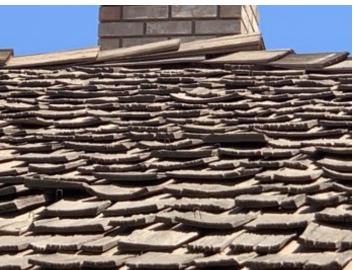
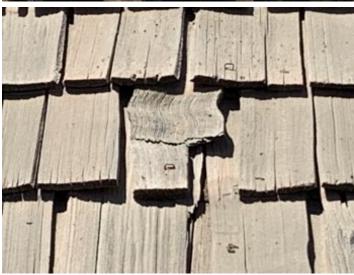
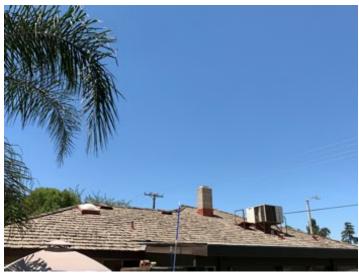
1. Roof Condition

- The wood shake roof covering material appeared to be in generally serviceable condition at the time of the inspection. Any observations listed below.
- At the time of the inspection, the wood shake roof covering material had moderate general damage and/or deterioration commensurate with its age. We suggest consulting a qualified roofer.
- At the time of the inspection, the wood shake roof covering material exhibited widespread moderate general cupping or curling at the time of the inspection. We suggest consulting a qualified roofer.

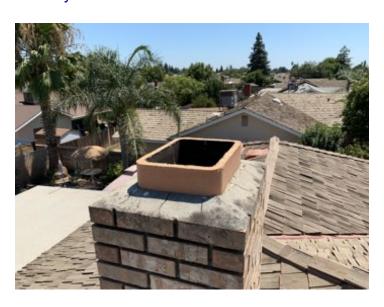
2. Chimney

- No rain cap was installed. A protective cover installed at the top of chimney flue to prevent rain from entering is referred to as a rain cap. Some rain caps are screened to keep out birds and rodents as well. Rain that mixes with soot form a chemical action which breaks the flue and chimney mortar down guicker.
- Damaged chimney crown observed. It is important for the crown to be in good condition as it provides a first line of defense against outdoor elements. When the crown is cracked, water gets in and freezes and thaws, causing larger cracks. A damaged chimney crown allows moisture to seep between the chimney and the liner as well as into the chimney, which can cause shaling and Spalling. We suggest repair. A great preventative measure against this type of damage after repair is to weatherproof the chimney crown and, while you're at it, the chimney itself.

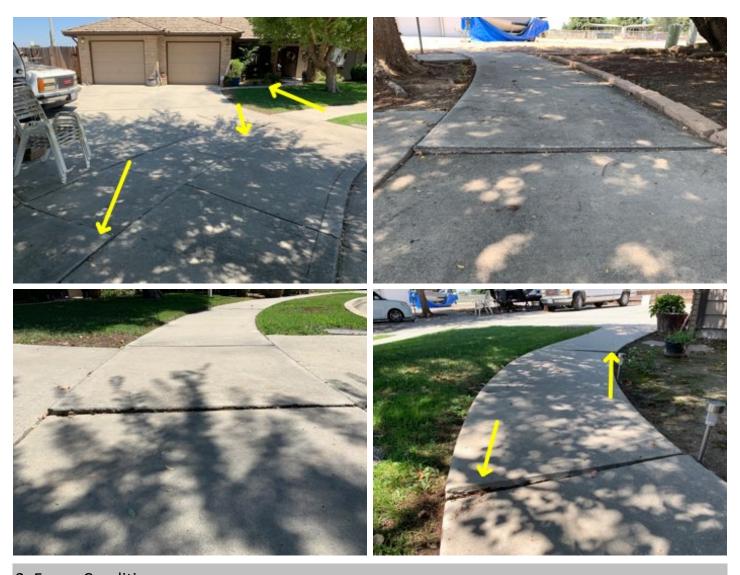
1. Walkway Condition

• Raising of walkway is visible on West side of front entry at the time of the inspection is a trip hazard. This appears to be caused by roots of large tree planted near. This results in a trip hazard in several locations. We suggest further investigation and repairs as needed.

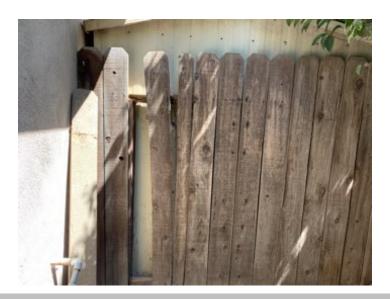
2. Fence Condition

• Wood boards forming the fence barrier on South side were damaged and in need of repair.

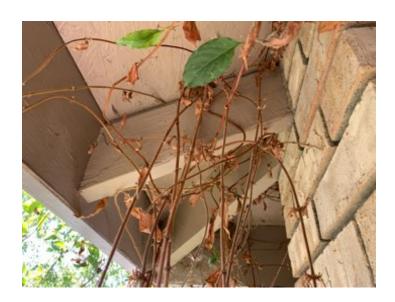
3. Shrubs

• Vine at front entrance is contacting and invading the structure. If this is allowed to continue affected items will be prone to early failure. We suggest really investigation and repairs as needed.

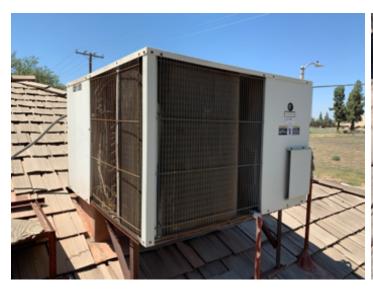
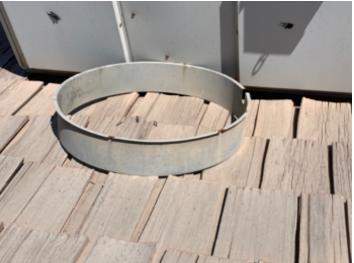
2. A/C Cabinet Location

- The air-conditioner compressor housing was located on the roof of the home to the East.
- A fan shroud was not installed at the time of inspection. We suggest further investigation with repairs as needed.

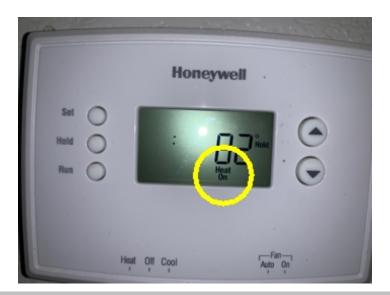
• The heater did not respond to the thermostat and did not light to provide heat after waiting five minutes. We suggest consulting a qualified professional.
