# Property Inspection Report

*1234 Woodland Dr, Hanford, CA, 93230*

*Date of Inspection: 4/14/2022*

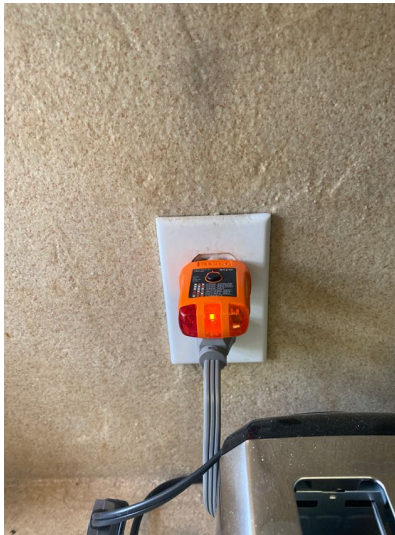
- All three prong electrical outlets in this room has an open ground. This outlet should be corrected by qualified professional.

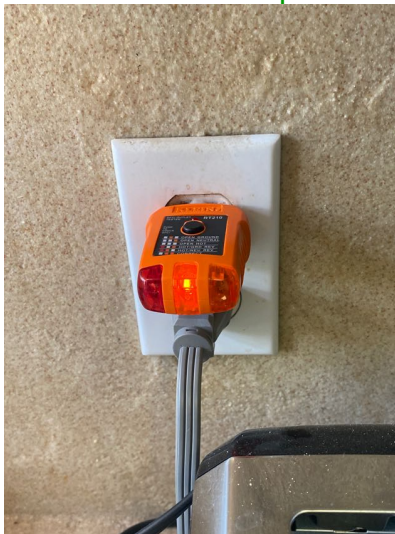
South wall

- No Ground Fault Interrupter (GFI) protection was provided for this rooms electrical outlets located within six feet of a plumbing fixture. Although this may not have been required at the time the home was built, The Inspector recommends installation of ground fault circuit GFI protection as a safety precaution.

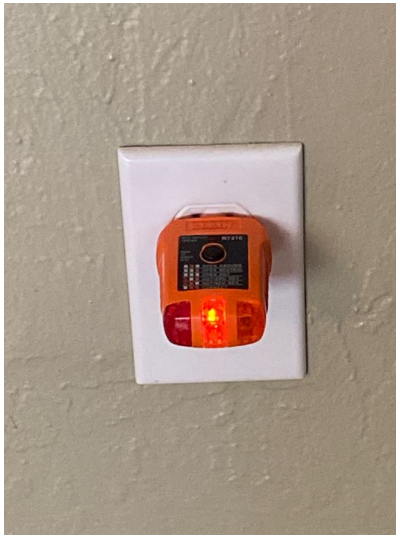
- All three prong electrical outlets in this room had an open ground. This outlet should be corrected by qualified professional.

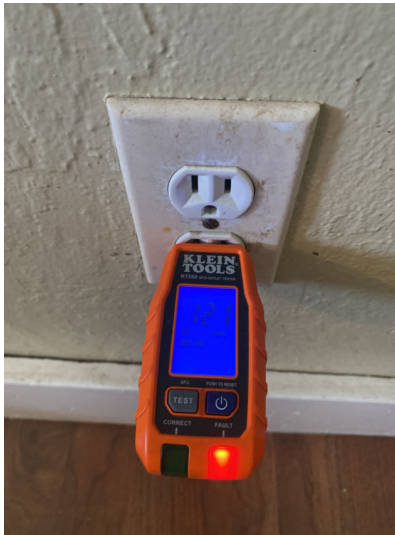
East wall

A three prong electrical outlet in this room had an open ground. This outlet should be corrected by qualified electrician.

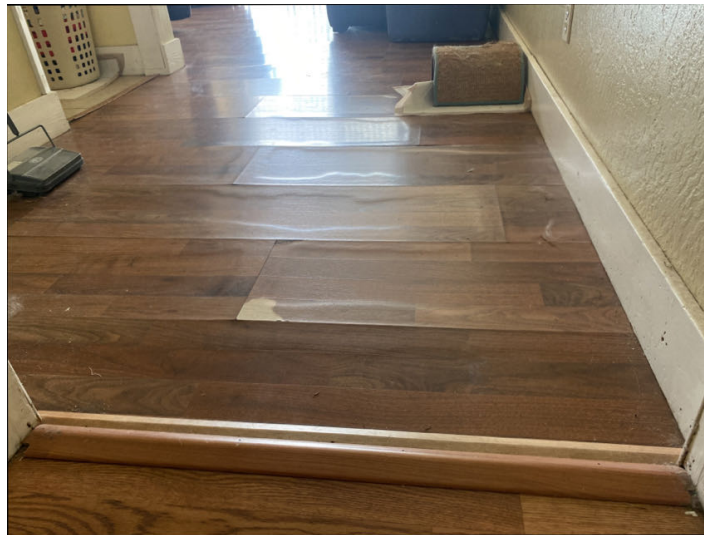
- Flooring displayed moisture damage at the time of the inspection.

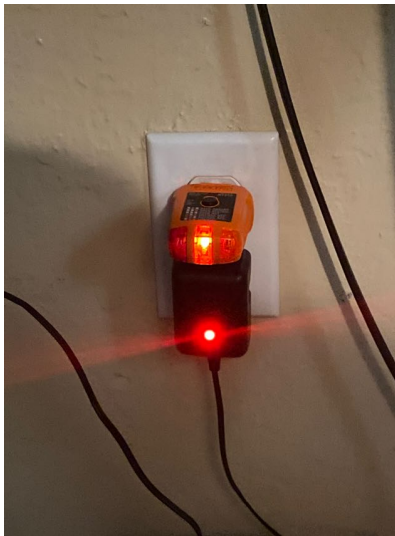
East wall

- A three prong electrical outlet in this room had an open ground. This outlet should be corrected by qualified professional.

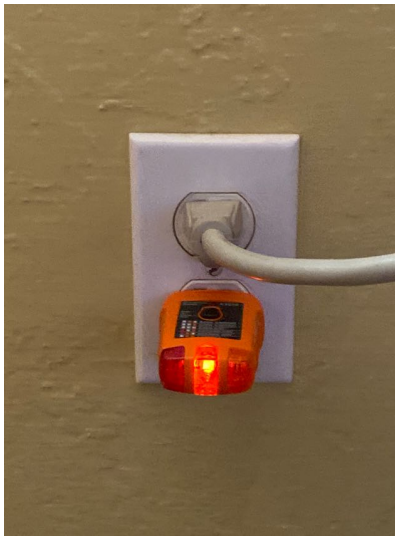
West wall

- A three prong electrical outlet in this room had an open ground. This outlet should be corrected by qualified professional.

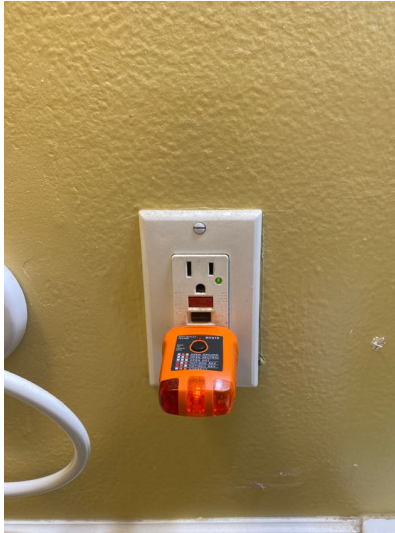
East wall

- A three prong electrical outlet in this room had an open ground. This outlet should be corrected by qualified professional.

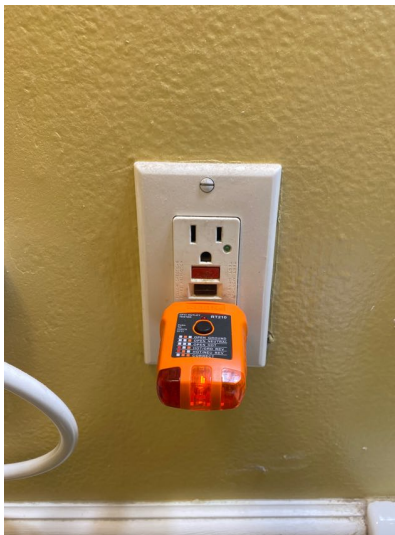
East wall

- A Ground Fault Interrupter (GFI) electrical outlet in this room displayed an open ground and did not respond to the test button. The Inspector recommends further investigation and repairs as needed by a qualified professional.

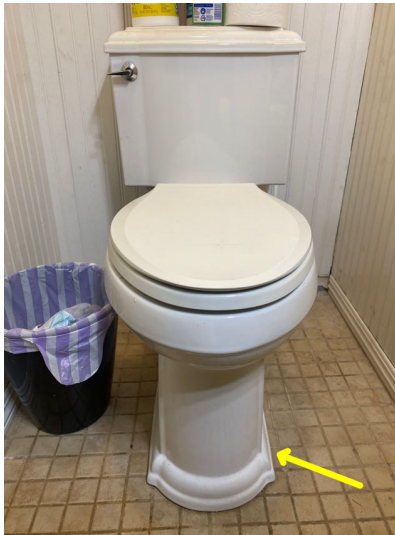
- The toilet was loose at the floor and should be re-attached by a qualified professional.

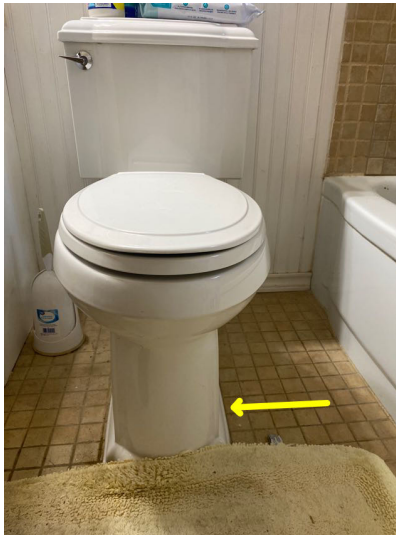
- The toilet was loose at the floor and should be re-attached by a qualified plumber.

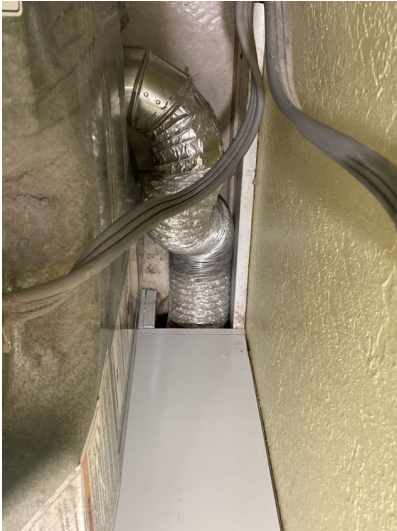
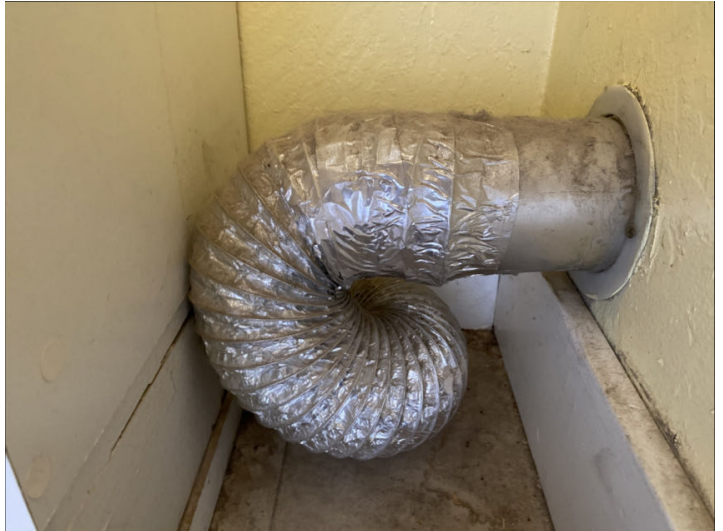
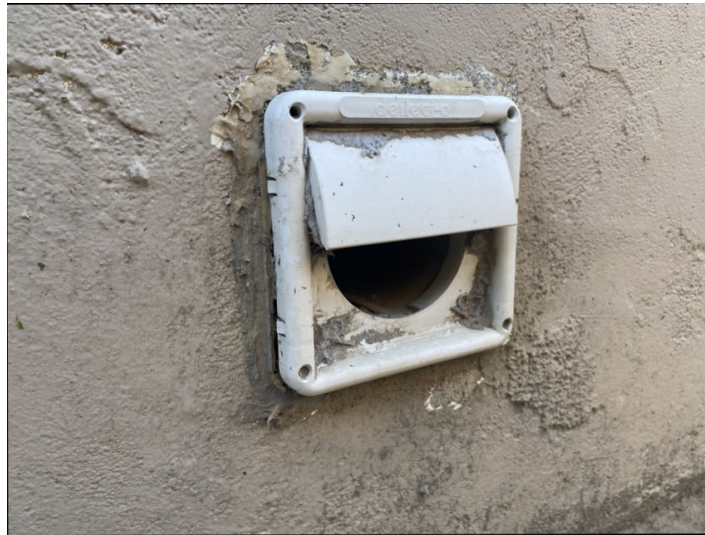
- Exhaust line was kinked and bent in different locations. This could resist and collect lint attempting to be discharged. Blockage of dryer vent may reduce efficiency of unit and may be a cause for fire. We suggest straighten a line out and ensuring cleanliness within.
- Dryer vent exhaust flaps were missing at time of inspection. The sleeves area open to atmosphere pest and rodents. We suggest repair.

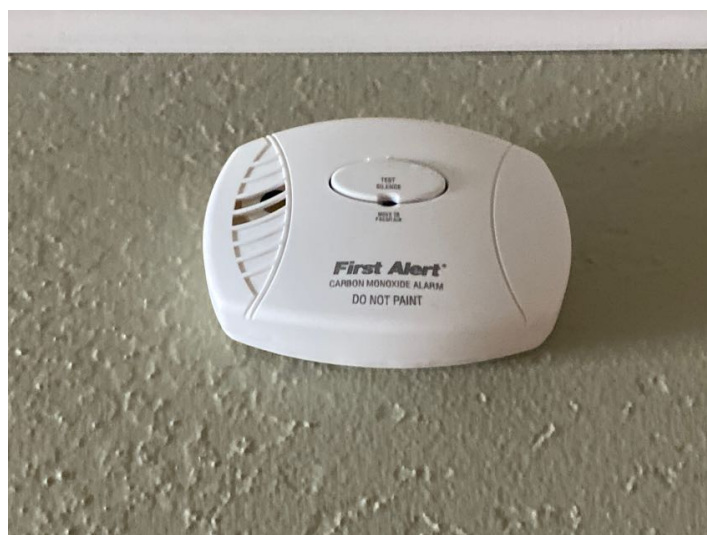
- Carbon Monoxide Detector was inoperable at time of inspection. We suggest prompt repairs.

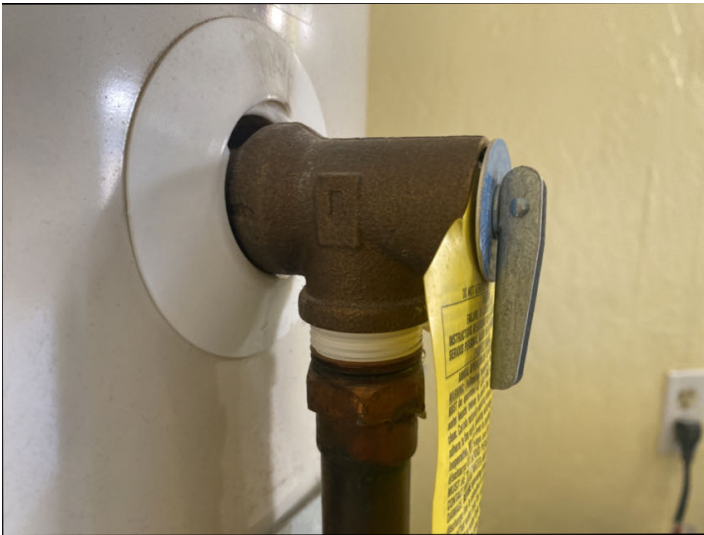
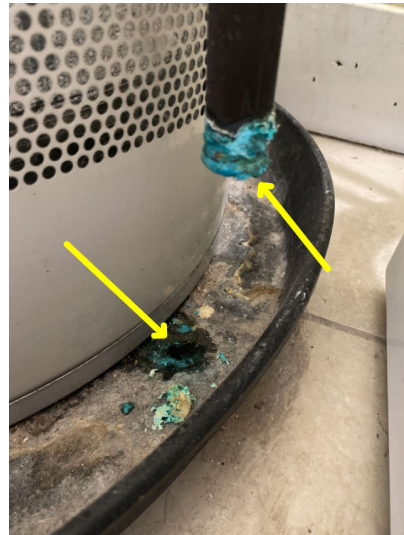
The water heater is equipped with a Temperature Pressure Relief Valve (TPRV).
- The pressure relief valve was leaking at the time of the inspection and should be replaced.

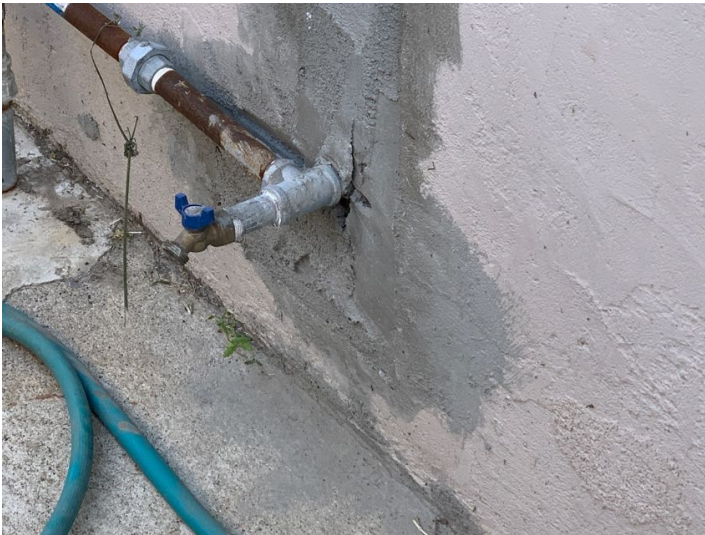
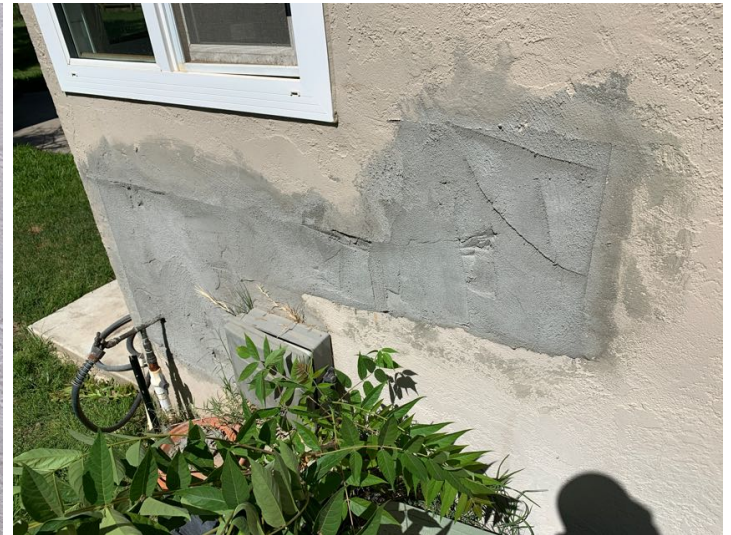
West side of structure

- Exterior walls of the home were covered with stucco. Repairs noted on South East corner of structure.

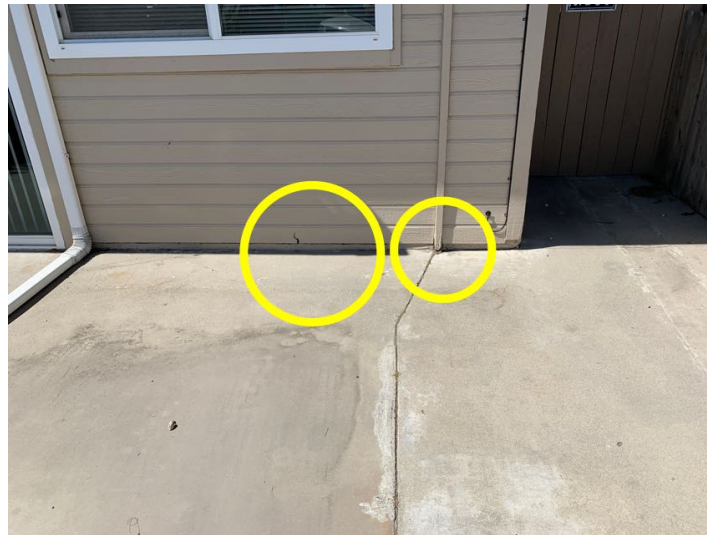
Northside of structure

- Dryrot observed at locations listed by pictures. We suggest further investigation and repairs as needed.

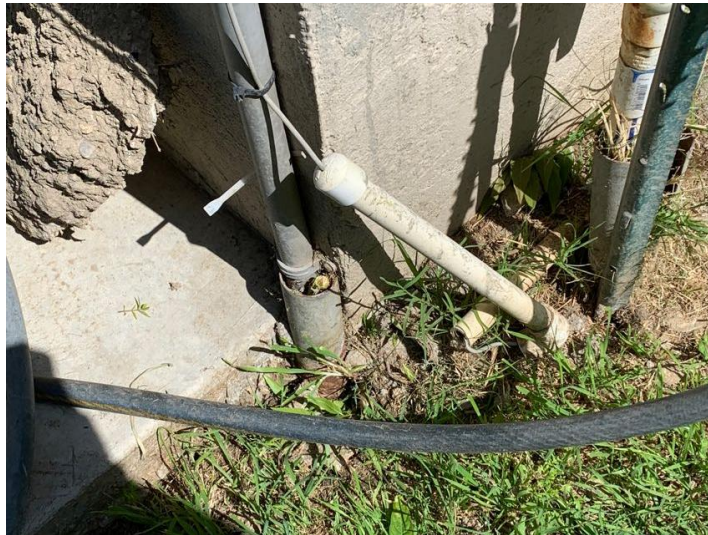
- Open conduit observed on South East corner of structure. We suggest further investigation and repairs as needed by a qualified professional.

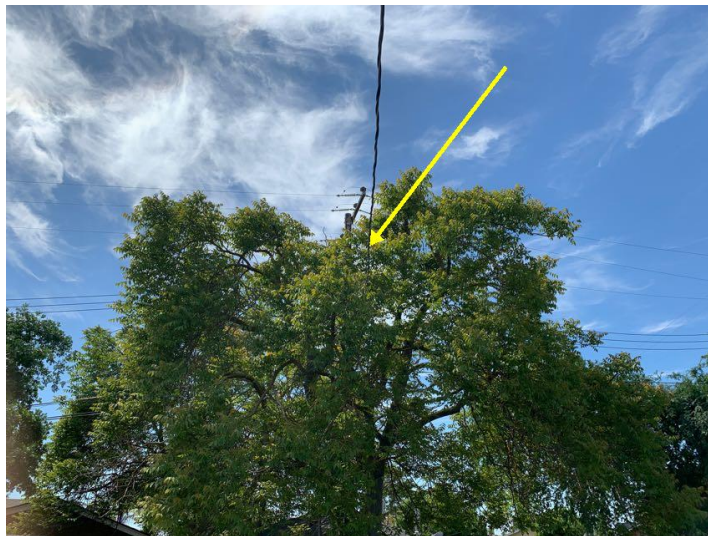
- The overhead service drop conductors had inadequate clearance from tree branches. This condition should be corrected by a qualified contractor to avoid abrasion and damage to the conductors. Work around the service conductors should be performed by a qualified professional only. Injury or death may result from attempts at correction by those without proper qualifications.

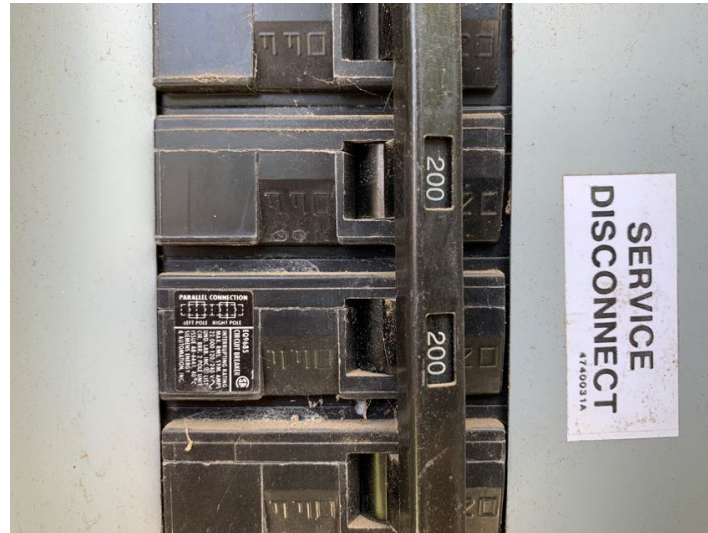
- The manufacturer's label was missing from the main electrical service panel. The manufacturer's label typically provides information describing the main panel such as the name of the panel manufacturer, the panel model number, the panel amperage rating, limitations related to the environment in which the panel was designed to be installed and grounding/bonding information for that particular panel.

Main service disconnect is ready to 200 amps

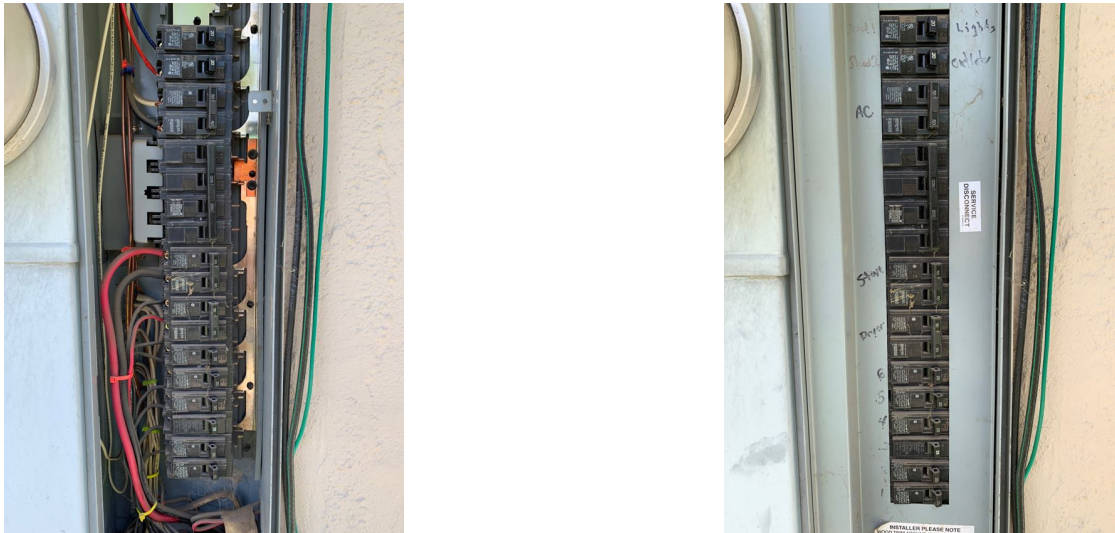
- The label identifying individual circuits at the main electrical service panel was almost illegible as it was written with a pencil. The service panel should contain a clearly marked label identifying individual circuits so that in an emergency, individual circuits can be quickly shut off. The Inspector recommends that a circuit label be installed.

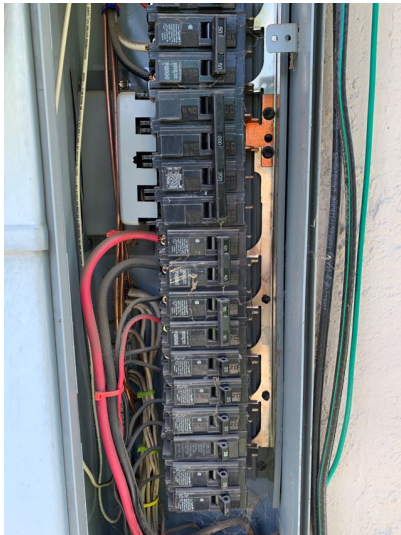
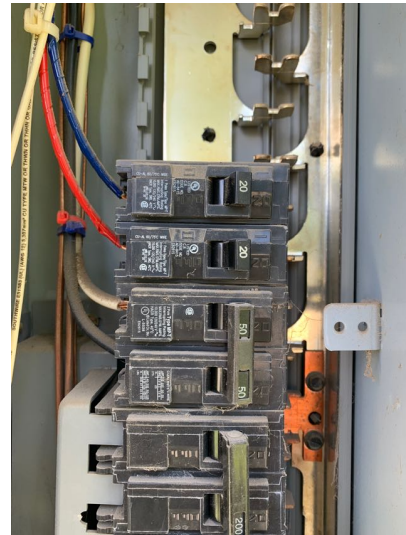
- All branch wiring appeared to be in serviceable condition at time of inspection.
- White wire observe landed on 50 amp breaker at the top of the panel. The white wires normally used in a neutral circuit, not attached to the powered side as installed. We suggest properly mark in this wire to avoid possible confusion in the future.

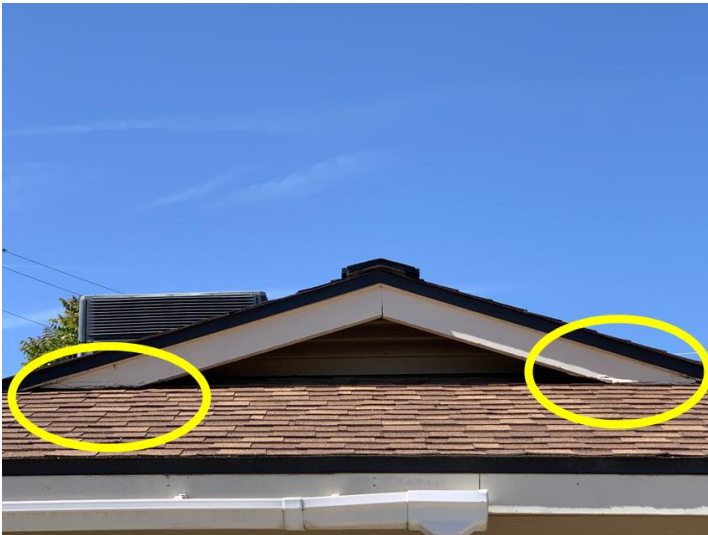
Northside of structure

- Fascia at the locations listed by pictures had moisture damage visible. Please refer to Hexapod report for further details and exact locations.

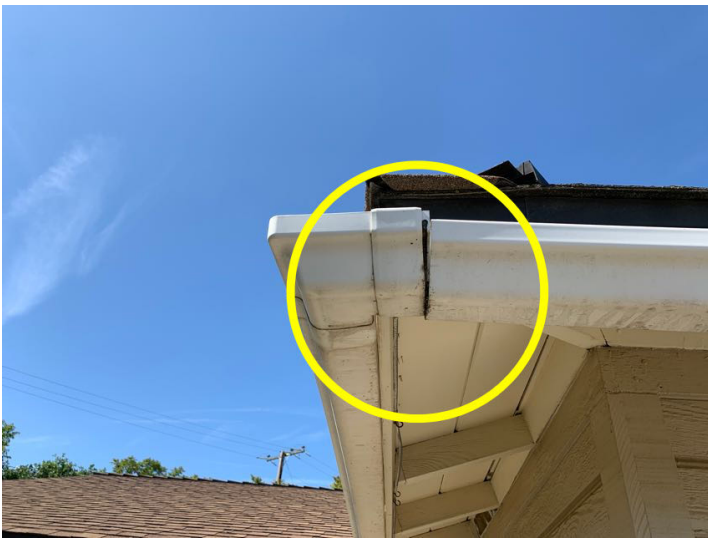
North center of structure

- One or more gutter sections needed to be re-connected in order to properly control roof run-off. The Inspector recommends repair of the roof drainage system to help protect the home structure and occupants. We suggest consulting a qualified professional.

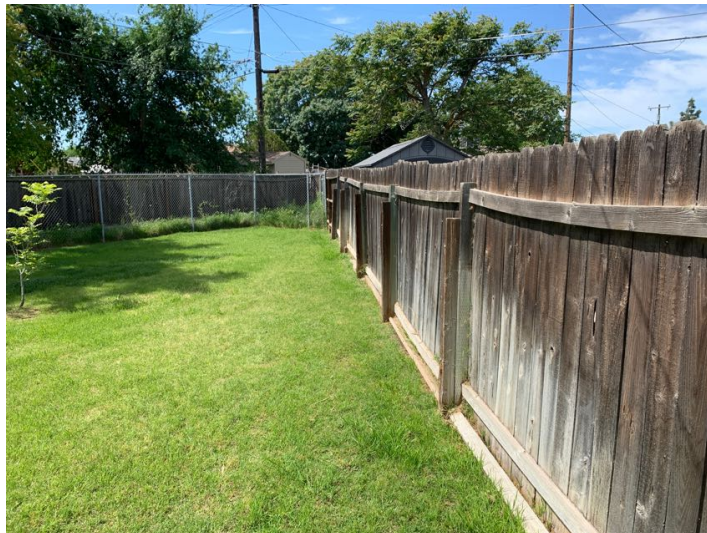
North fence line

- Some wood posts on the fence line examined during the inspection were loose and needed maintenance or replacement.

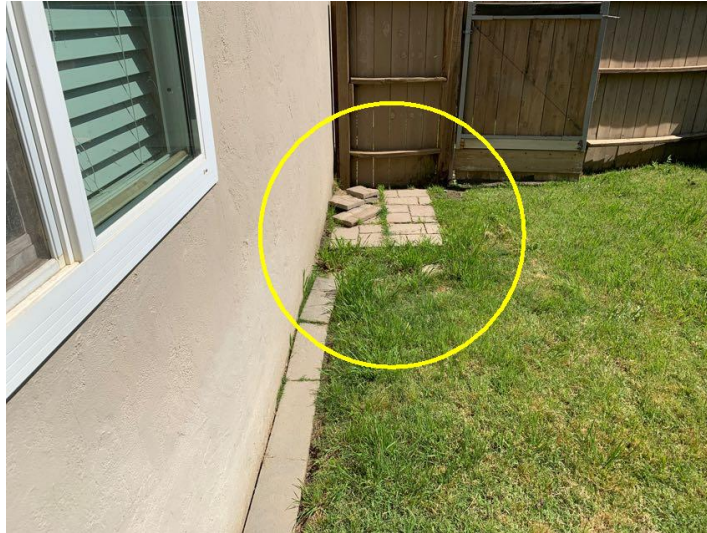
North East corner of structure

- The home had areas of neutral or negative drainage at grade on the South East side and at the North side of home which will route runoff from precipitation to the foundation.

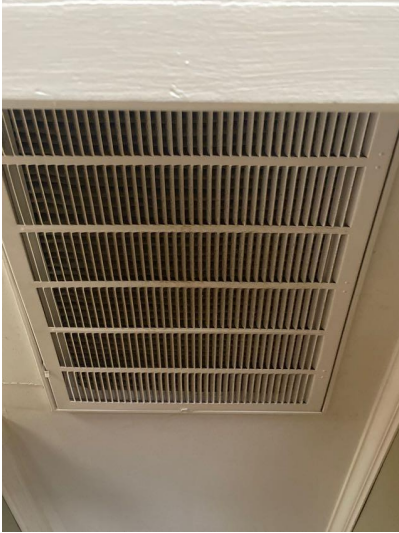
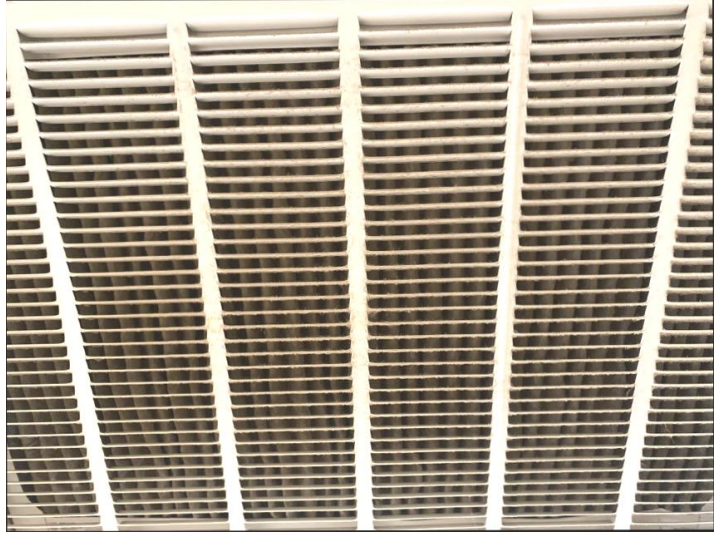
- The air filter was dirty and needed replacement at the time of the inspection. Air filters should be changed monthly while the air-conditioning system is in operation.
