DRAFT Technical Memorandum

Date: September 1, 2020

Project: Water System Recommendations Improvements

Re: Water System Evaluation and Recommended Improvements

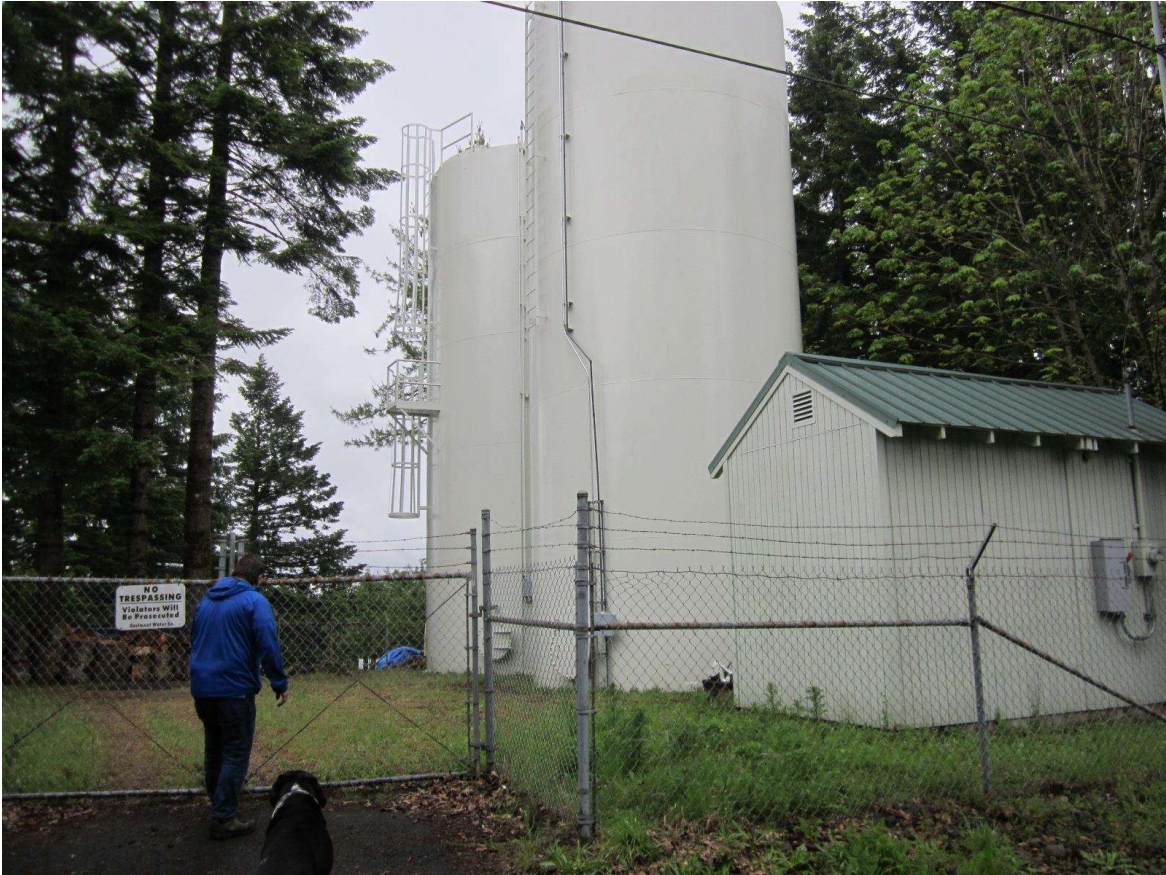
General reservoir and pump station site area as viewed from SE Castle Court.

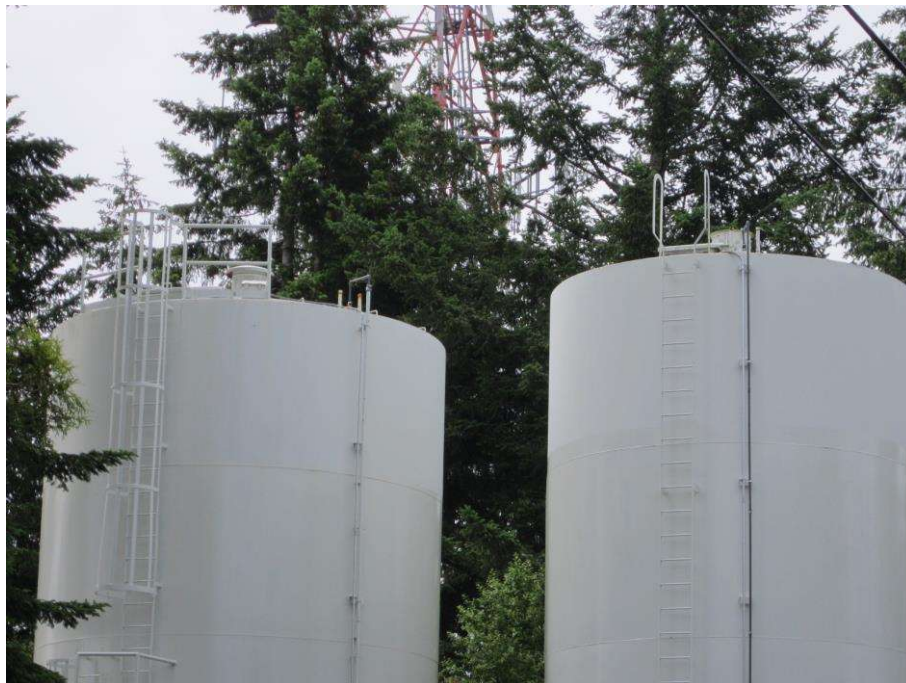
Reservoir exterior upper areas as viewed from SE Castle Court, Reservoir 1 on right and 2 on left.

The exterior of each reservoir was overcoated approximately 15 years ago per EWC records. The exterior coating still appears to be in good condition, with minor chalking and moderate color and gloss reduction. The interior coating systems for Reservoir 1 and Reservoir 2 have been in service approximately 29 and 36 years, respectively. The EWC noted during the site visit that the reservoir interiors are inspected and cleaned by divers approximately every five years, and the exterior is cleaned by pressure washing regularly. From a review of the dive report information, the reservoir interiors are in good condition, with little corrosion evident. Due to the EWC system not using any chemicals regularly such as chlorine, the reservoir interiors do not experience as corrosive of an environment as a typical water storage reservoir, which helps with coating longevity for the interior, especially when the reservoir is not seal-welded in the headspace (area above the water surface).

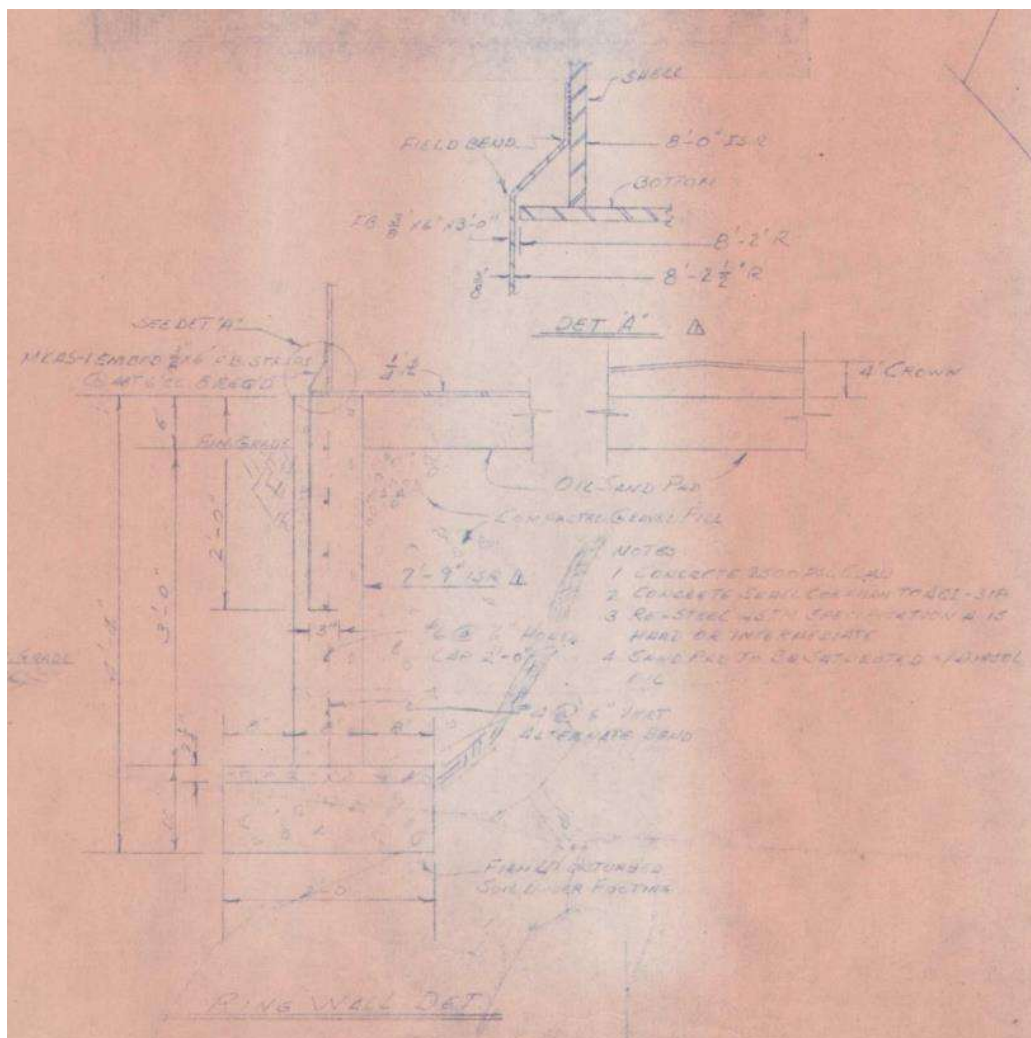
Figure 4
Reservoir 1 Foundation and Anchorage

The Reservoir 1 concrete foundation and anchor straps appear to be in good condition as visible at grade. Although the Reservoir 1 foundation and anchorage has not been structurally evaluated as part of this report, it is clear based on our experience evaluating similar structures that the existing foundation does not meet current code for seismic resiliency, and possibly other parameters. The structure should be further evaluated for options to upgrade the foundation and anchorage to meet current seismic codes, as well as other reservoir elements such as shell thickness for wind and hydrostatic loading, and roof and freeboard for seismic slosh wave requirements.

Project R2 - Full evaluation of both Reservoirs 1 and 2 to analyze the structures and engineering / design of seismic upgrades and appurtenance improvements.

Project R3 - Construction of seismic upgrades and appurtenance improvements of both Reservoirs 1 and 2 (assumed upgrades are based on similar project experience).

- Expand concrete foundation, including doweling into existing foundation
- Addition of steel anchor chairs and anchor bolts for mechanical anchoring of foundation to reservoir shell.
- Appurtenance improvements, such as vent replacement, ladder modifications, etc.
- Major Cost Assumption: Site soils are suitable for standard upgrades and will not require deep ground improvements such as micropiles or similar.

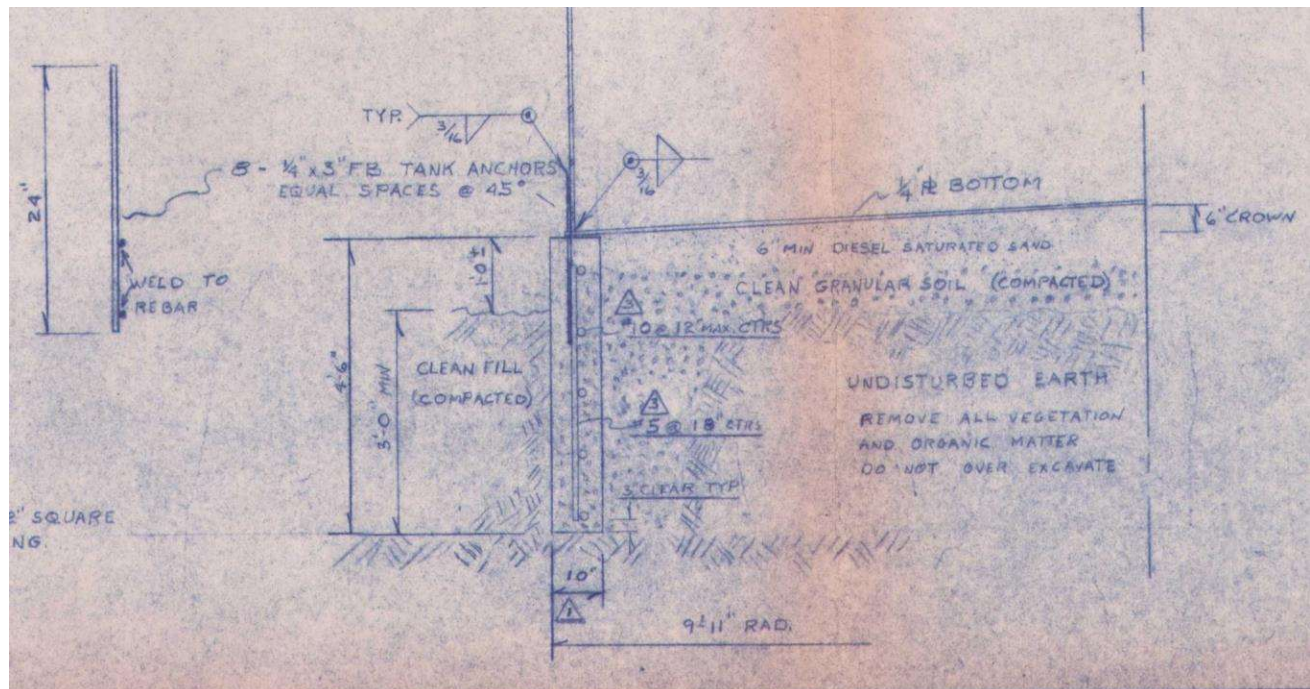
Figure 5
Reservoir 2 Foundation and Anchorage

The Reservoir 2 concrete foundation and anchor straps appear to be in good condition as visible at grade. Although the Reservoir 2 foundation and anchorage has not been structurally evaluated as part of this report, it is clear based on our experience evaluating similar structures that the existing foundation does not meet current code for seismic resiliency, and possibly other parameters. The structure should be further evaluated for options to upgrade the foundation and anchorage to meet current seismic codes, as well as other reservoir elements such as shell thickness for wind and hydrostatic loading, and roof and freeboard for seismic slosh wave requirements.

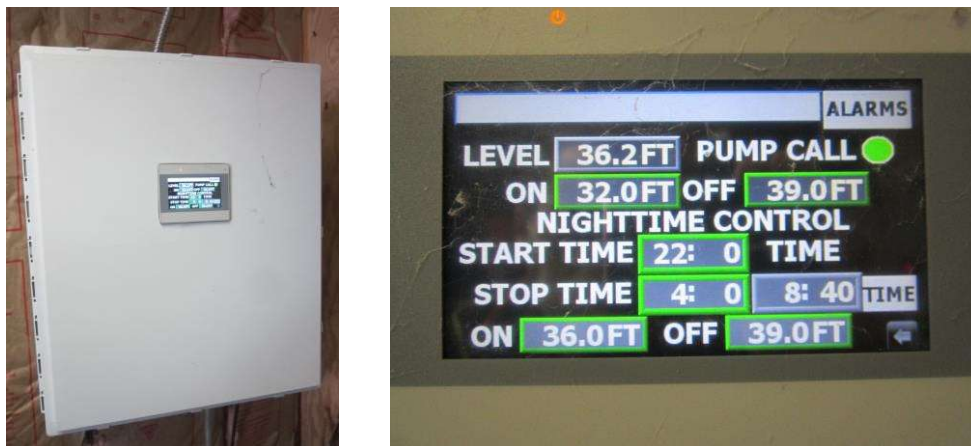
The EWC system underwent telemetry and controls upgrades in 2016, designed and installed by Portland Engineering, Inc. (PEI). The control strategy for the well pump to turn on to increase reservoir level is accomplished via cell modem communication between two telemetry cabinets. There is a control panel mounted on the wall of the main floor of the High Zone pump station (discussed in Section 1.3 below) with a human machine interface (HMI) screen that reads current tank water surface level, well pump on/off settings as relates to reservoir level, and other information shown in the photo below. Reservoir sensing lines are routed from each tank as discussed above to the High Zone pump station for hydrostatic pressure sensing. The telemetry control panel receives a signal from the pressure transducer(s) in the building basement and converts it to feet of water in the reservoirs, and then calls the well pump (discussed in Section 1.4, below) to turn on and off based on programmable settings. There is currently no standby backup power generation at the reservoir site, although the telemetry panel discussed in Section 1.3 below does have a small backup power unit to keep communication alive for a short period of time with the well site in the event of a power outage, per the PEI telemetry system Operations and Maintenance (O&M) Manual. The High Zone pump and the reservoir mixers would not function in the event of a power outage.

Reservoir level and well pump control panel and interface screen, in the High Zone pump station.

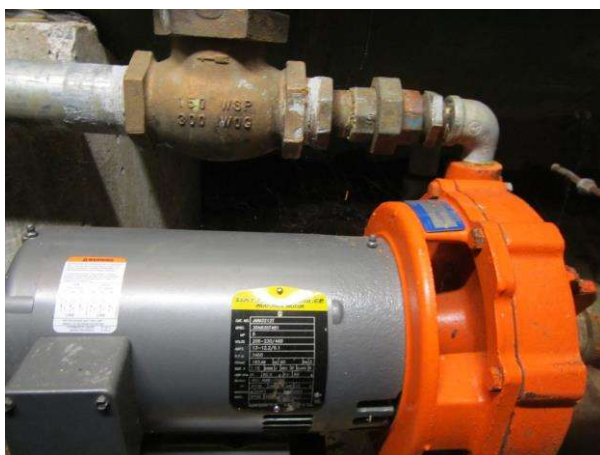
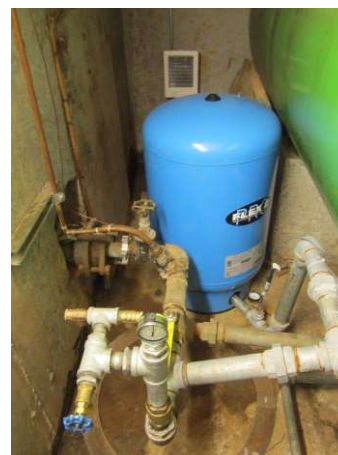
High Zone pump and hydro-pneumatic tank in the High Zone pump station basement.

The pump station and storage building at the reservoir site is generally in good condition for continued service. The EWC has noted that they are comfortable with the operations of the High Zone Pump Station, and that no upgrades to that facility need to be included in this report. In the future, the EWC could consider making upgrades including tying the pump station operations into an overall supervisory control and data acquisition (SCADA) system.

Project P1 - Design and install standby power generator and remove unused electrical / telemetry equipment.

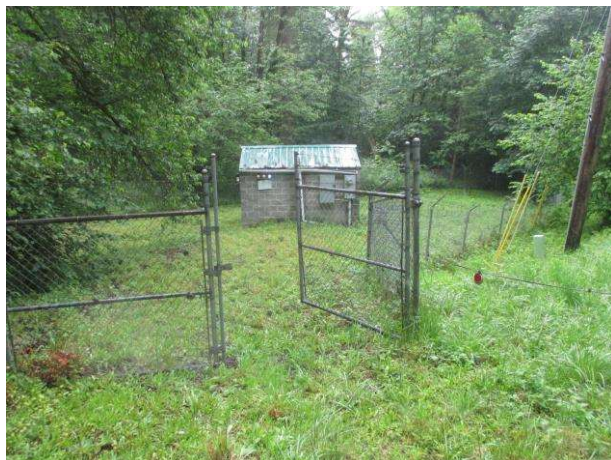
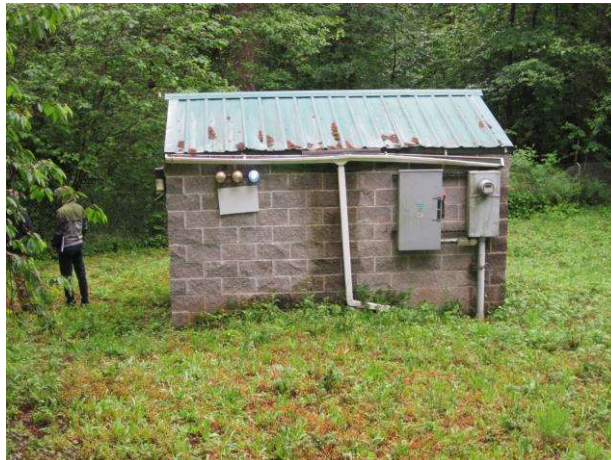
There is currently no standby backup power generation at the well site, although the telemetry panel discussed above does have a small backup power unit to keep communication alive for a short period of time with the reservoir site in the event of a power outage, per the PEI telemetry system O&M Manual. The well pump and the solenoid-operated control valves would not function in the event of a power outage.

Well house exterior.

Project W1 - Design and install standby power generator and remove unused electrical / telemetry equipment.

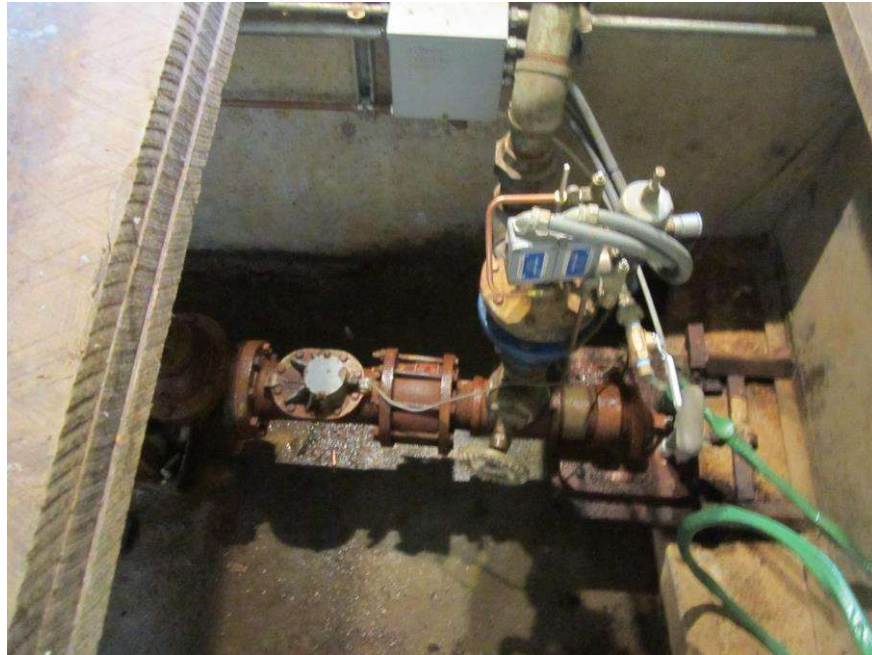
Well discharge piping and solenoid-operated pump control valve.

Although no original construction drawings were made available for the well site, it is assumed it was built in 1965 along with Reservoir 1. The exposed piping in the well house has been in service for approximately 55 years, and it is showing signs of corrosion and should be considered for replacement. The EWC is also interested in having emergency standby power generation

Project W2 - Retrofit well house to replace submersible well pump with vertical turbine well pump and replace piping and valving in the well house.

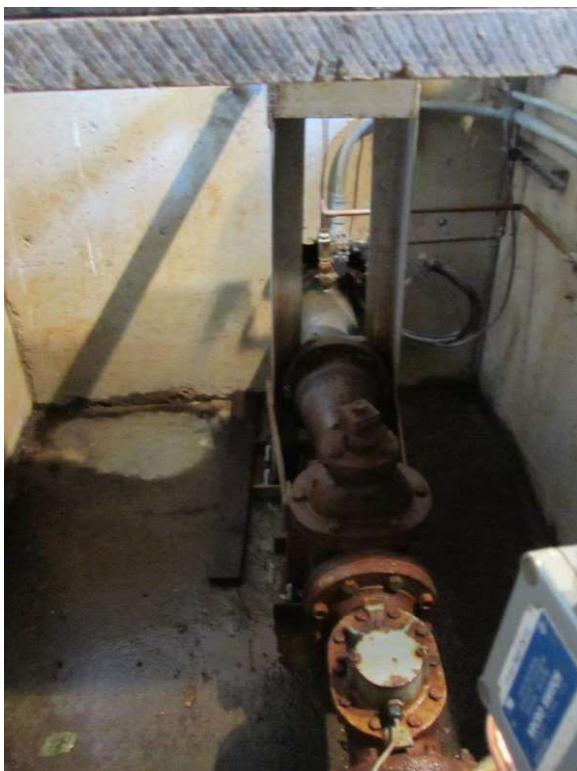
Well discharge piping.

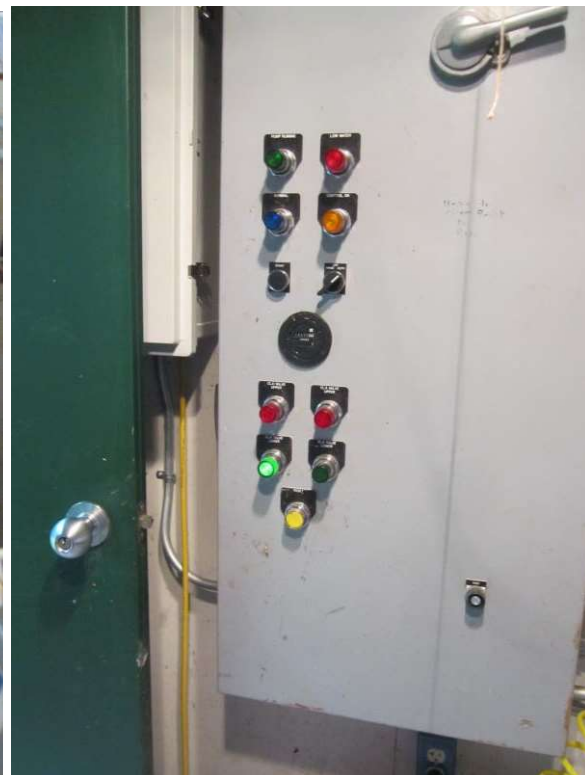
Well pump status lights and HOA switch.
