DEPARTMENT OF TRANSPORTATION

Swansboro Country Airport El Dorado County Suspense: February 28, 2019

January 14, 2019

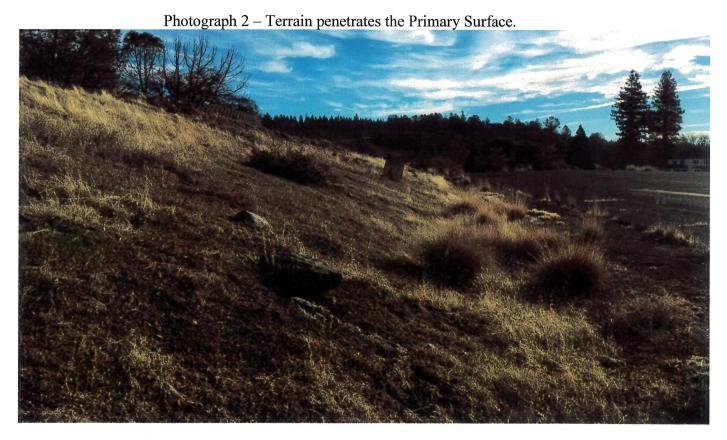
- 2. Structures, trees, brush, and areas of high ground along both sides and down the entire length of Runway 9/27 are within the Federal Aviation Regulation (FAR) Part 77, Primary Surface (please see enclosed Photographs 1 through 7). The Primary Surface extends 200 feet beyond each runway end, 125 feet each side of the runway centerline, with an elevation equal to the nearest point on the runway centerline. Although, some of the following items were varianced for aircraft parking we recommend mitigating each to the degree possible:

Photograph 1 - Penetrations of the Primary Surface

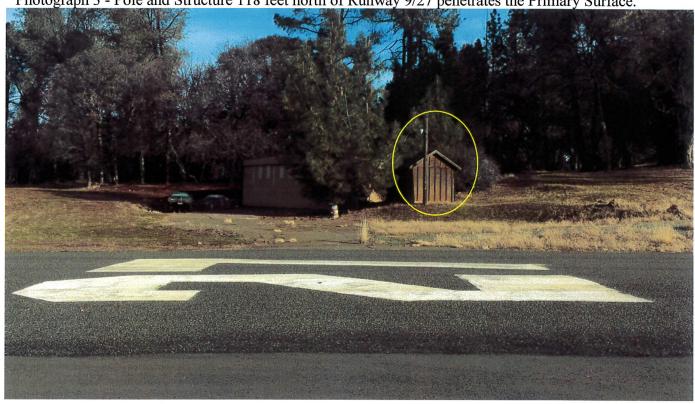
- b. A utility pole and a structure abeam and 115 feet north of the Runway 27 Displaced Threshold penetrates the Primary Surface by 10 feet (please see enclosed Photograph 3). We recommend you work with the homeowner and the power provider to relocate the pole and structure clear of the primary surface.

Photograph 3 - Pole and Structure 118 feet north of Runway 9/27 penetrates the Primary Surface.

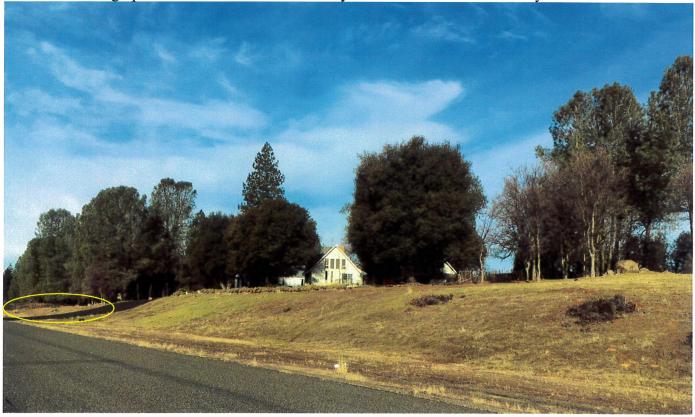
- c. Trees, brush, and high ground penetrate the Primary Surface on the north side of the runway and from 450 to 1,300 feet west of the Runway 27 Displaced Threshold (please see enclosed Photograph 4). At a minimum, this area should be kept clear of trees and brush with the artificial raised berm graded flush to the elevation of the runway centerline.

Photograph 4 - Penetrations of the Primary Surface north side of Runway 9/27

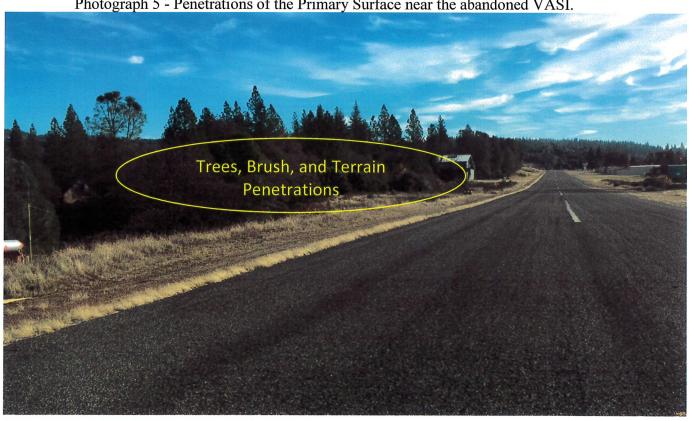
- d. Small trees, brush, and high ground penetrate the Primary Surface on the north side of the runway from 450 to 885 feet east of the Runway 9 Displaced Threshold (please see enclosed Photograph 5). Although Lot 60 is varianced for aircraft parking, at a minimum this area should be kept clear of trees and brush.

Photograph 5 - Penetrations of the Primary Surface near the abandoned VASI.

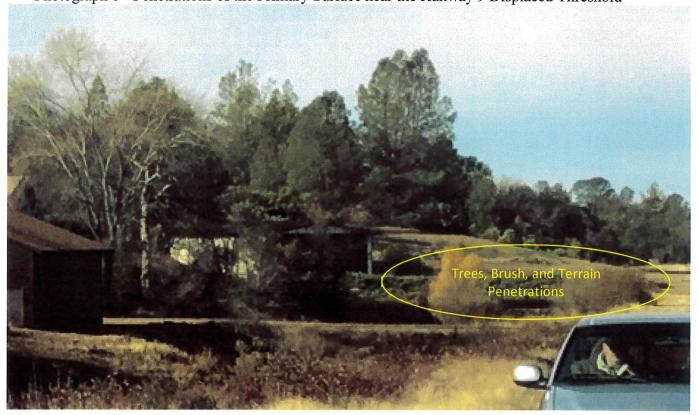
- e. Small trees, brush, and high ground penetrate the Primary Surface on the south side of the runway from 300 feet west of the Runway 9 Displaced Threshold to the edge of the westernmost pond (please see enclosed Photograph 6). Although Lot 10 and 710 are varianced for aircraft parking, at a minimum this area should be kept clear of trees and brush.

Photograph 6 - Penetrations of the Primary Surface near the Runway 9 Displaced Threshold

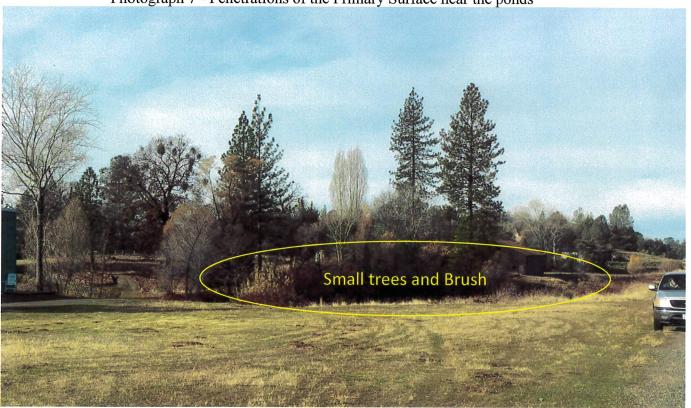
- f. Small trees, brush, and high ground penetrate the Primary Surface on the south side of the runway from 580 to 770 feet east of the Runway 9 Displaced Threshold (please see enclosed Photograph 7). At a minimum this area should be kept clear of trees and brush.

Photograph 7 - Penetrations of the Primary Surface near the ponds

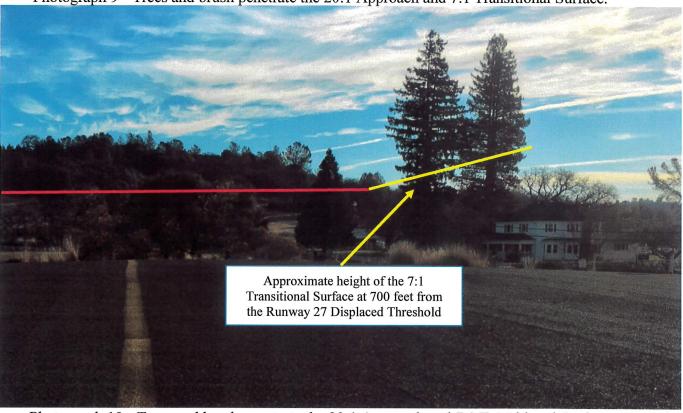
- 4. Two redwoods, specifically varianced in 1978 when each was 70 feet in height, are now well over 100 feet in height and constitute a significant obstruction hazard. Located 800 feet east of the Runway 27 Displaced Threshold and 155 feet south of the extended runway centerline, these trees penetrate the Transitional Surface by over 60 feet. These trees are located just outside and to the left of the Runway 27 Approach Surface close to aircraft performing normal traffic pattern operations. We recommend that these trees be trimmed as shown in enclosed Photograph 9 or be removed as soon as possible.

Photograph 9 - Trees and brush penetrate the 20:1 Approach and 7:1 Transitional Surface.

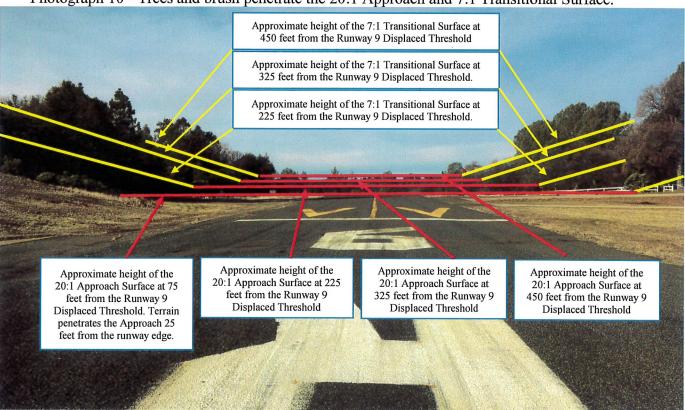
- 5. Trees, brush, and terrain 75 to 550 feet west of the Runway 9 Displaced Threshold penetrate the FAR Part 77, 20:1 Approach and the 7:1 Transitional Surfaces. Although, a variance exists for aircraft parking in Lots 10 and 718, terrain penetrates the Approach Surface at 75 feet west of the Runway 9 Displaced Threshold to the runway end as close as 55 feet south from the runway centerline. We recommend this area be graded level to the elevation of the runway centerline to provide a clear approach for incoming traffic. Additionally, both Transitional Surfaces are varianced, however, many trees are taller than when the variance was granted in 1978 with many trees now penetrating both the Approach and Transitional Surfaces by more than 50 feet. At a minimum, trees in the Approach Surface must be trimmed, and Transitional Surface penetrations should be trimmed as shown in enclosed Photograph 10 or be removed.

Photograph 10 - Trees and brush penetrate the 20:1 Approach and 7:1 Transitional Surface.

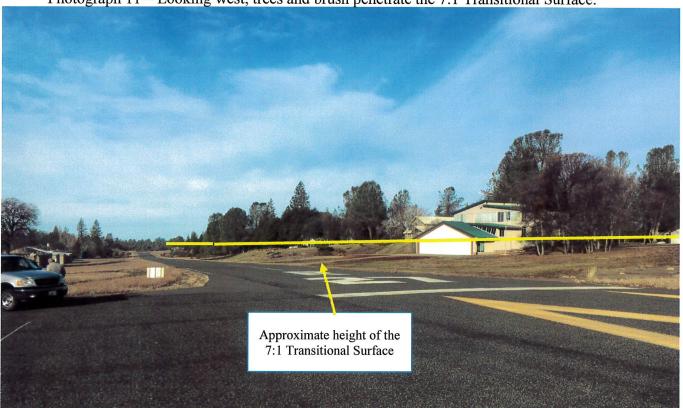
- 6. Structures, trees, brush, and areas of raised terrain on both sides and down the entire length of Runway 9/27 penetrate the FAR Part 77, Transitional Surface. Trees, high ground, a hangar, and parked aircraft in the Transitional Surfaces are varianced on both sides of the runway. However, comparing photographs taken during the inspection (please see enclosed Photographs 11 and 12) to those taken in 1976, trees adjacent to the runway have grown in number and are substantially higher. We recommend that these trees be trimmed as shown in enclosed Photographs 11 and 12 or be removed to be clear of the Transitional Surface as soon as possible.

Photograph 11 – Looking west, trees and brush penetrate the 7:1 Transitional Surface.

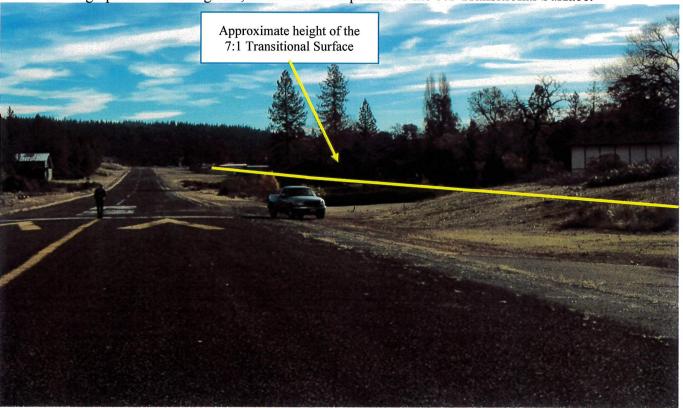
Photograph 12 – Looking east, trees and brush penetrate the 7:1 Transitional Surface.
