October 9, 2019

Project B1909885

Re: Assessment of Building Exterior and Interior Recommendations
Valhalla Condominiums - Building #11
342 Elton Hills Drive Northwest
Rochester, Minnesota

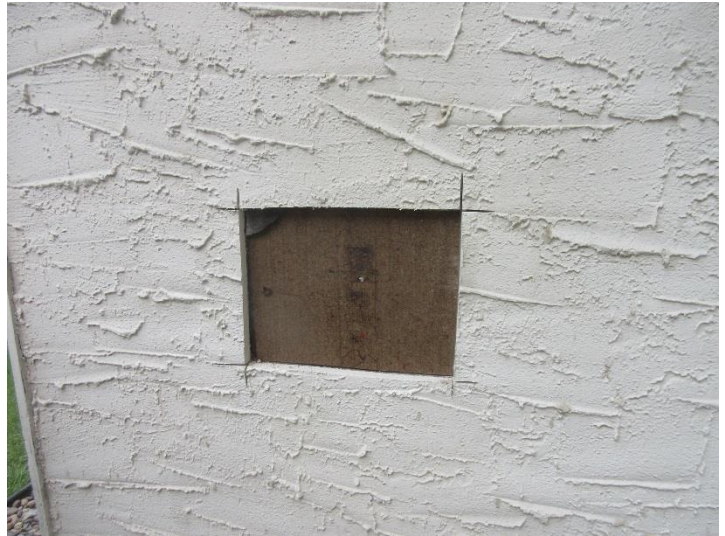
Photograph 16

View of stucco and felt underlayment removed-buffalo board was dry.

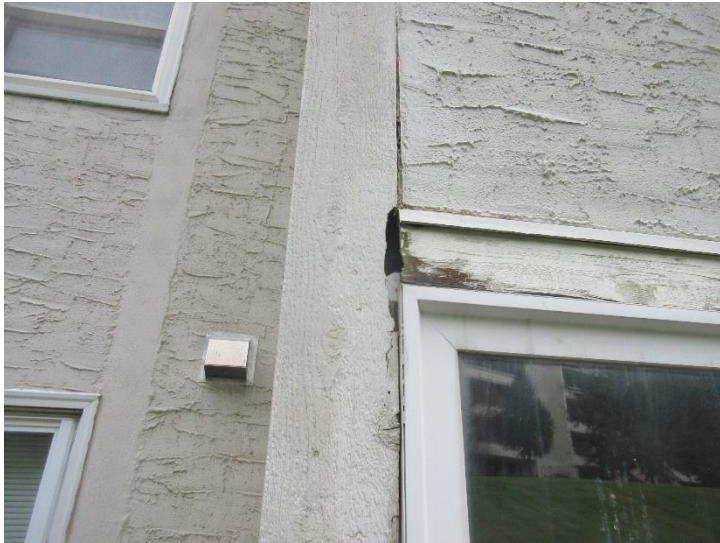
Photograph 31

View of rotted trim boards at corner and window head-west elevation.
