Report of Investigation

Title of Investigation:
743 Main St. Fire (Firefighter Fatality)

Investigation Number:
765070-23-0021

ORIGIN AND CAUSE REPORT

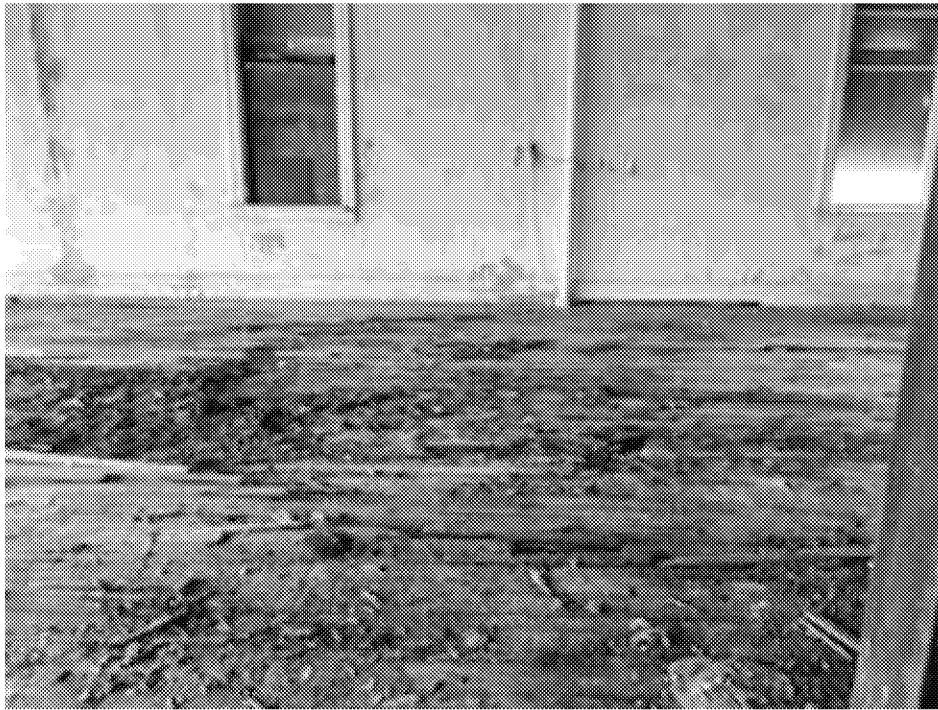
31. The walls that enclosed the staircase for the second and third floors were comprised of wood-framed construction, sheathed with lathe and plaster. Based on witness statements everything but the exterior walls, flooring, and support structure for the second and third floors had been removed prior to the fire. Plaster sheathing was present on the exterior walls. However, pre-fire photographs showed that the metal I-beam posts, metal I-beam joists, and the wooden joists were all exposed with no sheathing. Additionally, preexisting damage to the wood floor was present on the second and third levels. See Figure 11.

Figure 11 - Pre-fire damage to the flooring on the third floor, facing north.

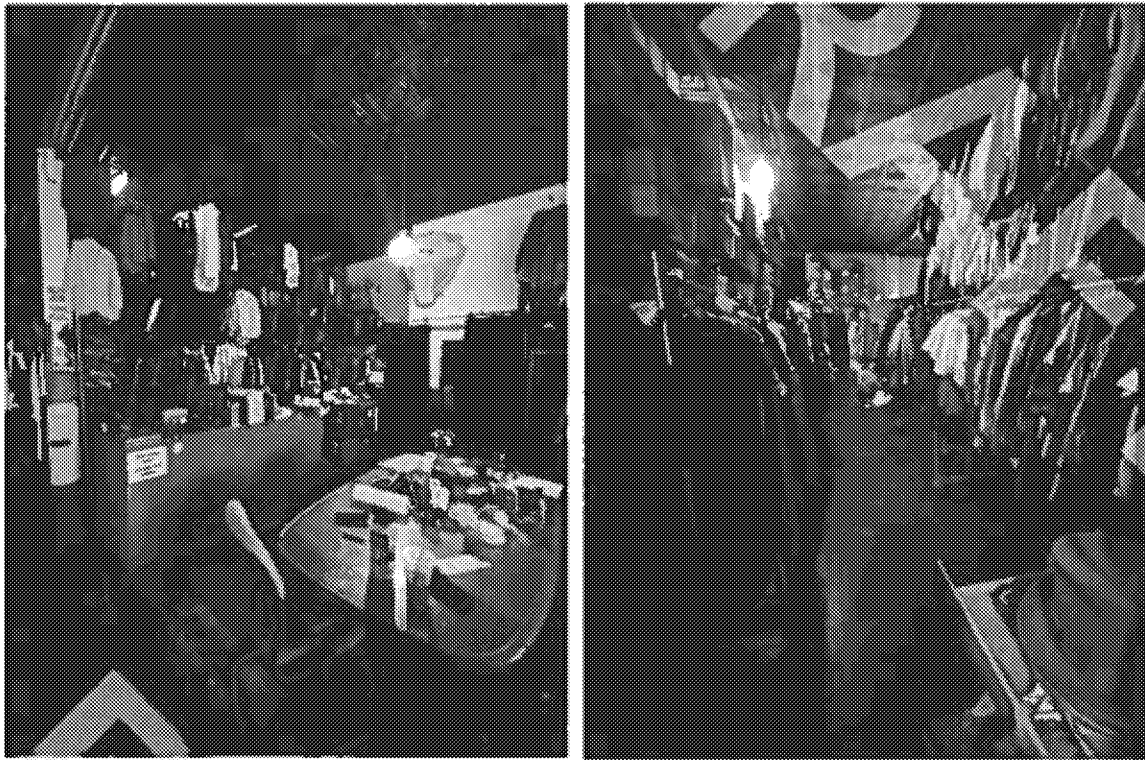
39. **ATF ROI # 84** – Investigators received photographs of the interior of the structure from James O'Neill Investigations Inc. This company is representing Buffalo NY Claims Services, which is adjusting the claim for Dryden Mutual Insurance. The photographs were taken in September 2022 and show the interior of DC Theatricks. Some of the photographs show clothing/costumes displayed on vertical surfaces extending to near ceiling level (Figure 12 and Figure 13).

Figure 12 and Figure 13 – Clothing and costumes on vertical surfaces to near ceiling level.

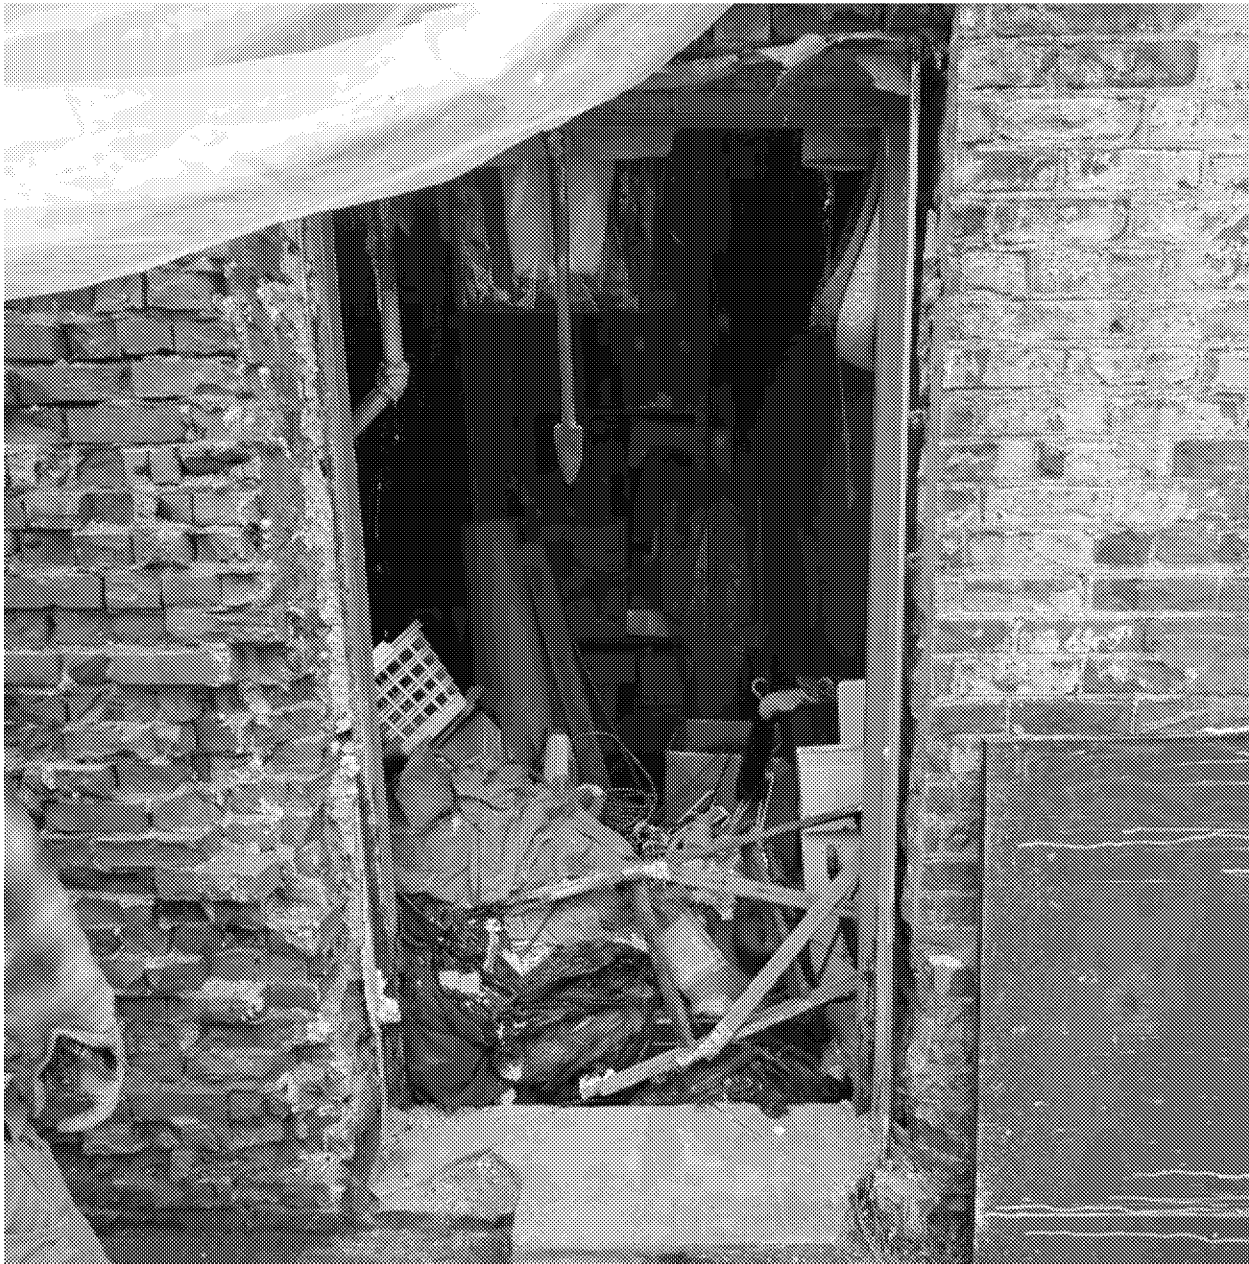
54. Additionally, (b)(6)/(b)(7)(C) stated workers had removed a metal door on the north side of the structure and replaced it with a piece of particle board. Investigators showed (b)(6)/(b)(7)(C) a photo of the doorway prior to the piece of wood being installed. (b)(6)/(b)(7)(C) was able to list items that he believed were still near that doorway prior to the fire. The list of items included bags of costumes as well as costumes inside clear plastic bags that were hanging above the doorway (Figure 17).

Figure 17 – North exterior door to DC Theatricks and interior contents.

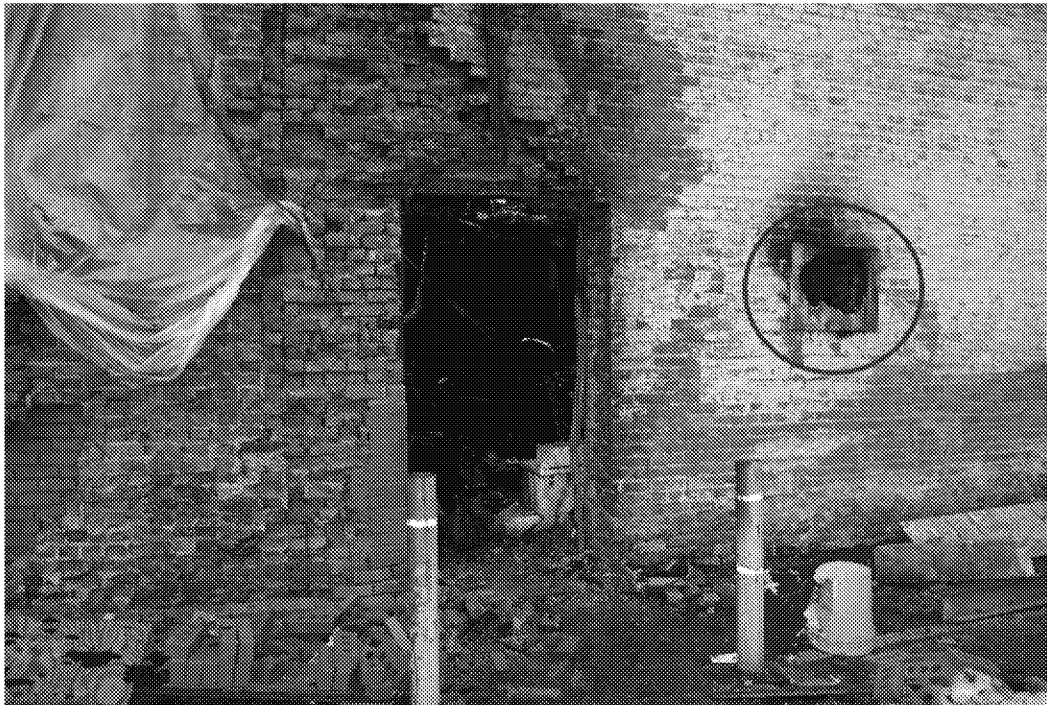
the building. Additionally, (b)(6)(b)(7)(C) and (b)(6)(b)(7)(C) are working near the wall, doorway, and plastic and neither report seeing or smelling smoke from a fire at that time. At 09:00 and 09:05, (b)(6)(b)(7)(C) was in between the doorway and the camera when a puff of material came between (b)(6)(b)(7)(C) and the camera. These perspectives demonstrate the material was not emanating from the doorway but was coming from the area west of the doorway. This was the area that the intake and exhaust piping for the basement furnace are located. On the morning of the fire, temperatures were in the low 30's (F) with relative humidity near 70%. Investigators now believe the material referenced as smoke in ROI 69 is actually condensation/water vapor coming from an exhaust pipe located to the west of the doorway.

Figure 21 – North door to DC Theatricks, intake and exhaust vent circled.

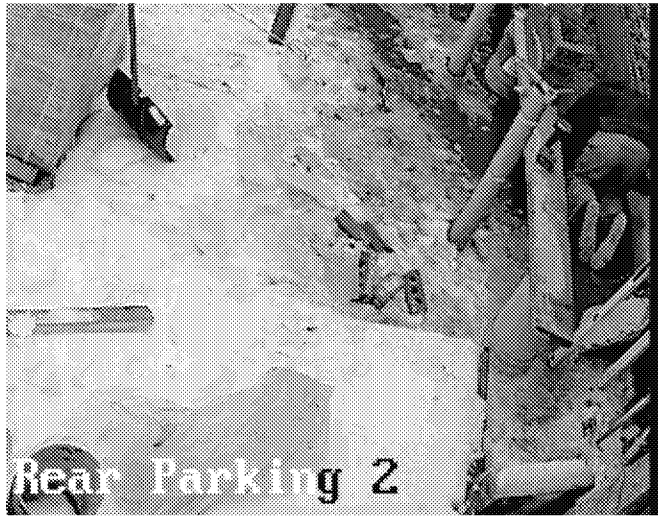
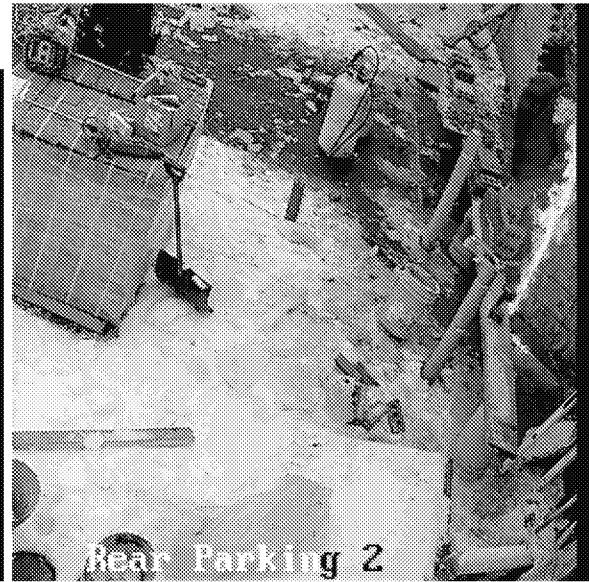
109. Fire Discovery – At 09:53 (b)(6)(b)(7)(C) appeared to notice something in the doorway and tossed his trowel to the ground. He bent down and appeared to look under the plywood attached to the door frame (Figure 22). (b)(6)(b)(7)(C) then threw a bucket of water into the doorway, which can be seen washing back toward the parking lot. He then began to unscrew the east side of the plywood from the frame, partially opening the plywood covering and was met with flames (Figure 23). He then kicked the plywood fully open. At approximately 09:55, (b)(6)(b)(7)(C) called 911 to report the fire.

Figure 22 – (b)(6)/(b)(7)(C) looking under plywood.

Figure 23 – Flames as board is opened.

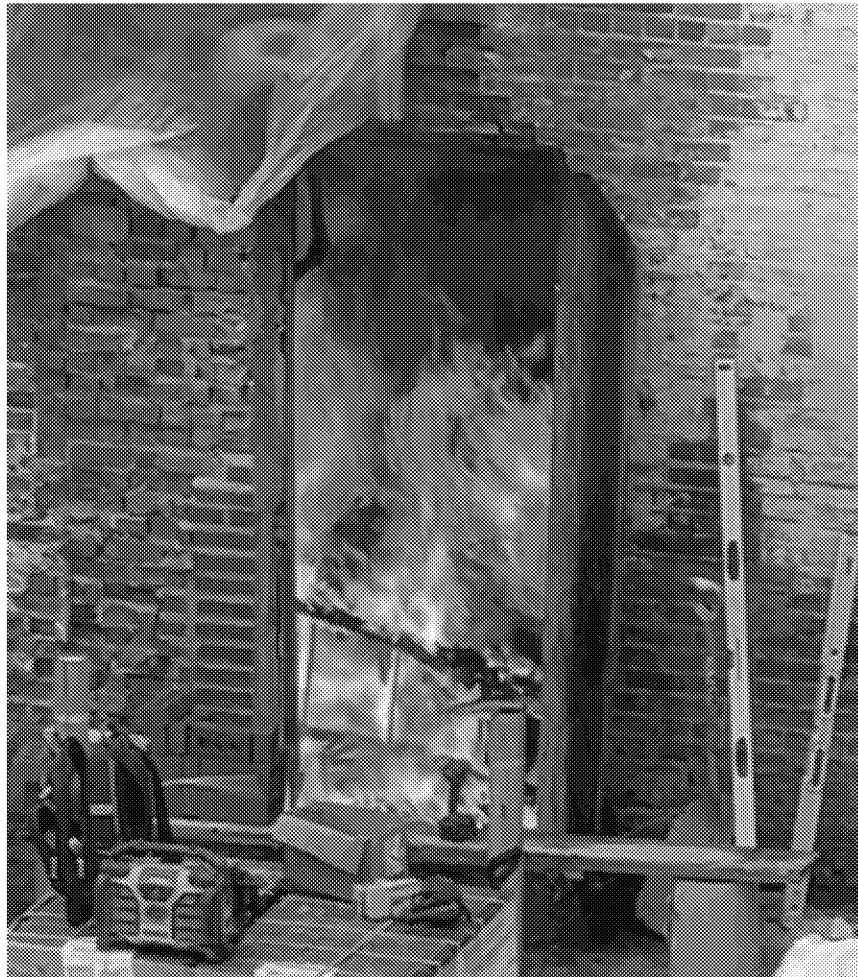
110. Approximately two and a half minutes after (b)(6)/(b)(7)(C) kicked the plywood open (09:59), (b)(6)/(b)(7)(C) took a video of the building. She filmed the video from her apartment located just north of 743/745/747 Main Street. Her video showed the plywood still attached to the west side of the door frame and in a vertical position. At this point, fire was seen inside of 743/745/747 Main Street but smoke and fire were not venting from the doorway.
111. Of note is the condition of the inside surface of the plywood board. The interior surface of the plywood showed charring only on the east side, while the west side was relatively undamaged. While in the original closed position, this charring would have been closest to the east side of the doorway where the brickwork was taking place (Figure 24).

Figure 24 – Cropped image from (b)(6)/(b)(7)(C) video showing charring on the east interior face of the plywood.

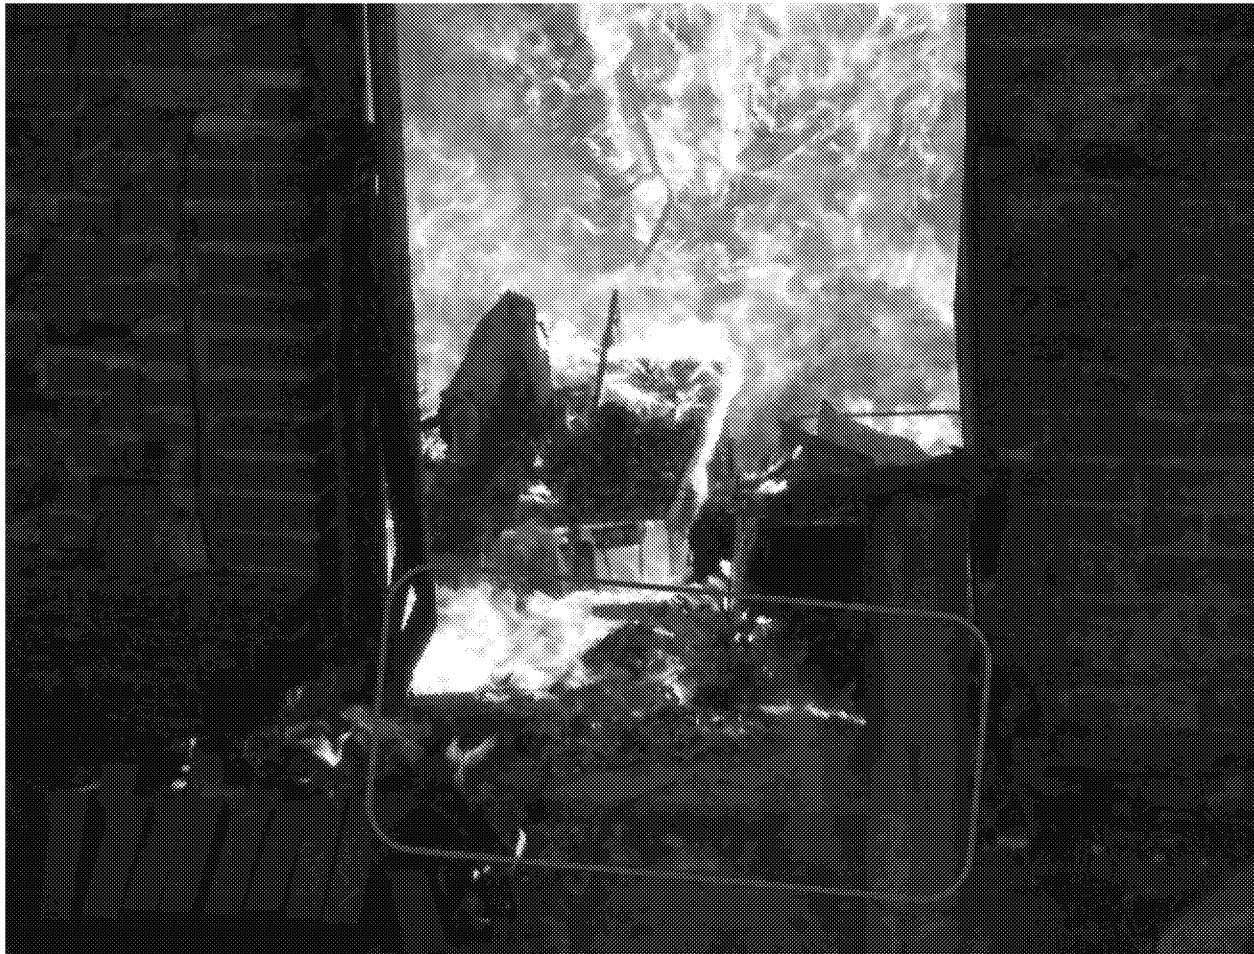
113. On March 3, 2023, Investigators interviewed Buffalo Fire Marshal (b)(6)/(b)(7)(C). Investigator (b)(6)/(b)(7)(C) was the on-duty fire investigator when the fire at 743/745/747 Main Street occurred. Investigator (b)(6)/(b)(7)(C) responded to the scene and began to take photographs. Investigator (b)(6)/(b)(7)(C) reported seeing smoke originating from the first floor on the west side of the building. He then walked down the north side of the building and continued to take photographs. Investigator (b)(6)/(b)(7)(C) observed the north doorway to DC Theatrics. He observed heavy fire in this area. However, most of the smoke and flames were within the structure and not venting out of the doorway. Investigator (b)(6)/(b)(7)(C) provided his photographs to the rest of the investigative team. One of the photographs of the north doorway showed smoldering debris on the concrete threshold (Figure 25). This photo was taken at approximately 10:05 and, by this time, the plywood had been removed from the door frame by a firefighter.

Figure 25 – Cropped image taken showing debris on concrete threshold.

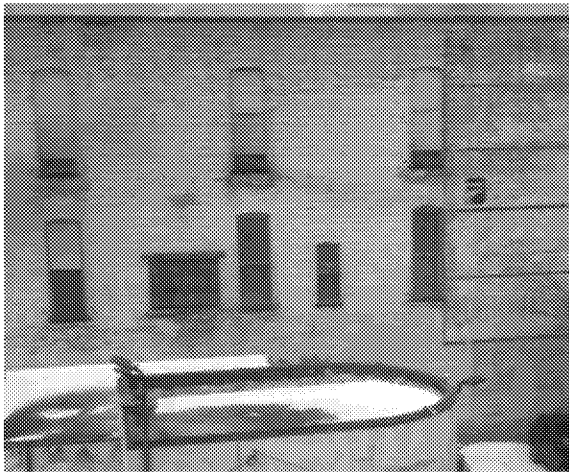
114. Approximately 30 seconds after Investigator (b)(6)/(b)(7)(C) took the photo of the doorway (10:06), (b)(6)/(b)(7)(C) began filming a video of the building. (b)(6)/(b)(7)(C) filmed the video from his apartment located just north of 743/745/747 Main Street. The video panned back and forth across 743/745/747 Main Street and captured different parts of the building at different times. At first, the only flames visible were inside the north doorway to DC Theatrics. Heavy smoke could be seen emanating from the west side of 743/745/747 Main Street. One minute and seven seconds into the video, all the windows were dark with no visible fire (Figure 26). From one minute and five seconds to one minute and thirteen seconds into the video, flames were seen venting from the west side of the structure and building in intensity until they eventually extended above the structure. The video then panned from west to east. From one minute and thirteen seconds to one minute and twenty-five seconds into the video, flaming combustion can be seen in all the second-floor windows (Figure 27). Additionally, at one minute and fourteen seconds into the video (10:07) an over-pressure event (backdraft) is observed at the north doorway to DC Theatrics (Rear Parking 2) and at the roof hatch to the building. NFPA 921 defines a backdraft as, “[a] deflagration resulting from the sudden introduction of air into a confined space containing oxygen-deficient products of incomplete combustion.” [1] During this event, smoke was also seen pushing out of the third-floor windows.

Figure 26 - Smoke on second floor.

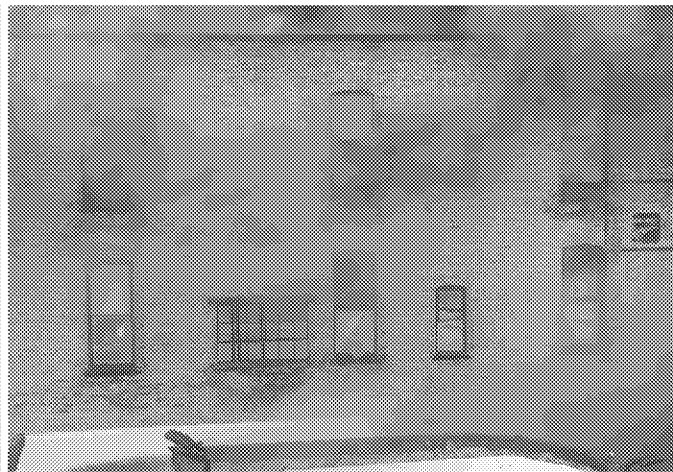
Figure 27 – Seconds later, flaming combustion.

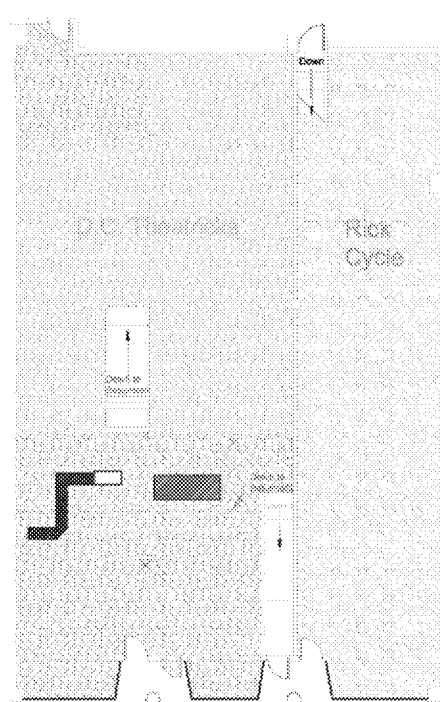
149. Investigators examined the interior of the structure. Due to structural collapse, the second and third stories were determined to be unsafe to work in. These areas were examined with the use of camera systems and UASs. Additionally, the area to the east of the centrally located stairs on the first floor of DC Theatricks was deemed unsafe to work in. Again, these areas were examined with the use of camera systems and UASs. However, the Buffalo Fire Department USAR team was able to shore the flooring of the first floor in the far northeast corner of DC Theatricks, so this area could be processed by the investigative team. The warehouse will be described first, followed by the three-story structure.

Figure 28 – First floor - Areas highlighted in yellow were deemed unsafe to work in.

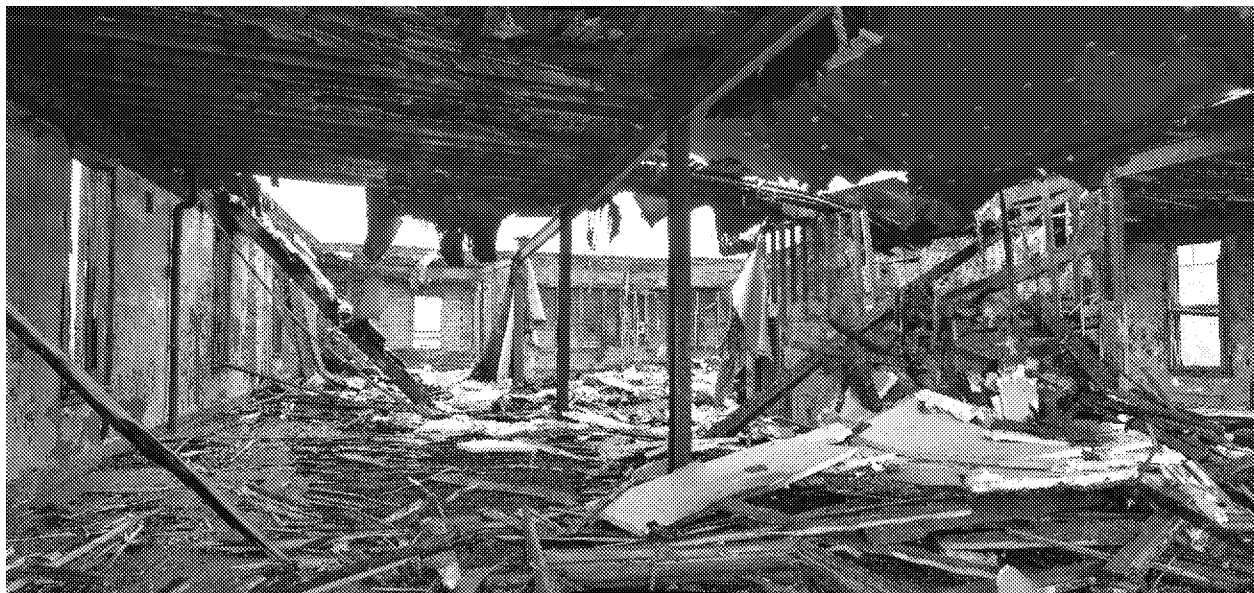
153. Sections of the floor in the southeast corner of the third floor had collapsed into the second floor. Some areas of the floor in this area were still attached to the south wall of the structure, indicating the failure of the floor occurred toward the center of the building. The flooring surface was covered in soot and smoke deposits. However, the surfaces were not deeply charred. Conversely, the exposed wooden floor joists showed deep charring, indicating a fire underneath the floor.

Figure 29 – Third floor, stitched and cropped image taken from UAS photographs facing east.

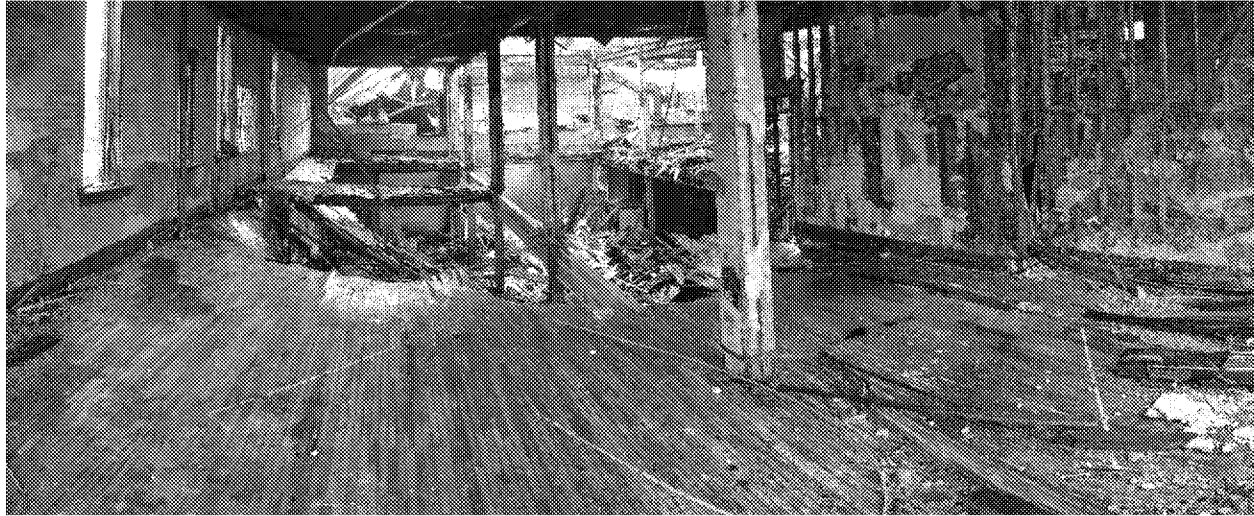
(above DC Theatricks) had failed and collapsed into the first floor. Some areas of the floor in this area were still attached to the north wall of the structure, indicating the failure of the floor occurred toward the center of the building. The floor on the west side of the structure did not fail during the fire. Additionally, much of this flooring had light to moderate soot and smoke staining. However, there were many areas where the wood surface of the floor survived, relatively undamaged. Conversely, the exposed wood floor joists showed deep charring, indicating a fire underneath the floor.

Figure 30 – Second floor, stitched and cropped image taken from UAS photographs facing east.

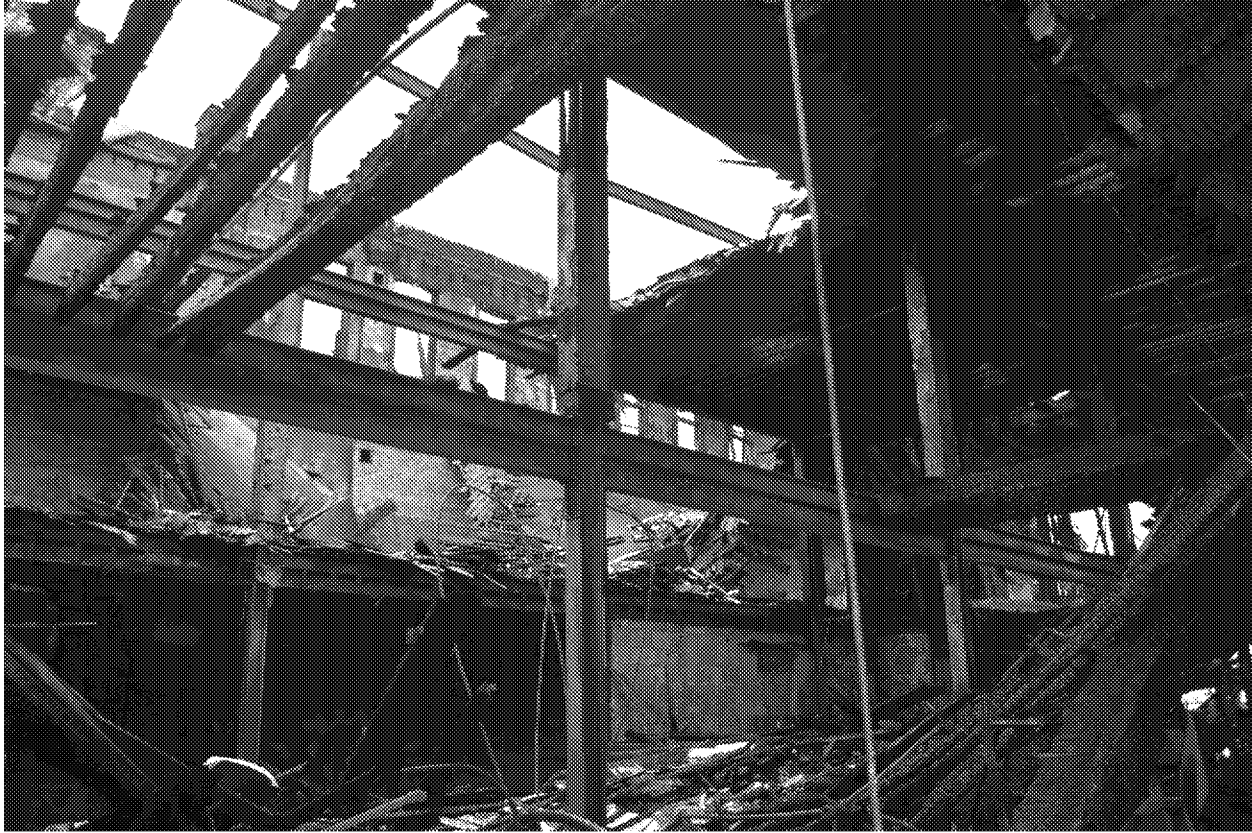
present on both the vertical and horizontal I-beams. The oxidation of the I-beams lessened in severity when moving west through the structure. The furthest west vertical I-beam exhibited almost no oxidation.

Figure 31 – Oxidized I-beams in the northeast corner facing southwest.

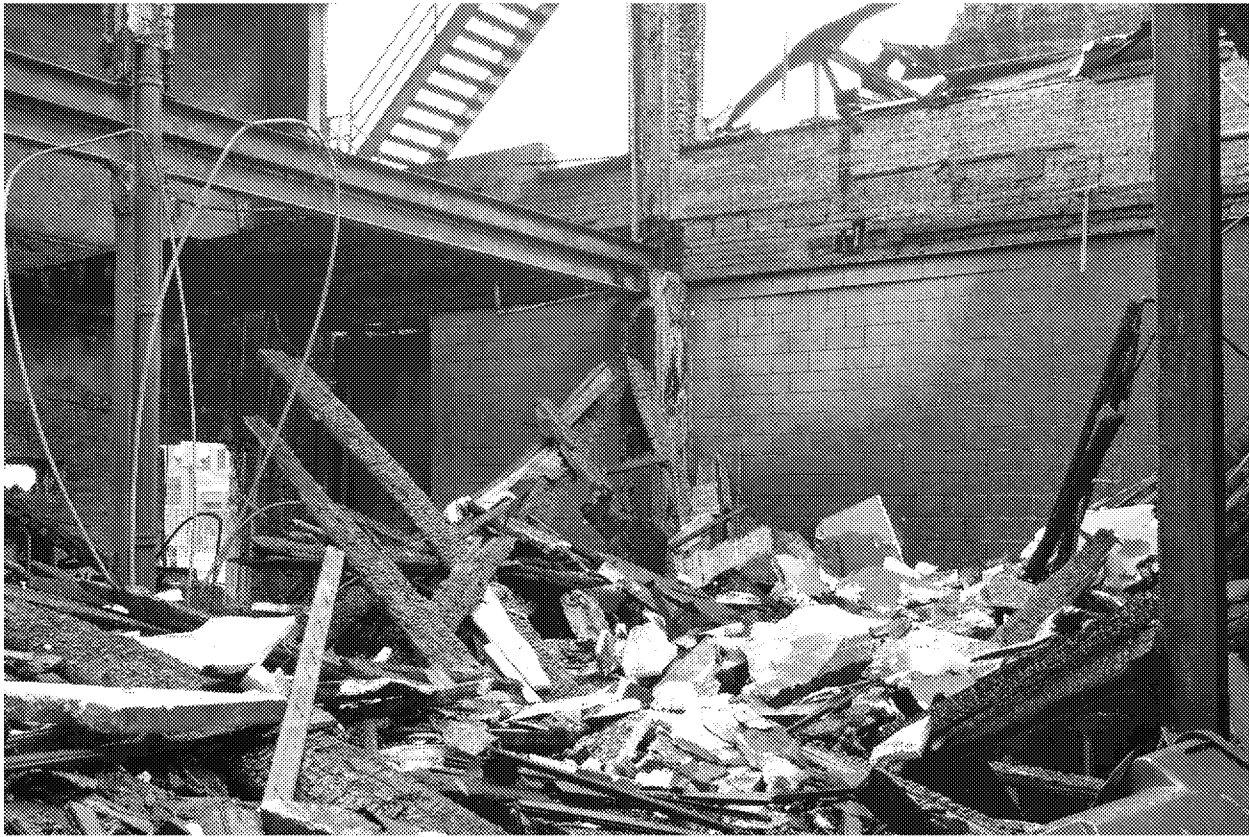
187. Additionally, investigators observed a clean burn pattern along the east wall. The line of demarcation separating the area of clean burn from the area with soot and smoke deposits rose when moving toward the south (Figure 32). The directional oxidation and clean burn patterns indicate longer duration and intensity of burning in the northeast corner of DC Theatricks.

Figure 32 – Clean burn pattern along the east wall facing northeast.

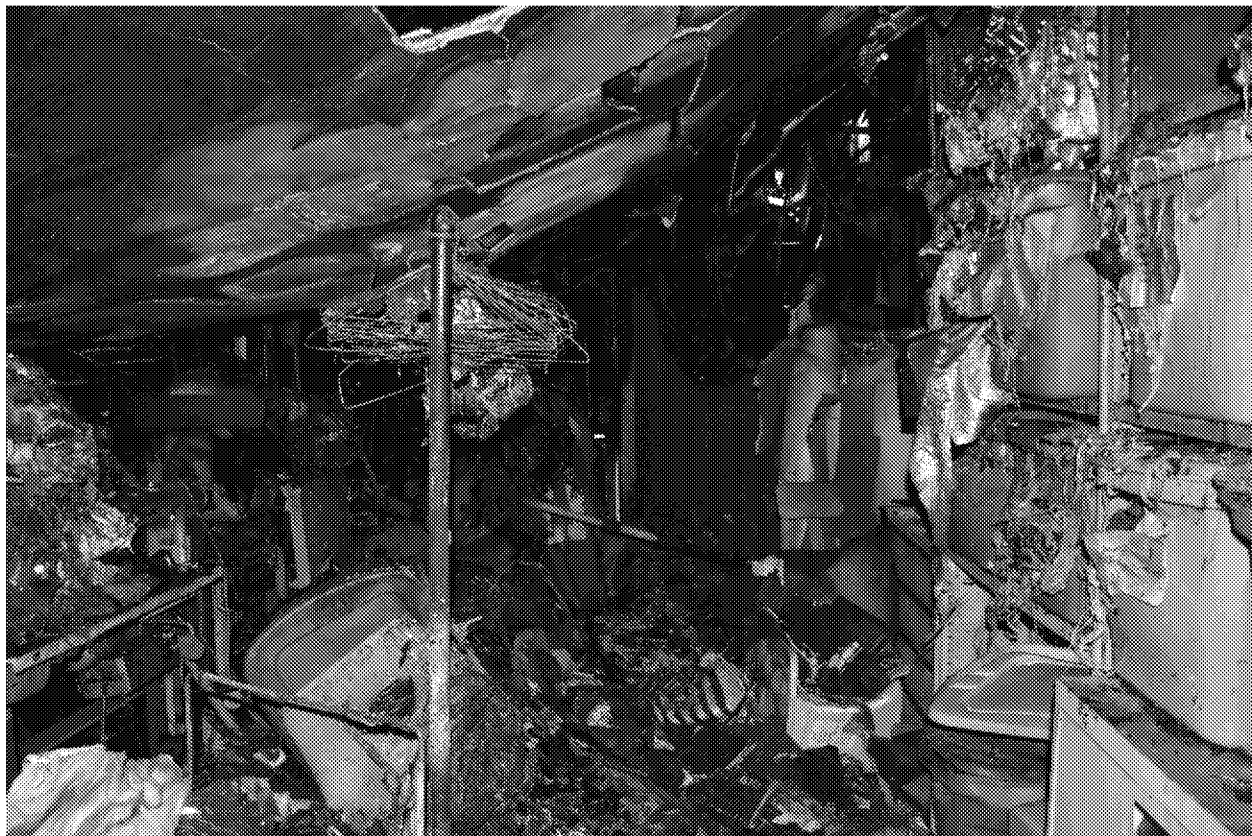
192. Metal storage racks were located along the south wall next to the southernmost clothing rack in the southeast corner of the basement. Plastic tubs of fabric materials were located on these racks. The racks at floor level suffered minor deformation and melting. However, the tubs and fabric at ceiling level suffered significant charring, melting and mass loss.

Figure 33 – Photo facing east into the southeast corner of the basement.

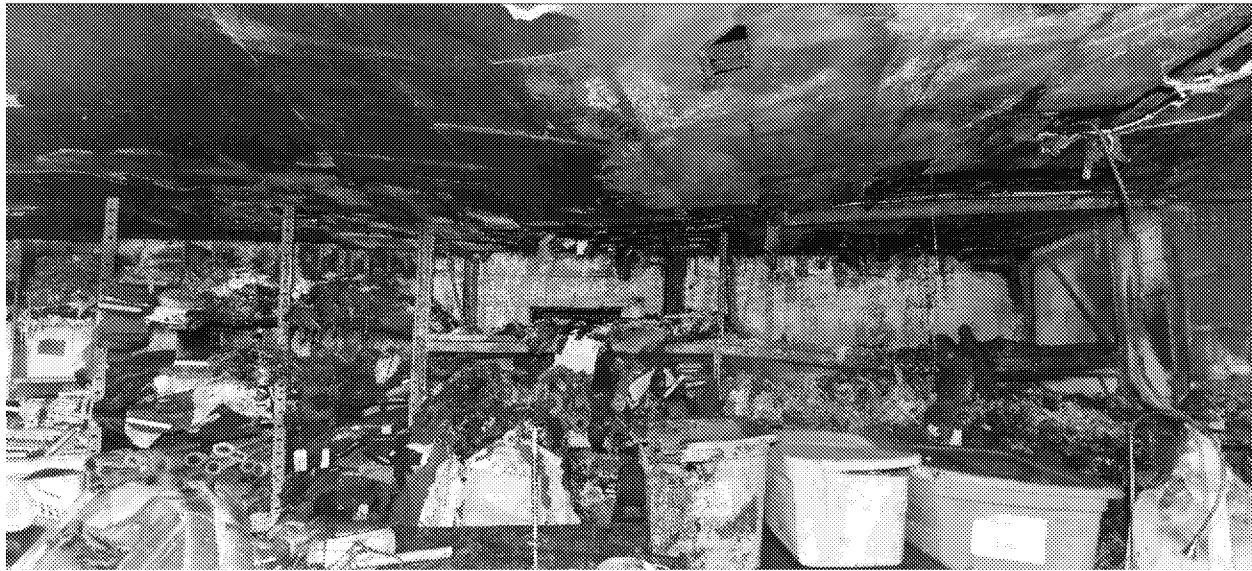
shelf had melted from the top down with the bottoms surviving. The wall behind the shelves sustained thermal damage. The paint on the wall had been consumed and there were areas of significant soot and smoke deposits.

Figure 34 – South wall of basement.

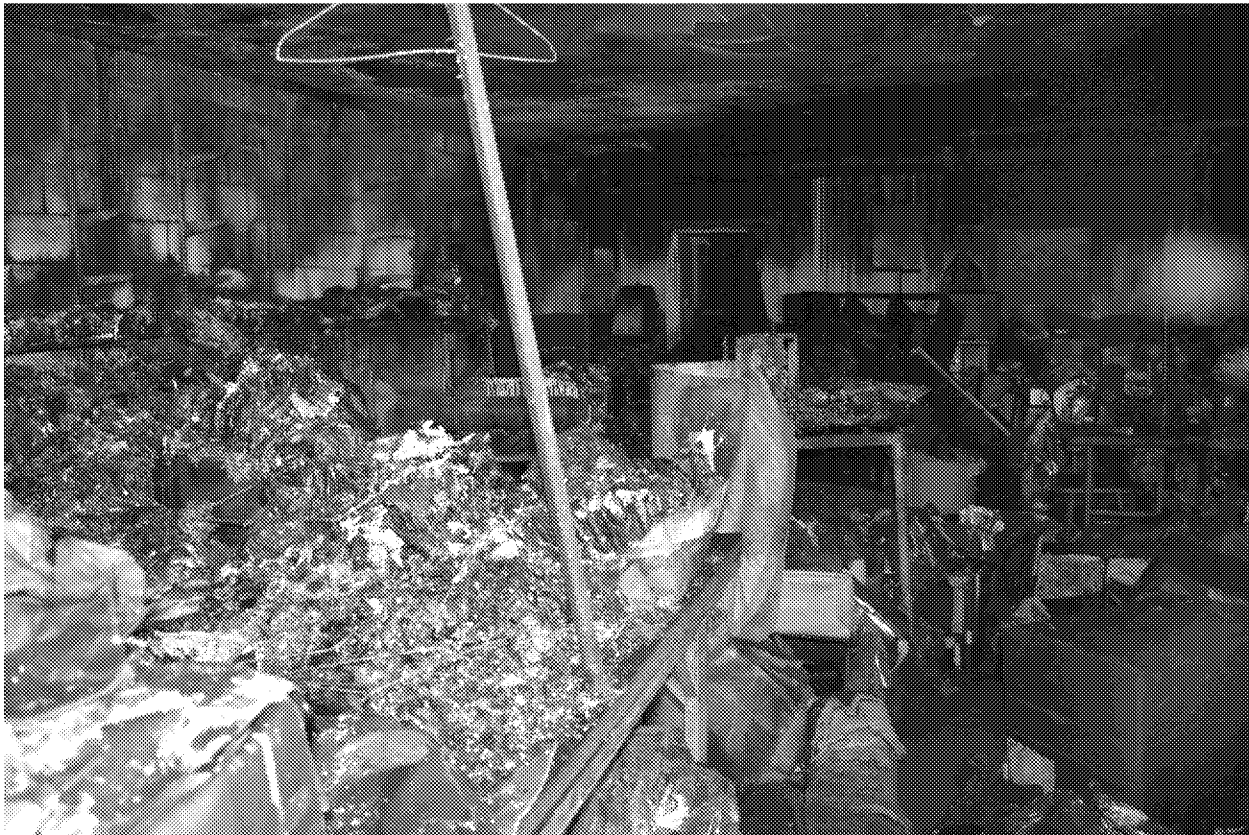
198. Each cutting table had thermal damage to fabric and boxes located on top of the tables. The most significant damage was on the west end of the eastern table and on the east end of the western table. These areas sustained significant damage and the boxes and fabric in these areas were reduced to fine, white ash. However, lightweight fuels nearby on the tables, such as cardboard boxes, foam, and fabrics, remained relatively free from thermal damage (Figure 35).

Figure 35 – Southwest basement including cutting tables.

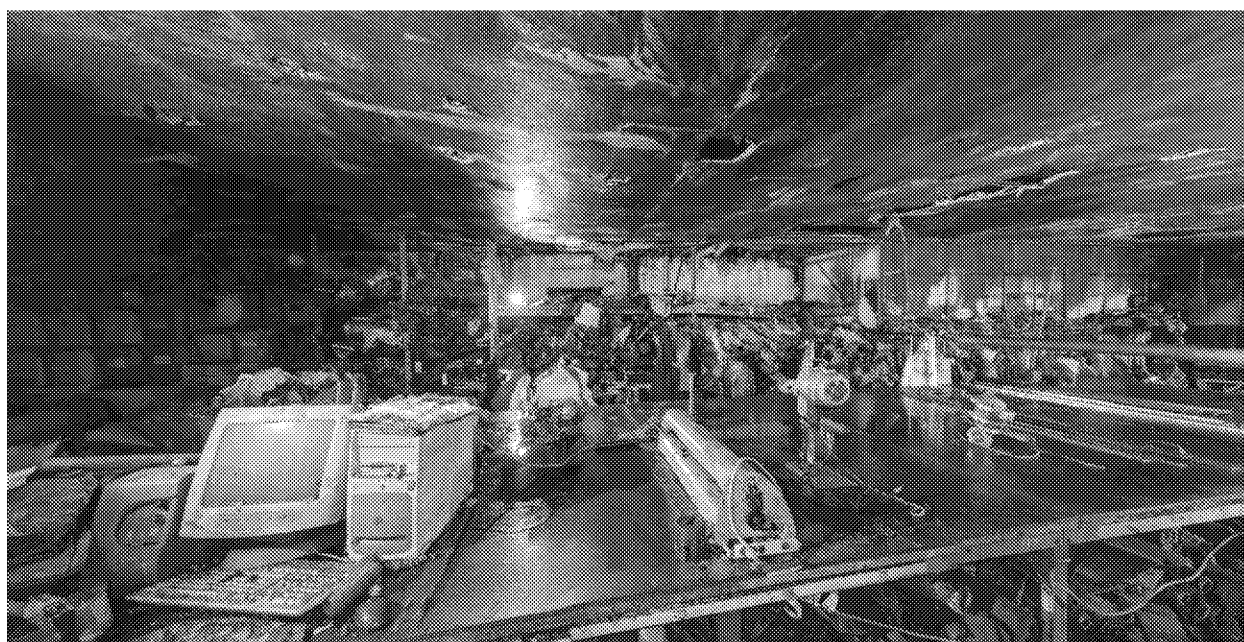
200. Investigators located the tools referenced by employees during their interviews. The computer, vinyl cutter, Eastman rotary cutter, and hot cutter were all located in the central portion of the eastern cutting table. These tools did not sustain any significant fire damage and did not show any signs of failure (Figure 36). These tools were also located to the east of the significant damage on top of the tables. A large cardboard roll on top of the table separated the area of significant fire damage from the tools. The only damage to the cardboard roll was on the top side nearest the south wall. In this area, the cardboard sustained some charring and mass loss. The tools were collected and turned over to the Buffalo Fire Department.

Figure 36 – Eastern cutting table with tools intact.

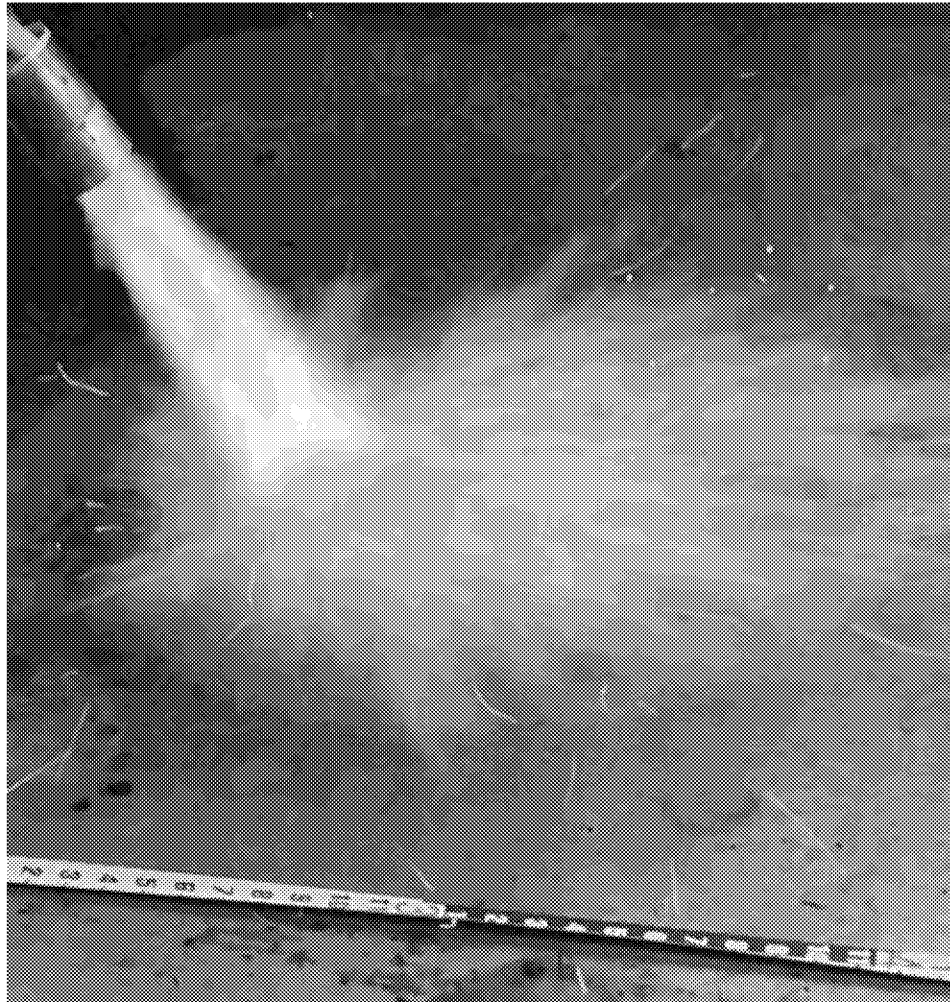
206. Investigators conducted tests with the propane torch used by (b)(6)/(b)(7)(C) and (b)(6)/(b)(7)(C). Investigators operated the torch and observed the visible flames. With the handle on the torch fully depressed the visible flames impacted the concrete floor and extended for approximately two feet (Figure 37).

Figure 37 – Propane torch flames.

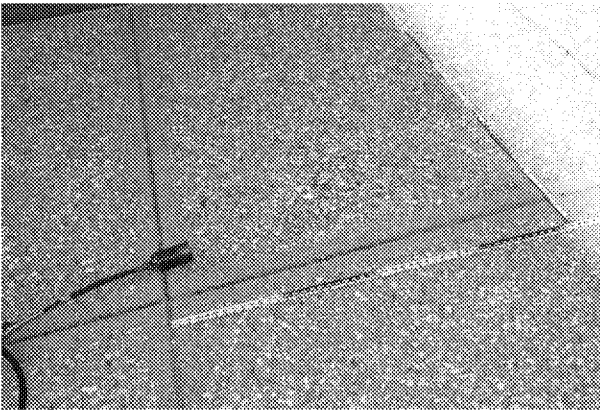
207. Investigators utilized pocket rod measuring devices when conducting the tests. During one of the tests, the torch was located approximately three and a half feet away from the pocket rod. The handle on the torch was fully depressed however, flames were not constantly visible and would intermittently appear and disappear. Despite visible flames only sporadically appearing, the pocket rod began to discolor and ignited resulting in charring and melting (Figures 38 and 39).

Figure 38 – Torch and pocket rods.

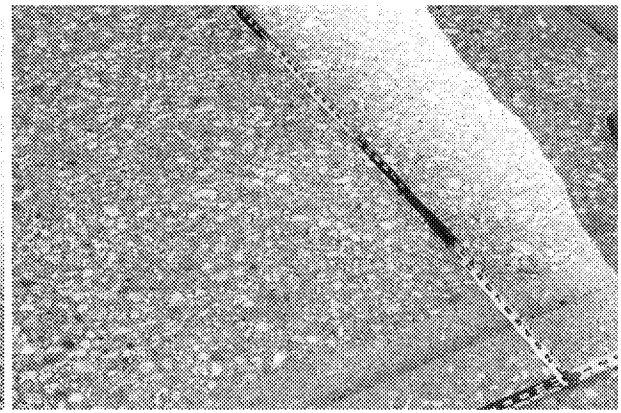
Figure 39 – Discolored and melted section.

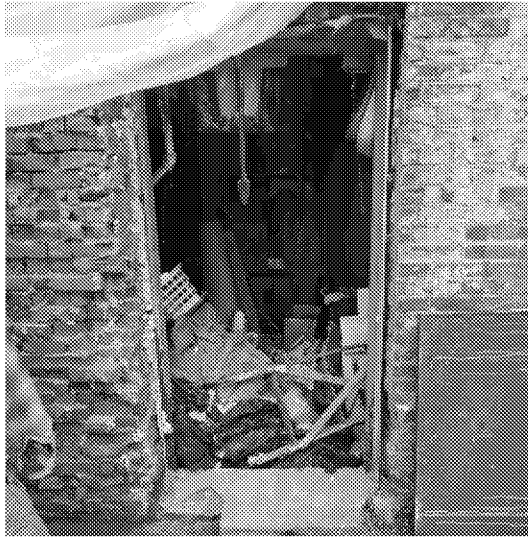
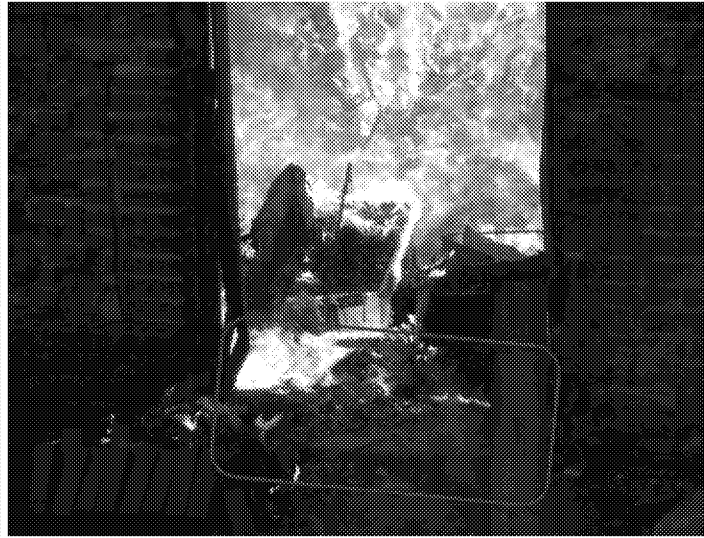
246. Propane Torch: While conducting the video review, investigators observed a propane torch being used on the north exterior side of the structure. As previously stated, the torch is used in and around the north doorway to DC Theatricks. The door had been removed and a piece of plywood had been installed over the opening. There was a gap under the plywood, as evidenced by (b)(6)/(b)(7)(C)'s actions on video (kneeling down to look under the plywood) and (b)(6)/(b)(7)(C)'s 911 call. Investigators were able to determine that items inside the doorway were in close proximity to the plywood, and possibly directly against it. This was evidenced by photographs obtained during the investigation, including Figure 25, which shows flaming debris spilling across the concrete threshold shortly after the fire was discovered.

Figure 17 – Pre-fire, north doorway.

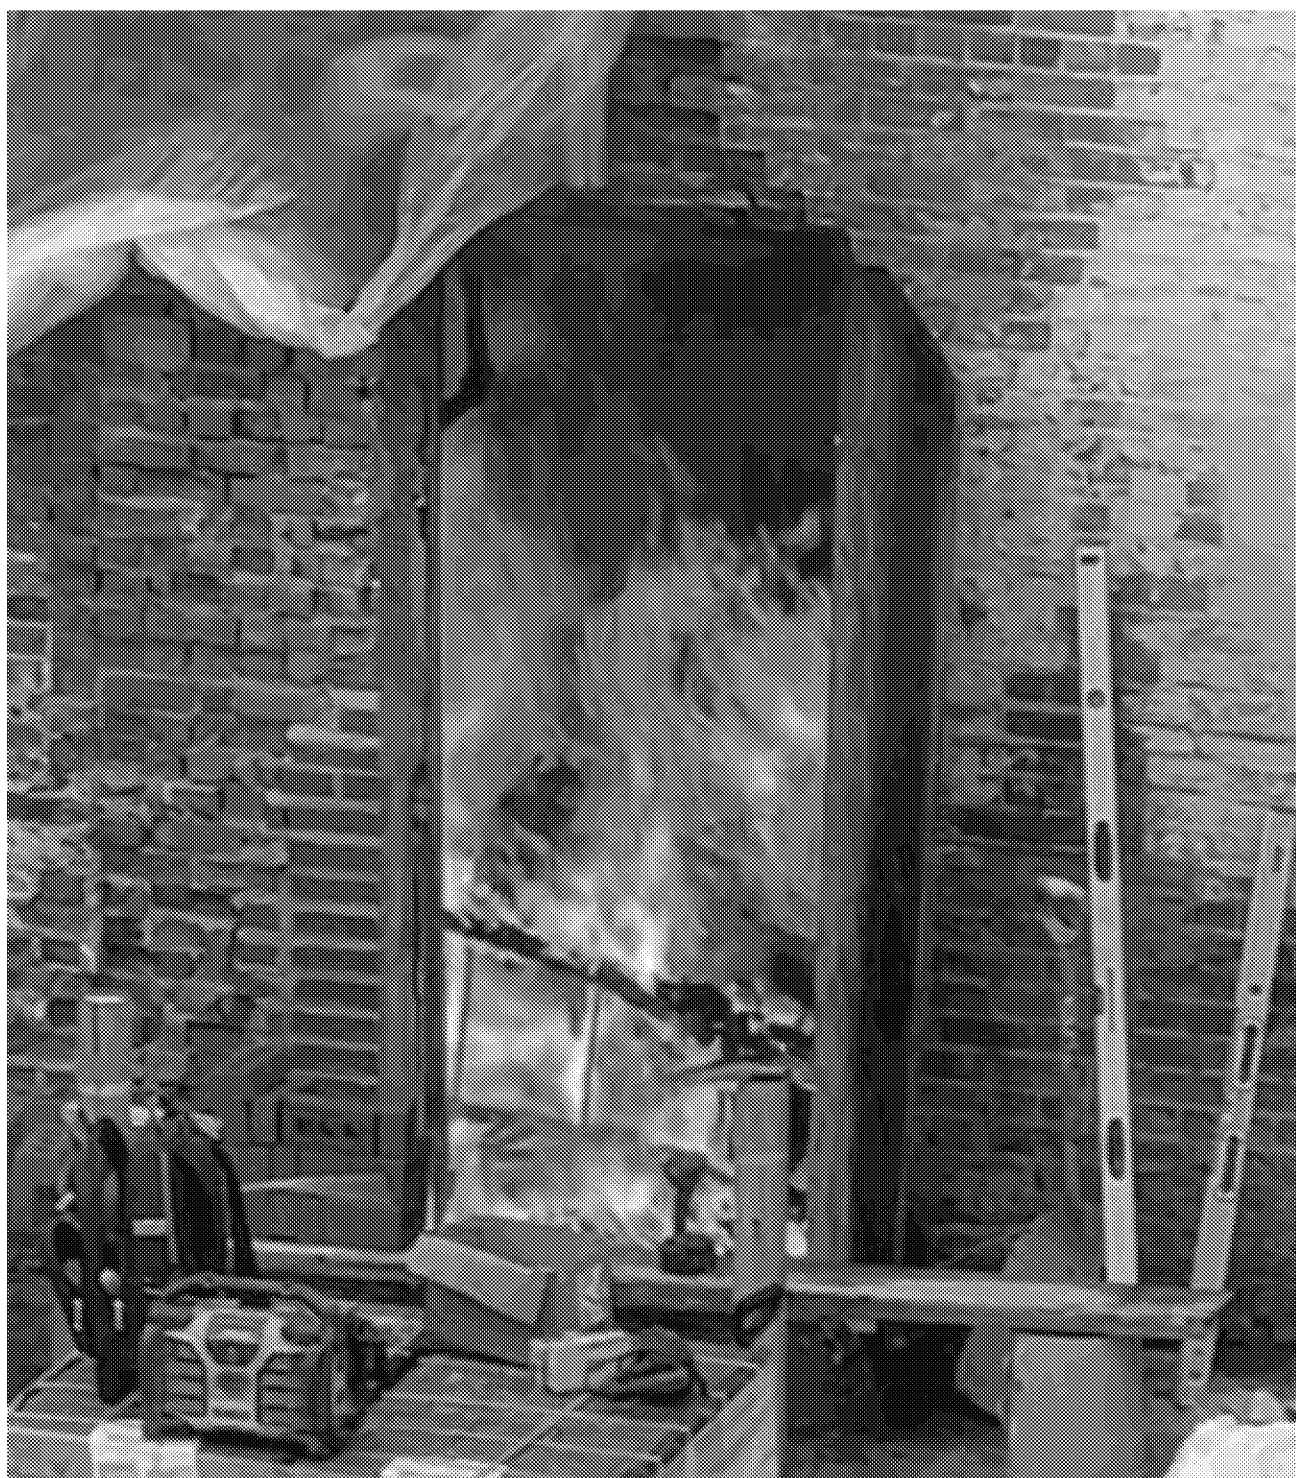
248. Additionally, a leaf blower was used in and around the doorway as well. The additional air movement would have aided in ignition of the material just inside the doorway. Application of an accelerated air flow would have also aided in the growth of the fire once established. Additionally, shortly after the fire was discovered, (b)(6)/(b)(7)(C) opened the plywood which exposed the interior surface. A video was taken shortly after the plywood was opened, and investigators were observed a steep V shaped pattern on the east interior surface of the plywood (Figure 24). This is consistent with a fire originating in that area. Moreover, had a large fire originated elsewhere in the structure, the radiant heat from that fire would have caused uniform damage to the interior surface of the plywood. Additionally, costumes in plastic bags were hanging on the wall and extending down into the doorway, as evidenced by Figure 17. Once a fire was established just inside the doorway, it would easily spread to the material above it. Investigators were unable to eliminate the propane torch as a potential ignition source.

Figure 24 - Charring on the east interior face of the plywood
