Property Inspection Report

**PROSPECTOR
HOME INSPECTIONS**

**123 Main St.
Inspection Prepared For: Joe Smith
Agent: Top Seller -**

**Date of Inspection: 9/13/2023
Home Age: 47 yrs Size: 1700 Sq. Ft.**

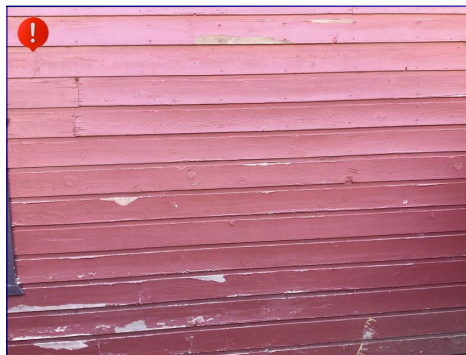
A large portion of the siding on the home is in good condition. There are places where the siding paint is peeling. The peeling paint can hold moisture and pests which can further deteriorate the wood siding. I recommend having a painting contractor evaluate the siding and repair and paint the areas that are showing bare wood and peeling paint.

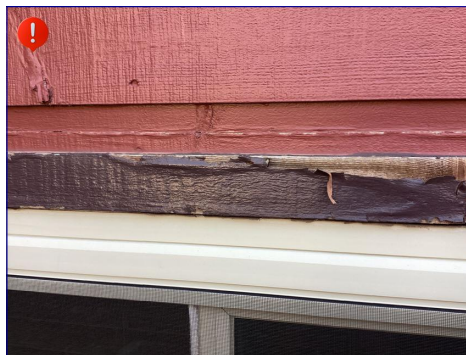
The trim is in a similar condition to the siding. There are portions of the trim that are in good condition. There are also portions of the trim that need to be maintained. The peeling paint can hold moisture and pests and lead to further wood damage. I recommend a painting contractor evaluate and repair the trim.

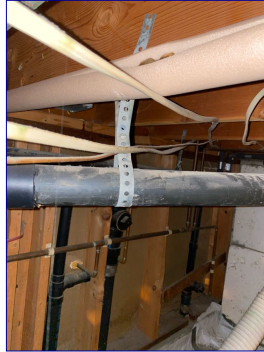
I observed plastic drain piping supported with metal hangers. Metal hangers can damage the plastic piping over time. I recommend having the metal hangers replaced with the proper hangers.

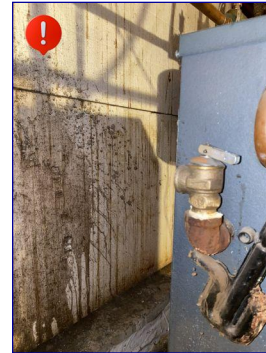
The temperature pressure release valve did not have the proper extension on it. I recommend having the proper extension added.

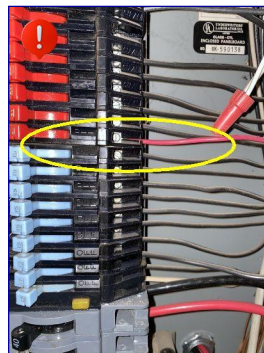
I observed one branch wire was undersized. A 14awg was used where a 12awg wire should be used based on the breaker size. This is a safety hazard. I recommend a licensed electrician evaluate and repair.

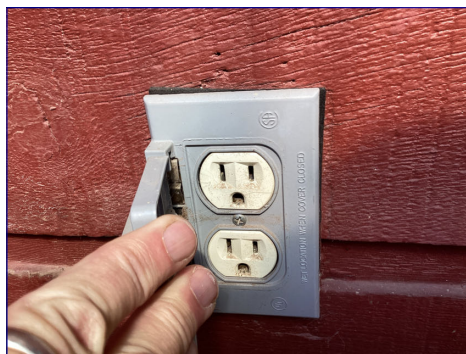
I observed GFCI receptacles were not installed on the exterior of the home. This is a safety concern. However, at the time the home was built, installing GFCI receptacles was not part of standard building requirements. I recommend upgrading the receptacles to current standards.

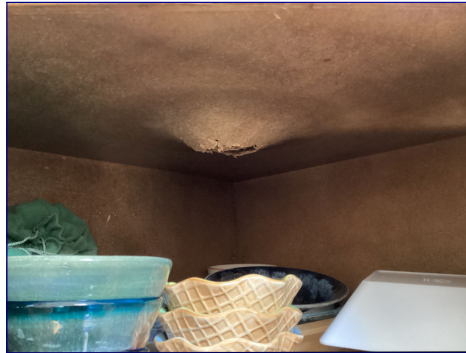
Pretty severe water damage in the top of one of the kitchen cabinets.

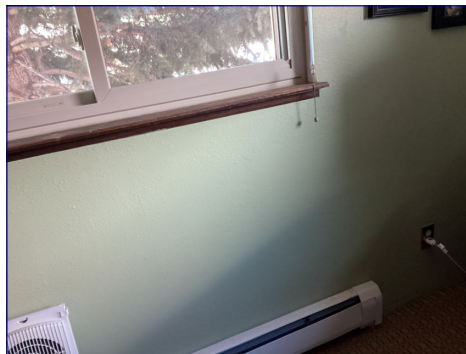
The bottom of the windows in the Bedroom were 44" or more above the floor level. This restricts egress in case of an emergency. This is a safety concern. I recommend consultation with a qualified contractor to address the issue.

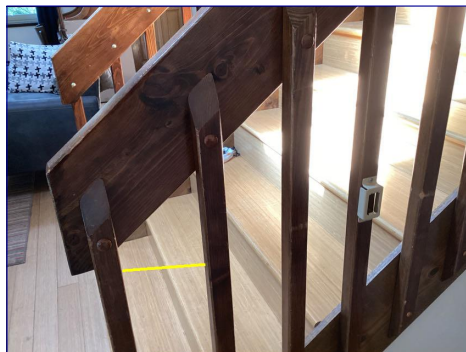
Balusters are too far apart on the railing. Most of the balusters are correct. There is uneven spacing allowing for one space to be too big. This is a safety concern for small children. It is recommended balusters be a maximum 4 inches apart. I recommend a qualified builder address this issue.

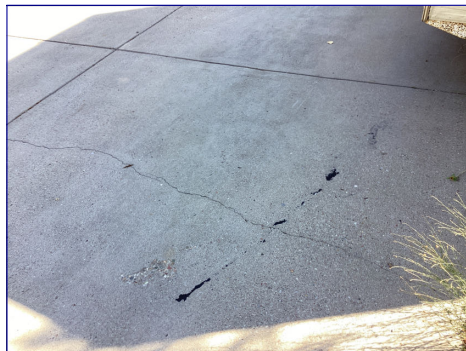
I observed cracks in the driveway and parking area. These cracks look like settling cracks. I recommend sealing and monitoring the cracks. If the cracks get larger, I recommend a qualified contractor evaluate the driveway.

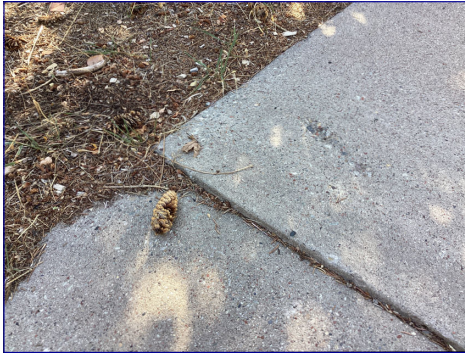
I observed the walkways had some settling but were usable. I recommend monitoring the walkways for tripping hazard.

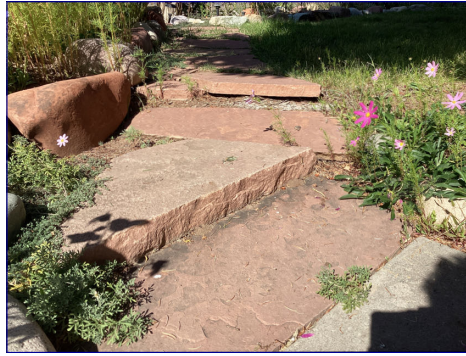
I observed uneven slabs at the walkways. This is a tripping hazard. I recommend using additional caution in these areas.

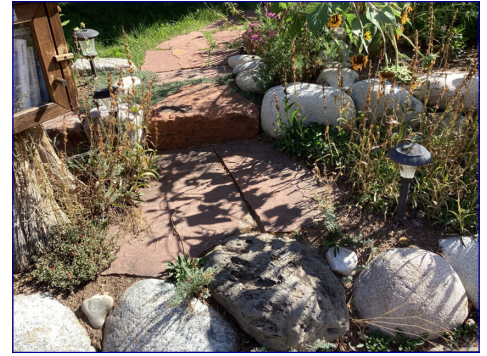
The home has a very creative walkway from the service walk through the yard. There are some tripping hazards as the steps are not consistent. Use caution in these areas.

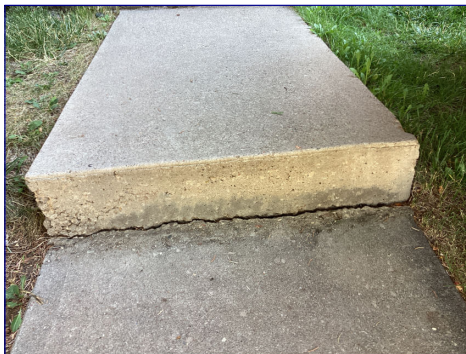
I observed settling cracks in the steps. I recommend having the cracks sealed to help prevent additional damage to the concrete.

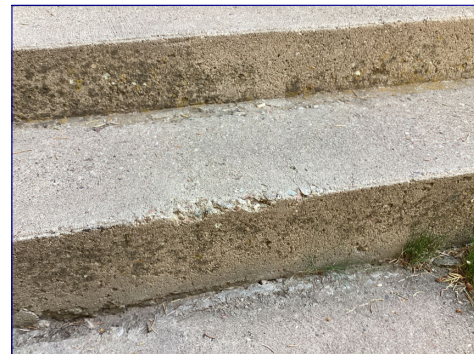
I observed minor damage to the front steps. Some spalling, a little bit of settling, and some chipping. The steps are in good condition for their age. I recommend having the cement sealed to help prolong the life of the front walk and steps.

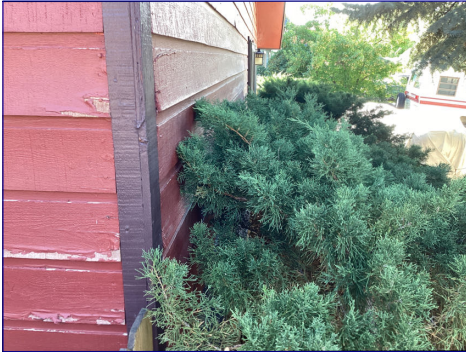
I observed vegetation in contact with the house. I recommend trimming trees/vegetation, so it doesn't come into contact with the home.

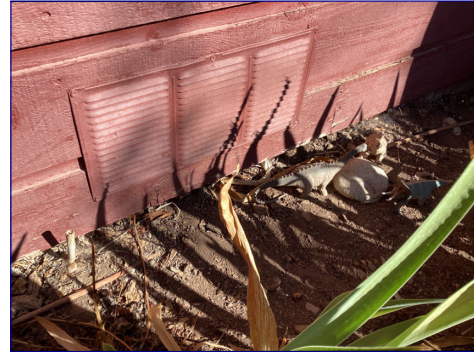
I observed an improper clearance from the siding to the ground. This can cause moisture damage over time. The recommended clearance is 6-8" from the ground to the bottom of the siding. I recommend repairing and monitoring.

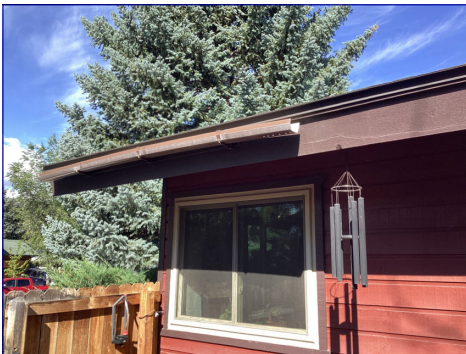
The gutters were only installed on a portion of the house. I recommend a licensed roofer add gutters to properly direct water flow away from the home and the foundation.

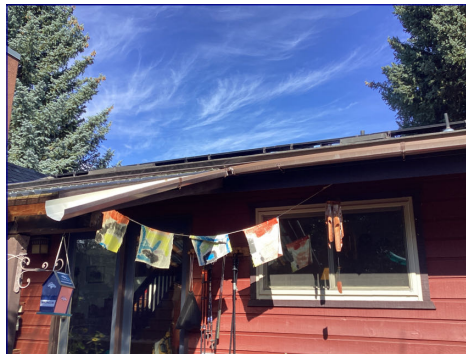
I observed there were no downspouts installed on the gutters. I recommend adding downspouts to the gutters.

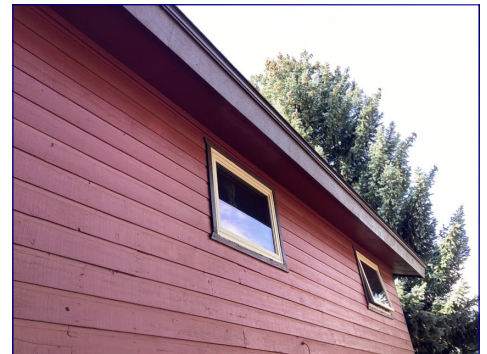
The gutters were only installed on a portion of the house. I recommend a licensed roofer add gutters to properly direct water away from the home and the foundation.

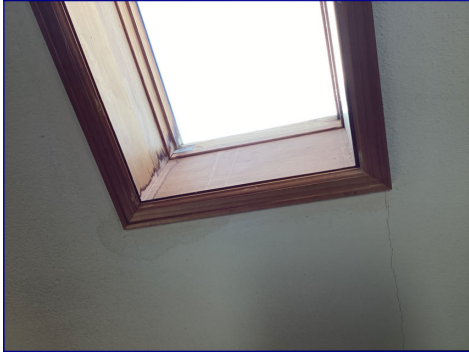
There were indications of moisture around the skylights. I recommend a licensed contractor evaluate and repair.

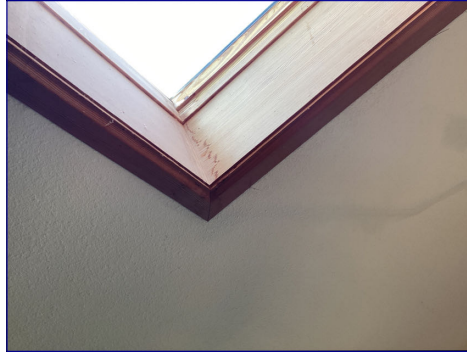
There were indications of moisture around the skylights. I recommend a licensed contractor evaluate and repair.

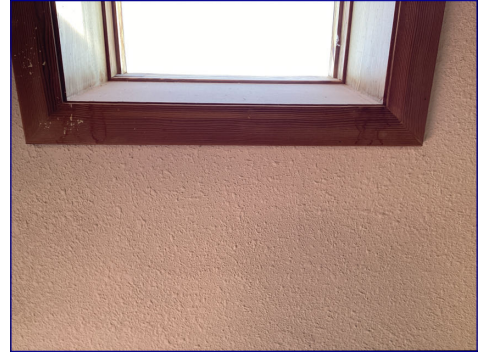
There were indications of moisture around the skylights. I recommend a licensed contractor evaluate and repair.

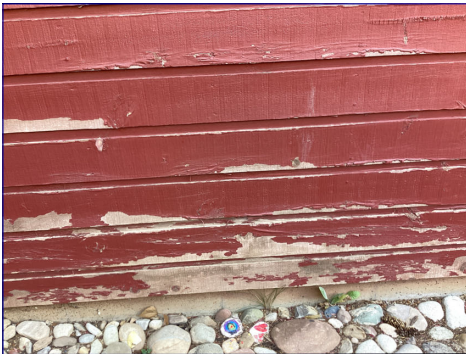
The siding needs routine repair and painting maintenance. I recommend a licensed contractor repair and paint the siding.

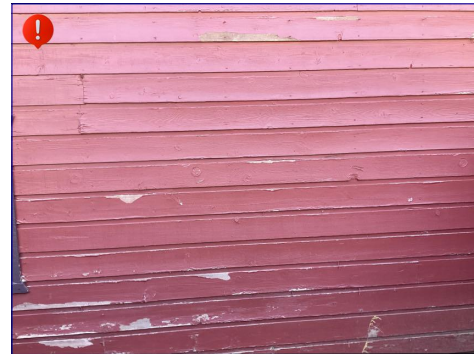
A large portion of the siding on the home is in good condition. There are places where the siding paint is peeling. The peeling paint can hold moisture and pests which can further deteriorate the wood siding. I recommend having a painting contractor evaluate the siding and repair and paint the areas that are showing bare wood and peeling paint.

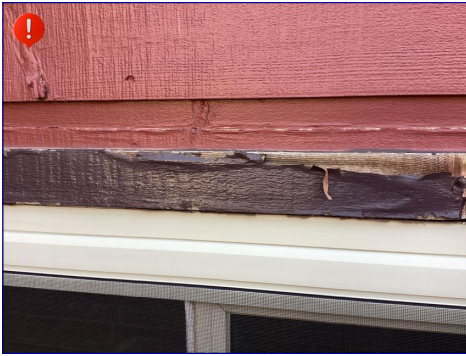
The trim is in a similar condition to the siding. There are portions of the trim that are in good condition. There are also portions of the trim that need to be maintained. The peeling paint can hold moisture and pests and lead to further wood damage. I recommend a painting contractor evaluate and repair the trim.

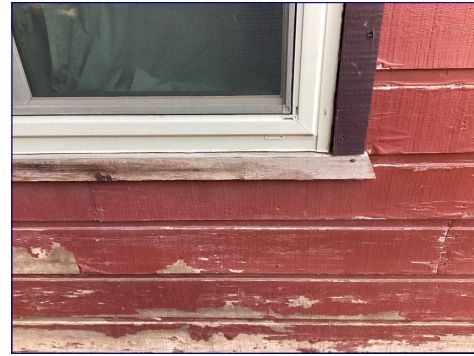
Similar to the other comments, there are multiple places around the house where bare wood is showing and paint is peeling. I highly recommend having a painting contractor repair and paint these areas.

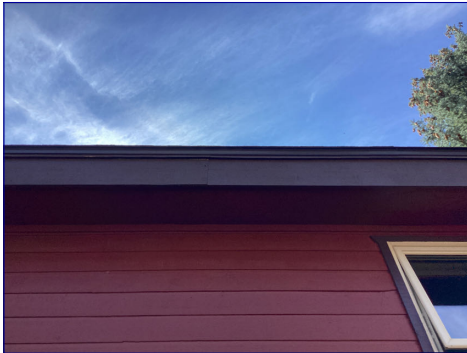
This is photo of a nail pop on the fascia. I recommend having this issue addressed when the painting contractor is working on the siding and the trim.

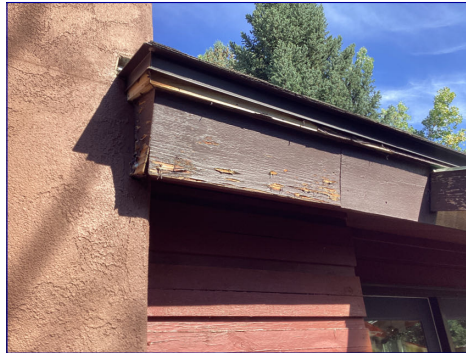
I observed the fascia board shows cupping and other wood damage possibly caused by previous moisture. It is important to maintain the exterior of the home to protect your investment.

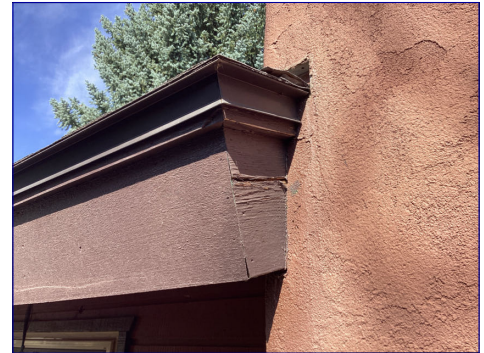
I observed the fascia was damaged. I recommend repair by a qualified professional.

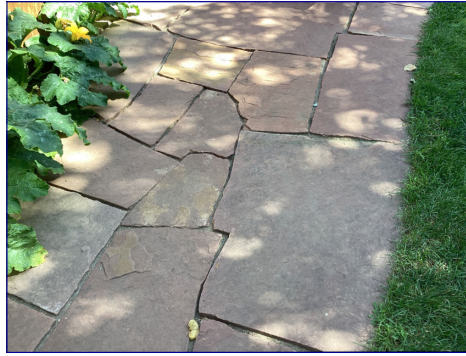
The home has a flagstone patio and flagstone walkways. I recommend monitoring and maintaining the stones in a level orientation.

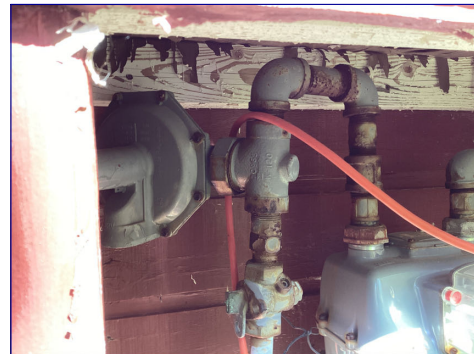
I observed the gas service pipes were corroded. I recommend contacting the gas provider to service their equipment.

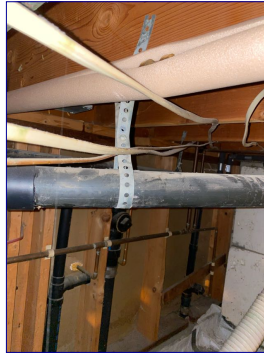
I observed plastic drain piping supported with metal hangers. Metal hangers can damage the plastic piping over time. I recommend having the metal hangers replaced with the proper hangers.

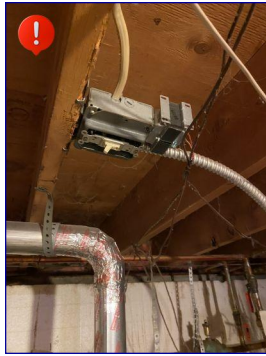
The Master Shut-off for the Boiler. I recommend installing a cover plate. Not having a cover plate is a safety hazard.

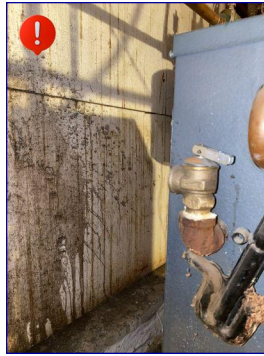
The temperature pressure release valve did not have the proper extension on it. I recommend having the proper extension added.

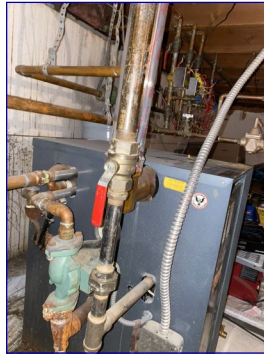
I observed corrosion on multiple parts of the boiler. The boiler worked fine. The boiler is past the normal operating life span. I recommend budgeting for a new boiler.

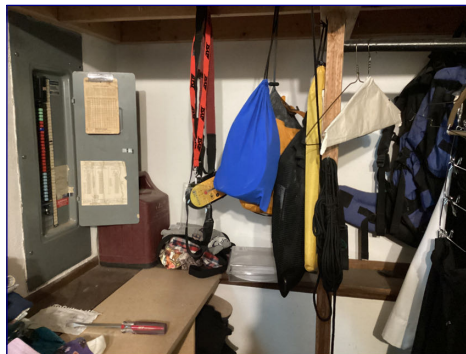
- I observed there was insufficient clearance to the electrical panel. A clearance of 3 feet around the electric panel is standard. I recommend moving items to create safe access to the electric panel.

The area surrounding the electric panel is crowded by personal belongings. I recommend keeping the area surrounding the electric panel clear.

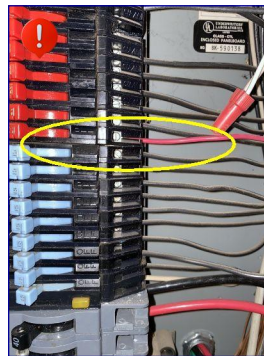
I observed one branch wire was undersized. A 14awg was used where a 12awg wire should be used based on the breaker size. This is a safety hazard. I recommend a licensed electrician evaluate and repair.

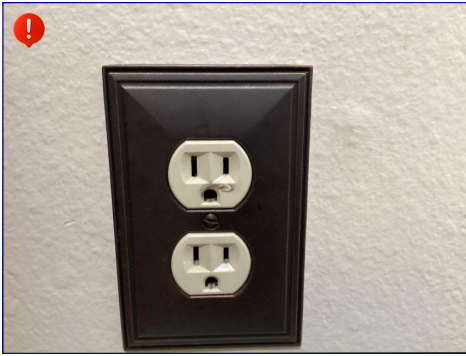
I observed a scorched receptacle. This could be a safety hazard. I recommend evaluation by a licensed electrician.

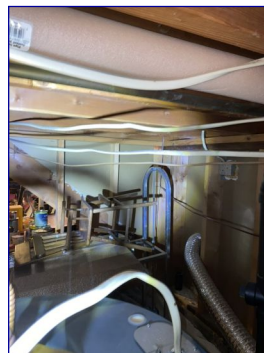
I observed wiring not attached properly. I recommend evaluation and correction by a licensed electrician for safety.

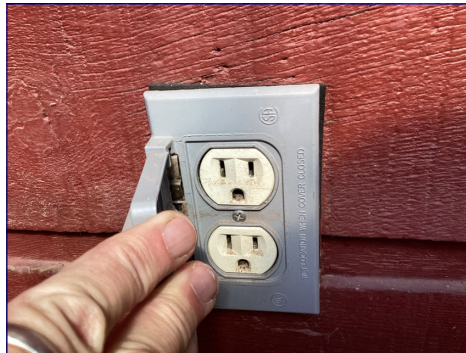
I observed GFCI receptacles were not installed on the exterior of the home. This is a safety concern. However, at the time the home was built, installing GFCI receptacles was not part of standard building requirements. I recommend upgrading the receptacles to current standards.

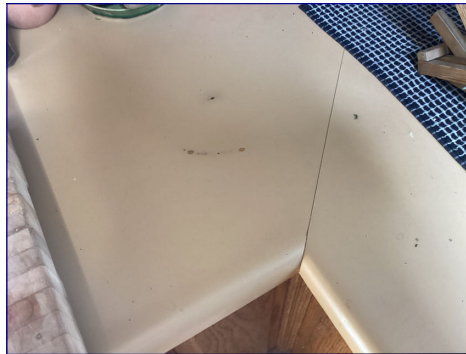
The kitchen countertops were damaged in one or more areas. I recommend a professional contractor repair or replace as needed.

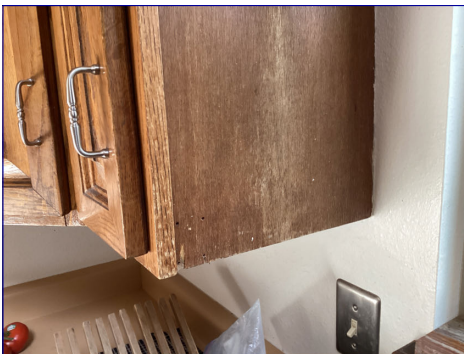
The cabinets had minor damage. This can be expected in a 40+ year old home.

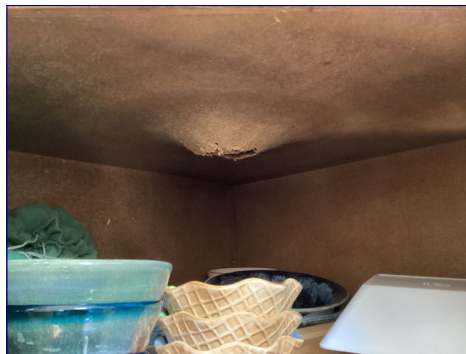
Pretty severe water damage in the top of one of the kitchen cabinets.

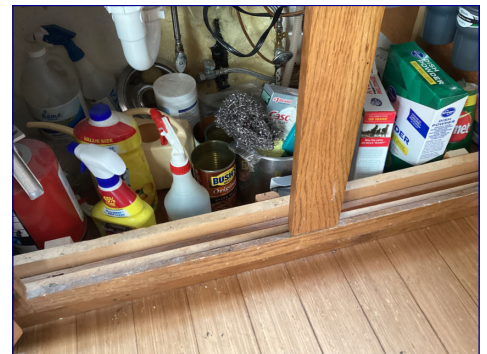
The under sink cabinet floor is nonexistent.

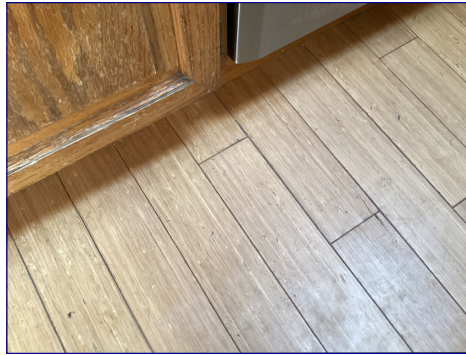
There was a little bit of damage and staining where the bamboo boards meet each other. I discussed with the homeowner and was informed that there were multiple leaks from the water filter, disposal, and dishwasher. All three appliances have since been replaced.

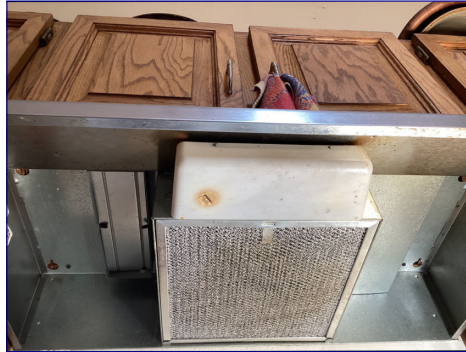
The exhaust vent fan exhausts inside the kitchen. Ideally, the fan would exhaust to the exterior of the home. I recommend exhausting the fan to the exterior of the house.

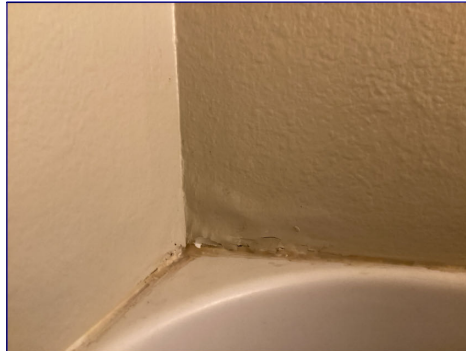
There is bubbling and peeling paint in the corner of the shower insert. Most likely caused by water pooling during showers. The Drywall in the immediate area is mostly firm. I recommend repairing the area and keeping it painted and caulked.

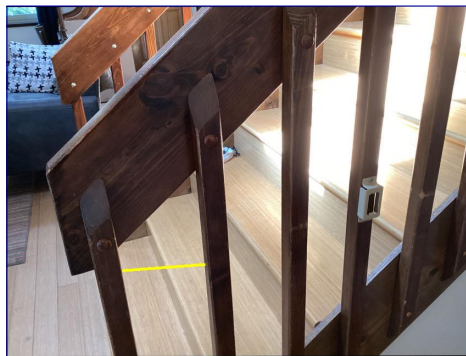
Balusters are too far apart on the railing. Most of the balusters are correct. There is uneven spacing allowing for one space to be too big. This is a safety concern for small children. It is recommended balusters be a maximum 4 inches apart. I recommend a qualified builder address this issue.

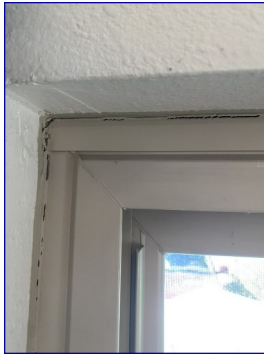
I recommend caulking around windows. Air can leak in and out of a building through gaps and cracks around the window frames.

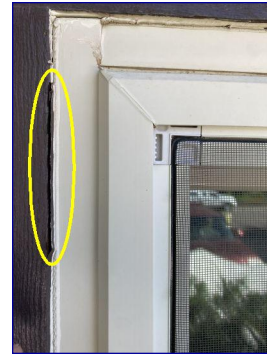
I observed gaps around the windows on the exterior of the house. I recommend repair the caulking around the windows to prevent moisture and pest intrusion.

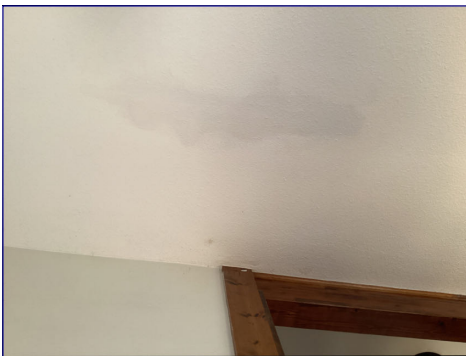
There is staining on the living room ceiling. Monitor and repair as needed. Owners stated the damage occurred before a new roof and the solar system were installed.
