Property Inspection Report

**PROSPECTOR
HOME INSPECTIONS**

**123 Main St.
Inspection Prepared For: Joe Smith
Agent:**

**Date of Inspection: 9/13/2023
Home Age: Size: 1700 Sq. Ft.**

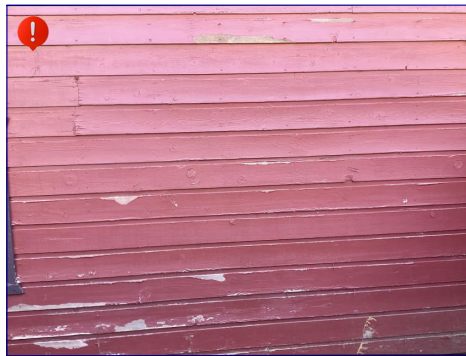
A large portion of the siding on the home is in good condition. There are places where the siding paint is peeling. The peeling paint can hold moisture and pests which can further deteriorate the wood siding. I recommend having a painting contractor evaluate the siding and repair and paint the areas that are showing bare wood and peeling paint.

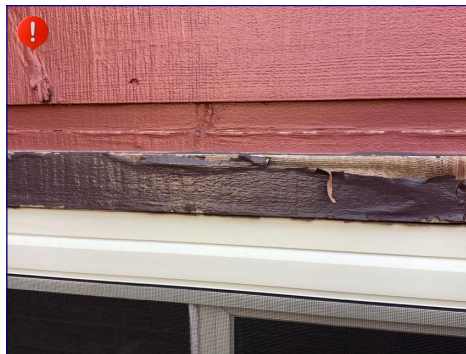
The trim is in a similar condition to the siding. There are portions of the trim that are in good condition. There are also portions of the trim that need to be maintained. The peeling paint can hold moisture and pests and lead to further wood damage. I recommend a painting contractor evaluate and repair the trim.

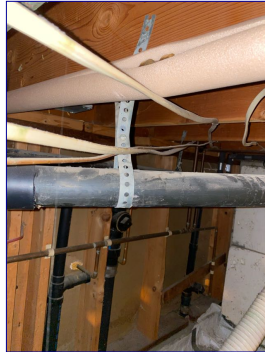
I observed plastic drain piping supported with metal hangers. Metal hangers can damage the plastic piping over time. I recommend having the metal hangers replaced with the proper hangers.

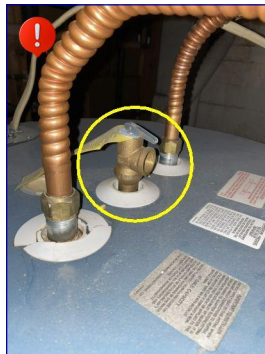
I observed the temperature-pressure relief valve extension was improper on the water heater. This is a safety concern. The extension should be installed to run to the side of the unit and terminate 4"-6" off the floor. I recommend a licensed plumber make the necessary repair.

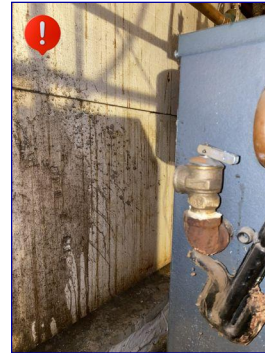
The temperature pressure release valve did not have the proper extension on it. I recommend having the proper extension added.

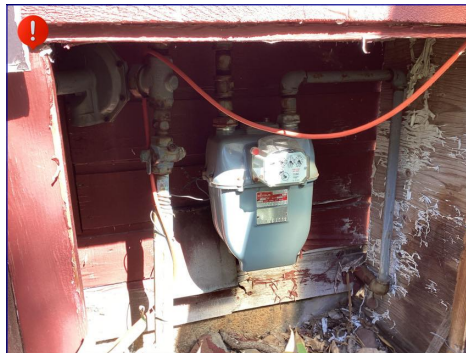
The gas meter and furnace exhaust are too close to each other. This is not acceptable according to today's standards. This is a safety issue. I recommend an HVAC technician evaluate and address this safety issue.

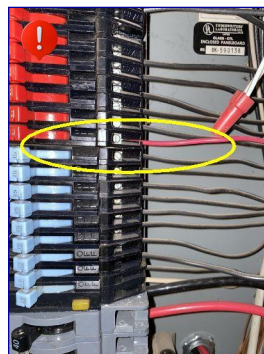
I observed one branch wire was undersized. A 14awg was used where a 12awg wire should be used based on the breaker size. This is a safety hazard. I recommend a licensed electrician evaluate and repair.

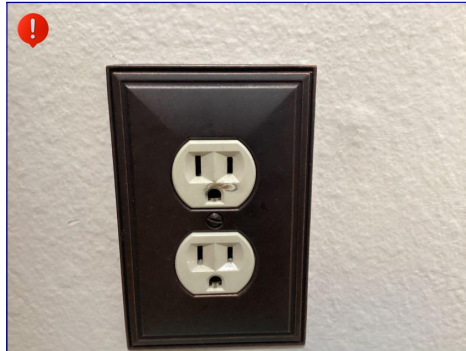
I observed a scorched receptacle. This could be a safety hazard. I recommend evaluation by a licensed electrician.

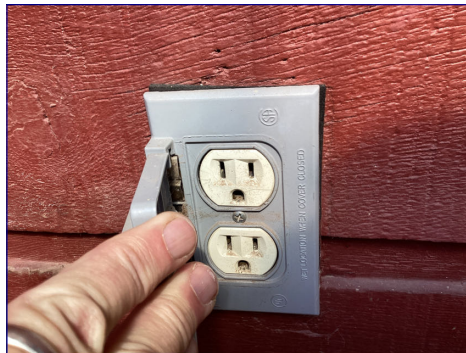
I observed GFCI receptacles were not installed on the exterior of the home. This is a safety concern. However, at the time the home was built, installing GFCI receptacles was not part of standard building requirements. I recommend upgrading the receptacles to current standards.

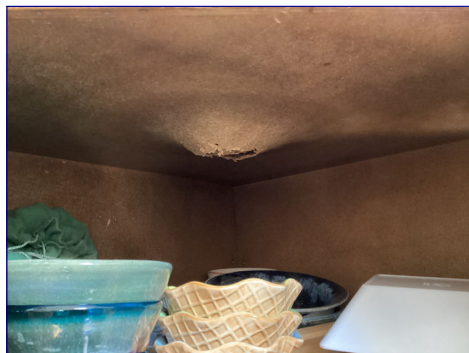
Pretty severe water damage in the top of one of the kitchen cabinets.

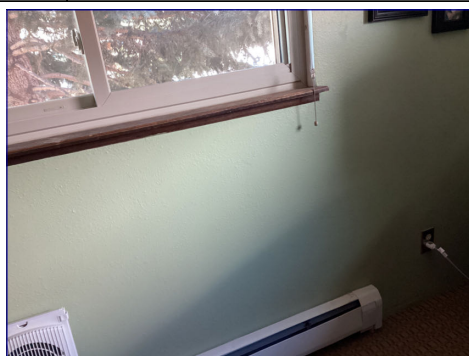
The bottom of the windows in the Bedroom were 44" or more above the floor level. This restricts egress in case of an emergency. This is a safety concern. I recommend consultation with a qualified contractor to address the issue.

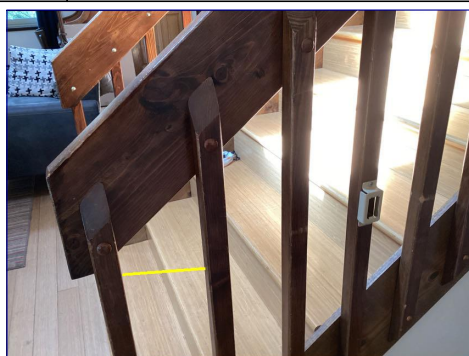
Balusters are too far apart on the railing. Most of the balusters are correct. There is uneven spacing allowing for one space to be too big. This is a safety concern for small children. It is recommended balusters be a maximum 4 inches apart. I recommend a qualified builder address this issue.

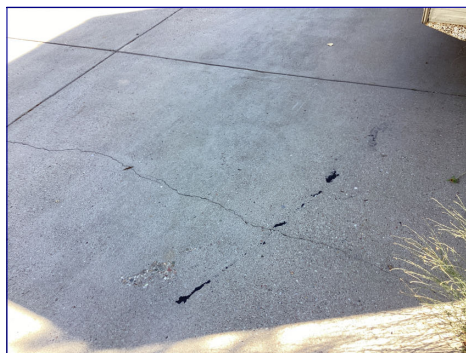
I observed cracks in the driveway and parking area. These cracks look like settling cracks. I recommend sealing and monitoring the cracks. If the cracks get larger, I recommend a qualified contractor evaluate the driveway.

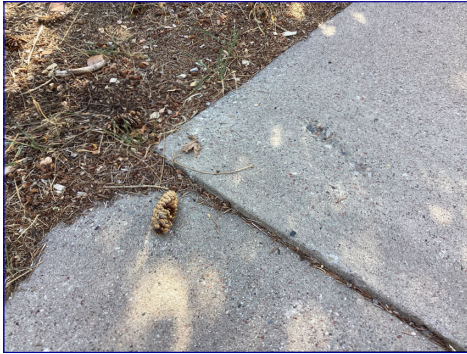
I observed the walkways had some settling but were usable. I recommend monitoring the walkways for tripping hazard.

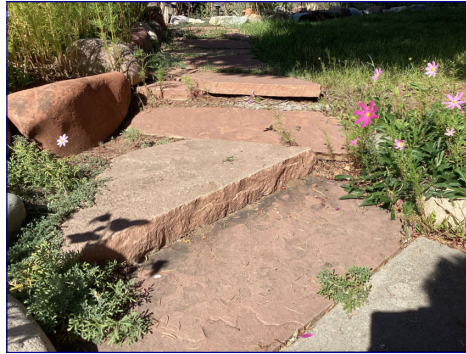
I observed uneven slabs at the walkways. This is a tripping hazard. I recommend using additional caution in these areas.

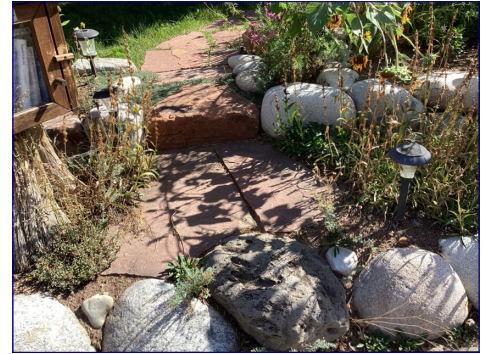
The home has a very creative walkway from the service walk through the yard. There are some tripping hazards as the steps are not consistent. Use caution in these areas.

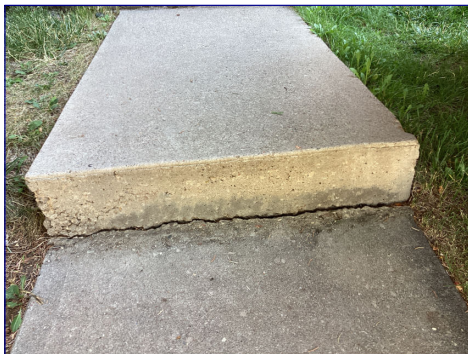
I observed settling cracks in the steps. I recommend having the cracks sealed to help prevent additional damage to the concrete.

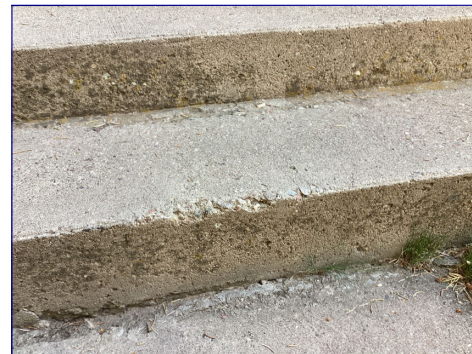
I observed minor damage to the front steps. Some spalling, a little bit of settling, and some chipping. The steps are in good condition for their age. I recommend having the cement sealed to help prolong the life of the front walk and steps.

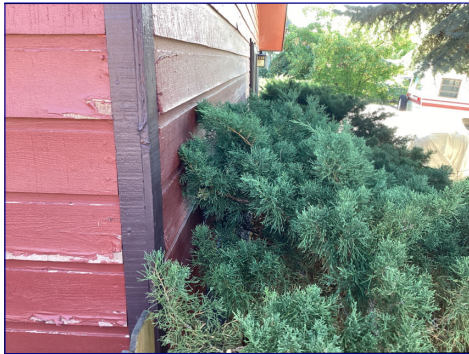
I observed vegetation in contact with the house. I recommend trimming trees/vegetation, so it doesn't come into contact with the home.

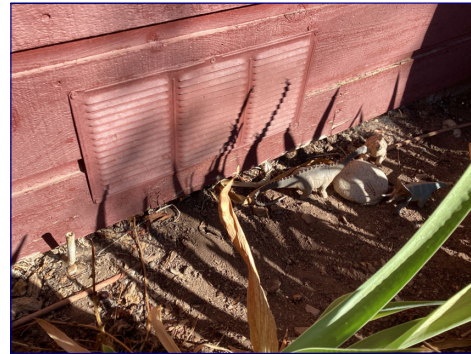
I observed an improper clearance from the siding to the ground. This can cause moisture damage over time. The recommended clearance is 6-8" from the ground to the bottom of the siding. I recommend repairing and monitoring.

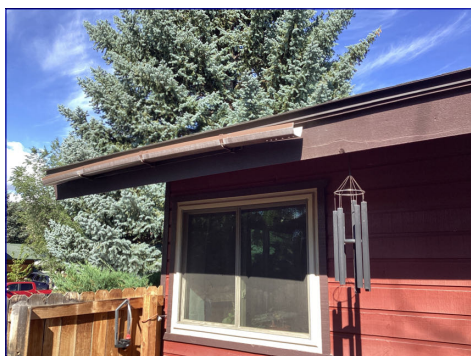
The gutters were only installed on a portion of the house. I recommend a licensed roofer add gutters to properly direct water flow away from the home and the foundation.

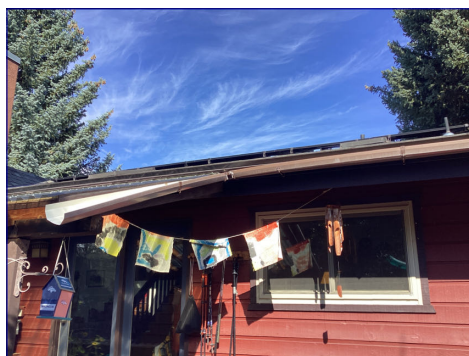
I observed there were no downspouts installed on the gutters. I recommend adding downspouts to the gutters.

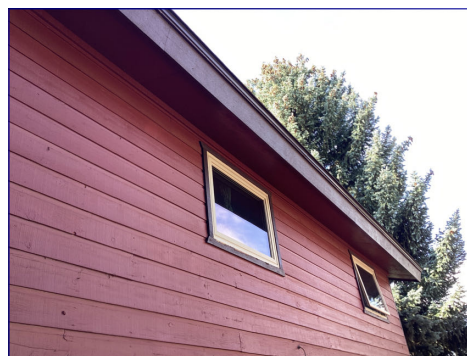
The gutters were only installed on a portion of the house. I recommend a licensed roofer add gutters to properly direct water away from the home and the foundation.

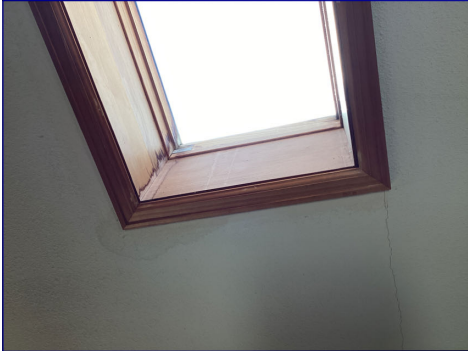
There were indications of moisture around the skylights. I recommend a licensed contractor evaluate and repair.

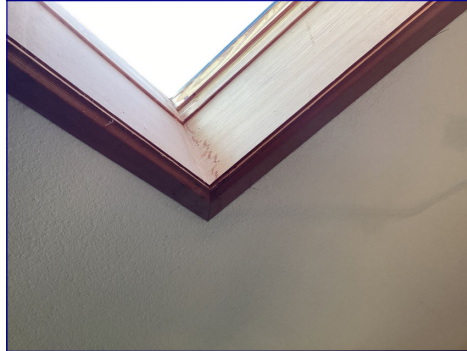
There were indications of moisture around the skylights. I recommend a licensed contractor evaluate and repair.

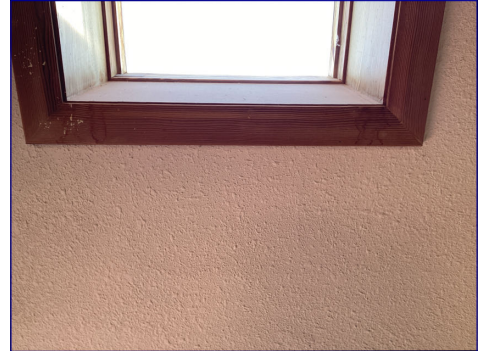
There were indications of moisture around the skylights. I recommend a licensed contractor evaluate and repair.

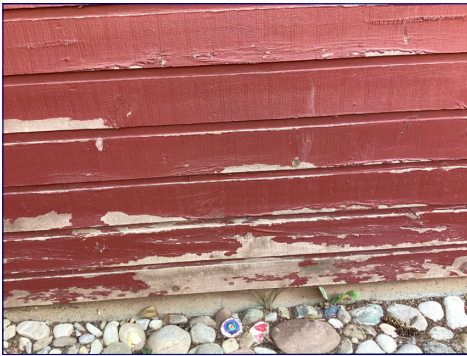
The siding needs routine repair and painting maintenance. I recommend a licensed contractor repair and paint the siding.

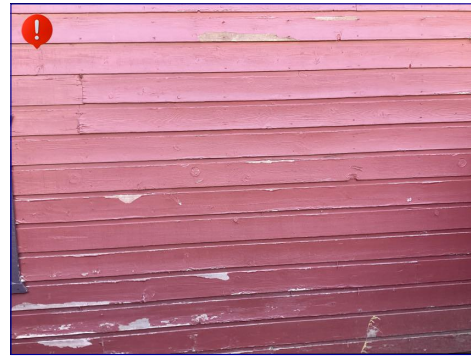
A large portion of the siding on the home is in good condition. There are places where the siding paint is peeling. The peeling paint can hold moisture and pests which can further deteriorate the wood siding. I recommend having a painting contractor evaluate the siding and repair and paint the areas that are showing bare wood and peeling paint.

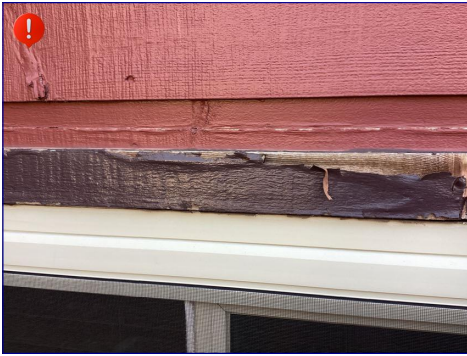
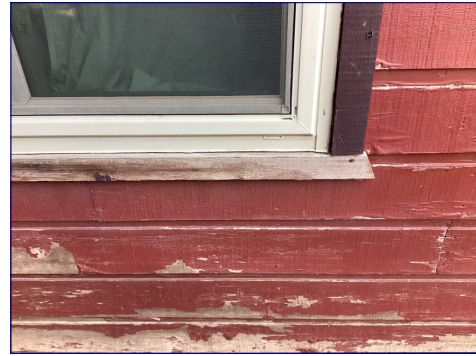
The trim is in a similar condition to the siding. There are portions of the trim that are in good condition. There are also portions of the trim that need to be maintained. The peeling paint can hold moisture and pests and lead to further wood damage. I recommend a painting contractor evaluate and repair the trim.

Similar to the other comments, there are multiple places around the house where bare wood is showing and paint is peeling. I highly recommend having a painting contractor repair and paint these areas.

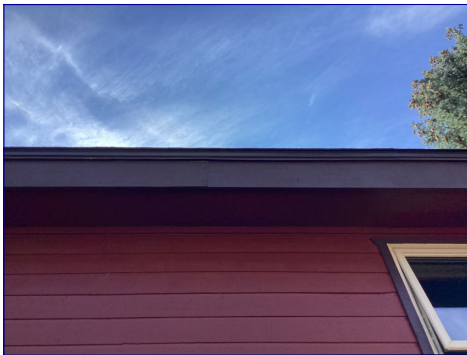
This is photo of a nail pop on the fascia. I recommend having this issue addressed when the painting contractor is working on the siding and the trim.

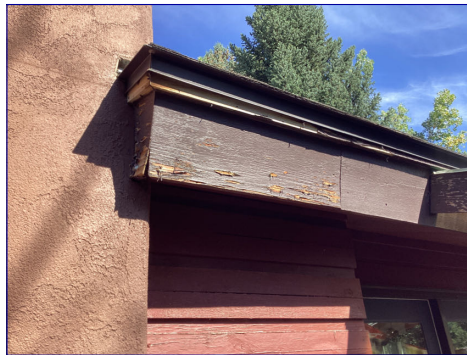
I observed the fascia board shows cupping and other wood damage possibly caused by previous moisture. It is important to maintain the exterior of the home to protect your investment.

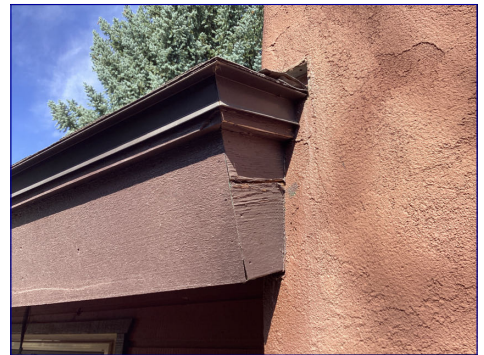
I observed the fascia was damaged. I recommend repair by a qualified professional.

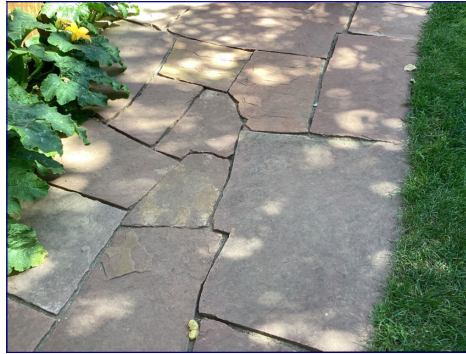
The home has a flagstone patio and flagstone walkways. I recommend monitoring and maintaining the stones in a level orientation.

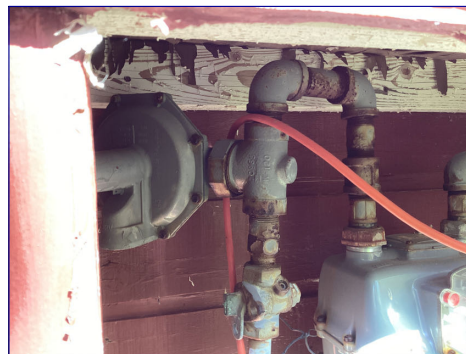
I observed the gas service pipes were corroded. I recommend contacting the gas provider to service their equipment.

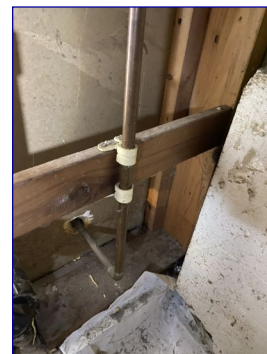
The distribution pipe hanger is broken. I recommend having the issue corrected. This is in the crawl space.

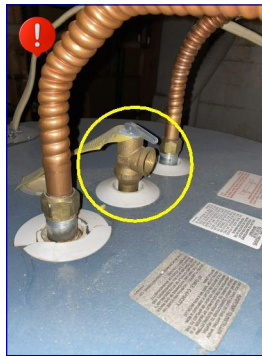
I observed the temperature-pressure relief valve extension was improper on the water heater. This is a safety concern. The extension should be installed to run to the side of the unit and terminate 4"-6" off the floor. I recommend a licensed plumber make the necessary repair.

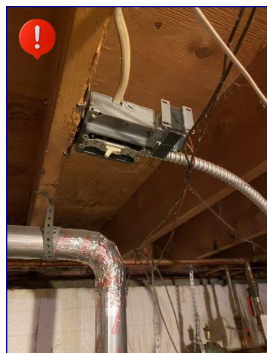
The Master Shut-off for the Boiler. I recommend installing a cover plate. Not having a cover plate is a safety hazard.

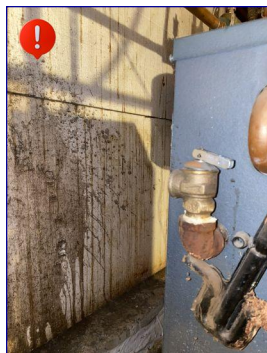
The temperature pressure release valve did not have the proper extension on it. I recommend having the proper extension added.

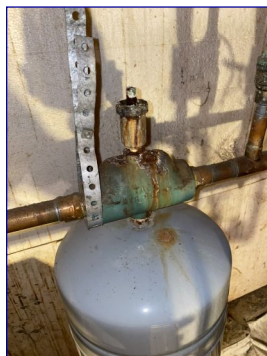
I observed corrosion on the air scoop and air vent. This could affect the operation of the **expansion tank**. I recommend evaluation by a licensed HVAC technician.

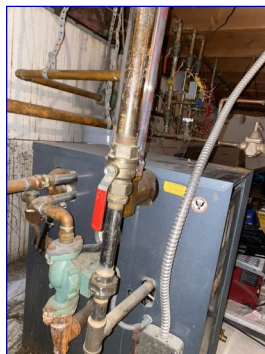
I observed corrosion on multiple parts of the boiler. The boiler worked fine. The boiler is past the normal operating life span. I recommend budgeting for a new boiler.

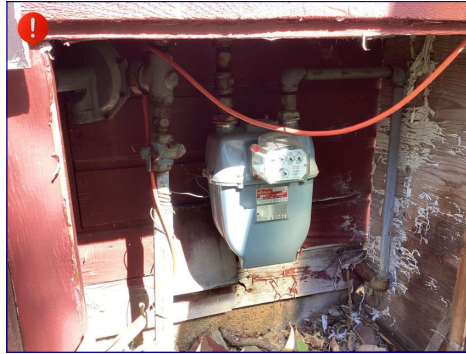
The gas meter and furnace exhaust are too close to each other. This is not acceptable according to today's standards. This is a safety issue. I recommend an HVAC technician evaluate and address this safety issue.

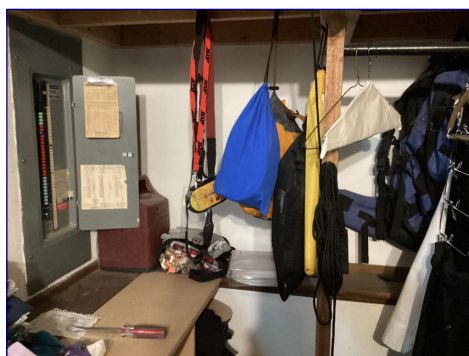
- I observed there was insufficient clearance to the electrical panel. A clearance of 3 feet around the electric panel is standard. I recommend moving items to create safe access to the electric panel.

The area surrounding the electric panel is crowded by personal belongings. I recommend keeping the area surrounding the electric panel clear.

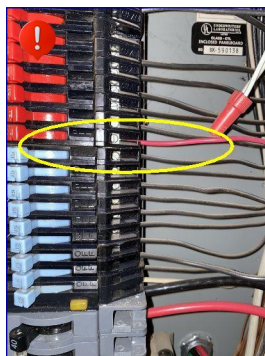
I observed one branch wire was undersized. A 14awg was used where a 12awg wire should be used based on the breaker size. This is a safety hazard. I recommend a licensed electrician evaluate and repair.

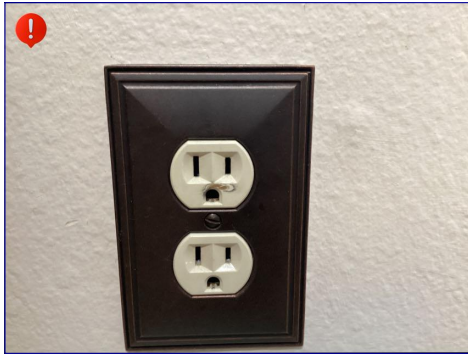
I observed a scorched receptacle. This could be a safety hazard. I recommend evaluation by a licensed electrician.

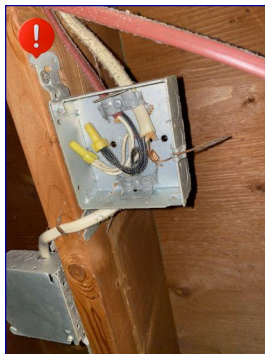
There were open junction boxes in the crawl space. I recommend having covers installed. This is considered a safety hazard.

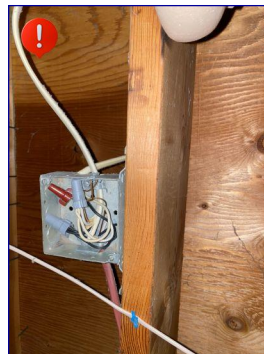
This is a second junction box without cover. I recommend installing a cover. This is considered a safety hazard.

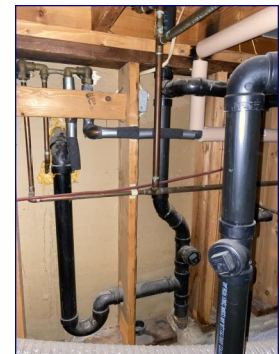
I observed wiring not attached properly. I recommend evaluation and correction by a licensed electrician for safety.

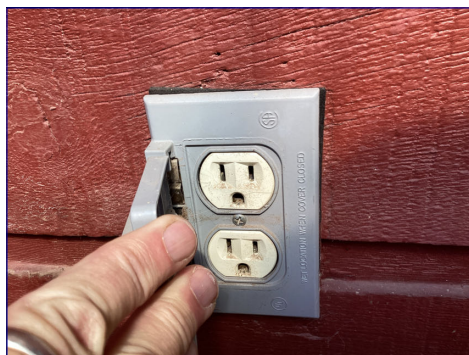
I observed GFCI receptacles were not installed on the exterior of the home. This is a safety concern. However, at the time the home was built, installing GFCI receptacles was not part of standard building requirements. I recommend upgrading the receptacles to current standards.

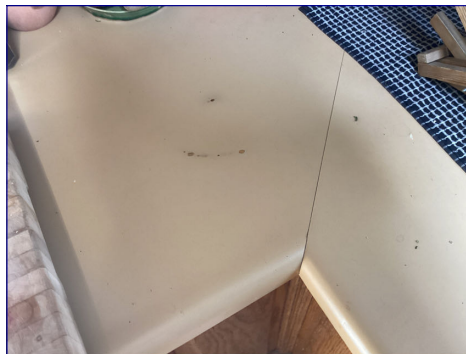
The kitchen countertops were damaged in one or more areas. I recommend a professional contractor repair or replace as needed.

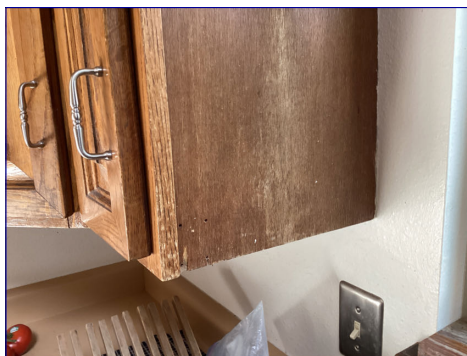
The cabinets had minor damage. This can be expected in a 40+ year old home.

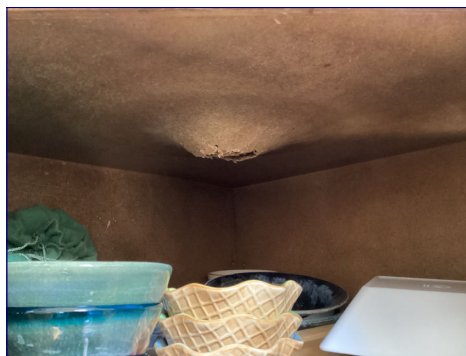
Pretty severe water damage in the top of one of the kitchen cabinets.

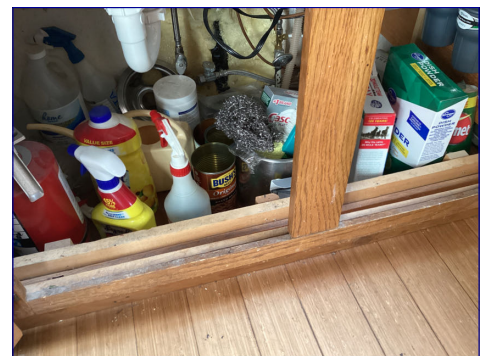
The under sink cabinet floor is nonexistent.

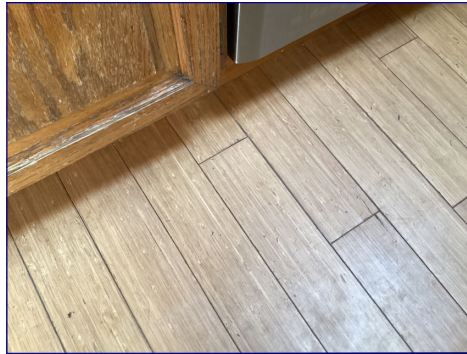
There was a little bit of damage and staining where the bamboo boards meet each other. I discussed with the homeowner and was informed that there were multiple leaks from the water filter, disposal, and dishwasher. All three appliances have since been replaced.

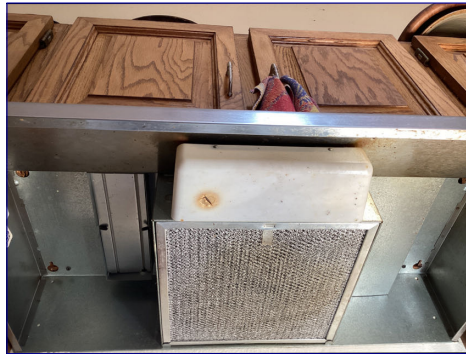
The exhaust vent fan exhausts inside the kitchen. Ideally, the fan would exhaust to the exterior of the home. I recommend exhausting the fan to the exterior of the house.

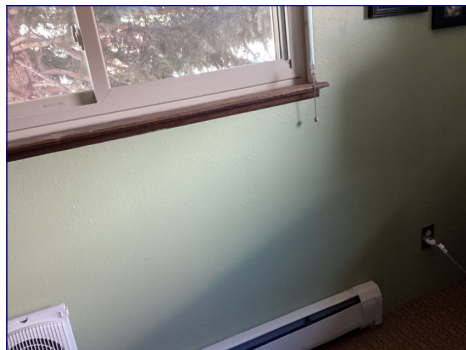
The bottom of the windows in the Bedroom were 44" or more above the floor level. This restricts egress in case of an emergency. This is a safety concern. I recommend consultation with a qualified contractor to address the issue.

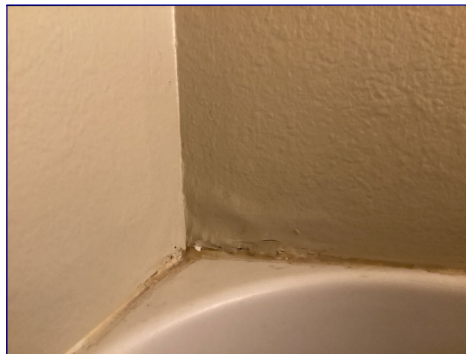
There is bubbling and peeling paint in the corner of the shower insert. Most likely caused by water pooling during showers. The Drywall in the immediate area is mostly firm. I recommend repairing the area and keeping it painted and caulked.

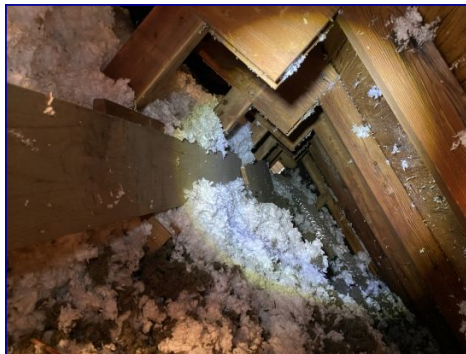
The bathroom fan exhausts into the attic. This adds moisture to the attic and can create problems. I recommend running the vent to the exterior.

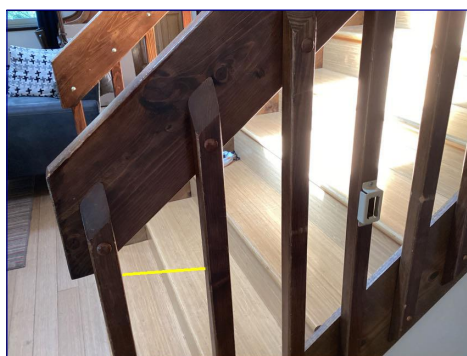
Balusters are too far apart on the railing. Most of the balusters are correct. There is uneven spacing allowing for one space to be too big. This is a safety concern for small children. It is recommended balusters be a maximum 4 inches apart. I recommend a qualified builder address this issue.

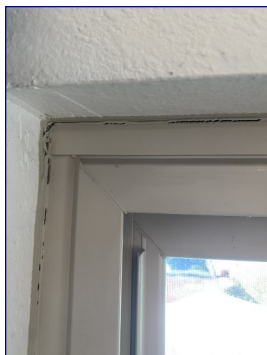
I recommend caulking around windows. Air can leak in and out of a building through gaps and cracks around the window frames.

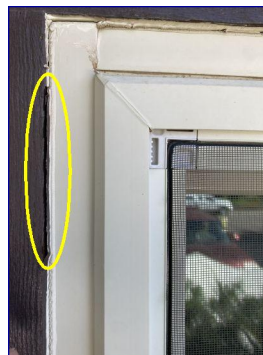
I observed gaps around the windows on the exterior of the house. I recommend repair the caulking around the windows to prevent moisture and pest intrusion.

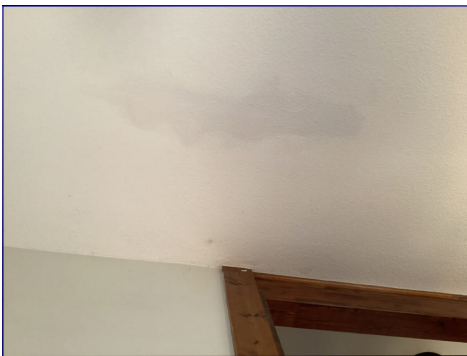
There is staining on the living room ceiling. Monitor and repair as needed. Owners stated the damage occurred before a new roof and the solar system were installed.

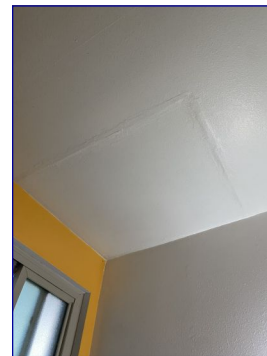
I observed repairs that do not appear to be professional. I recommend asking the current owners about the repair. The second floor shower/tub is above this repair, likely a past drain issue. There was no water staining present at the time of inspection.
