Property Inspection Report

**PROSPECTOR
HOME INSPECTIONS**

**757 Main St.
Inspection Prepared For: Mary Doe
Agent: Support - Home Inspector Pro**

**Date of Inspection: 12/5/2022
Home Age: 22 Size: 1448**

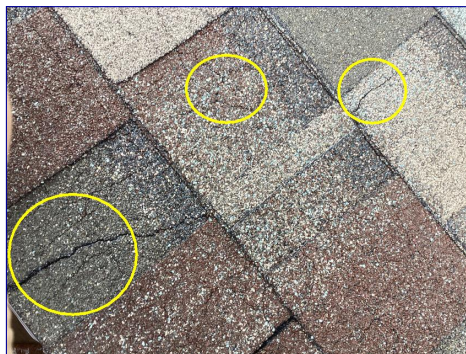
The shingles are showing signs of age through cracking. I recommend consulting with a professional roofer to determine the life expectancy of the roof.

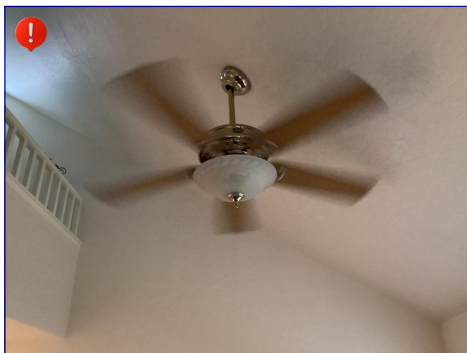
The ceiling fan is out of balance and wobbles at high speed. I recommend balancing the fan blades to prevent creating a safety issue when using the fan at high speeds.

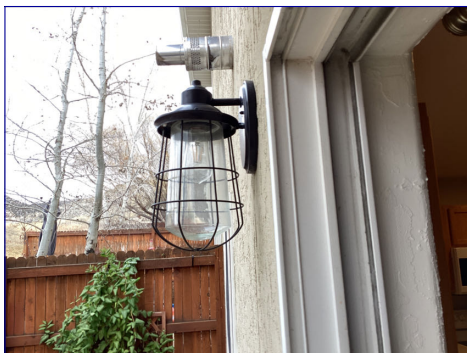
I believe the switch to this exterior light is in the dining room. This light did not come on when the switch was used. I recommend replacing the bulb and confirming that the light switch and the light work.

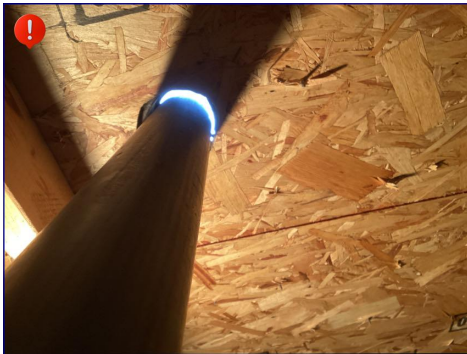
The plumbing vent stack is not properly sealed at the entry through the roof. I recommend a roofer repair this issue.

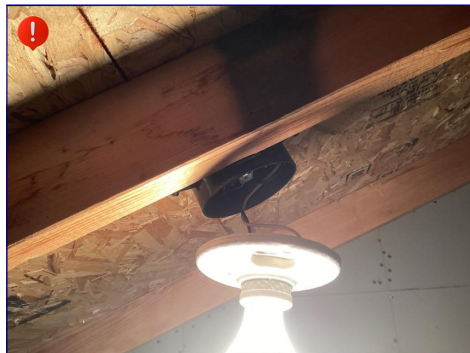
The light fixture needs to be secured to the housing.

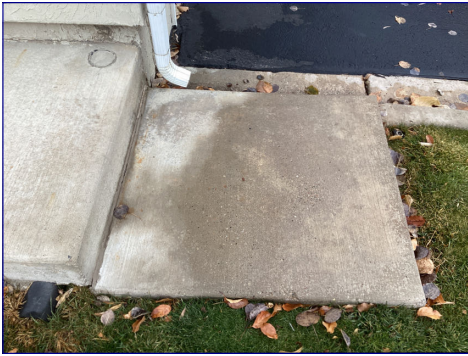
There is spalling on the service walks. Spalling is a common surface imperfection. In most cases, the defect does not affect the slab's service life if untreated. I recommend sealing the walkway and stairs to help prevent additional damage.

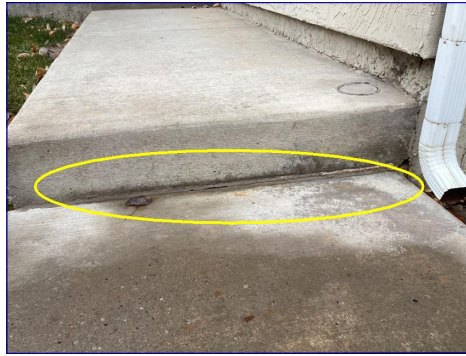
The walkways had some settling but were usable. I recommend monitoring and caulking as necessary to prevent water intrusion.

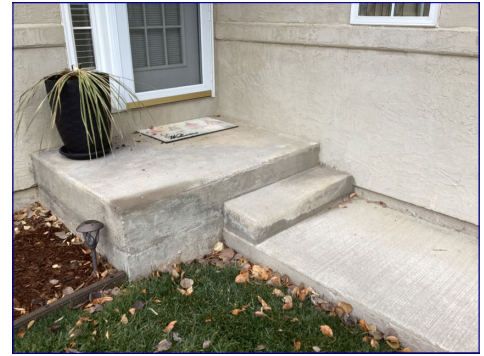
Generally, when there are three or more steps a handrail is recommended.

- There are one or more missing railings on the exterior steps. This is a safety issue. I recommend a licensed contractor install proper railings.

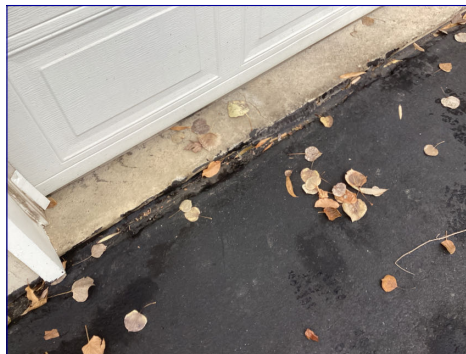
There is a gap between the driveway and the home. I recommend monitoring and sealing the gap between the driveway and the home to help prevent water penetration.

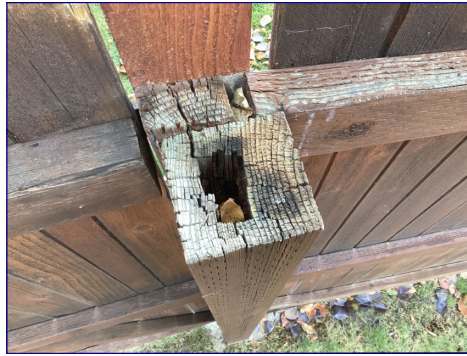
The fence is not part of the inspection. This comment is for courtesy purposes. Fence posts need maintenance to prevent further damage. The gate is attached to this post.

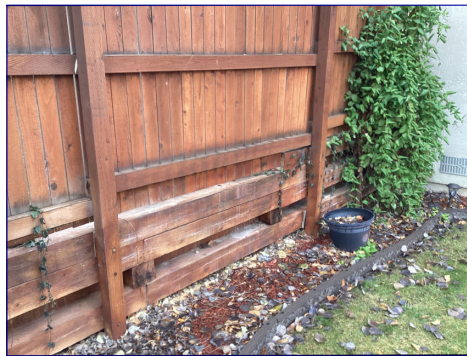
The retaining wall is bowing towards the yard. I recommend monitoring the wall and repairing if needed.

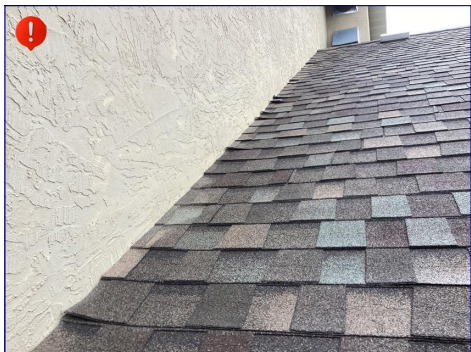
Flashing is not visible between the roof and the wall. I recommend consulting with a qualified roofer to address this concern.

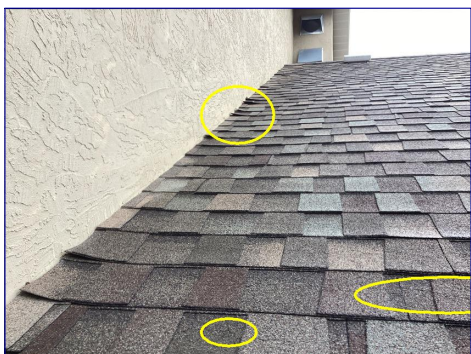
Roof covering showed signs of curling, cracking, and aging.

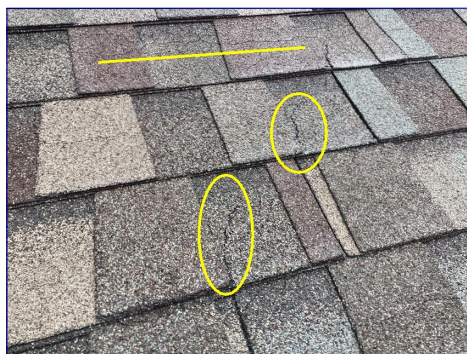
Roof covering showed signs of curling, cracking, and aging. I recommend evaluation by a qualified roofing contractor to determine the life expectancy of the roof.

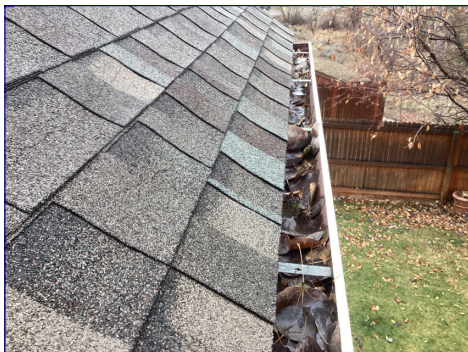
The gutters are dirty. I recommend cleaning the gutters to ensure proper water flow to the downspouts.

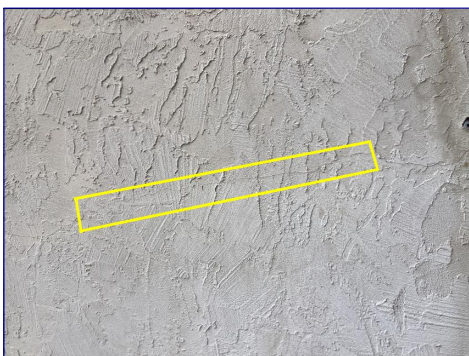
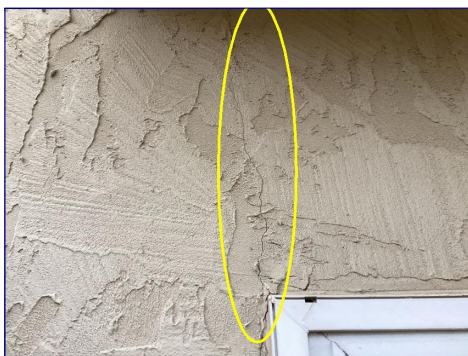
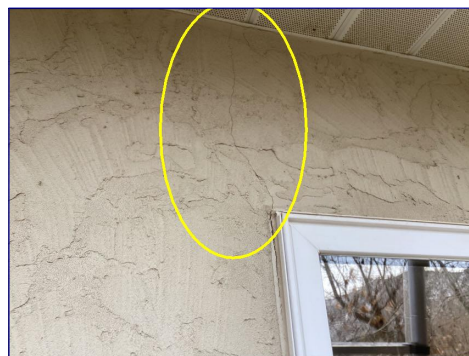
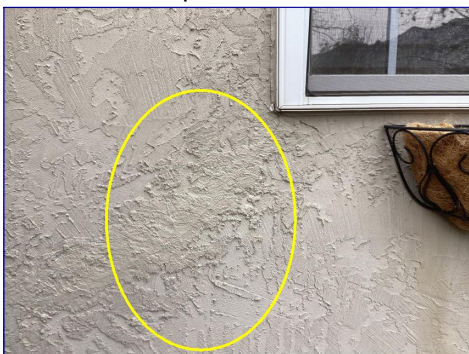
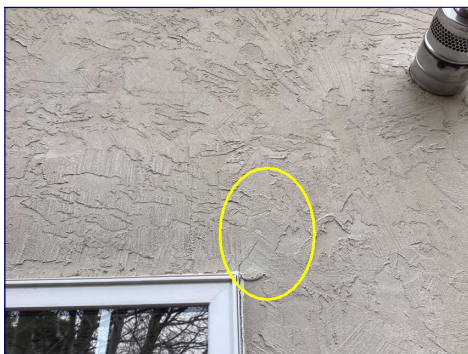
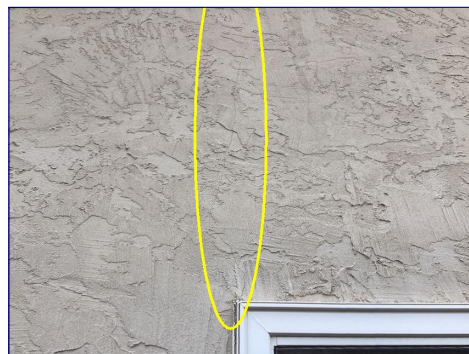
• The stucco siding has multiple cracks radiating from the corners of the windows. There are also previous repairs done in these areas. I recommend a qualified professional evaluate the stucco.

The stucco siding had typical cracking present in one or more areas. Monitor and repair as needed.

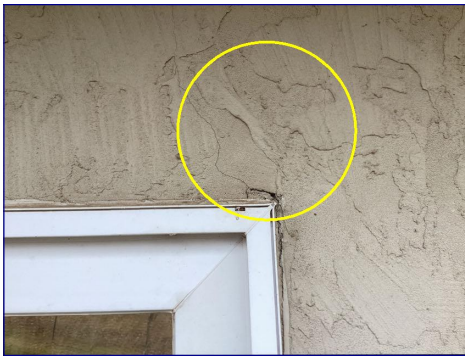
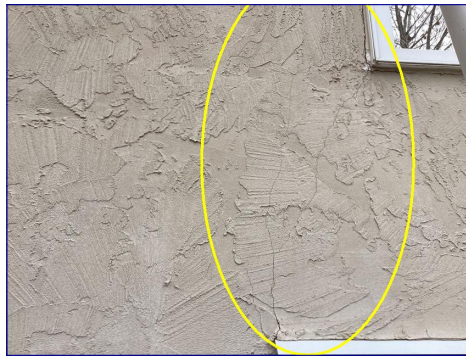
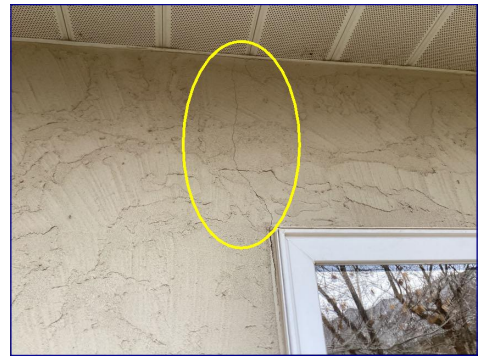
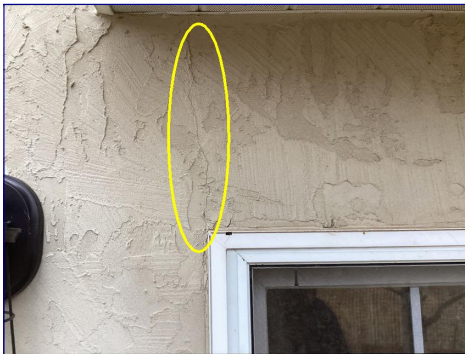
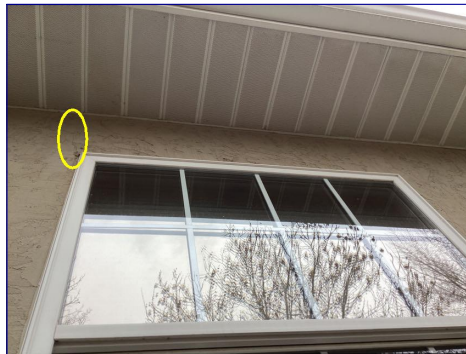
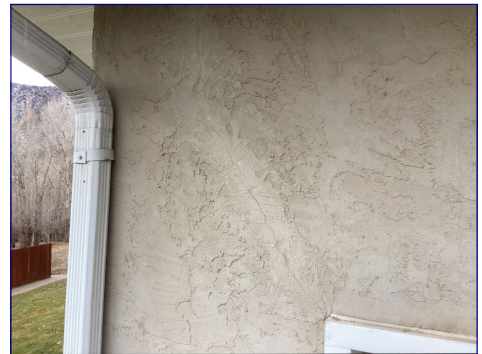
There are multiple cracks in the stucco around window corners and door corners. Water can enter through cracks in the walls. I recommend consulting a qualified professional to repair and maintain the stucco.

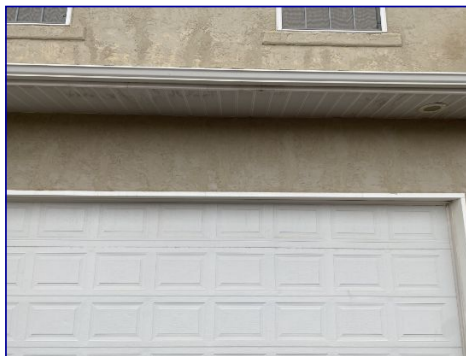
There have been repairs made to the stucco above the garage.

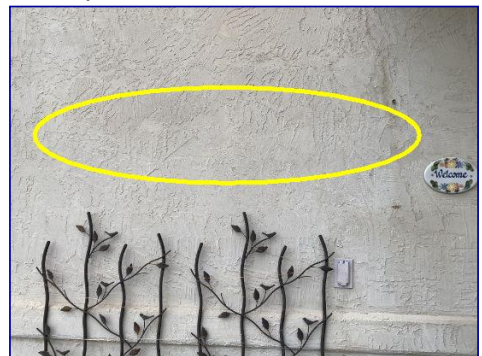
Additional cracking in the stucco.

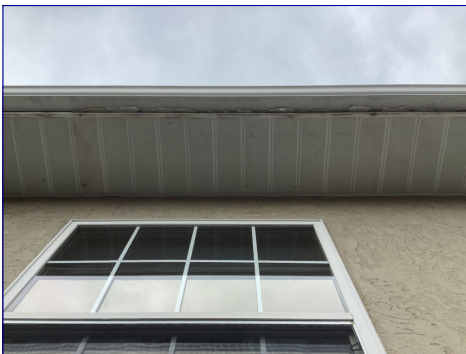
The paint is peeling on the exterior trim and soffit of the house. I recommend having these areas painted to maintain the house.

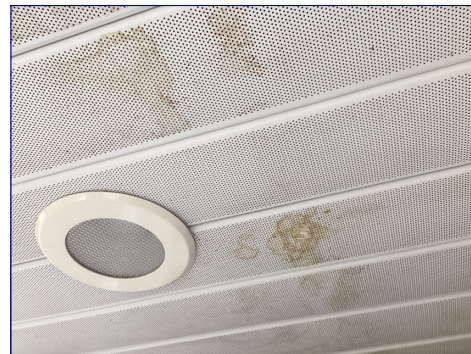
Soffit shows water penetration. This is most likely caused because of water leaking through from above. I recommend a licensed roofer evaluate the shingles and the flashing between the walls and the roof.

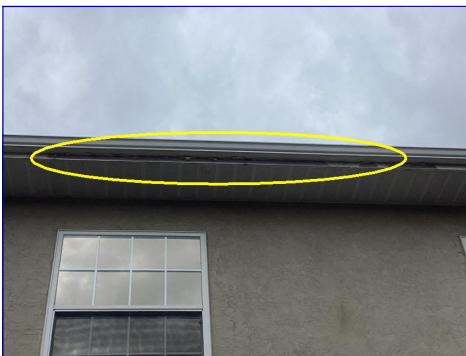
The fascia needs routine painting maintenance. I recommend a qualified professional paint the fascia.

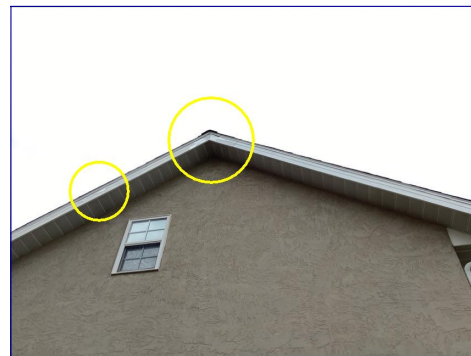
The fascia needs routine painting maintenance.

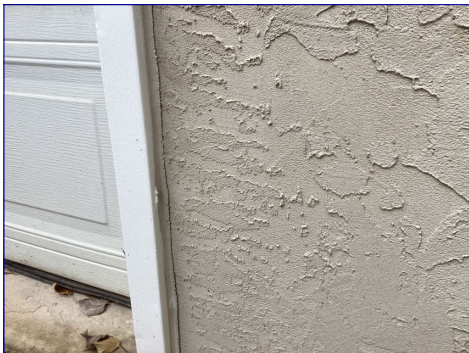
I recommend monitoring the caulking around windows, doors, corners, and utility penetrations to prevent moisture and pest intrusion.

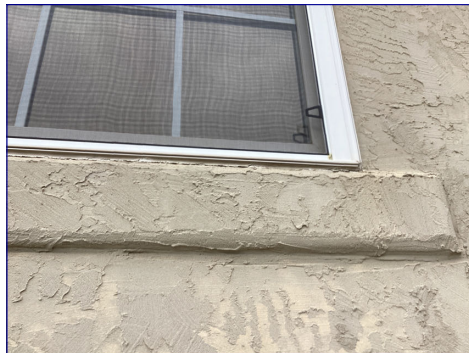
The caulking around the windows needs maintenance.

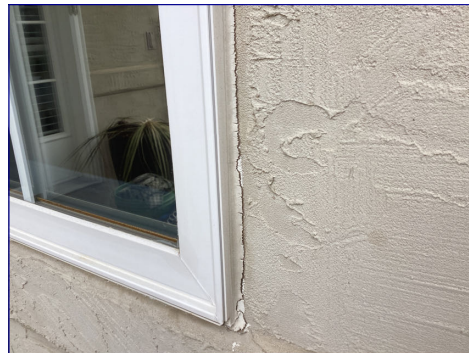
The caulking is dried and cracked. I recommend a qualified professional remove and replace the caulking. This should help protect the house from further damage.

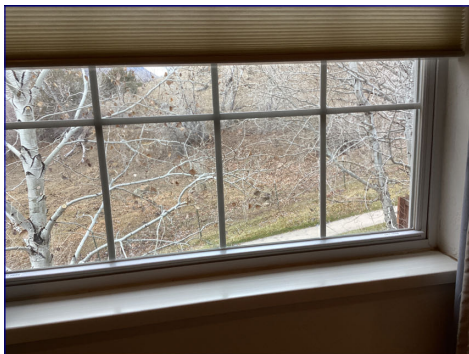
The screen for the master bedroom window is leaning against the wall in the master bedroom.

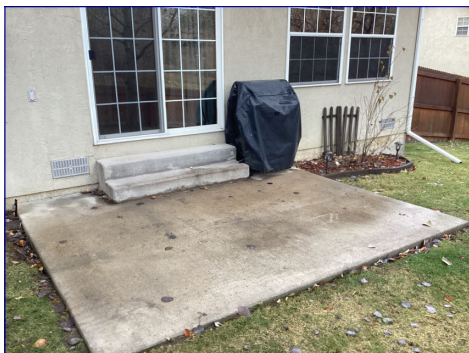
Because of the fact that there are uneven risers and multiple steps, I recommend the patio stairs should have a railing for safety reasons.

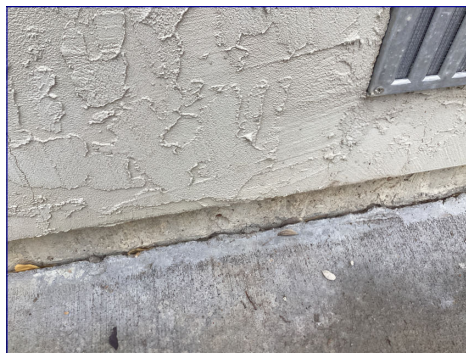
There is a gap between the patio and the house. I recommend sealing the gap between the patio and the house to help prevent water penetration.

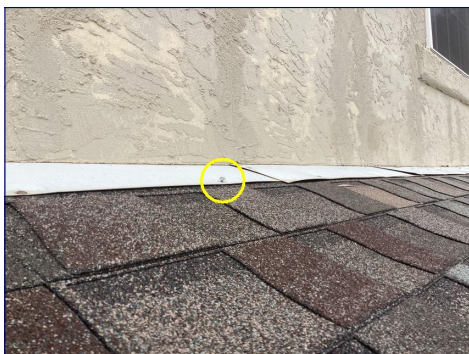
Nail pop in flashing above garage door. I recommend repair to prevent water intrusion.

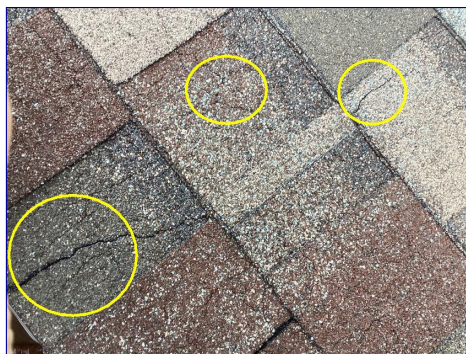
The shingles are showing signs of age through cracking. I recommend consulting with a professional roofer to determine the life expectancy of the roof.

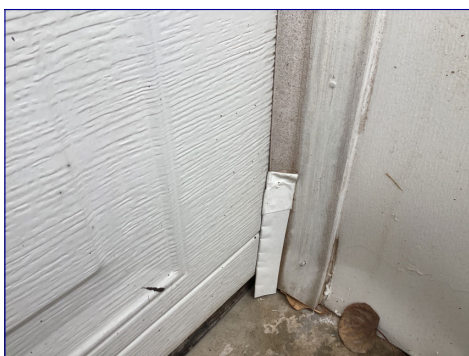
I recommend a qualified professional fix the handyman repair on the garage door trim.

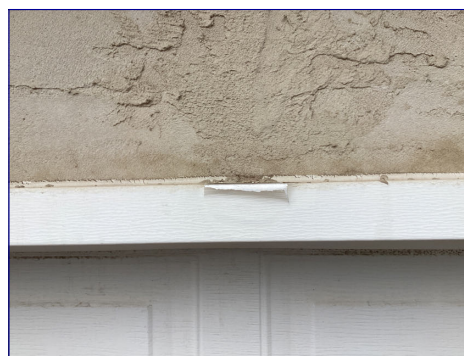
The garage exterior trim needed routine painting maintenance. I recommend a professional painter paint the exterior trim.

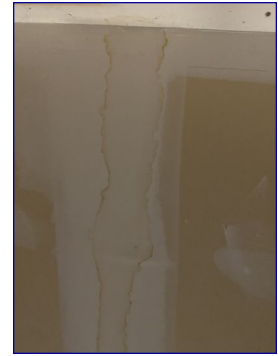
There are signs of water leaking on the garage ceiling. I recommend further investigation to determine the cause of the water staining. It could be associated with the disconnected water line and water damage in the upstairs bathroom or the non-booted vent in the attic.

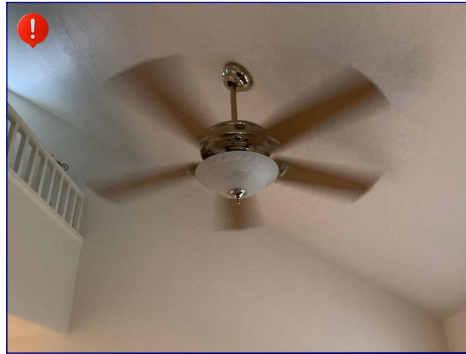
The ceiling fan is out of balance and wobbles at high speed. I recommend balancing the fan blades to prevent creating a safety issue when using the fan at high speeds.

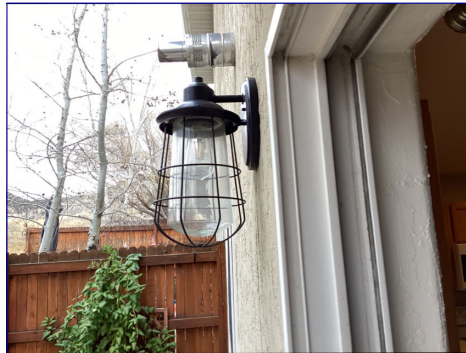
I believe the switch to this exterior light is in the dining room. This light did not come on when the switch was used. I recommend replacing the bulb and confirming that the light switch and the light work.

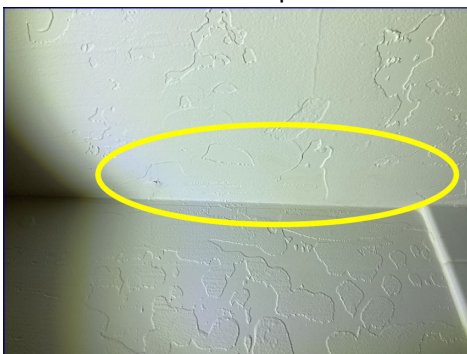
There is some minor discoloration/staining and a nail pop on the ceiling in the second-floor bathroom. This could be from moisture from the shower or from the roof vent stack that is missing a boot, the evaporative cooler drip tray overflowing, or a different cause. I recommend repairing the missing vent stack boot and monitoring the area to ensure the issue has been fixed.

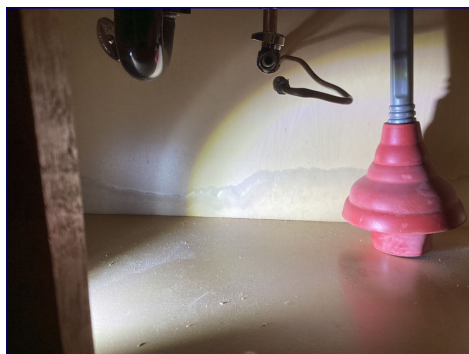
There is staining on the bathroom cabinets. There was no current moisture at the time of the inspection. This could be associated with the disconnected water line in the sink cabinet. I recommend the cabinet be monitored and repaired as needed.

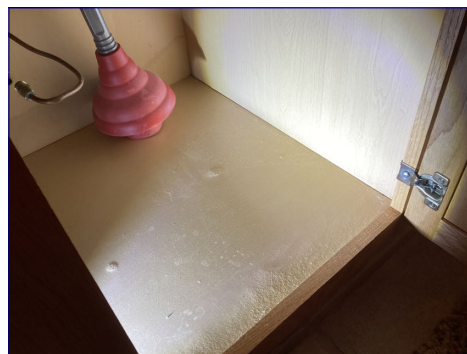
Additional photo of the sink cabinet water damage

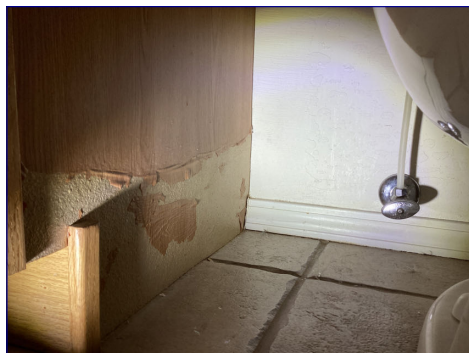
Additional photo of the sink cabinet water damage

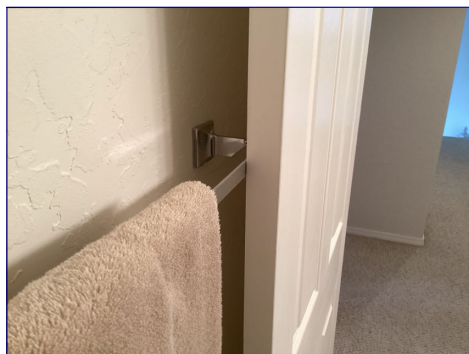
The bathroom door upstairs opens into the towel rod. I recommend installing a door stop to help prevent damage to the door from the towel rod.

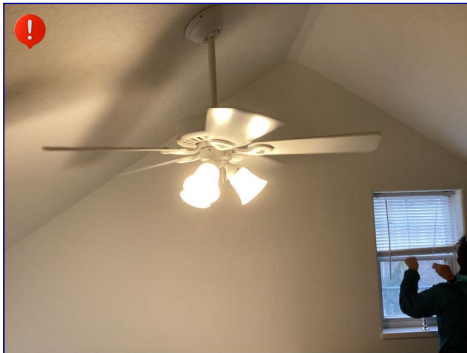
The hallway ceiling fan wobbles at high speed. I recommend balancing the fan blades if the fan will be used on high speed. Otherwise, this could become a safety issue.

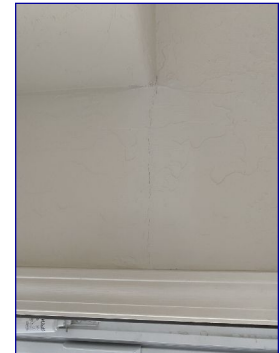
More cracks above the stairs. I do not know the cause of these cracks. There is no water staining associated with the cracks. These could be typical cracks that are associated with the age of the home.

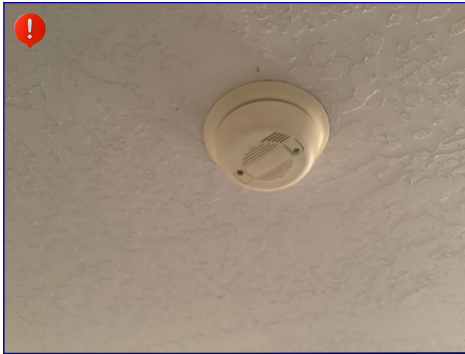
The smoke detector could be original with the house. The yellow color indicates aging of the smoke detector. I recommend installing new smoke detectors.

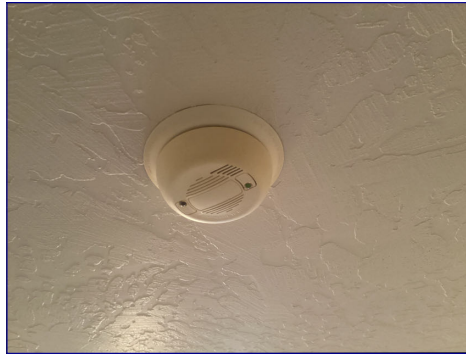
The yellow color of the smoke detector indicates old age. I recommend replacing the smoke detectors.

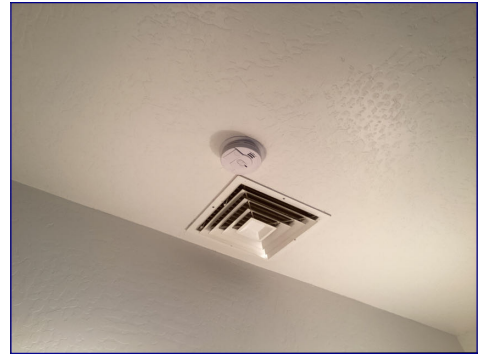
The smoke detector in the master bedroom is newer. I recommend investigating the age and making sure it is up-to-date.

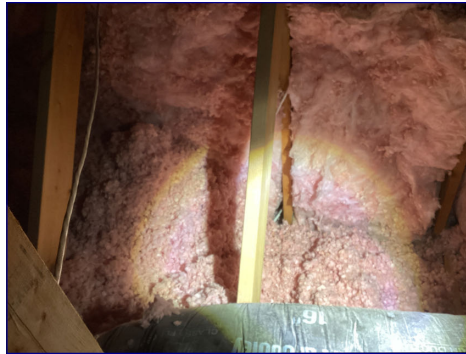
There are small areas in the attic where the insulation has been displaced. For increased energy efficiency I recommend a re-distribution of the insulation. This should be done to insulate the ceiling and walls and also to ensure proper air flow from the soffit vents.

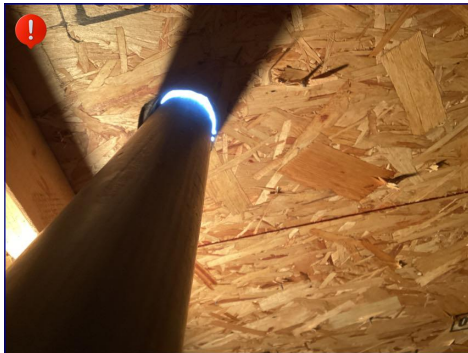
The plumbing vent stack is not properly sealed at the entry through the roof. I recommend a roofer repair this issue.

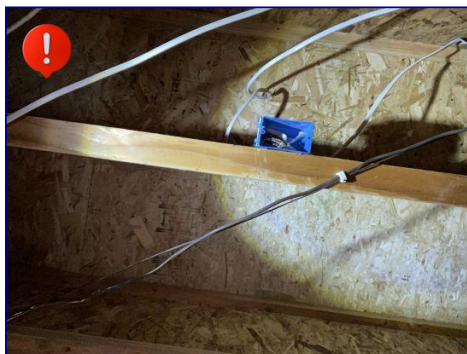
The junction box needs a cover. I recommend having a cover installed on the junction box for safety.

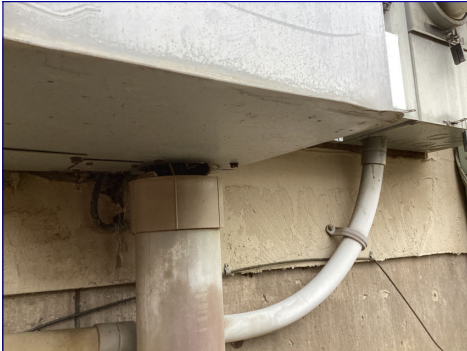
Electric conduit is cracked and disconnected from the electric box. This can allow pests and could create damage to the electric lines. I recommend a qualified licensed electrician repair. This is a community/HOA electric box

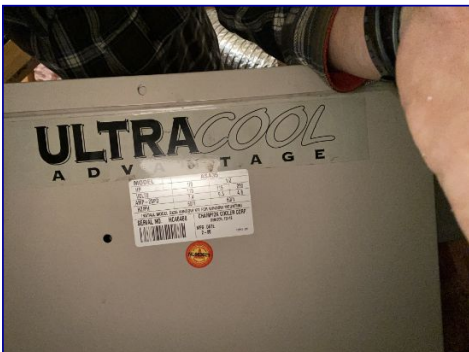
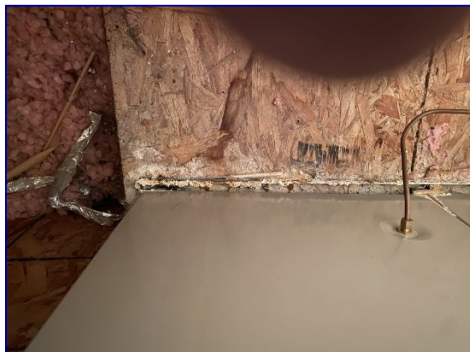
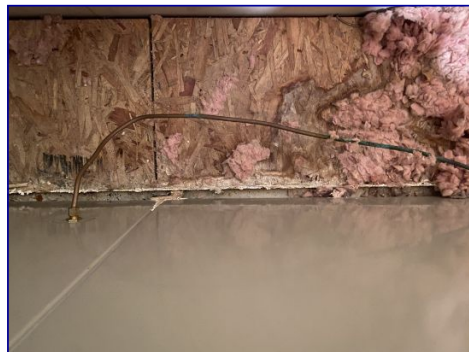
The evaporative cooler in the attic has leaked water over the drip pan. This could be the cause of water staining in the second floor bathrooms.

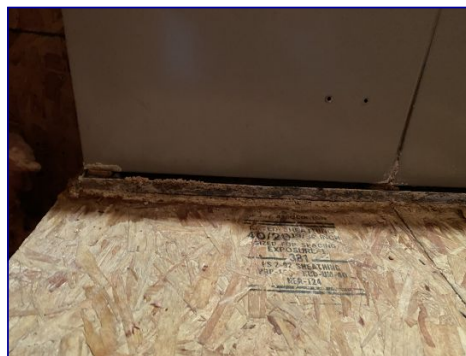
The cooling system was not tested. I tried to test the blower and nothing happened when I flipped the switch. I believe the disconnected water line in the bathroom runs to the evaporative system. I recommend a licensed HVAC technician evaluate the system to ensure it works properly.
