Why Pumps Fail

Report by David White

9/12/2025

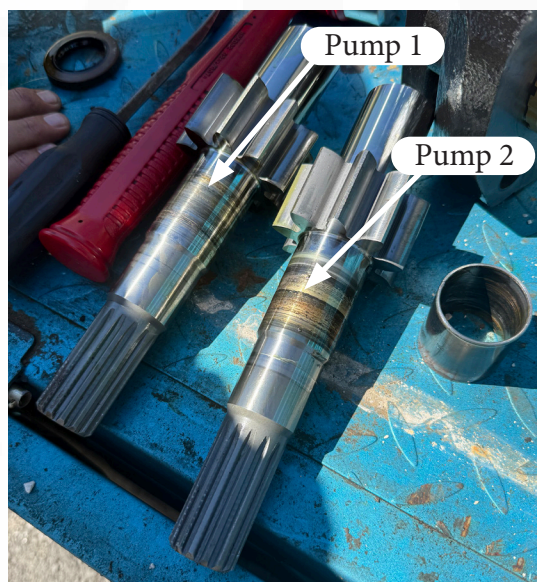
Upon inspection, the journals of both shafts exhibit severe scoring. The bushings—within which the journals are designed to rotate—had worked loose, and both shafts show nearly identical patterns of damage.

It is evident that the journal and bushing experienced significant overheating. Under normal operating conditions, the journal is supplied with oil, providing the lubrication necessary to prevent exactly this type of damage. In these failed pumps, however, the journals appear to have been deprived of adequate lubrication at this location, leading directly to failure. This observation lends some credence to the long-standing theory that "early pump failures are related to oil starvation". However, a closer inspection of the pump reveals something peculiar: only the drive-end bushing failed. None of the other bushings within the pump show comparable damage.

This leads to an important question: **if the pump were truly starved of oil, why is it that only the front drive bushing fails? In a scenario where no oil enters the pump, we would expect ALL of the bushings to suffer comparable damage. Yet, in practice, the failure is consistently confined to the front bushing.** What makes the front bushing uniquely vulnerable?

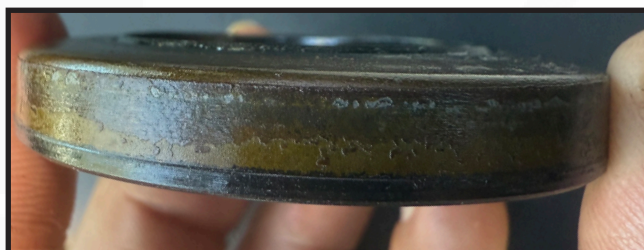
Front and Back of broken shaft seal

The consistent pattern across these early-life pump failures points to a common mechanism: **air intrusion at the drive shaft**. The shaft side is the only location where air can enter the system, and once the shaft seal is compromised, air is drawn into the pump. This air displaces the oil film beneath the drive-end bushing, cutting off lubrication to the journal.

Notice the burnt uneven areas of the side of this shaft seal. This is important clue as to how this pump is failing, I believe air is escaping through this failed outer seal and destroying the pump.

1.) **Incorrect Sealant selection during the assembly procedure.** Instead of using Permatex Aviation Form-A-Gasket No. 3—a non-hardening sealant that maintains flexibility over time—many assemblies have been completed with Loctite. Because Loctite hardens and becomes brittle, it is less forgiving in dynamic applications. Approximately 10–15% of the time, either excessive or insufficient Loctite is applied, leading to deformation of the seal or the creation of micro-gaps through which air can be drawn. Loctite is **NOT** allowed by pump manufactures, like Permco, for use on the shaft seal,

2.) **Insufficient curing time:** Proper sealing requires that the sealant cure for 24–48 hours. When this step is skipped or rushed, the shaft seal is left vulnerable to leakage, compromising its ability to maintain an airtight barrier. It seems to be very common that pumps that have been made in an urgent timeline fail much more often than pumps that have sat on the shelf. I believe it has to do with the curing time of the shaft sealant that was used.
