N123AB

Pre-Purchase Squawk List

Prepared by
Owen Poirier

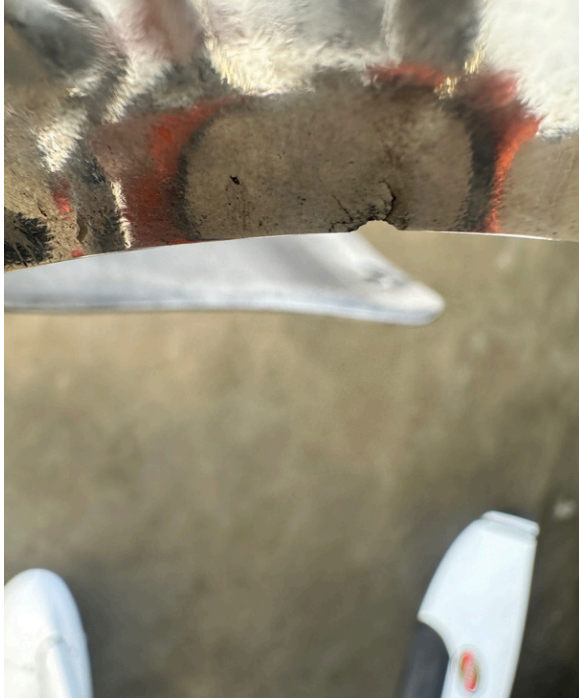
Item #7

Item	Description	Reference	Reccomendations	Estimated Correction Cost
6	Popped rivet in center rubber baffling around magnetos	SR22 MM	Remove and replace rivet	\$25
7	Spinner cracked at TKS drip nozzle. Nozzles are chafing spinner. (AIRWORTHINESS ITME)	Hartzelle CS Prop MM	Dress spinner to remove cracks. Adjust TKS nozzle to prevent chafing	\$250
8	Propeller TKS boots cracking and dry-rotting	Hartzelle CS Prop MM	Apply PBS boot sealant to preserve boots. Eventually these will need to be replaced if they begin to tear	\$350
9	Battery #2 is past the 2 year replacement recommendation	SR22 MM	Remove and replace #2 batteries <u>PN:50979-001</u>	\$400
10	LH/RH wing fuel vent panels cracked near fuel vent inlet. Tygon tubing is stiff and clamps are rusting (AIRWORTHINESS ITEM)	SR22 MM	Repair/replace fuel tank vent inlets. Remove and replace tygon vent tubing and clamps	\$450

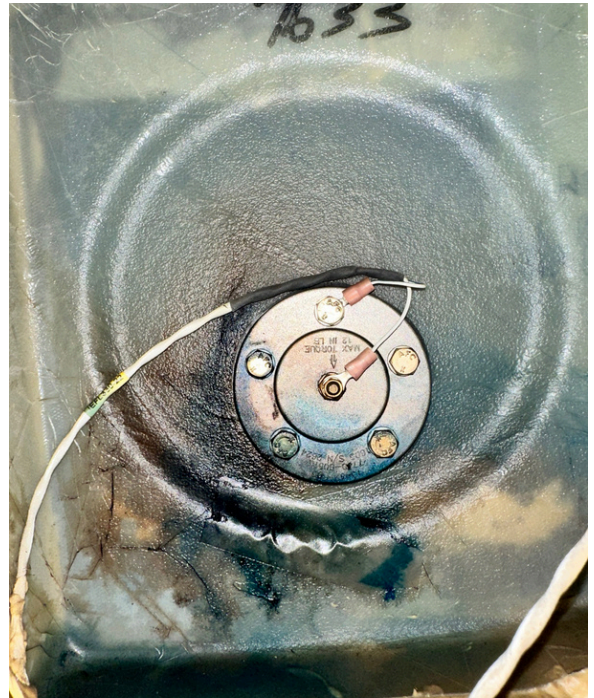
Item #11

Item	Description	Reference	Reccomendations	Estimated Correction Cost
11	LH wing, inboard fuel sending unit leaking at base gasket (AIRWORTHINESS ITEM)	SR22 MM	De-fuel tank. Remove and replace base gasket, complete a leak check	\$350
12	Popped rivet noted in RH wing, inboard TKS panel (AIRWORTHINESS ITEM)	SR22 MM	Install new rivet as required	\$100
13	Upper fueslage antenna seals dry and deteriorating	SR22 MM	Reseal bases of antennas	\$350
14	Main cabin door foam seals deteriorating	SR22 MM	Remove and replace seals	\$350
15	Ignition switch loose in panel (AIRWORTHINESS ITEM)	SB2X-74-02	Comply with Cirrus SB2X-74-02	\$150

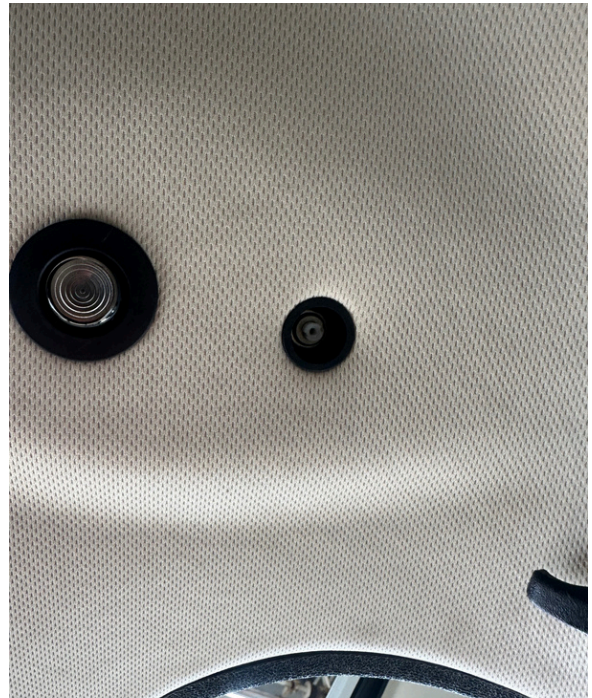
Item #17

Item	Description	Reference	Reccomendations	Estimated Correction Cost
16	Avionics had numerous faults during run-up (AIRWORTHINESS ITEM)	SR22 MM	Owner had swapped #2 430 with similar unit for repair. Configuration errors were found that need to be corrected	UNK
17	Aft RH overhead light missing switch cover	SR22 MM	Install switch cover as needed	UNK
18	Cirrus SB2X-95-27R Rocket Ignitor Replacement overdue (AIRWORTHINESS ITEM)	SB2X-95-27R	Comply with mandatory SB by replacement of rocket ignitor assembly	UNK
19	Cirrus SB2X-95-31R1 due at next repack	SB2X-95-31R1	Comply with SB at rocket/chute repack	UNK
20	Cirrus SB2X-25-30R1 Crew Seat Break-Over is due	SB2X-25-30R1	Comply with SB by inspection seat break-over tension	\$250
