Affordable Home and Building Inspections

Property Inspection Report

115 Main Court, Community Name, Milford, PA 18337
Inspection prepared for: Carl Cass
Real Estate Agent: YOUR REALTOR - REAL ESTATE COMPANY

Date of Inspection: 5/7/2021 Time: 12:00 pm
Report # 1234

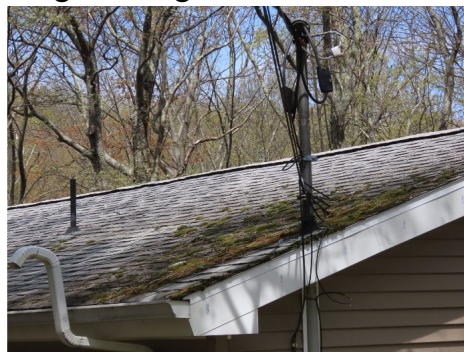
Moss present on roof. To remove it, it is best to spray with a moss killer and allow to remain on roof and fall off naturally. Do not remove with hand, rake, or power washing; this method will damage shingles.

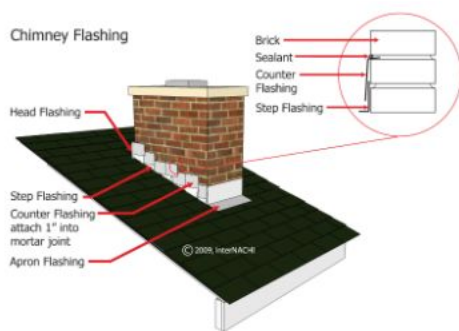
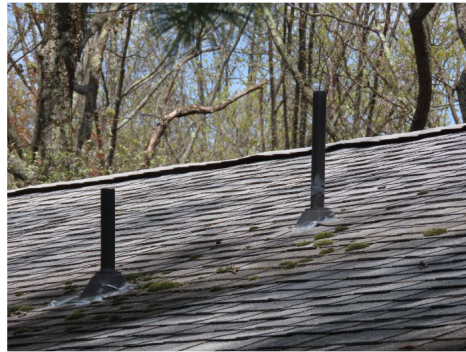
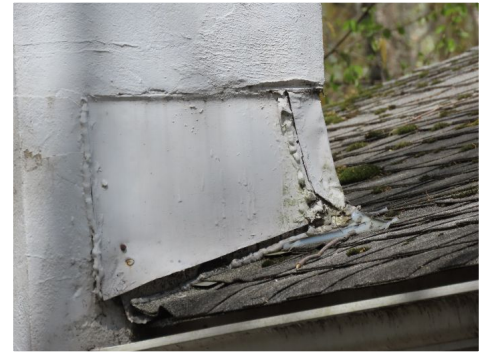
Observations: Flashings chalked on all protrusions indicates prior leaks repaired. Flashing is lifted on chimney. Corrective action is recommended. Monitor area(s) and periodically re-tar.

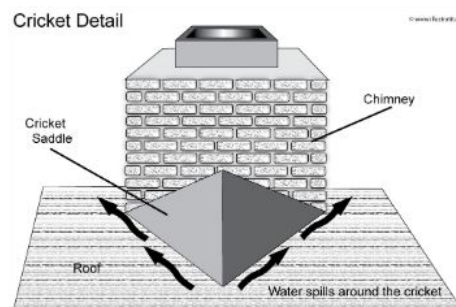
Example of a roof cricket

Observations: No cricket installed but should be considered to redirect water and debris.

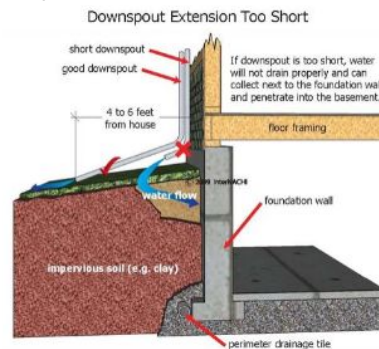
Effect of short downspouts

Observations: Overall satisfactory condition. Recommend installing gutter extensions around home to divert water away from home.

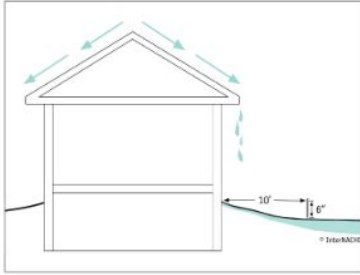
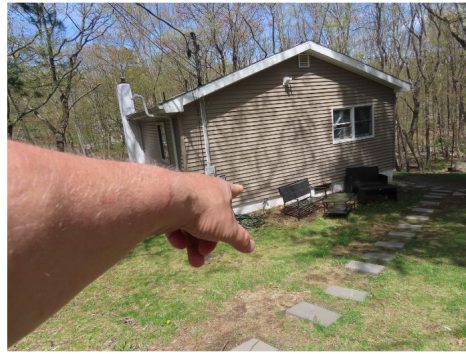
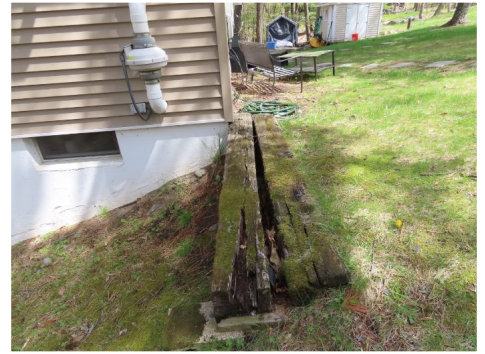
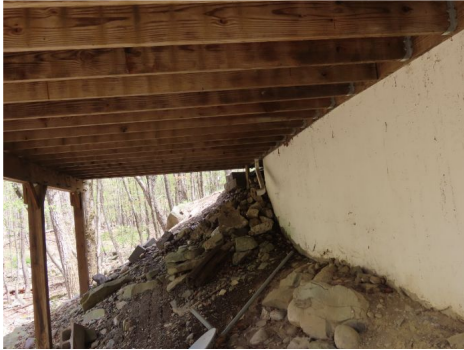
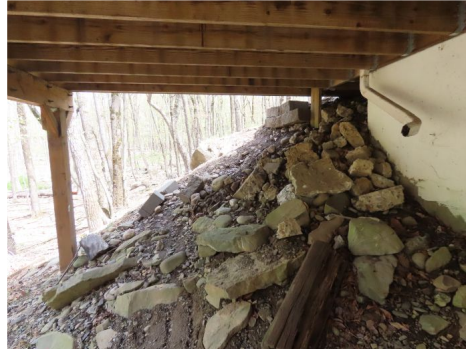
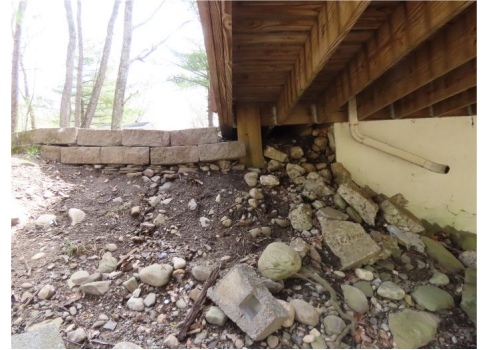
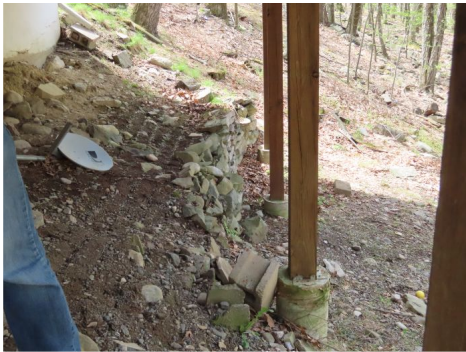
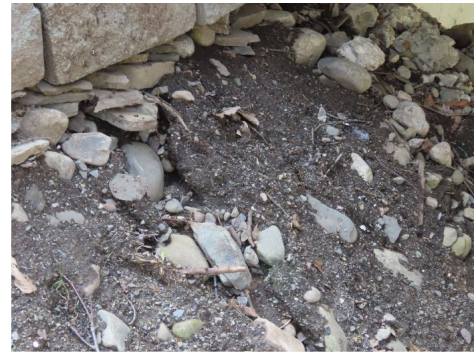
Grade is pitched towards foundation front, sides. Retaining walls have shifted and have water damage. Some of the grade is raw and has no stability. Erosion is noted on right side and under rear deck. Further evaluation is needed by a qualified escalator to determine the scope and cost of corrections. Ideally, the grading should slope away from the house's foundation about 6 inches over the first 10 feet. Adjust grade in area to divert/remove surface water.

Type: Railroad tie, Concrete block retaining wall located sides

Observations: Shifting and water damage is noted to retaining walls and corrective action is needed.

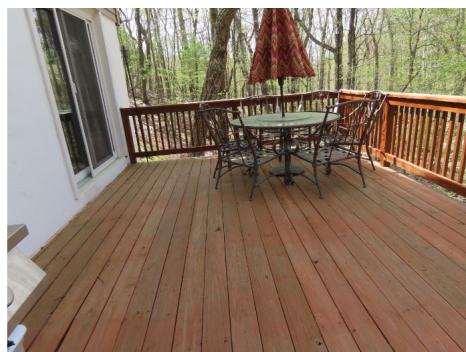
Observations: Deck surface appears to be functional. Delayed maintenance - deck should be cleaned and boards checked for damage and nail popping. Wood treatment should be applied on a regular basis to protect from water and pest penetration.

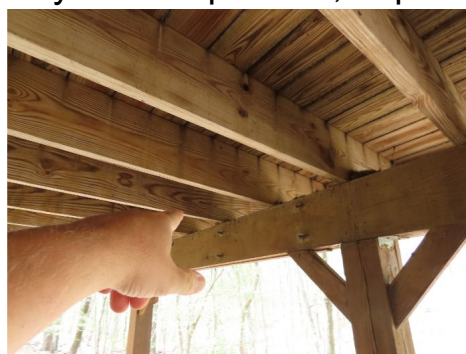
Observations: Recommend securing girders to posts and joist with metal brackets as an upgrade, in areas where they are not present, to prevent movement.

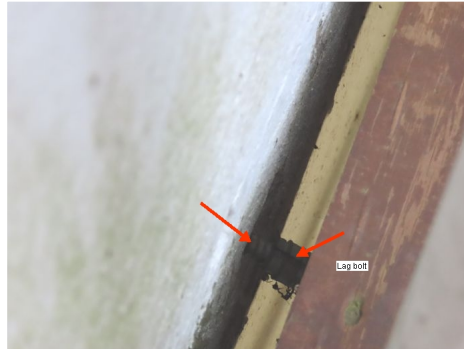
| Page 18 | Bolt and hanger condition | The ledger board appears to be pulling away from the house in the rear., as viewed from the deck above. Further evaluation and corrective action is needed. |

Observations: The ledger board appears to be pulling away from the house in the rear., as viewed from the deck above. Further evaluation and corrective action is needed.

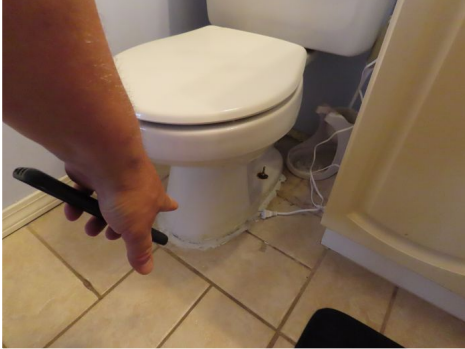
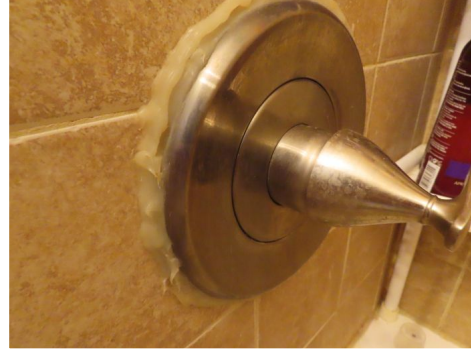
Observations: Sinks are slow to drain. May be clogged, further evaluation needed. Heavy caulk is noted around the 2nd floor toilet and around the tub fixtures. No leaking is evident on the day of inspection. Spray foam is noted on the side of the tub.

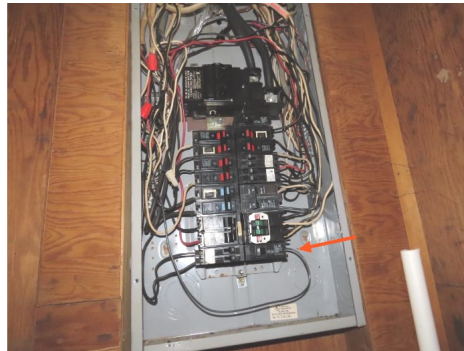
| Page 26 | Electrical panels and wiring | Breakers are partially labeled. Breaker on bottom right is over-fused. Wire amp rating is smaller than that of the breaker which will cause the wire to overheat rather than trip the breaker in case of overload. Corrective action is recommended by a qualified professional. |

Observations: Breakers are partially labeled. Breaker on bottom right is over-fused. Wire amp rating is smaller than that of the breaker which will cause the wire to overheat rather than trip the breaker in case of overload. Corrective action is recommended by a qualified professional.

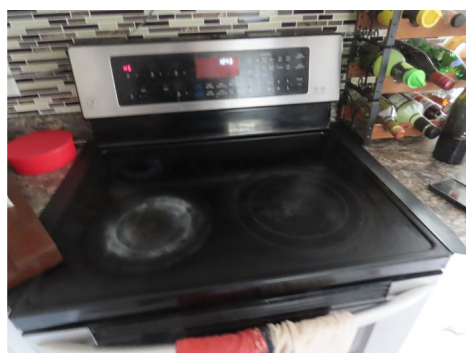
| Page 29 | Range/Oven | The right front and rear burner did not get hot. Further evaluation is needed by a qualified expert. |

Observations: There is no anti-tip bracket installed which provides extra protection when excess force is applied to an open oven door.

The right front and rear burner did not get hot. Further evaluation is needed by a qualified expert.

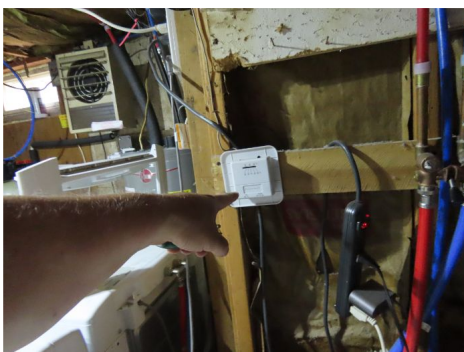
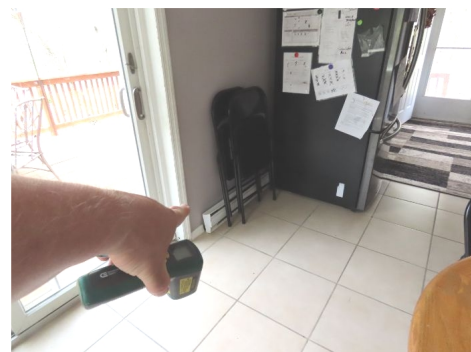
| Page 31 | Zones and delivery method | The hanging unit in the laundry room did not respond. The unit behind the fridge did not get hot. Further evaluation is needed. |

Observations: The hanging unit in the laundry room did not respond. The unit behind the fridge did not get hot. Further evaluation is needed.

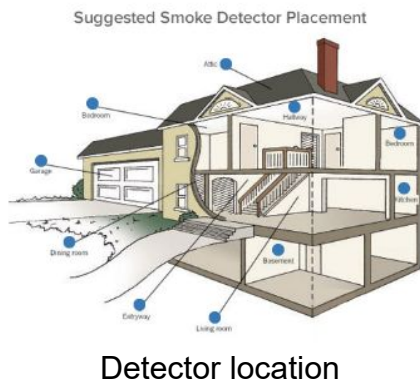
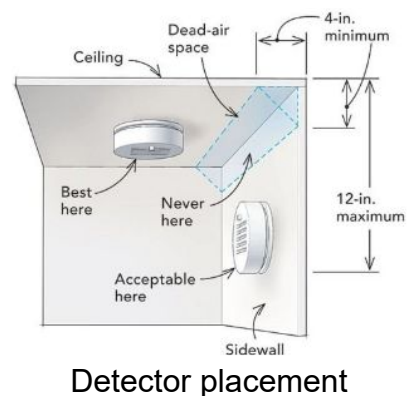
Observations: Lack of and older detectors in place. Upgrade and add detectors according to guidelines.

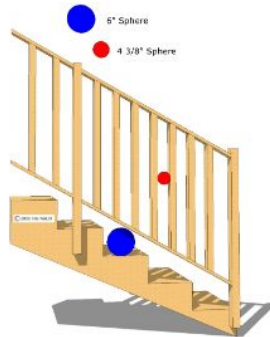
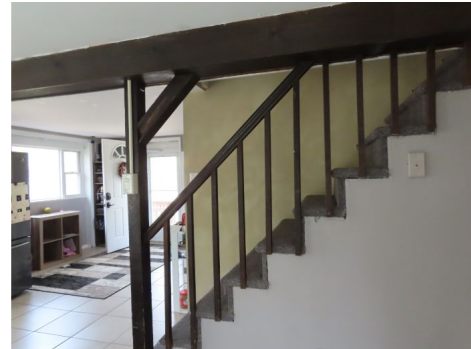
Observations: Safety rails have large spacing between spindles
