Your survey and valuation report

The House
The Street
The Town
AA1 7AB

31st December 2021

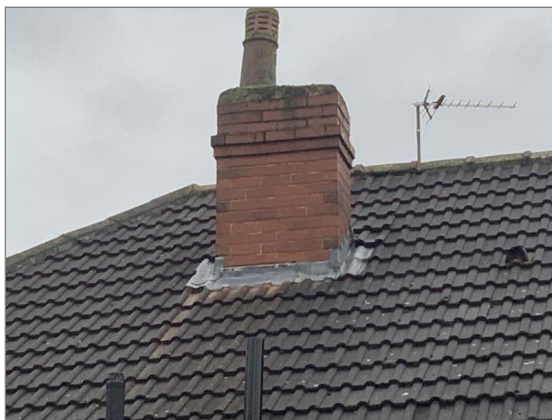
Photo - 2 Chimney stack

The brickwork forming the chimney stack is showing signs of general weathering and the mortar between the bricks (called pointing) is starting to erode. As such, I would recommend that you budget for repointing the brickwork within the next 3 to 5 years. This will involve removing the existing weathered mortar from the bed of the masonry and renewing with the correct mix or mortar. You should ensure the contractor chosen to undertake this work is competent as it takes great skill and care to ensure the pointing is renewed neatly and in a good workmanlike manner. Poorly applied mortar pointing is very unsightly and if the incorrect mortar mix is used can cause excessive weathering to the masonry forming the chimney stack.

The chimney stack is shared with the adjoining owner. As such, they have a number of legal rights over the stack, particularly in relation to the Party Wall etc act 1996. Before undertaking any works to the shared stack or associated shared chimney breast you should seek appropriate advice from a suitably qualified person and ensure that permission is gained from the joint owner of the stack prior to undertaking any work.

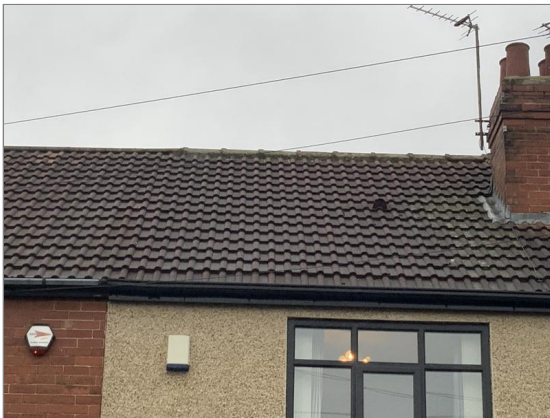
Photo - 3 Main roof coverings

The surface of the roof is slightly uneven, most notably to the front slope. When roof timbers are put under load for sustained periods of time they can become distorted therefore causing the roof surface to appear uneven. In this case, I would consider the degree of unevenness to be slight. I would not consider the relatively minor degree of unevenness noted at the time of inspection to be a significant defect and is often encountered within properties of this age and type.

The tiles to the apex of the roof, called ridge tiles, are starting to become weathered, and the mortar on which they are set is starting to erode. As such, I would recommend that you budget for re-pointing the ridge tiles within the next three to five years. This will involve lifting the weathered ridge tiles, hacking off the weathered and defective mortar and re-bedding on new, high cement content, mortar.

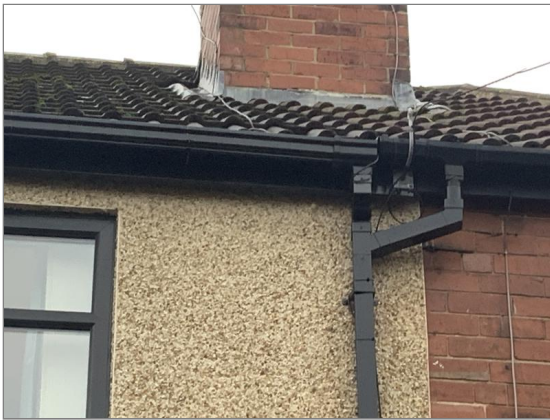
Photo - 4 Rainwater pipes and gutters

On the whole, the rainwater pipes and gutters are considered to be in fair condition for their age, with no signs of defects noted at the time of inspection.

You should also be aware that it is good practice to ensure that the gutters are cleared out on an annual basis, in order to ensure that the surface water is discharged efficiently from the property and does not back up within the guttering, which can cause water ingress issues to occur around the roofline.

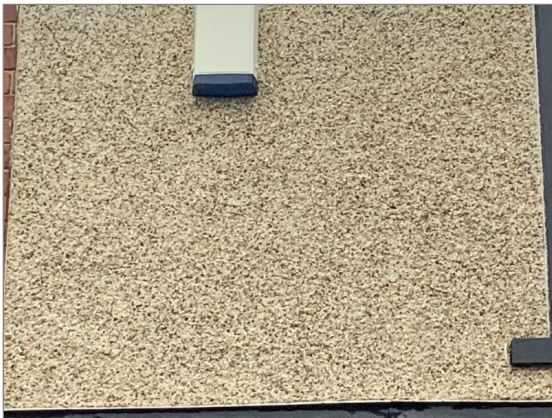
Photo - 5 Typical outside wall surfaces

The thickness of the walls have been measured and are noted to be approximately 260mm in overall thickness. Given the age of the property and the bonding of the masonry, it is likely that the walls are of solid construction, meaning that there is no air gap between the inner and outer leaves of masonry. This is unlike more modern building techniques whereby a small air gap, called a cavity, is incorporated into the structure of the wall and is designed to help prevent the transfer of moisture passing through the wall from the external environment and presenting as damp patches on the inner surfaces.

There is some evidence of a moisture barrier within the structure of the walls, called a damp proof course, which is designed to help prevent dampness occurring to the walls at low level, which is often referred to as rising damp. The damp proof course consists of a bituminous felt layer at low level within the bed of the brickwork. The continuity and adequacy of the damp proof course could not be fully established at the time of inspection. However, any inefficient or defective damp proof course is often evidenced by low level dampness occurring internally to the walls within the property. Further advice in respect of low level internal dampness is provided within section E3 of this report.

Throughout the property, the walls have been tested with a 1m spirit level, and were found to be generally level and even. I did not identify any significant fracturing, or other significant building defects such as outward bulging or outward lateral rotation of the wall surfaces, as such, I am of the opinion that the main walls are stable and not suffering from any significant or inherent structural defects.

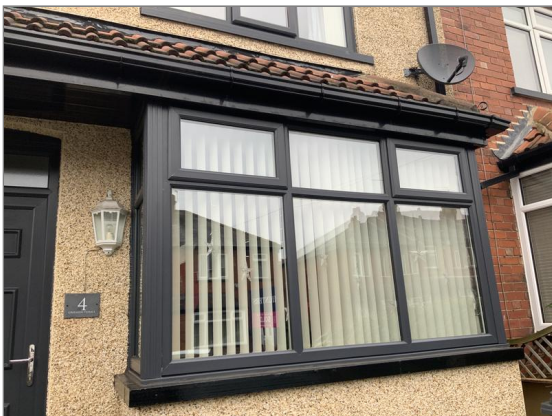
Photo - 6 UPVC double glazed windows

The windows are clearly not the original windows which would have been installed when the property was first built, as such, replacement windows installed after 1st April 2002 are required to comply with building regulations and should have been installed by a FENSA registered contractor. FENSA is a government approved trade association whose members can self-certify that their installations meet the standards of the building regulations. You should ask the vendor to provide the FENSA certificate.

Although the windows are considered to be in reasonable condition, with no signs of significant defects identified at the time of inspection, you should be aware that sealed double glazed units to the windows do not last indefinitely. Sometimes the seal fails and the gap between the panes of glass mists over due to condensation. The exact lifespan of any of the double-glazed units is not easily established and you should factor into long-term maintenance the possibility that some of the sealed glazed units will require replacement.

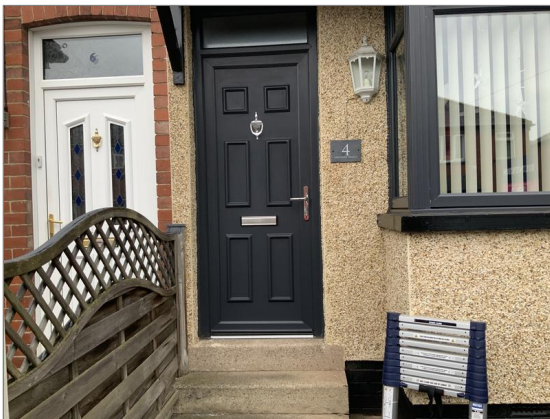
Photo - 7 Main entrance door

On the whole, I would consider the external doors to the property to be in satisfactory condition, with no signs of significant defects noted at the time of inspection.

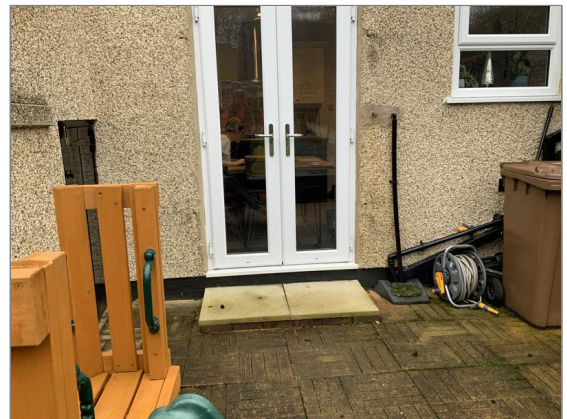
Photo - 8 Patio doors to rear

There is a set of patio doors located to the rear elevation which are made of UPVC with double panels, set within a UPVC frame. These doors are installed with a multipoint locking mechanism which satisfies the requirements of most UK insurance companies.

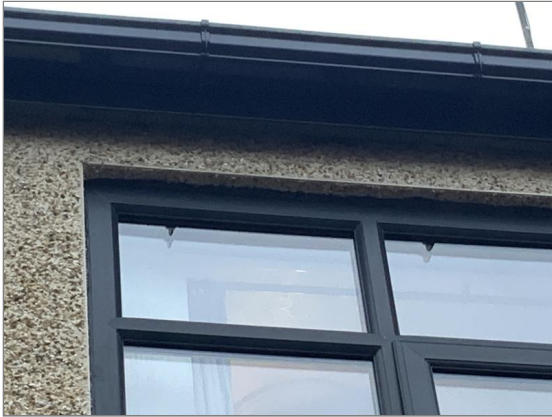
Photo - 9 UPVC roofline joinery

The external joinery to the property is limited the roofline fascia boards and soffit boards which are made of UPVC. 1

The UPVC roofline joinery is considered to be in satisfactory condition, with no signs of significant defects noted at the time of inspection. In addition, UPVC joinery is considered to be superior to traditional timbers as it tends to have a longer lifespan and requires much less maintenance.

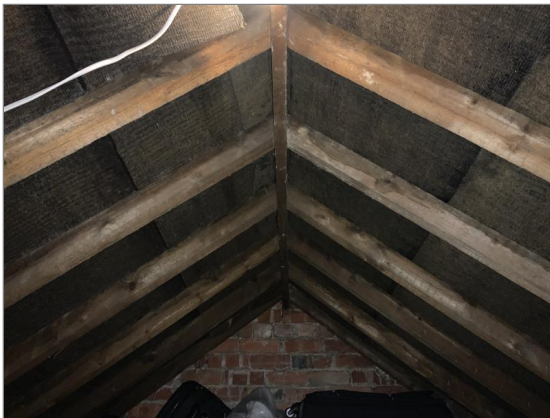
Photo - 10 Roof structure

I did not identify any form of ventilation within the roof void. Although this does not appear to be causing any particular problems at the current time, you should be aware that the lack of ventilation can cause condensation to occur within the roof void. If condensation does occur and goes unnoticed for long periods of time, it can cause serious defects to the structural timbers forming the roof structure, such as timber decay or rot.

The level of thermal insulation within the roof void is reasonably good, with approximately 200mm of woollen quilt type insulation laid throughout the roof void, which is generally in line with current Government guidance.

To reduce this risk I would recommend that you budget for installing some form of ventilation within the roof void in order to provide a cross-flow of air, which in turn will help to prevent the build-up of condensation from occurring. Suitable ventilation within roof voids is often achieved by the installation of vent outlets to the eaves of the roof, or a series of vent outlets positioned at various locations to the roof surface.

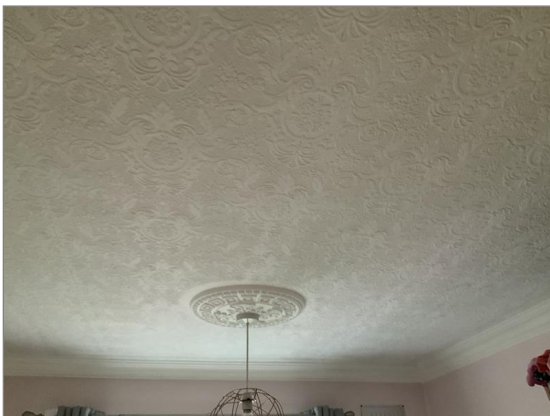
Photo - 12 Typical ceiling

On the whole, I would consider the ceilings within the property to be in satisfactory condition, but you should be aware that under normal usage, lath and plaster ceilings can become unstable when the layer of plaster becomes detached from the laths beneath. Although I could see no particular problems at the time of inspection, you should expect to undertake repairs to the ceilings in the future, particularly when you redecorate.

There are noted to be some minor fractures to the ceiling surfaces to various locations. These fractures are generally less than 1mm in width, as such are considered to be of a very minor nature and are not structurally significant. However, where fractures are occurring, you should ensure that they are filled with a suitable internal grade filler prior to redecoration.

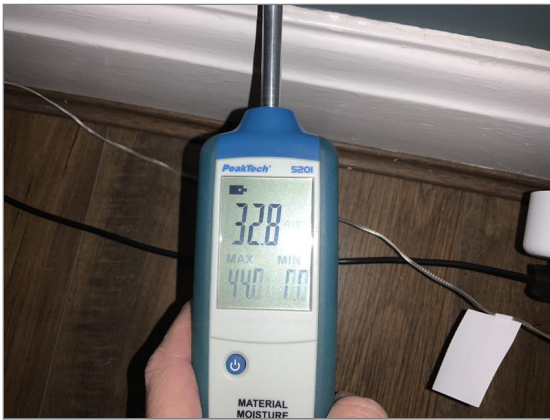
Photo - 13 Dampness within the acceptable range

Throughout the property, the walls have been tested with a damp meter and the readings were found to fall within the acceptable range. The type of instrument we use to test the walls for dampness is a dual mode moisture meter that allows the surveyor to distinguish between sub-surface and surface moisture, this is essential to distinguish between dampness within the structure of the property, such as rising dampness, or surface condensation. When testing the walls for rising dampness the instrument measures moisture beneath the surface without drilling holes to a nominal depth of around 20mm.

The moisture meter readings indicate that there are no excessive areas of dampness or water penetration identified at the time of inspection. However, you should be aware that some parts of the wall surfaces are inaccessible, such as walls concealed by fixtures and fittings and therefore these parts of the walls could not be tested.

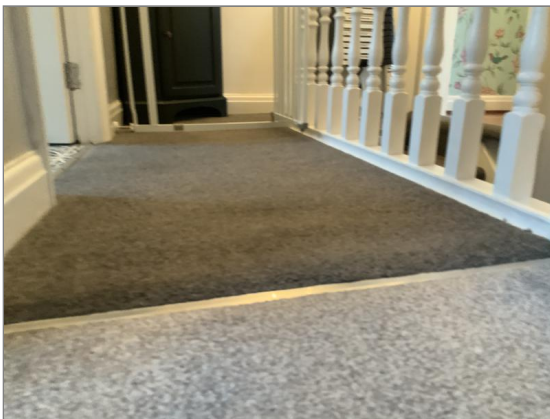
Photo - 14 Level and even floor surfaces

The floors throughout the property consist of a combination of a suspended timber deck and a ground bearing concrete slab. 2

Some of the floorboards noted to the first floor are slightly loose, as such creak when walked upon. During the course of normal refurbishment I would recommend that you take the opportunity to re-secure any loose floorboards and replace any which are damaged prior to relaying new floor coverings. This will help to provide a more consistent and solid feeling floor surface throughout.

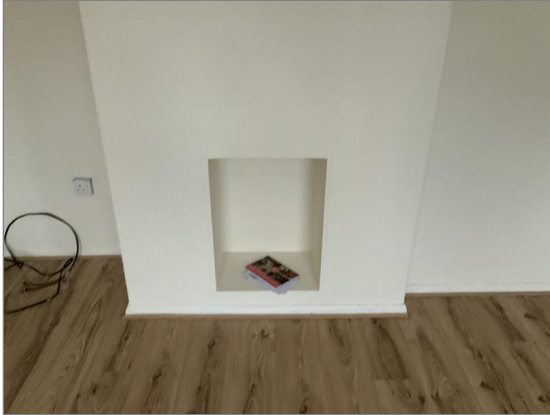
Photo - 15 Decommissioned fireplace

The sealed-up fireplaces within the property have been installed with ventilation. This helps to ensure that there is a flow of air within the chimney flue which helps to prevent the build-up of corrosive condensation with the flue which can result in discoloured damp patches occurring to the surface of the chimney breast. You should ensure that the vents are left unobscured to allow ventilation to occur.

The chimney breasts within the property appear to be intact throughout their full length.

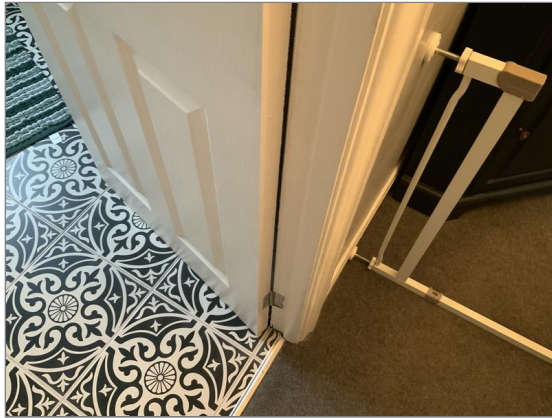
Photo - 17 Typical internal joinery

The internal joinery throughout the property has clearly had the benefit of general maintenance and upkeep over the years. As such, it is considered to be in overall satisfactory condition, with no signs of significant defects noted at the time of inspection.

However, you should be aware that the internal joinery will require periodic redecoration at least every 3 to 5 years. The cost of this should be included within your maintenance plans over the medium to long term.

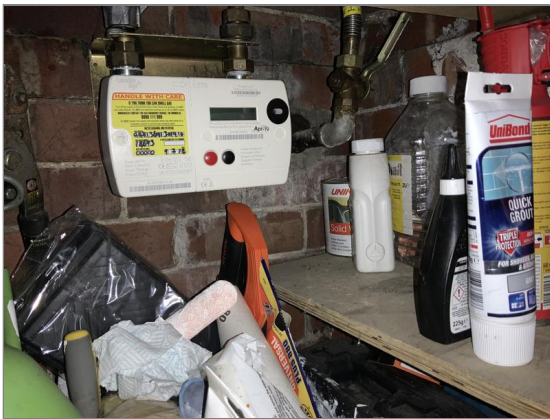
Photo - 21 Mains gas intake and meter

There is a mains gas supply, and the meter and control valve are located in the under stairs cupboard. During my inspection, I was only able to make a superficial examination of the pipework but from their appearance I am satisfied they are in reasonable condition. It is nevertheless recommended that you obtain a copy of a GasSafe™ certificate from the vendor.

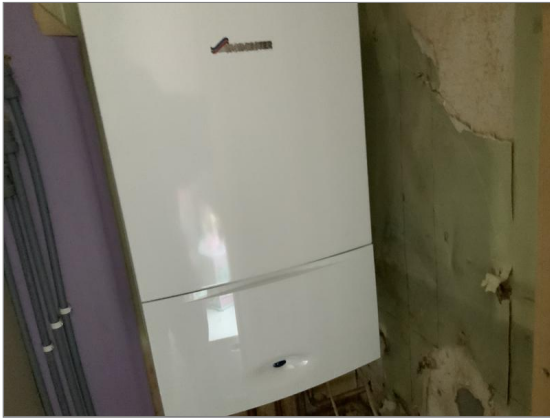
Photo - 23 Mains gas fired boiler

It should be noted that I am not a qualified mechanical or electrical engineer and therefore I cannot comment on the adequacy of the heating system; however, from my visual inspection, the boiler appears to be modern and in fair condition.

The heating system could not be tested at the time of inspection, and therefore, I would consider it prudent for a specialist test and report to be undertaken prior to entering into a legally binding commitment to purchase in order to determine its adequacy and any upgrading works required.

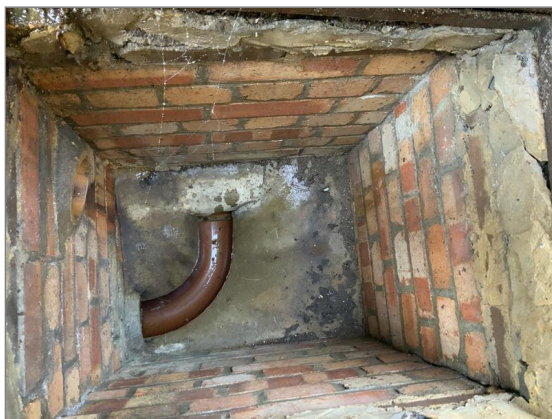
Photo - 25 Below ground drainage

The drainage gullies were available for inspection and were noted to be discharging surface water sufficiently from the property.

Where visible, the sanitary appliances within the property are connected to plastic waste pipes and traps. There are a number of inspection chambers located around the property which were lifted as part of the survey. At the time of inspection, the drainage channels were generally clear, although some debris was noted within them.

There was some standing water within the inspection chamber channels and some general silting up. You should arrange for this to be jetted out by high pressure water to ensure the drainage runs clear and efficiently discharging the foul waste into the local sewerage system.
