LEVEL 3

Your survey report

The House
Any Street
Any Town
AN1 2OW

22nd April 2022

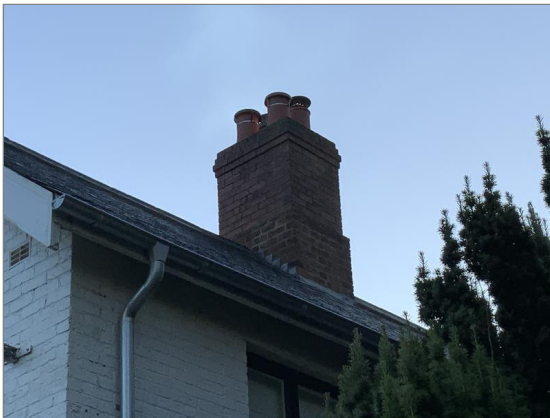
The brickwork forming the two stacks is showing signs of general weathering and the mortar between the bricks (called pointing) is starting to erode. As such, I would recommend that you budget for reporting the brickwork within the next 3 years. This will involve removing the existing weathered mortar from the joints of the masonry and renewing with the correct mix or mortar. You should ensure the contractor chosen to undertake this work is competent as it takes great skill and care to ensure the pointing is renewed neatly and in a good workmanlike manner. Poorly applied mortar pointing is very unsightly and if the incorrect mortar mix is used can cause excessive weathering to the masonry forming the chimney stack.

Photo - 2 Main chimney stack

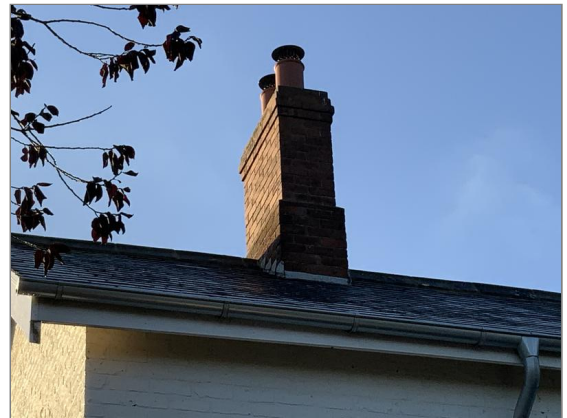
Photo - 3 Rear subsidiary chimney stack

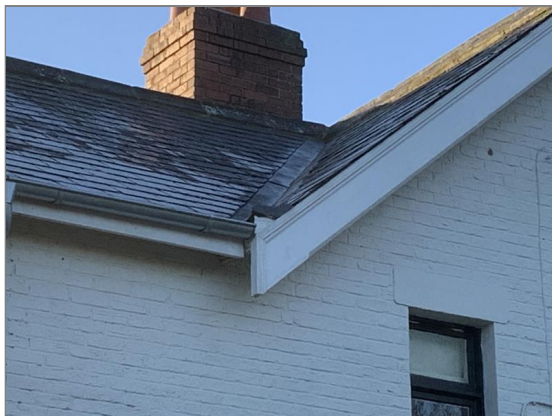
gutters are starting to show signs of general degradation, and there is some evidence of water ingress starting to occur to the underside of the valley gutter, when inspected from within the roof void (see section E1). As such, you should plan to repair the valley gutters at in the near future. The repairs will involve removing the existing valley gutter linings and replacing with either Code 4 leadwork or a composite valley gutter lining. It is likely that the roof coverings will be disturbed whilst undertaking this work, as such, you should budget a contingency sum to deal with any repairs required to the roof coverings. The contractor undertaking this work will also require specialist access equipment, most likely scaffolding, which will add to the overall cost of the repair.

Photo - 4 Main roof coverings showing valley gutter

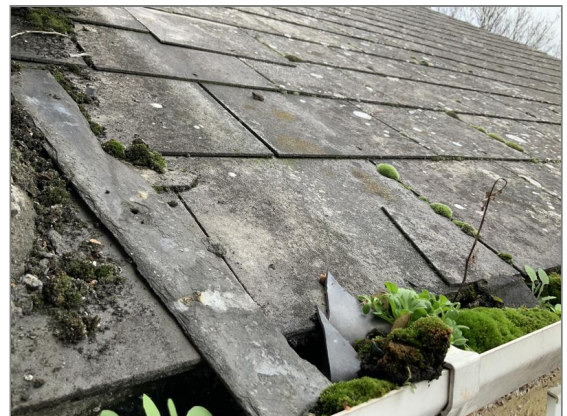
The tiles throughout the main roof are showing signs of general weathering and starting to deteriorate. Although there does not appear to be any significant water ingress occurring as a result, you should be aware that the roof coverings are approaching the end of their useful life, as such, I would recommend that you budget for recovering the roof within the next 3 to 5 years.

Photo - 5 Damaged slipped and missing roof tiles

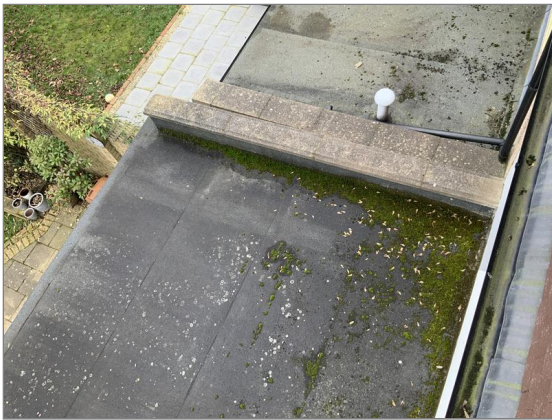
This section of roof is considered to be in generally poor condition, badly weathered and is allowing a degree of water ingress to occur internally (see section E2). I would recommend that you budget for completely recovering the flat roof immediately. This will involve stripping back the existing covering and renewing with either a built-up bituminous felt system or a more modern composite system.

Photo - 6 Defective flat roof coverings

It may be possible to undertake temporary repairs to the roof surface, but in my view, the coverings have reached the end of their useful life, and it would be more economical to recover the roof surface rather than try to repair it.

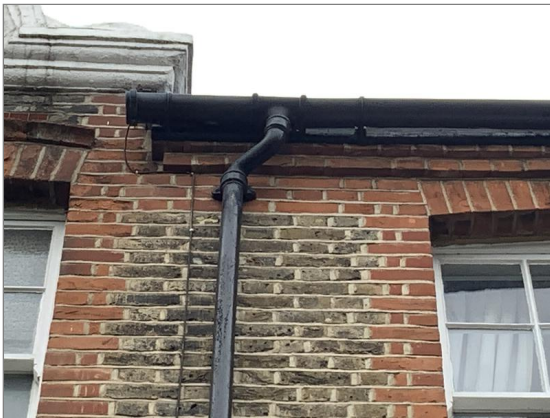
There is some evidence of historic leaks noted to the intermediate joints of both the pipes and gutters, as such, I would recommend that you budget for clearing out the gutters and resealing the intermediate joints of both the pipes and gutters accordingly.

Photo - 7 Rainwater pipes and gutters

The more traditional cast iron rainwater pipes can rust and leak without warning and are generally considered to be dated. As such, you are advised to plan for the replacement of the cast iron elements in the near future.

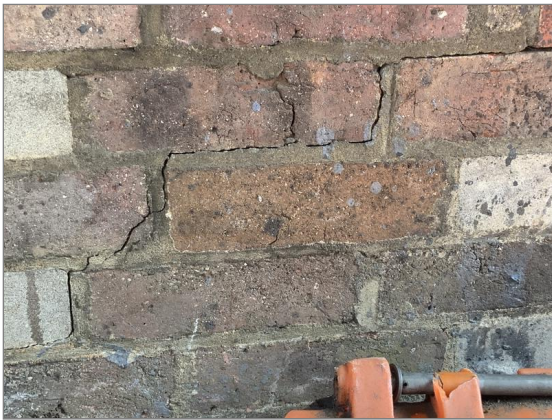
Photo - 8 Fracture to wall surface

If the minor fractures to the wall recur, then a more permanent solution such as crack stitching can be implemented. In basic terms crack stitching is a type of masonry repair used to stabilise and reinforce fractured walls. It involves retrofitting several crack stitching bars which are grouted across cracks in walls in order to reconnect them and provide stability to the masonry. This is a relatively straight forward task which most competent contractors would be able to perform.

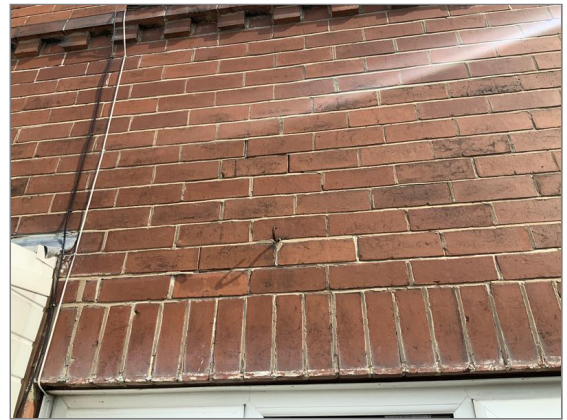
Photo - 9 Settlement fracture

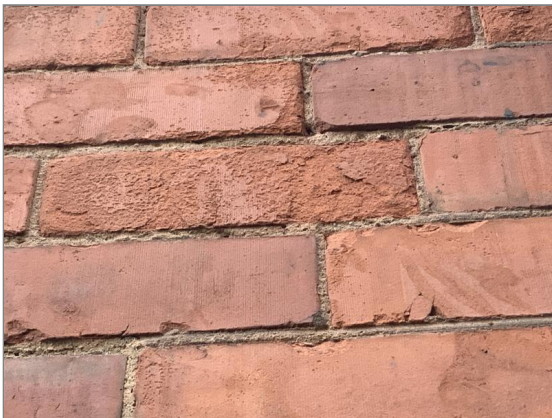
Photo - 10 Weathered and frost damaged brickwork

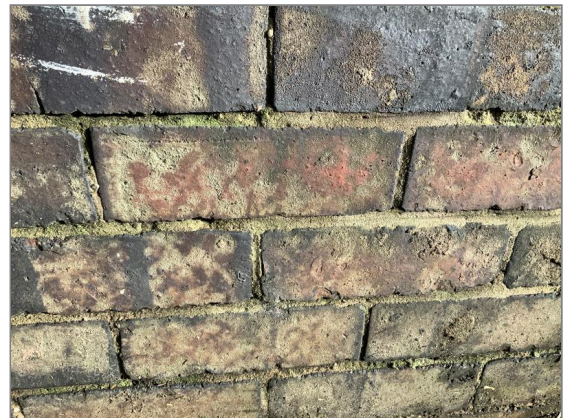
Photo - 11 Eroded mortar pointing to brickwork

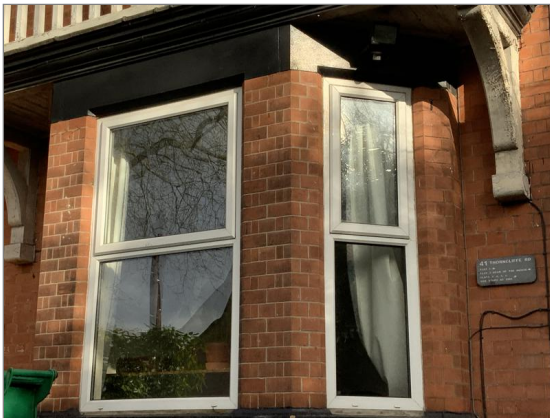
Photo - 12 Windows

I would recommend that they are replaced with more modern UPVC double glazed windows which are much more thermally efficient, require less maintenance and tend to have a longer life span than traditional timber windows. In addition, modern UPVC double glazed windows are available in a range of styles and designs which are in keeping with the style and character of most properties, although you should seek advice from the local authority if the property is either listed or within a conservation area.

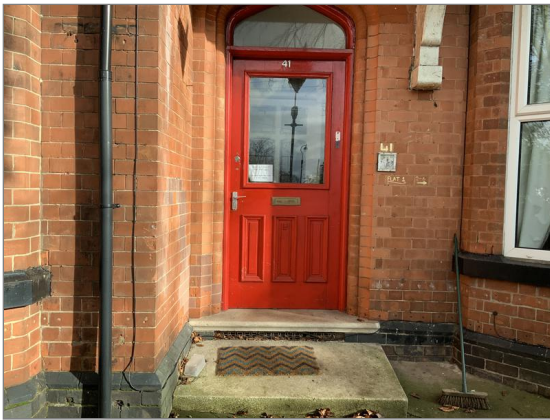
The three doors are poorly decorated with of timber decay noted the doors and frames. In my view, these doors are beyond economic repair, as such, you should budget for replacing them in the near future. I would recommend that you replace them with a modern UPVC double glazed panel door with a high security multi-point locking mechanism. This type of door is more secure, much more thermally efficient, requires less maintenance and tends to have a longer lifespan than traditional timber doors.

Photo - 13 Main entrance door

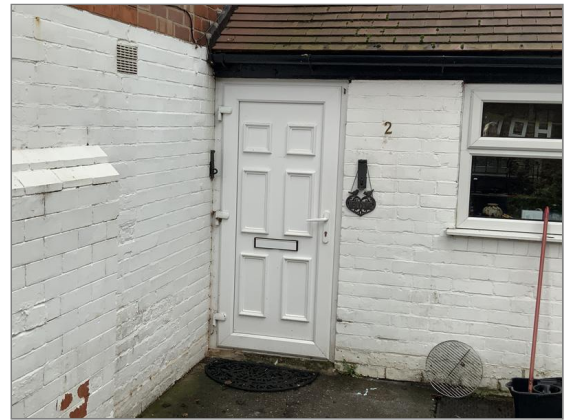
Photo - 14 Rear door

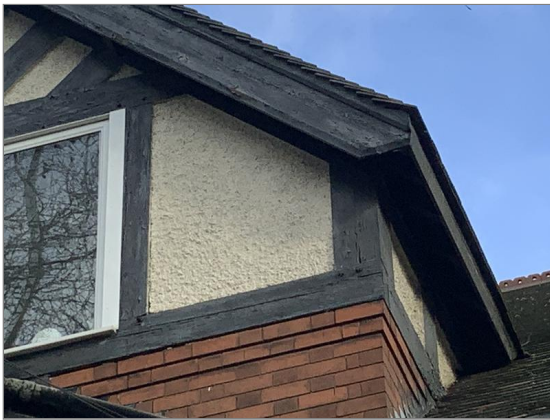
In addition to the roofline joinery the property also has ||a timber canopy|| located to ||the main entrance||. This element is presenting signs of timber decay and is poorly decorated. I recommend that the surfaces be fully prepared with timber repairs undertaken to the decaying sections prior to redecorated with a suitable primer, one coat of a suitable external grade undercoat and two coats of a suitable external grade topcoat within the next 12 months. The process of redecoration should also be repeated at least every 3 to 5 years thereafter.

Photo - 15 Exterior joinery

Over the longer term it may be prudent to budget for replacing the roofline timbers in their entirety. I would recommend that you replace them with more modern uPVC products, which although may be slightly more expensive initially, they do require much less maintenance and tend to have a longer lifespan.

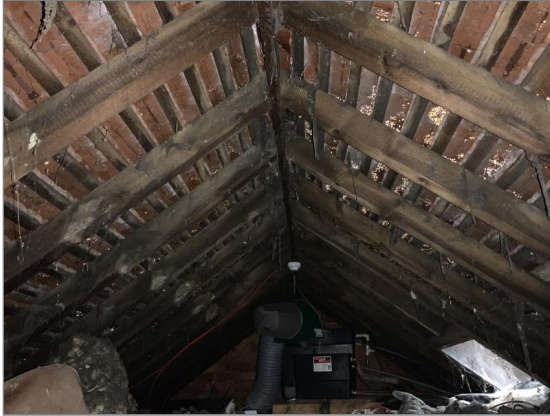
At the time of inspection, I identified a minor infestation of a wood boring insect, most likely the common furniture beetle. Although active infestations of these insects can be serious, I saw only a small infestation that usually requires limited treatment and repair. You should instruct a suitably qualified and competent timber treatment specialist in order to eradicate the infestation and undertake the necessary repairs.

A sprayed foam coating has been applied to the underside of the roof covering. This prevents ventilation within the roof void and the roof timbers could be affected by condensation and timber decay which is concealed by the sprayed-on coating. In addition, the coating is firmly stuck to the roof structure and covering, as such, removing it will cause further damage. You should plan for the worst-case scenario which will involve the complete replacement of the roof covering and parts of the roof structure.

Photo - 16 Main roof structure

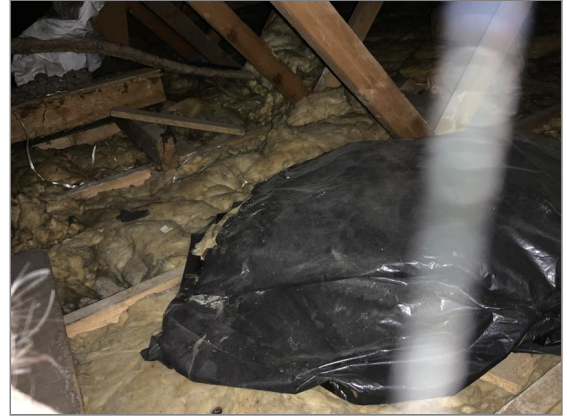
Photo - 17 Insufficient insulation

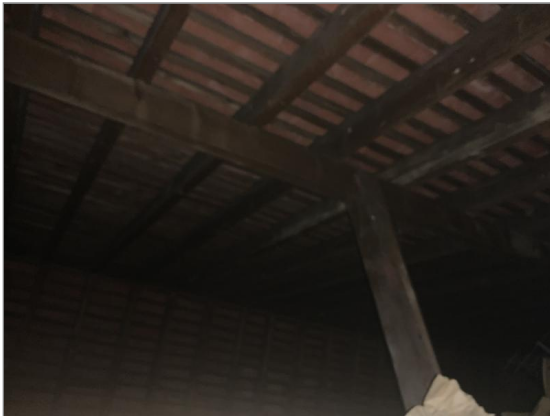
Photo - 18 Roof structure

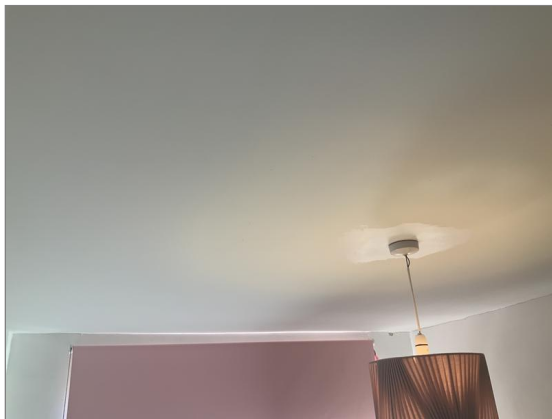
A textured decorative coating covers the ceilings to most areas. Some textured coatings may contain small amounts of asbestos fibres which, if disturbed, could be a safety hazard. The only way to categorically confirm if the textured coating contains asbestos fibres is to have a sample of the surface tested by an appropriately qualified professional in laboratory conditions. I would strongly recommend that you do not sand down the textured coating, or drill through the ceilings until you have ascertained whether, or not, asbestos is present.

Photo - 19 Typical ceiling

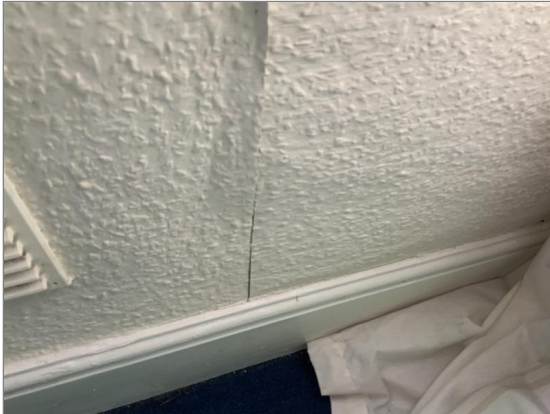
Photo - 20 Damp wall surfaces

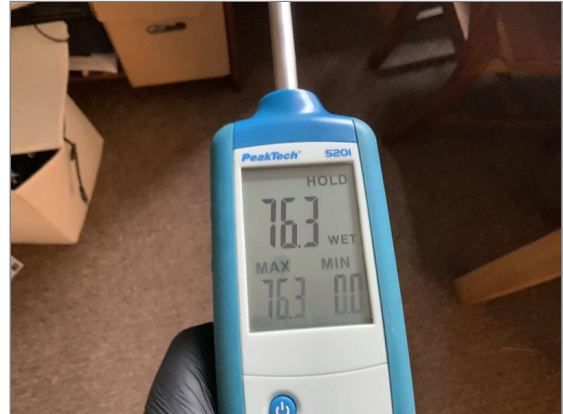
Photo - 21 High damp meter readings

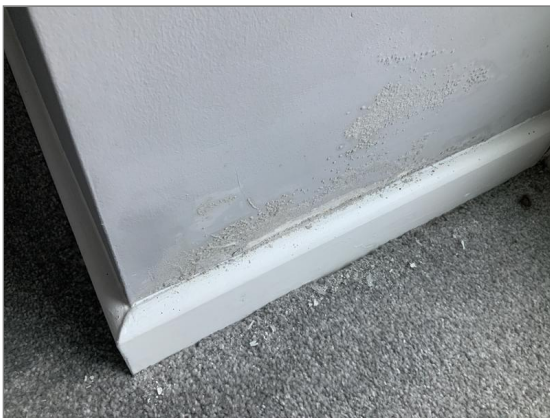
Photo - 22 Damp walls to rear

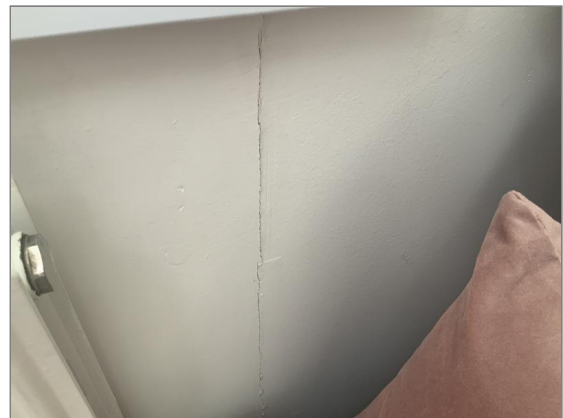
Photo - 23 Typical minor fracture to wall surface

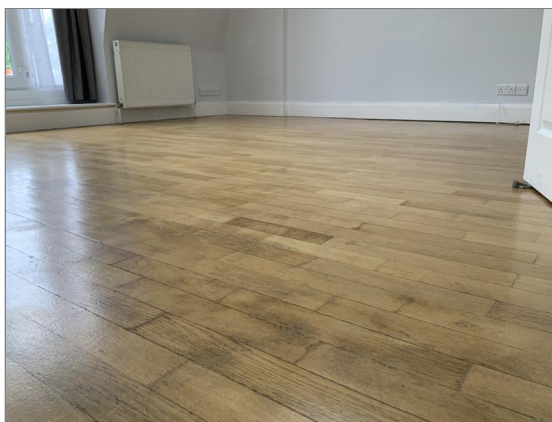
Photo - 24 Uneven floor surfaces

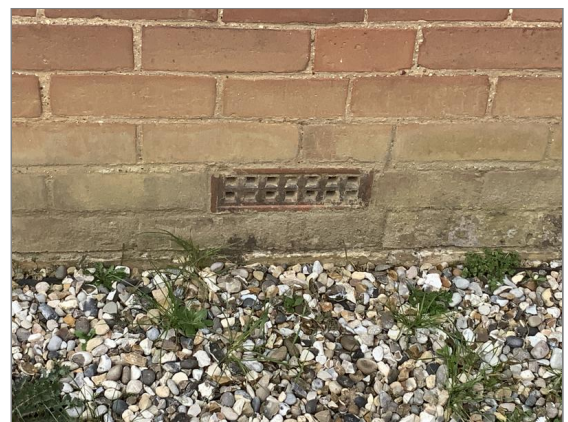
Suspended timber floors at ground level require cross flow ventilation in order to prevent the build-up of condensation within the floor void. This ventilation is usually provided by hollow bricks (called air bricks) located at low-level around the property. The number of air bricks provided is thought to be insufficient for purpose and therefore it is recommended that additional airbricks be provided.

Photo - 25 Insufficient subfloor ventilation

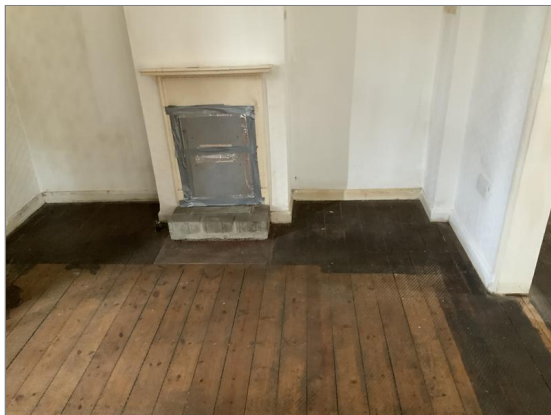
Photo - 26 Decommissioned fireplace

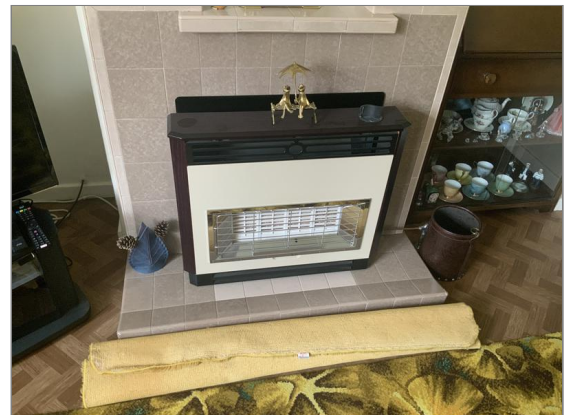
Photo - 27 Gas fireplace

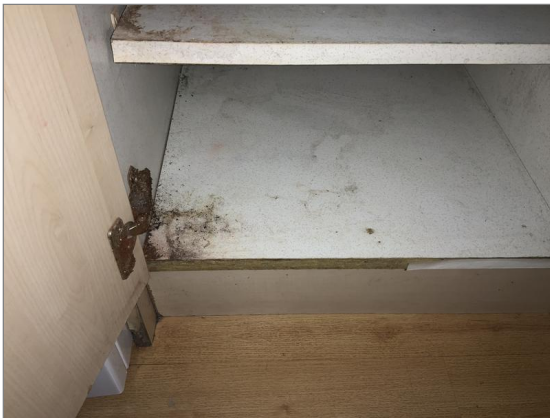
Although the kitchen fittings are generally functional, they are starting to show some signs of general degradation and wear and tear, particularly noted to the worktop and cupboard carcasses.

Photo - 28 Wear and tear to kitchen fittings

Over the longer term, it may be prudent to budget for replacing the kitchen fittings in their entirety. I would recommend that you plan to install a new range of kitchen fittings to include some integrated appliances which are popular with purchasers and therefore would make the property more desirable to future purchasers.

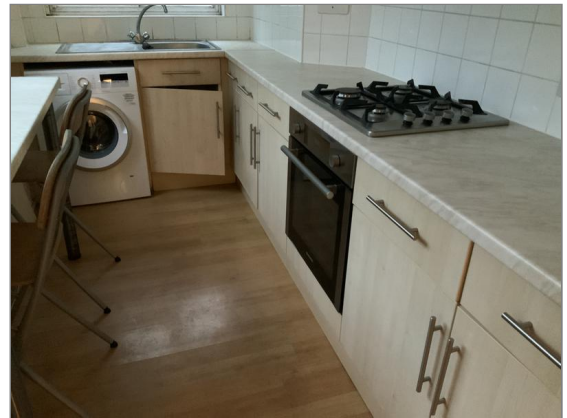
Photo - 29 Kitchen fittings

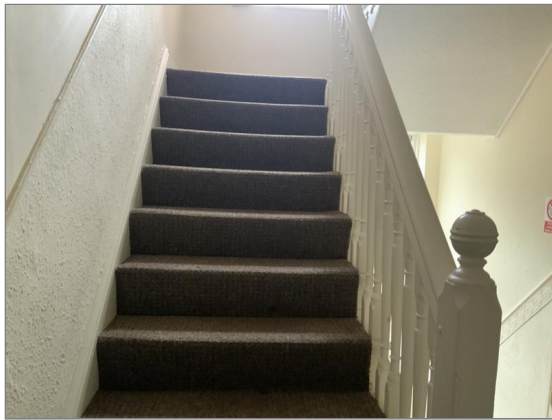
You should be aware that there is no handrail noted to the staircase leading from ground to first floor, you should therefore budget to install a handrail in the near future.

Photo - 30 Timber staircase

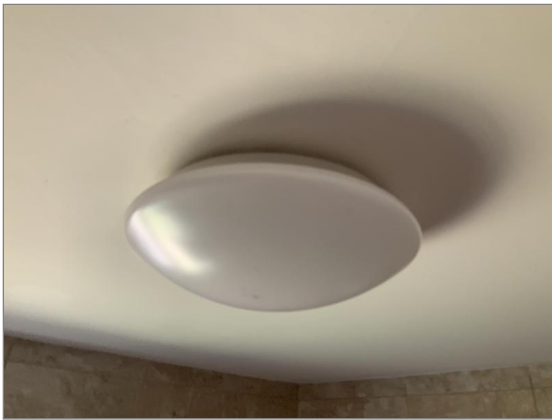
You should also be aware that the light fittings within the bathroom and en-suite do not comply with current requirements in respect of electrical appliances which could be affected by water ingress. It is recommended that the light fittings be replaced with suitable IP rated fittings. IP ratings or "ingress protection" ratings are defined in international standards EN60529 or British standard BSEN60529:1992. They are used to define the levels of sealing effectiveness of electronic enclosures against intrusion from various foreign objects including moisture. You should ask an appropriately qualified electrician to replace the light fittings with a minimum rating of IP65.

Photo - 32 None IP rated light fitting

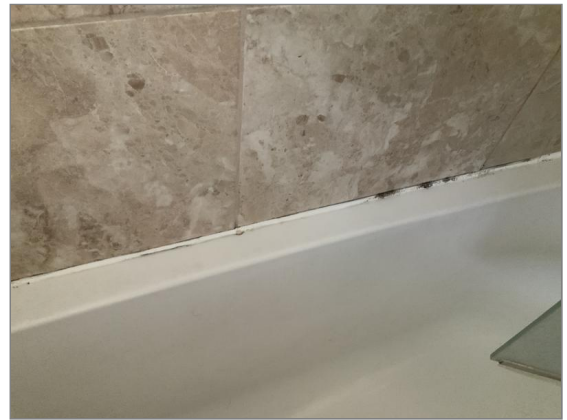
The tile grout adjacent to the bath is degrading and discoloured which in turn can allow water penetration to occur which can seep behind the tiles and damage the adjacent walls. This issue can also be the cause of discolouration to the ceiling surfaces to the rooms below. You should plan to re-grout the tiles as soon as practicably possible with a suitable product for use in wet areas.

Photo - 33 Defective sealant around bath

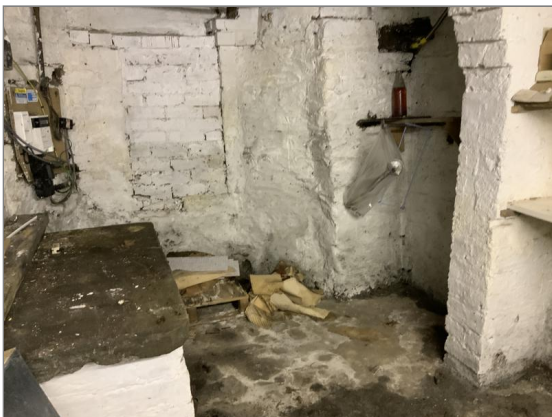
Photo - 34 Basement area - dampness and condensation

I would recommend that you plan to install some form of ventilation within the basement area which will help to control the level of condensation and will go some way towards alleviating the levels of dampness. Such ventilation is usually achieved by installing a ventilation outlet to the door leading to the basement and additional hollow bricks, cold air bricks around the perimeter of the wall at low-level.

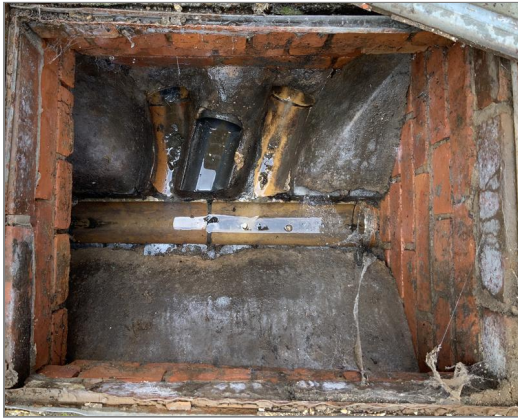
There was some standing water within the inspection chamber channels and some general silting up. You should arrange for this to be jetted out by high pressure water to ensure the drainage runs clear and efficiently discharging the foul waste into the local sewerage system.

Photo - 41 Below ground drainage

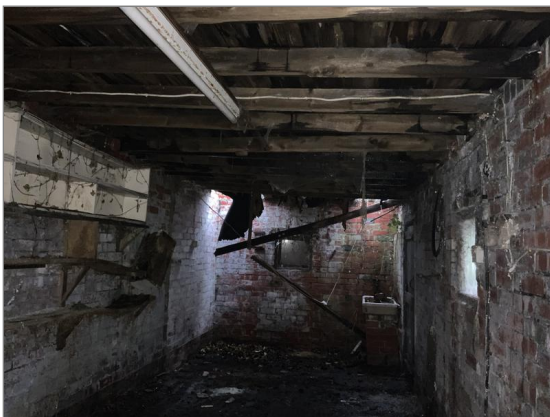
In this condition, the garage does not add any particular value to the property, and in many ways could detract from the overall desirability of the property which is likely to have a negative impact on the valuation. I would therefore recommend that you plan to completely demolish the existing garage and remove all debris from site prior to re-constructing a new single car garage on the same site.

Photo - 42 Dilapidated garage
