## “Project Rainwater”

*Work in May has focused on inspecting the cause of plaster damage related to water and moisture entering the interior east wall of the church. This is the current top priority before many other areas of the church are addressed.*

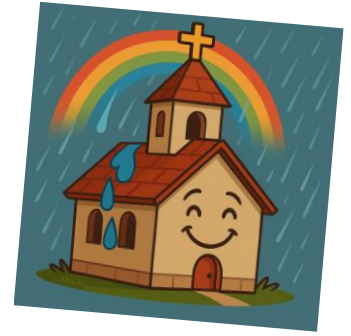
1. **Gutter Blockage:** Complete blockage of the east gutter directly above the windows with plaster damage was found due to large collection of tree debris and pine needles with a minor amount of roof tile debris from loss or shedding of slate pieces. Blockage has now been cleared and gutter cleaned from debris.

2. **Slate Roof Inspection at East Wall Eave:** The condition of what is the original slate roof tiles at the roof edge just above where the plaster damage is located appears to be in a greatly “aged” but acceptable condition. No roof leakage is believed to be present in this area. This is additionally supported by interior attic inspection which shows no visible signs of water damage from inside the church attic.

3. **Gutter and Upper Exterior Wall Inspection:** Visual inspection shows a marked difference between the north (no plaster damage) and south area (plaster damage) of this exterior brick wall. The south area presents signs of discoloration resembling darker green/brown/black which is likely caused by organic growth of mold and mildew due to the pine needles and tree debris being carried from a leaking gutter down along the wall face with some water entering the interior of the church causing plaster damage. This approximate 24’ length of box gutter is lined with a rubber membrane and appears to have failed, likely due to both age and additional damage likely caused by freezing of the blockage debris due to seasonal winter temps.

4. **Repair Activity:** Further close up/hands on inspection of the box gutter is needed which is at a height of 28’ above ground. Scaffolding has been purchased to allow this inspection to occur. It is quite likely that the entire approximate 48’ (2 x 24” sections) of box gutter on this east side wall will need to be rebuilt and repaired with a new liner.
