| DIFFICULT TO DIAGNOSE REFERENCE | | |

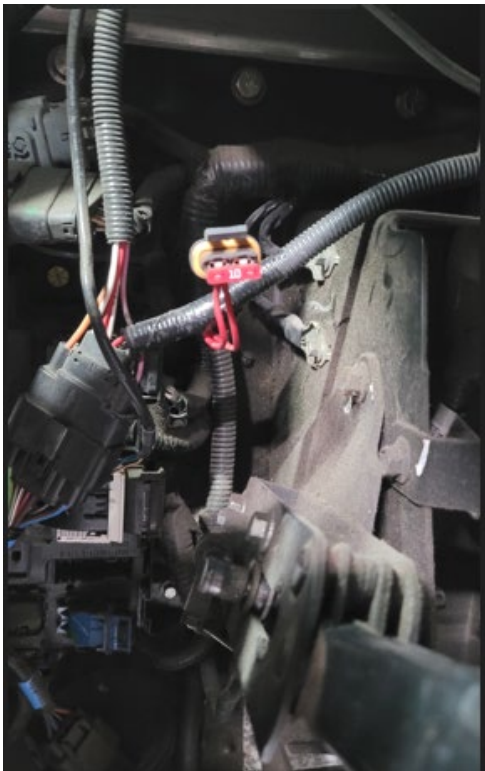
| DIFFICULT TO DIAGNOSE REFERENCE | | |
|---|---|---|
| 20 & newer (7.3) | No crank, no start | Blown 10A fuse in Morgan Olson Keyless wiring harness. See "10A MO fuse" tab |

From Victor Edgell on 2/10/25: The harness that you are seeing with the blown fuse is actually a rework harness that is not standard. This is intended to separate the Keyless system from the keyed switch on the IP. I am unsure how many units have been upfit with this harness, I believe it was a field campaign

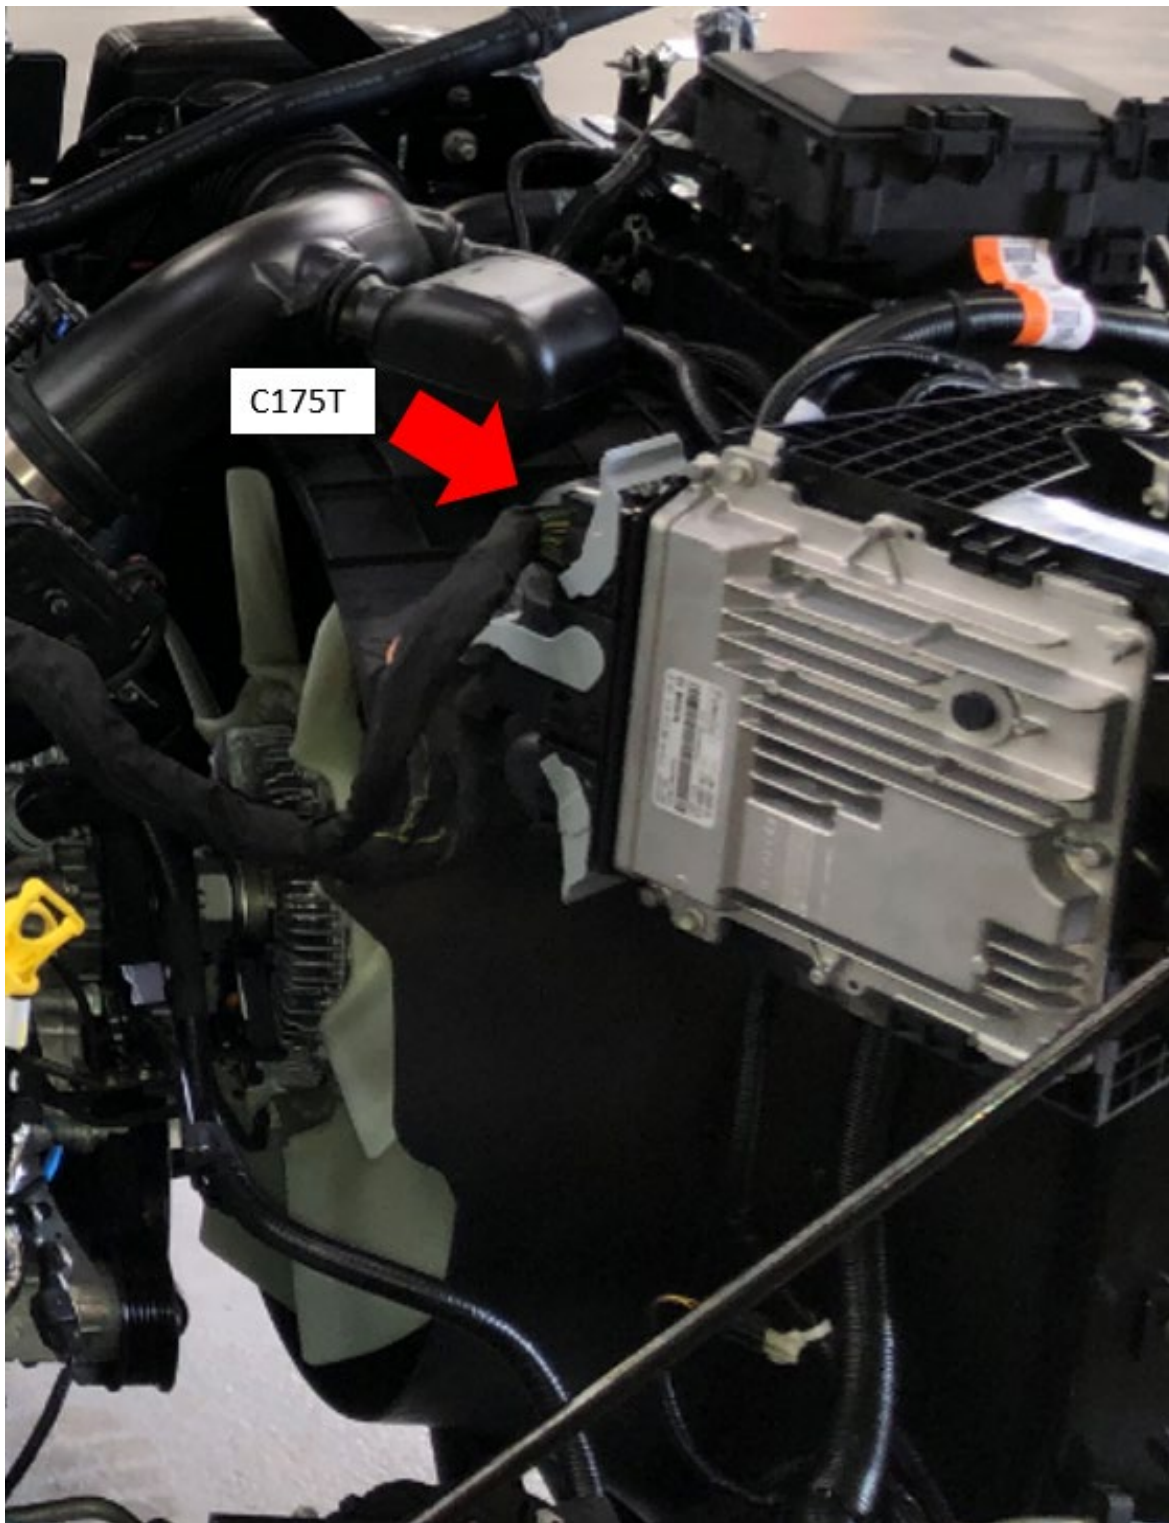
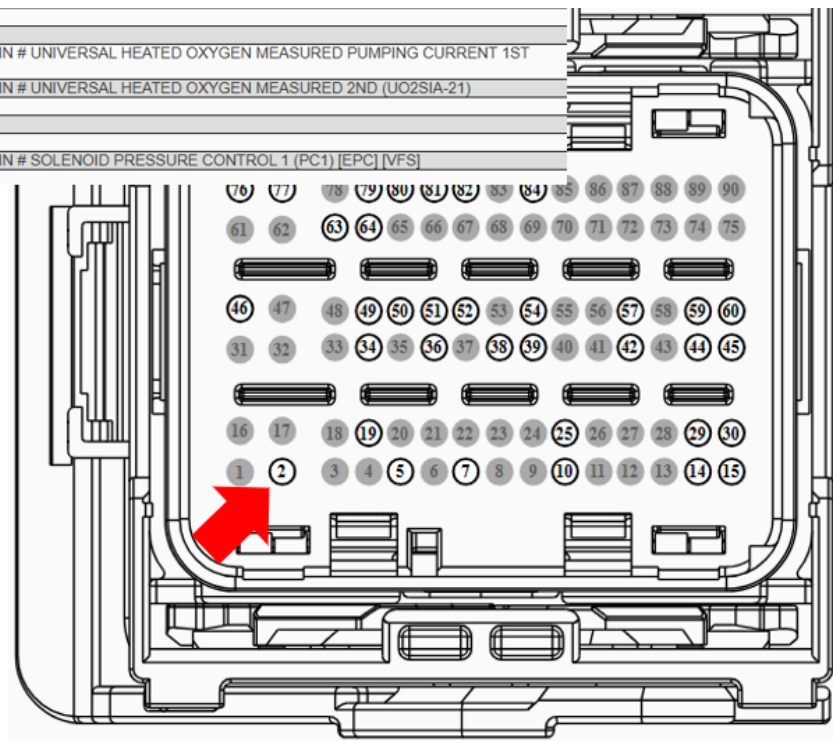
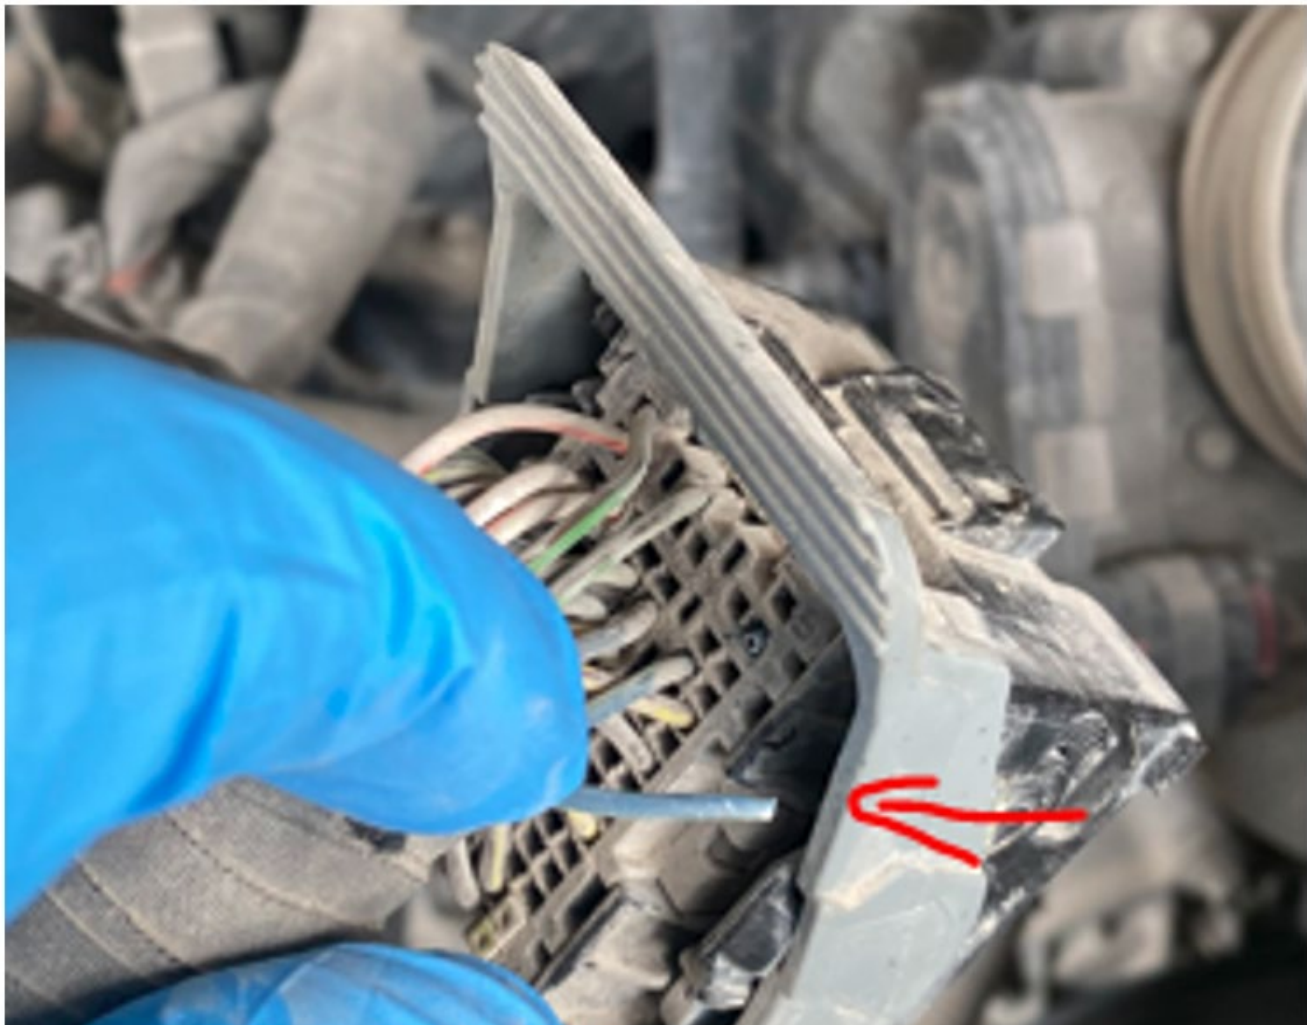
| DIFFICULT TO DIAGNOSE REFERENCE | | |
|---|---|---|
| 20 & newer (7.3) | P0657 / P0769 | broken wire @ C175T pin 2. See "MY20-22 P0657-P0769" tab |

| Pin | Circuit | Gauge | Circuit Function |
|---|---|---|---|
| 2 | CET25 (BU-GN) | 18 | CTRL MOD. - POWERTRAIN # TRANSMISSION SOLENOID POWER CONTROL (TSPC) |
