UPS # 5320054

Transmission Filter for the 6R140

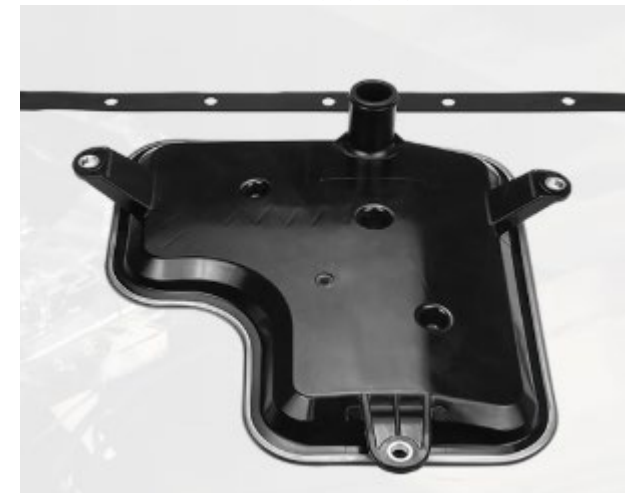
KRB Ford Trans
Filter
KRB126585

The Transmission filters we have been getting are no longer the Ford OEM FT187 or BC3Z-7A098-B. We have been getting KRB 126585, The KRB filter's O'ring is too small, at cold start the transmission shows 0 PSI (cavitation) until the unit warms up and stops cavitating As the transmission warms up it swells the O'ring and allows the seal to complete and operate properly. The O'ring on the KRB filter is .0027 smaller than the OEM filter. This allows the transmission to slip, or in some incases not to shift at all. Either way causing premature failure, on our units anywhere from 80k to 95k. All of the units we had fail had the KRB filter in it upon inspection.

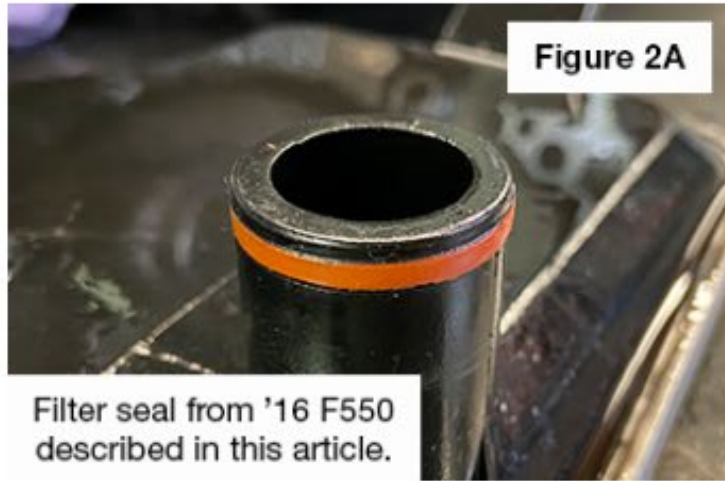
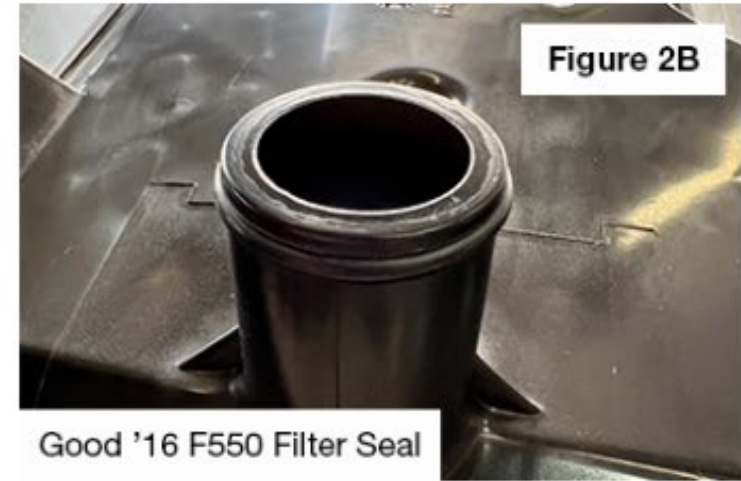
Figure 2 – Filter Seal

THIS IS FROM AN ARTICLE FROM BEFORE WHERE THE OLD OEM WITH TIME WORE DOWN AND CAUSED THE SAME ISSUE.

NEW REPLACEMENT SEAL SAID TO FIX ORIGINAL ISSUE

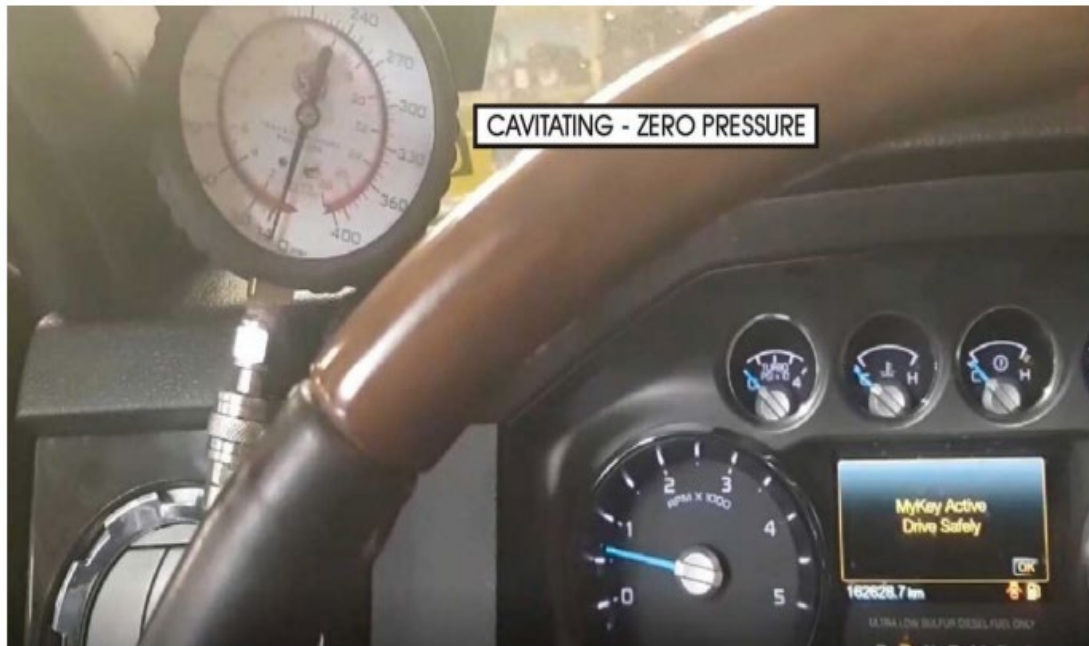
Figure 2.

An undersized o-ring seal on the new filter neck, seen in Figure 1 above, is causing cavitation. The pressure gauge connected to the line pressure port indicates zero pressure (see Figure 2), which would explain the no-engagement complaint.

Even with the case connector disconnected, the gauge still indicated zero pressure.

Replacement of the filter with a good o-ring seal eliminated the engagement problem entirely. The above listed trouble codes were cleared and did not return, as those code definitions were falsely generated.

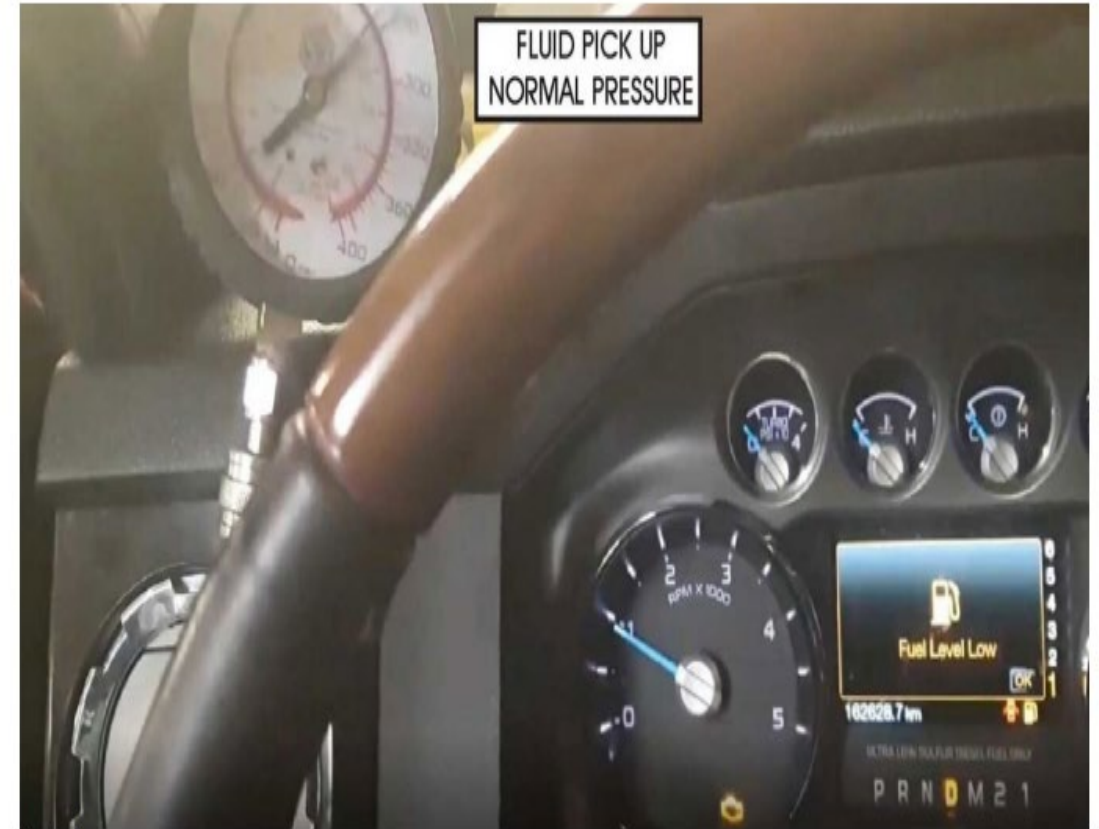
As the transmission warms, the o-ring seal swells enough to allow fluid to be picked, at which point the pressure gauge jumps up to the correct line pressure, as seen in Figure 3.
