CORPORATE AUTOMOTIVE BULLETIN

Subject: Ford Drag Link -Torn Boots

Bulletin #: D19-09

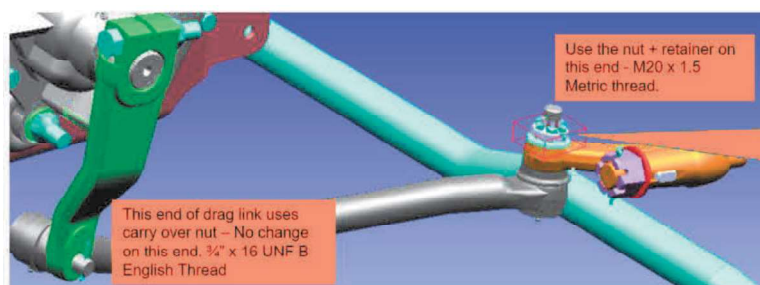
Nut – UPS # ~~5211910~~ (5211910)
Castellated Retainer – UPS# 5211913
Cotter pin – UPS# 5211916

Torque, for latest Drag link only, is 250Nm (184 ft/lb) with the required hardware.
