INSPECTION REPORT

For the Property at:
57 CARMICHAEL CRESCENT
KING CITY, ON L7B 1B5

Prepared for: C/O MICHAEL BERNARDI
Inspection Date: Monday, September 30, 2024
Prepared by: Steven Love

Report No. 2119

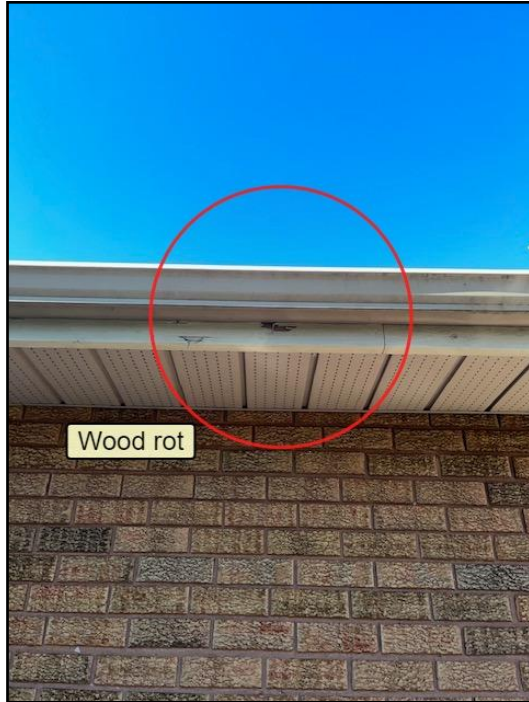
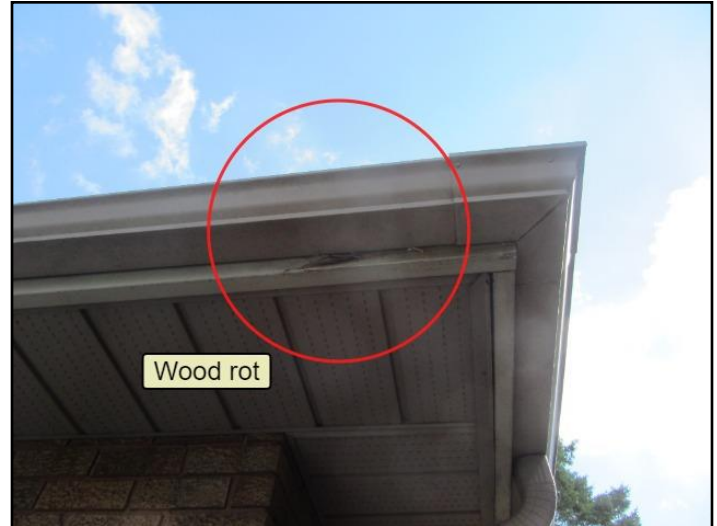
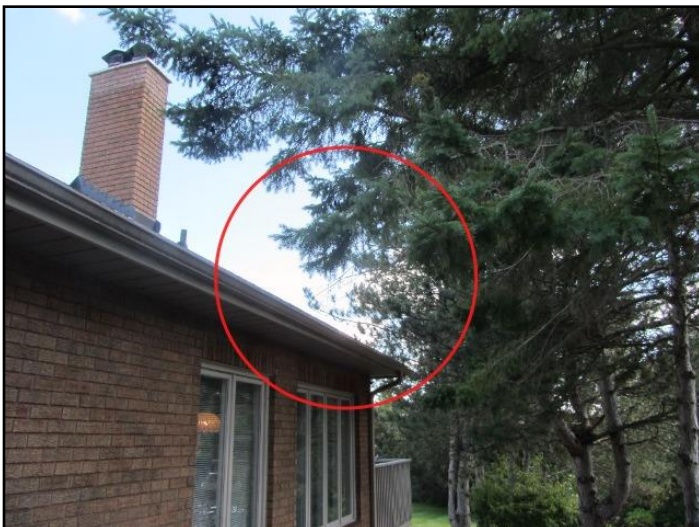
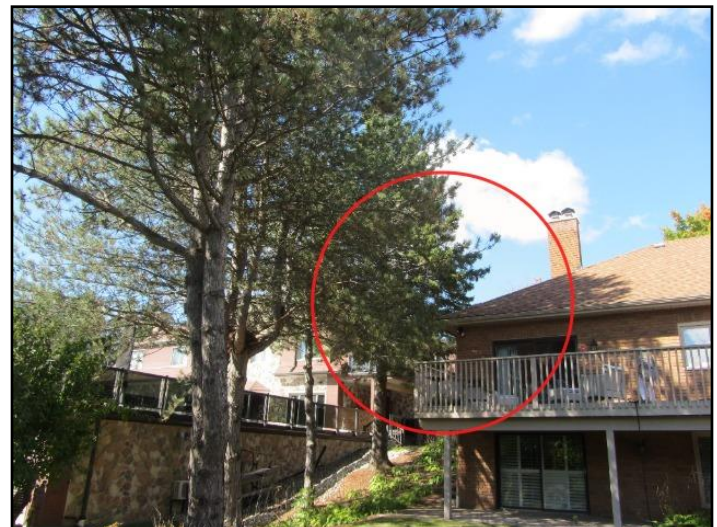
1. Condition: • The overall shingled areas looked good today. We suggest trimming back / removing the overhanging trees and greenery. In addition, some of the wooden fascia areas will need spot repairs or replacement.

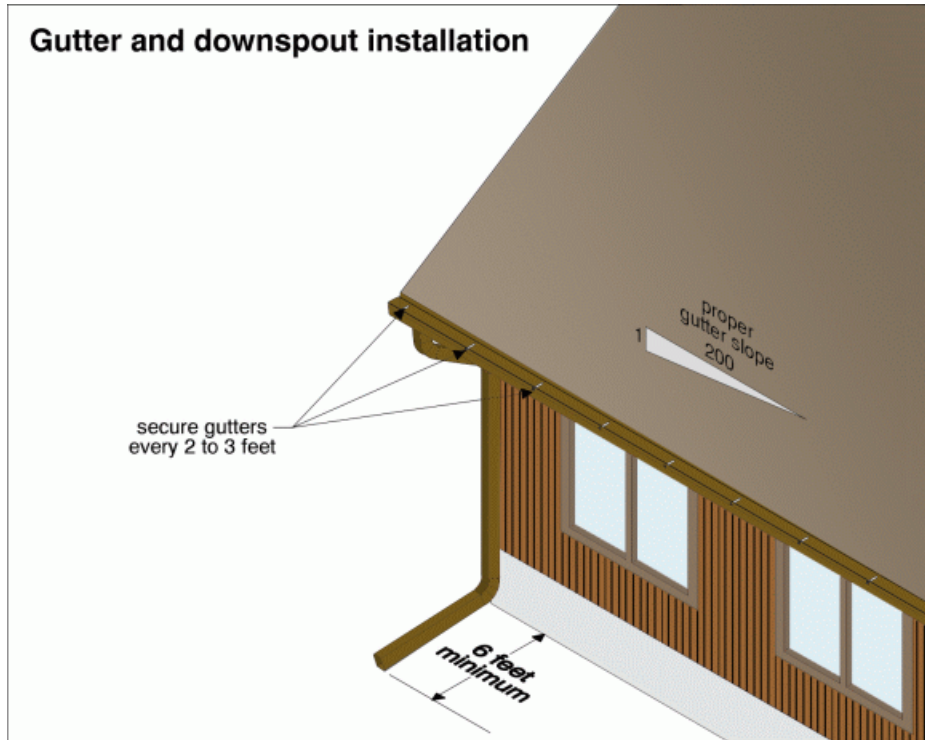
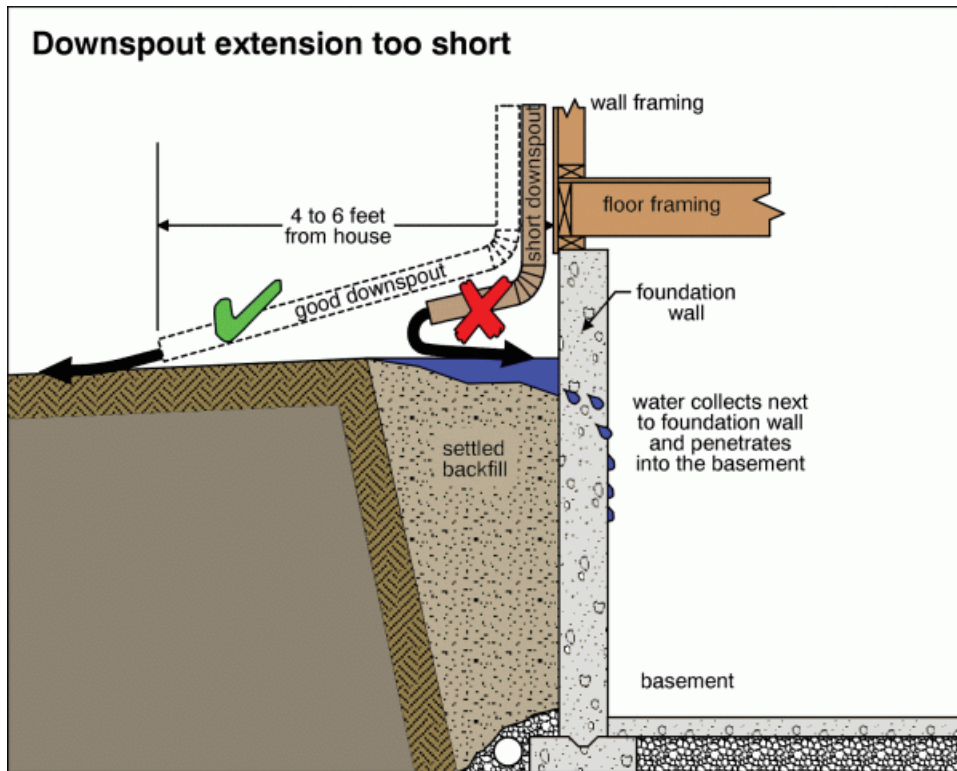
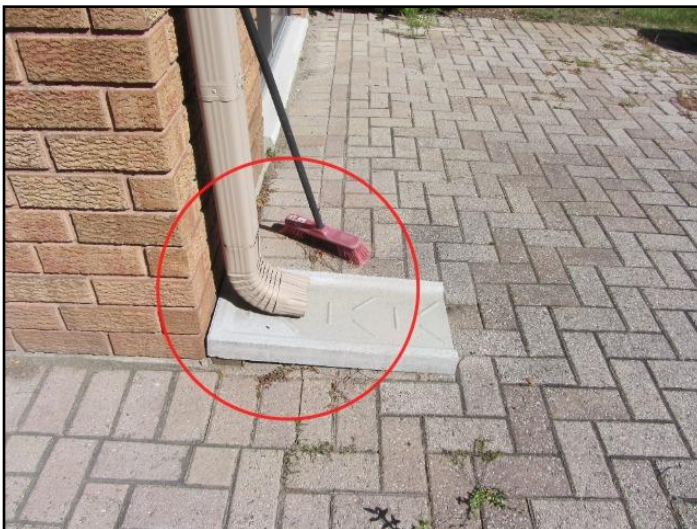
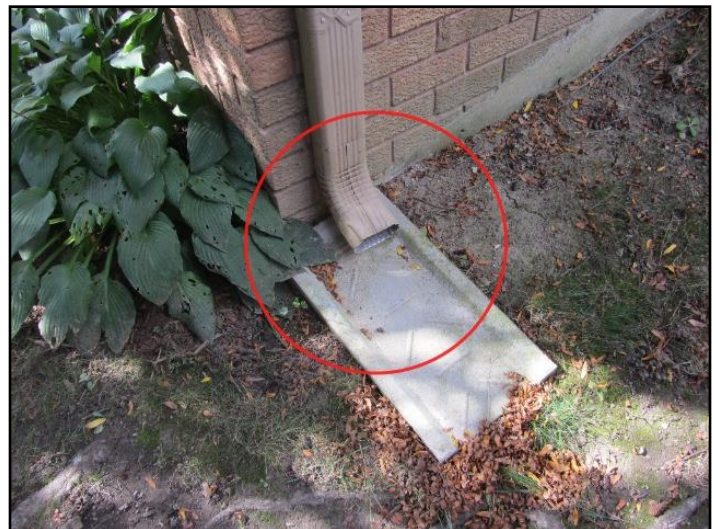
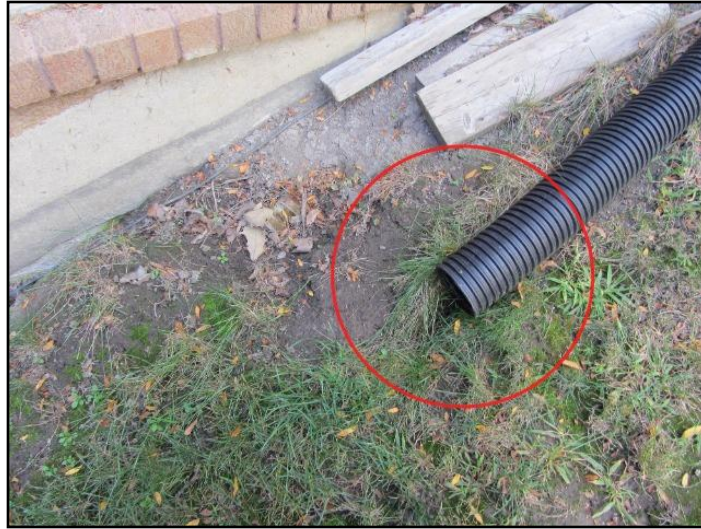
2. Condition: • Discharge to close to the building.

Implication(s): Chance of water damage to structure, finishes and contents

5. Discharge too close to the building.

6. Discharge too close to the building.

7. Discharge to close to the building.

Task: Improve

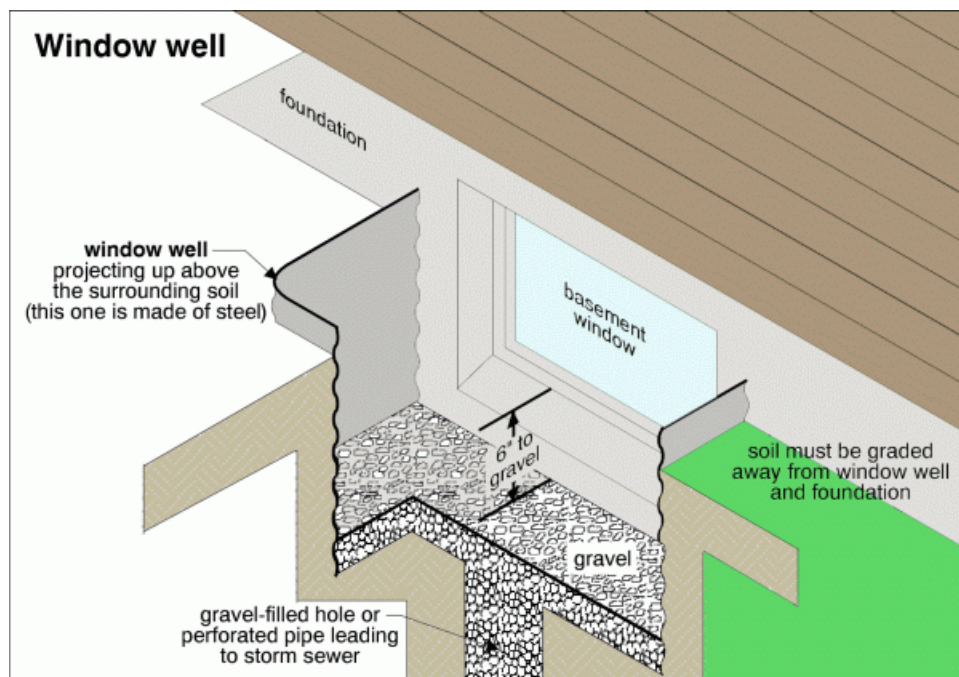
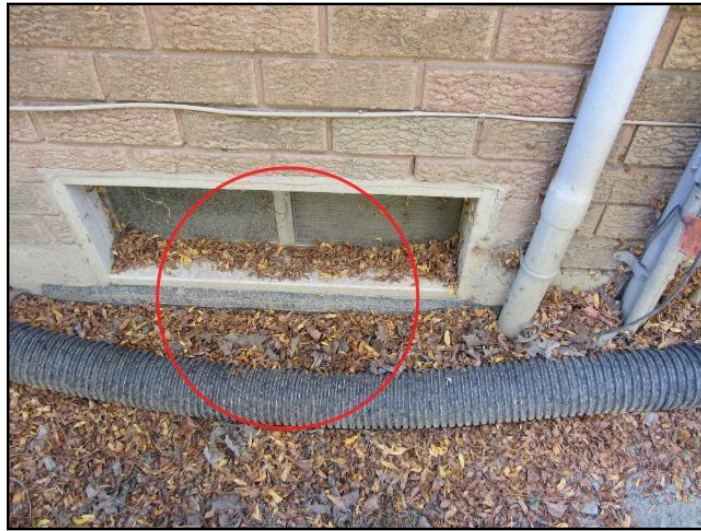
3. Condition: • [Less than 6 inches below window](#)

Implication(s): Chance of water entering building

8. Less than 6 inches below window

Task: Improve

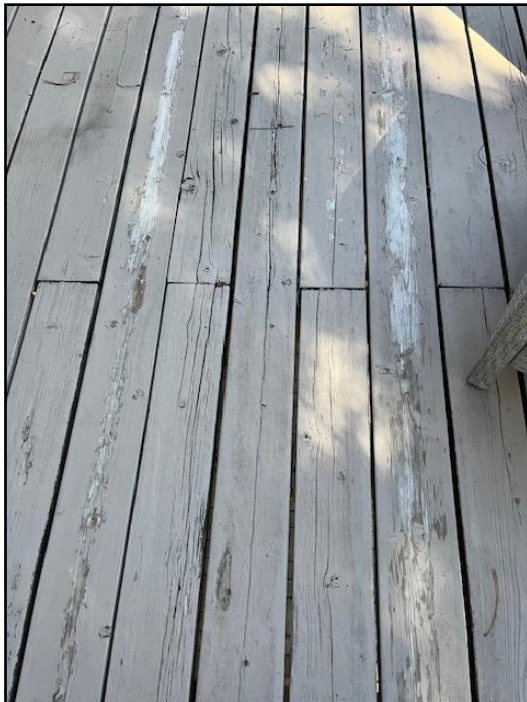
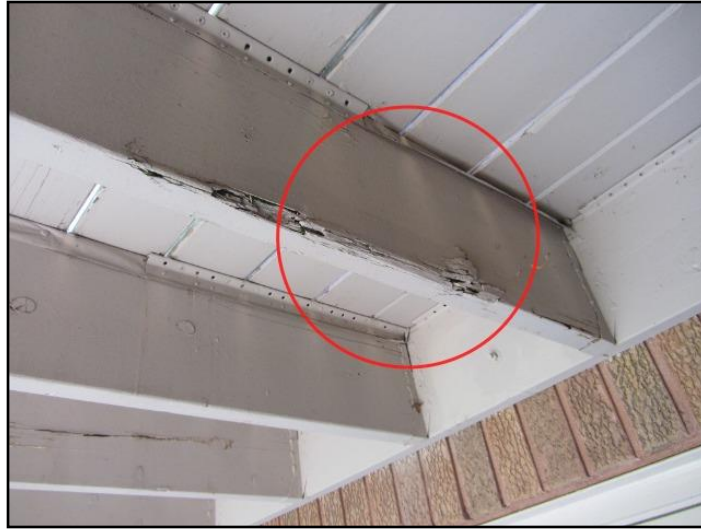
4. Condition: • Worn / older.

9. Worn / older.

11. Worn / older.

Task: Further evaluation Upgrade

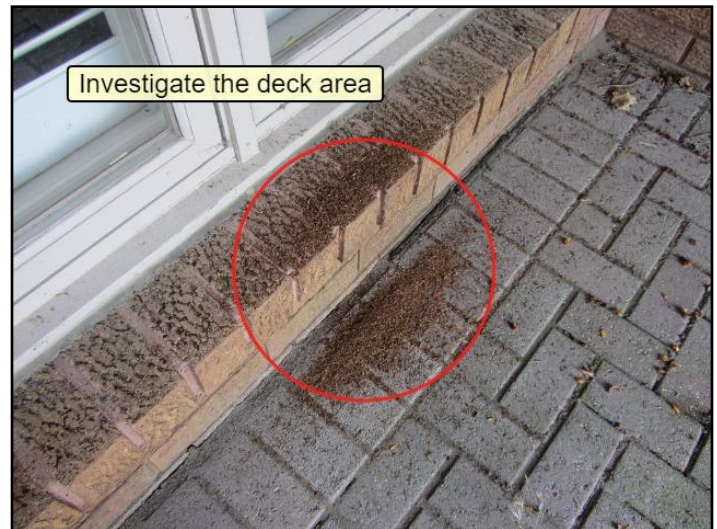
10. Possible carpenter ants

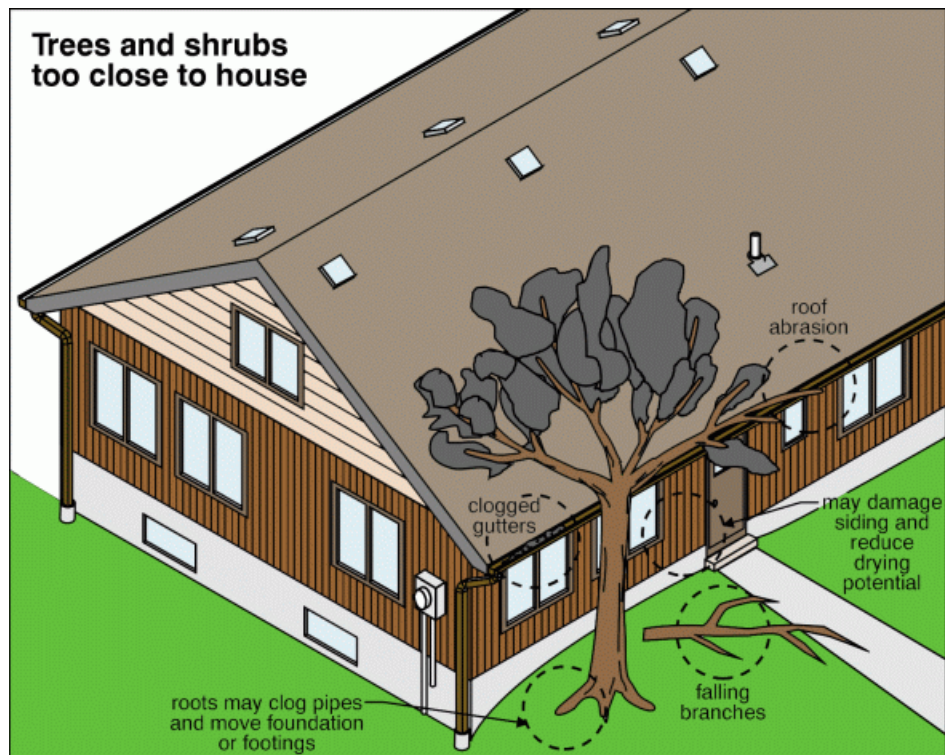
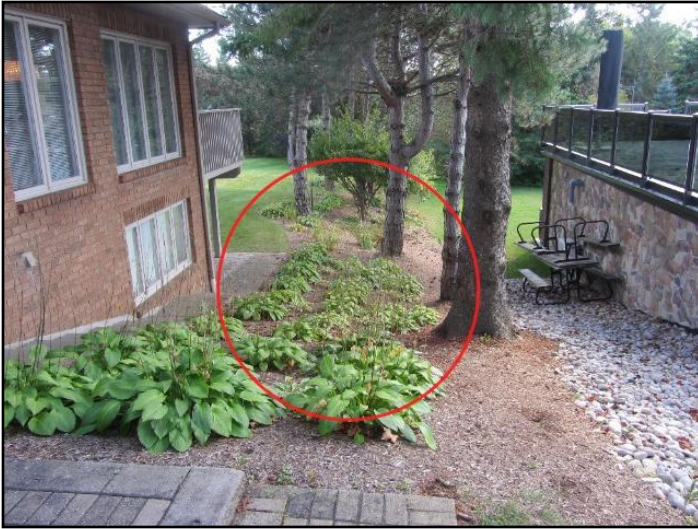
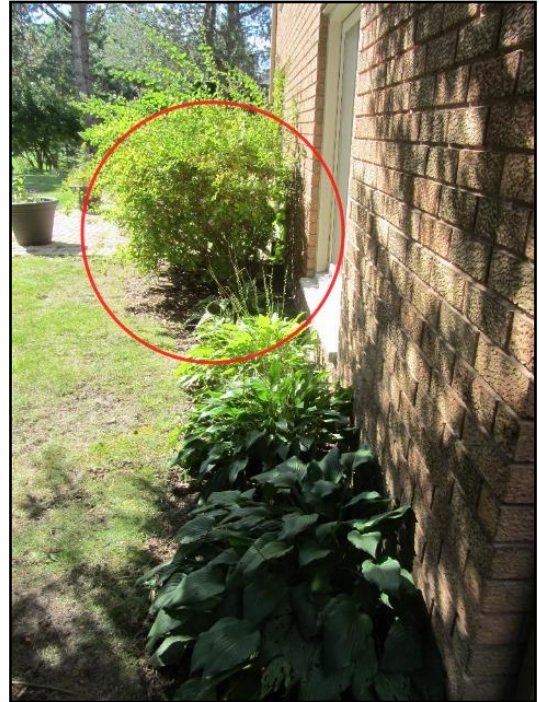
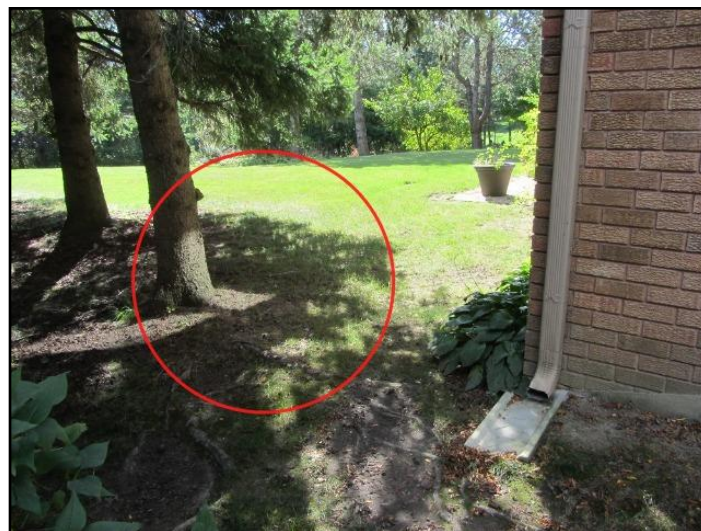
5. Condition: • [Trees or shrubs too close to building](#)

Implication(s): Chance of water damage to structure, finishes and contents | Chance of pests entering building | Material deterioration

12. Trees or shrubs too close to building

13. Trees or shrubs too close to building

14. Trees or shrubs too close to building

Task: Improve

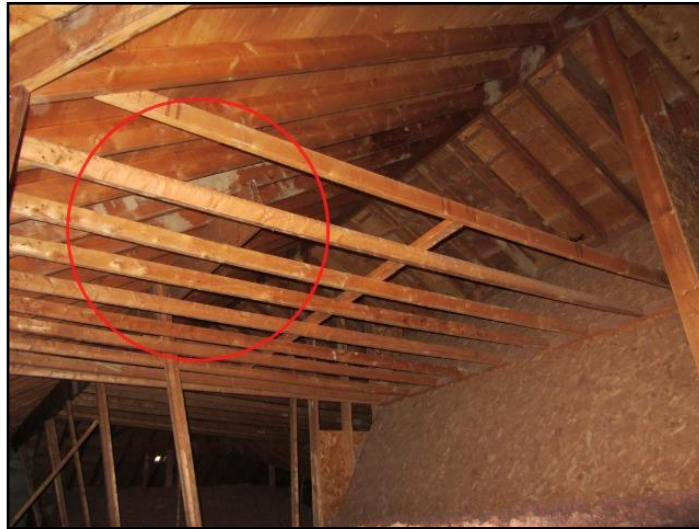
15.

8. Condition: • Prior repairs noted. We suspect that the roof framing was improved possibly during the last shingle upgrade - Typical

Task: Monitor

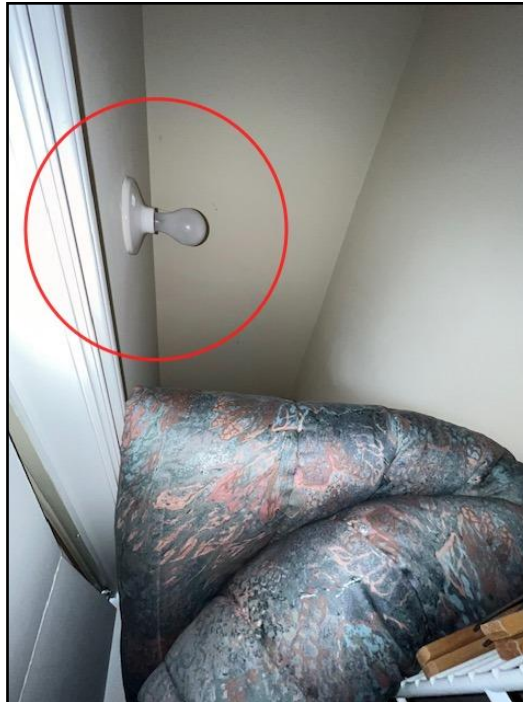
17.

10. Condition: • The home has many premium upgrades. One of the upgrades was closet lighting in some rooms. We suggest these fixtures get upgraded to a covered fixture with a low-heat LED bulb.

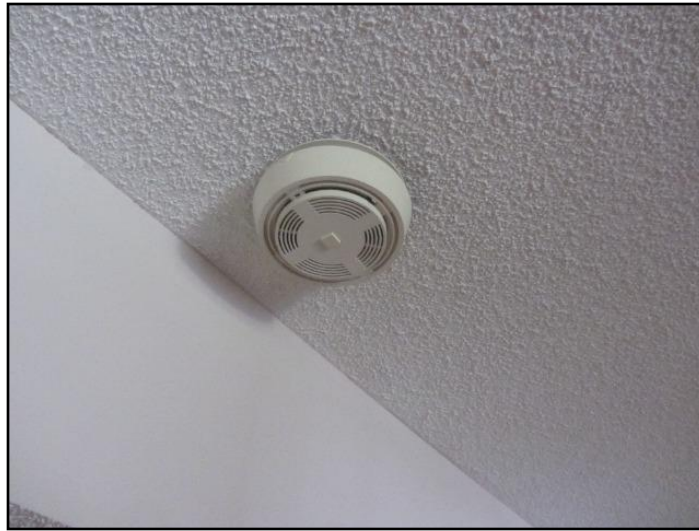
11. Condition: • Upgrade Smoke and CO detectors

18. Upgrade Smoke and CO detectors

12. Condition: • Recent changes to the Ontario Fire Code call for smoke detectors in the bedroom areas of new buildings. The client(s) should consider upgrading smoke & CO detectors to new build standards.

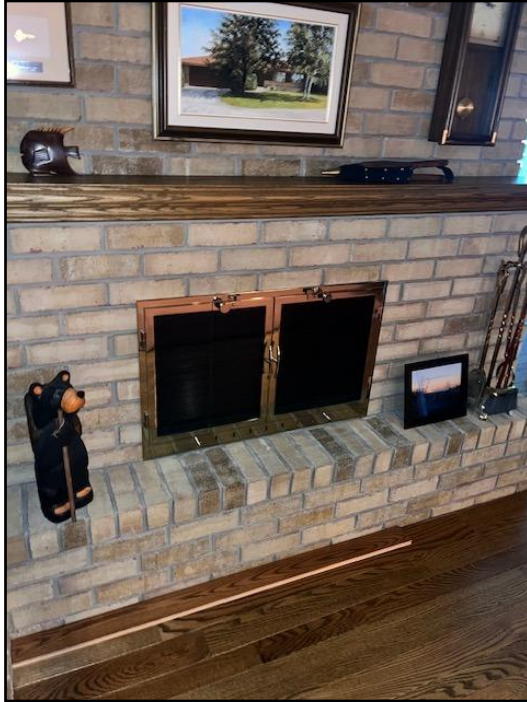
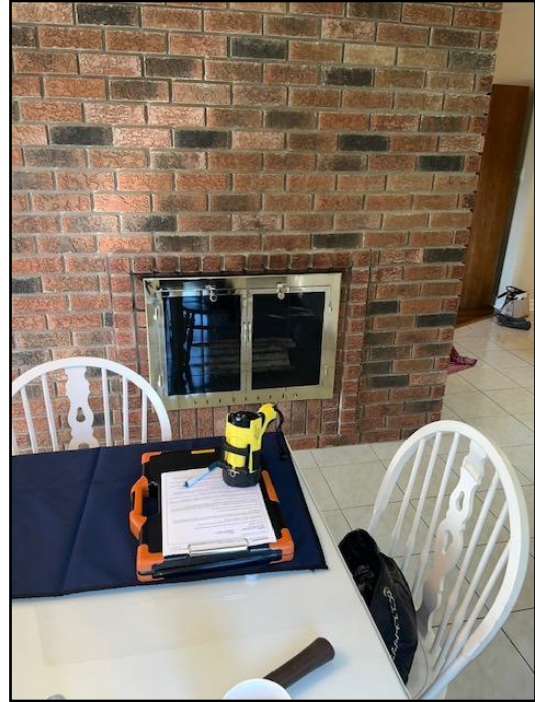
22. Wood-burning fireplace

23. Wood-burning fireplace

16. Condition: • Before use, provide a level three WETT inspection (interior of the flue inspected too), check with insurance restrictions as well. Most local fire departments will offer building inspections with their fire prevention sections. Consider the unit non-functional until proven safe.

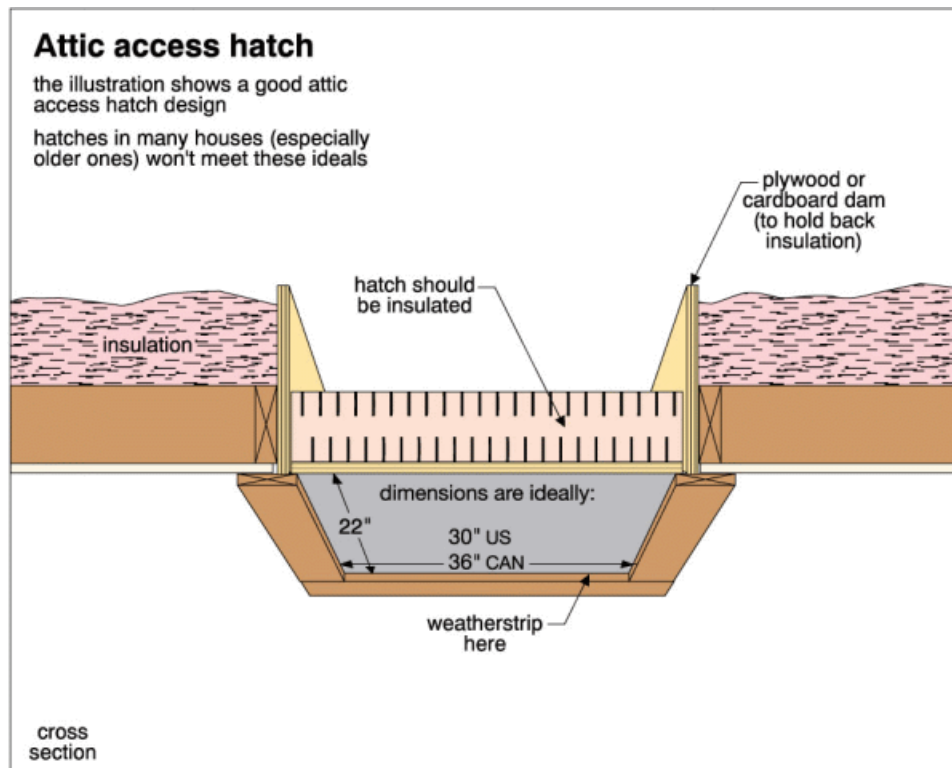
20. Condition: • [Not weatherstripped](#)

Implication(s): Chance of condensation damage to finishes and/or structure | Increased heating and cooling costs

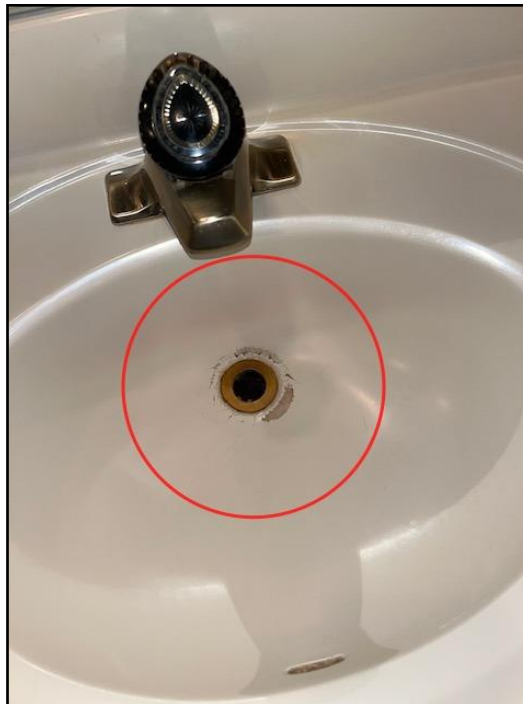
22. Condition: • Chipped paint/rust.

27. Chipped paint/rust.

Task: Upgrade

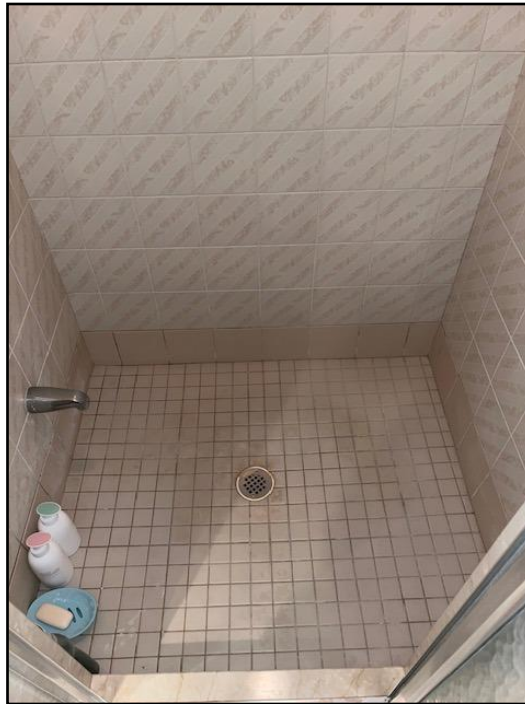
23. Condition: • [Caulking loose, missing or deteriorated](#)

Implication(s): Chance of water damage to structure, finishes and contents

28. Caulking loose, missing or deteriorated

Task: Improve

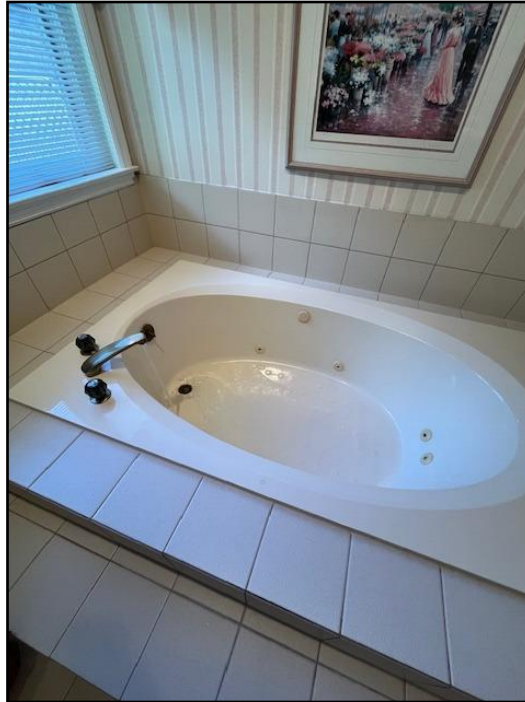
24. Condition: • There have been some questions about hydro-massage tubs, and cleaning/sterilizing the jet tubes. Investigate (possible upgrade).

29. Consider an upgrade.

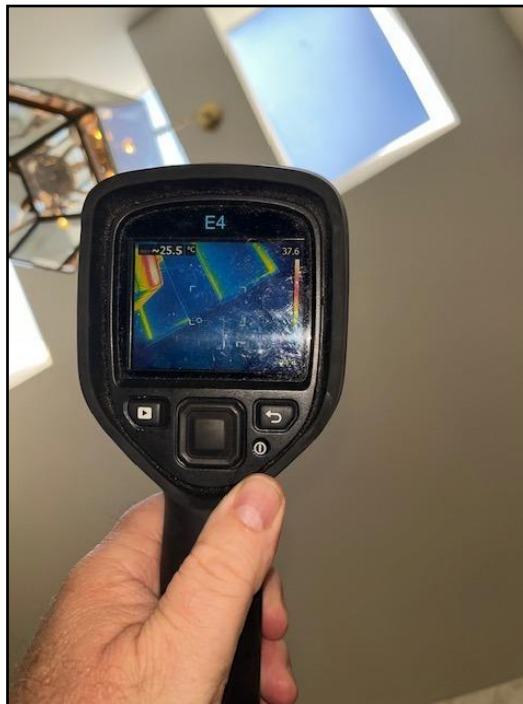
26. Condition: • Stains

Implication(s): Chance of water damage to structure, finishes and contents

34. Stains - Skylight (tested dry)

Task: Monitor

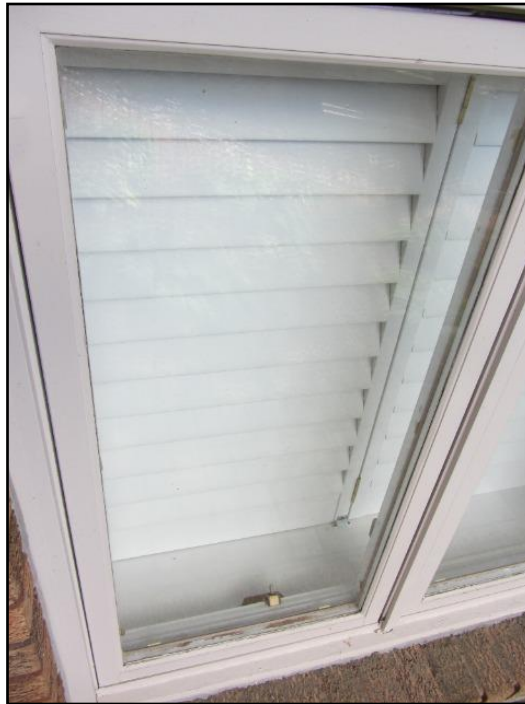
27. Condition: • A mixture of older & newer windows were noted. Further upgrades to be considered.

The original windows installed were considered the "Cadillac" windows of the time. Many windows have since been upgraded, we suggest maintaining all windows now, budgeting for further upgrades.

35. A mixture of older & newer windows.

Task: Improve Upgrade

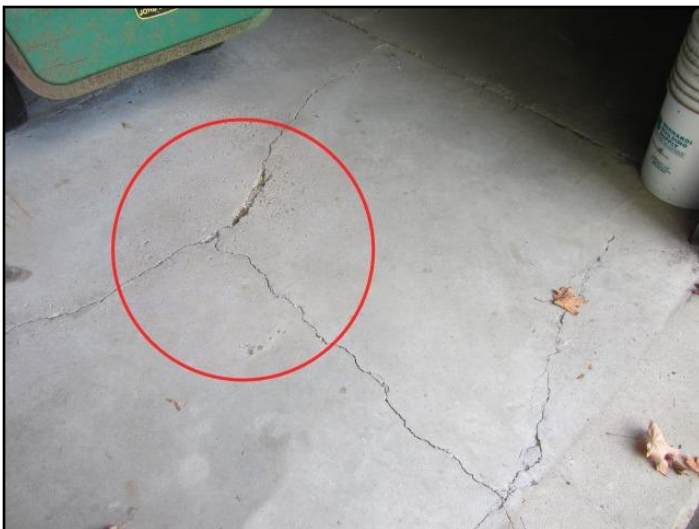
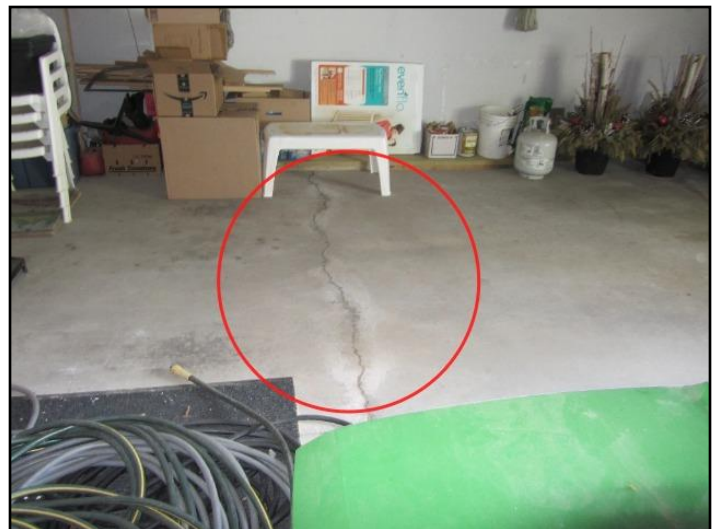
28. Condition: • [Cracked](#)

Implication(s): Uneven floors

36. Cracked

37. Cracked

Task: Monitor

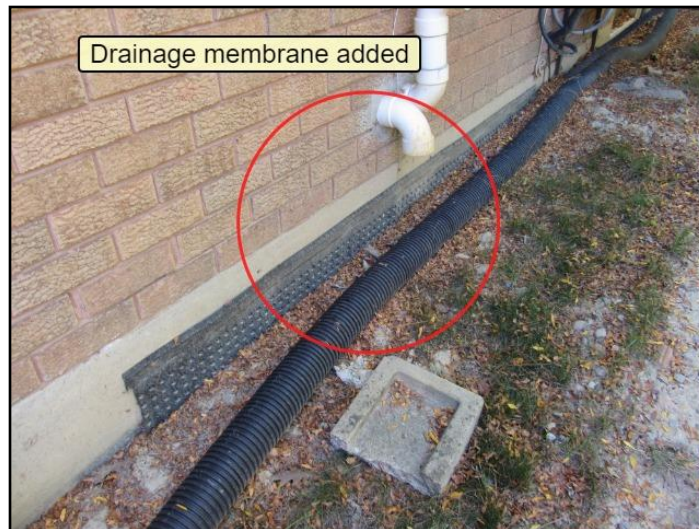
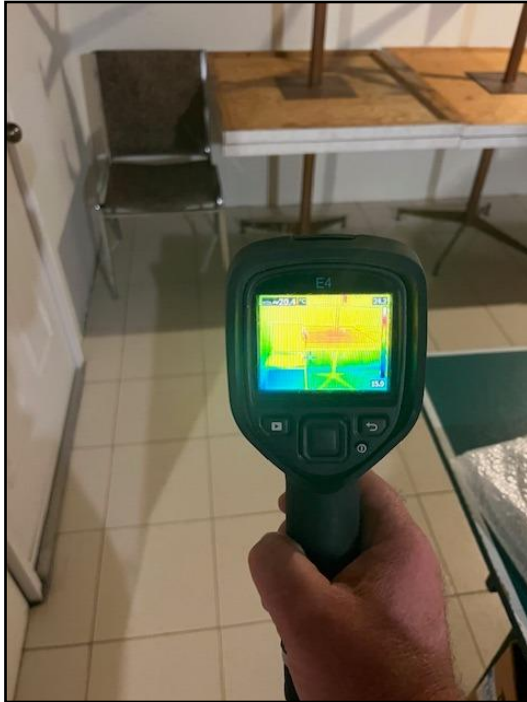
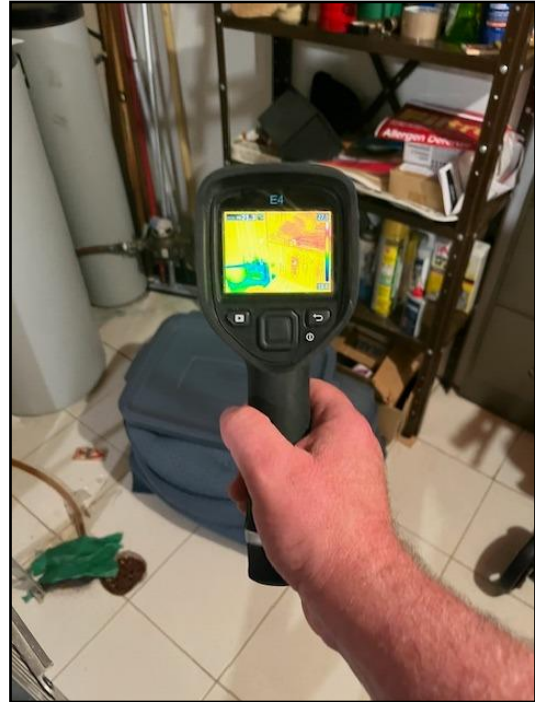
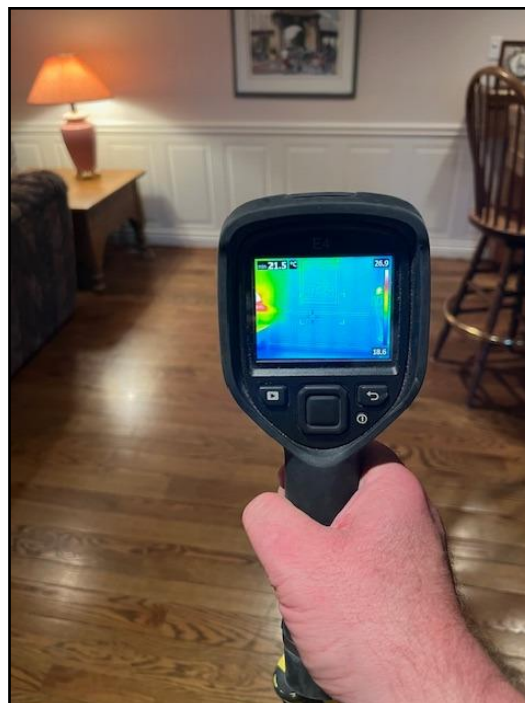
The east wall shows some history of prior repairs to help stop any water entry (typical repair).

38. Prior repairs

39. Tested dry today.

40. Tested dry today.

41. Tested dry today.

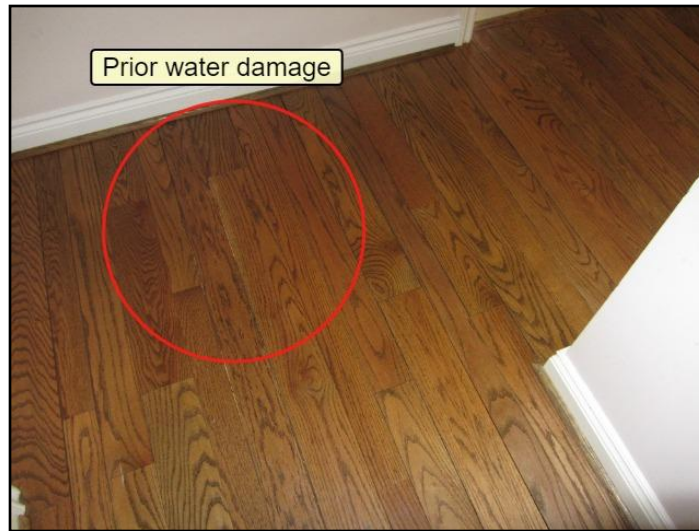
42.

Evidence of basement leakage: • The hardwood floor in the east basement area showed signs of prior water entry (tested dry today). We did see some localized waterproofing on the exterior, maintain and monitor repairs at the exterior east wall.
