## Property Inspection Report

Property address: **6145 Parrish Rockford Illinois**

Inspection date: **Sunday, May 30, 2021**

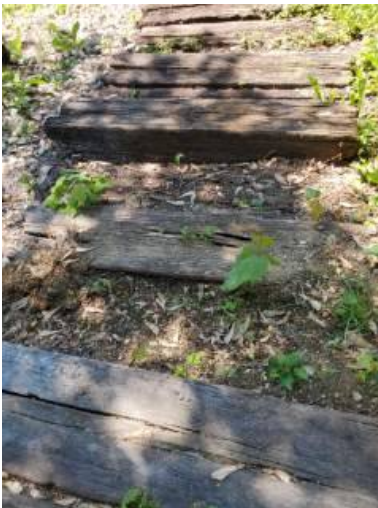
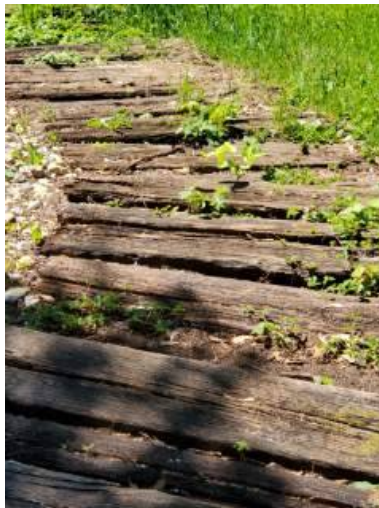
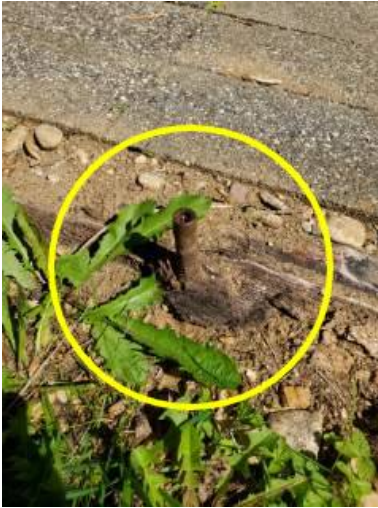
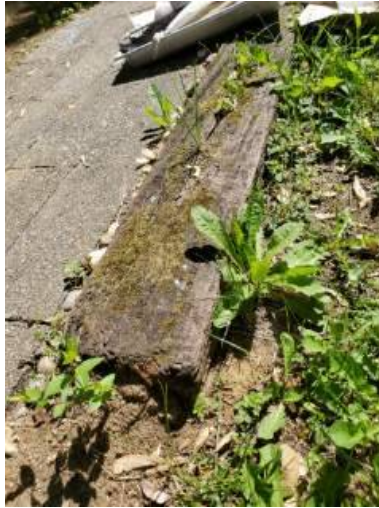
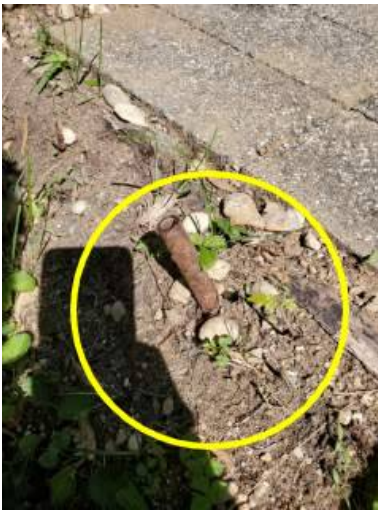
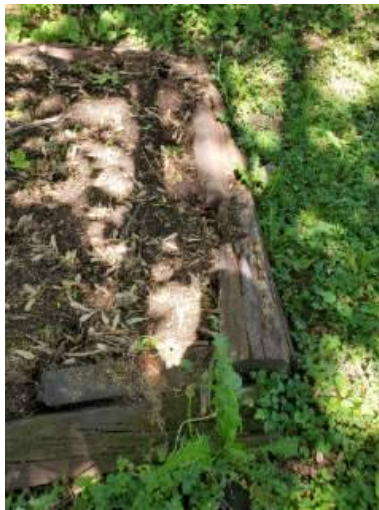
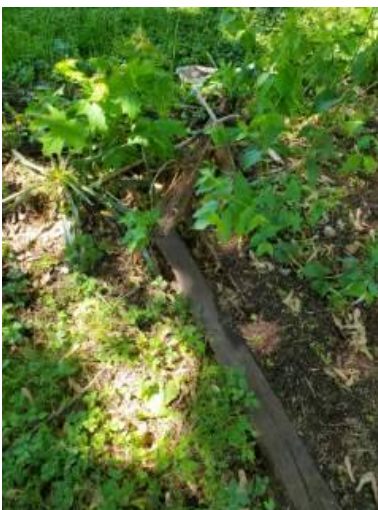
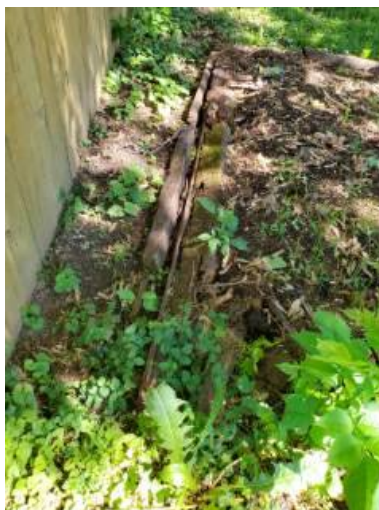
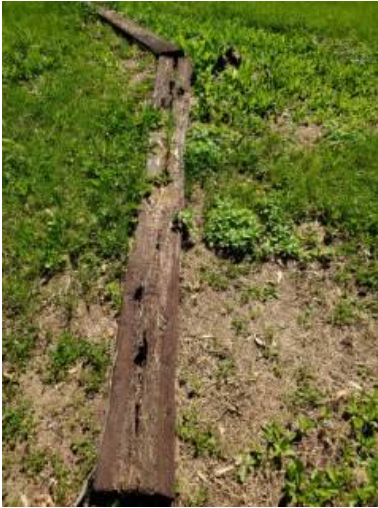
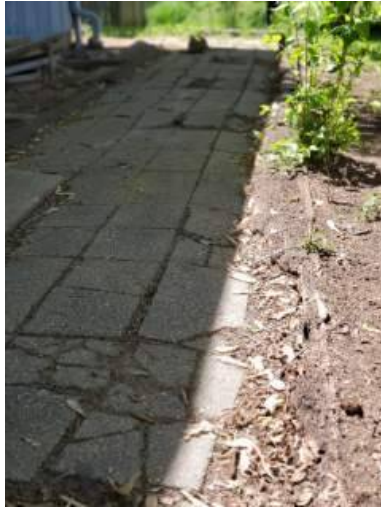
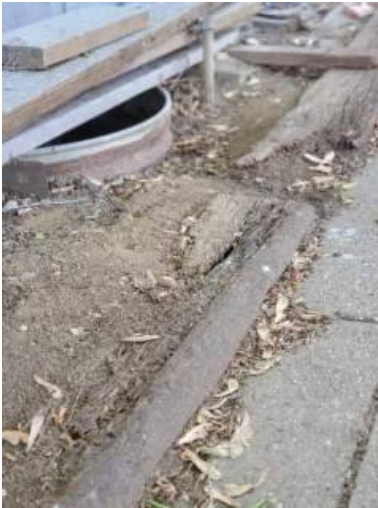
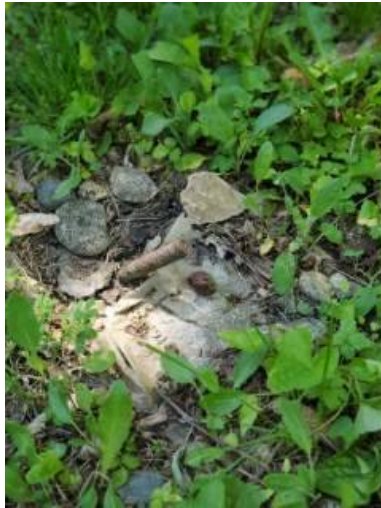
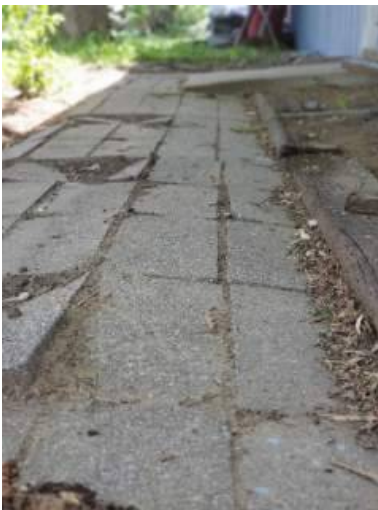
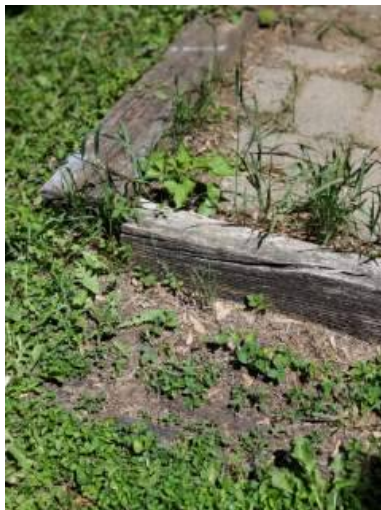
One or more landscaping timbers used in steps or walkways were rotten or damaged by wood-destroying insects and posed a trip or fall hazard. Recommend that a qualified person replace landscaping timbers as necessary.

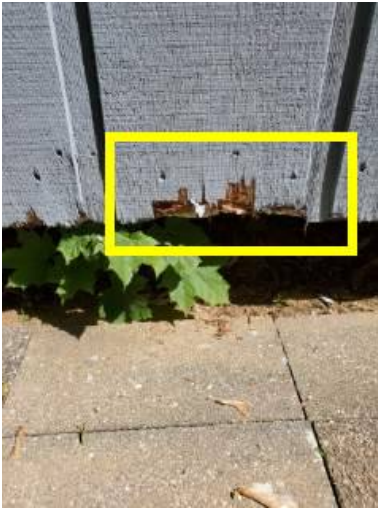
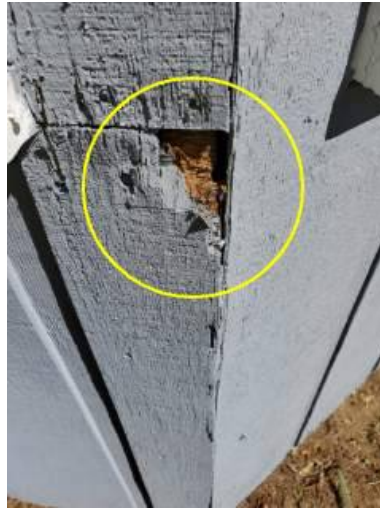
Many sections of siding and/or trim were deteriorated and/or rotten. Recommend that a qualified person repair, replace or install siding or trim as necessary.

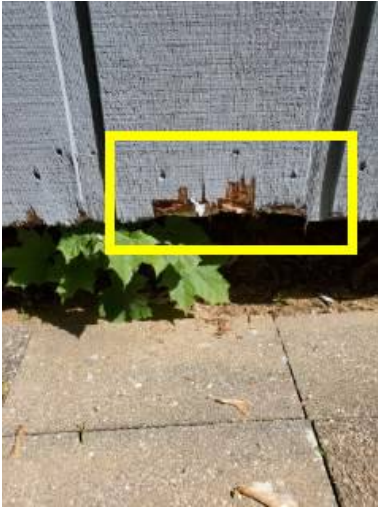
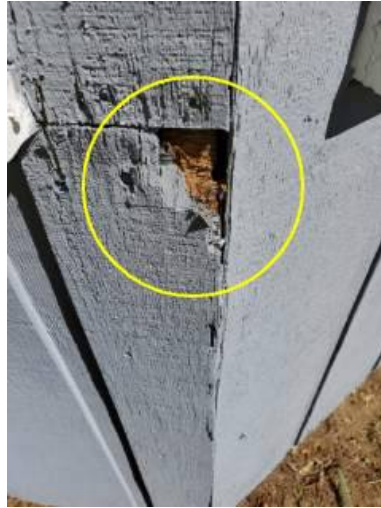
This property was clad with composition wood-fiber siding. Various manufacturers (e.g. Louisiana Pacific, Weyerhaeuser and Masonite) have produced this type of siding, which is made from oriented strand board (OSB) or "hardboard." It is prone to deteriorate and/or fail prematurely due to moisture penetration, especially when the paint coating is substandard or has not been maintained. Failure is typically visible in the form of swelling, cracking, buckling, wafer pops, delamination and fungal growth.

Some areas of siding on this structure showed symptoms described above and need replacement and/or maintenance. Some manufacturers (e.g. Louisiana Pacific) recommend a repair process for this siding where affected areas are sealed with Permanizer Plus, a flexible primer made by Pittsburgh Paint, followed by two coats of 100% acrylic latex paint. This sealant must be applied to the bottom edges using a brush. The face of the siding can be sprayed. The Permanizer Plus sealer isn't required for edges that aren't swollen, cracked or deteriorated, but the acrylic latex should still be brushed on these edges.

Recommend that a qualified contractor evaluate and replace siding as necessary, and/or seal and repaint as necessary. Repairs should be made per the siding and/or sealant manufacturer's installation instructions, and per standard building practices.

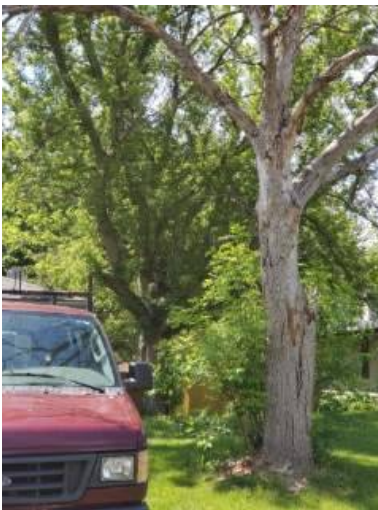
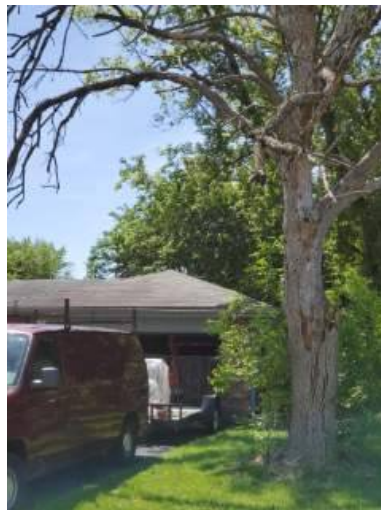
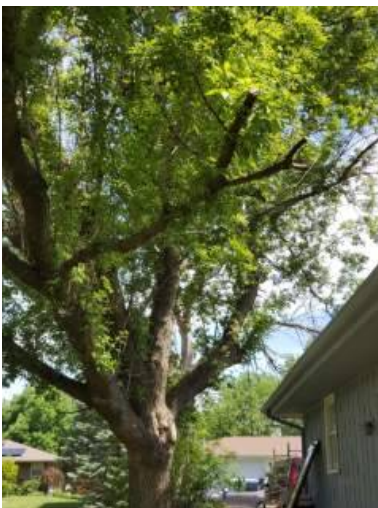
4) 🚧 Trees were in contact with or were close to the building at one or more locations. Damage to the building may occur, especially during high winds, or may have already occurred (see other comments in this report). Recommend that a qualified tree service contractor or certified arborist remove trees as necessary to prevent damage to the building exterior.

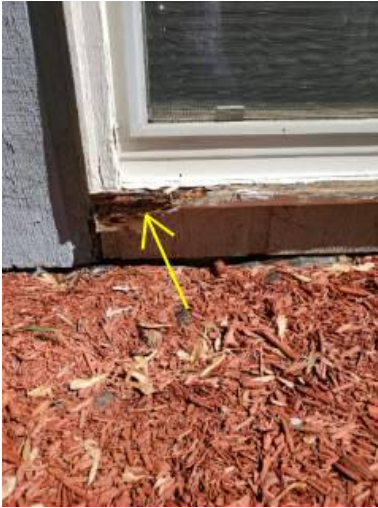
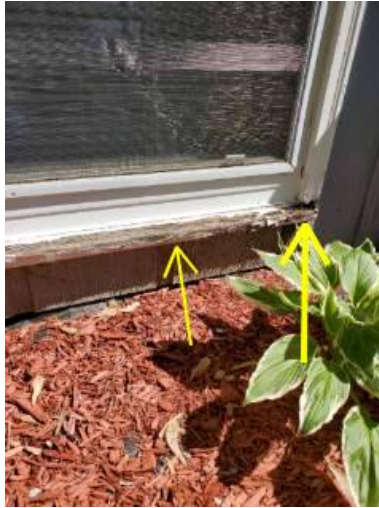
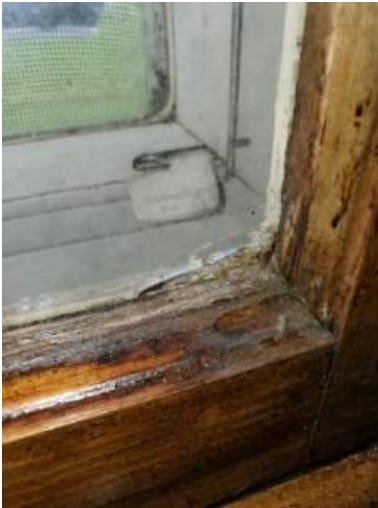
The paint or stain finish in some areas was failing (e.g. peeling, faded, worn, thinning). Siding and trim with a failing finish can be damaged by moisture. Recommend that a qualified contractor prep (e.g. clean, scrape, sand, prime, caulk) and repaint or restain the building exterior where necessary and per standard building practices. Any repairs needed to the siding or trim should be made prior to this.

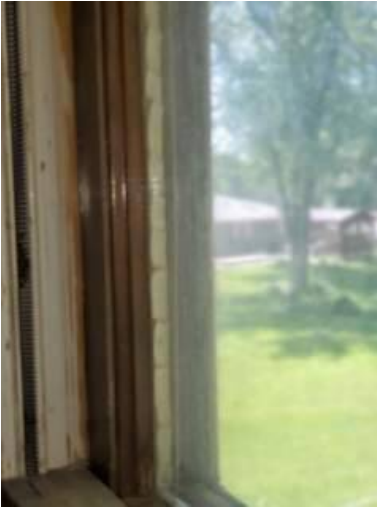
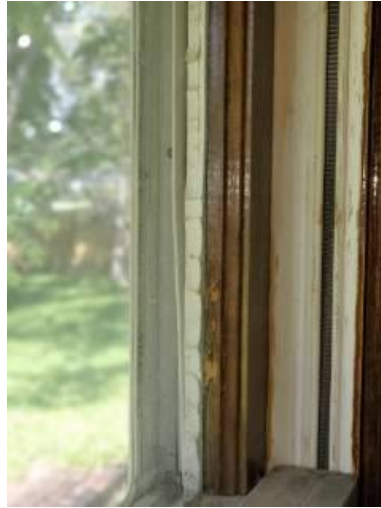
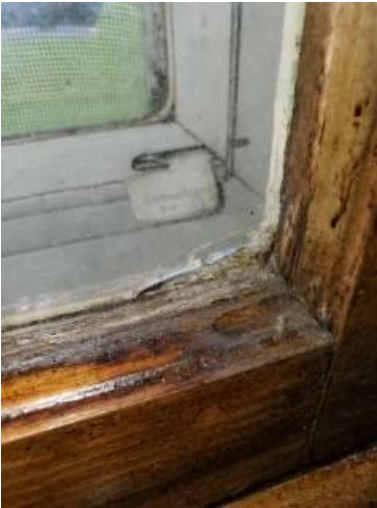
Caulk was deteriorated in some areas. For example, around windows. Recommend that a qualified person renew or install caulk as necessary. Where gaps are wider than 1/4 inch, an appropriate material other than caulk should be used. For more information, visit: <https://www.reporhost.com/?CAULK>

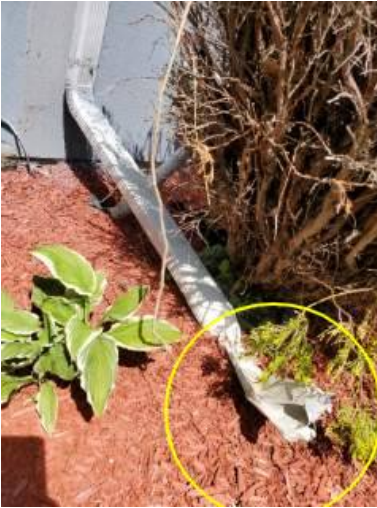
Photo 10-1

Extensions such as splash blocks or drain pipes for one or more downspouts were damaged. Water can accumulate around the building foundation or inside crawl spaces or basements as a result. Recommend that a qualified person install, replace or repair extensions as necessary so rainwater drains away from the structure.

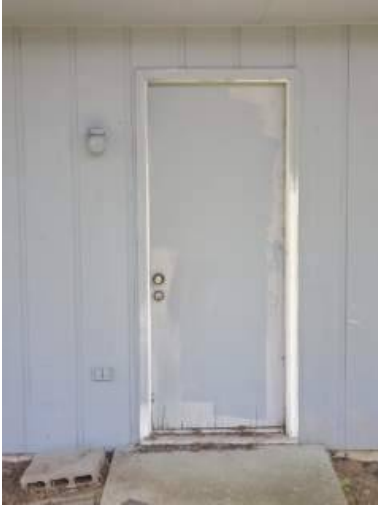
Photo 15-1

One or more exterior doors were significantly damaged or deteriorated. Recommend that a qualified person replace door(s) as necessary.

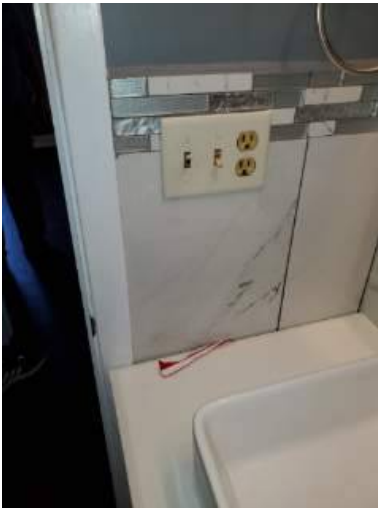
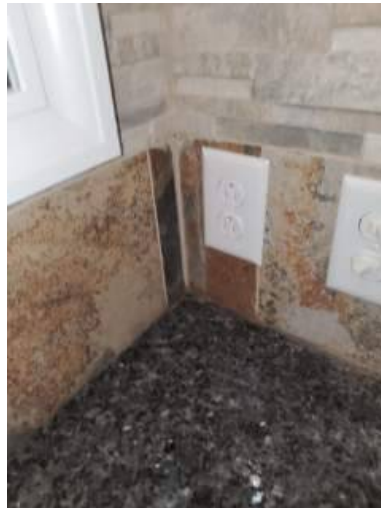
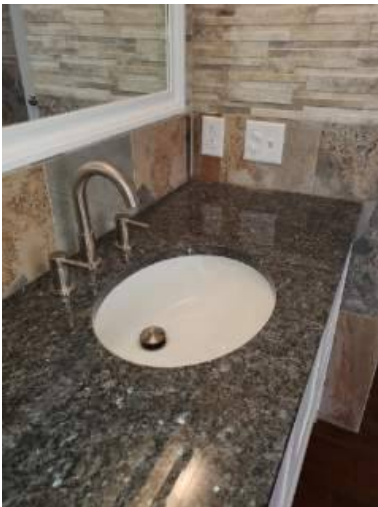
One or more electric receptacles at the kitchen, bathroom(s) and/or basement had no visible ground fault circuit interrupter (GFCI) protection, or the inspector was unable to determine if GFCI protection was present. If not GFCI-protected, receptacles in wet areas pose a shock hazard. Recommend that a qualified electrician evaluate and install GFCI protection if necessary and per standard building practices. General guidelines for GFCI-protected receptacles include the following locations:

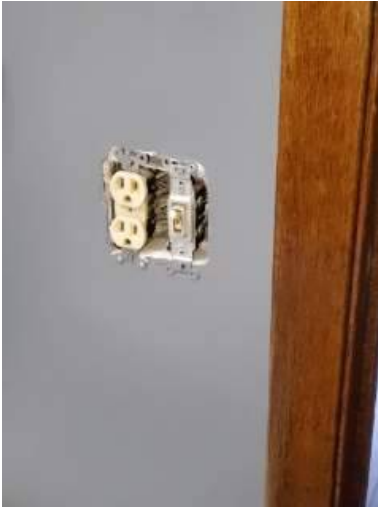
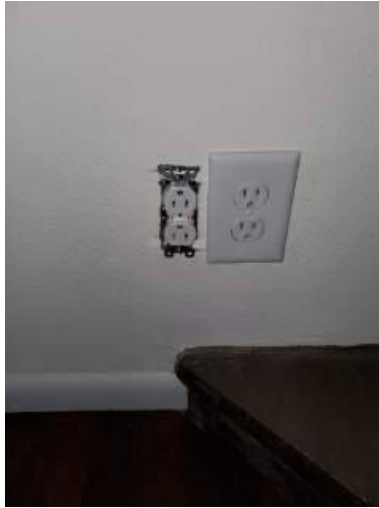
One or more cover plates for switches, receptacles or junction boxes were missing or broken. These plates are intended to contain fire and prevent electric shock from occurring due to exposed wires. Recommend that a qualified person install cover plates where necessary.

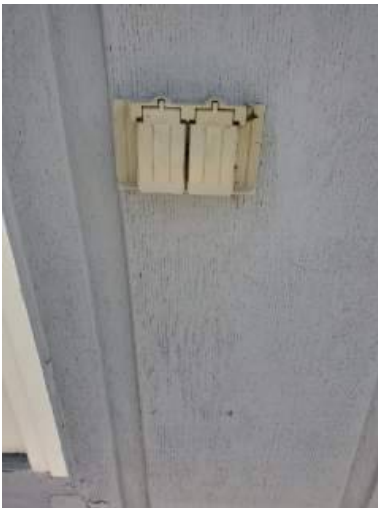
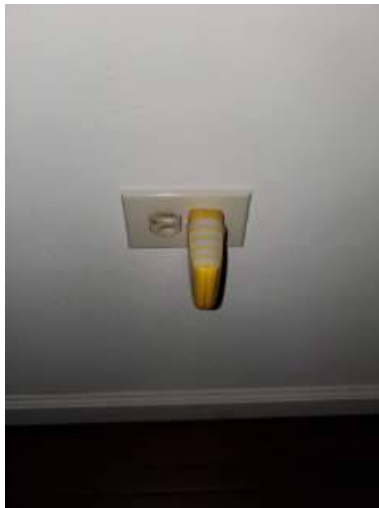
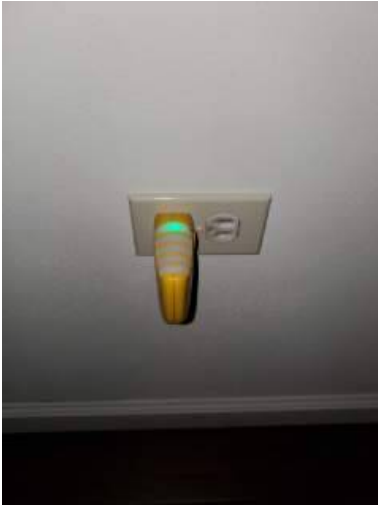
One or more electric receptacles appeared to have no power. Recommend asking the property owner about this. Switches may need to be operated or GFCI/AFCI protection may need to be reset to make some receptacles energized. If necessary, recommend that a qualified electrician evaluate and repair.

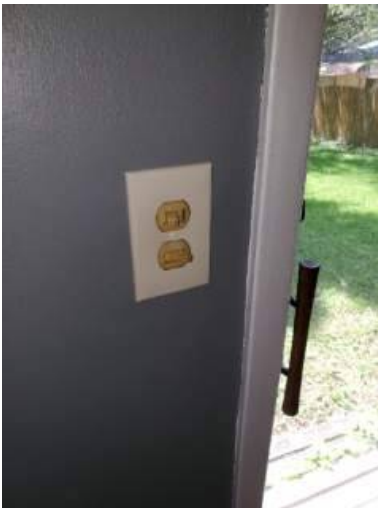
Photo 23-1

23) 🔧 One or more wall switches were broken or damaged. Recommend that a qualified electrician replace wall switches as necessary.

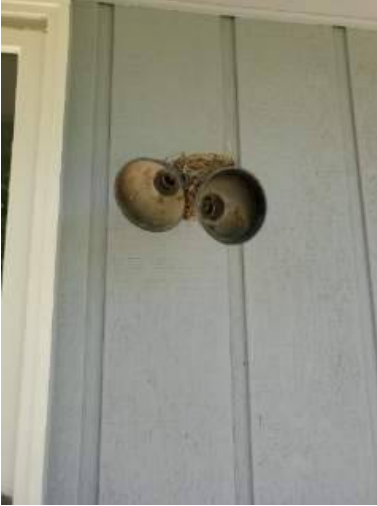
Photo 24-1

24) 🔍 Bulbs in one or more light fixtures were missing or broken. These light fixtures couldn't be fully evaluated. If replacement bulbs are inoperable, then recommend that a qualified electrician evaluate and repair or replace light fixtures as necessary.

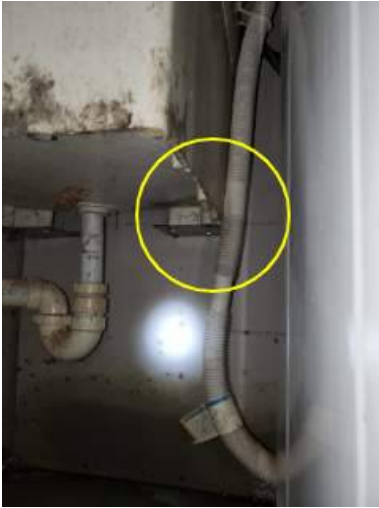
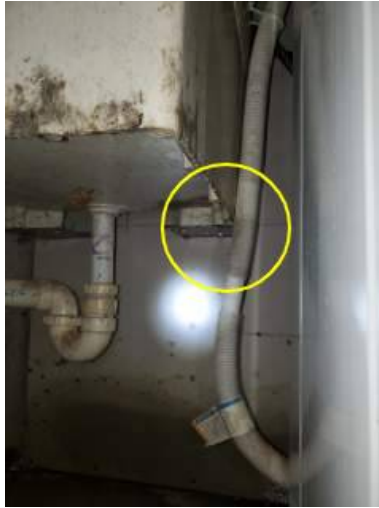
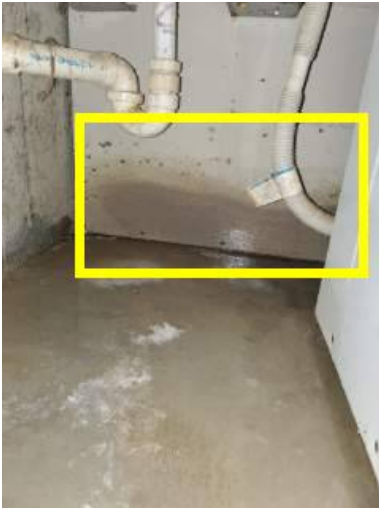
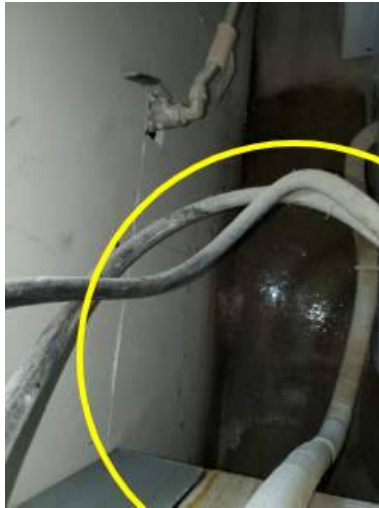
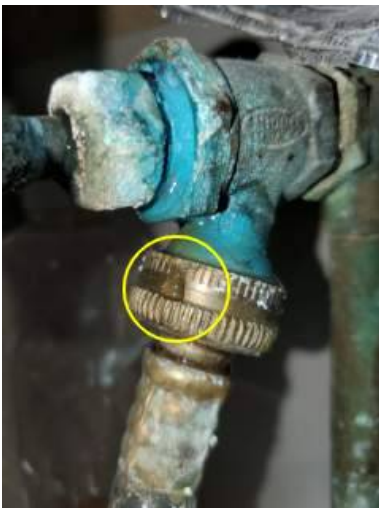
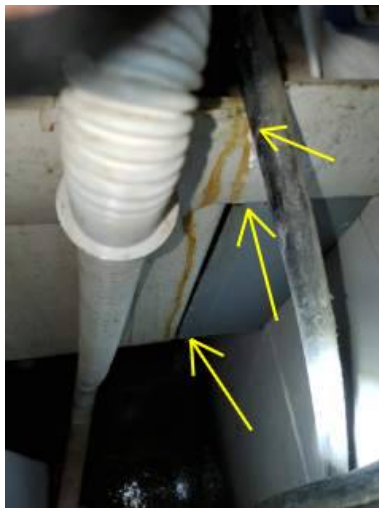
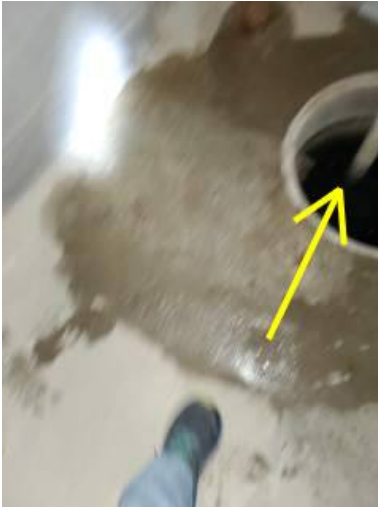
One or more leaks were found in water supply pipes or fittings. A qualified plumber should evaluate and repair as necessary.

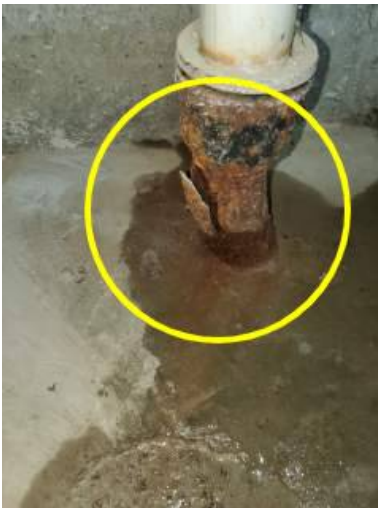
Photo 26-1

One or more leaks were found in drain pipes or fittings. A qualified plumber should evaluate and repair as necessary.

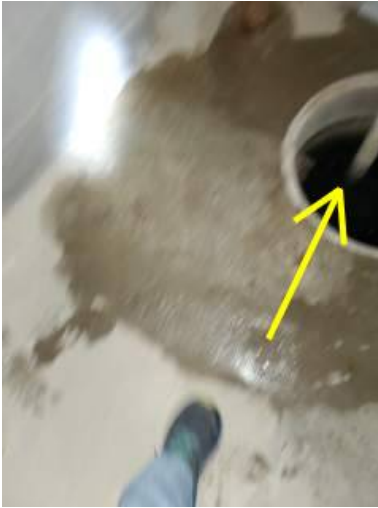
Photo 28-1

**Condition of sump pump:** Required repairs, replacement and/or evaluation (see comments below), 2 sump pumps. The one in the lau dry room seems to be defective and not working. Standing stale water in pit above the top of the pump.

Both sump pumps appeared to be inoperable. Water may accumulate in the building substructure during periods of heavy rain. Recommend that a qualified contractor evaluate and repair or replace the sump pump as necessary. The sump pump in the laundry area is the one this refers to.

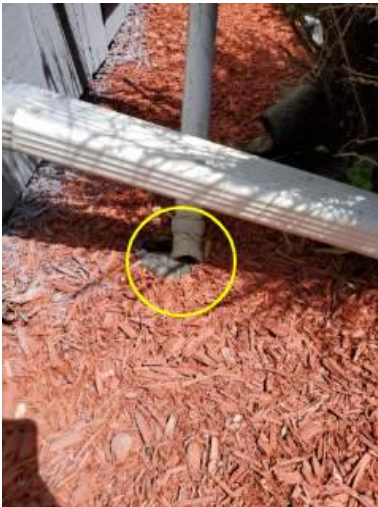
Photo 30-1

The sump pump discharge pipe was routed so that it drained close to the foundation. Prolonged, high levels of moisture in soil can cause foundation settlement and failure. If drainage is near a crawl space or basement, water can accumulate in these spaces. Recommend that a qualified contractor repair as necessary so the discharge pipe terminates well away from the foundation and to soil that is sloping down and away from the foundation.

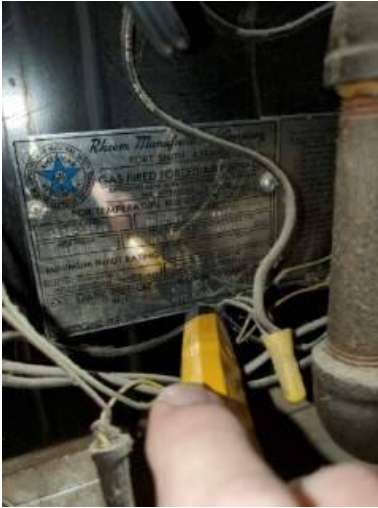
Photo 33-1

The estimated useful life for most forced air furnaces is 15-20 years. This furnace appeared to be beyond this age and/or its useful lifespan and may need replacing or significant repairs at any time. Recommend budgeting for a replacement in the near future.

The furnace appears to be a 1975 furnace.

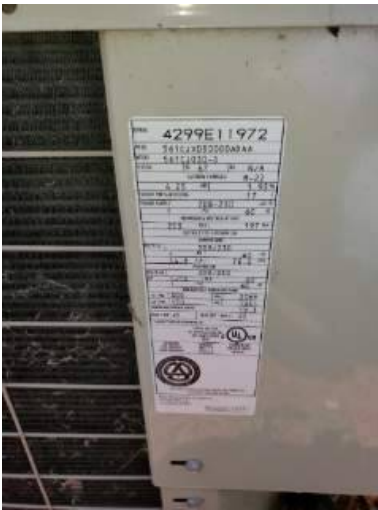
Photo 34-1

The estimated useful life for most heat pumps and air conditioning condensing units is 10-15 years. This unit appeared to be beyond this age and/or its useful lifespan and may need replacing or significant repairs at any time. Recommend budgeting for a replacement in the near future.

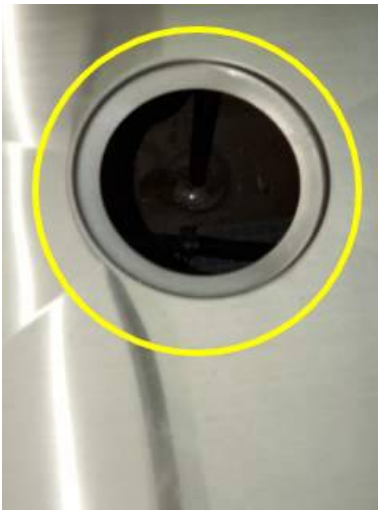
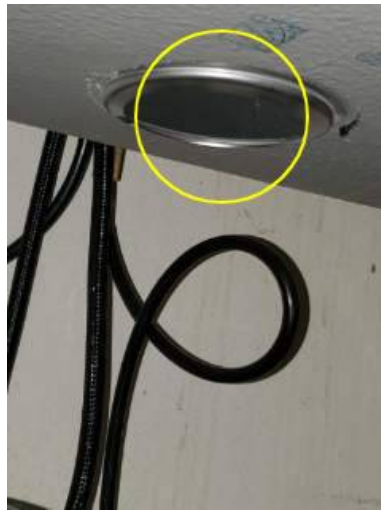
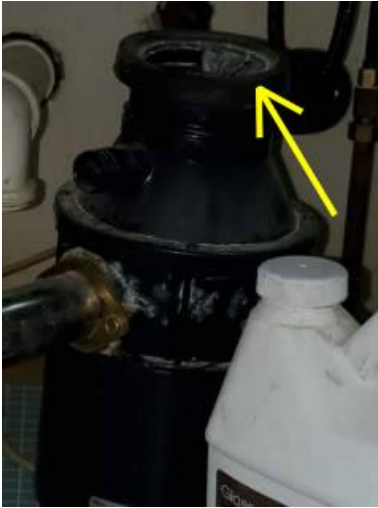
The sink was damaged or significantly deteriorated. Recommend that a qualified contractor replace the sink. No drain or plumbing installes under sink.

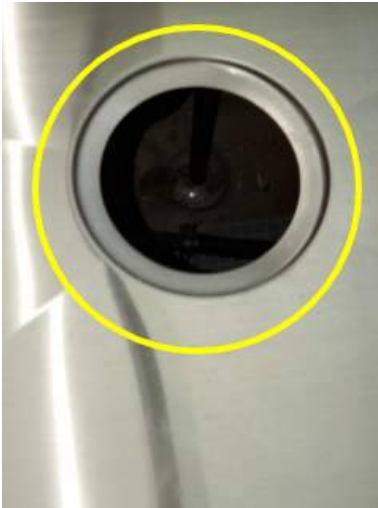
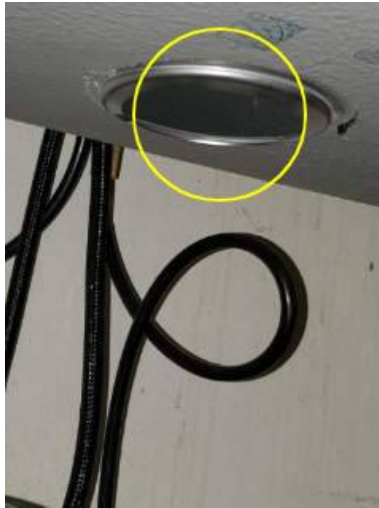
Substandard repairs were found at the sink drain (e.g. tape, sealant, non-standard components). Recommend that a qualified plumber repair per standard building practices. No drain installed.

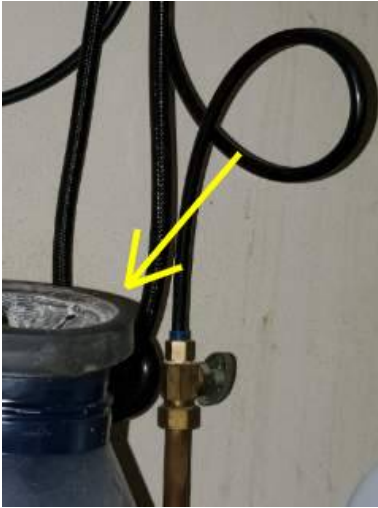
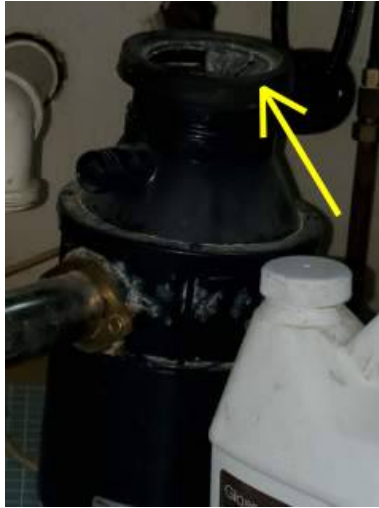
The under-sink food disposal was inoperable. Recommend that a qualified contractor repair or replace as necessary.

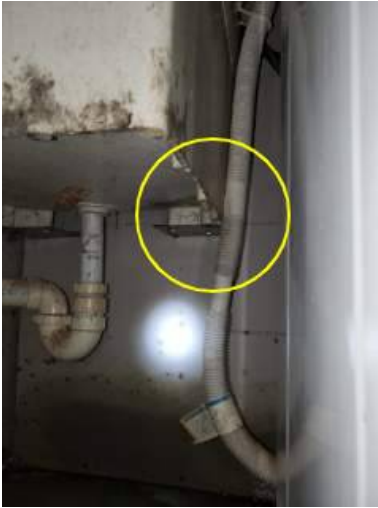
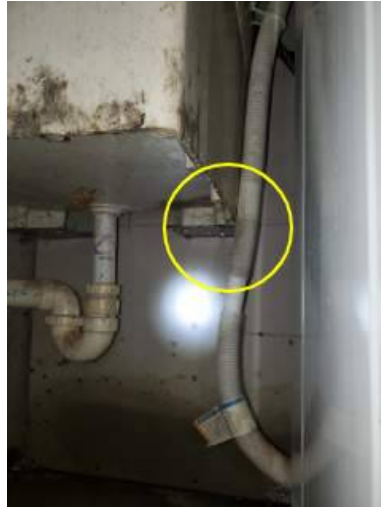
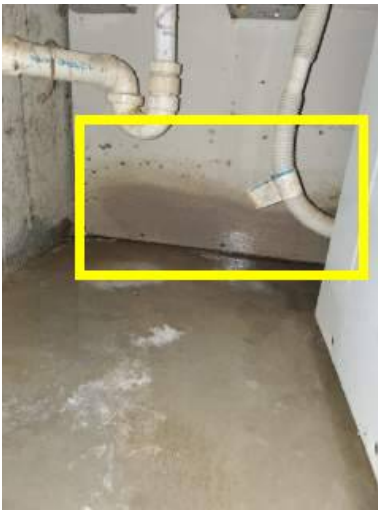
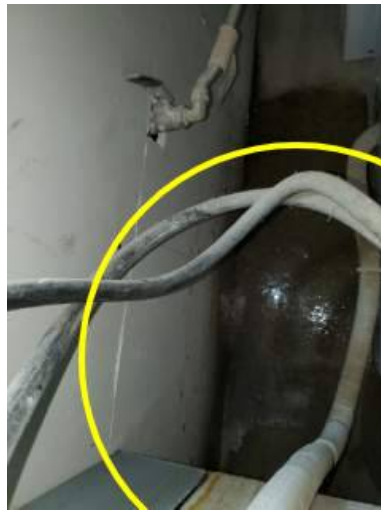
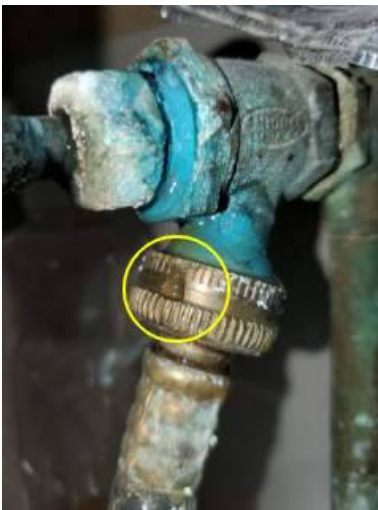
- 
- 45) 🔧 One or more leaks were found at water supply lines for the clothes washer. A qualified plumber should repair as necessary.

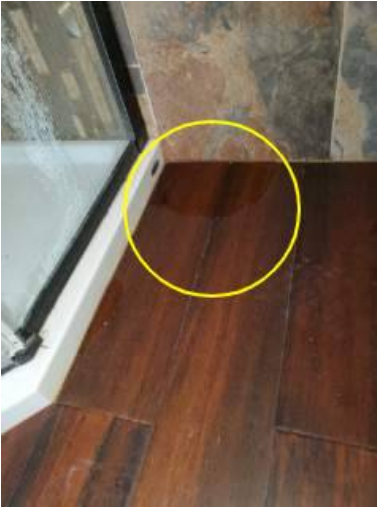
Photo 46-1

Gaps, no caulk, or substandard caulking were found between the shower enclosure and the floor at location(s) #A. Water can penetrate these areas and cause damage. Recommend that a qualified person re-caulk or install caulking as necessary.

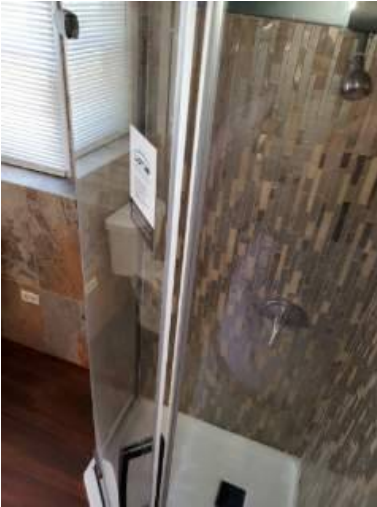
Photo 48-1

The shower door at location(s) #A wouldn't latch or close fully. Water can leak out of the enclosure during showers. Recommend that a qualified person repair as necessary.

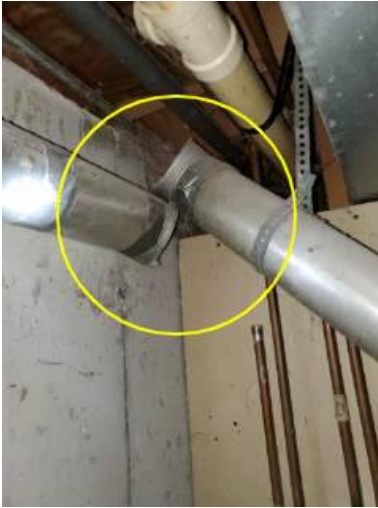
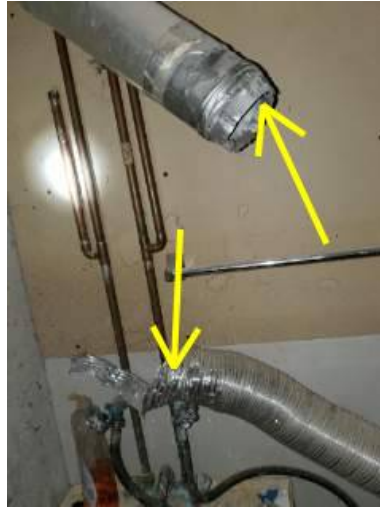
The clothes dryer exhaust duct was broken and/or disconnected in one or more places. Clothes dryers produce large amounts of moisture which should not enter structure interiors. Moisture can accumulate and result in mold, bacteria or fungal growth. Recommend that a qualified person make permanent repairs as necessary. For more information, visit: <https://www.reporthost.com/?DRYER>

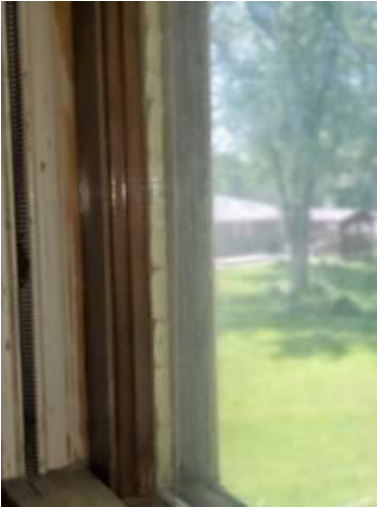
Photo 50-1

Condensation or staining was visible between multi-pane glass in one or more windows. This usually indicates that the seal between the panes of glass has failed or that the desiccant material that absorbs moisture is saturated. As a result, the view through the window may be obscured, the window's U-value will be reduced, and accumulated condensation may leak into the wall structure below. Recommend that a qualified contractor evaluate and repair windows as necessary. Usually, this means replacing the glass in window frames.

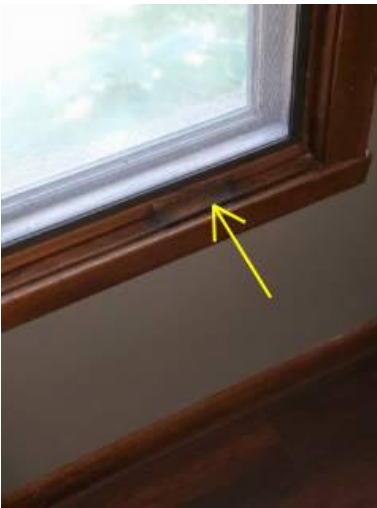
Photo 52-1

One or more windows that were designed to open and close were stuck shut. Recommend that a qualified person repair windows as necessary so they open and close easily.
