**Illuminating real estate  
investment decisions since 1999**

1568 Sample Street , Any City, CA  
Inspection prepared for: Sample Client  
Date of Inspection: 3/26/2022

Inspector: Scott Schildknecht  
ASHI Certification # 252268  
1485 Maria Avenue , Concord , CA 94518  
Phone: (707)649-8700  
Email: [scott@northbayinspection.com](mailto:scott@northbayinspection.com)  
[Northbayinspection.com](http://Northbayinspection.com)

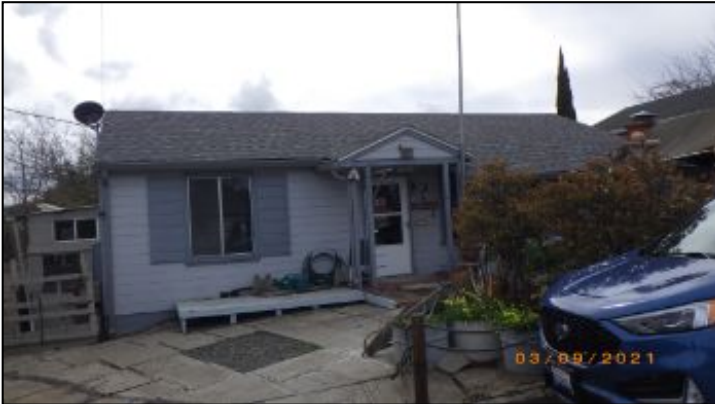
The configuration of the landscaping makes it difficult to achieve proper drainage adjacent to the foundation. This building would benefit from having a subsurface drainage system installed uphill of the building to capture surface runoff and divert it safely past the building. This will help to limit the likelihood of ponding near the foundation or footing drains that back up below grade next to the foundation and cause infiltration into/beneath the building. For more information we recommend our client contact a professional drainage contractor to discuss options and cost. Note: Water cannot be directed toward a neighbor's property, ideally the water is diverted by gravity to the street storm drain system.

slope at front

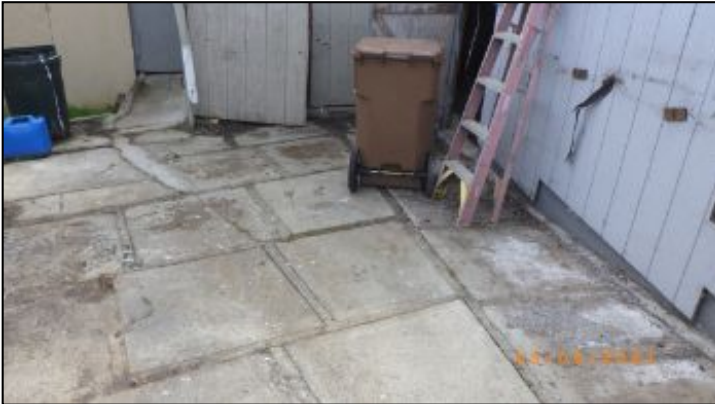
The walkway is cracked or damaged in several places; walkway are in generally worn condition. We advise monitoring these areas and consider having a qualified contractor make the appropriate repairs

generally worn

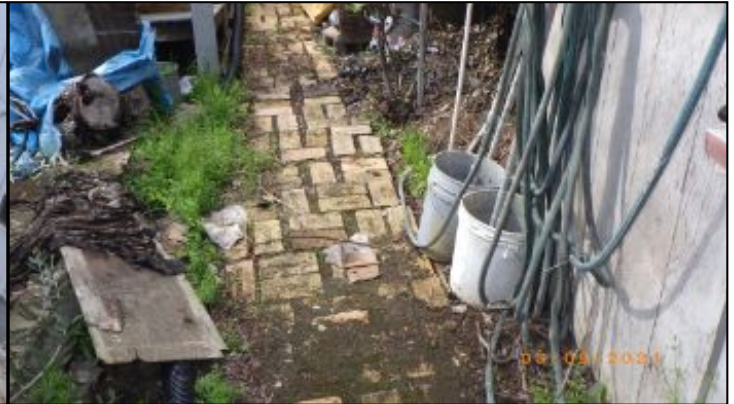
There are one or more trip hazards around this home. We advise that these areas be well lit at night. We also recommend making appropriate changes to the walking surfaces to reduce trip hazards.

trip hazards

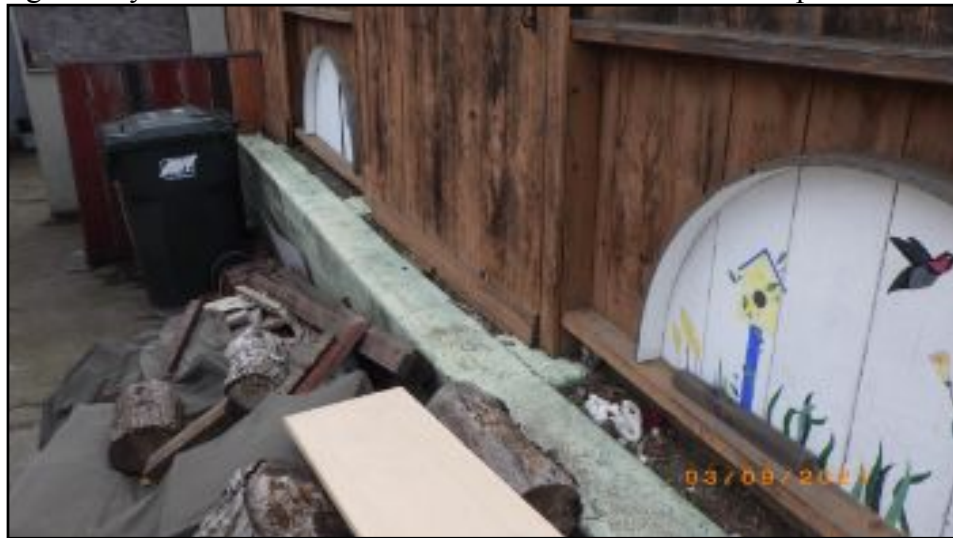
There is an excessive amount of debris on this property. Debris, garbage, excessive personal property can conceal issues, contributes to vermin activity and can be a hazard. We recommend obtaining bids from qualified hauling/ landscape contractors to remove all debris from this property.

debris on lot

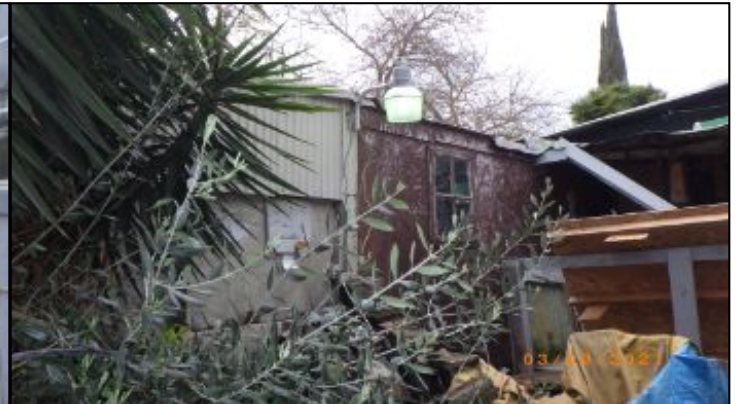
detached buildings not inspected, but in generally poor condition

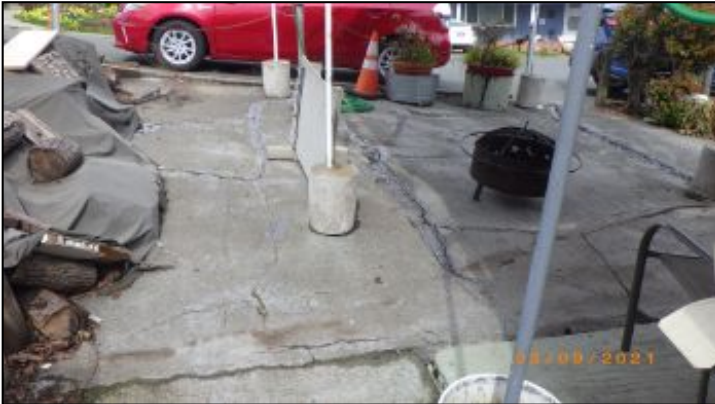
generally worn

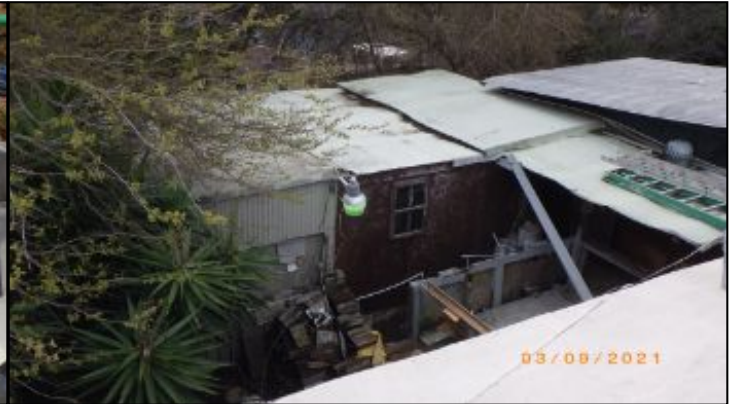
detached structures; bad condition

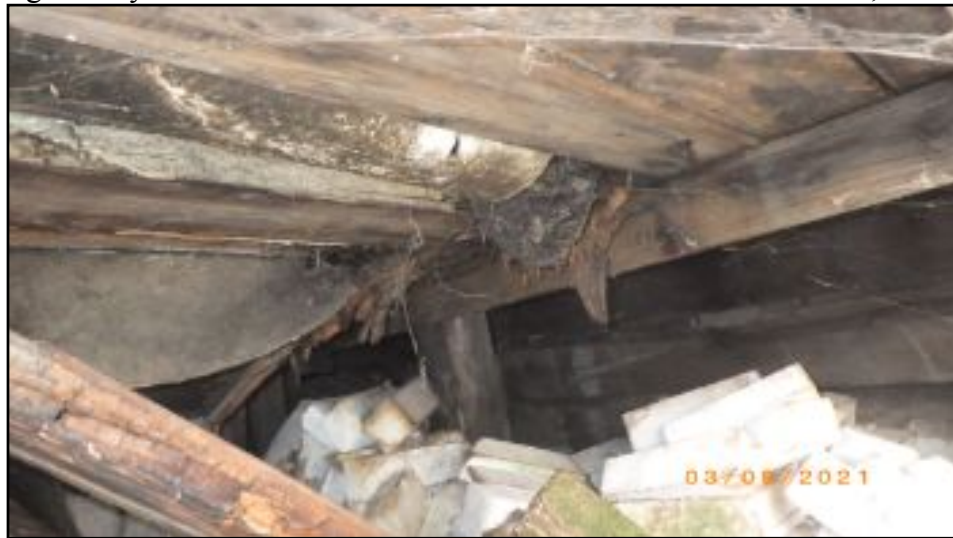
several aspects of outbuildings poor

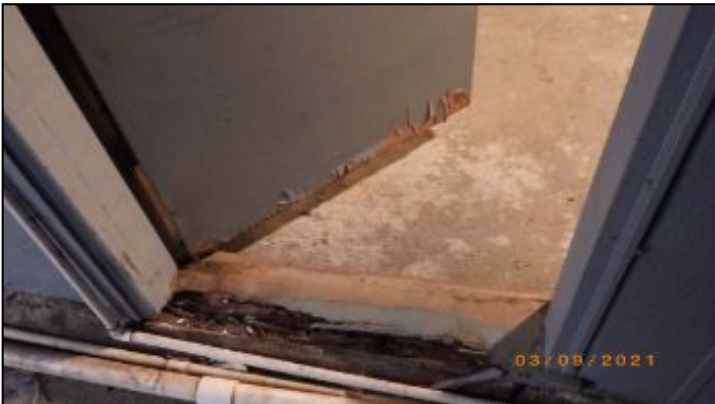
**The door, door threshold and door jamb at the right side of the home is moisture/fungus damaged. We recommend further inspection by a class three structural pest control firm.**

moisture damaged door

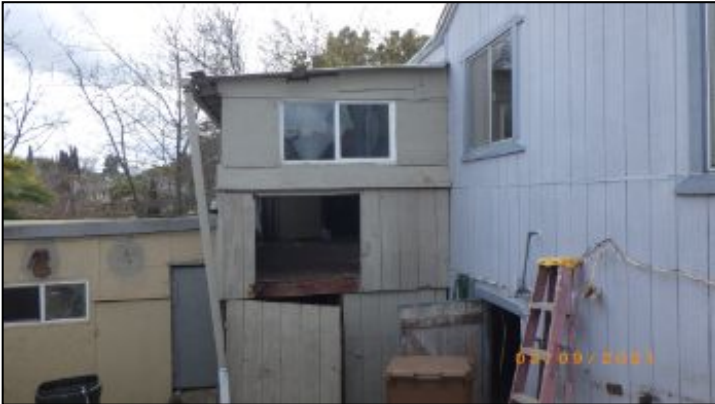
This home has undergone many changes over the years. It appears much of the work may not have been completed with the benefit of building permits or qualified trades persons. There are likely to be unseen issues that are not included in this report. It is beyond the scope of this inspection to identify each deficiency. We recommend having this home evaluated by trade specialists as indicated in other portions of this report.

improper additions

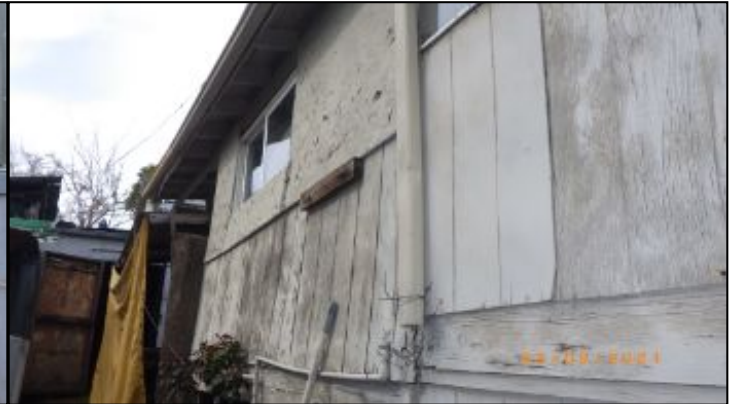
several aspects bad

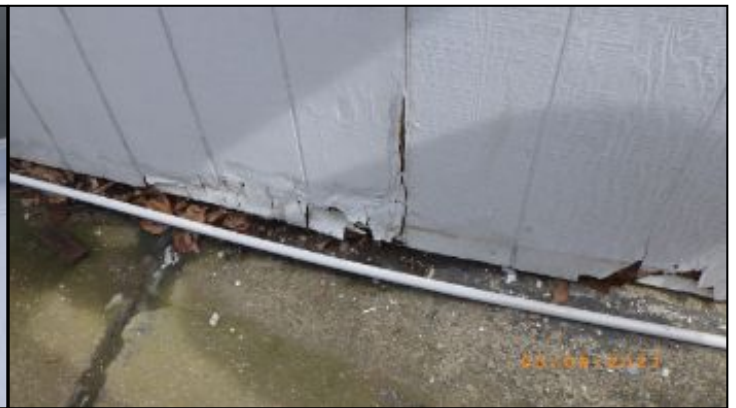
The siding is moisture and/or fungus damaged at several places around the home. This damage can spread to areas adjacent to the siding including framing. We recommend further evaluation and inspection by a licensed Class Three Structural Pest firm.

moisture damaged siding

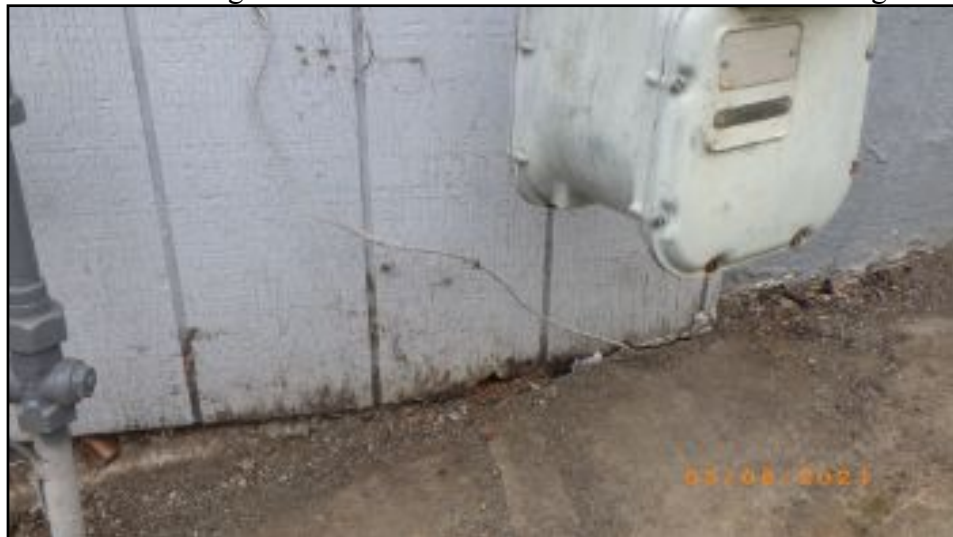
siding in contact with concrete

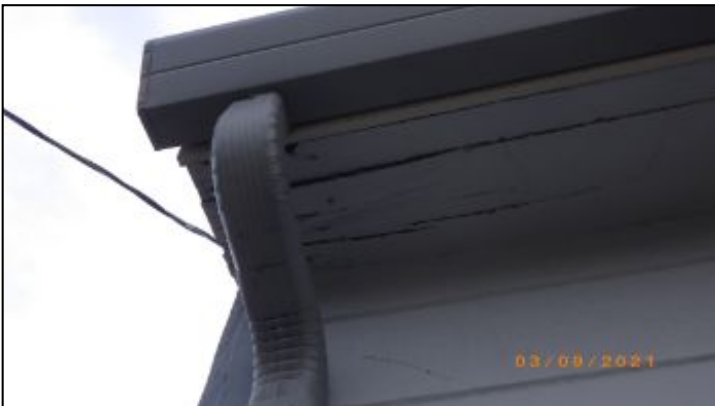
The wood trim is moisture/fungus damaged at several places around this home. This damage can spread to areas adjacent to the damaged trim. We recommend further evaluation and inspection by a licensed Class Three Structural Pest firm.

moisture damage

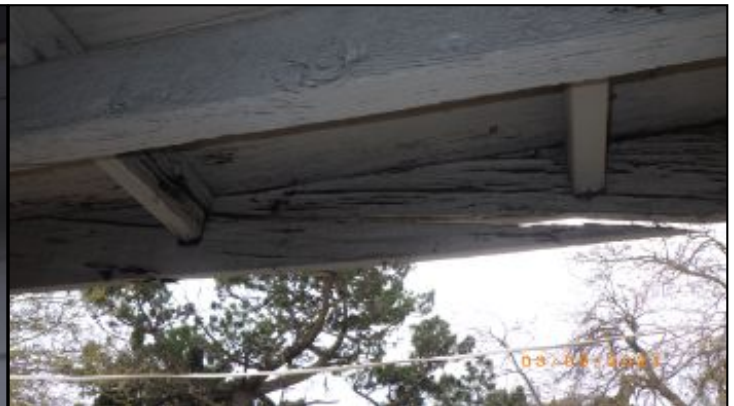
moisture damage

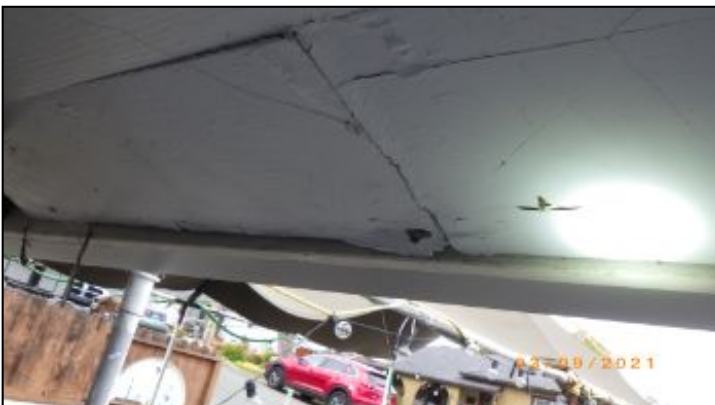
moisture damage

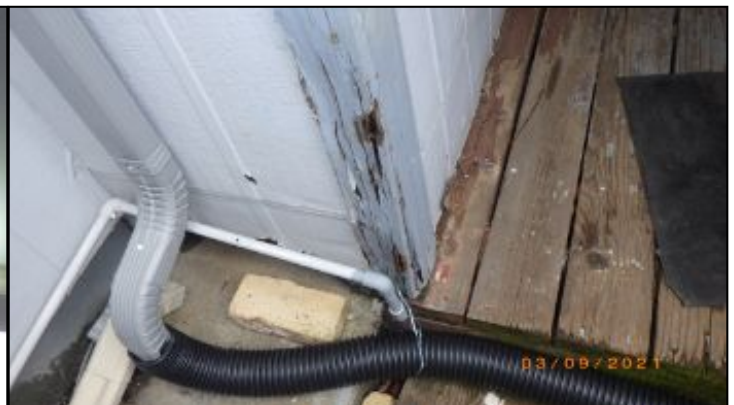
moisture damaged trim

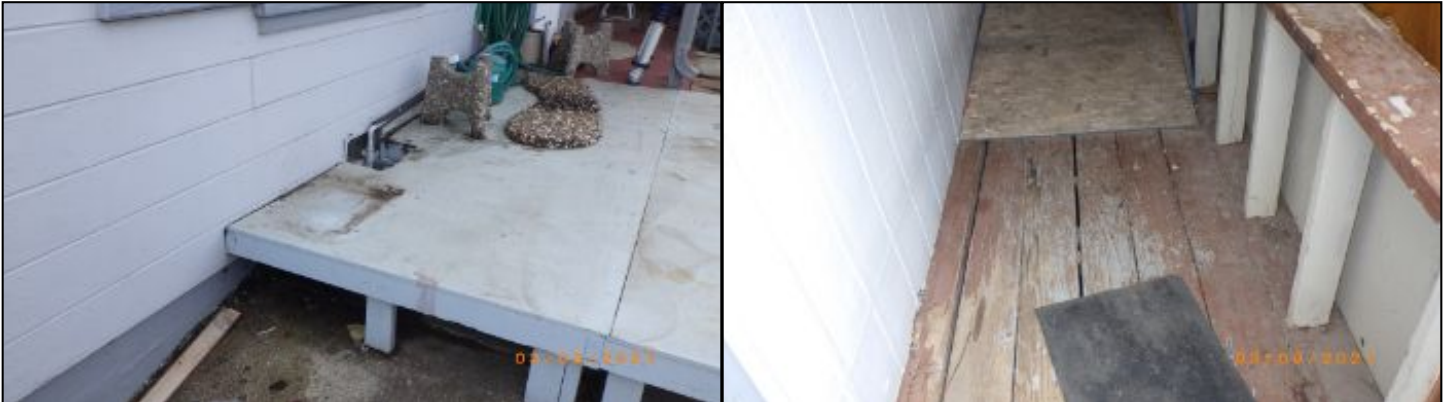
**The decks" are moisture/fungus damaged at several places. This damage can spread to areas and cause this deck to become unstable or even unsafe over time. We recommend further evaluation and repairs by a Class Three Structural Pest firm.**

moisture damaged decking

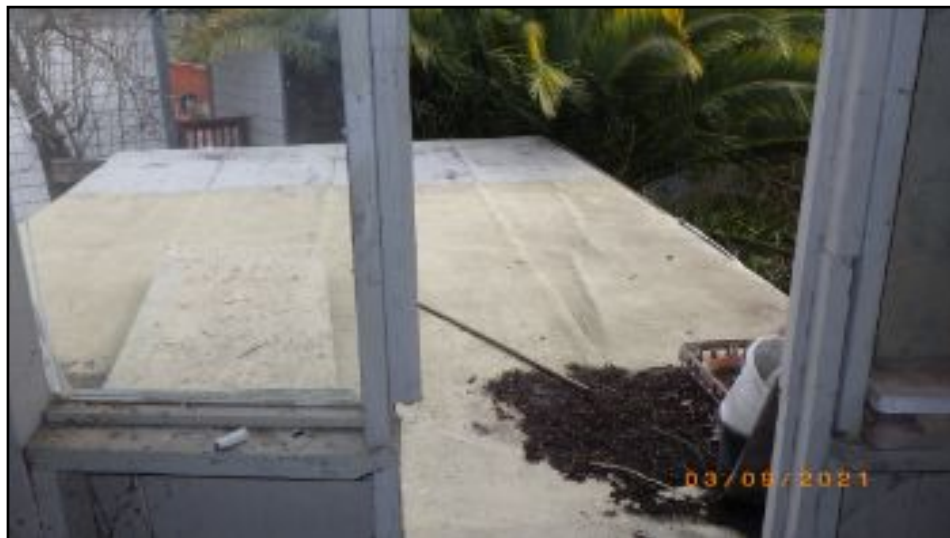
missing railings

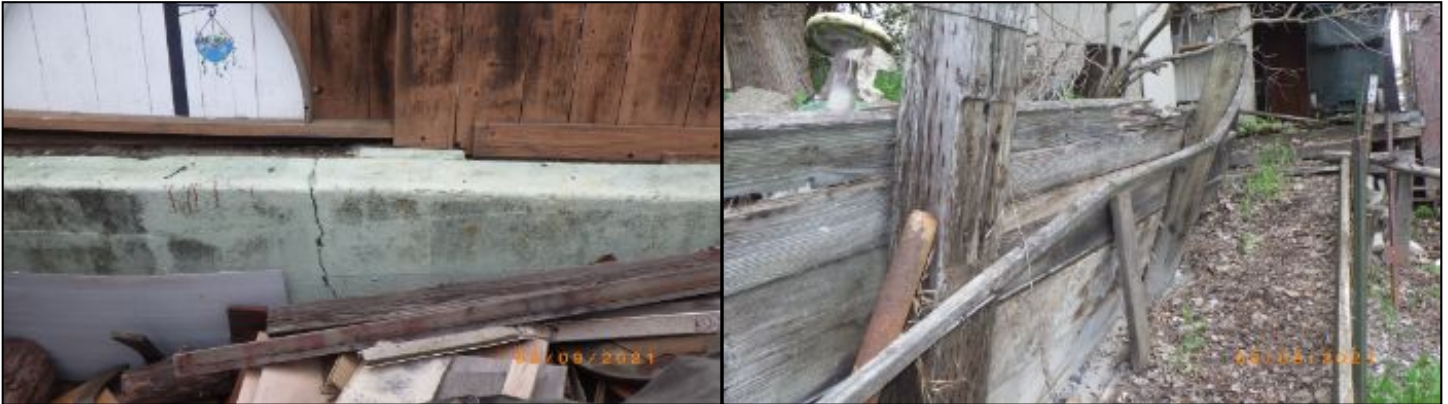
**The wood retaining wall at the rear is deteriorated due to age, moisture damage, and/or insect infiltration. We recommend the client consult a qualified landscape contractor to discuss options and cost of replacement.**

displacement visible at retaining wall

poor condition

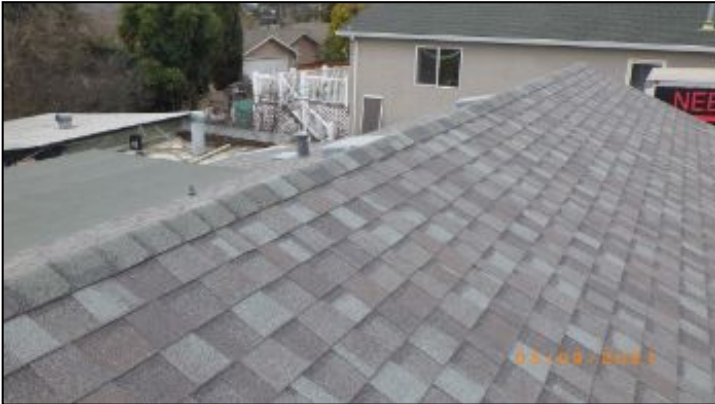
The roof is relatively new. The roof appears to have been installed by a qualified roofer. We recommend asking the owner for the name of the roofer who installed this roof, if any warranties are transferable, and check the building permit history of this home.

relatively new

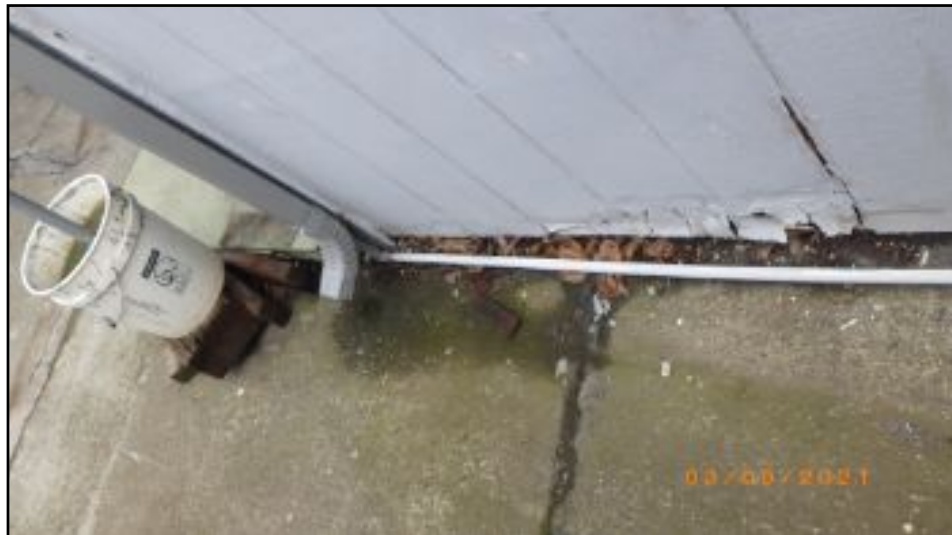
The downspouts generally spill out directly onto the soil near the base of the foundation. This is undesirable, as the water tends to saturate the ground beneath the foundation possibly. The foundation can more easily suffer from significant settling and related problems due the wet/muddy condition. We recommend extending the downspouts (with pipes, splashblocks, etc.) to an area at least two to three feet away from the base of the foundation. The water should then follow a slight grade away from the home.

extend downspouts away

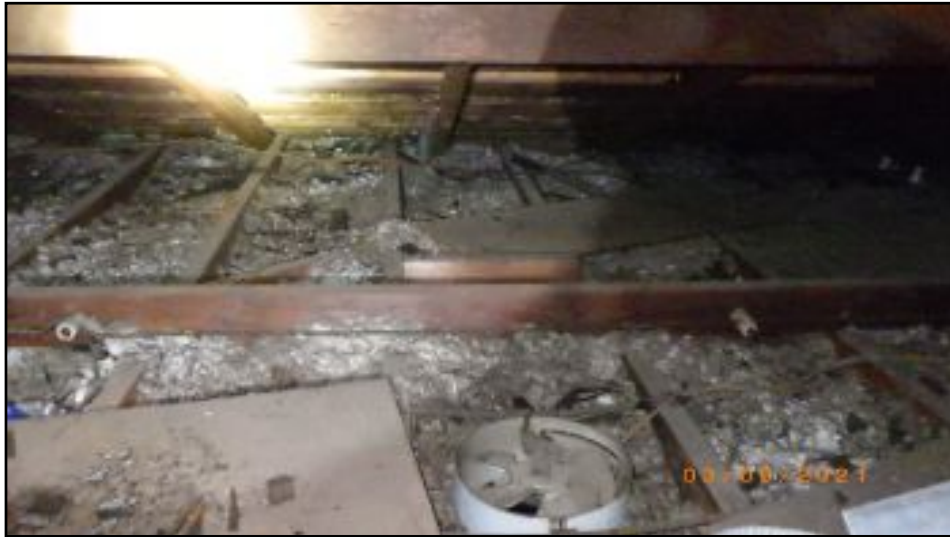
The attic insulation is worn, matted, and may need replacement soon. This condition reduces the intended purpose and may harbor debris such as vermin feces. A professional insulating contractor can provide information on the best way to go about accomplishing this. Note: If you are considering remodeling, electrical, plumbing, HVAC, or other improvements/repairs soon, we recommend waiting until work is completed before insulating.

worn and heavy debris

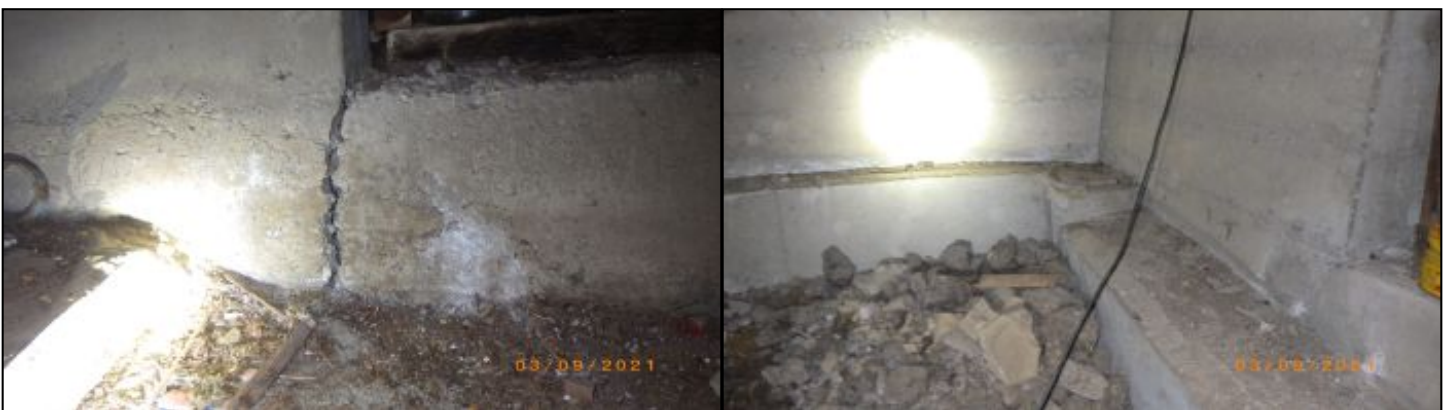
settlement visible

reinforced foundation

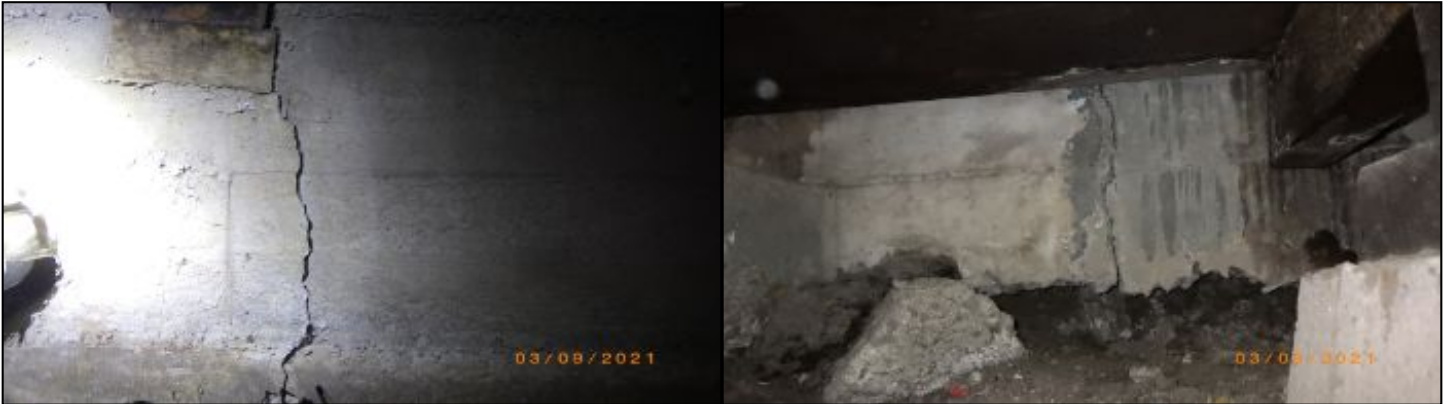
The foundation/support at the right rear side is unknown. There was no access to this area. It appears to be a pored concrete foundation but may not be a conforming foundation for a living space. Only destructive/further evaluation can determine the exact composition. There were no obvious indications of failure. The client should understand that this is the assessment of a home inspector - not a professional engineer - and that despite this assessment, there is no way we can provide any guaranty that this foundation will never settle any further. We suggest that if the client is at all uncomfortable with this condition or our assessment of it, a structural engineer be consulted to independently evaluate the condition prior to making a final purchase decision.

moderate cracks

likely substandard foundation

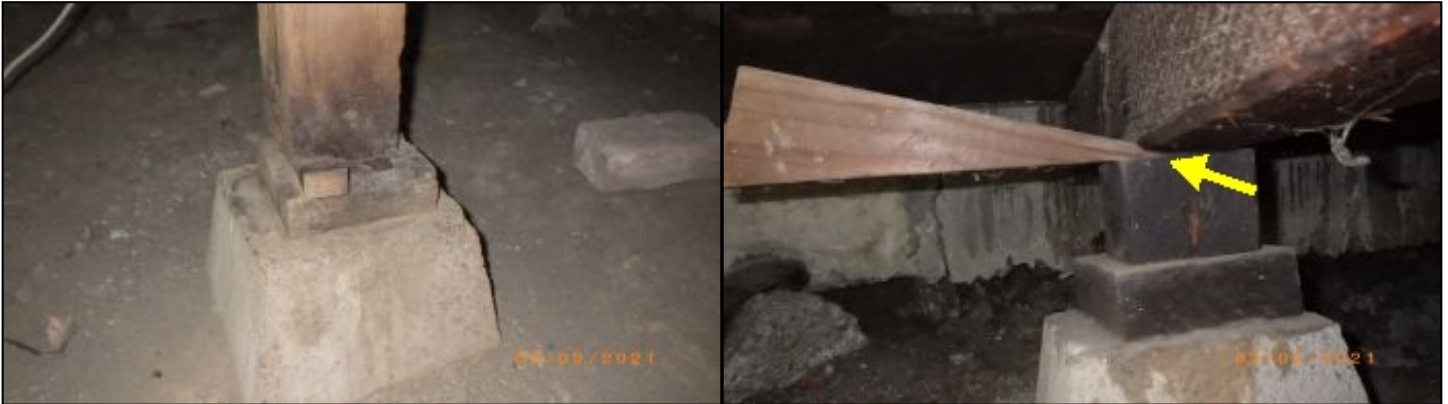
no footings

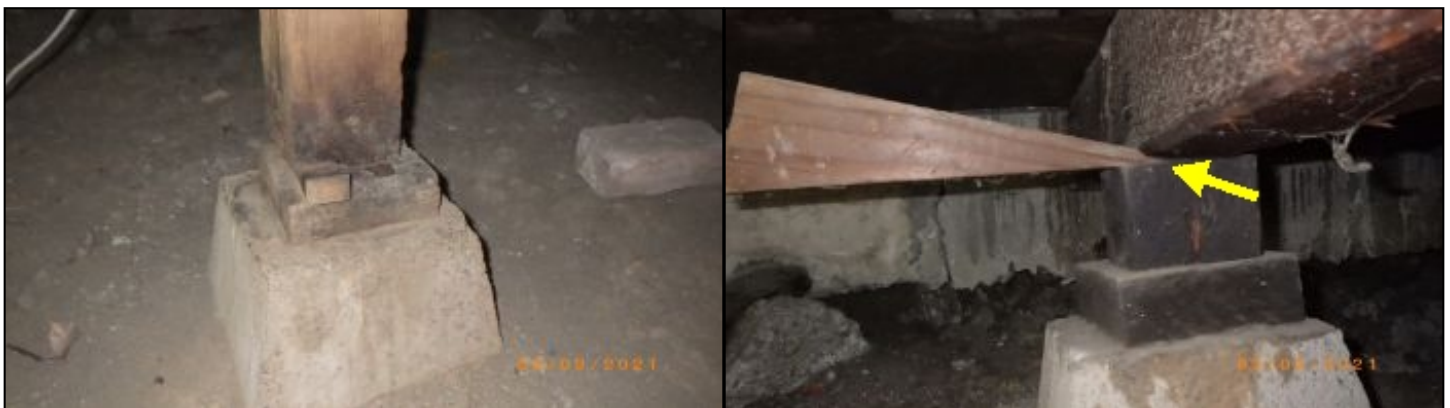
There are apparently no foundation footings at the base of piers at the addition of the home. These piers may tend to settle more rapidly than a conforming pier. Over time this can cause uneven floors in the building. This condition is sometimes encountered with older homes or in situations where nonprofessional(s) have performed work without permits. We recommend further evaluation and repairs by a qualified contractor familiar with local construction codes.

no footings

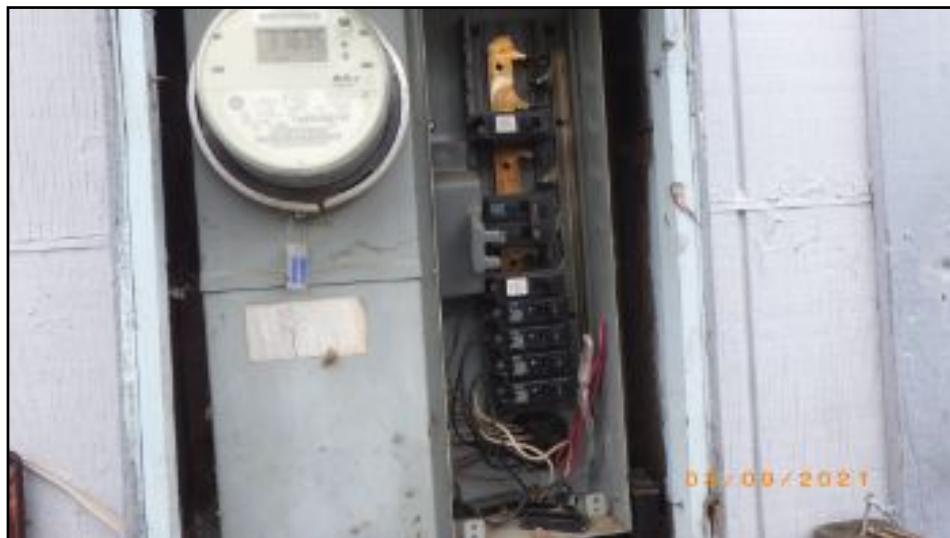
**The inner protective panel is missing on the main panel. This is a potential safety hazard as persons could touch the energized interior of the service box. We recommend having a qualified electrician install the missing inner panel on this device.**

breakers not labeled; inner panel missing

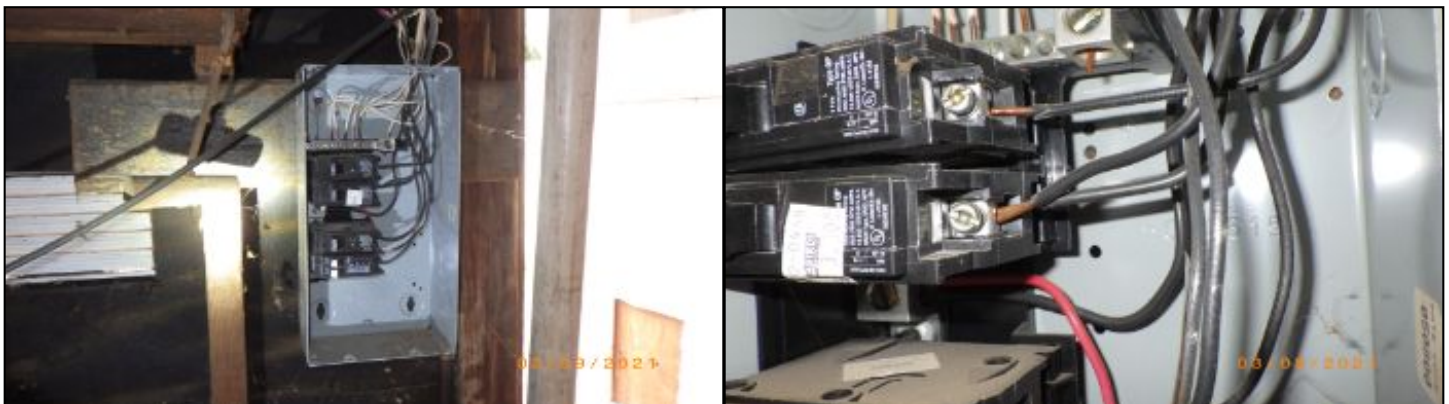
not bonded

double tap

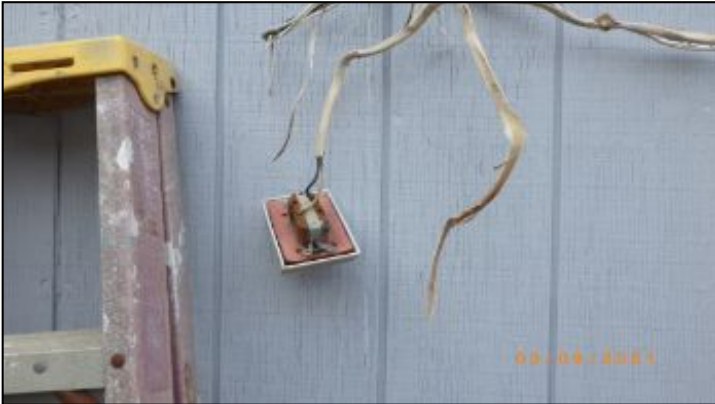
There is some improper wiring at several places of this home. Please read the entire electrical section carefully for further details. It is beyond our scope to perform a specialized electrical inspection. We recommend further inspection by a qualified electrician.

several aspects bad

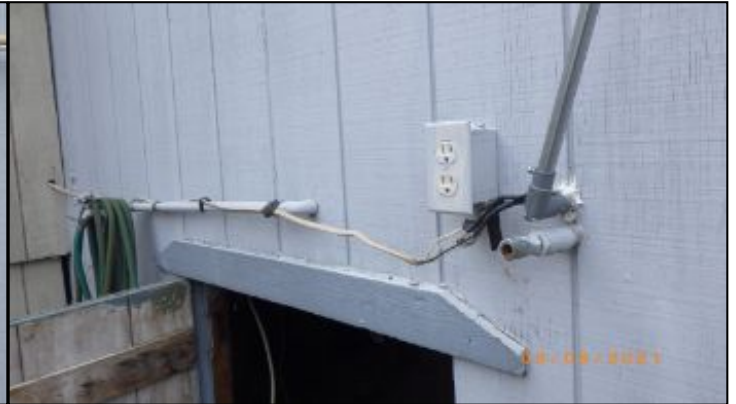
improper wiring

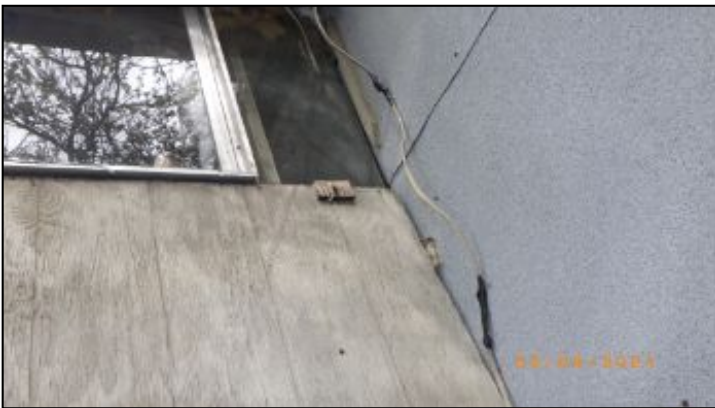
improper splices

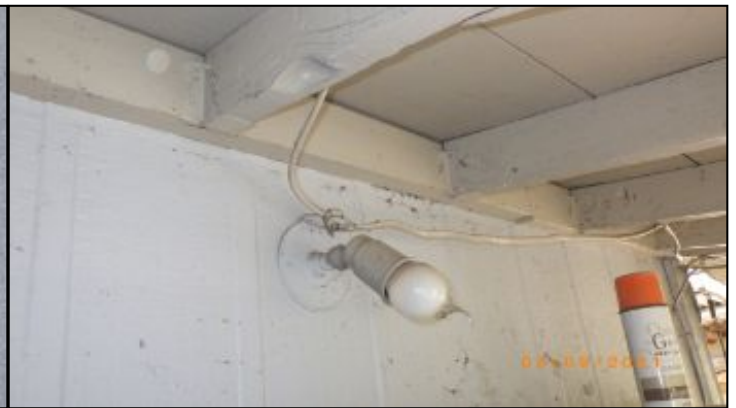
exposed cables/wire

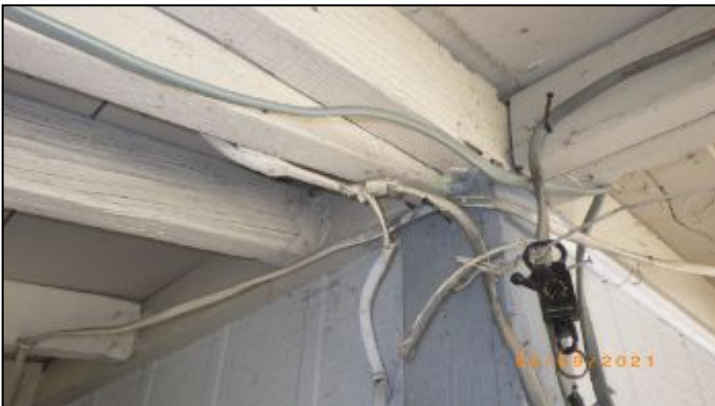
improper wiring

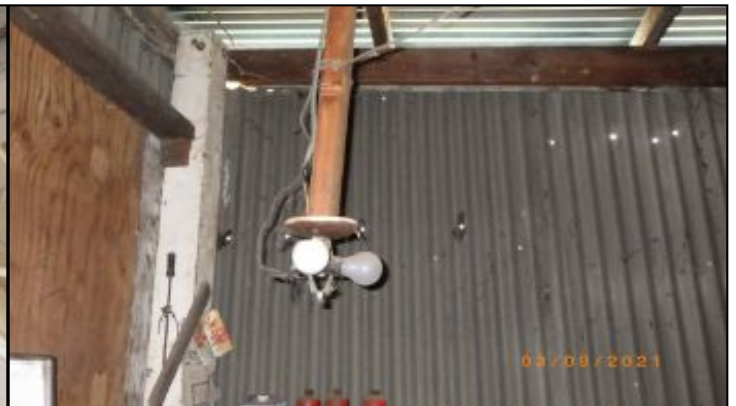
improper wiring

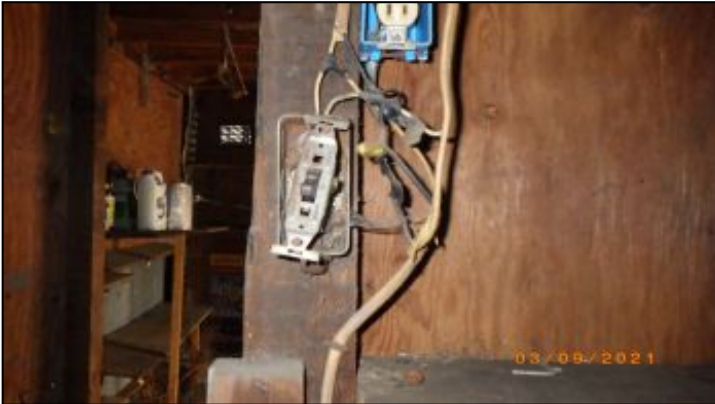
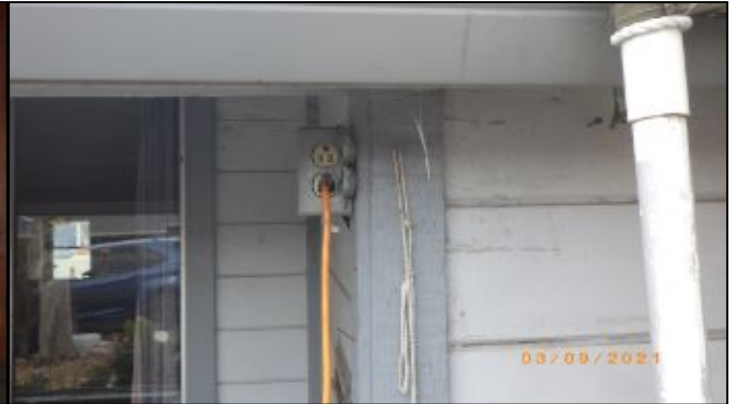
extension cord

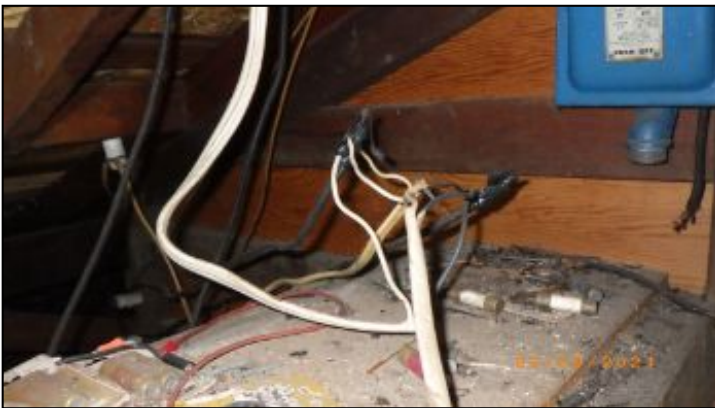
improper splices

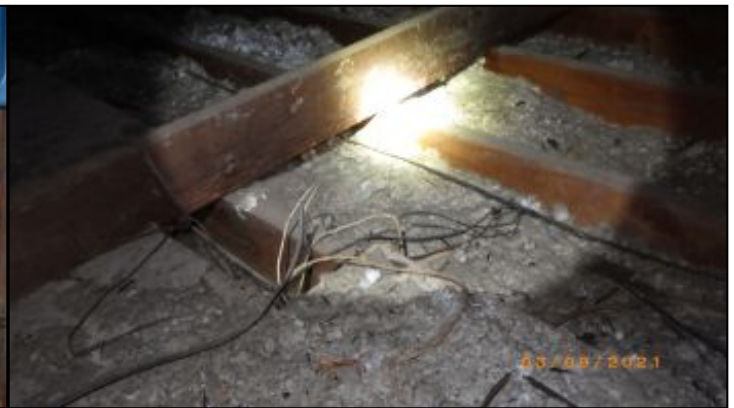
abandoned wiring

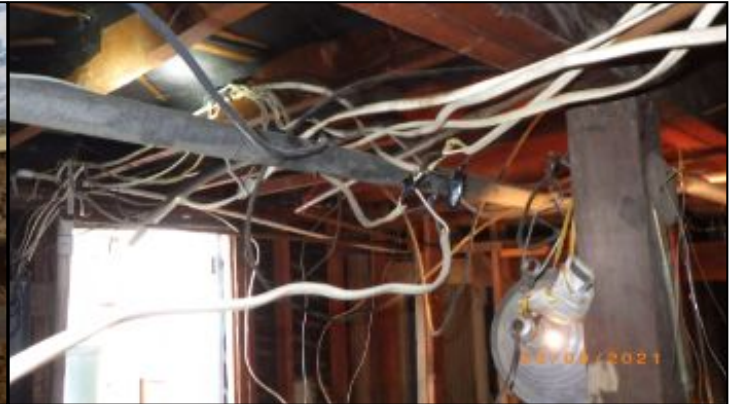
loose wires\improper wiring

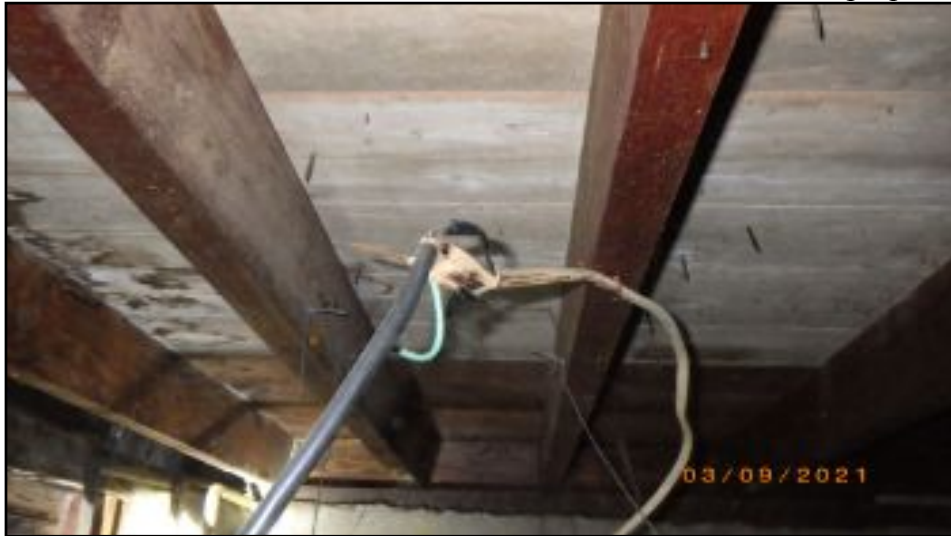
improper splices

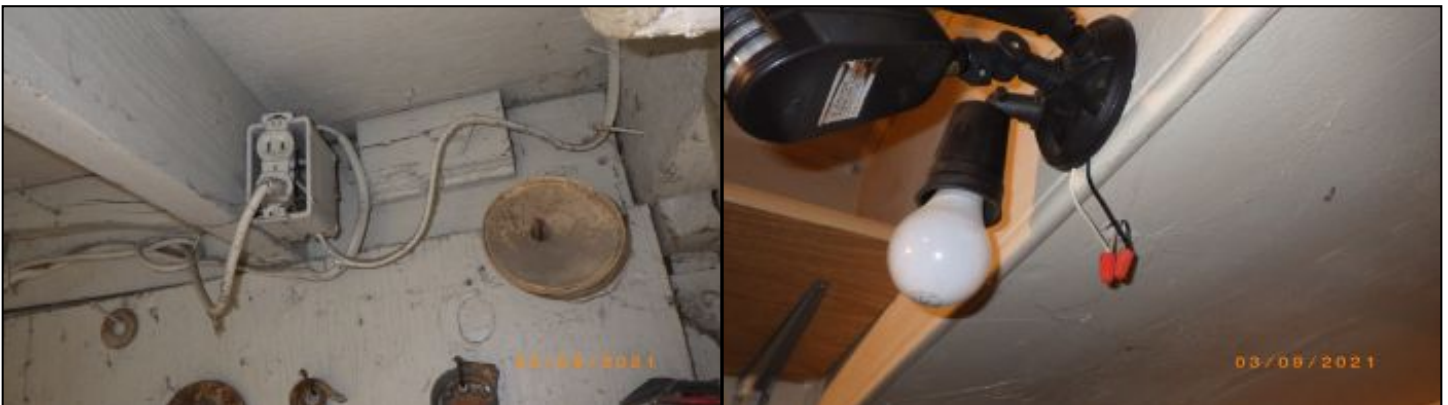
We found that several outlets in this home are missing covers. It is possible for persons to come in contact with energized components - a significant safety hazard. To achieve the intended level of safety we recommend all missing covers be immediately installed.

outlet missing cover

missing globe

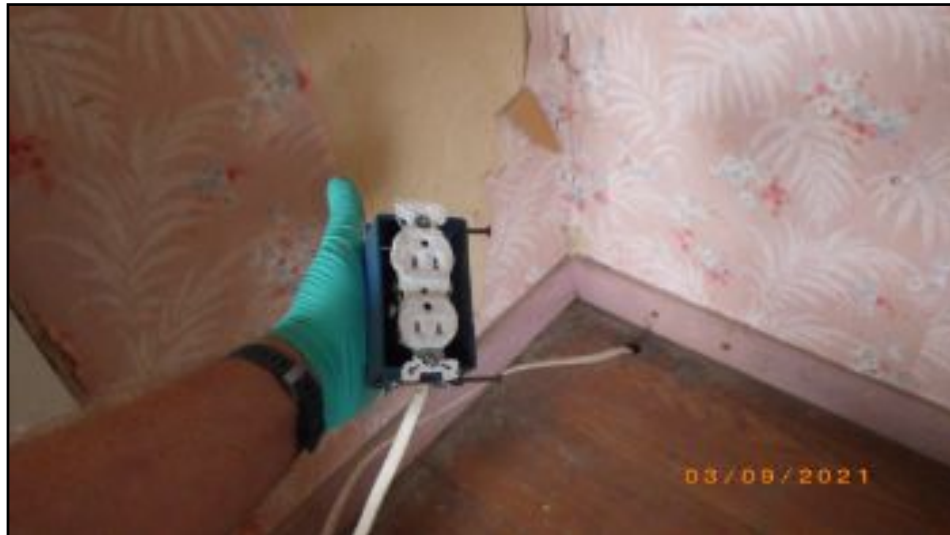
several aspects improper

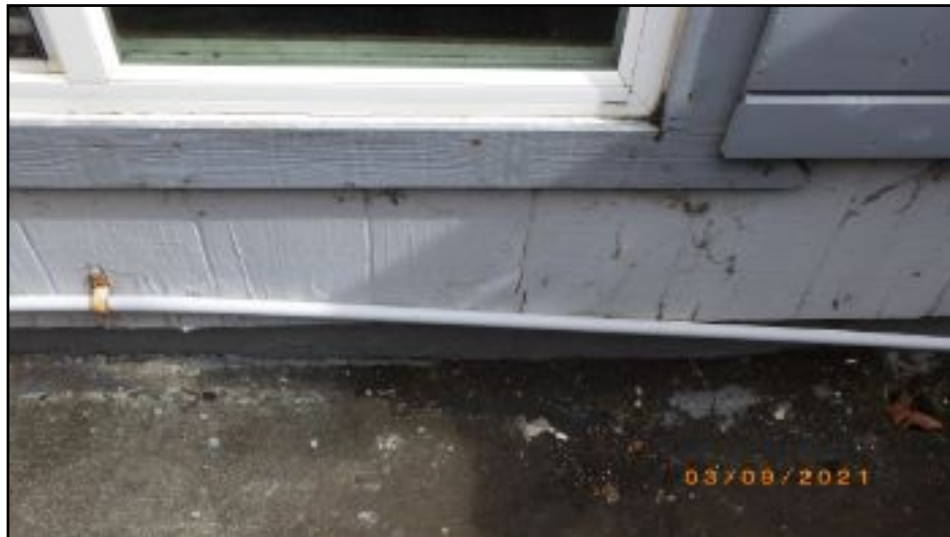
There are several aspects of this homes plumbing that are incomplete, improper, and in some cases leaking now. Please read this entire section carefully. It is beyond a basic home inspection to identify each and every deficiency beyond a general overview of problem types found. A complete survey of a homes plumbing system is considered technically exhaustive and well beyond the scope of established standards set forth by the American Society of Home Inspectors (ASHI). We recommend our client retain the services of a qualified plumber to provide further review and make repairs.

PVC distribution plumbing

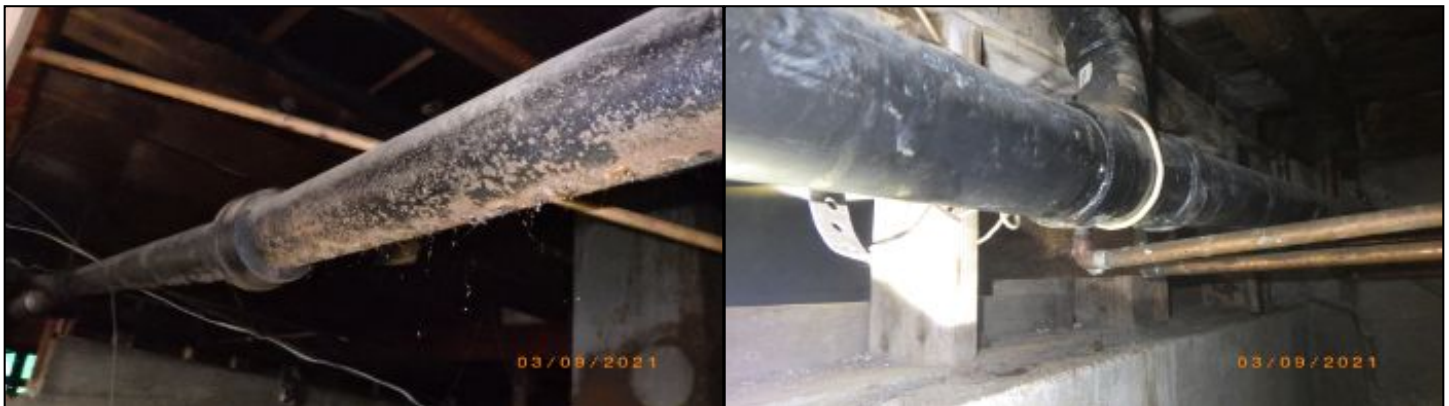
cast iron waste line

waste line not secure

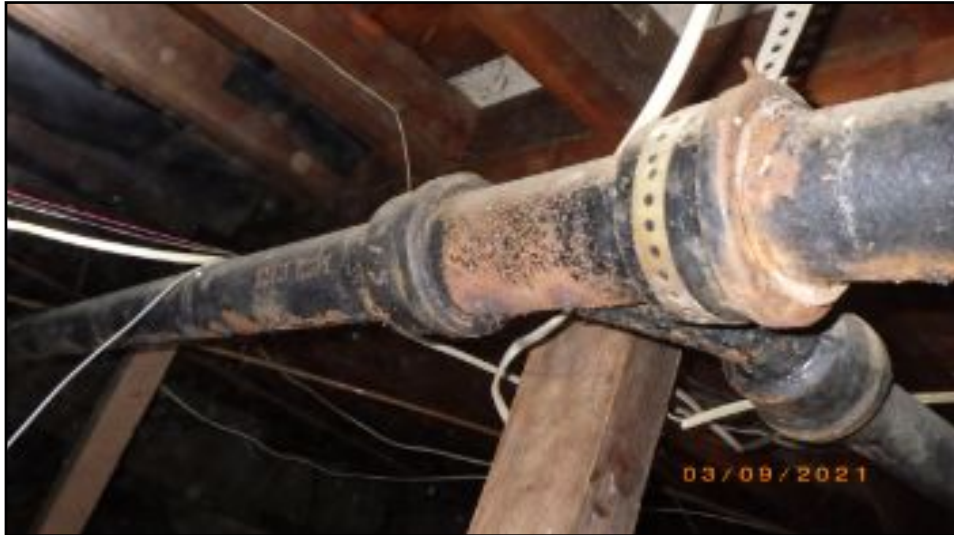
There are straight sections of cast iron waste pipe that have rust deposits, staining, and/or rust cysts. This is evidence of possibly occluded or heavily rusted pipes that may need replacement now or in the near term. Most cast iron pipe has an expected service life of about 50 to 70 years before it becomes so occluded by rust that replacement is necessary. This plumbing may be at that point. We recommend further evaluation and correction or replacement as necessary.

waste line rust cysts

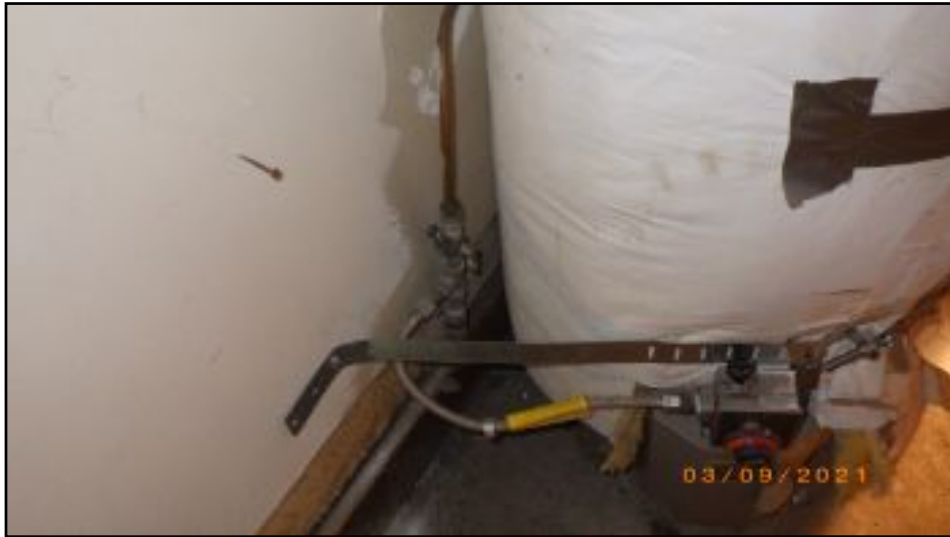
The water heater has rigid water supply pipes. Rigid pipes can break during an earthquake and the subsequent leaks can cause significant water damage to a home. We recommend replacing these supply lines with the flexible type for enhanced protection.

not secure

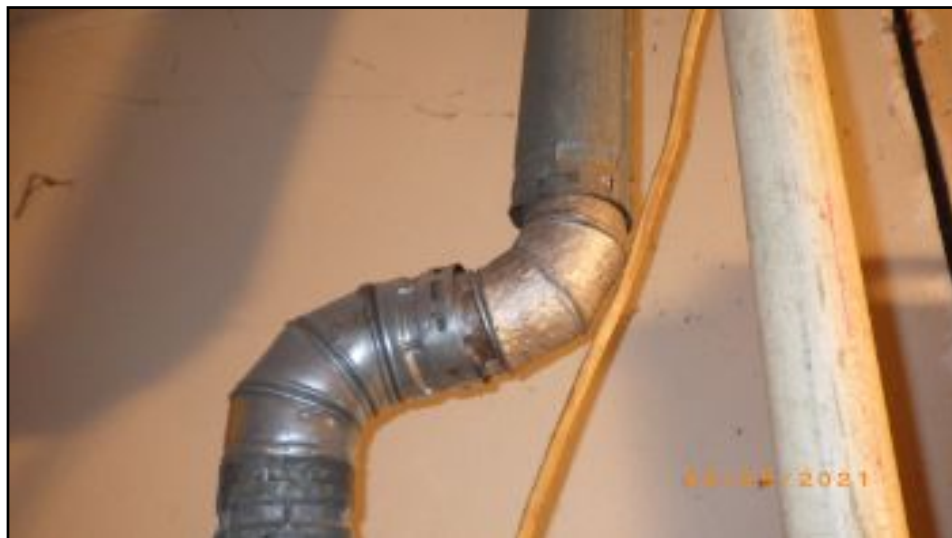
**The flue for the gas fired water heater is improperly configured. This condition can allow deadly hot gases to enter the structure - a life safety hazard. We recommend immediate repairs and further evaluation by a mechanical (sheet metal) contractor or qualified plumber.**

flue not secure

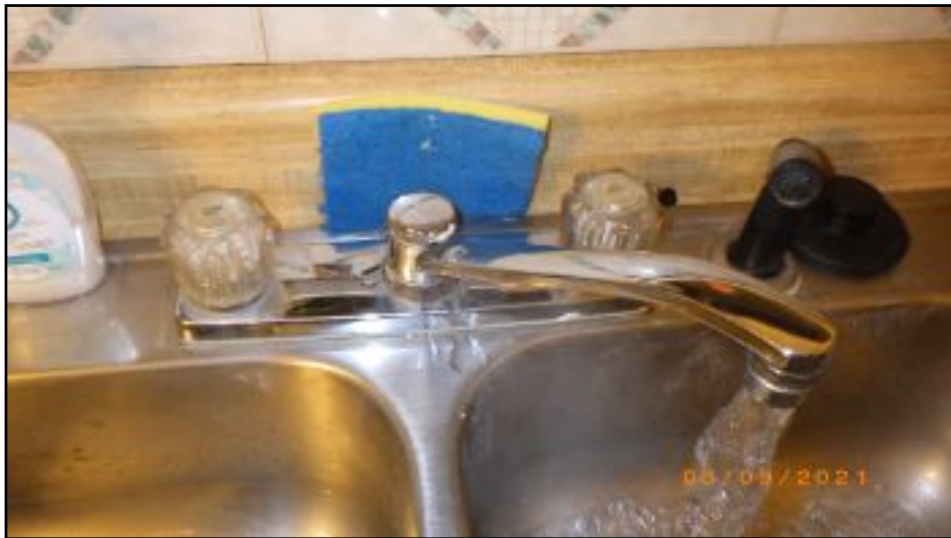
There is a waste line leak below the kitchen sink. Plumbing leaks can cause significant water and fungus related damage. We recommend immediate evaluation and repairs by a qualified plumber.

leak at kitchen sink
