**Illuminating real estate  
investment decisions since 1999**

1568 Sample Street , Any City, CA  
Inspection prepared for: Sample Client  
Date of Inspection: 3/26/2022

Inspector: Scott Schildknecht  
ASHI Certification # 252268  
1485 Maria Avenue , Concord , CA 94518  
Phone: (707)649-8700  
Email: [scott@northbayinspection.com](mailto:scott@northbayinspection.com)  
[Northbayinspection.com](http://Northbayinspection.com)

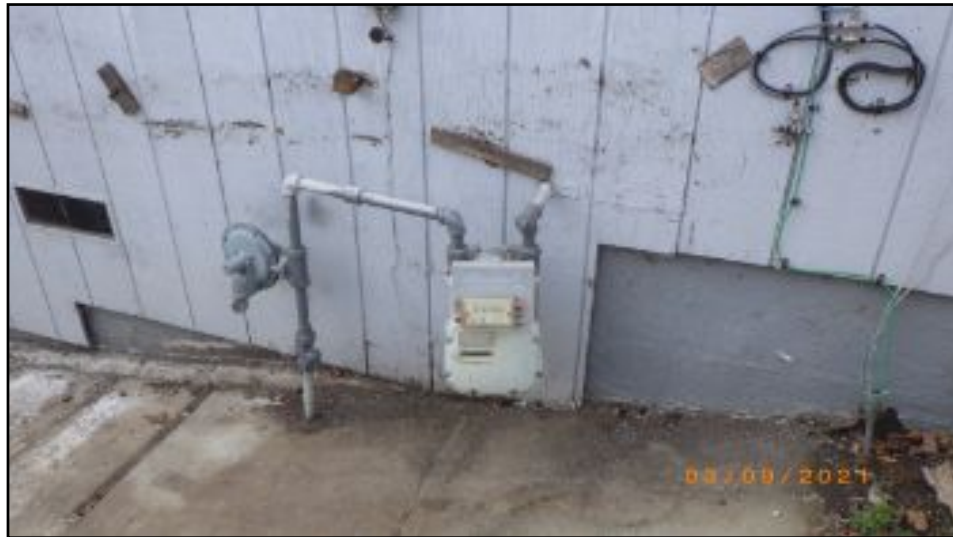
gas meter

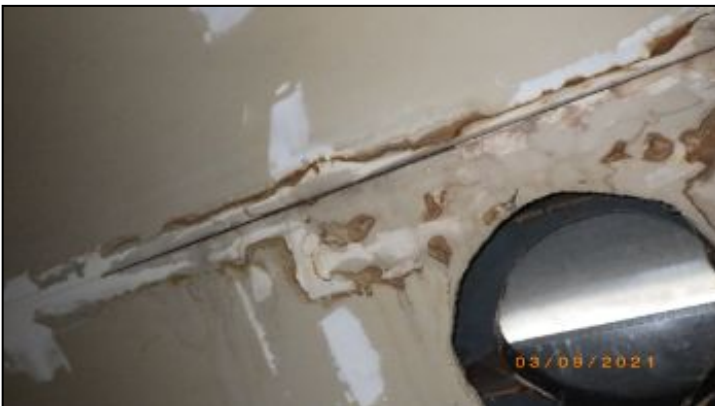
There is evidence of previous repairs to the wall or ceiling surfaces in the home. It is difficult for the average handyperson to make repairs to walls/ceilings as this takes special skills and equipment to make the patches match adjacent surfaces. Although this is primarily a cosmetic issue, extensive repairs might be an indication of significant previous water damage or other kinds of damage.

water stains

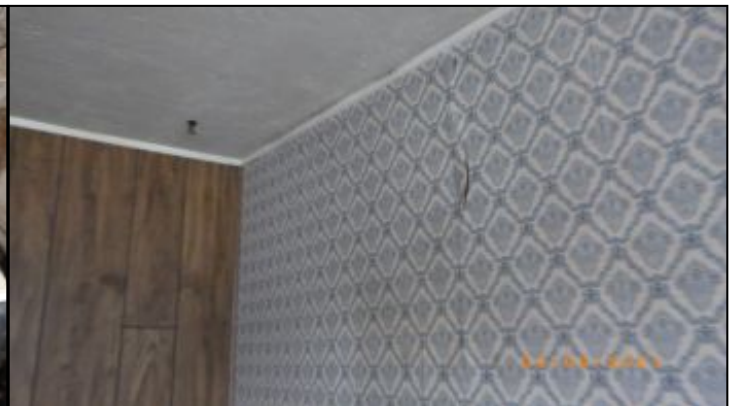
wall blemishes

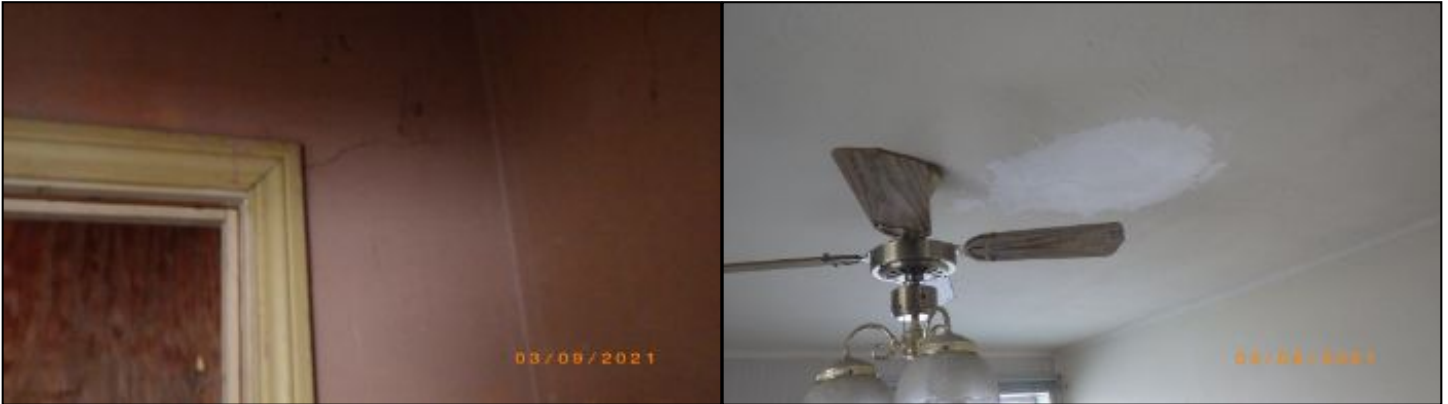
settlement cracks

previous repairs

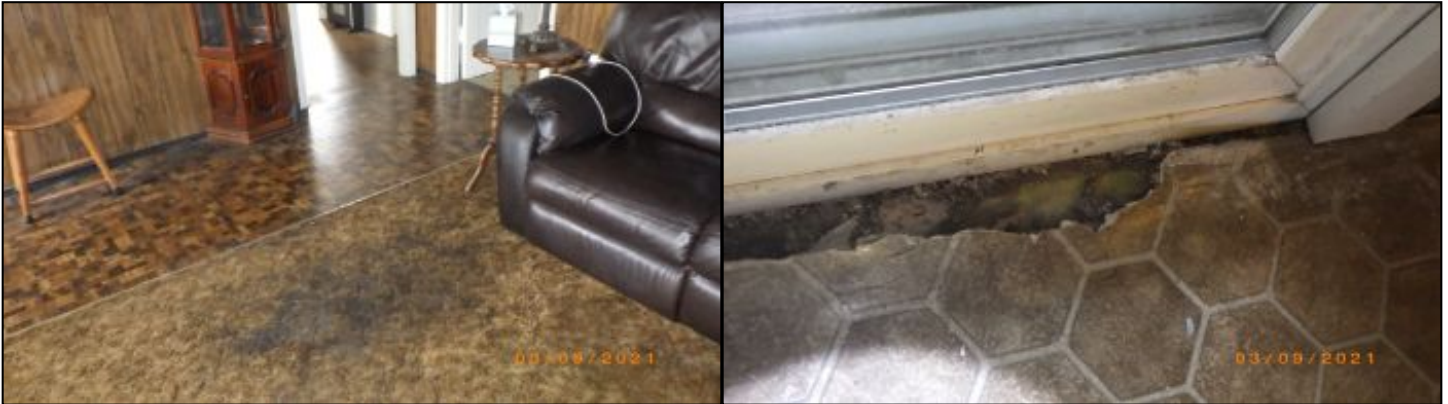
The flooring is worn by appearance at several places in this building. Although this flooring may still be serviceable it is worn and likely will need attention, repairs, or even replacement soon. For more information we recommend further evaluation by a qualified flooring contractor.

generally worn condition

generally worn

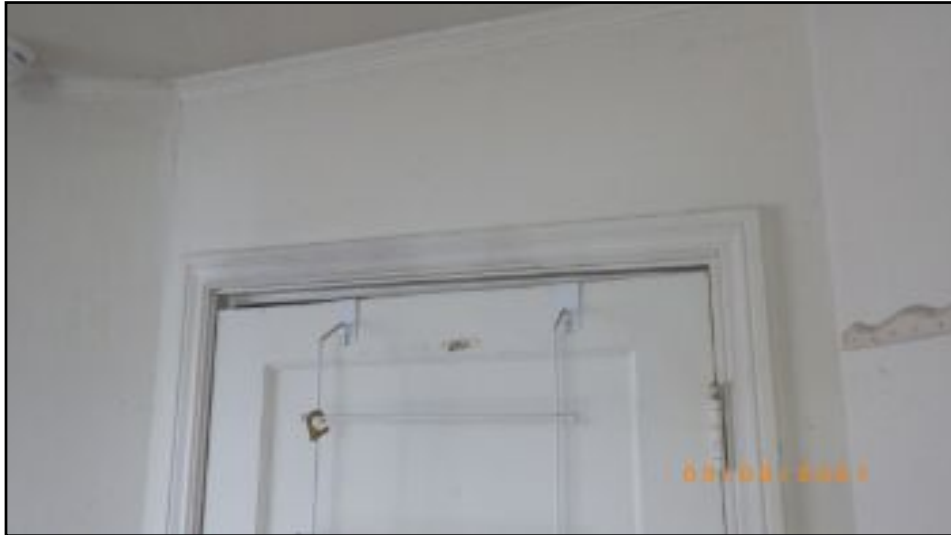
doors out of square

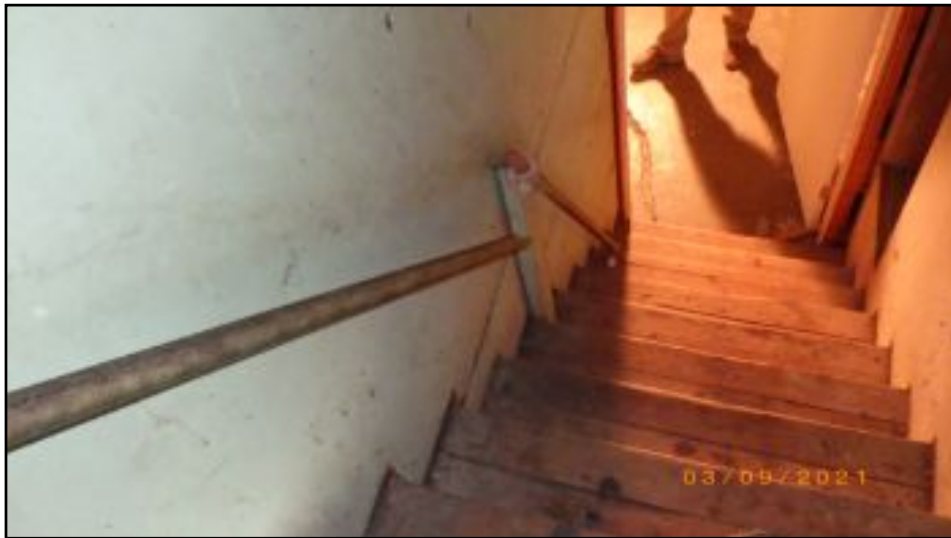
The interior handrail at the attic is damaged. This is a significant safety/fall hazard, we recommend repair by a qualified contractor.

damaged handrail

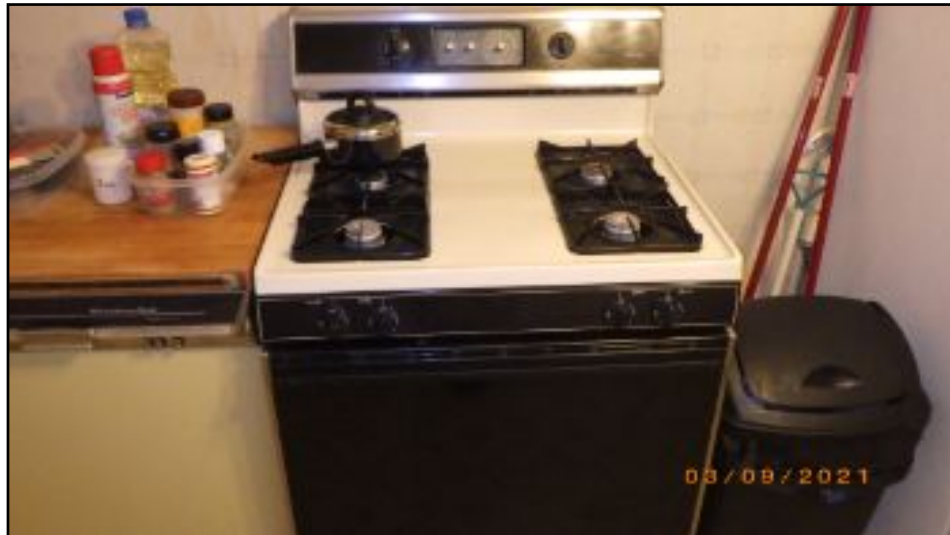
The range is generally worn and likely at or near the end of its service life. This unit may need replacement soon.

generally worn

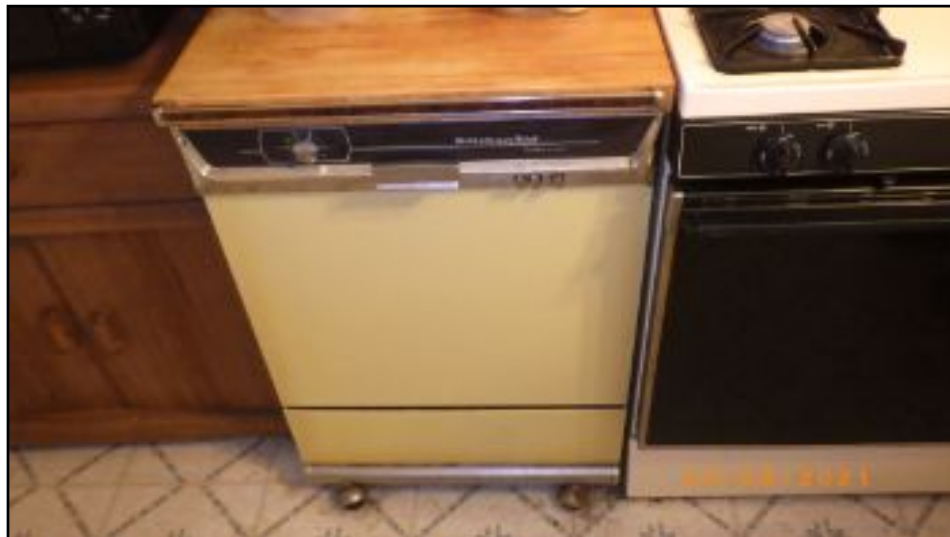
The home appears to be equipped with a portable type dishwasher. It is beyond the scope of this inspection to test this type of appliance. We recommend asking your real estate professional if the unit transfers and ask the seller for more information regarding the function/history of the dishwasher.

portable dishwasher

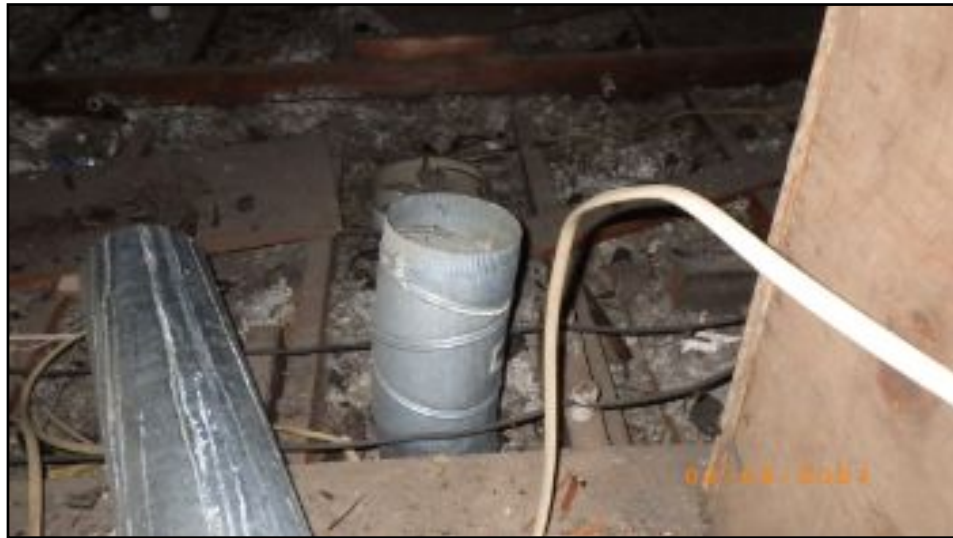
The kitchen exhaust fan was found to be venting into the attic because no duct has been added in the attic. This is an unsatisfactory condition and a potential fire hazard. In the event of a fire at the range top, hot gases and possibly flames would be drawn into the attic. Exhaust devices are supposed to be connected with insulated ductwork directly to dedicated exhaust hoods positioned as close to the device as possible - either at the plane of the roof or a side wall. We recommend that a qualified contractor perform further evaluation and repairs.

vents to attic

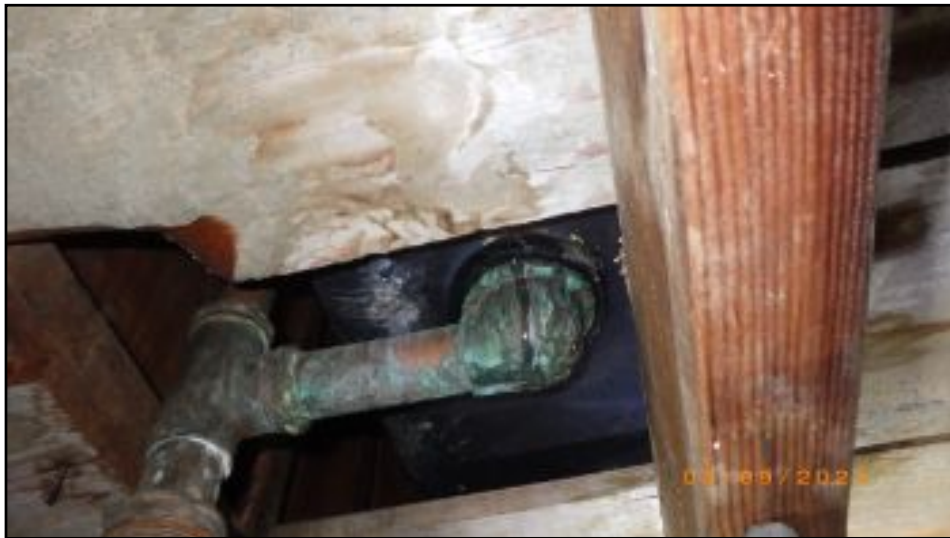
drain leak

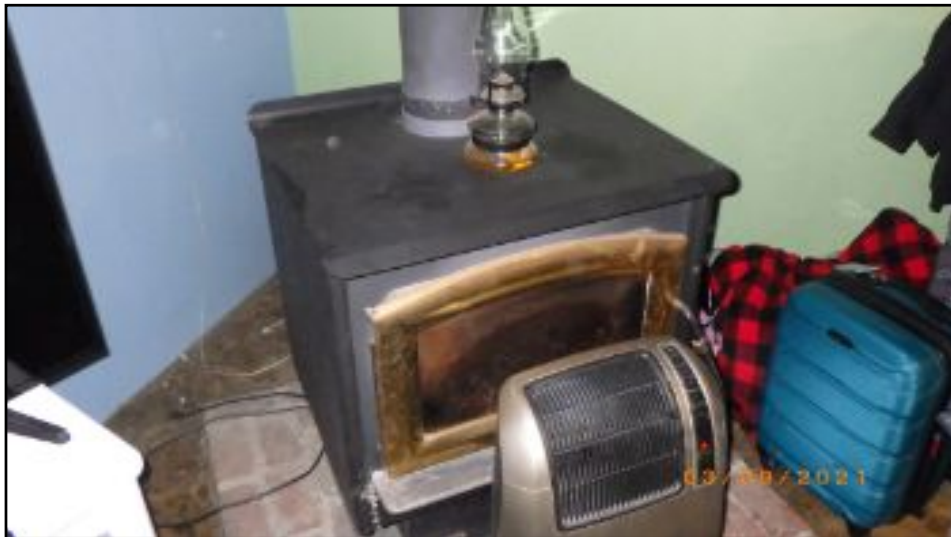
There is no damper on the wood burning fireplace/stove. Correction by a qualified wood burning stove mechanic is recommended.

wood burning stove

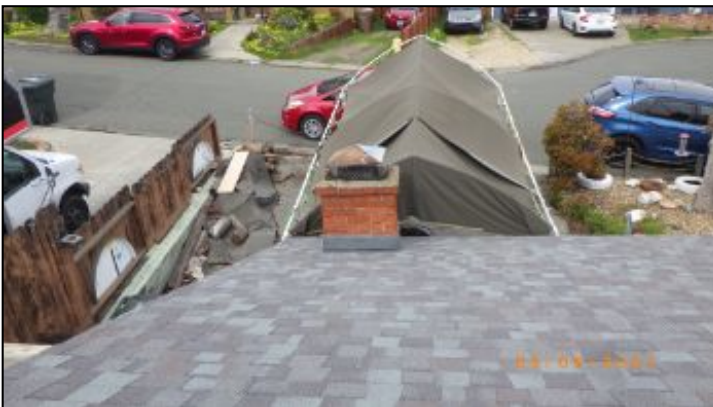
chimney too short

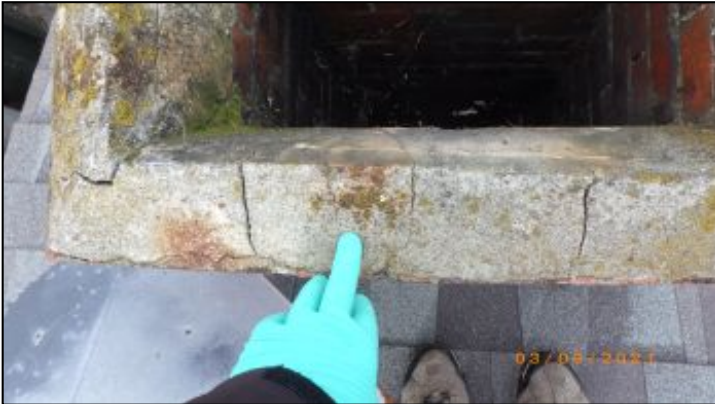
The water resistant surface at the top of this chimney is cracked worn or otherwise in need of some maintenance. The top of this chimney should be properly sealed to prevent water entry and prevent future damage to the internal components of this fireplace. We recommend having a qualified handyperson or chimneysweep perform proper repairs on this chimney cap.

worn cap

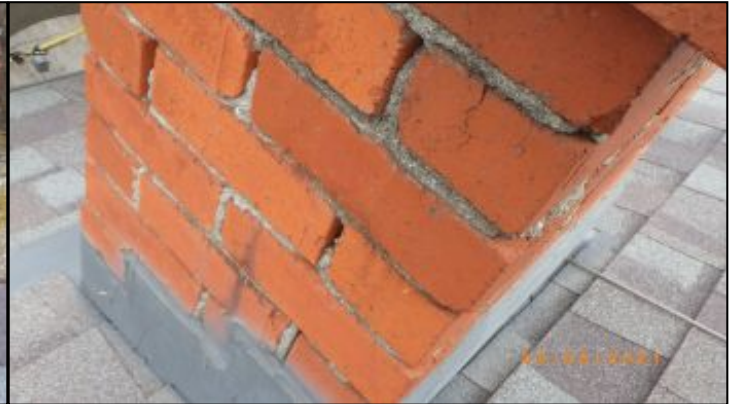
deteriorated mortar

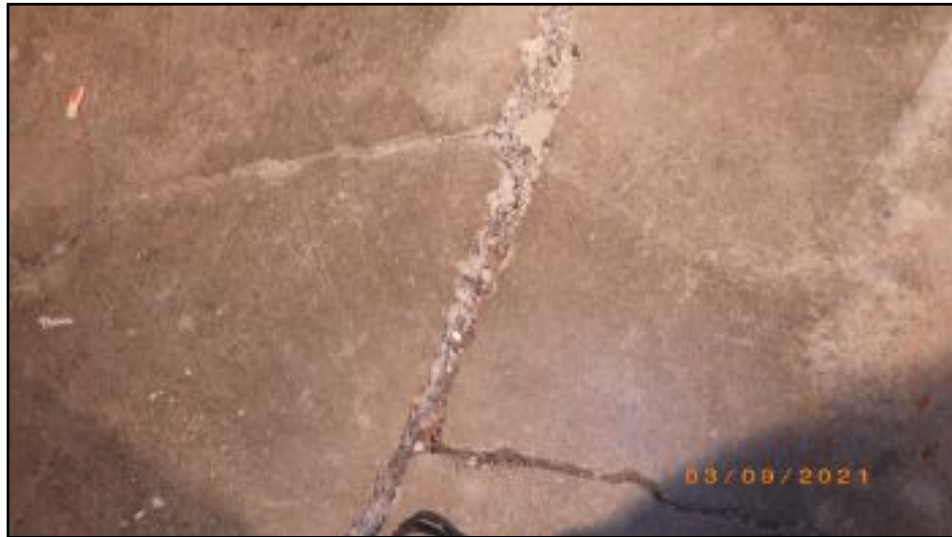
The floor slab of the garage is cracked and/or settled at several places. Exactly what caused the settling is unknown. This may be the result of organic material left under the slab or more likely - foundation settlement and expansive soils. This inspector does not anticipate any sudden changes. Please read the structural section carefully. We recommend further evaluation and repair by a concrete contractor.

settlement visible

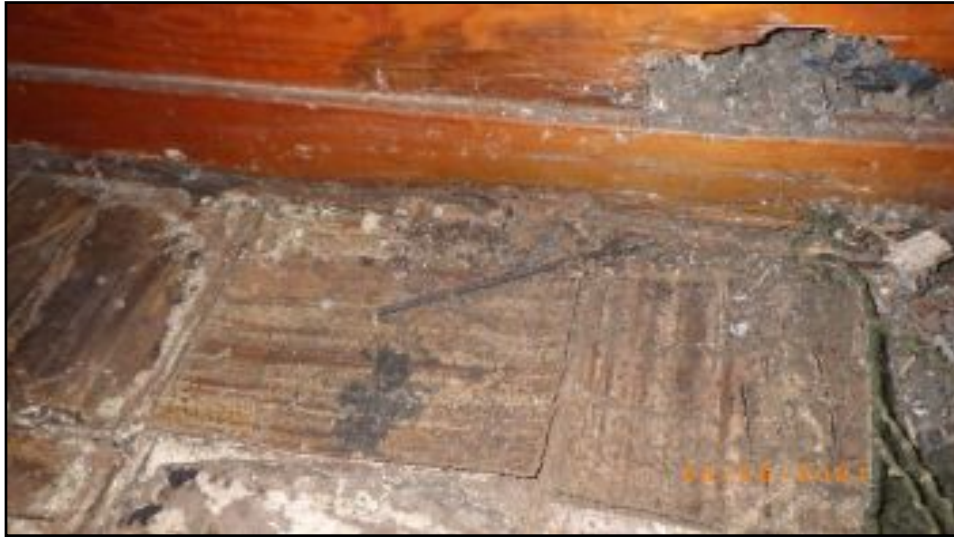
We found indications of wood destroying insects in the garage at several places. Infestation by wood destroying insects is normally a symptom of high moisture levels in wood that have caused the wood to rot or soften enough to make tunneling by insects possible. If we saw a water intrusion issue that contributed to this, it has been documented elsewhere in this report. Otherwise, we don't know what led to this infestation. We recommend further inspection by a qualified Class Three Structural Pest Control firm to identify the insects involved, determine the exact cause of infestation, and the extent of damage to the home, prescribe repairs, and treat the home as necessary to eliminate the infestation and provide residual protection. Thereafter, we recommend followup inspections and treatment as necessary at two to three year intervals.

wood destroying pests

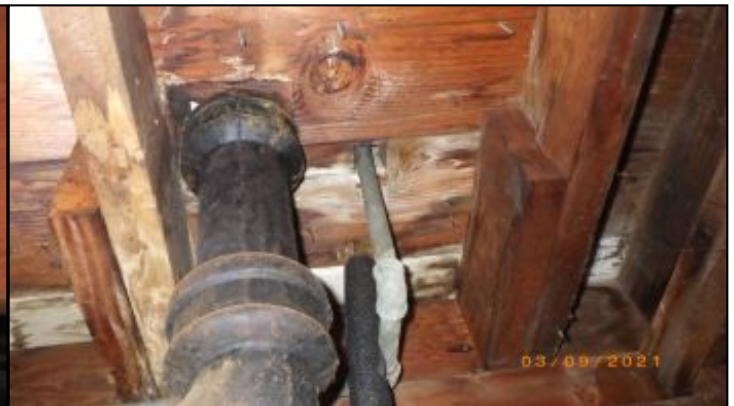
framing stained

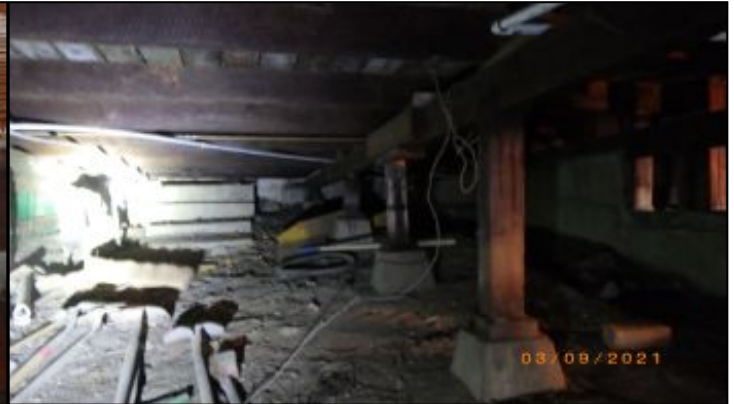
improper framing

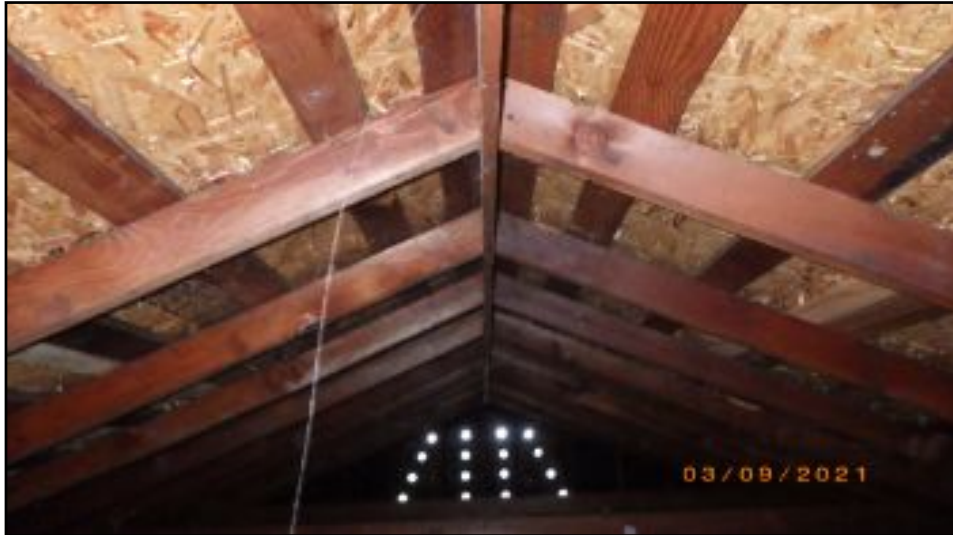
OSB over skip sheathing

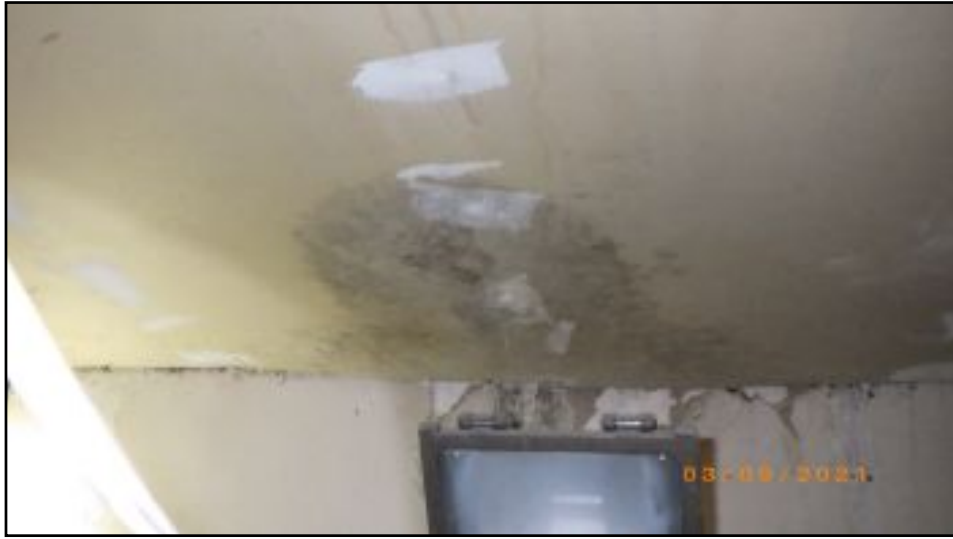
mold visible in laundry room

We strongly recommend further evaluation and remediation by a qualified environmental contractor.
