HOME INSPECTION REPORT

[REDACTED]
Dartmouth, NS
[REDACTED]

Date of inspection: March 11, 2026
Time of inspection: 2:00PM
Report #: 1
Inspected by: Mark Chiasson

LifeHouse Inspections

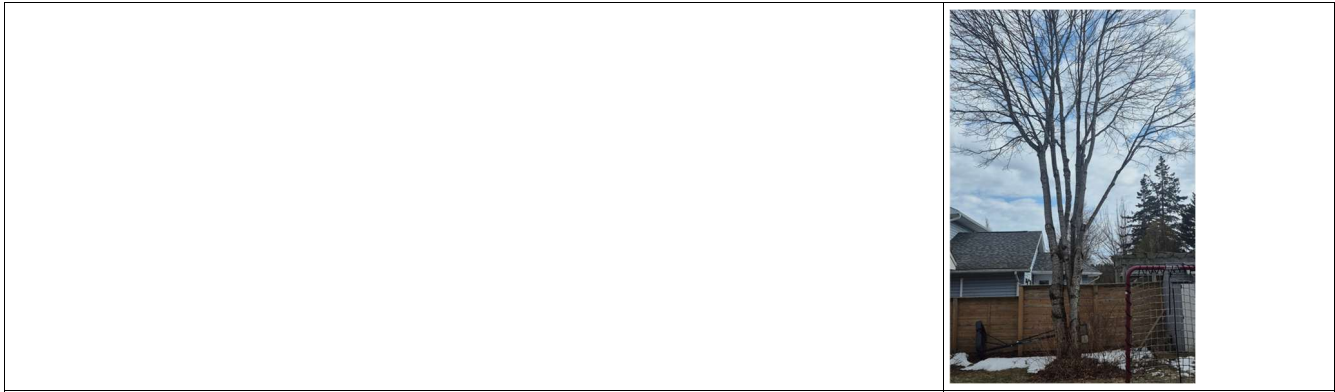
Water pooling towards the rear right end of back yard.

Large maple tree in backyard has previously been significantly cut. No signs that it hangs over the roof top.

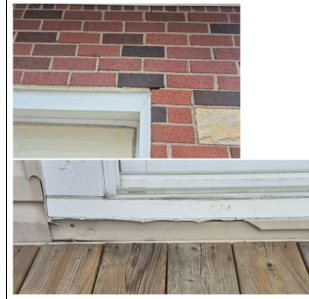
Front facade is brick and is generally in good condition. Some areas require repointing; in particular above the garage door.

Vinyl on the back and sides is in good general condition. J-trim requires repair around patio door.

Recommend consulting a mason for advice on repairs.

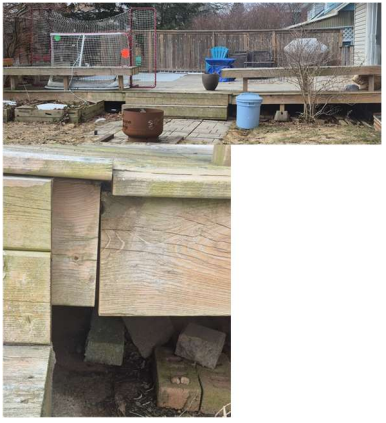
<p>Structure: Front step is in good condition. Back patio is showing signs of settling.</p> <p>Recommend the settling be monitored and repaired if it becomes worse.</p>

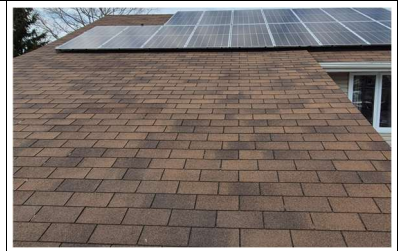
Roof shingles are in good condition. No missing or damaged shingles identified.

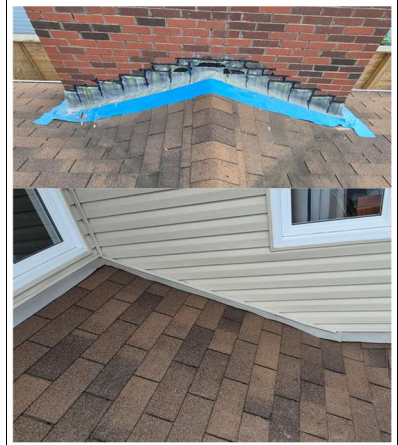
Blue skin covers flashing around the chimney. Unable to confirm if it is properly installed.

Step flashing on roof / wall intersection above front door not installed properly.

Recommend further investigation by a professional.

Recommend installation of step flashing by a professional.

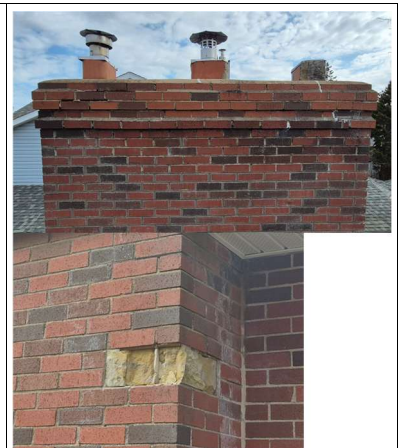
Chimney requires re-pointing in various places.

Cornerstones of chimney are becoming displaced and need to be repaired.

Recommend consulting professional to repair chimney.

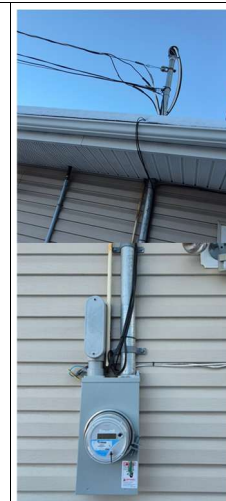
Main service entrance in good condition. No defects identified.

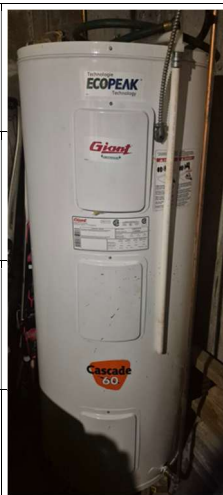
General Operation: Producing hot water at the taps.

Location / Obstructions: In the basement at the bottom of the stairs to the right.	
General Condition: Excellent condition.	
Pressure Relief Valve: Exists.

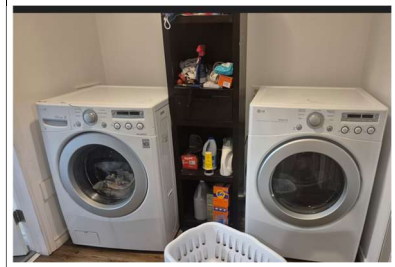
General Condition: Machines are in fair condition.

Dryer Vent: Flex vent is too long and compressed. Distance to outside is approximately 30ft with two 90deg turns. This is at the far range of allowable distances and should be monitored. If issues with drying are identified, the exhaust may need to be relocated.

Recommend addressing the flex pipe immediately.

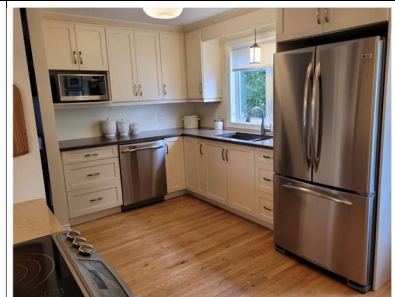
Cabinets / Counters: Operate as expected and in good condition. Counters are stone.

Ceilings / Walls: Drywall walls and ceilings in good condition. Ceiling has evidence of staining due to lack of exhaust fan.
