# HOME INSPECTION REPORT

[REDACTED]  
Dartmouth, NS  
[REDACTED]

Date of inspection: March 11, 2026  
Time of inspection: 2:00PM  
Report #: 1  
Inspected by: Mark Chiasson

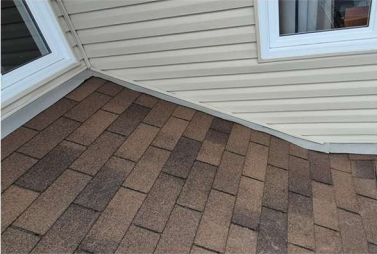
<b>System / Location:</b> Flashing where roof meets vertical wall above front door.	<b>Condition:</b> No step flashing.

<b>Risk / Impact:</b> Potential entry point for water into the home.	<b>Recommendation:</b> Consult a qualified professional and repair immediately.
5	 	<b>System / Location:</b> Gutter system at front right side of house.	<b>Condition:</b> Downspout extension is missing.
		<b>Risk / Impact:</b> Water being dispersed at foundation of home. Potential entry point	<b>Recommendation:</b> Consult a qualified professional and repair immediately.

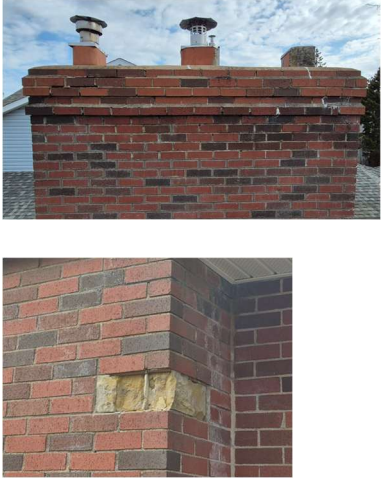
<b>System / Location:</b> Chimney	<b>Condition:</b> Chimney requires re-pointing in various places.  Cornerstones of chimney are becoming displaced and need to be repaired.
		<b>Risk / Impact:</b> Impacts stability of bricks and chimney. Potential entry point for water into the home.	<b>Recommendation:</b> Consult a qualified professional and repair immediately.
7

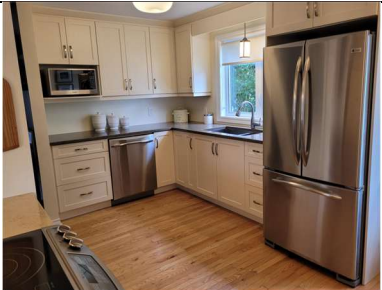
<b>System / Location:</b> Kitchen	<b>Condition:</b> No GFCI plugs as required by code.
		<b>Risk / Impact:</b> GFCI plugs protect against potential electric shock. This is of particular importance in areas where water is in close proximity to plugs.	<b>Recommendation:</b> Consult a qualified professional and repair immediately.
12		<b>System / Location:</b> Plugs / Master bedroom	<b>Condition:</b> Plugs operate with an open ground.
