This **Summary Report** is meant to organize any **Moderate Recommendations** and **Significant and/or Safety Concerns** into a shorter, straight to-the-point format. It does not, however, include **Upgrade/Maintenance** recommendations or Informational data that can be found in the Full Report.

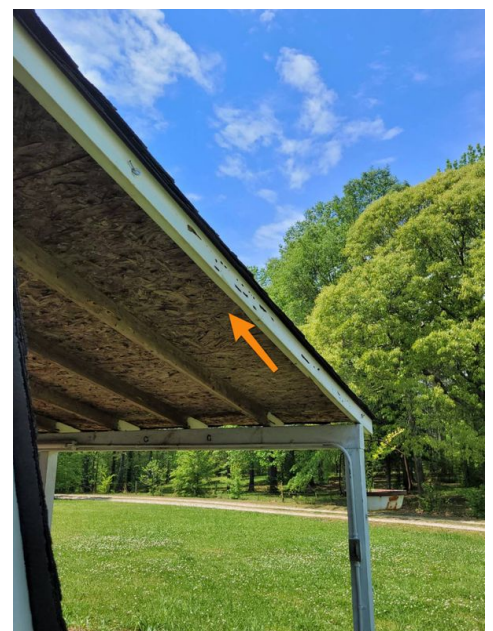
**EVIDENCE OF INSECTS, BIRDS OR RODENTS PRESENT**

We observed evidence that the home appears to be infested with insects, birds and/or rodents. We recommend having the home treated for insects and/or rodents prior to occupation.

Carpenter bees. Detached building

Recommendation  
Contact a qualified professional.

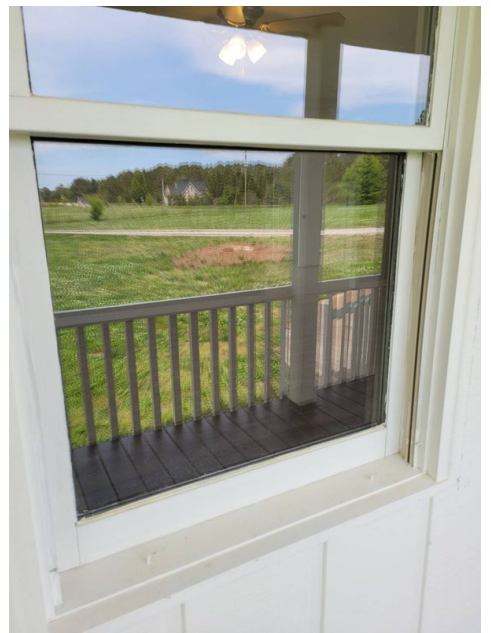
**SCREENS - DAMAGED AND/OR MISSING.**

One or more screens were damaged and/or missing at the time of the inspection.

No screens present

Contact a qualified window repair/installation contractor.

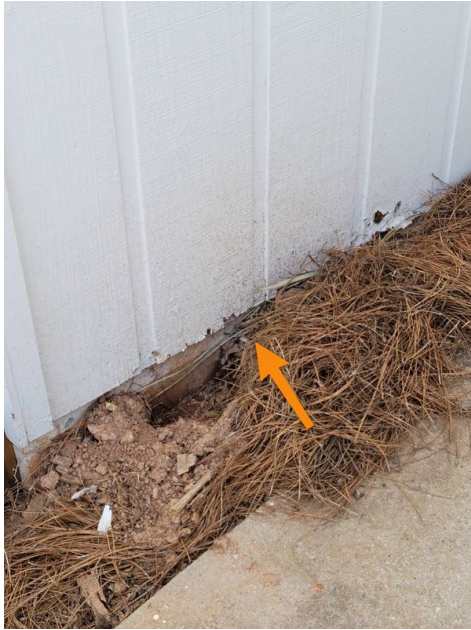
Right front

### WOOD ROT

There is wood rot that should be repaired to prevent further damage and deterioration.

Contact a qualified siding specialist.

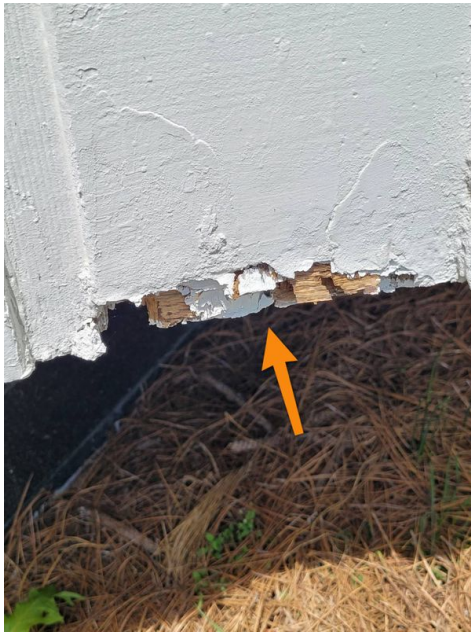
Left around kitchen bay window.  
Multiple locations

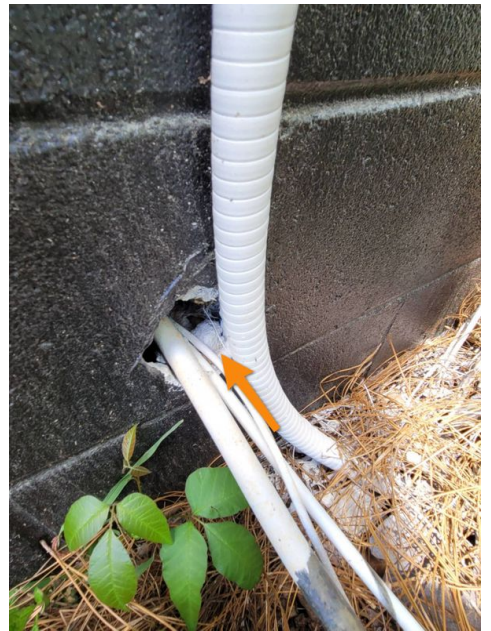
All penetrations

#### **GAP NEEDS FILLED**

Recommend sealing or filling gaps to prevent moisture, rodent, or insect damage.

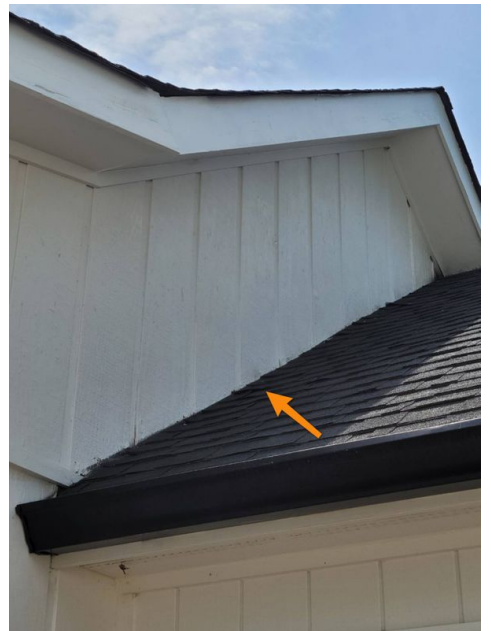
Right front and back

#### **SIDING ROOF CLEARANCE**

Siding on the home did not have the recommended clearance of 1.5" to the roof. Running siding close to asphalt shingles results in moisture damage and premature failure. Recommend trimming or replacing the siding for proper clearance.

Contact a qualified professional.

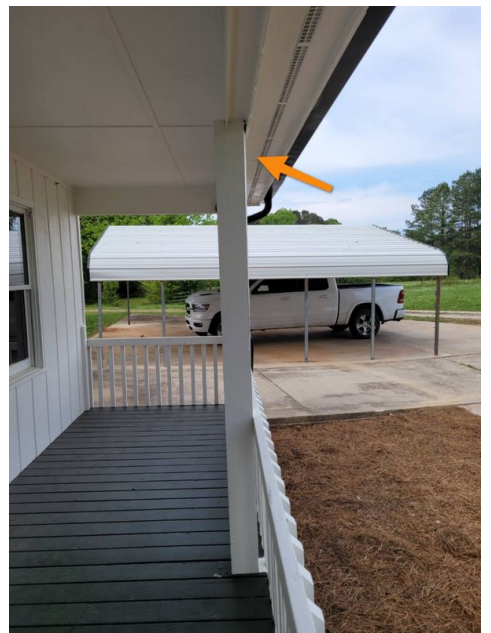
**DECK/BALCONY UNSTABLE SUPPORT**

One of more areas of the deck or balcony support appears unstable. This could cause a safety hazard and further deterioration of the deck or balcony

Warped post

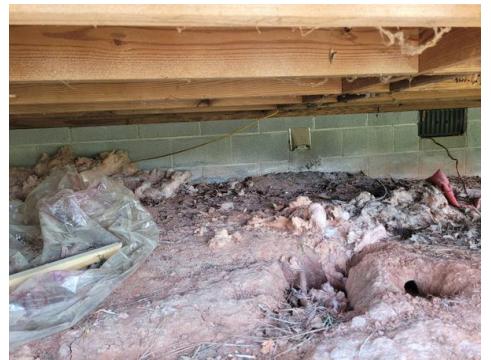
Throughout deck

**JOIST HANGERS**

Joist hanger(s) are missing or improperly installed. This could cause the deck structure to fail.

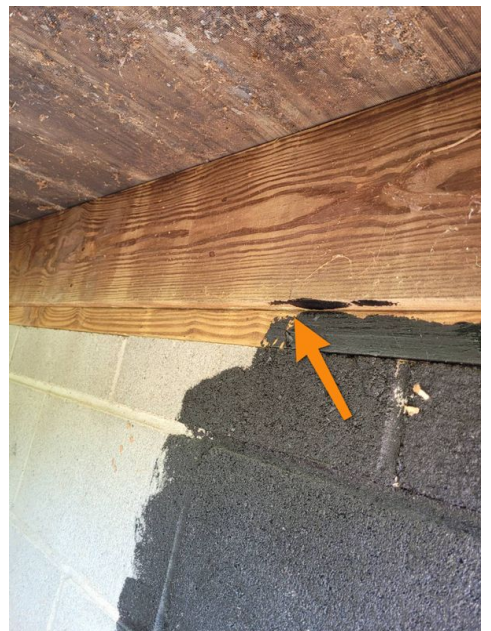
Rear deck

**LEDGER BOARD IMPROPERLY INSTALLED**

The ledger board is not properly attached to the building. This can cause the deck to pull away from the building and possibly collapse.

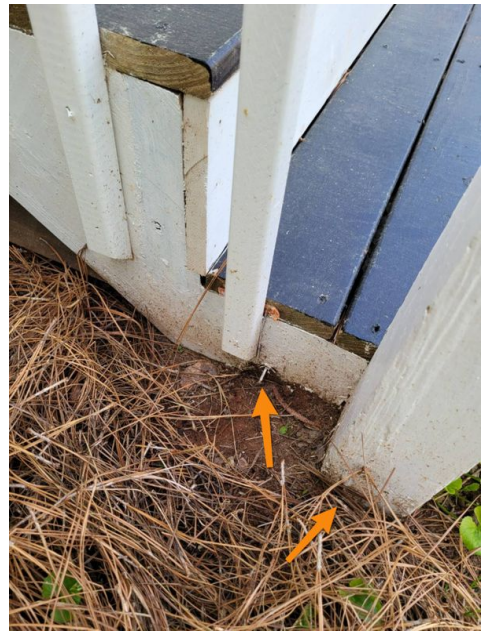
Front & Rear Porches

### WOOD TO GROUND CONTACT

One or more parts of the structure were in direct contact with the ground. This can cause premature deterioration and should be fixed to prevent further damage.

Contact a qualified professional.

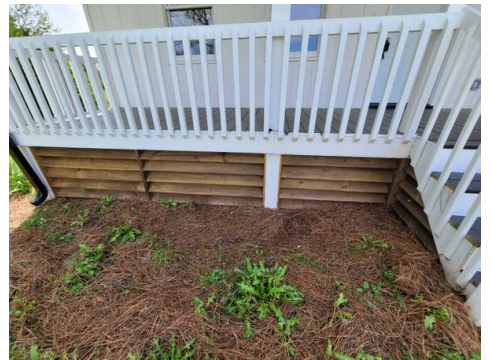
Underneath front porch

### INACCESSIBLE

One or more portions of the exterior decks were inaccessible and unable to be inspected.

Contact a qualified professional.

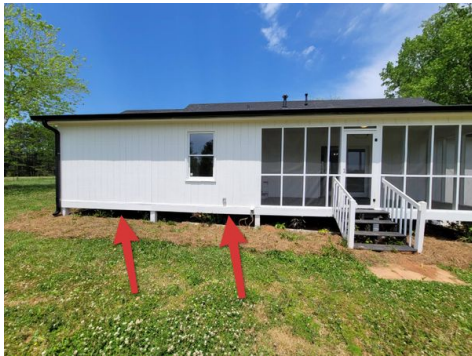
Master Bath & middle rear room bumpout

**LIVING SPACE BUILT OVER PORCH****Significant and/or Safety Concern**

One or more additions to the home were added above an existing porch. In addition to plumbing, wiring, and ductwork being exposed to the elements, this may also be of structural or safety concerns. Recommend further evaluation by a qualified contractor in addition to asking for permits in reference to the additions.

Contact a qualified professional.

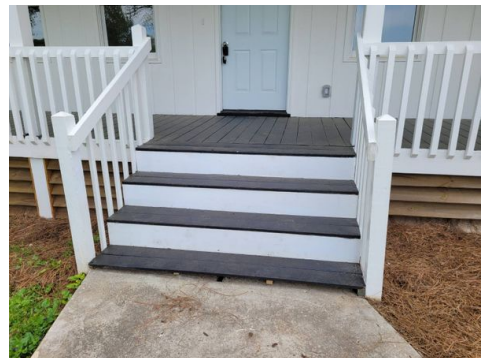
Front porch

**HANDRAIL(S) - MODERN REQUIREMENTS****Moderate Item**

Although it may have met with generally-accepted standards during the time period in which it was built, this exterior staircase handrail did not meet generally-accepted current standards. Standards change over time. Homes are not required to be constantly upgraded to meet newly-enacted building codes or standards. Some generally-accepted current standards regarding handrails are as follows:

1. A 4 3/8 inch sphere may not pass through the handrail at any point.
2. The handrail should not be climbable (especially by children).
3. Handrail height should be between 34 and 38 inches from tread nosing.
4. The handrail should protect the entire staircase and be continuous.

5. The handrail should be graspable.

All corrections should be made by a qualified contractor.

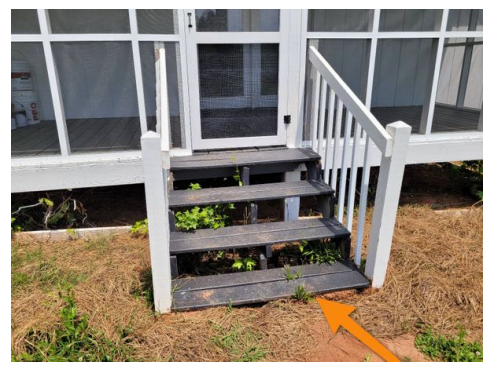
Rear steps

## EXTERIOR STAIRS (MODERATE DETERIORATION)

At the time of the inspection, these exterior stairs exhibited moderate general deterioration. Good maintenance practices will maximize the lifespan of this staircase.

Contact a qualified professional.

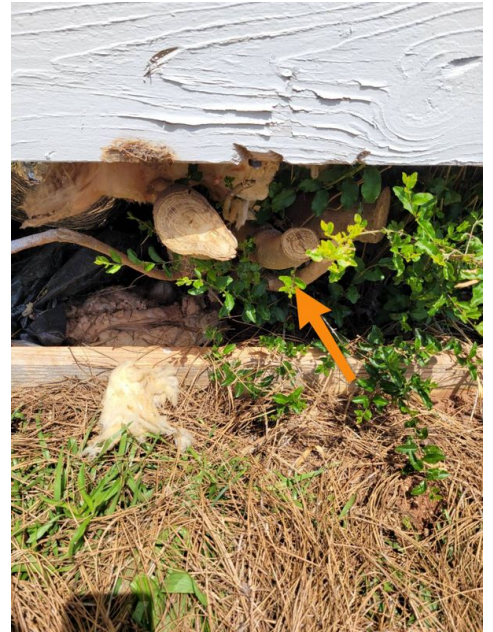
Rear

## TREES AT FOUNDATION

Trees are growing too close to the foundation.

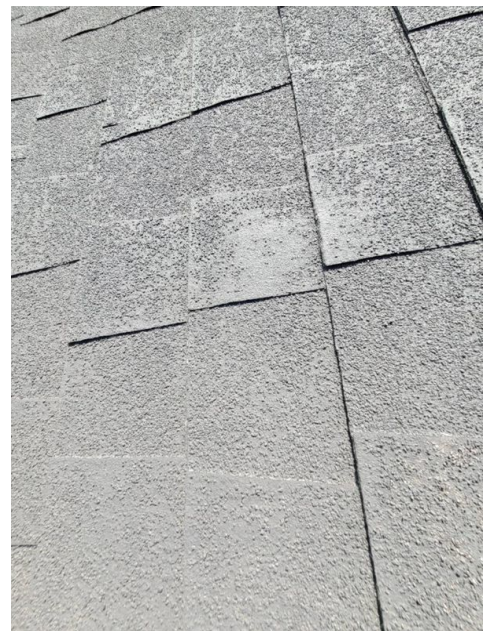
## SUBSTANDARD ROOF INSTALLATION

The roof appeared to be modified, installed, and/or added on to in a manner that is inconsistent with modern building practices. The roof covering may have been installed incorrectly which could lead to moisture intrusion or structural issues. Further evaluation by a licensed roofing contractor is recommended.

Roof appears to have been painted

Contact a qualified professional.

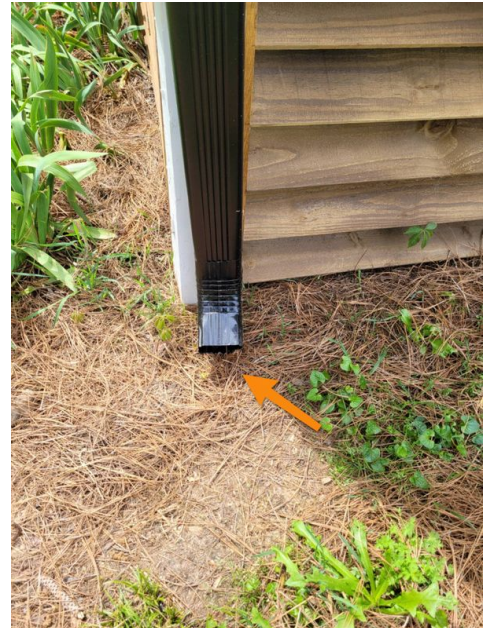
Multiple locations

## DOWNSPOUTS DRAIN NEAR HOUSE

One or more downspouts drain too close to the home's foundation. [Adjust downspout extensions to drain at least 4-6 feet from the foundation.](#)

Recommendation  
Contact a qualified gutter contractor

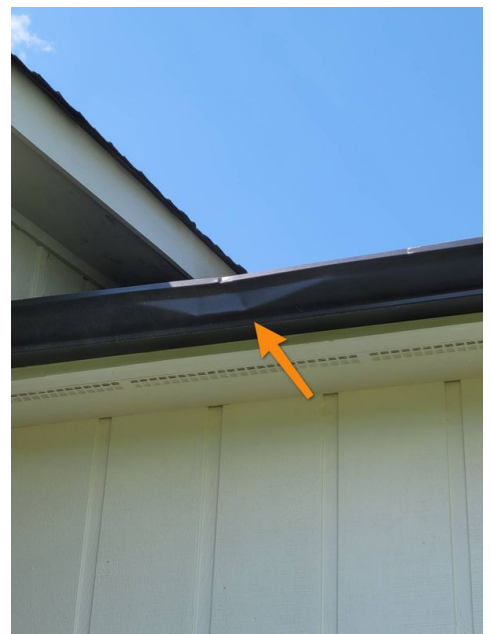
Left rear

## GUTTER DAMAGED

Gutters were damaged. This can result in excessive moisture in the soil at the foundation, which can lead to foundation/structural movement.

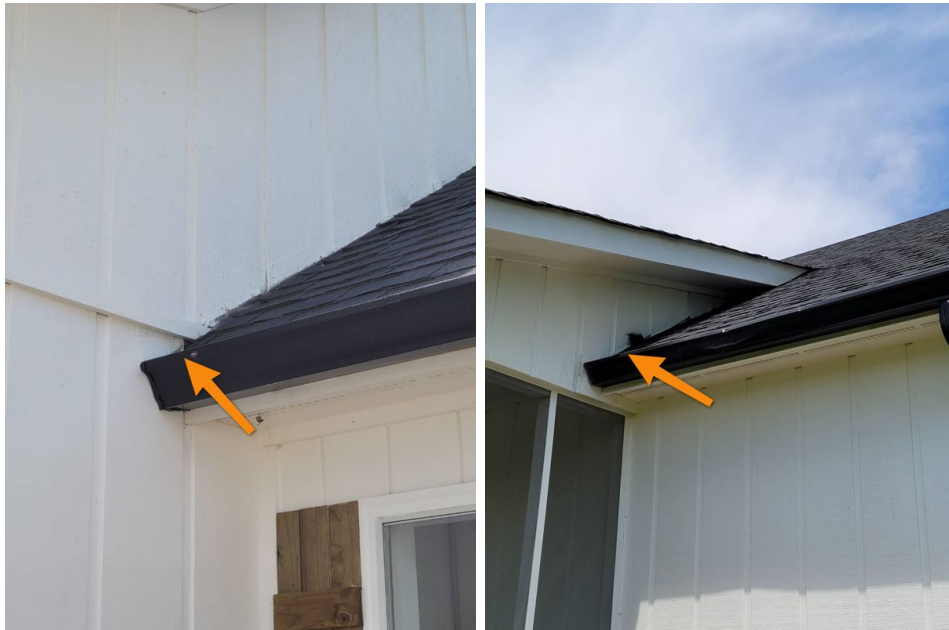
### MISSING KICKOUT FLASHING

Kick-out flashing was missing where walls extended past roof edges.

Right front and back

Left rear

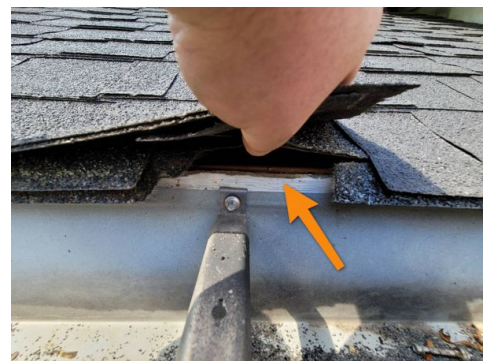
### ROOF EDGE FLASHING MISSING

Areas of the roof were missing roof edge flashing. Lack of roof edge flashing leaves the edges of roof sheathing and underlayment exposed to potential moisture damage from wood decay and/or delamination. The inspector recommends replacement of roof edge flashing in areas where it is missing. All work should be performed by a qualified contractor.

It is worth noting this was not a requirement in the state of GA until January 2014.

Contact a qualified roofing professional.

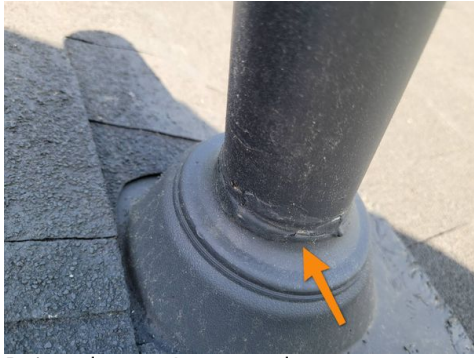
### PLUMBING VENT - DAMAGED BOOT

One or more plumbing vents were damaged. Recommend repair.

Painted over. Separated

Contact a qualified professional.

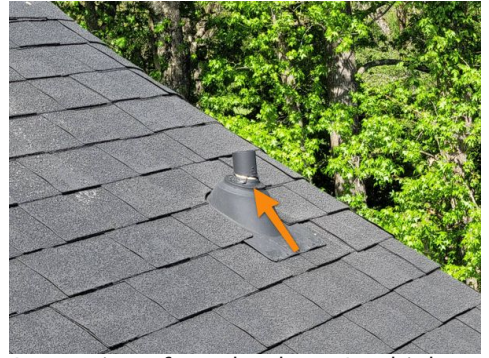
Separation of another boot (multiple locations)

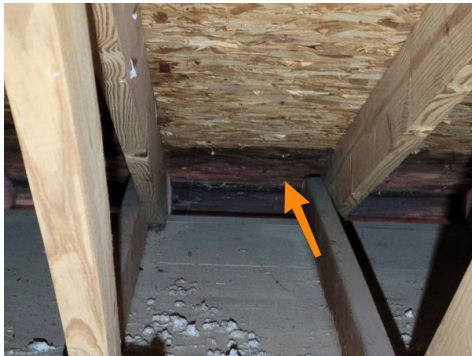
Front porch

### MOISTURE STAINS

Stains were visible in one or more areas. The stains may be caused by a past leak. Recommend asking the property owner(s) about past leaks. The client(s) should monitor these areas in the future, especially after heavy rains, to determine if active leaks exist. If leaks are found, a qualified roofing contractor should evaluate and repair as necessary.

Contact a qualified professional.

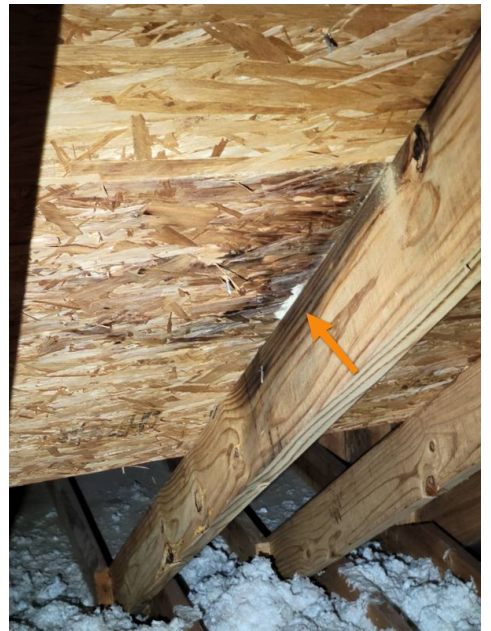
Multiple locations

#### 4.1.2 Roof Structure & Attic **POSSIBLE MOLD AND/OR MILDEW**

A possible source of moisture is the bathroom exhaust venting into the attic.

Recommendation  
Contact a qualified professional.

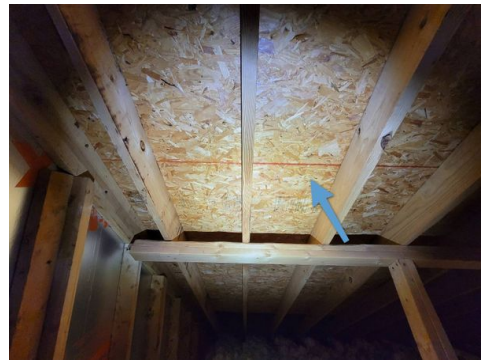
#### 4.1.3 Roof Structure & Attic **NO H-CLIPS**

There were no h-clips installed between the edges of the roof sheathing. The lack of h-clips decreases the stiffness and the ability of the roof sheathing to withstand vertical forces at or near the edges of abutting roof sheathing.

Recommendation  
Contact a qualified roofing professional.

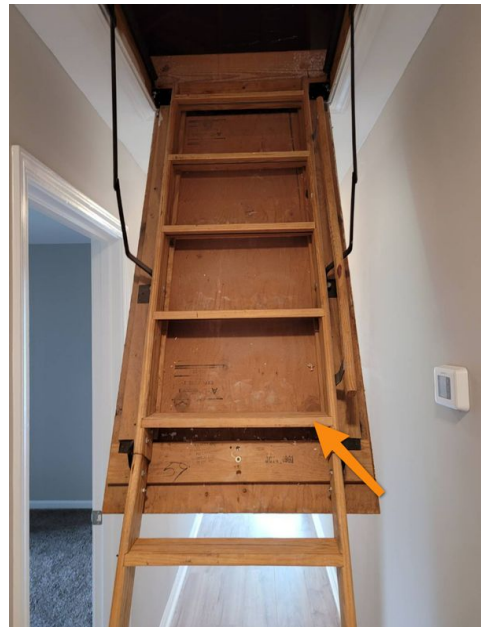
#### 4.2.1 Attic Ladder & Attic Access **ATTIC DOOR NOT INSULATED**

The attic door was not insulated. This leads to increased heat transfer and lower energy efficiency.

Recommendation  
Contact a qualified professional.

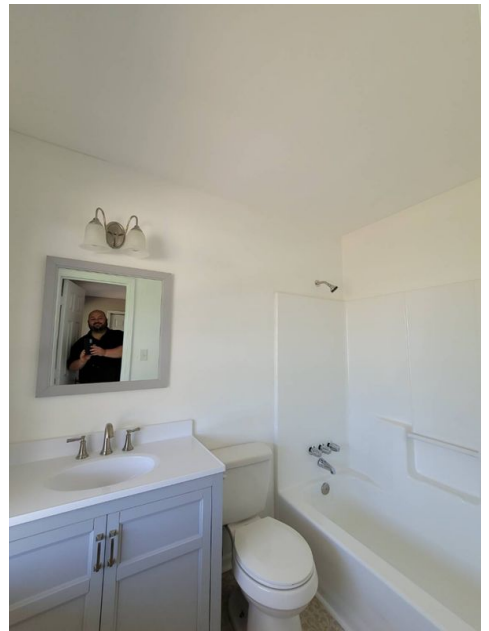
Front center bedroom attached bathroom

4.5.1 Exhaust Systems  
**NO VENTILATION IN BATHROOM**

There is no ventilation in the bathroom other than a window. Install an exhaust fan or ventilation system that discharges to the exterior.

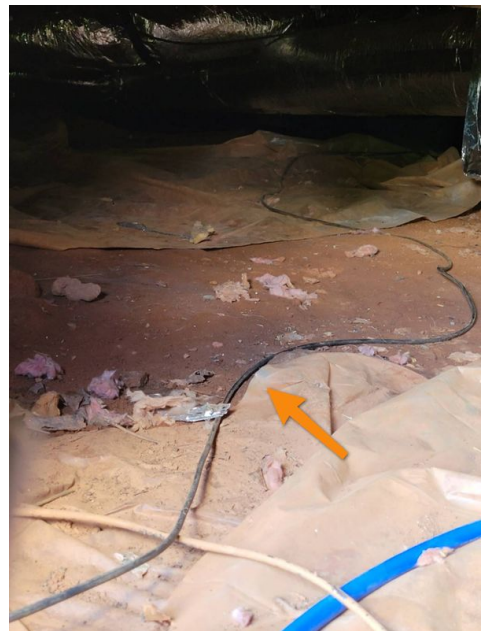
Multiple locations

4.6.1 Vapor Retarders (Crawlspace or Basement)  
**IMPROPER INSTALLATION**

Vapor barrier is improperly installed. This can result in unwanted moisture. The inspector recommends having a qualified insulation contractor evaluate and repair.

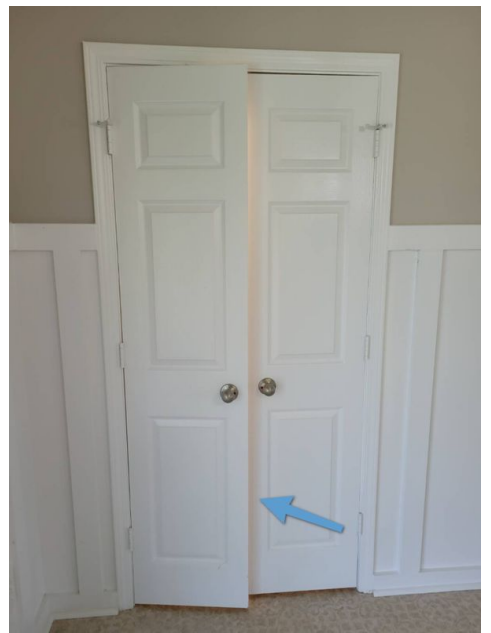
Laundry

**DOOR DOESN'T LATCH**

Door doesn't latch properly.

Contact a handyman or DIY project

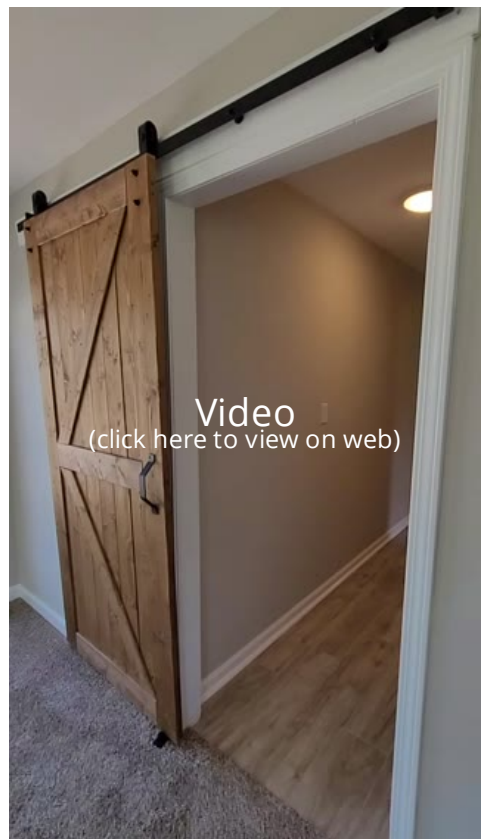
**NON-PROFESSIONAL INSTALLATION**

Multiple doors appeared to have been installed by persons lacking adequate skills.

Contact a qualified professional.

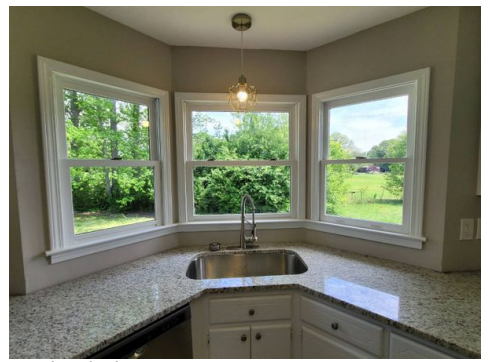
Multiple locations

## OPERATION DIFFICULT

One or more windows throughout the home were difficult to operate. Adjust/repair as needed.

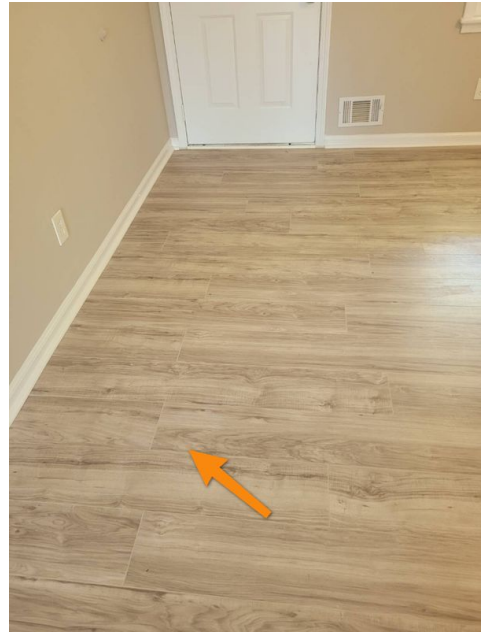
## FLOORING - SOFT AND/OR EXCESSIVE MOVEMENT

Flooring was soft and/or moved excessively when pressure was applied. This could be the result of deteriorated floor sheathing/structure, fastener failure, or foundation degradation.

Lifted flooring

Contact a qualified professional.

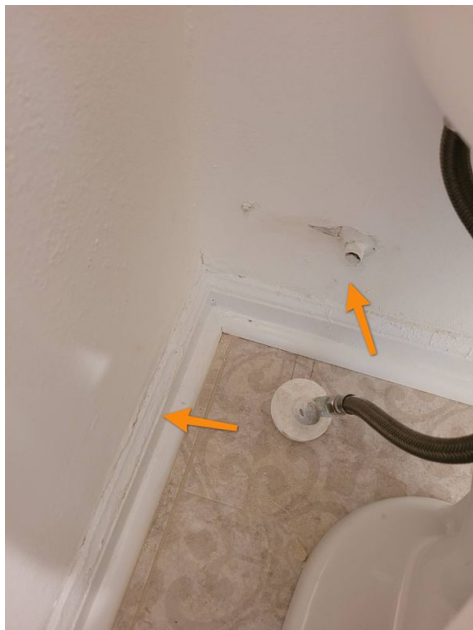
Multiple locations

### POOR INSTALLATION PRACTICES

Wall covering exhibited signs of poor installation practices.

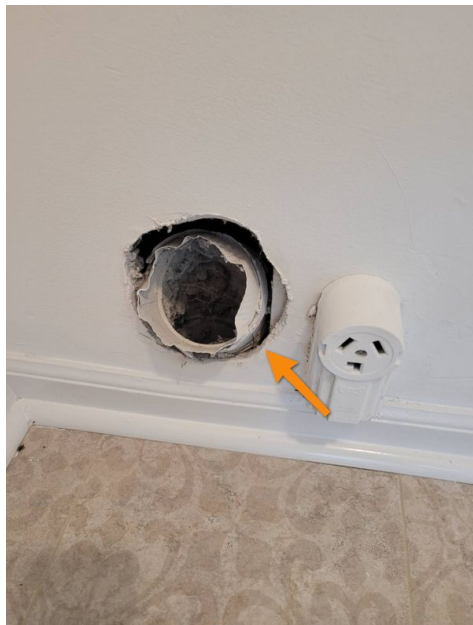
Dryer vent recessed and not sealed off to crawl

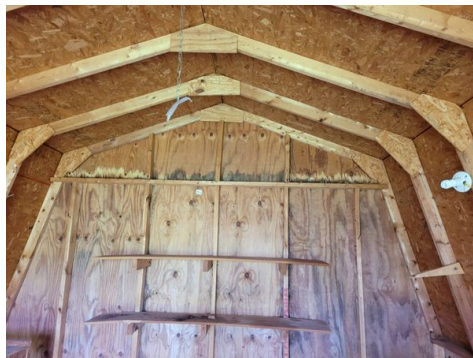
Detached building

### MOISTURE DAMAGE- ACTIVE LEAKS

Stains on the walls were visible at the time of the inspection appeared to be the result of moisture intrusion. The moisture meter showed elevated moisture levels in the affected areas at the time of the inspection, indicating that the leakage has been recent. The Inspector recommends consultation with a qualified contractor to discuss options and costs for correction and repair.

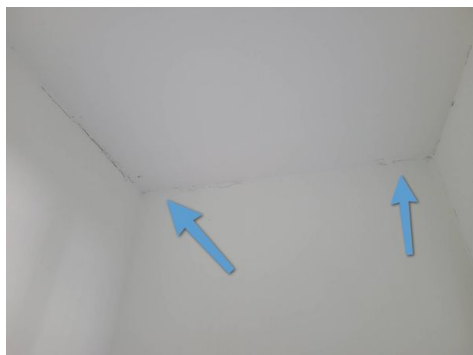
Master Closet

### CEILING DAMAGE

General damage to the ceilings was visible at the time of the inspection.

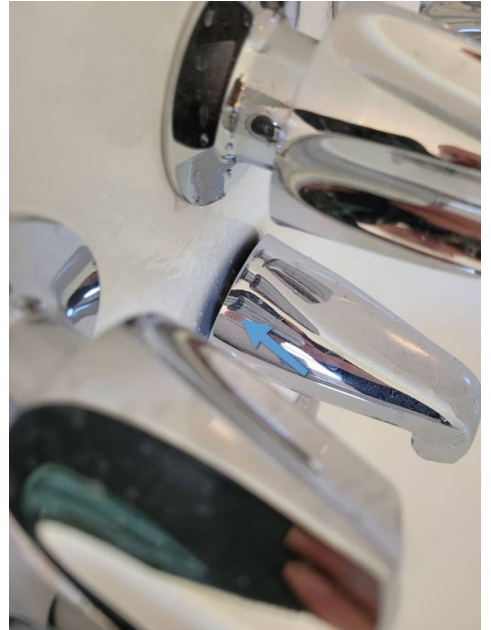
Multiple locations

**SEALANT MAINTENANCE**

Sealant maintenance is recommended around tubs, showers and sinks to prevent moisture intrusion.

Recommendation  
Recommended DIY Project

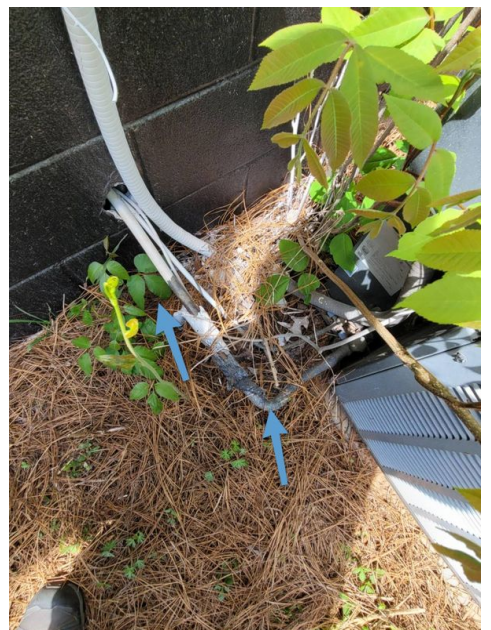
6.1.1 Cooling Equipment  
**INSULATION MISSING OR DAMAGED**

Refrigerant line insulation is missing and/or damaged. Missing or damaged insulation on refrigerant lines can cause energy loss and condensation buildup - leading to moisture intrusion. Recommend repair area of concern by owner or hvac contractor.

Recommendation  
Contact a qualified HVAC professional.

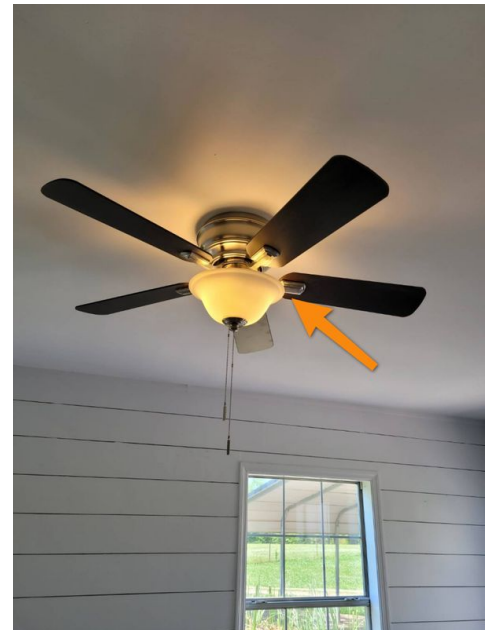
Master

#### **INOPERABLE**

The ceiling fan was inoperable at the time of the inspection. It might be operated by a remote control which was not found during the inspection.

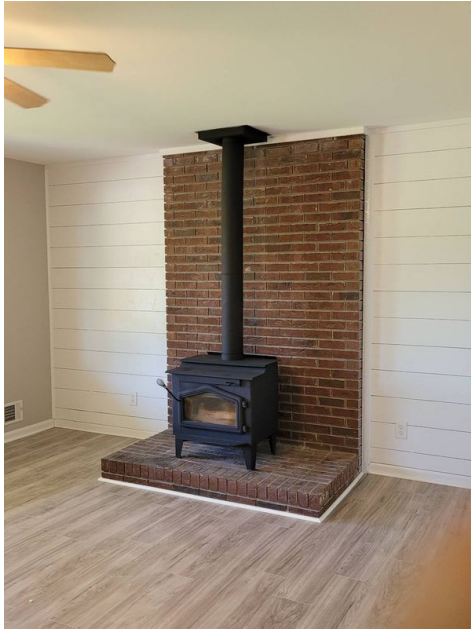
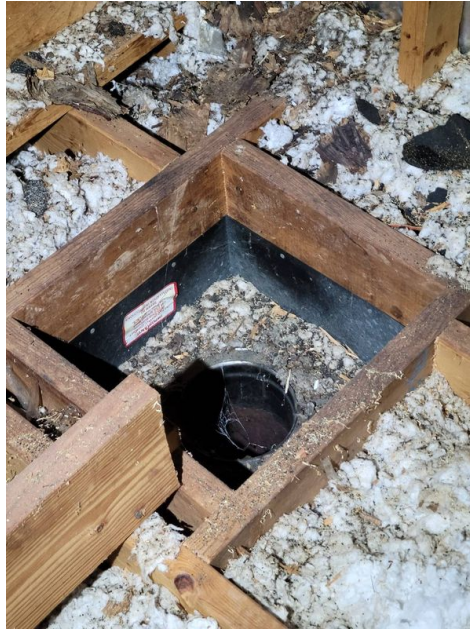
### VENTED INTO ATTIC

The wood burning stove was vented directly into the attic. This is a fire hazard and should be remedied immediately.

Recommendation  
Contact a qualified professional.

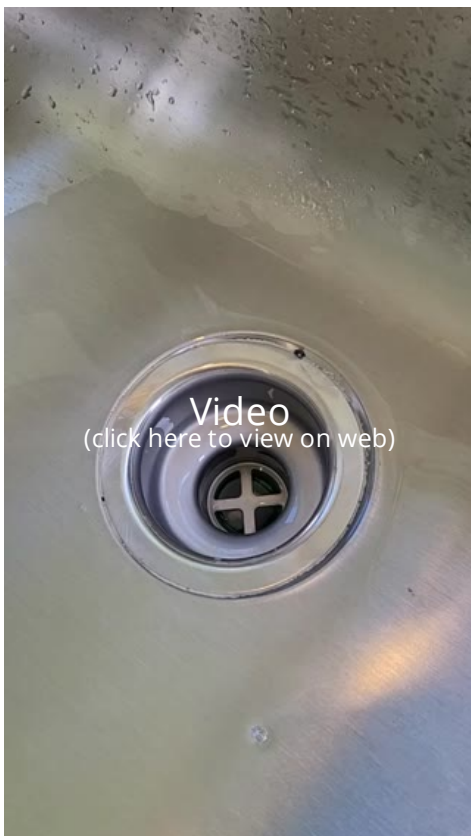
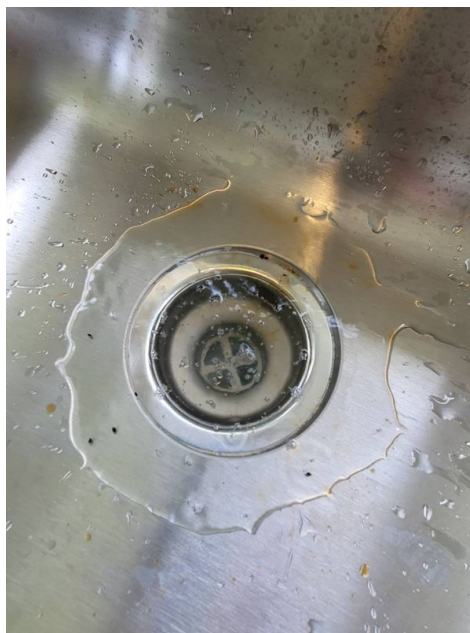
### CLOGGED DRAIN

One or more drain lines were clogged at the the time of inspection. Recommend a licensed plumber for further evaluation.

As dishwasher drains

Recommendation  
Contact a qualified plumbing contractor.

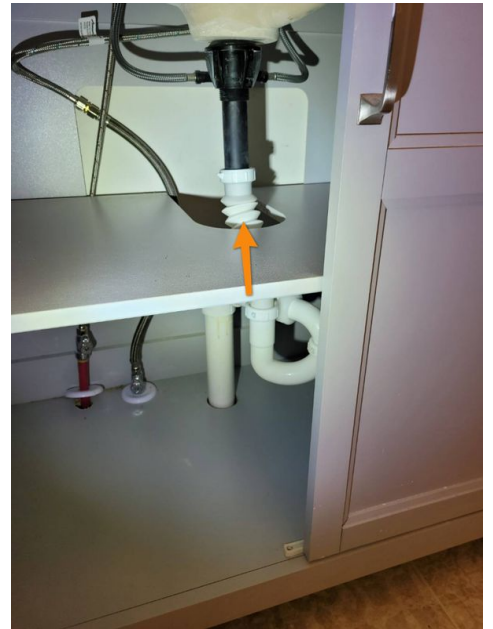
Multiple locations throughout

**FLEXIBLE DRAIN PIPE**

Ribbed, flexible drain pipe was used at one or more locations of the drain system. This type of drain pipe accumulates debris more easily than smooth wall pipe and is likely to clog. Recommend that a qualified plumber replace flexible piping with standard plumbing components (smooth wall pipe) to prevent clogged drains.

Recommendation  
Contact a qualified plumbing contractor.

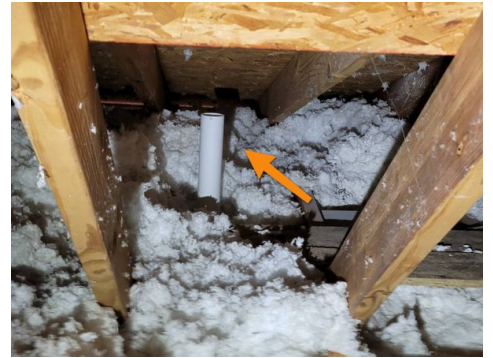
**PLUMBING VENT IN ATTIC**

One or more plumbing vents were routed into the attic instead of through the roof. This allows moisture into the attic and should be extended through the roof by a licensed professional.

Recommendation  
Contact a qualified professional.

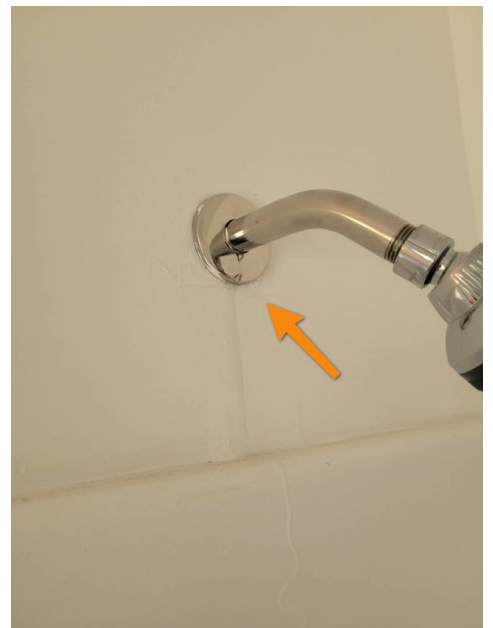
Front center bedroom attached bathroom

**DISTRIBUTION PIPE LEAKING**

Actively leaking water distribution pipes visible and should be repaired by a qualified plumbing contractor to avoid damage to home materials or the development of conditions which encourage the growth of microbes such as mold.

Recommendation  
Contact a qualified plumbing contractor.

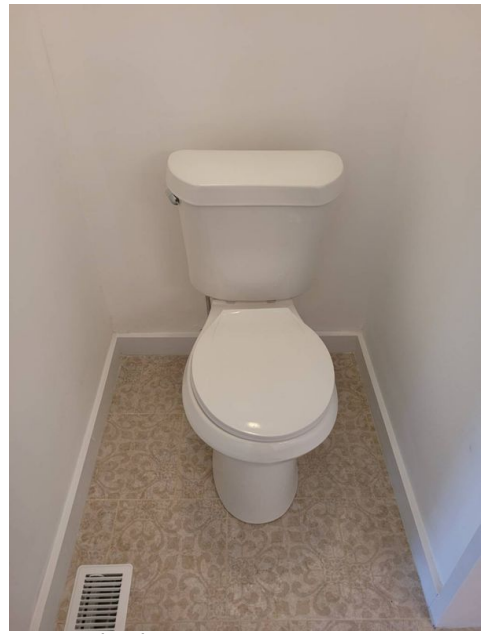
Master bath

### TOILET TANK LOOSE

One or more toilet tanks are loose where the tank meets the bowl. Secure as needed.

Recommendation  
Contact a qualified professional.

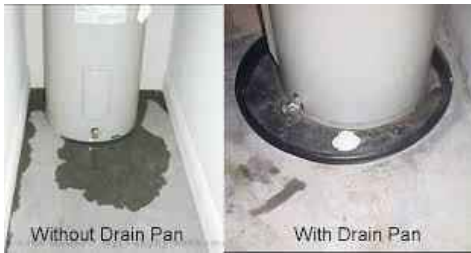
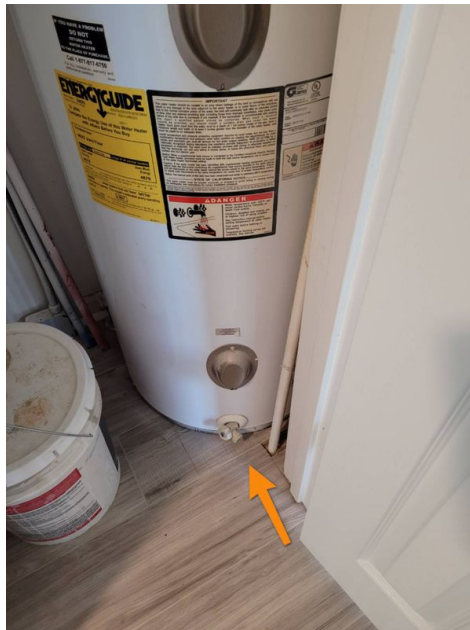
### NO DRIP PAN

No drip pan was present at the water heater.

Not required, but good idea

Recommendation  
Contact a qualified plumbing contractor.

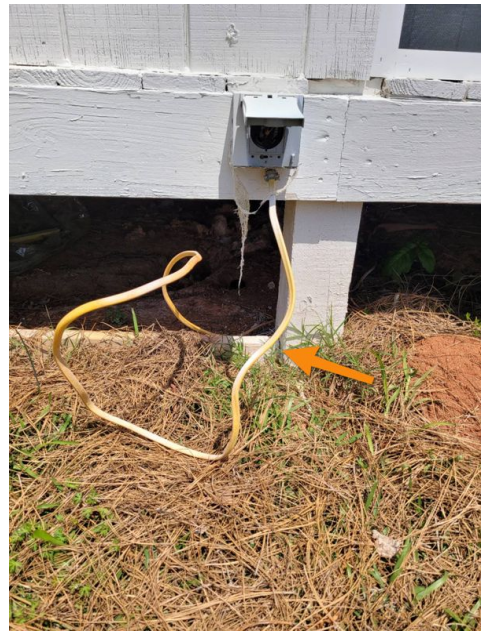
### WIRE OUTSIDE OF CONDUIT

One or more sections of wiring were exposed and subject to damage. This is a potential shock hazard. Recommend that a qualified electrician repair per standard building practices. For example, by installing conduit, re-routing wires or replacing wiring.

Back porch. Hot!

Contact a qualified electrical contractor.

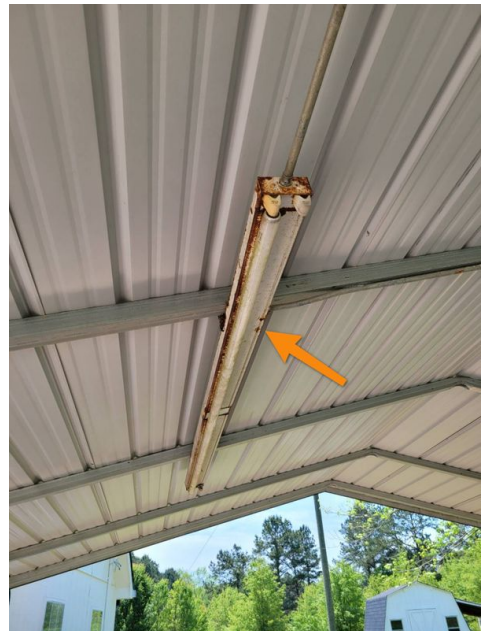
Both carport lights

### LIGHT INOPERABLE

Light fixture did not respond to the switch. The bulb may need to be replaced or there may be a problem with the switch, wiring or light fixture.

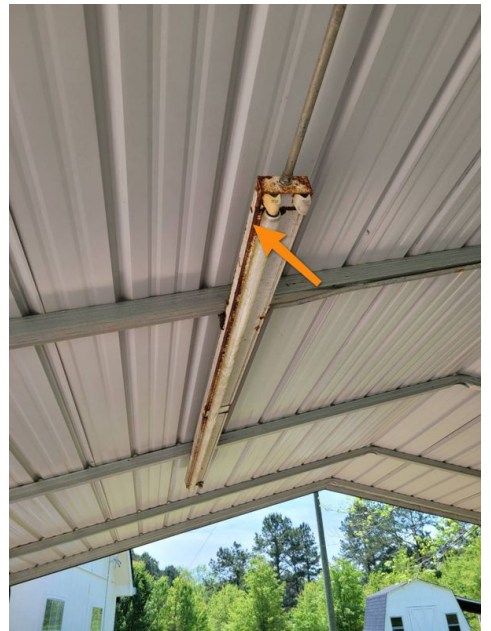
**DAMAGED/LOOSE LIGHT FIXTURE**

A light fixture showed visible damage or was not secure at time of inspection.

Rust on carport fixtures

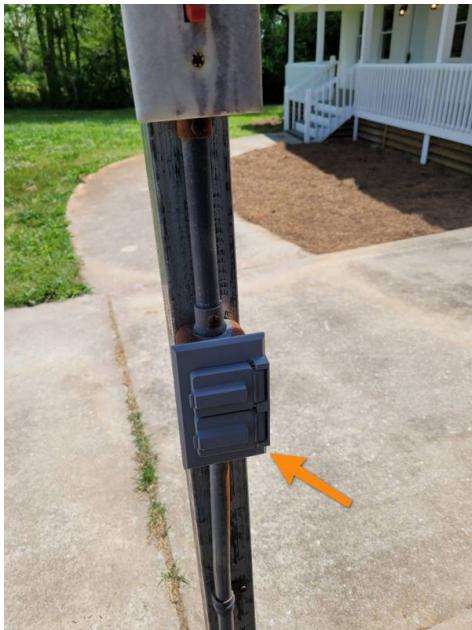
Carport

**INOPERABLE RECEPTACLE(S)**

An electrical receptacle was inoperable at the time of the inspection.

Contact a qualified electrical contractor.

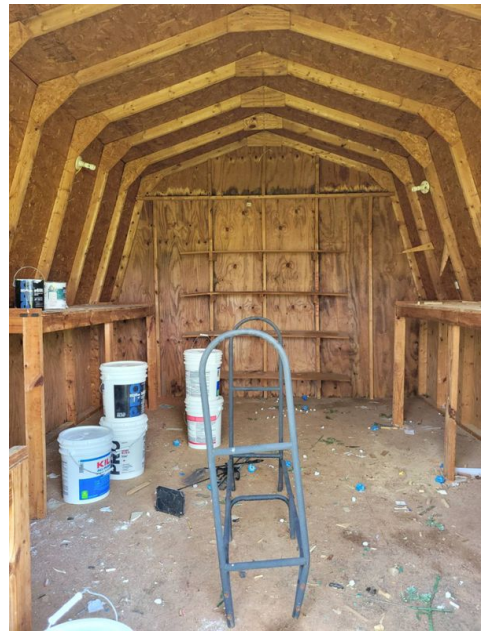
8.3.4 Lighting Fixtures, Switches & Receptacles  
**NO POWER TO DETACHED BUILDING**

The detached building did not have power at time of inspection.

Contact a qualified professional.

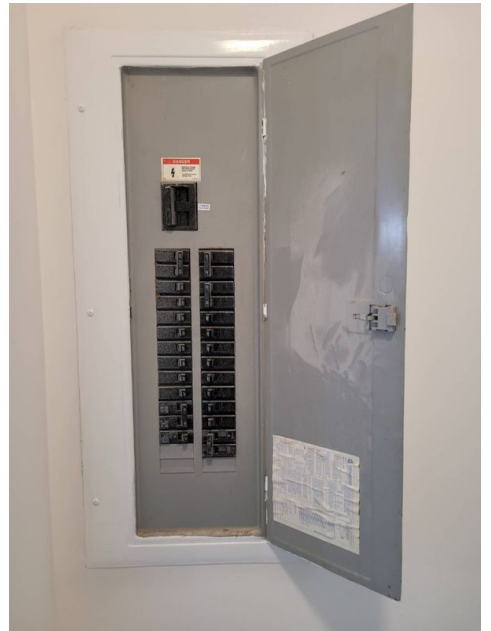
Challenger

**FEDERAL PACIFIC, SYLVANIA, OR CHALLENGER PANEL**

While it appears to be in good condition, the electrical panels would be an item to consider upgrading and/or having a licensed electrician evaluate to ensure all components are in safe, working order.

These panels have been recalled due to fire hazard issues and may require replacement before the home can be insured. Refer to your insurance agency for further details.

Contact a qualified electrical contractor.

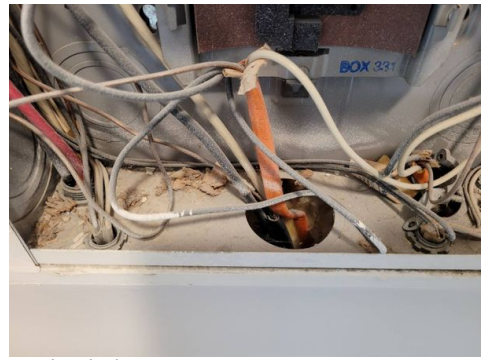
Multiple locations

**MISSING BUSHING**

Missing bushings should be repaired by a licensed electrician.

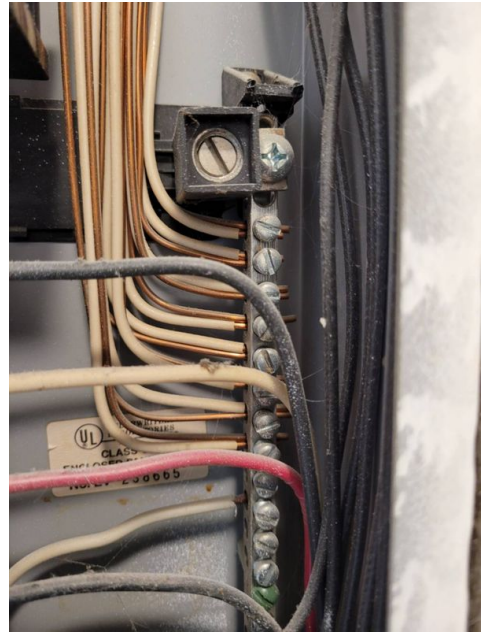
**DOUBLE TAPPED NEUTRALS**

There were lug(s) on the neutral/ground bus bar that have more than one neutral wire connected to them. Each neutral wire should be attached to a separate lug to ensure a proper physical connection and to make sure that each circuit can be worked on independently. Recommend to have this corrected.

Multiple locations. Neutrals with ground under same lug

Contact a qualified electrical contractor.

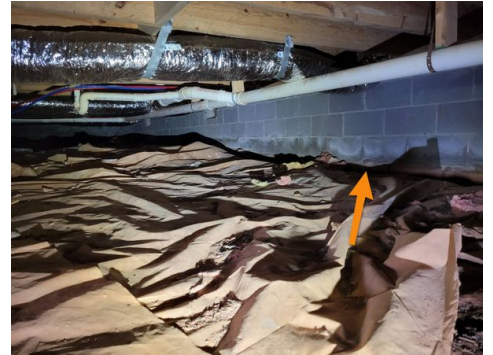
Multiple locations

## WATER INTRUSION

Water intrusion was evident on the surface of the floor slab or in the basement/crawlspace. This can compromise the soil's ability to stabilize the structure and could cause damage.

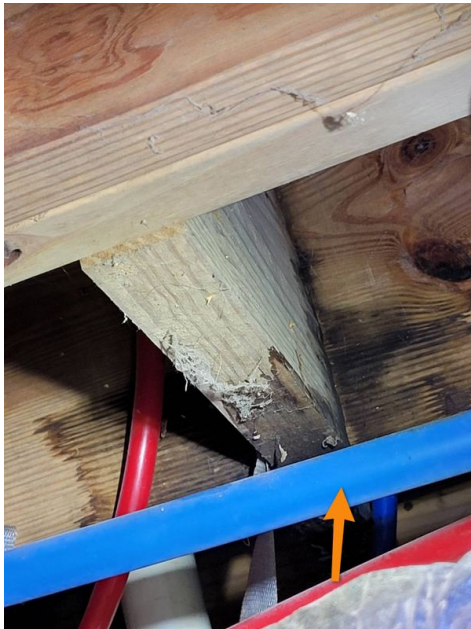
## EVIDENCE OF WATER INTRUSION

There were signs of water intrusion in the underlying floor structure.

Multiple locations. Previous water damage

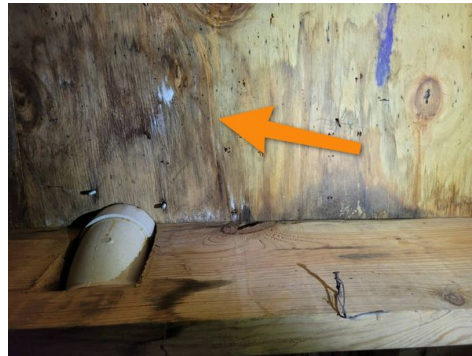
Multiple locations. Previous water damage

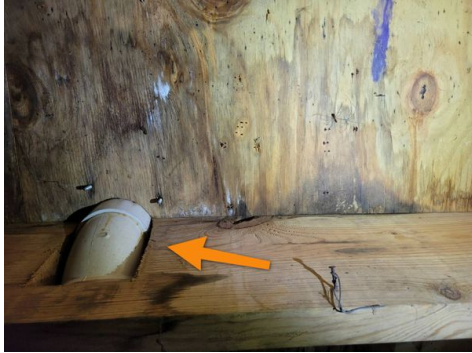
10.2.2 Floor Structure  
**JOISTS NEED REPAIR**

One or more floor joists were damaged or improperly installed. This can cause damage to the structural integrity of the home.

Multiple joists cut for plumbing

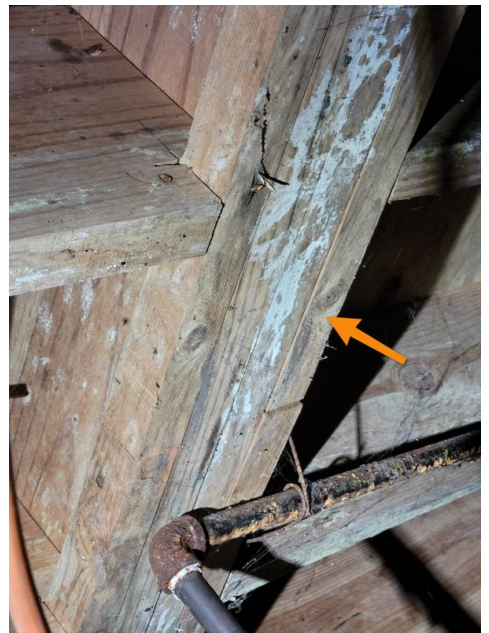
Multiple locations

10.2.3 Floor Structure  
**MOLD/MILDEW**

Observed signs of mold or mildew in one or more areas of the structure.

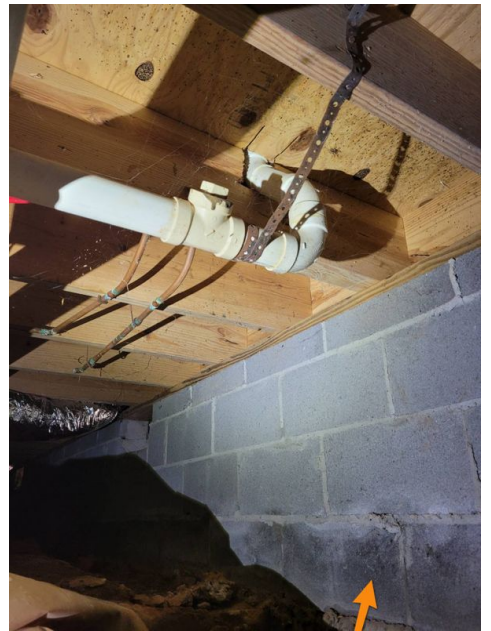
Multiple locations

**EFFLORESCENCE**

Efflorescence noted on the basement or crawl space surfaces.

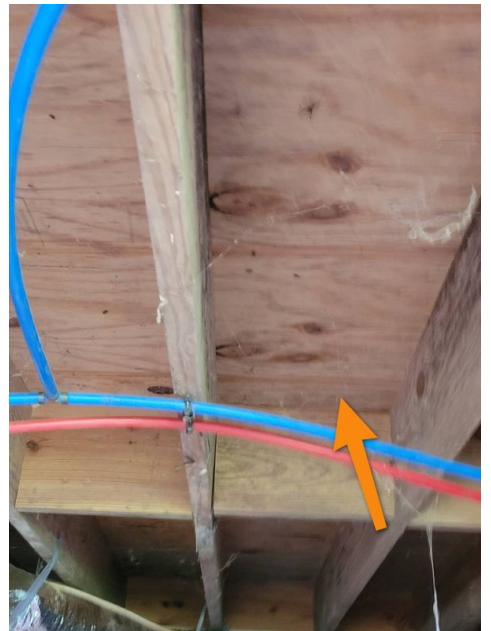
**DAMAGED OR MISSING INSULATION**

At time of Inspection, one or more areas of insulation were falling, damaged, or missing. Recommend repairing or replacing

None present

Recommendation  
Contact a qualified professional.

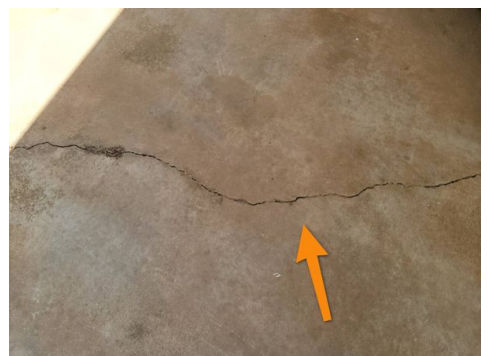
Multiple locations

**SETTLEMENT**

Carport exhibits signs of settlement. As it is poured independently of the foundation, this is not a structural concern.

Recommendation  
Contact a qualified professional.
