CONDITION ASSESSMENT OF LARGE DIAMETER CAST IRON OUTFALL PIPES UNDER PIERS 33 & 35 IN THE SAN FRANCISCO BAY

JDH CORROSION CONSULTANTS, INC.

12/7/2017

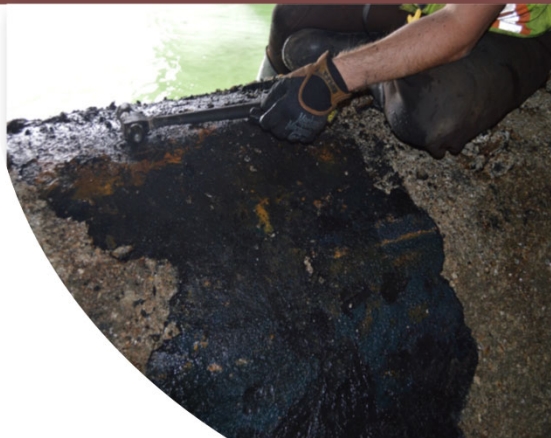
MARINE GROWTH REMOVAL

REMOVAL OF MARINE GROWTH AND MORTAR COATING TO PERFORM INSPECTION ON EXTERIOR OF OUTFALL PIPELINE.

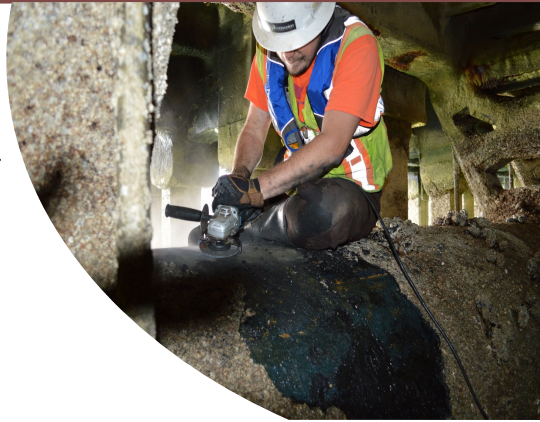
EXTERNAL VISUAL INSPECTION

- MARINE GROWTH & MORTAR COATING WAS REMOVED
- 1/6TH – 1/8TH INCH LAYER OF GRAPHITIZATION WAS FOUND
- NO SIGNIFICANT PITTING WAS OBSERVED
- THE PIPES WERE FOUND TO BE IN FAIR EXTERNAL CONDITION

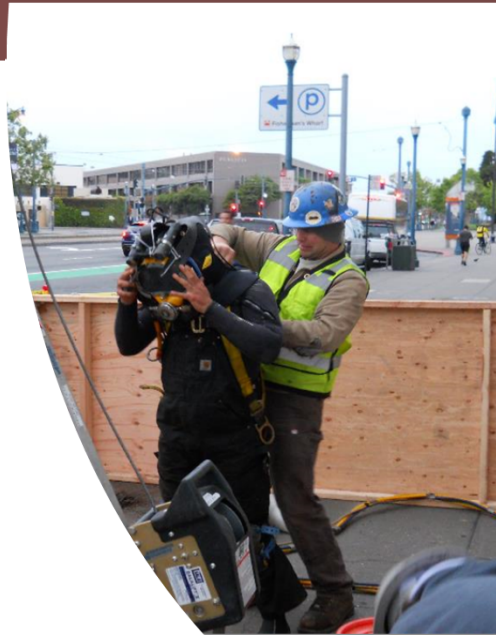
INTERNAL VISUAL INSPECTION WITH DIVER'S ASSISTANCE

- DIVERS WORKED ON THE DIRECTIONS OF OUR TEAM
- OUR TEAM VIEWED THE PROGRESS VIA DIVER WORN VIDEO CAMERAS
- DIVERS CHECKED FOR:
 - SEDIMENT & DEBRIS LEVEL
 - DEGREE & EXTENT OF CORROSION
 - PIPE JOINT GAP DISTANCE
 - CONDITION OF MORTAR LINING
 - IDENTIFY CORRODED AREAS TO BE UT TESTED FROM THE OUTSIDE
- A SIGNAL TRANSMITTER PINPOINTED THE LOCATION OF DIVERS FOR UT TESTING FROM OUTSIDE
- THE PIPE INTERIOR SURFACES WERE FOUND TO HAVE SIGNIFICANT CORROSION AND PITTING AS WELL AS LOSS OF MORTAR LINING

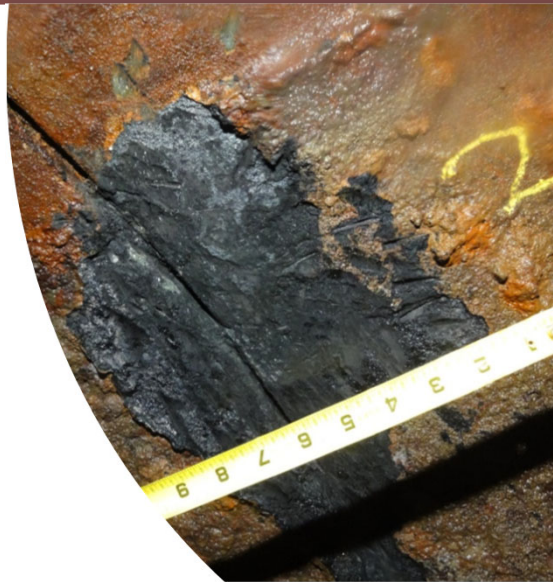
INTERIOR GRAPHITIZATION

GRAPHITIZATION
VISIBLE ON INTERIOR
OF OUTFALL PIPELINE

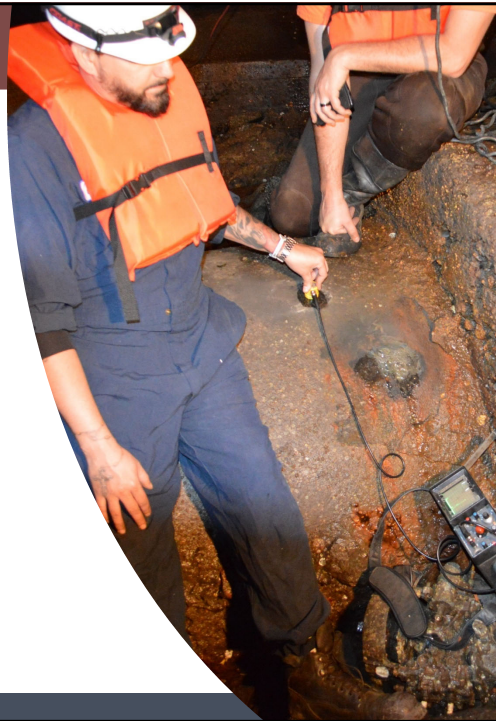
ULTRASONIC THICKNESS (UT) TESTING

WALL THICKNESS WAS MEASURED FROM THE EXTERIOR OF THE PIPE BECAUSE EXPOSURE TO SEA WATER WAS CAUSING THE PIPE TO CORRODE MORE RAPIDLY FROM EXTERIOR.

THE AVERAGE THICKNESS OF THE PIPE 1.45" WITH A MINIMUM THICKNESS OF 0.98"

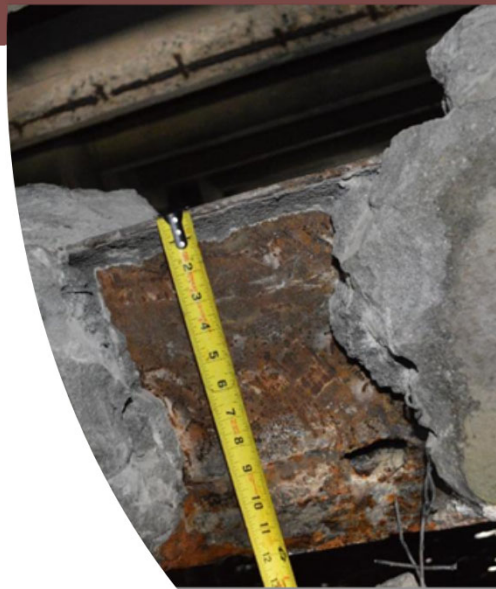
**PIER 33 B SOUTH PIPE
LONGITUDINAL BEAM
BAY 48.**

**CORROSION IS
OCCURRING ON THE
EMBEDDED C-CHANNELS
AS SHOWN AT THIS
LOCATION**

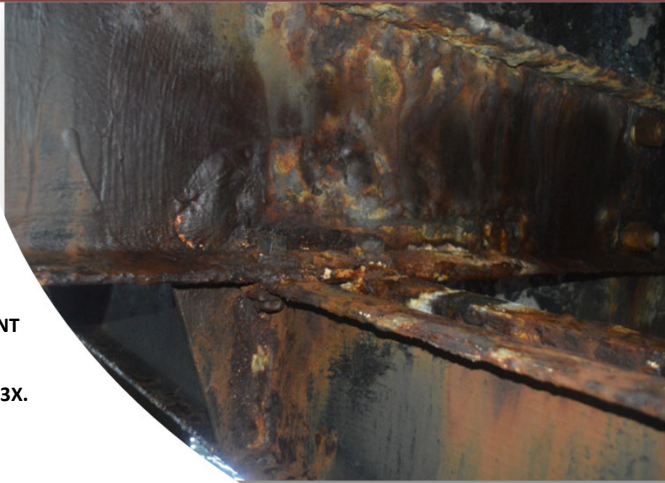
STEEL BEAMS

SEVERE CORROSION EVIDENT ON LONGITUDINAL AND TRANSVERSE BEAMS OF OUTFALL 35 A NORTH, BAY 3X. THESE BEAMS WERE ORIGINALLY COATED WITH COAL TAR EPOXY SYSTEM

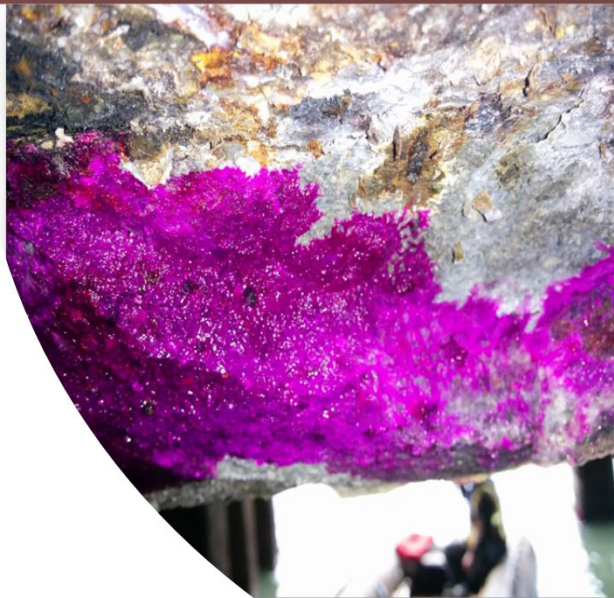
PHENOLPHTHALEIN TESTING ON LONGITUDINAL BEAM ALONG BROKEN SIDE. THE DEEP RED COLOR IS INDICATIVE OF HIGH PH, NON-CARBONATED CONCRETE
