AMPP NORCAL

jdH corrosion
CONSULTANTS, INC.

Lefty O'Doul Bridge Repair

October 14th, 2025

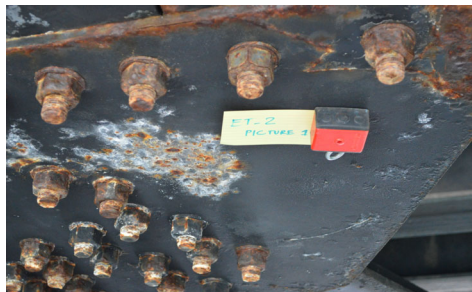
Typical Corrosion of steel plate and fasteners.

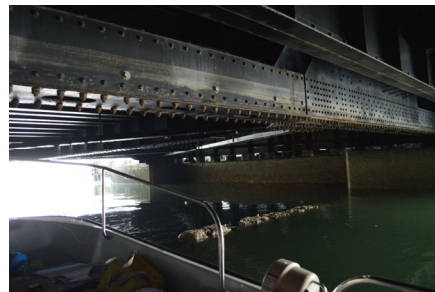
Bridge box beams, stringers, and girder.

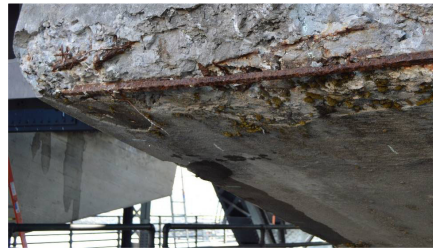
- Concrete counterweight faces were found to be generally in fair condition.
- Majority of the deterioration on the concrete counter weight occurs along the edges and where the steel girders connect to the counter weights, and along some edges where reinforcing steel has spalled concrete.
- This damage ranges from exposed steel mesh to concrete spalling with large chunks of concrete missing exposing the reinforcing steel to the elements.

- Depth of carbonation was found to be less than $\frac{1}{2}$ " at all locations tested.
