Re: Storm Related Structural Glazing Assessment

TSSA Project # [REDACTED] - 2021-10-29

Final Report Dated - 3/17/2022

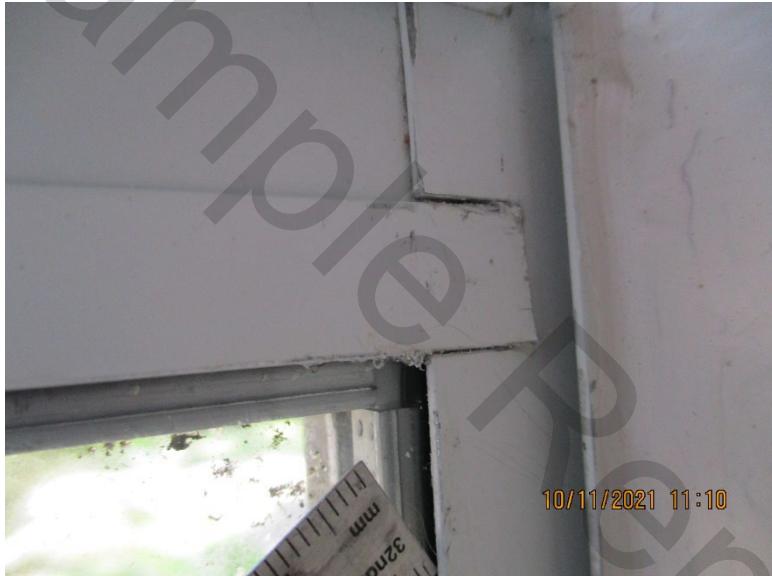
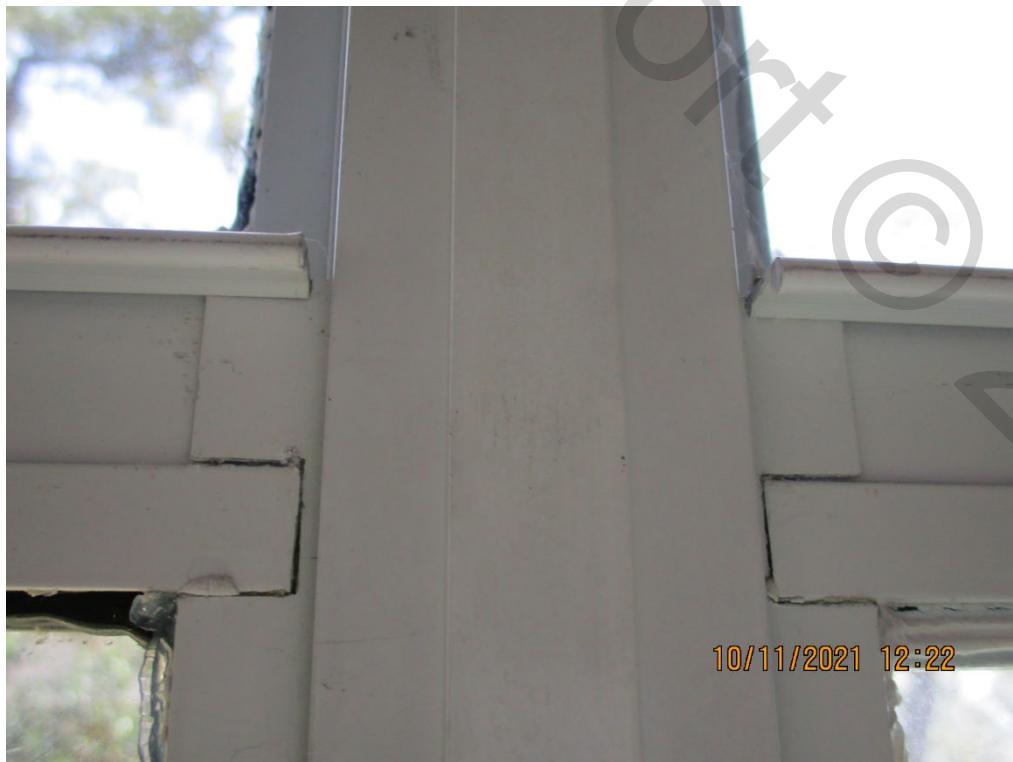
Frame Separation

During our investigation of the █ Residence, TSSA Storm Safe DAC Inc. inspectors witnessed frame separation seen at adjoined framing components of the installed Single Hung Window Systems. High wind created buffeting of the glazed systems and adverse framing system movement allowed the assembly systems to separate between adjoining frame members causing a diminishment of the window's capacity to keep a congruent envelope of protection. The glazed systems currently sit in a diminished state and are susceptible to moisture intrusion between the opened joints.

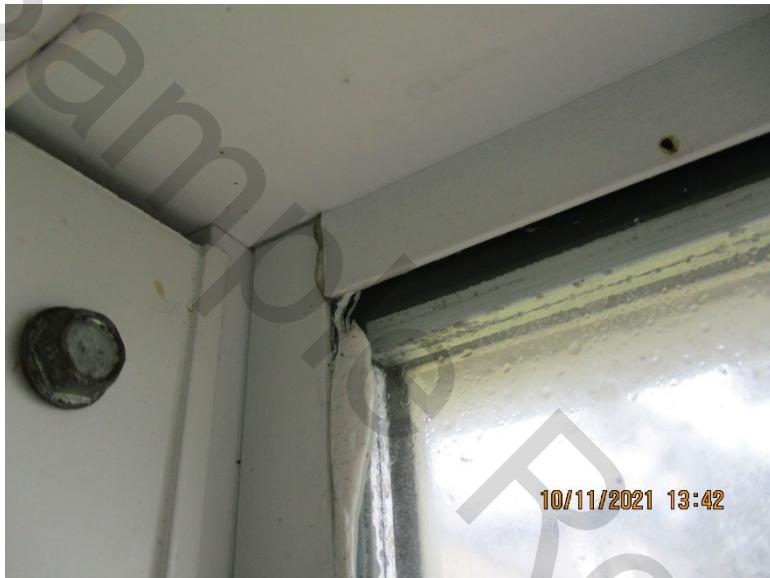
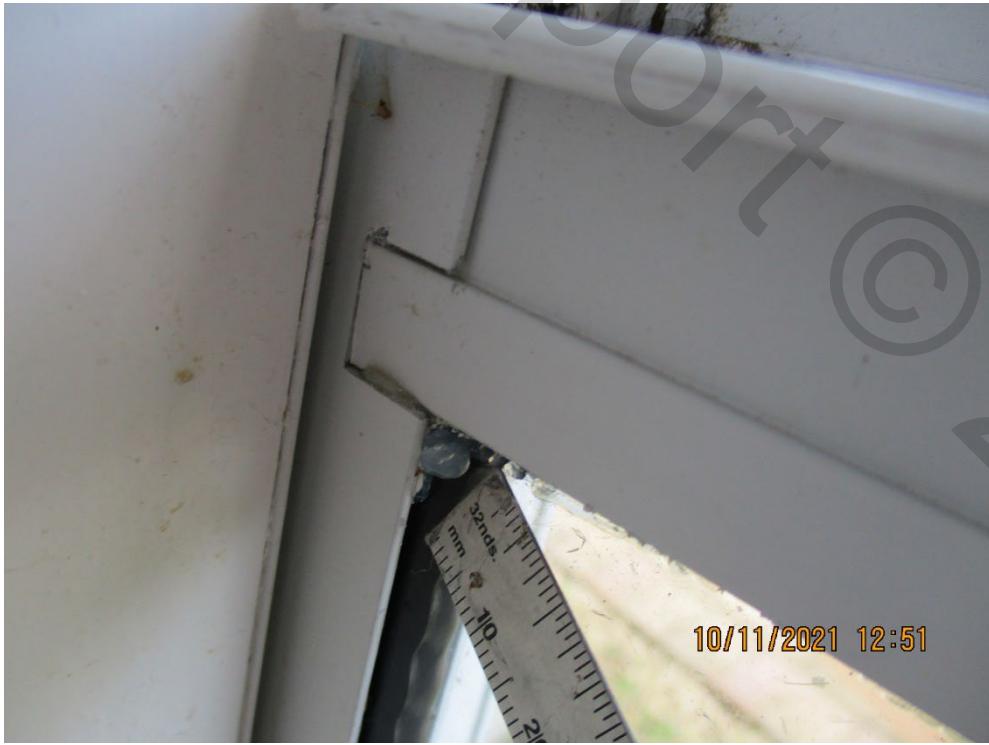
Frame Rotation

During our investigation of the █ Residence, TSSA Storm Safe DAC Inc. inspectors witnessed frame rotation seen at adjoined framing components of the installed Single Hung Window Systems. High wind created buffeting of the glazed systems and adverse framing system movement allowed the assembly systems to separate between adjoining frame members causing a diminishment of the window's capacity to keep a congruent envelope of protection. The glazed systems currently sit in a diminished state and are susceptible to moisture intrusion between the opened joints.

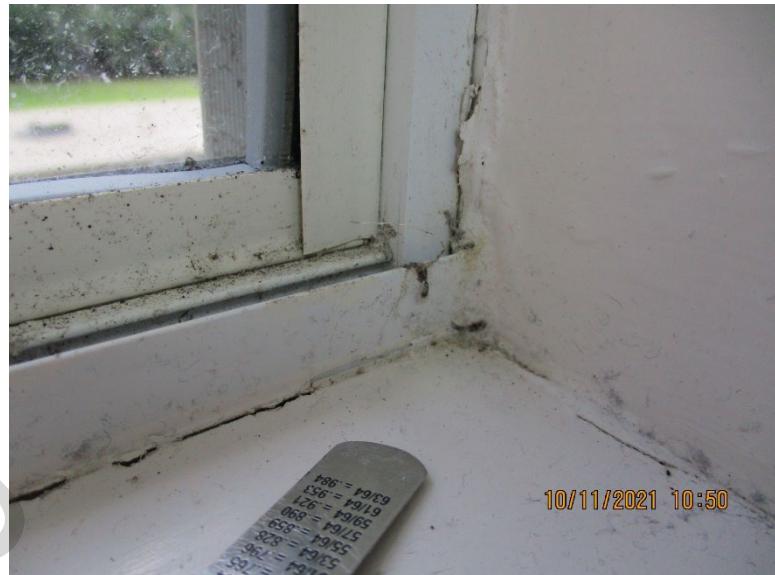
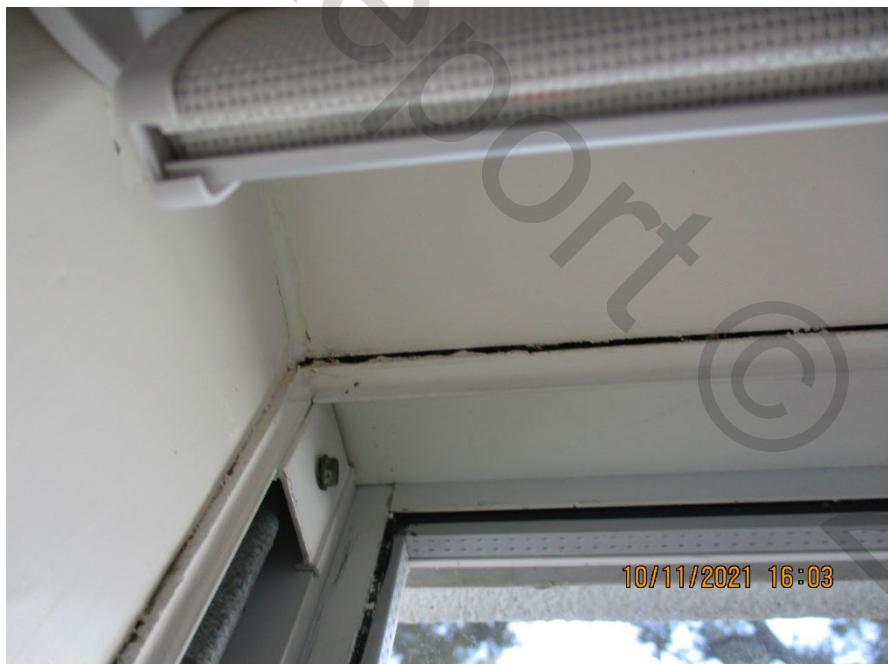
INTERIOR FINISH DISTRESS

Throughout the TSSA Storm Safe Inc. Glazing Damage Assessment of the [REDACTED] Residence, our inspectors witnessed interior finish distress. The buffeting of the systems during a high wind event allowed the glass systems to vibrate and move within their installed position. This movement affected the installation fastening system and created system movement which disrupted the interior finish between the systems framing and its interior finish reveal.

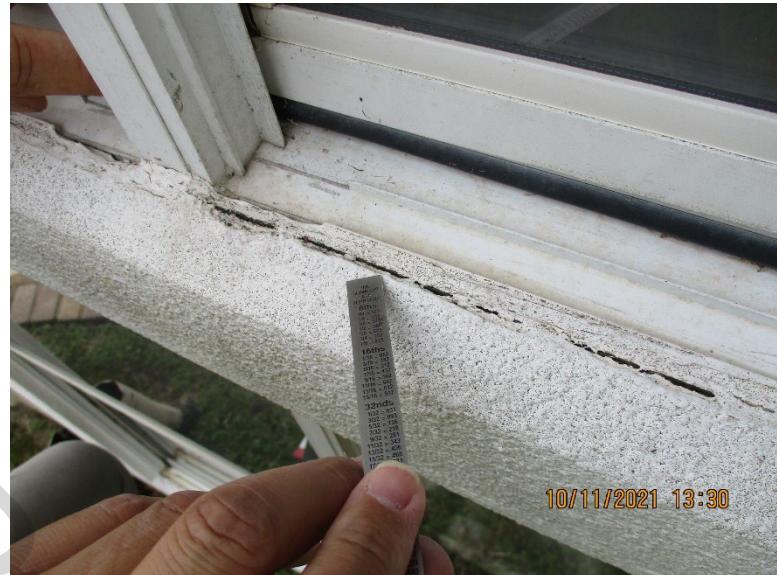
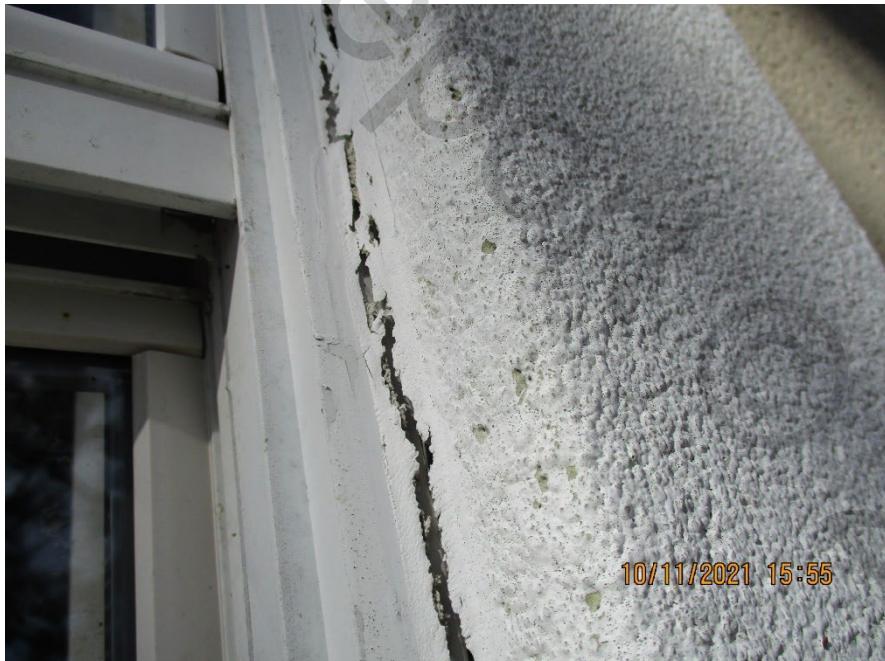
EXTERIOR FINISH DISTRESS

Throughout the TSSA Storm Safe Inc. Glazing Damage Assessment of the [REDACTED] Residence, our inspectors witnessed exterior finish distress. The buffeting of the systems during a high wind event allowed the glass systems to vibrate and move within their installed position. This movement affected the installation fastening system and created system movement which disrupted the exterior finish between the systems and its exterior finish.

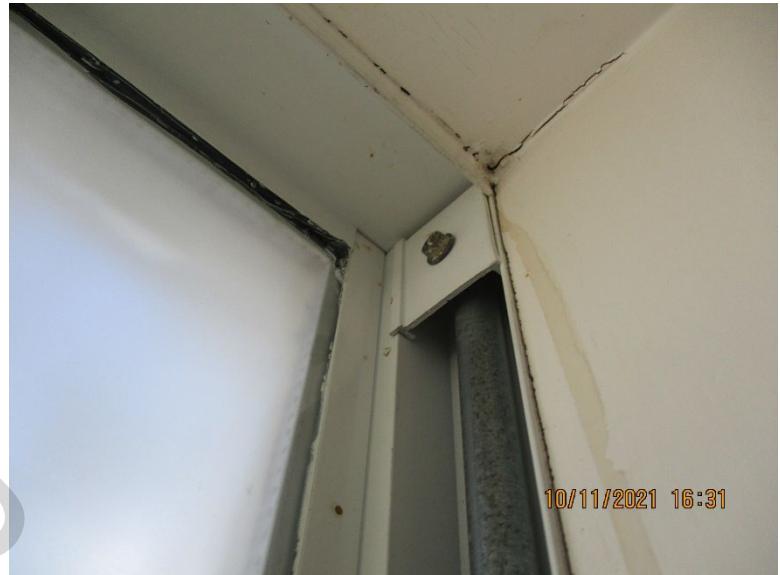
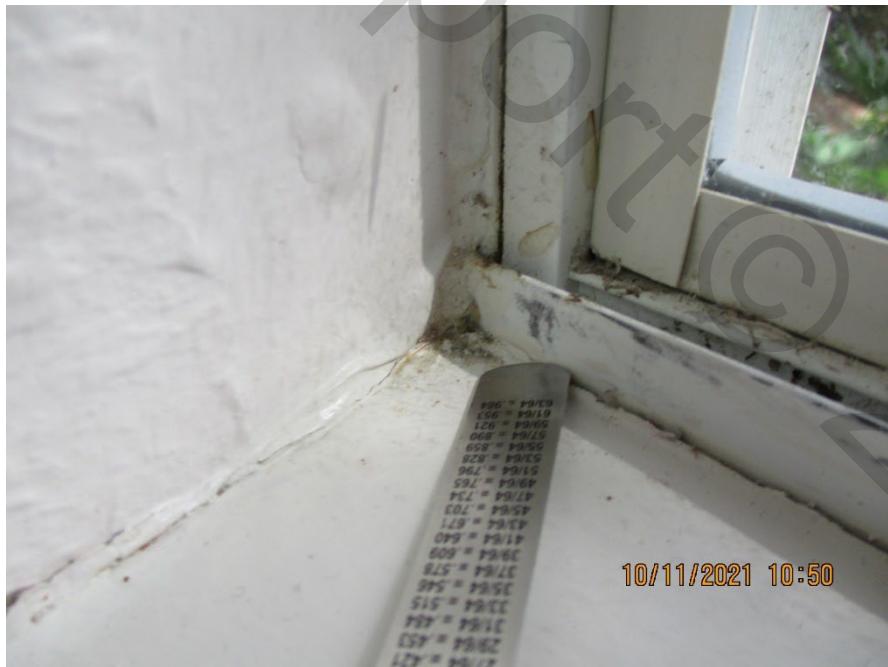
Moisture Intrusion

During our investigation of the [REDACTED] Residence, our inspectors witnessed moisture intrusion seen around the perimeter of the installed glazed systems. A combination of system movement and finish disruption allowed moisture to intrude between the installed stems and the weather barrier finding its way into the interior living space.

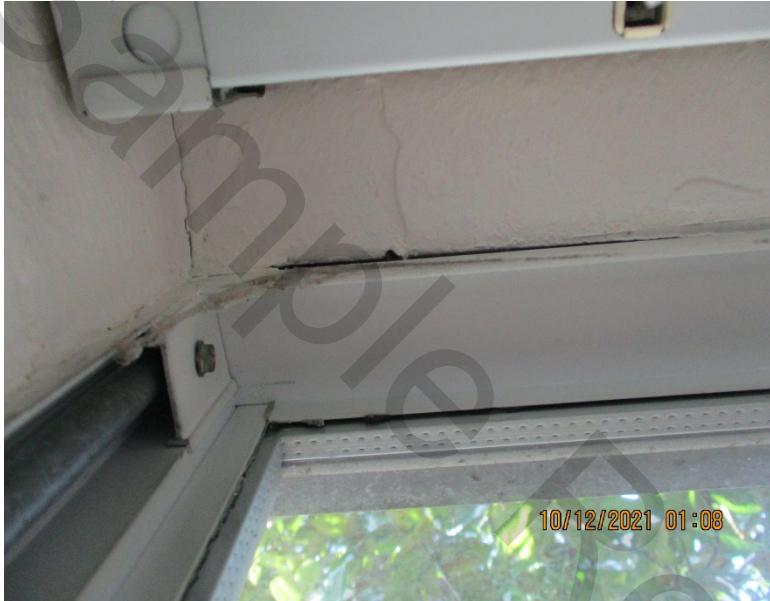
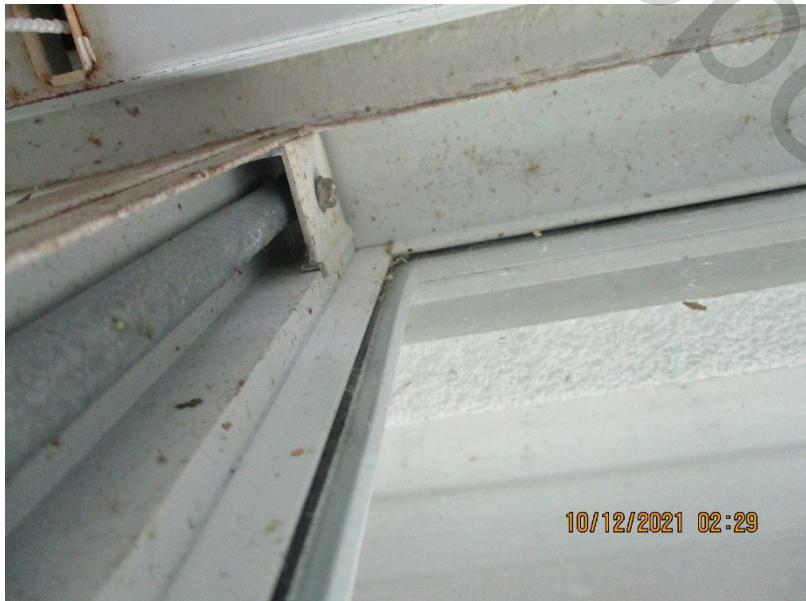
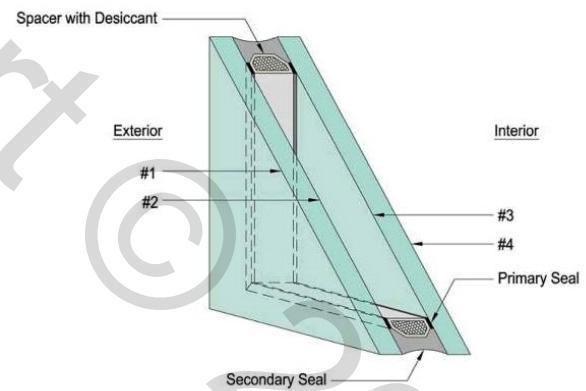
Damaged Spacer

During our investigation of the [REDACTED] Residence, our inspectors witnessed disruption of the Spacer found within the installed Insulating Glazing. Wind Buffeting and Pressure created during a high wind event effects the IGU Air Space, as well as the adherence of the IGU within its glazing pocket. Spacer Migration, Spacer Sealant Disruption, and Deglazing are all indicative of IGU glass movement and damage created during a high wind event.

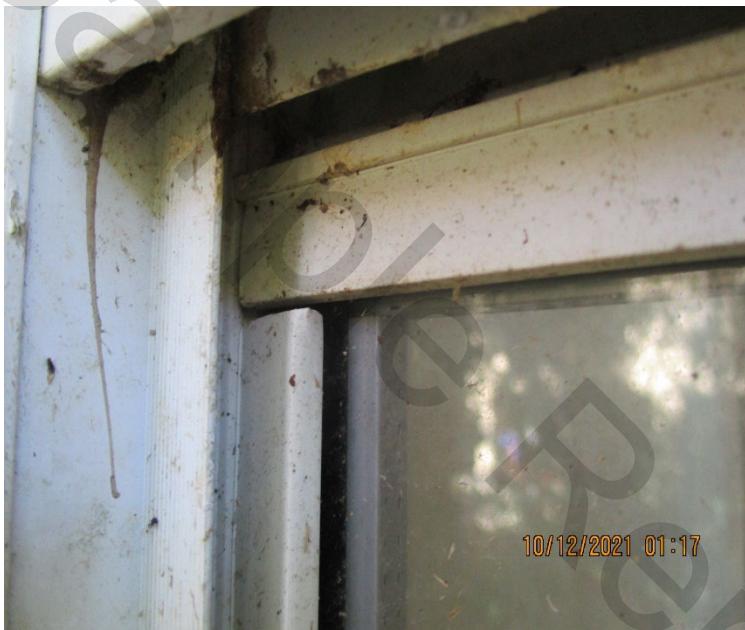
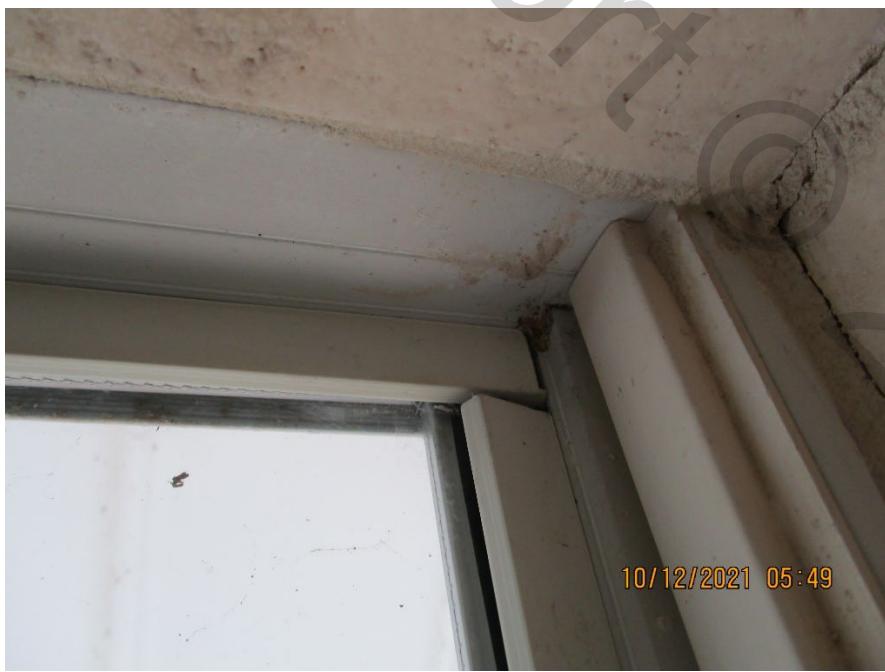
Glass Stop Damage

During our investigation of [REDACTED] Residence, our inspectors witnessed disruption of exterior Glass Stop system components. A Glass Stop a molding used to hold glazing infills in position, as well as keep the glazing pocket clean of debris. When high wind created buffeting vibrates a glass infill, the exterior glass stops become avulsed from their installed position no longer protecting the glazing channel and glass lite from the exterior elements. This damage will eventually lead to deglazing and moisture damage leaving the exterior envelope in a diminished and compromised state.

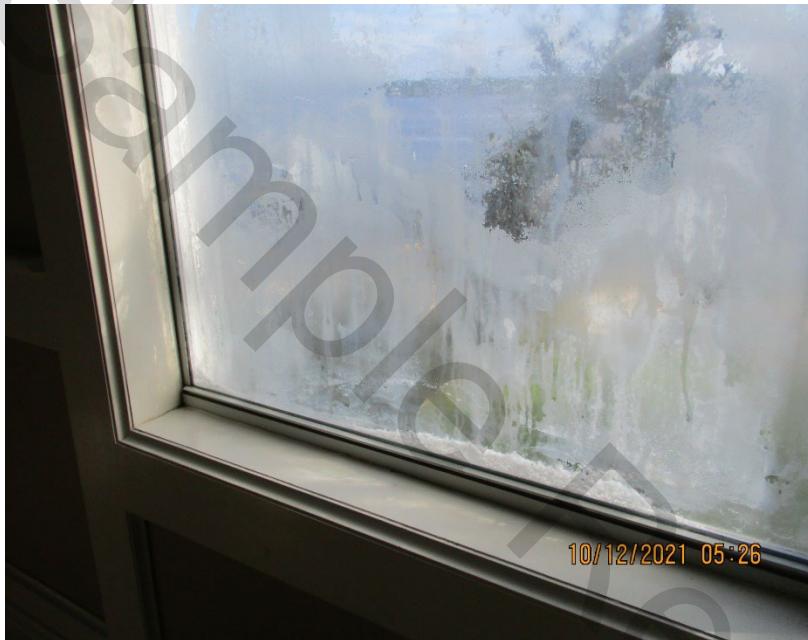
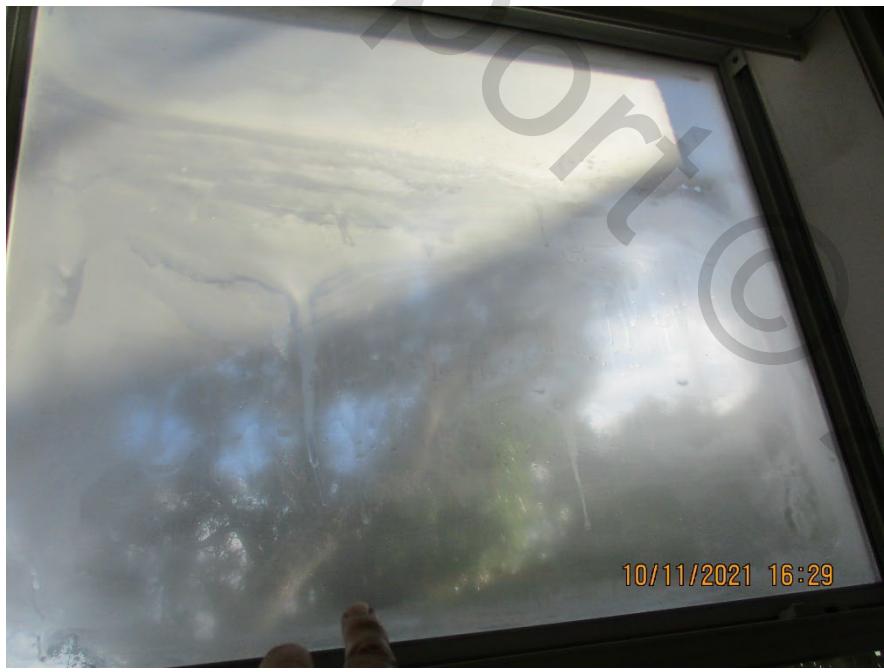
Throughout the TSSA Storm Safe Inc. Glazing Damage Assessment of the [REDACTED] Residence, our inspectors witnessed Seal Failure of the IGU "Insulated Glazing Unit." High wind buffeting, system movement, and wind-created pressure allowed the IGU to move within its installed position. This movement creates separations between the two panes of glass and the internal warm edge spacer, allowing moisture to intrude within the sealed airspace. If there is a gas fill (O₂, Argon, or Krypton) charged within the sealed air space, the Gas vacates the system, and the moisture remains. The desiccant found within the warm edge spacer is consumed by the excess moisture, which leaves the IGU in a compromised state. Eventually, internal fogging of the IGU demonstrates the seal failure damage rendering the glass pane unable to perform its function.

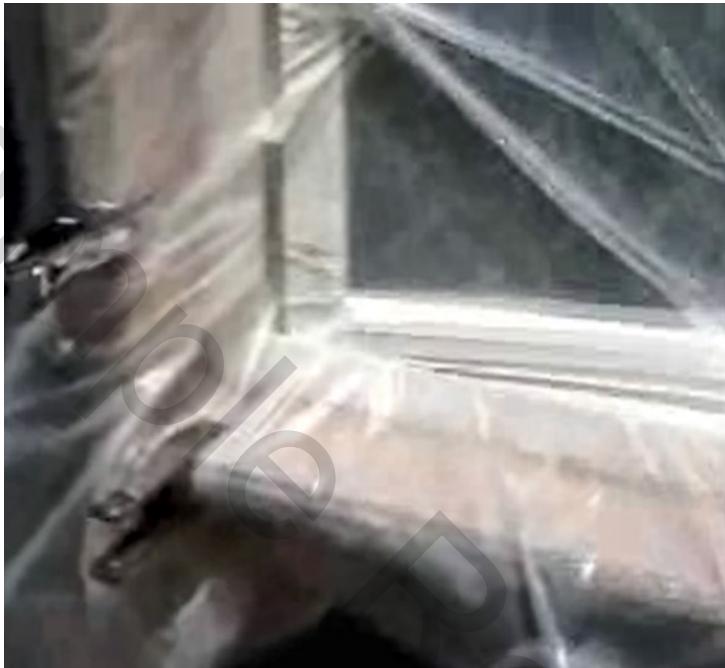
This photograph was taken during a cyclic pressure test of a single hung window system. This photograph demonstrates how high wind speed, pressure, and buffeting force affects glazed systems during a Hurricane. The rapid positive and negative cyclic movement and high wind buffeting create separations and disruptions in a window system framing joints, installation fasteners, and glazing system causing failure in the components allowing water to penetrate through the exterior building envelope into the interior living space.
