Water Penetration Forensic Investigation

FINAL – 5-5-21

## Glazing Inspection Report

[REDACTED]  
[REDACTED]  
**Tallahassee, Fl 32312**  
**FINAL - Report date 5-5-20**

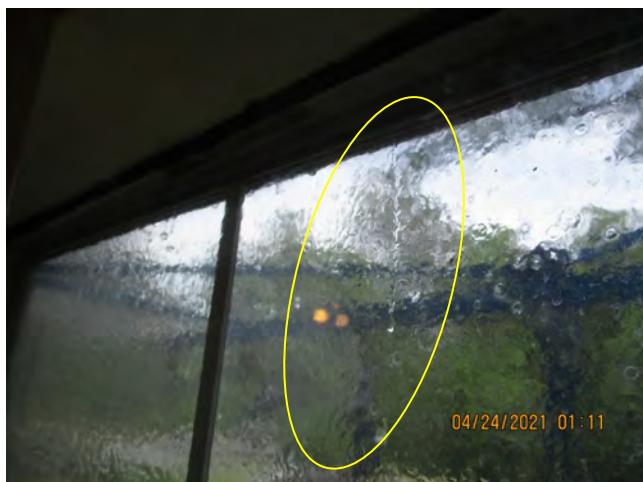
Water Penetration witnessed under the window sill – unit 917 – spec 1

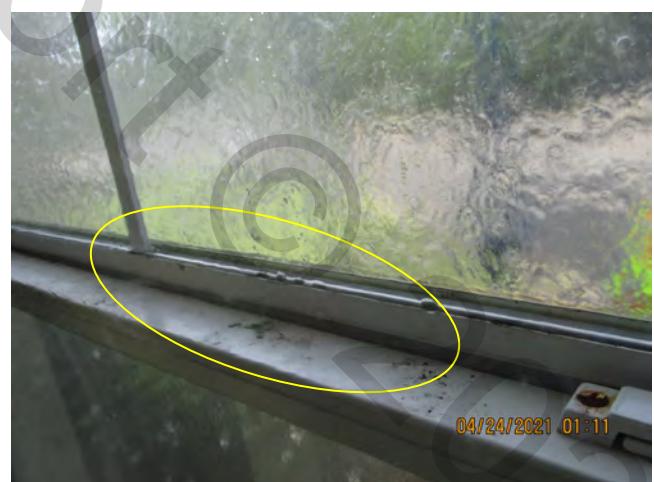
Water Infiltration witnessed at head Glazing Style – unit 917 – spec 2

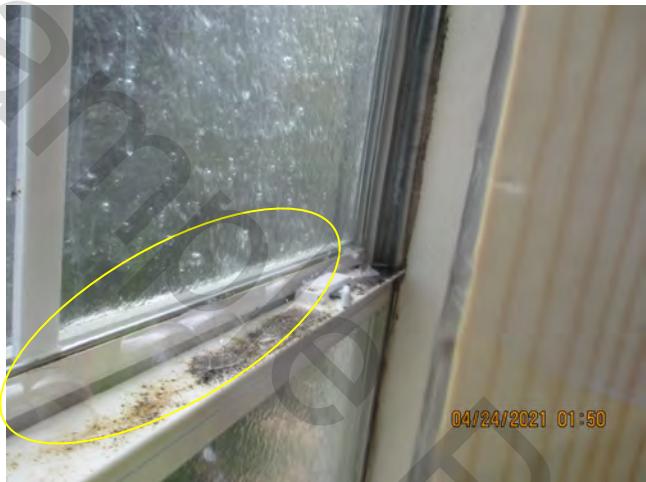
Water Infiltration witnessed at interlock Glazing Style – unit 917 – spec 2

Water penetration was witnessed at the interlocking frame member and sill frame member of window systems tested by the ASTM E-1105 field test.

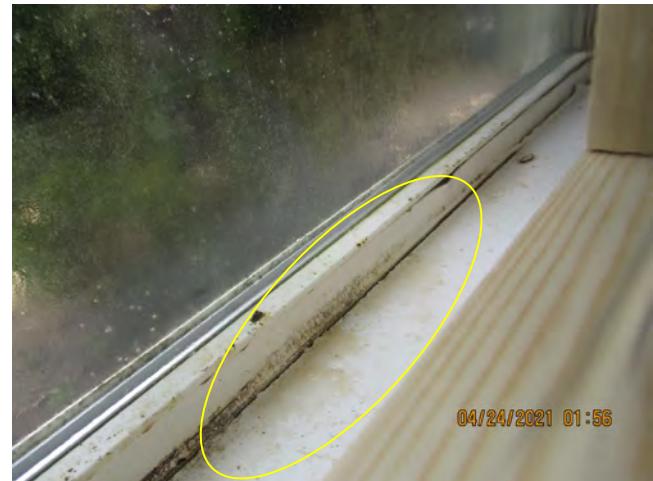
Water Infiltration witnessed at  
Interlocking window frame member –  
unit 917 – spec 3

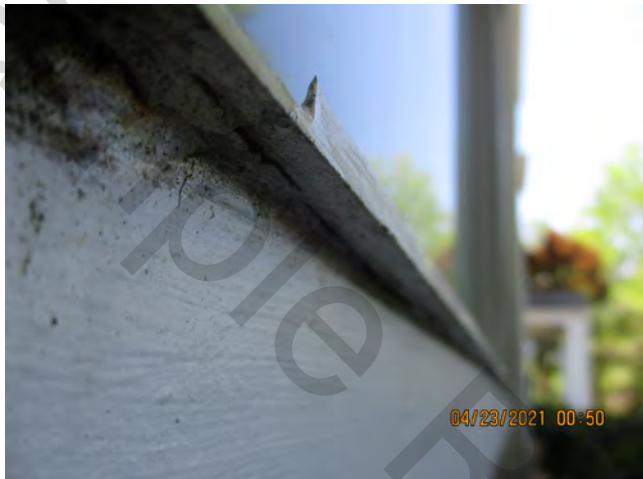
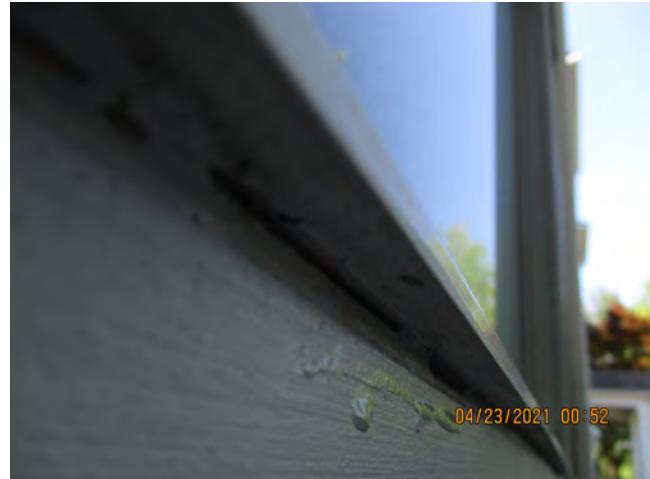
Water Penetration witnessed under the  
window sill – unit 917 – spec 3

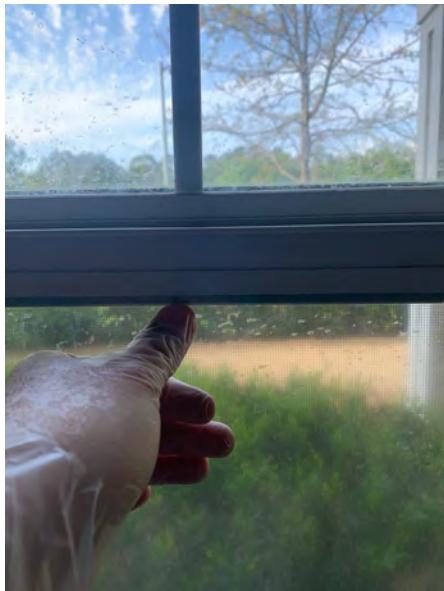
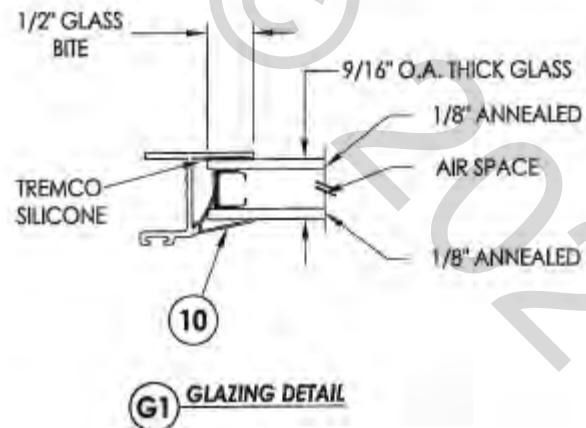
Upon inspection, TSSA Storm Safe DAC Inc has found several glass lites that are deglazed, allowing exterior water to infiltrate into the interior living space. This physical damage also allows interior Air-Conditioned air to escape to the exterior.

The glazing edge between the aluminum glazing style and the glass pane is used to set the primary glazing seal; in the same manner, the primary seal is set around the installation flange of the window framing system.

It is the recommendation of TSSA Storm Safe DAC Inc. that the [REDACTED] has a glazing company assess the condition of the installed glass lites and, if necessary, perform remedial reglazing of the glass lites within their glazing style to mitigate further water intrusion.

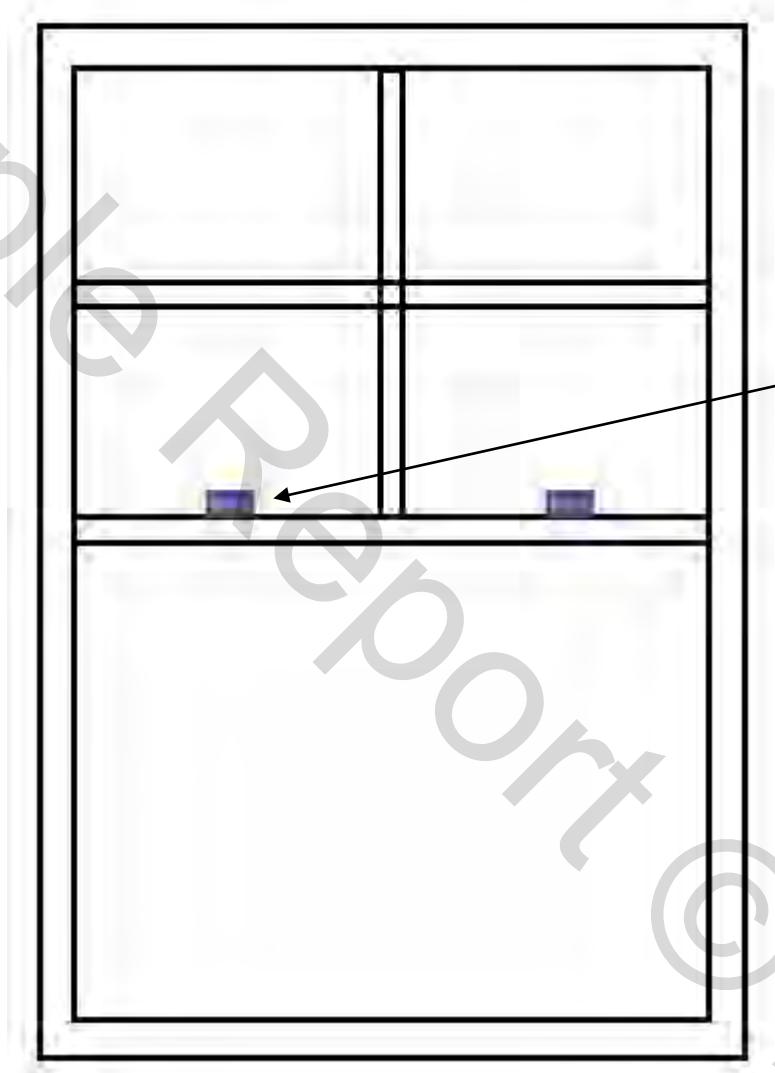
Cycle 2 – (Failure) 3:28 min  
Water Penetration witnessed  
at Sill Frame Member

Cycle 2 - Water  
Infiltration witnessed  
in IGU of Non-  
Operational Sash

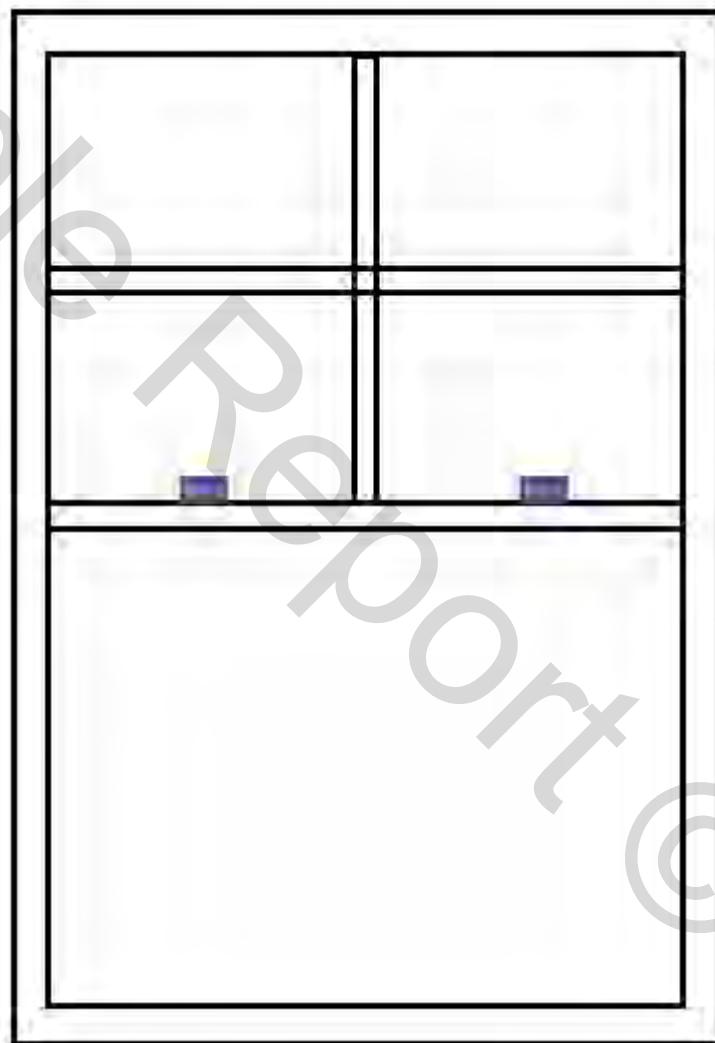
Note – Incidental moisture penetration occurred at window next to this specimen from over spray of our spray rack. This second window did not have a vacuum being created during the time of failure.

Cycle 1 – (Failure) 4:54 min  
Water Penetration witnessed  
at Sill Frame Member

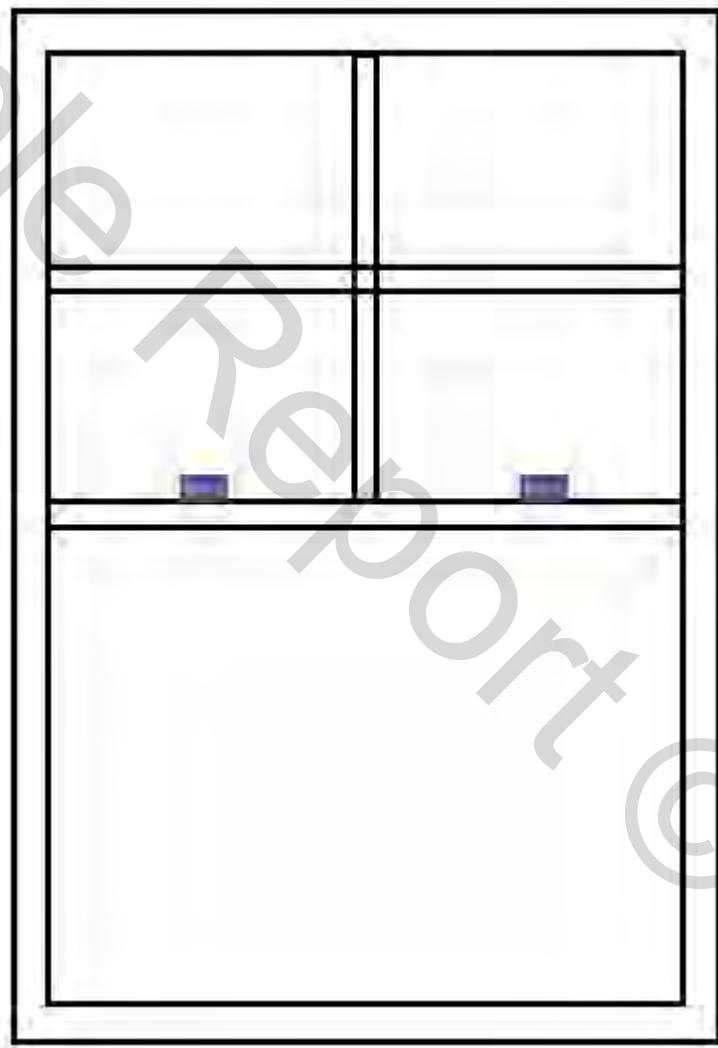
Cycle 2 – (Failure) 3:31 min  
Water Penetration witnessed  
at Sill Frame Member

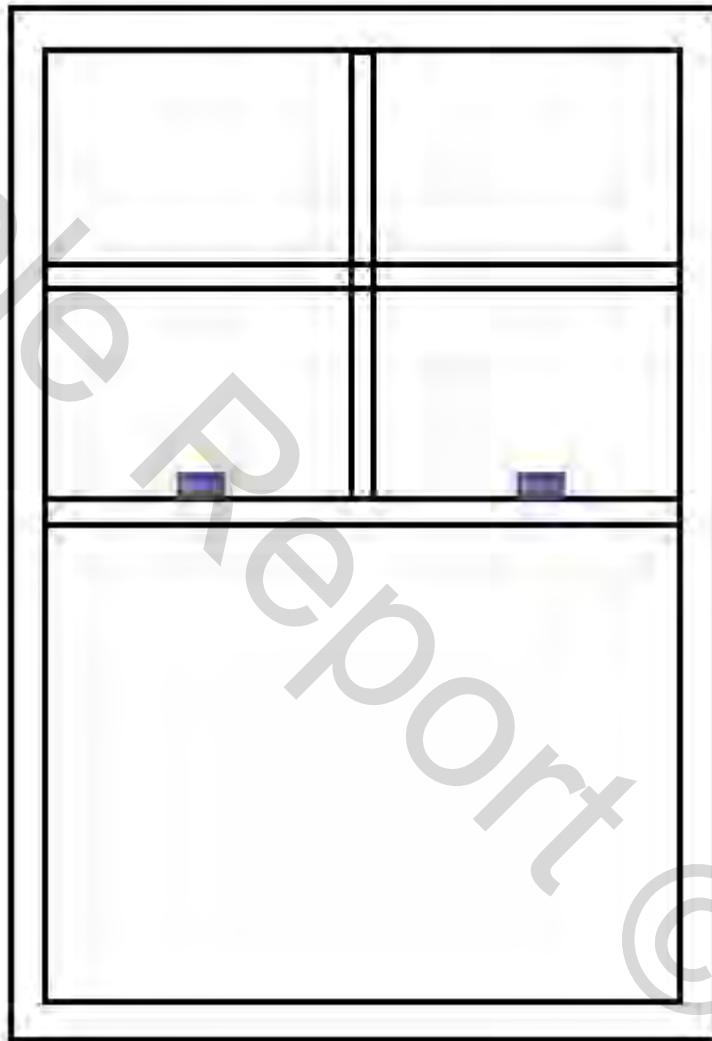
Cycle 1 – (Failure) 4:59 min  
Water Penetration witnessed  
at Sill Frame Member

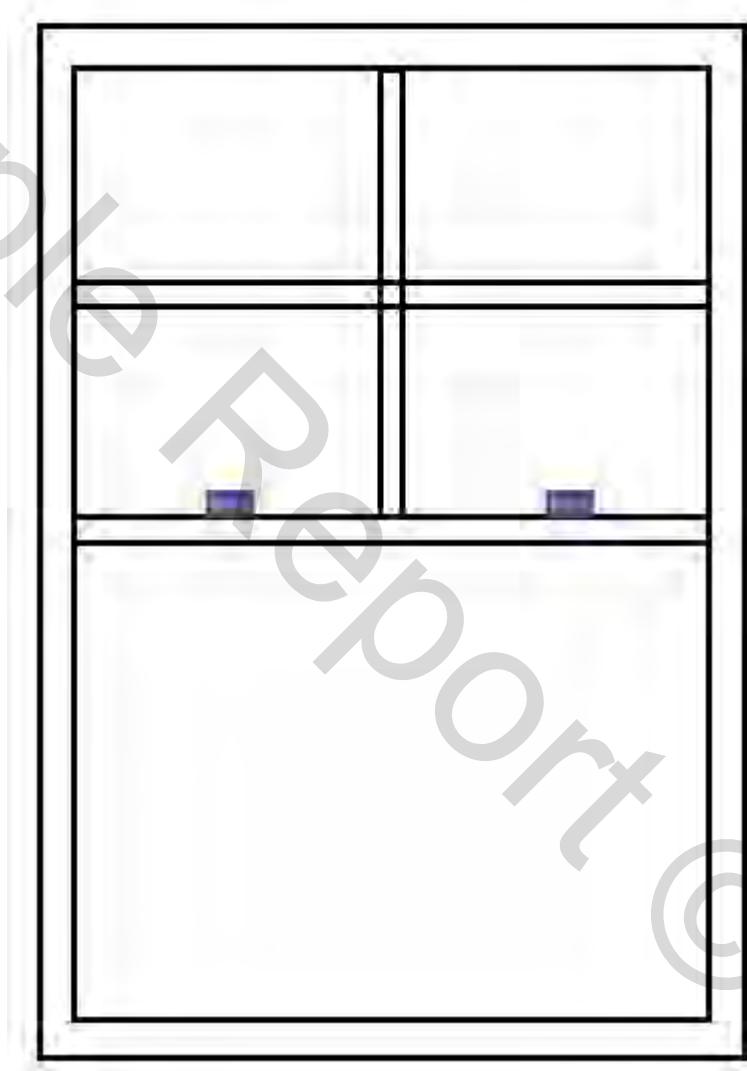
Cycle 2 – (Failure) 1:44 min  
Water Penetration witnessed  
at Sill Frame Member

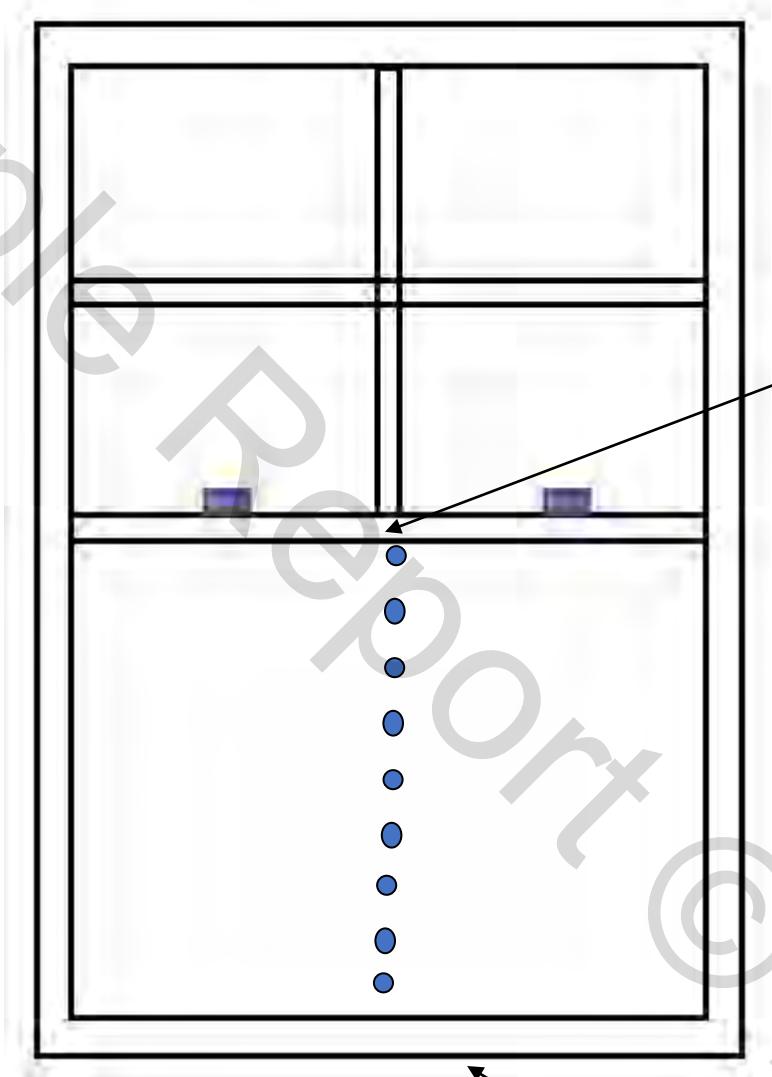
Cycle 2 - Water  
Infiltration witnessed  
at Interlocking  
Meeting Rail

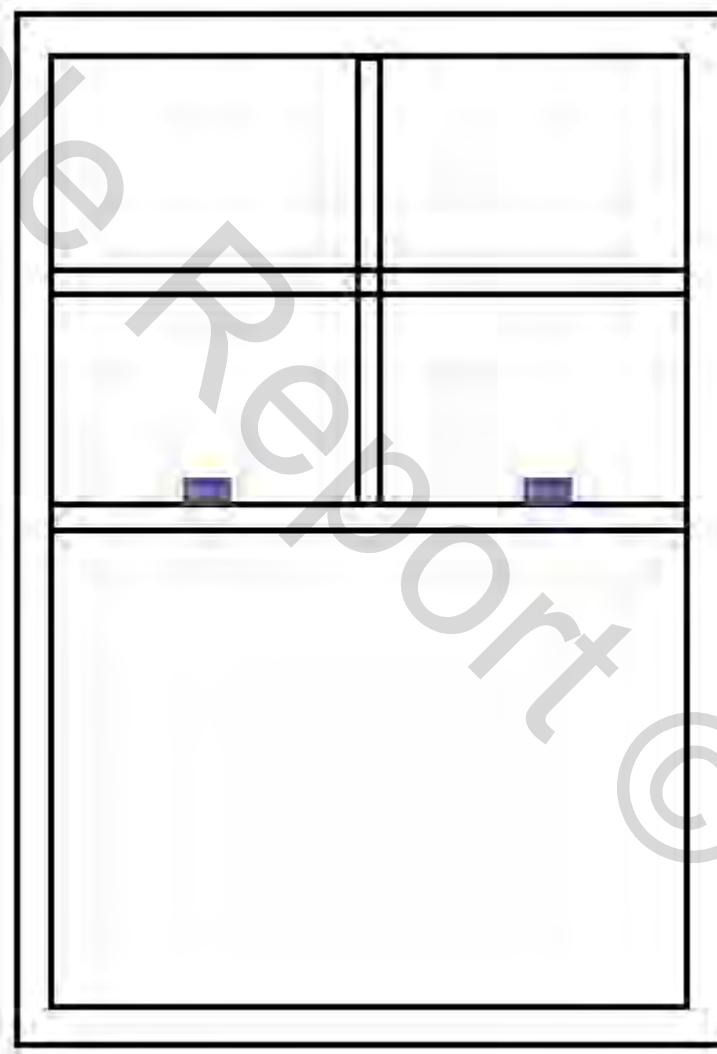
Note – This Specimen is a Pass  
No moisture penetration was witnessed  
during each of the three testing cycles.
