Glazing Inspection Report

[REDACTED]
[REDACTED]
[REDACTED]
Pembroke Pines, FL 33028

[REDACTED] Report date 8-1-21

At the request of [REDACTED] TSSA Storm Safe DAC Inc. performed a diagnostic water penetration inspection of the installed glazed systems at the [REDACTED] on the following dates:

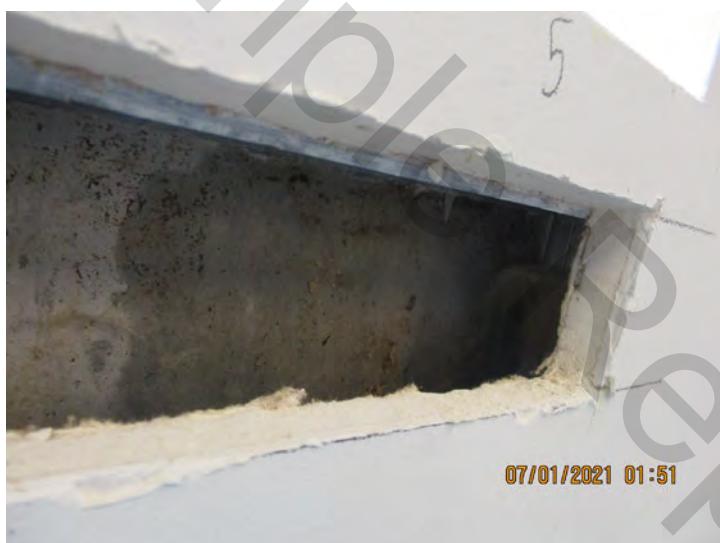
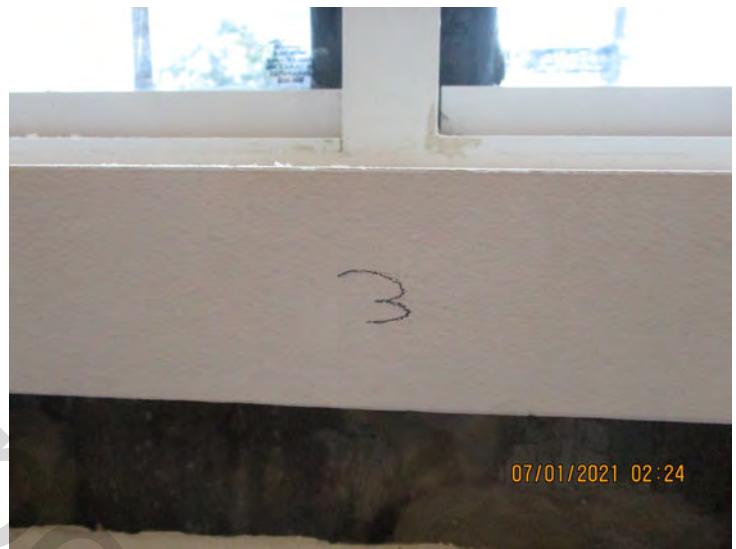
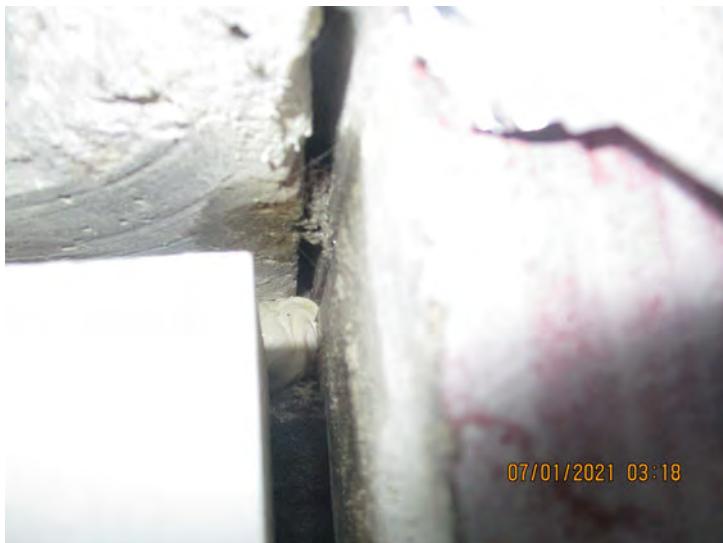
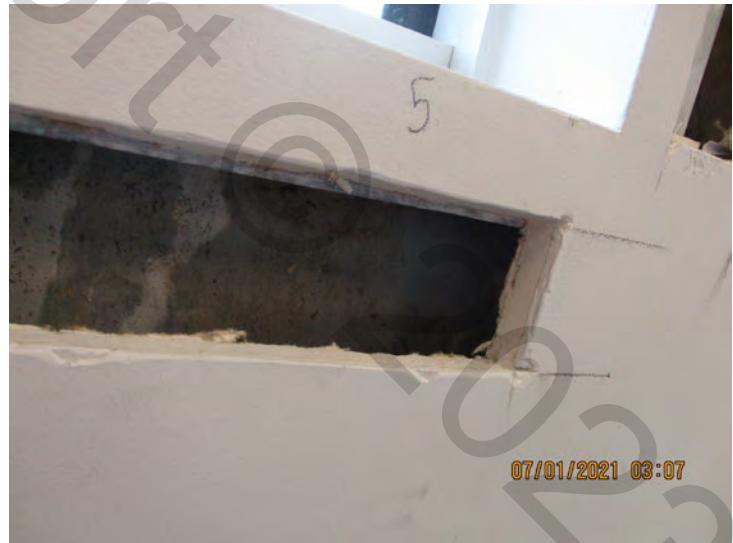
Step	Mullion type	Frame member (Interior view)	Mullion Testing Size				# Of 5 ft testing lengths per mullion	Minutes of testing	Water Penetration Witnessed (interior view)
1	Horizontal Mullion	Sill Frame Member	69.3	in.	5.77	ft.	1.154	5.77	1. Directly under Intermediate Vertical Mullion at Sill 2. Below right jamb at sill connection
2	Vertical Mullion	Right Jamb	54	in.	4.50	ft.	0.900	4.50	1. Below right jamb at sill connection
3	Vertical Mullion	Intermediate Vertical	54	in.	4.50	ft.	0.900	4.50	1. Directly under Intermediate Vertical Mullion at Sill
4	Vertical Mullion	Left Jamb	54	in.	4.50	ft.	0.900	4.50	1. Water witnessed at glass lite between the exterior sealant and foam glazing tape
5	Intermediate Horizontal	Intermediate Horizontal	69.3	in.	5.77	ft.	1.154	5.77	1. Directly under Intermediate Vertical Mullion at Sill 2. Below right jamb at sill connection
6	Vertical Mullion	Right Jamb	54	in.	4.50	ft.	0.900	4.50	1. Below right jamb at sill connection 2. At Head to Right jamb Connection point

7	Vertical Mullion	Intermediate Vertical	54	in.	4.50	ft.	0.900	4.50	1. Directly under Intermediate Vertical Mullion at Sill
8	Vertical Mullion	Left Jamb	54	in.	4.50	ft.	0.900	4.50	None
9	Horizontal Mullion	Head Frame Member	69.3	in.	5.77	ft.	1.154	5.77	1. At Head to Right jamb Connection point
			Totals	44.31	ft.	8.863	44.31

Water Penetration Witnessed During AAMA 501.2 Testing Operations

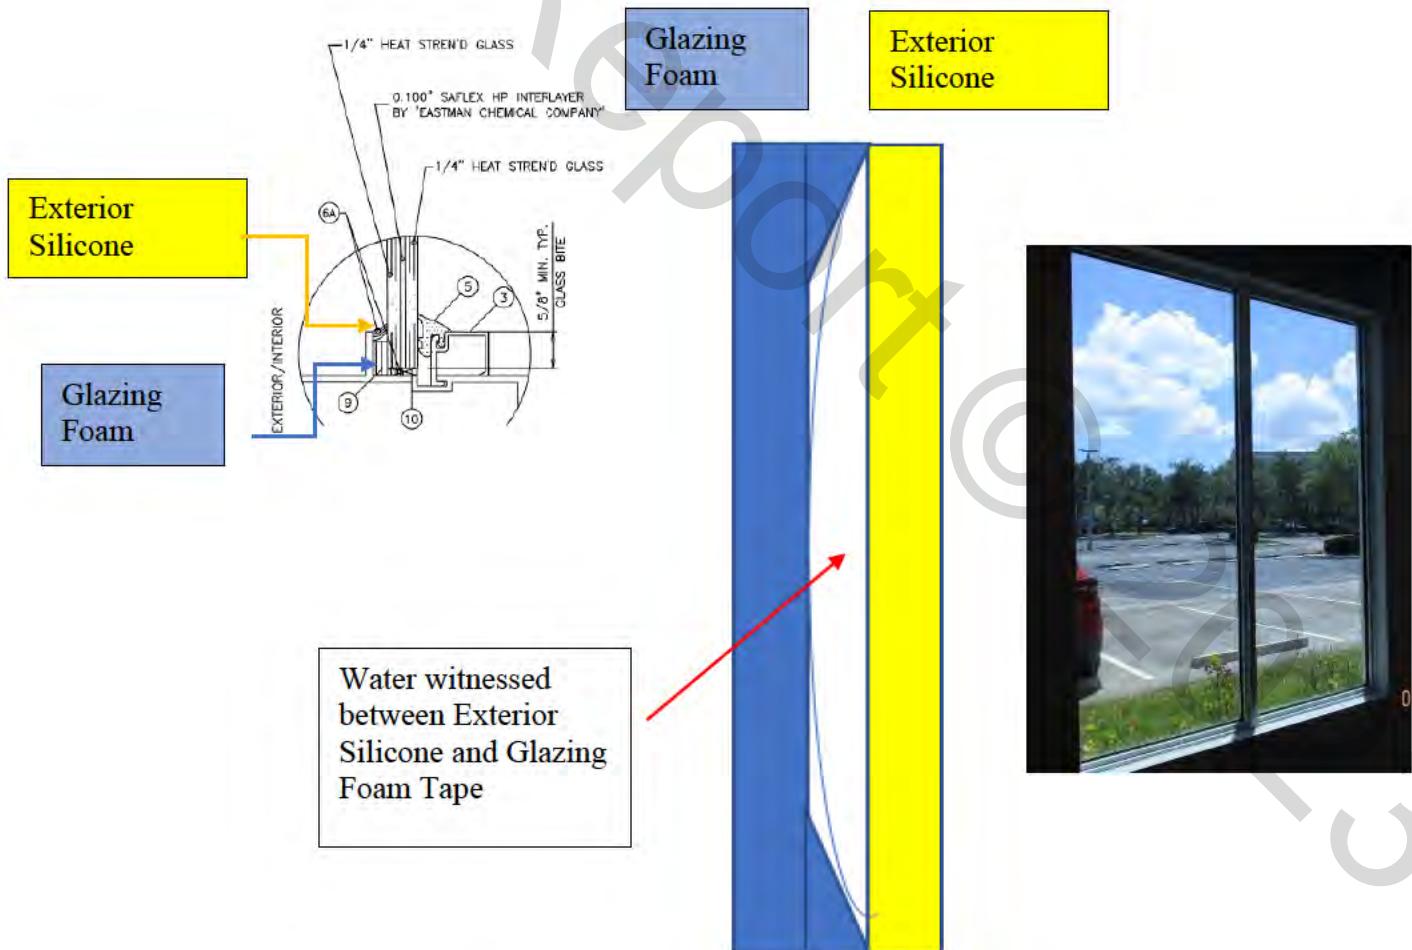
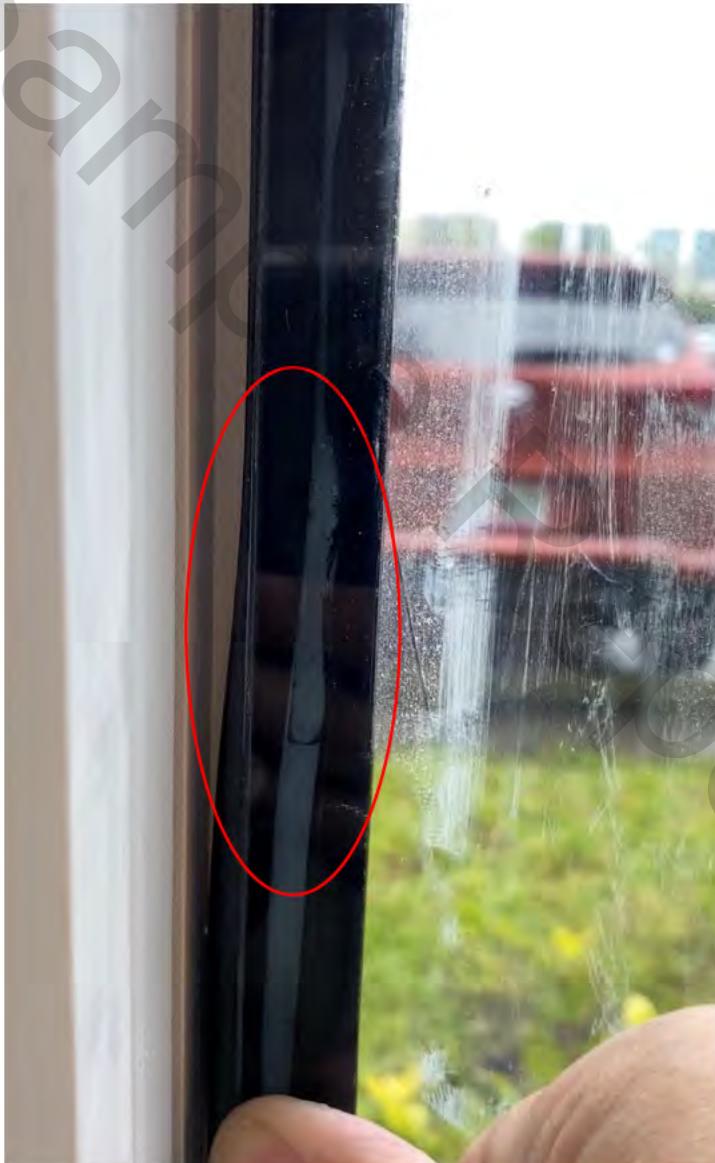
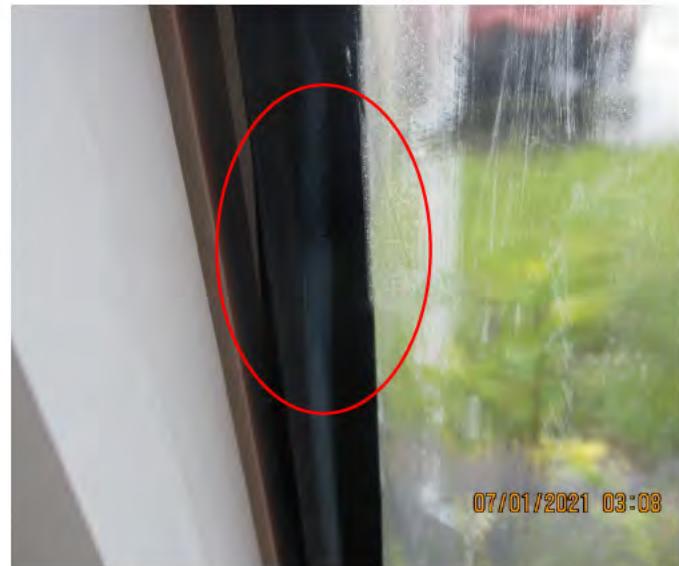
Water Penetration Between Exteriors Sealant Bead and Foam Glazing Tape

We witnessed at the Left Jamb of the installed Storefront movement and displacement of the Glazing Foam Tape from our inspection.

In the middle of the left jamb, the Glazing Foam Tape is seen entirely off to the side of the glass, leaving the glass not connected to the glazing style.

Also, the Exterior Silicone Sealant is supposed to be butted up against the Glazing Foam Tape. However, the undulation between the glazing foam tape and exterior sealant has allowed water to become trapped within the void created by this disconnection of materials.

3. Insert sufficient Silicone glazing sealant between the exterior glazing stile and glass lite (Note – Exterior Silicon should be applied consistently with equal pressure not to leave any voids between the glazing foam tape and the exterior edge of the glazing stile.)

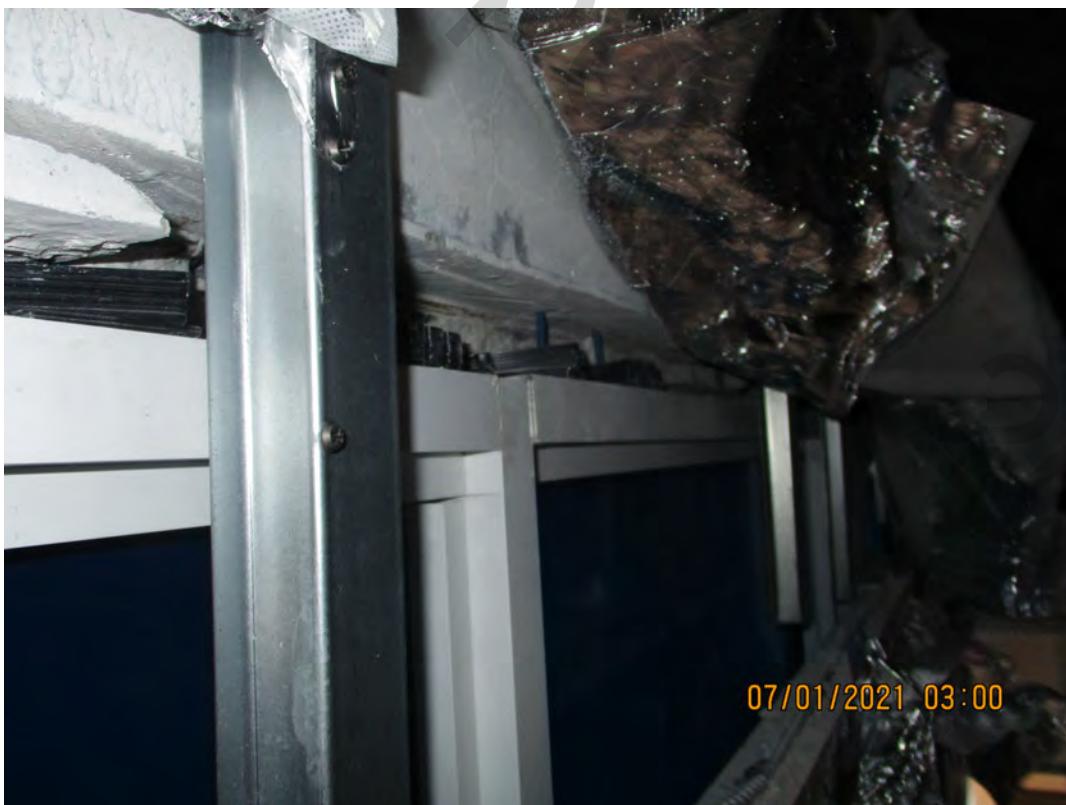
Structural Installation Issues Witnessed During Onsite Testing

Upon opening the Drop Ceiling to have a clear view of the Head Frame member, installation issues were discovered that contributed to water intrusion and left the system in a structurally unsafe condition.

On the left side of the head frame member and intermediate vertical mullion, a layer of grout was witnessed between the concrete lentil and horseshoe shims. The grout was soft enough to break into pieces with our inspectors' hands and cannot sustain loads imposed by the Glazing System and Transfer them to the building Structure as specified on page 9 of 11 in the Miami Dade NOA 17-1017.16.

At the right side of the head frame member and intermediate vertical mullion, there was an extremely large space between the head frame member and the concrete lintel. This excessive space does not allow the installation fasteners to adequately support the system in the masonry opening.

Page 9 of 11 in the Miami Dade NOA 17-1017.16 allows for the installation of the Storefront System into concrete with no bucking, as long as the min embedment into the concrete is adhered to, and the system is shimmed with $\frac{1}{4}$ " max space between the Masonry Opening and the system frame.

The window systems installed into the new punch openings were installed contrary to the directions outlined in the Miami Dade NOA 17-1017.16. An Example of the correct shim space for installation into concrete is shown below:

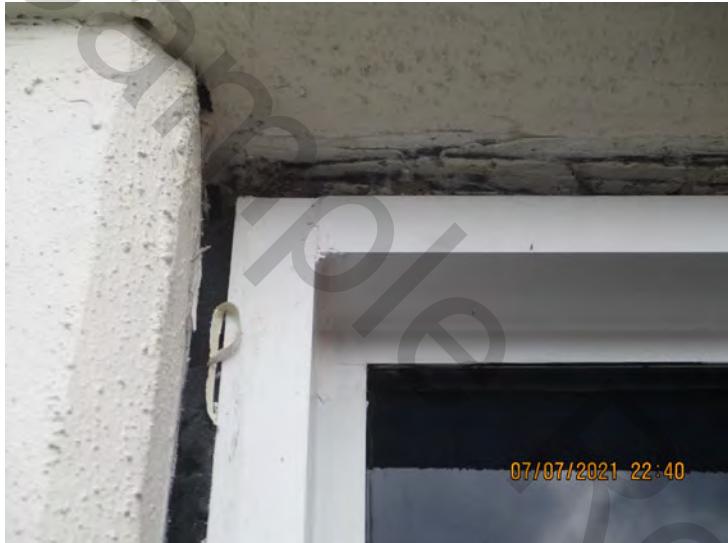
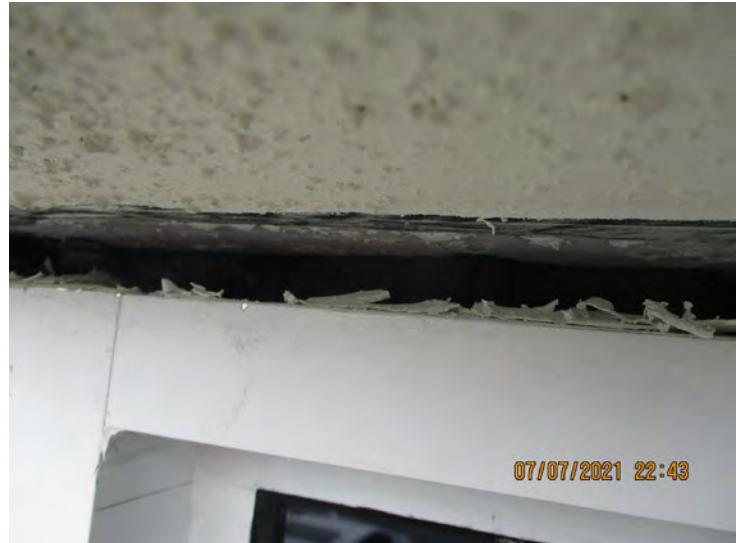
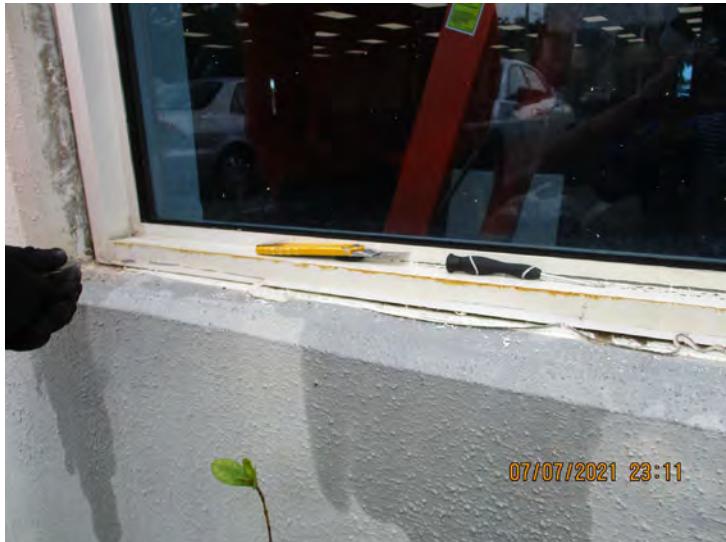
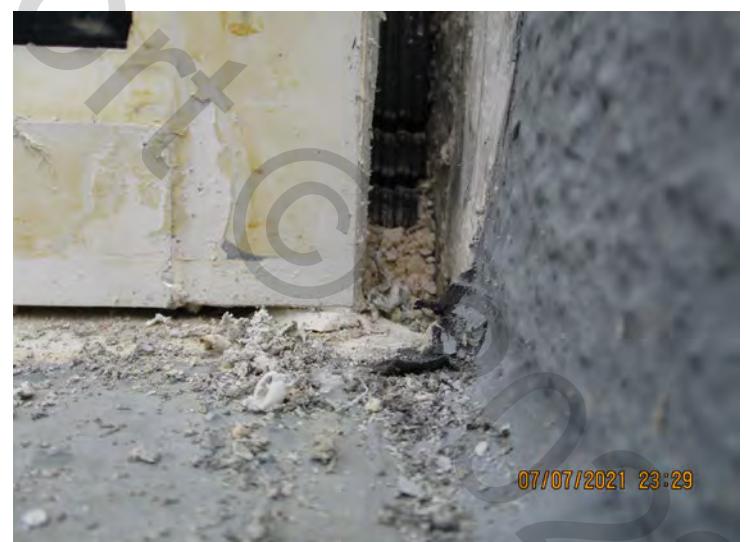
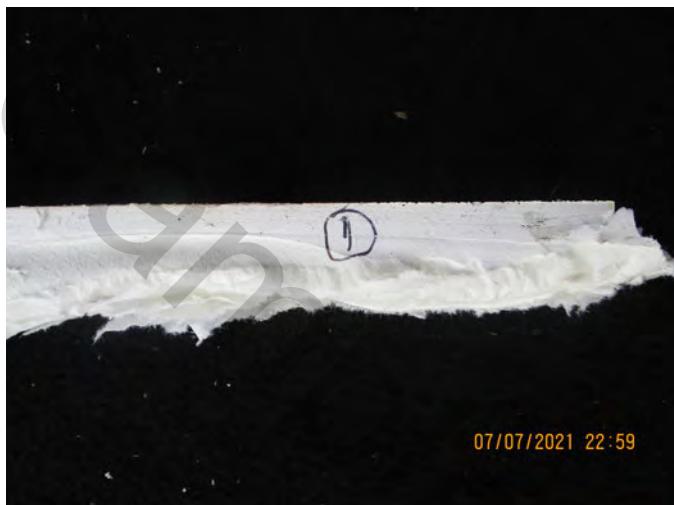
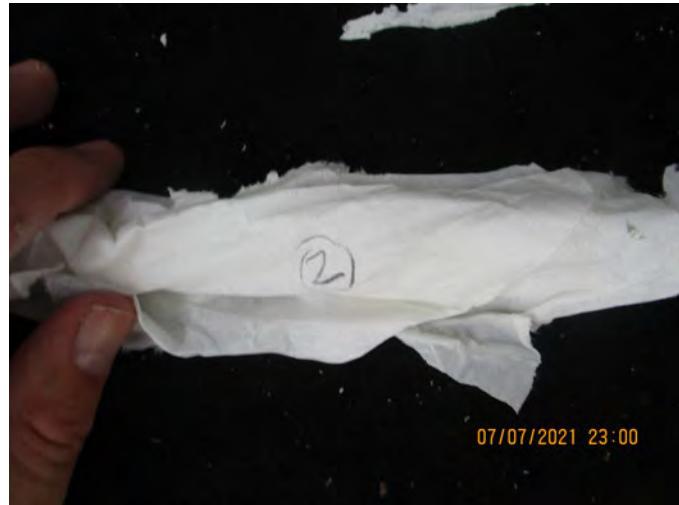
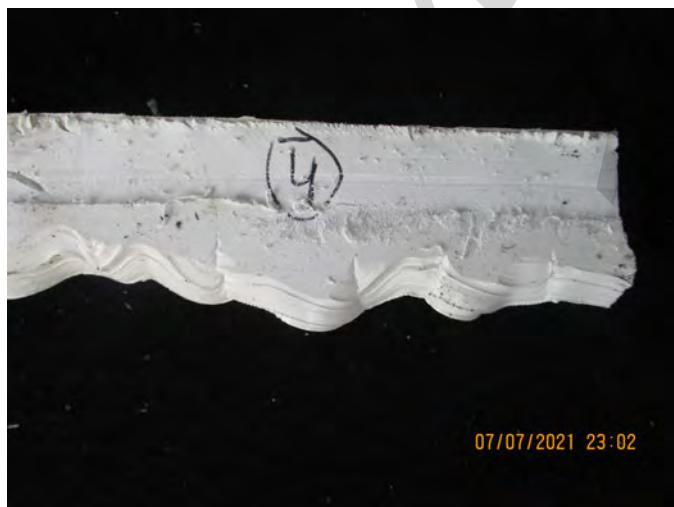
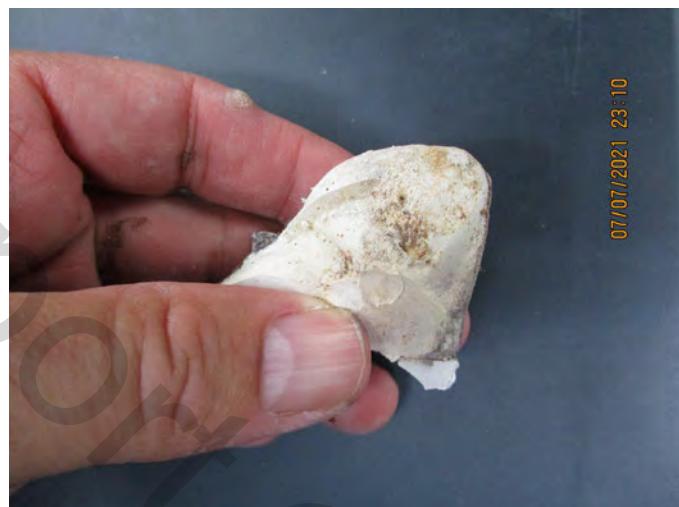
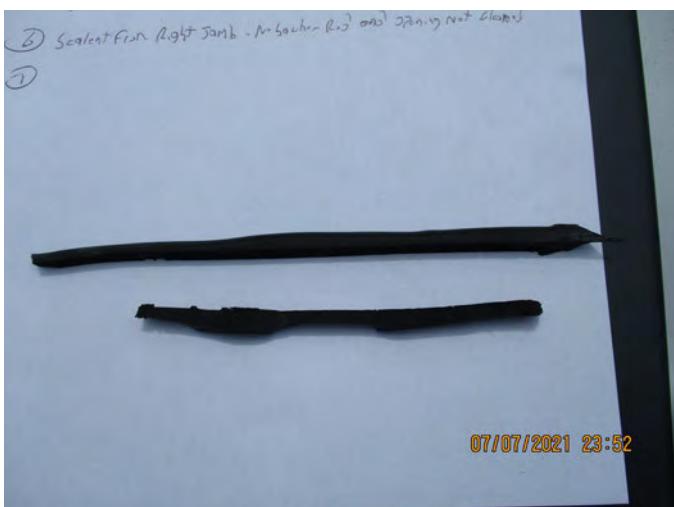
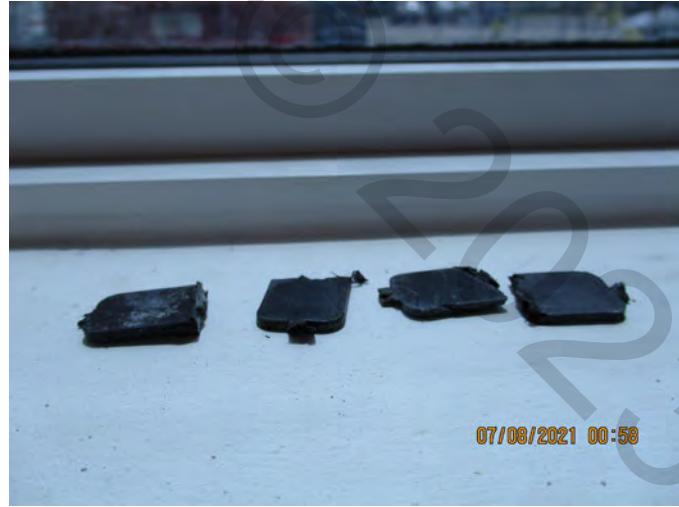
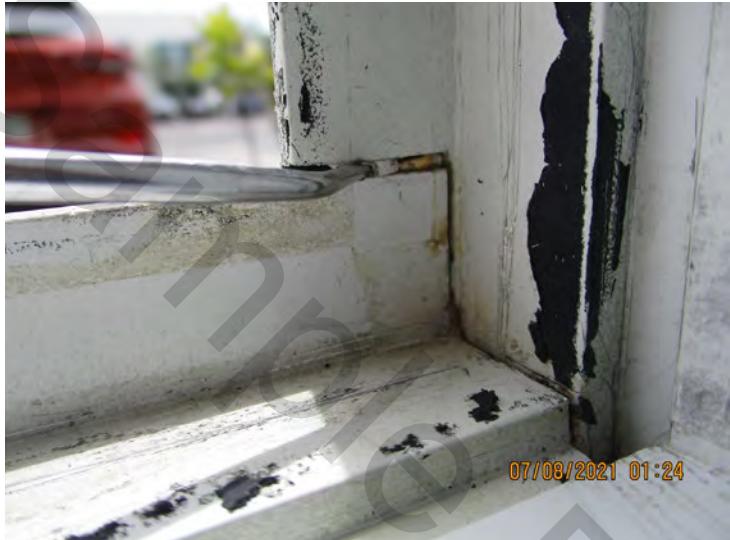
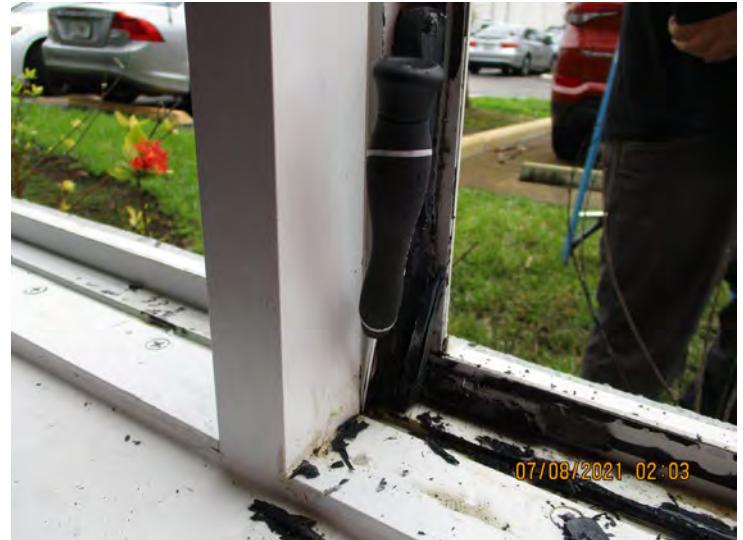
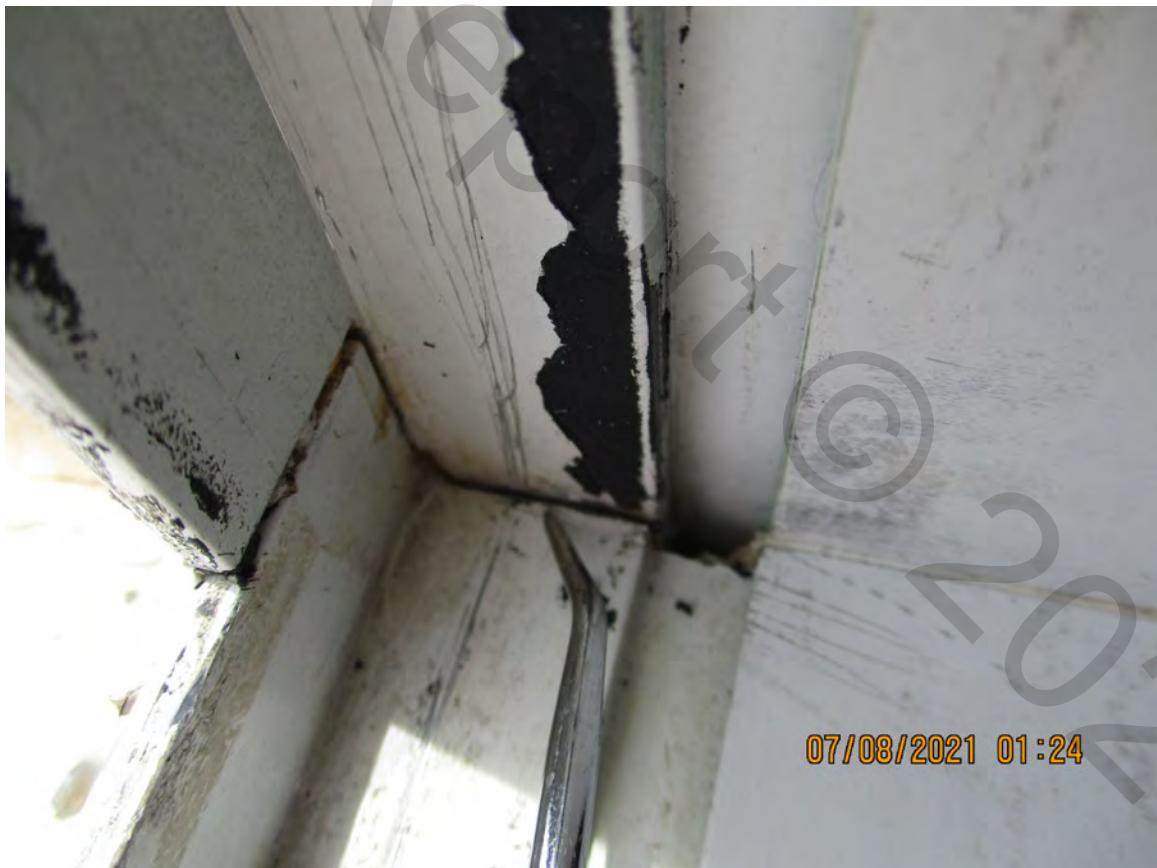
Damages Identified when
removing sealant and resetting system

1. Backer Rods not found installed between the Head, Right Jamb, and Sill frame members and the Masonry Opening.

2. Rolled-up paper was found to be used as a Backer Rod between the Head Frame member and Masonry Opening.

3. Due to the lack of an installed Backer Rod, the depth of sealant between the frame and masonry opening was not sufficiently controlled. This did not allow the sealant to bond between the two construction materials adequately.

4. Sufficient cleaning was not performed around the frame and masonry opening during the original installation allowing sediment and debris to interfere with the sealant's ability to create proper adhesion between the two construction materials.

5. Voids were witnessed between the exterior silicone bead and the glass to frame connection allowing water to intrude between the foam glazing tape and silicon exterior bead.

6. The Glass panes were found to be resting on small pieces of hard plastic shim material, which did not correctly support the entire width of the glazing edge.

- A Setting Block is made of an elastomeric material that supports the glazing weight and is in direct contact with an edge of the glazing after final installation.
- A hard plastic material creates the possibility of spontaneous glass breakage because the glass edge is the weakest part of the glass pane and is most susceptible to glass breakage.

7. One of the Glass lites was found to be 1/2" short, allowing excess space between the edge of the glass lite and the glazing frame.

8. Frame Corner joints and End Dams were not sealed before glass installation.

1. Seal Corner Frame Joints with Tremco Dymonic FC “High Performance, Fast-Curing, Single Component Hybrid Sealant.”
2. Apply new Foam Glazing tape to interior glazing style in a straight and uniform manner. (Note - leave sufficient room for the insertion of exterior silicone to create a watertight exterior seal around the glass lite and exterior glazing frame member.)
3. Reglaze window by inserting glass lite into the interior frame unto approved setting block and press glass against the newly installed glazing tape. (Note – be sure the glass is balanced in the frame between each side of the interior frame members.)
4. Replace the interior glass stops and glazing gaskets.

1. Insert Backer Rod between the exterior frame members and the masonry openings. (Note – Backer Rods should be installed between every side of the exterior framing system and building masonry openings.)

2. Apply Tremco Dymonic FC "High Performance, Fast-Curing, Single Component Hybrid Sealant." Between the exterior framing members and the building masonry openings. (Note – Sealant should be installed in a manner that allows sufficient adhesion to both the aluminum frame members and the masonry opening.)

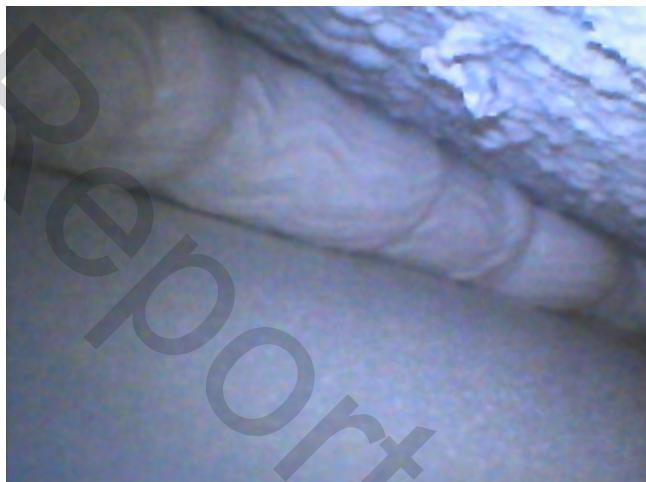
Newly Installed Sealant Bead fully adhered and cured.

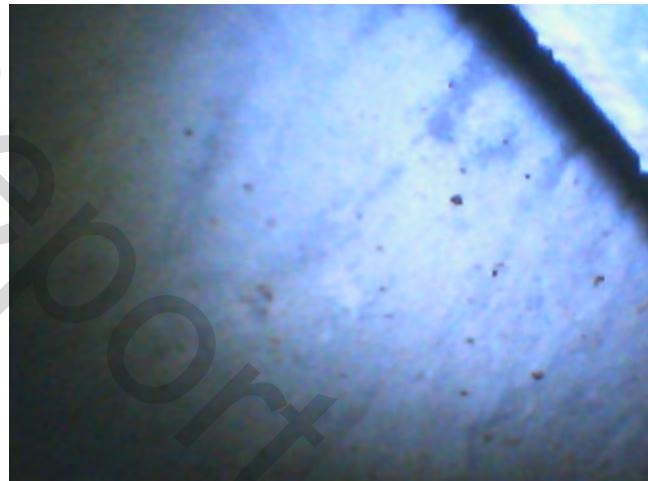
Borescope Image taken under the Right Jamb Mullion of the Storefront System showing old water staining, but no evidence of new water penetration during the retest.
