Glazing Inspection Report

XXXXXXXXXXXXXXXXXXXX
CONDOMINIUM ASSOCIATION.
1234 NE Testing Street
Anytown, USA
SAMPLE - Report date XXXXXXXX

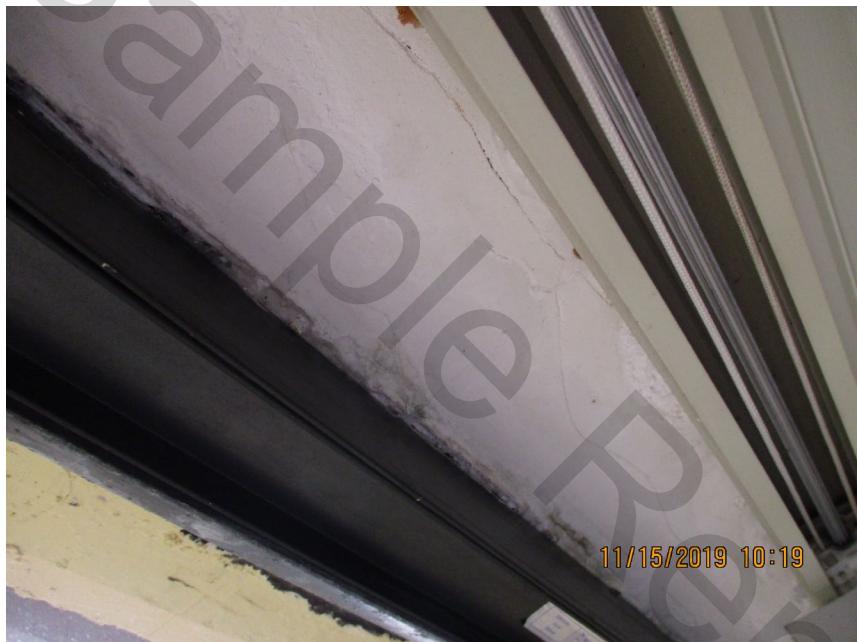
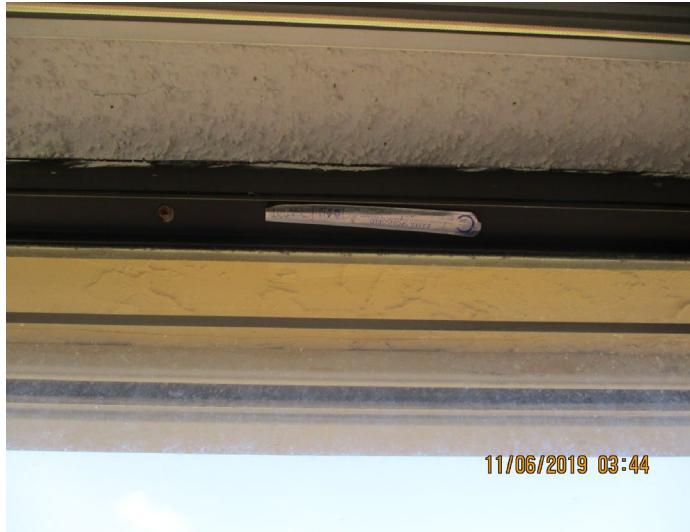
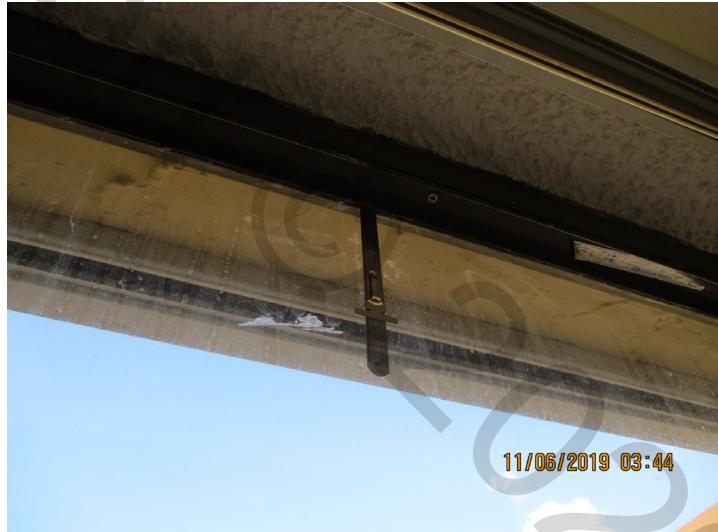
Moisture Intrusion

During our investigation of the XXXXXXXXXXXXXXXXXXXX Condominium Association, TSSA Storm Safe Inc. inspectors witnessed a great deal of moisture intrusion seen around the entire perimeter of the installed glazed systems. A combination of system buffeting with subsequent primary seal disruption allowed moisture to intrude between the installed systems and the weather barrier finding its way into the interior living space. This physical damage was noted on a large percentage of the units that we inspected.

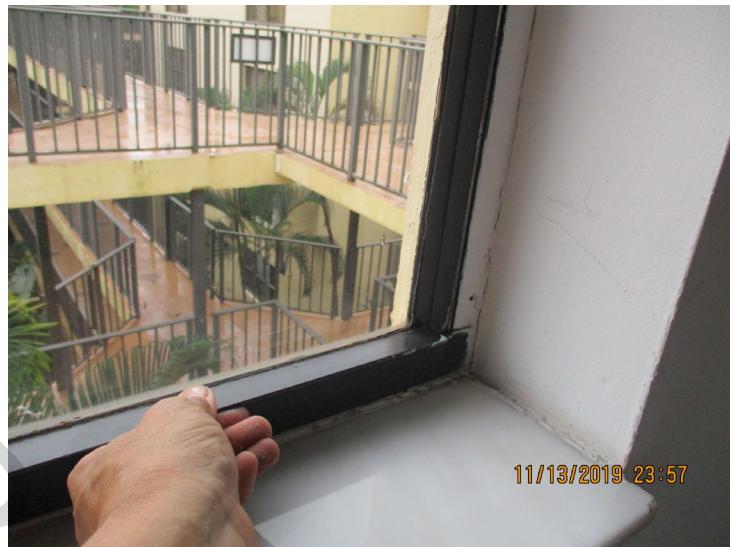
Loose Panels

Throughout the TSSA Storm Safe Inc. Glazing Damage Assessment of the XXXXXXXXXXXXXXXXXXXX Condominium Association, our inspectors witnessed wide spread loose panels on a great deal of the installed window and sliding glass door systems. As the window systems react to wind buffeting and cyclic pressure, the load is transferred from the installation system to the assembly system which eventually force the panels to become loosened in their operational tracks leaving them in a diminished state. This specific damage is difficult to capture photographically, as the panel movement is a physical reaction to our inspection

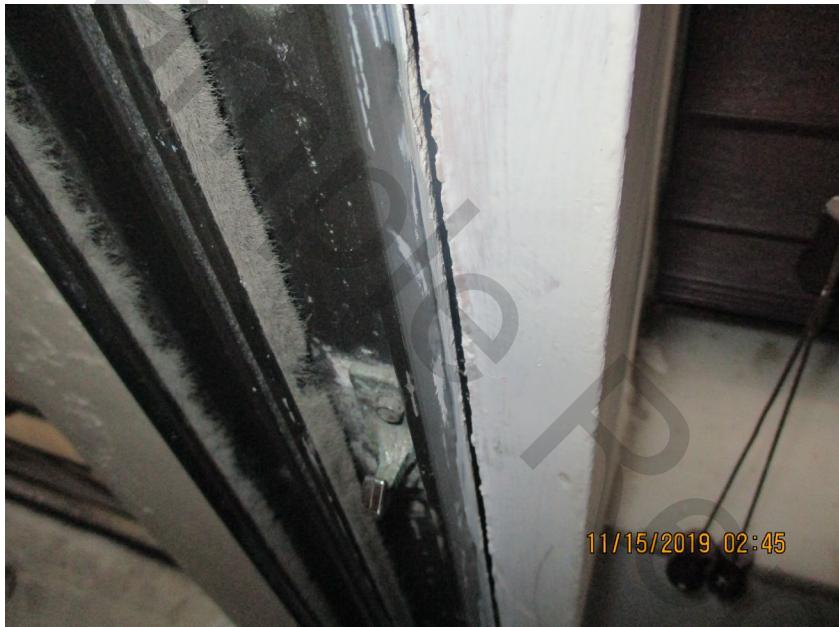
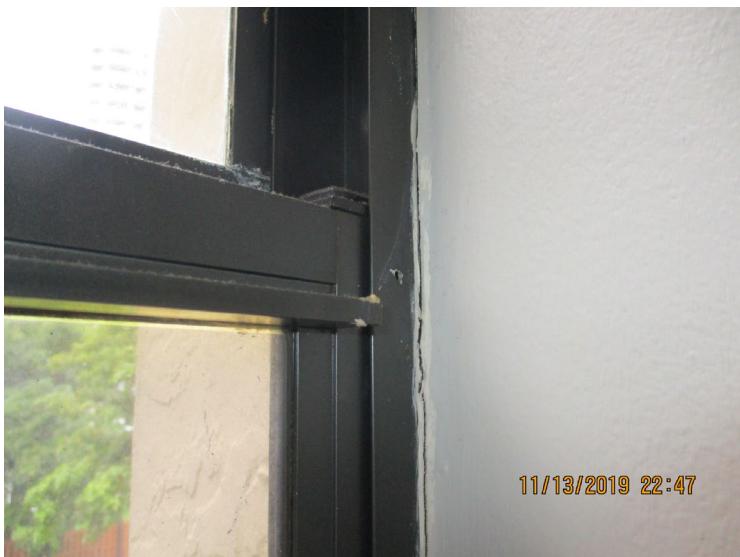
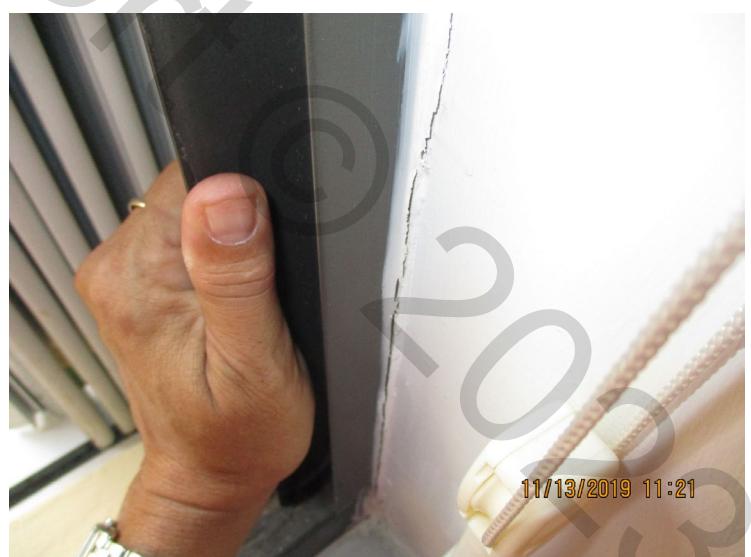
Jamb Movement

The following photos depict examples of the amount of system movement with corresponding interior finish distress that was witnessed during our investigation of the XXXXXXXXXXXXXXXXXXXX

Condominium Association inspection. The buffeting of the systems during a high wind event allowed the glazed systems to vibrate and move within their installed position. This movement affected the installation fastening system and created system movement which disrupted the interior finish between the systems framing and its interior finish reveal. (Note – the photo of the inspector's hand touching the framing system is to demonstrate that it was moving freely upon inspection.)

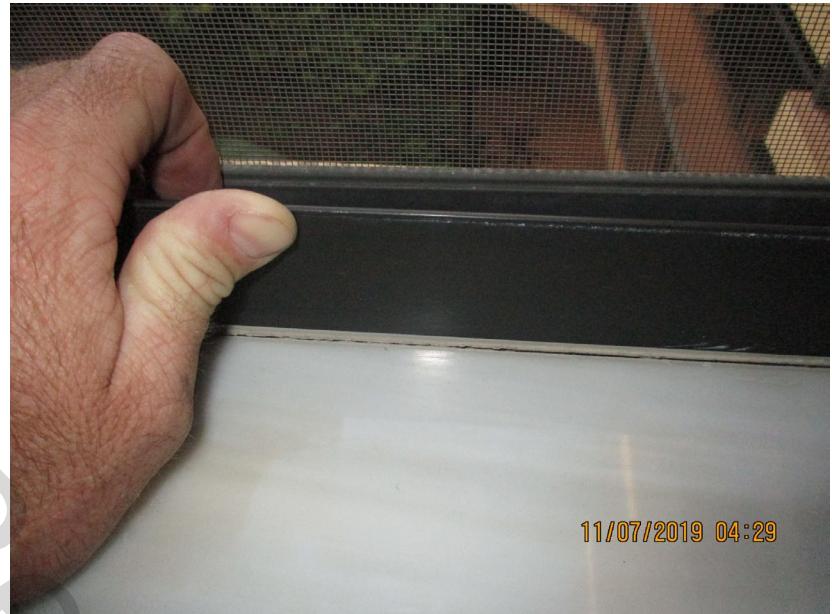
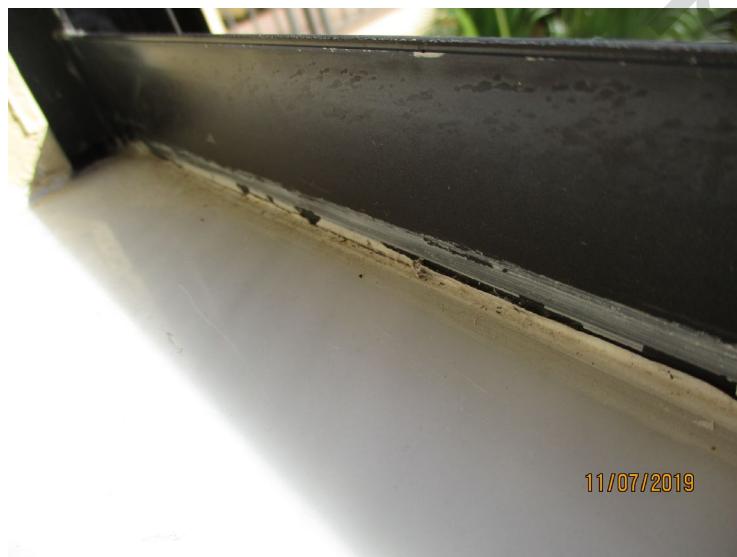
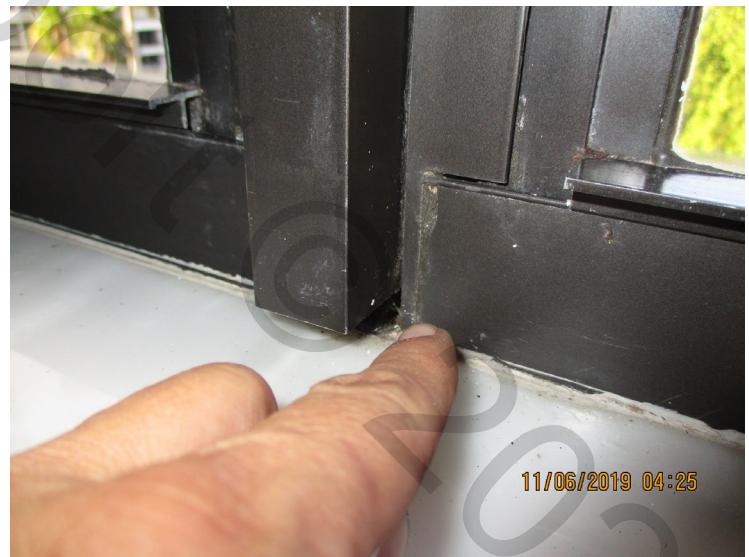
SILL MOVEMENT

The following photos depict examples of the amount of system movement with corresponding interior finish distress that was witnessed during our investigation of the XXXXXXXXXXXXXXXXXXXX Condominium Association inspection. The buffeting of the systems during a high wind event allowed the glazed systems to vibrate and move within their installed position. This movement affected the installation fastening system and created system movement which disrupted the interior finish between the systems framing and its interior finish reveal. (Note – the photo of the inspector's hand touching the sill frame member is to demonstrate that it was moving freely upon inspection.)

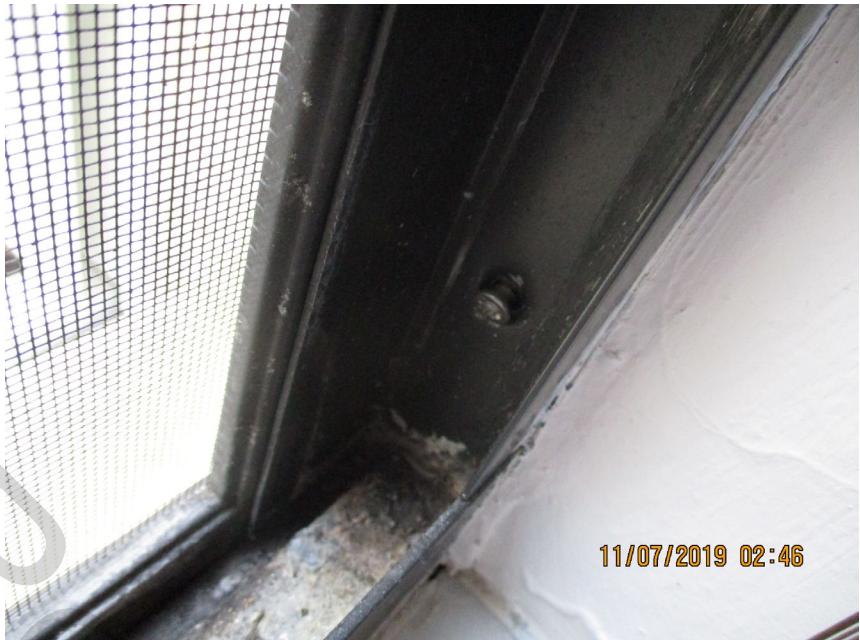
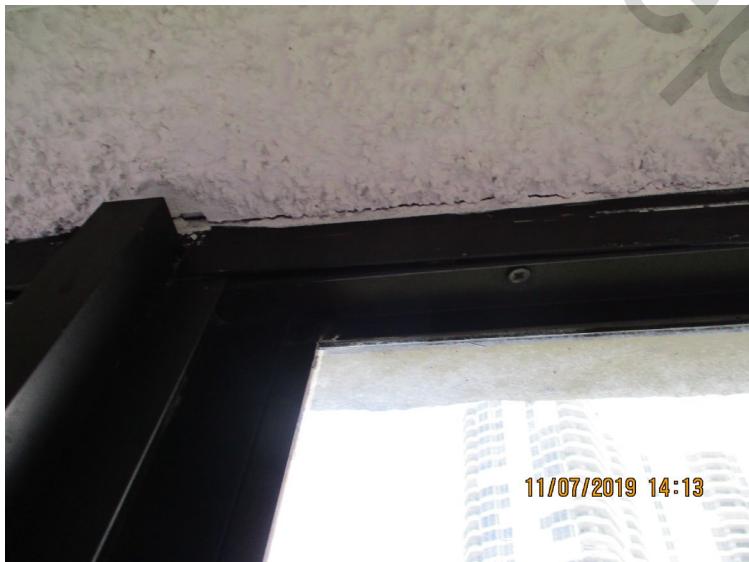
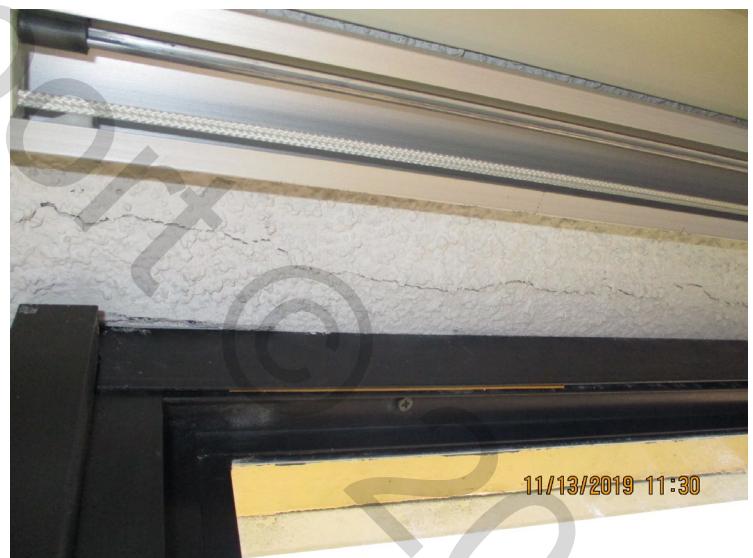
Damage Fasteners

The following photos depict evidence damage to the installation fasteners seen during our inspection. The intense buffeting of the window systems during Hurricane Irma allowed the attached window systems to vibrate and move within their installed positions. This movement affected and loosened the installation fasteners connection and attachment to the host structure leaving the window systems in a damaged and compromised state.

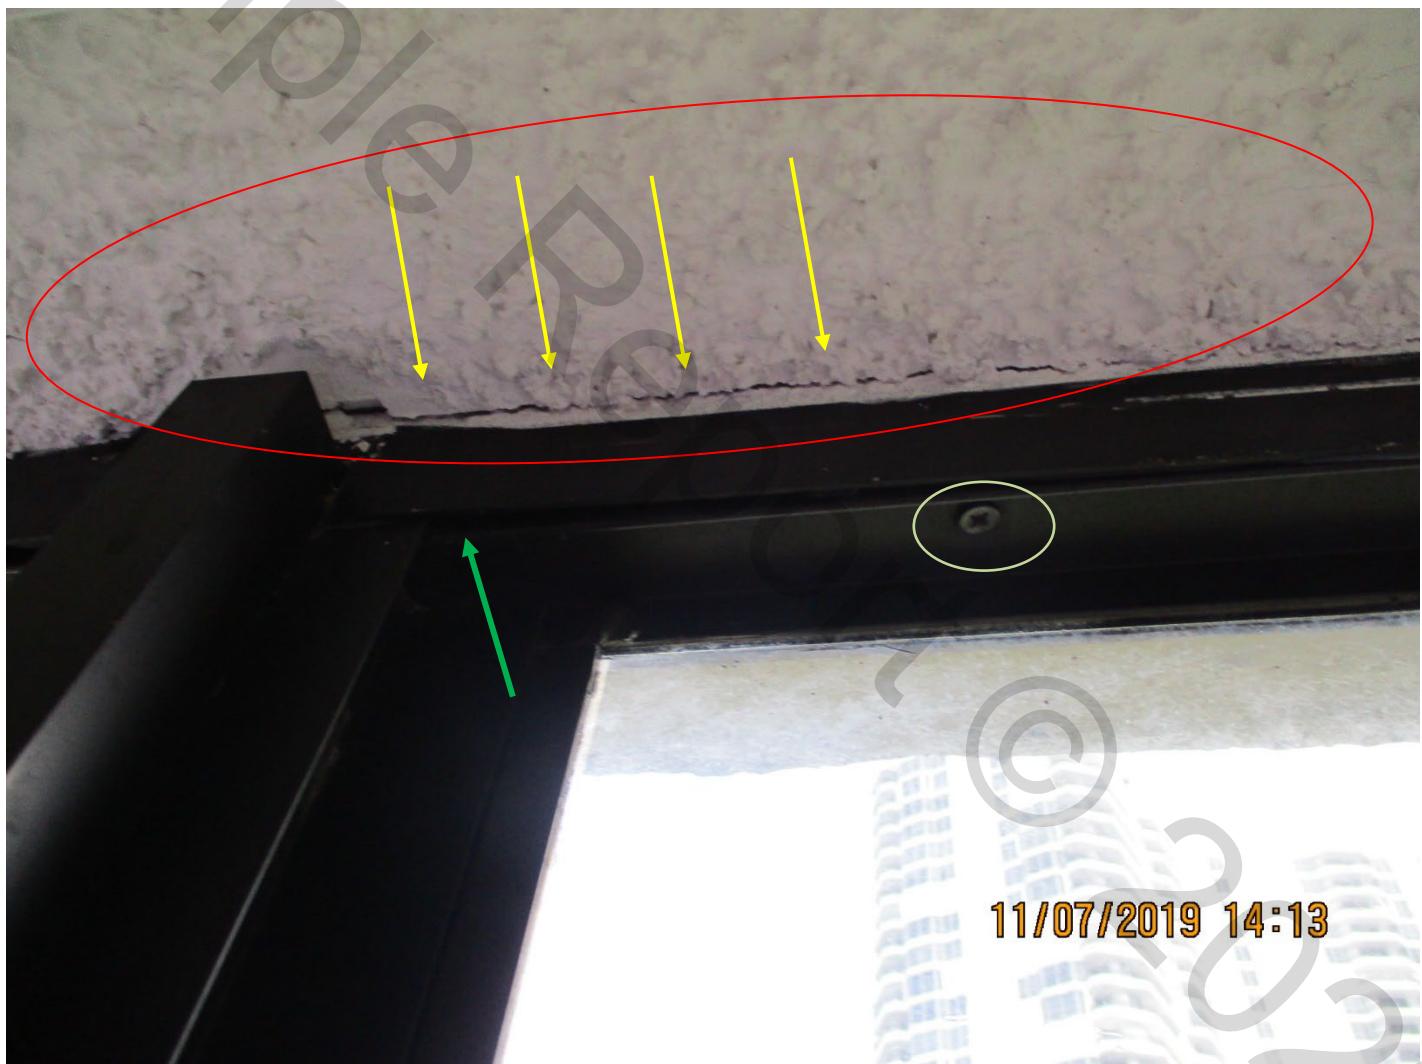
Picture #1

AN INTERIOR CASCADING DAMAGE PROFILE SHOWN AT THE HEADER TO MULL BAR CONNECTION POINT OF A QUAD MULLED SINGLE HUNG WINDOW SYSTEM DISPLAYING EVIDENCE OF HEADER MOVEMENT WITH SUBSEQUENT MOISTURE PENETRATION. ADDITIONAL PHYSICAL DAMAGES ALSO WITNESSED ON THIS SPECIMEN INCLUDES FASTENER DISTRESS, COVER PLATE DAMAGE, AND INTERIOR FINISH DISTRESS. – BLDG A – UNIT A-3C – LIVING ROOM

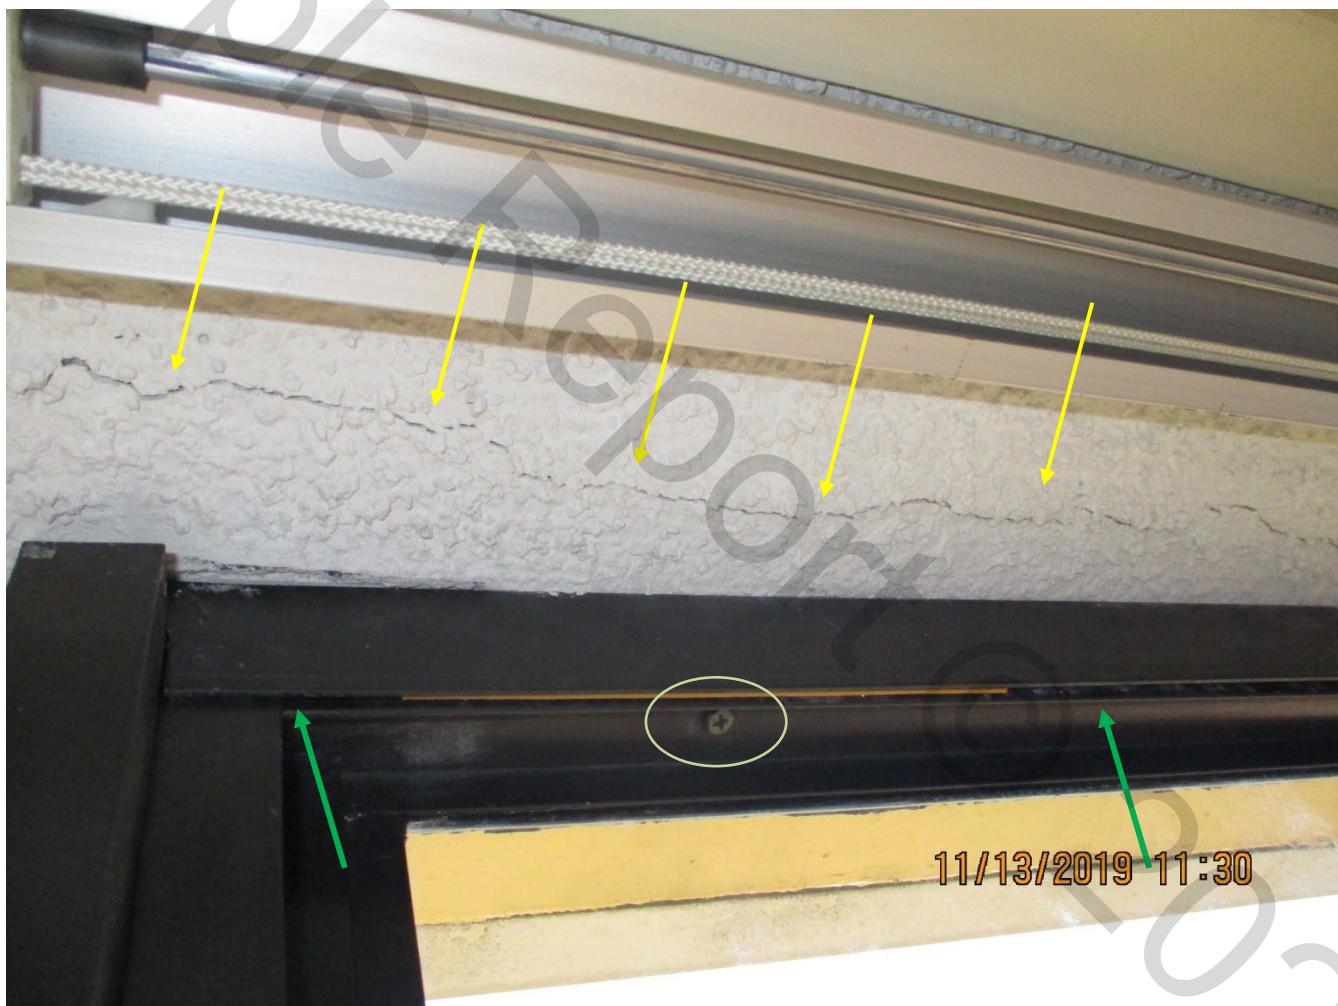
Picture #2

AN INTERIOR CASCADING DAMAGE PROFILE SHOWN AT THE HEADER TO MULL BAR CONNECTION POINT OF A QUAD MULLED SINGLE HUNG WINDOW SYSTEM DISPLAYING EVIDENCE OF HEADER MOVEMENT WITH SUBSEQUENT INTERIOR FINISH DISTRESS. ADDITIONAL PHYSICAL DAMAGES ALSO WITNESSED ON THIS SPECIMEN INCLUDES MOISTURE PENETRATION, COVER PLATE DAMAGE, AND FASTENER DISTRESS. – BLDG B – UNIT B-4E – LIVING ROOM

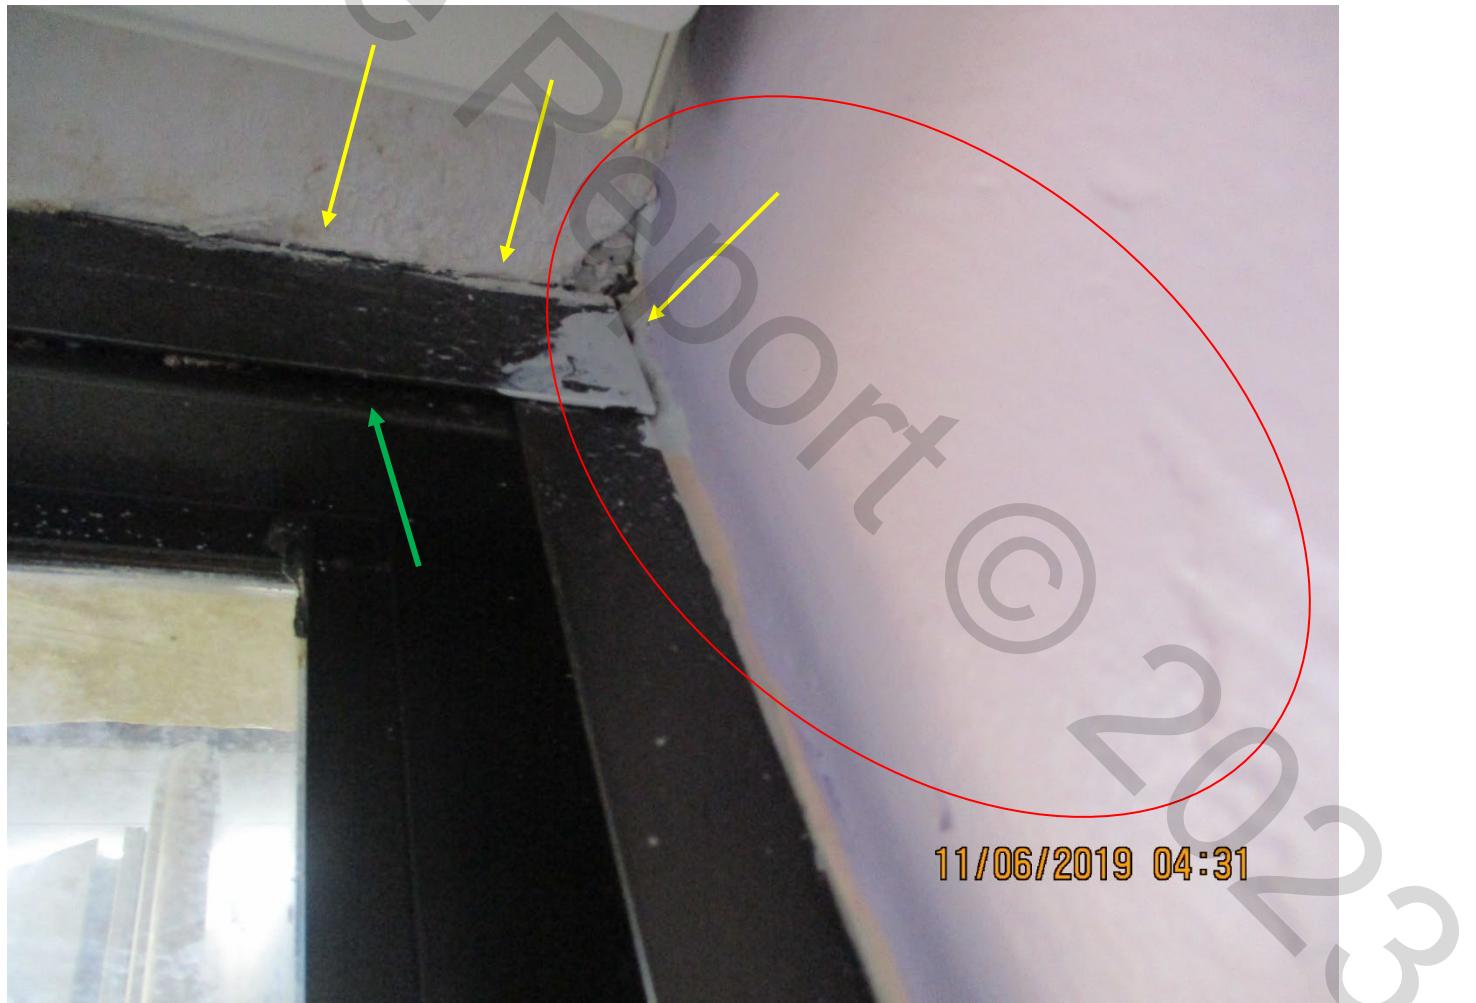
Picture #3

AN INTERIOR CASCADING DAMAGE PROFILE SHOWN AT THE HEADER TO RIGHT JAMB CONNECTION POINT OF A DOUBLE MULLED SINGLE HUNG WINDOW SYSTEM DISPLAYING EVIDENCE OF HEADER MOVEMENT WITH SUBSEQUENT INTERIOR FINISH DISTRESS. ADDITIONAL PHYSICAL DAMAGES ALSO WITNESSED ON THIS SPECIMEN INCLUDES COVER PLATE DAMAGE AND MOISTURE PENETRATION. – BLDG A – UNIT A-4Q – 2ND BEDROOM

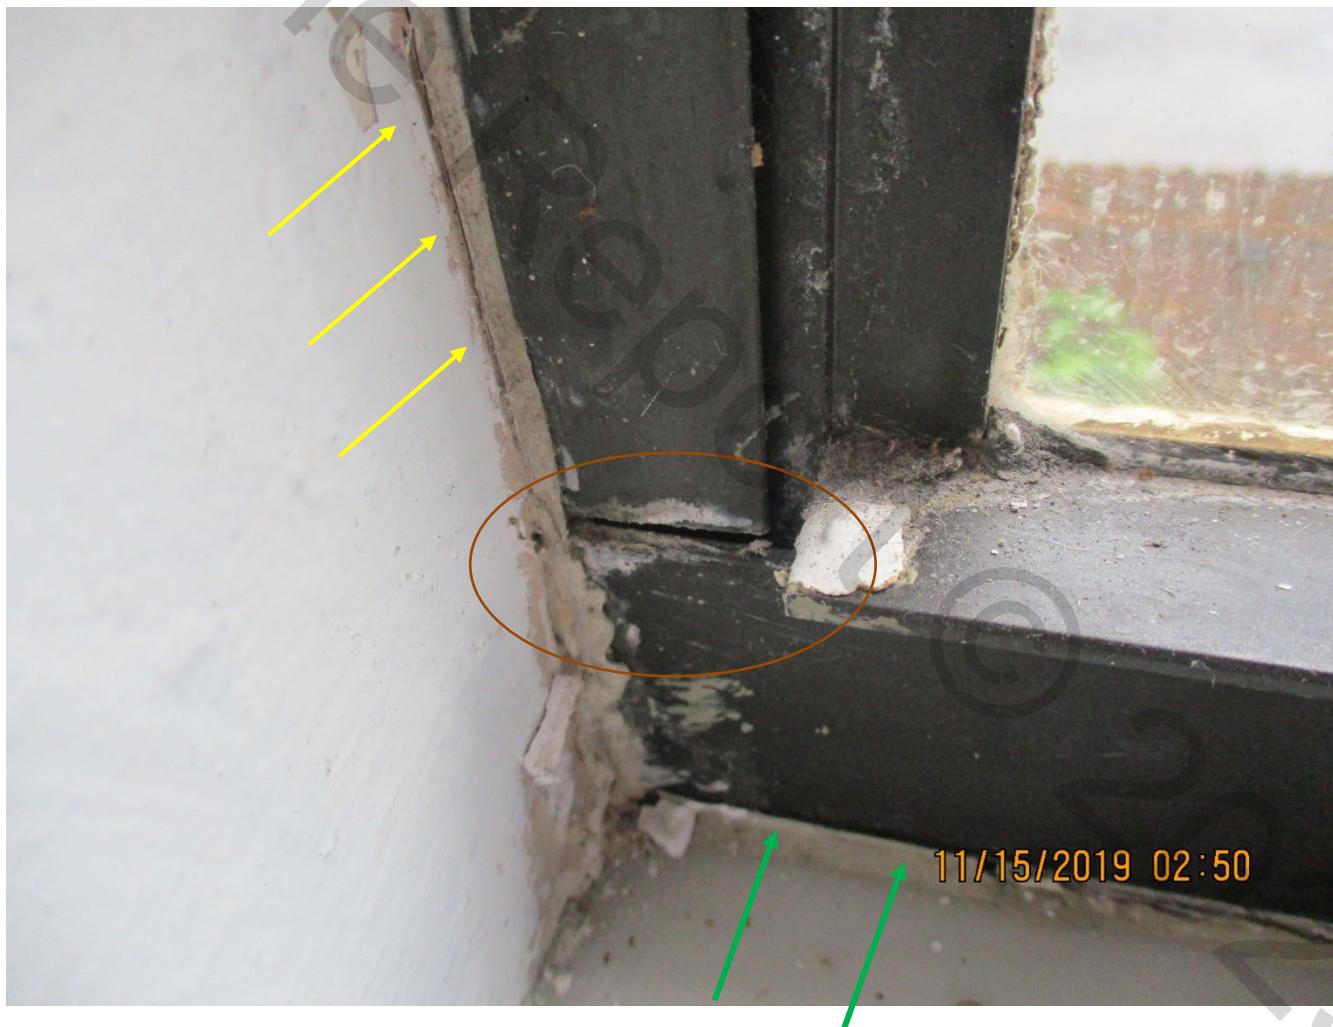
Picture #4

AN INTERIOR CASCADING DAMAGE PROFILE WITNESSED AT THE LEFT JAMB TO SILL CONNECTION POINT OF A QUAD MULLED SINGLE HUNG WINDOW SYSTEM DISPLAYING EVIDENCE OF FRAME SEPARATION WITH SUBSEQUENT INTERIOR FINISH DISTRESS. ADDITIONAL PHYSICAL DAMAGES ALSO WITNESSED ON THIS SPECIMEN INCLUDES MOISTURE PENETRATION AND SILL SEPARATION. – BLDG B – UNIT B-2D – LIVING ROOM (NOTE - PICTURES # 4, 5 AND 6 ARE A PHOTO SERIES FROM THE SAME SPECIMEN)

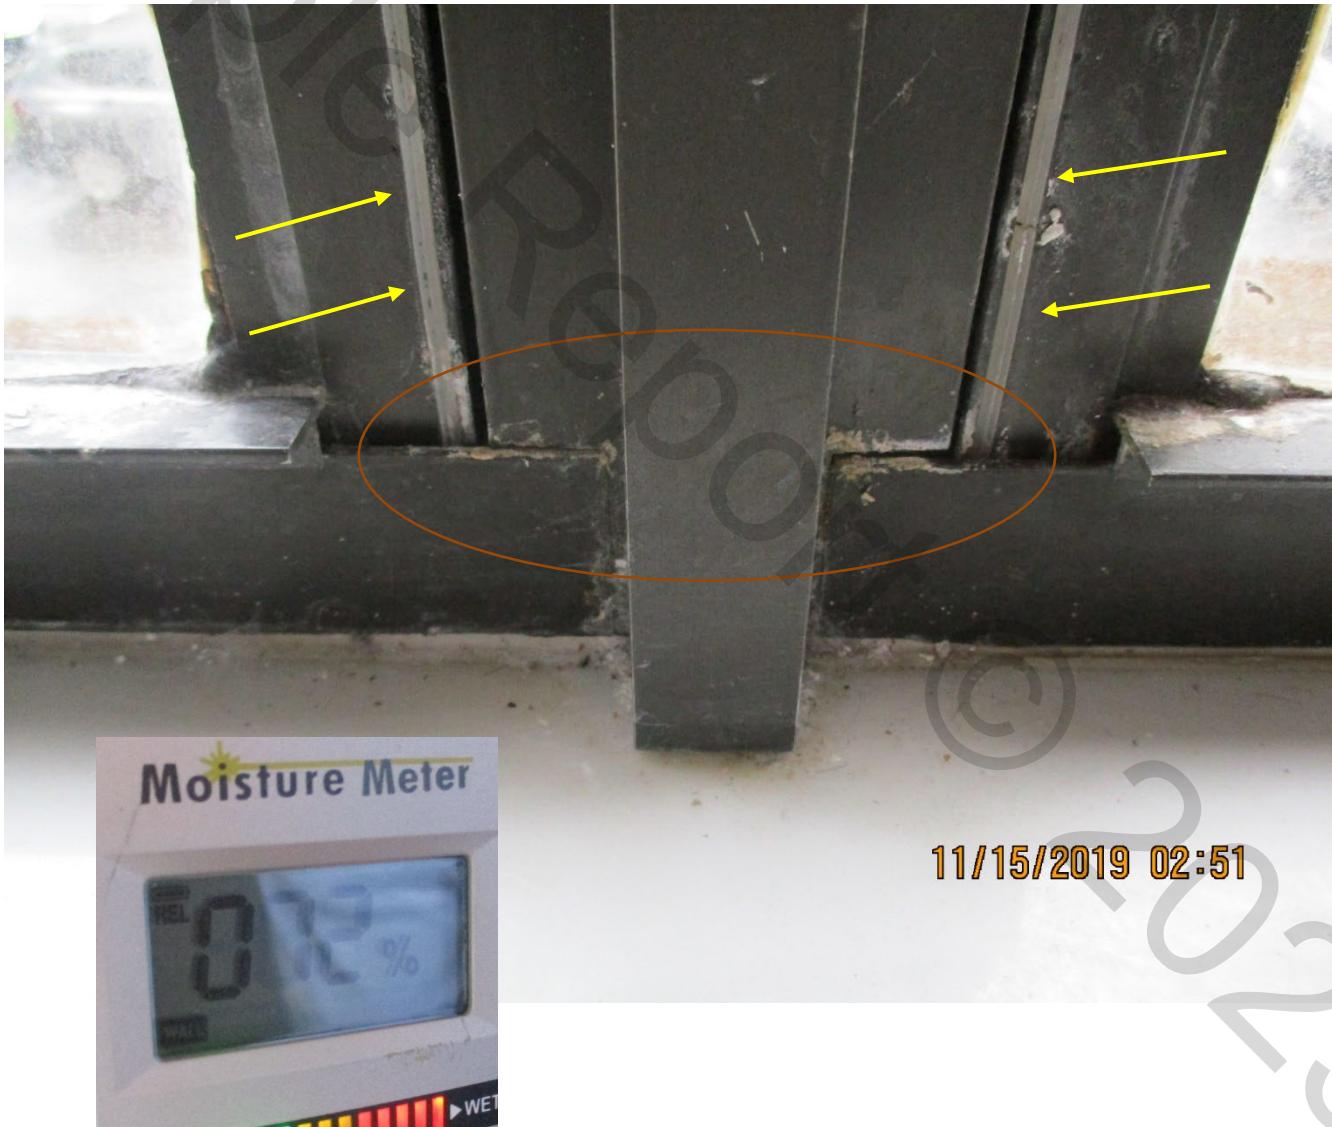
Picture #5

AN INTERIOR CASCADING DAMAGE PROFILE WITNESSED AT THE JAMB TO MULL BAR CONNECTION POINT OF A QUAD MULLED SINGLE HUNG WINDOW SYSTEM DISPLAYING EVIDENCE OF FRAME SEPARATION, LOOSE PANELS, AND MOISTURE DAMAGE. – BLDG B – UNIT B-2D – LIVING ROOM (NOTE - PICTURES # 4, 5 AND 6 ARE A PHOTO SERIES FROM THE SAME SPECIMEN)

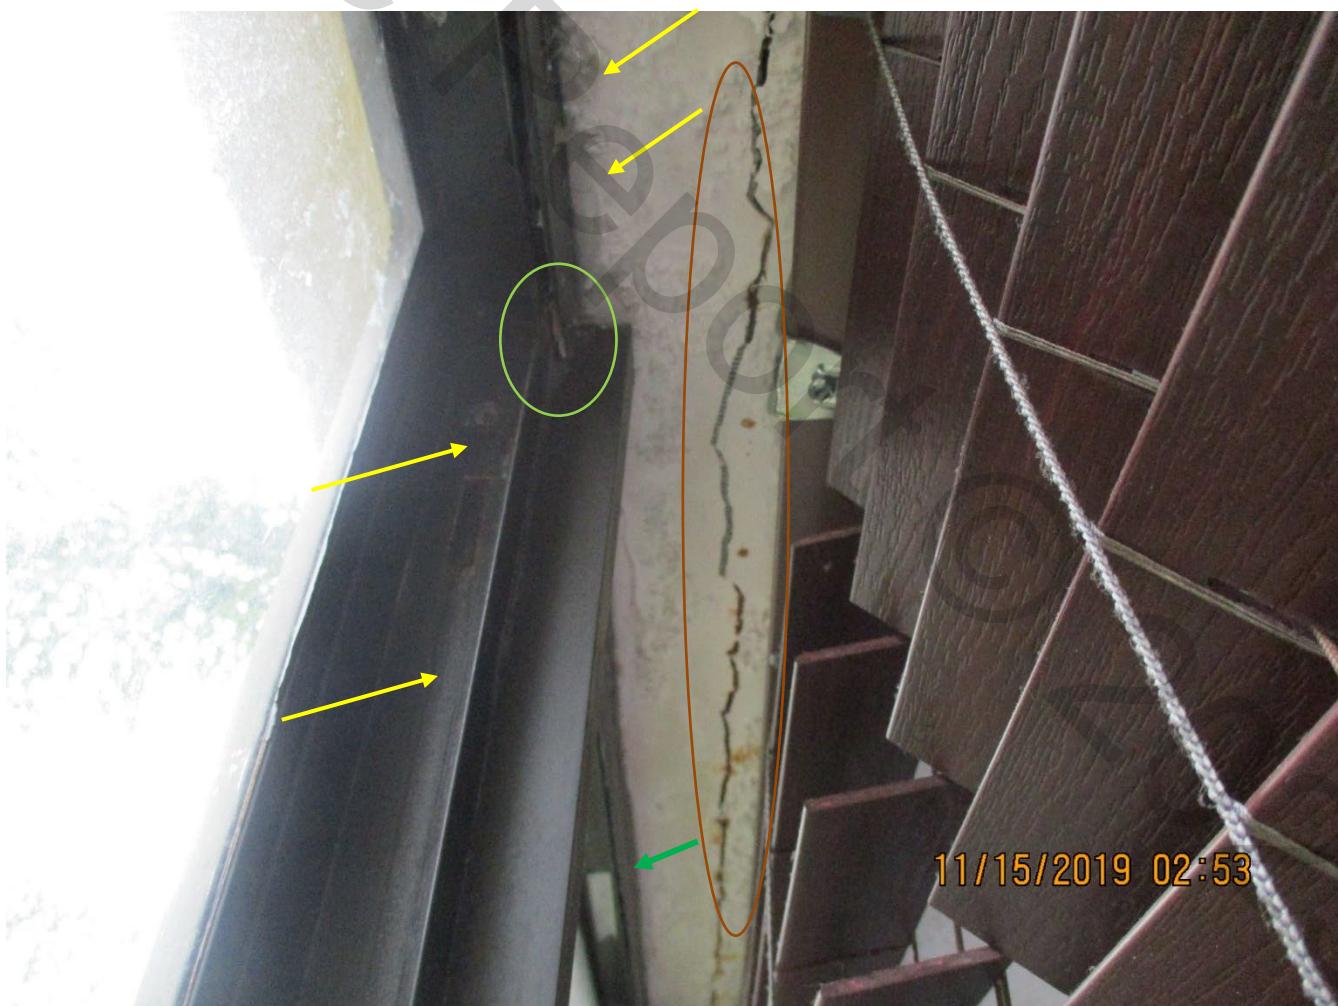
Picture #6

AN INTERIOR CASCADING DAMAGE PROFILE WITNESSED AT THE HEADER TO MULL BAR CONNECTION POINT OF A QUAD MULLED SINGLE HUNG WINDOW SYSTEM DISPLAYING EVIDENCE OF HEADER MOVEMENT WITH SUBSEQUENT FRAME SEPARATION. ADDITIONAL PHYSICAL DAMAGES ALSO WITNESSED ON THIS SPECIMEN INCLUDES MOISTURE PENETRATION, COVER PLATE DAMAGE, AND INTERIOR FINISH DISTRESS. - BLDG B – UNIT B-2D – LIVING ROOM (NOTE - PICTURES # 4, 5 AND 6 ARE A PHOTO SERIES FROM THE SAME SPECIMEN)

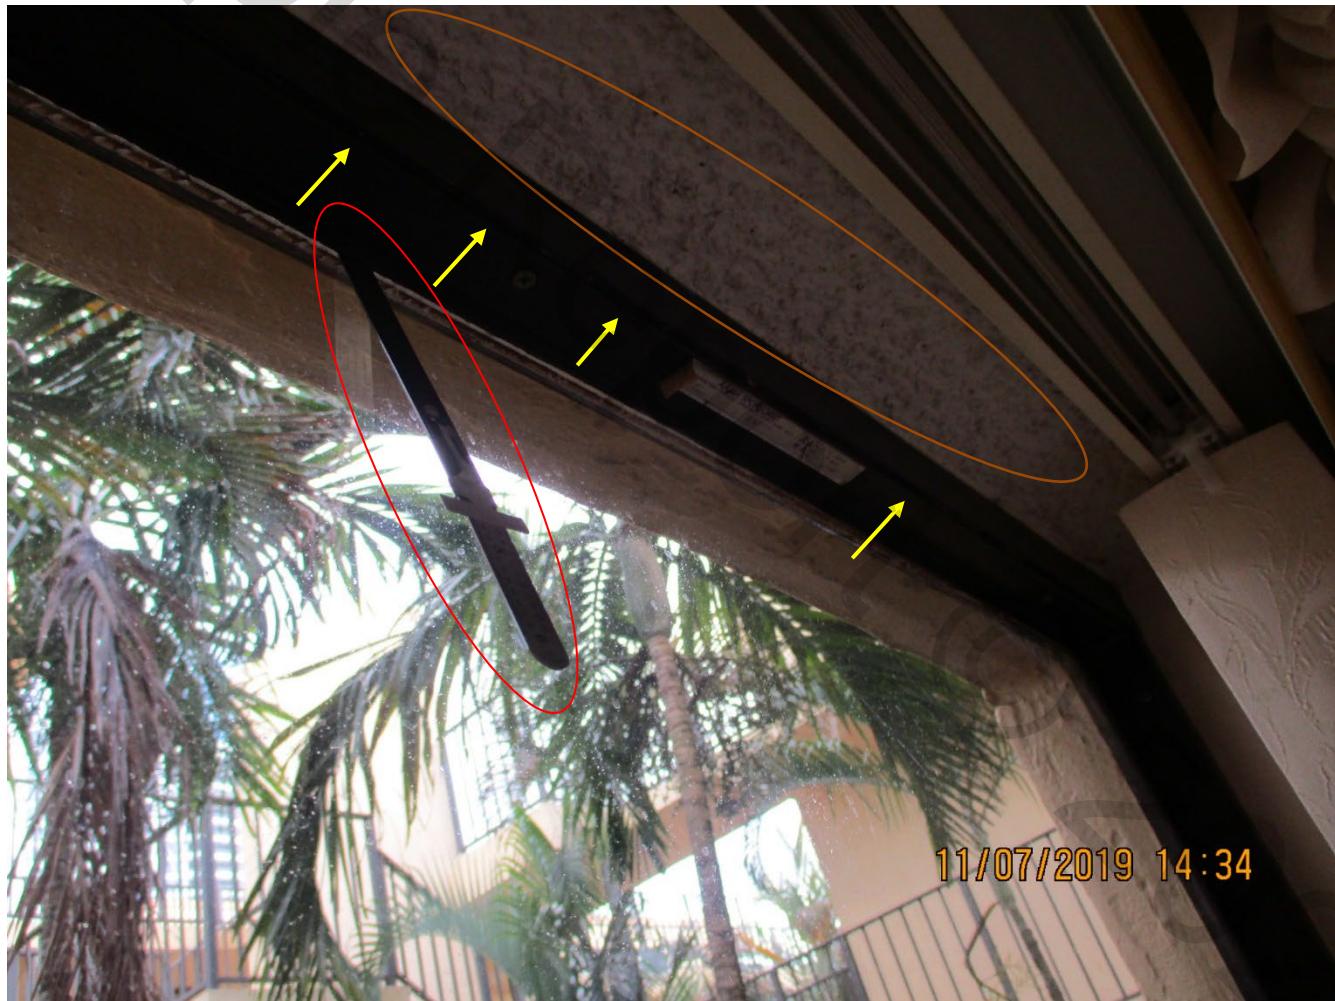
Picture #7

AN INTERIOR CASCADING DAMAGE PROFILE WITNESSED AT THE HEADER FRAME MEMBER OF A DOUBLE MULLED SINGLE HUNG WINDOW SYSTEM DISPLAYING EVIDENCE OF COVER PLATE DAMAGE, MOISTURE PENETRATION AND VISUAL SIGNS OF DEGLAZING.
– BLDG A – UNIT A-3M – DINING ROOM (NOTE- THE DEPTH GAUGE IN THIS PHOTOGRAPH IS ONLY BEING USED TO DEMONSTRATE THE AMOUNT OF DEGLAZING THE SYSTEM SUFFERED.)

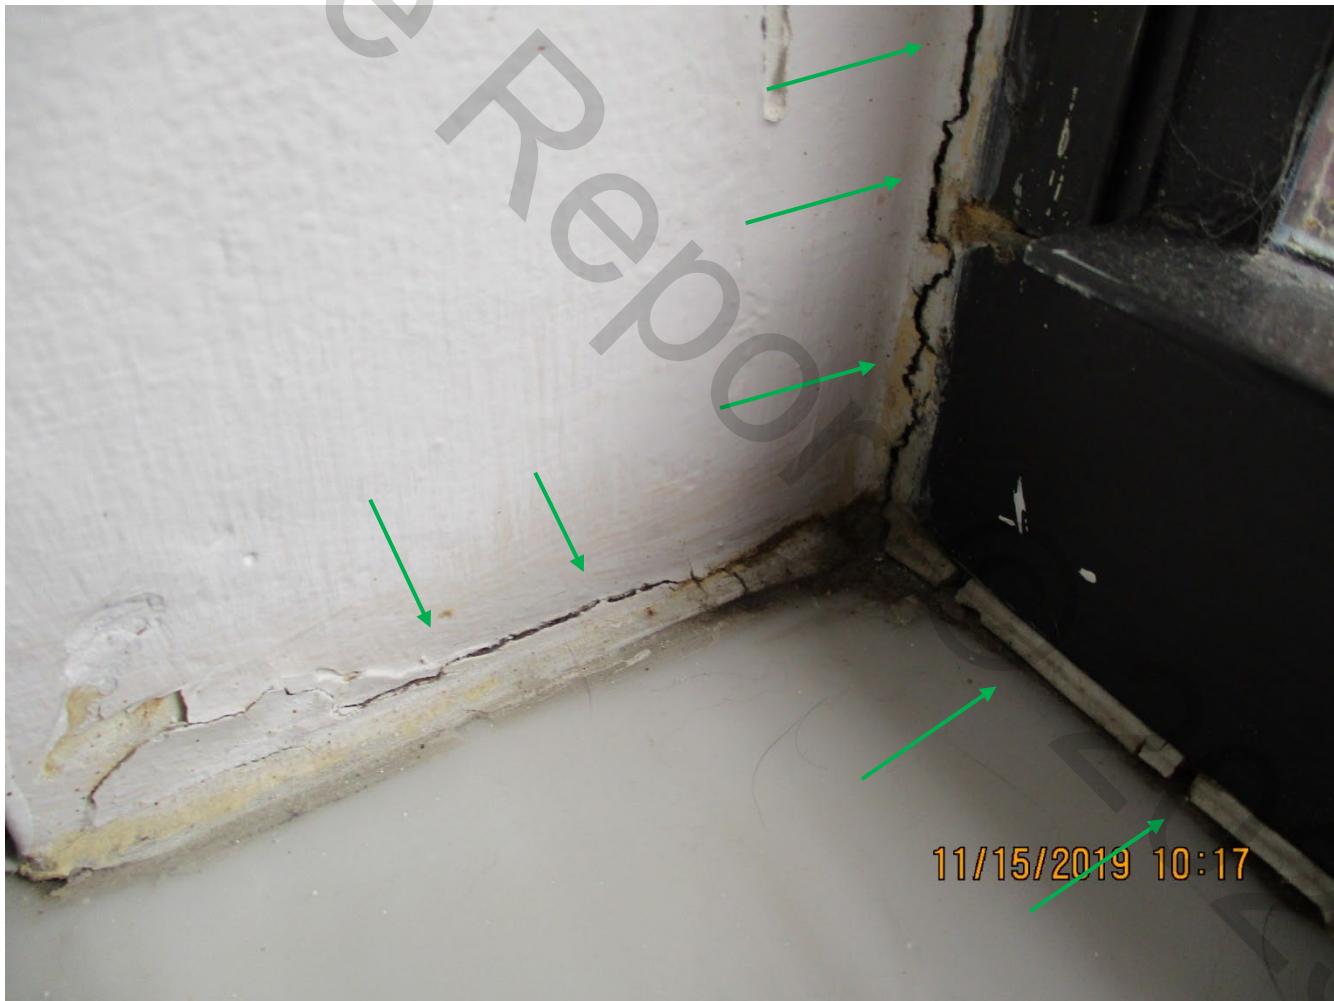
Picture #8

AN INTERIOR CASCADING DAMAGE PROFILE SHOWN AT THE RIGHT JAMB TO SILL CONNECTION POINT OF A QUAD MULLED SINGLE HUNG WINDOW SYSTEM DISPLAYING EVIDENCE OF SYSTEM MOVEMENT WITH SUBSEQUENT INTERIOR FINISH DISTRESS. ADDITIONAL PHYSICAL DAMAGES ALSO WITNESSED ON THIS SPECIMEN INCLUDES SILL SEPARATION AND MOISTURE PENETRATION. – BLDG B – UNIT B-1C – LIVING ROOM

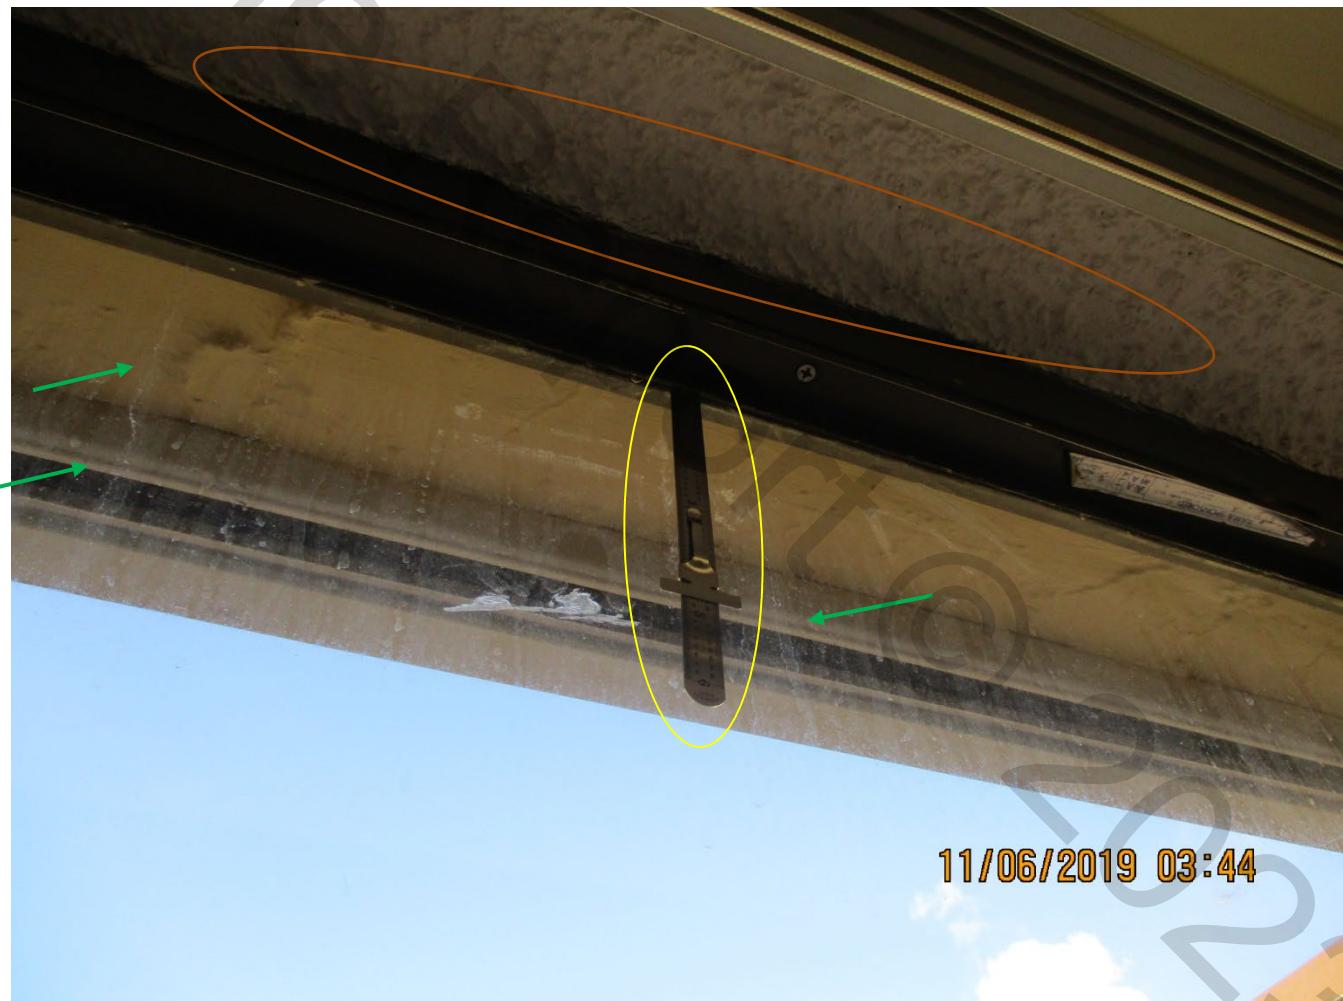
Picture #9

AN INTERIOR CASCADING DAMAGE PROFILE SHOWN AT THE HEADER FRAME MEMBER OF A DOUBLE MULLED SINGLE HUNG WINDOW SYSTEM DISPLAYING EVIDENCE OF HEADER MOVEMENT WITH SUBSEQUENT VISUAL SIGNS OF DEGLAZING. ADDITIONAL PHYSICAL DAMAGES ALSO WITNESSED ON THIS SPECIMEN INCLUDES MOISTURE PENETRATION AND COVER PLATE DAMAGE. – BLDG A – UNIT A-5H – DINING ROOM (NOTE- THE DEPTH GAUGE IN THIS PHOTOGRAPH IS ONLY BEING USED TO DEMONSTRATE THE AMOUNT OF DEGLAZING THE SYSTEM SUFFERED.)

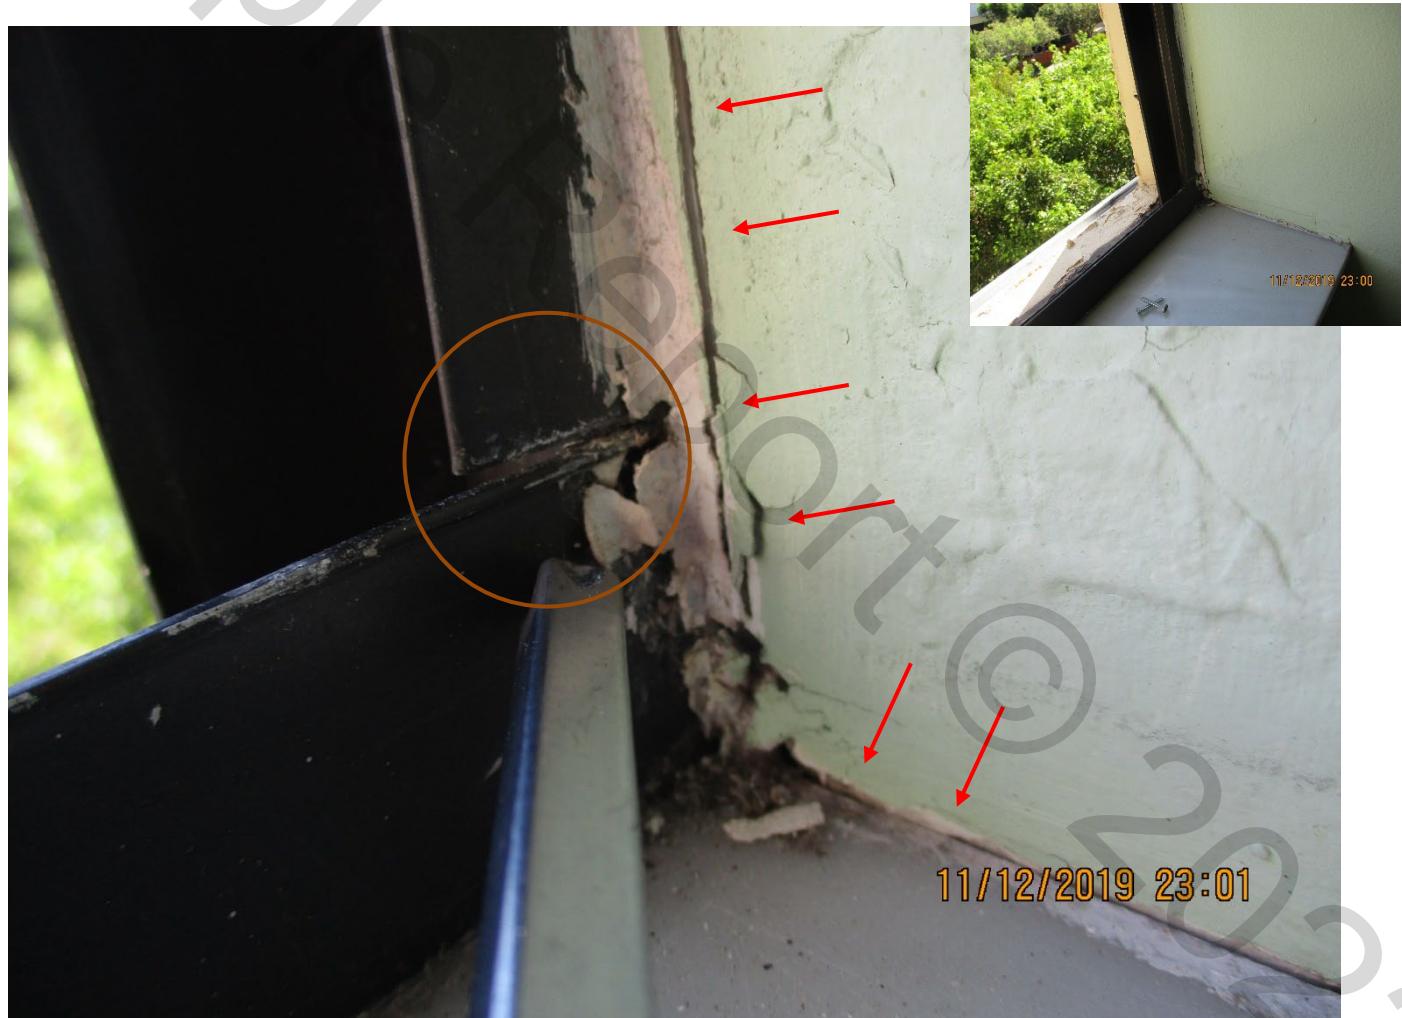
Picture #10

AN INTERIOR CASCADING DAMAGE PROFILE SHOWN AT THE RIGHT JAMB TO SILL CONNECTION POINT OF A SINGLE HUNG WINDOW SYSTEM DISPLAYING EVIDENCE OF FRAME SEPARATION, MOISTURE DAMAGE, AND INTERIOR FINISH DISTRESS. BLDG A – UNIT A-5R – 3RD BEDROOM

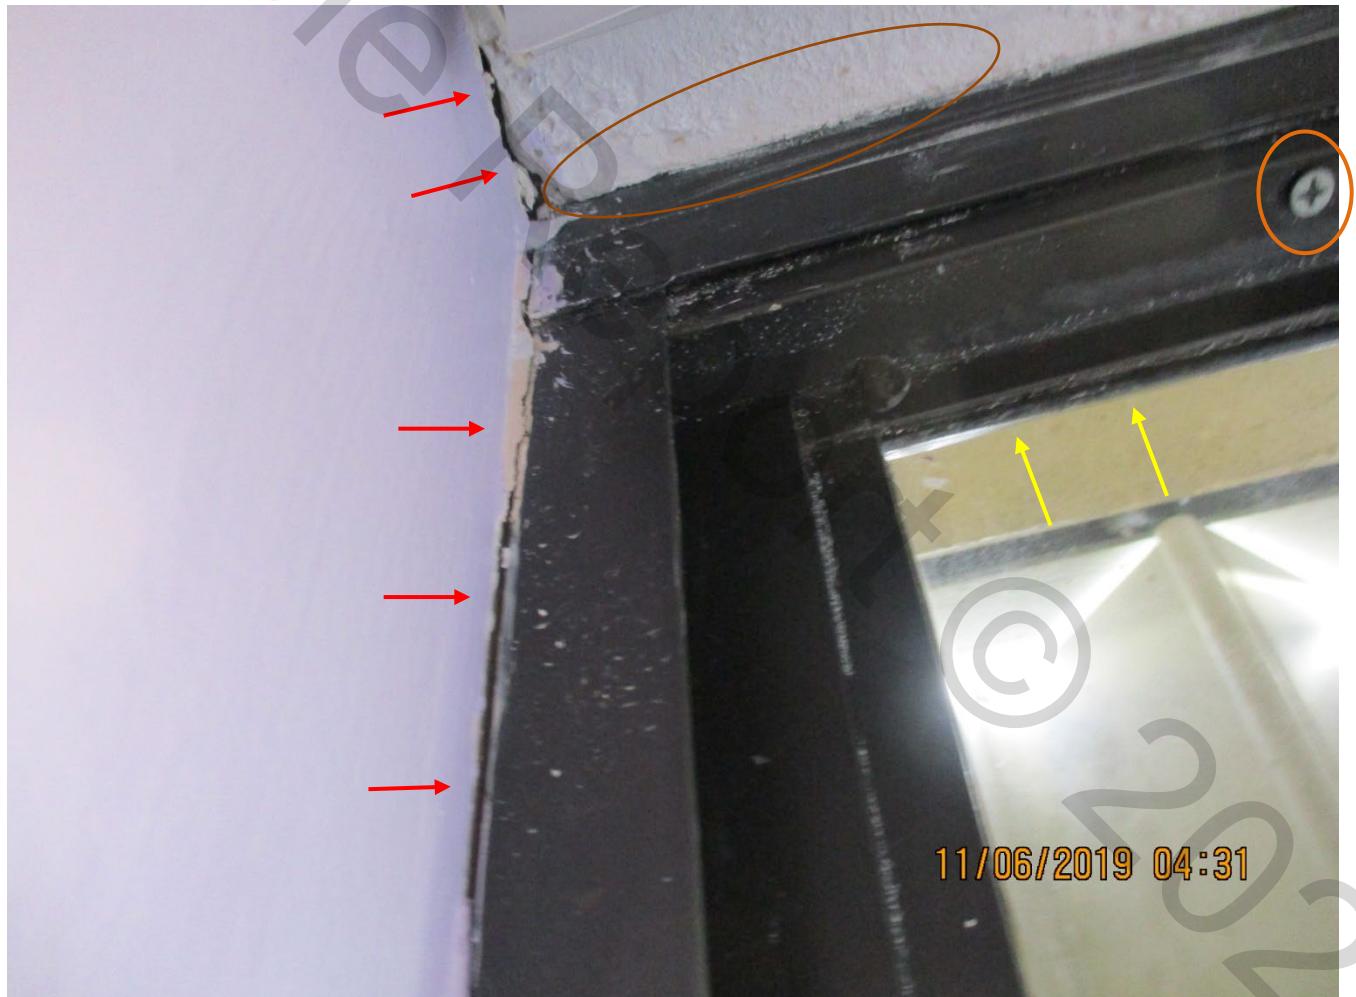
Picture #11

AN INTERIOR CASCADING DAMAGE PROFILE SHOWN AT THE HEADER TO LEFT JAMB CONNECTION POINT OF A DOUBLE MULLED SINGLE HUNG WINDOW SYSTEM DISPLAYING EVIDENCE OF SYSTEM MOVEMENT WITH SUBSEQUENT INTERIOR FINISH DISTRESS. ADDITIONAL PHYSICAL DAMAGES ALSO WITNESSED ON THIS SPECIMEN INCLUDES FASTENER DISTRESS, VISUAL SIGNS OF DEGLAZING AND MOISTURE PENETRATION. BLDG A – UNIT A-4Q – 2ND BEDROOM
