Glazing Inspection Report

XXXXXXXXXXXXXXXXXXXX
CONDOMINIUM ASSOCIATION.
1234 NE Testing Street
Anytown, USA
SAMPLE - Report date XXXXXXXX

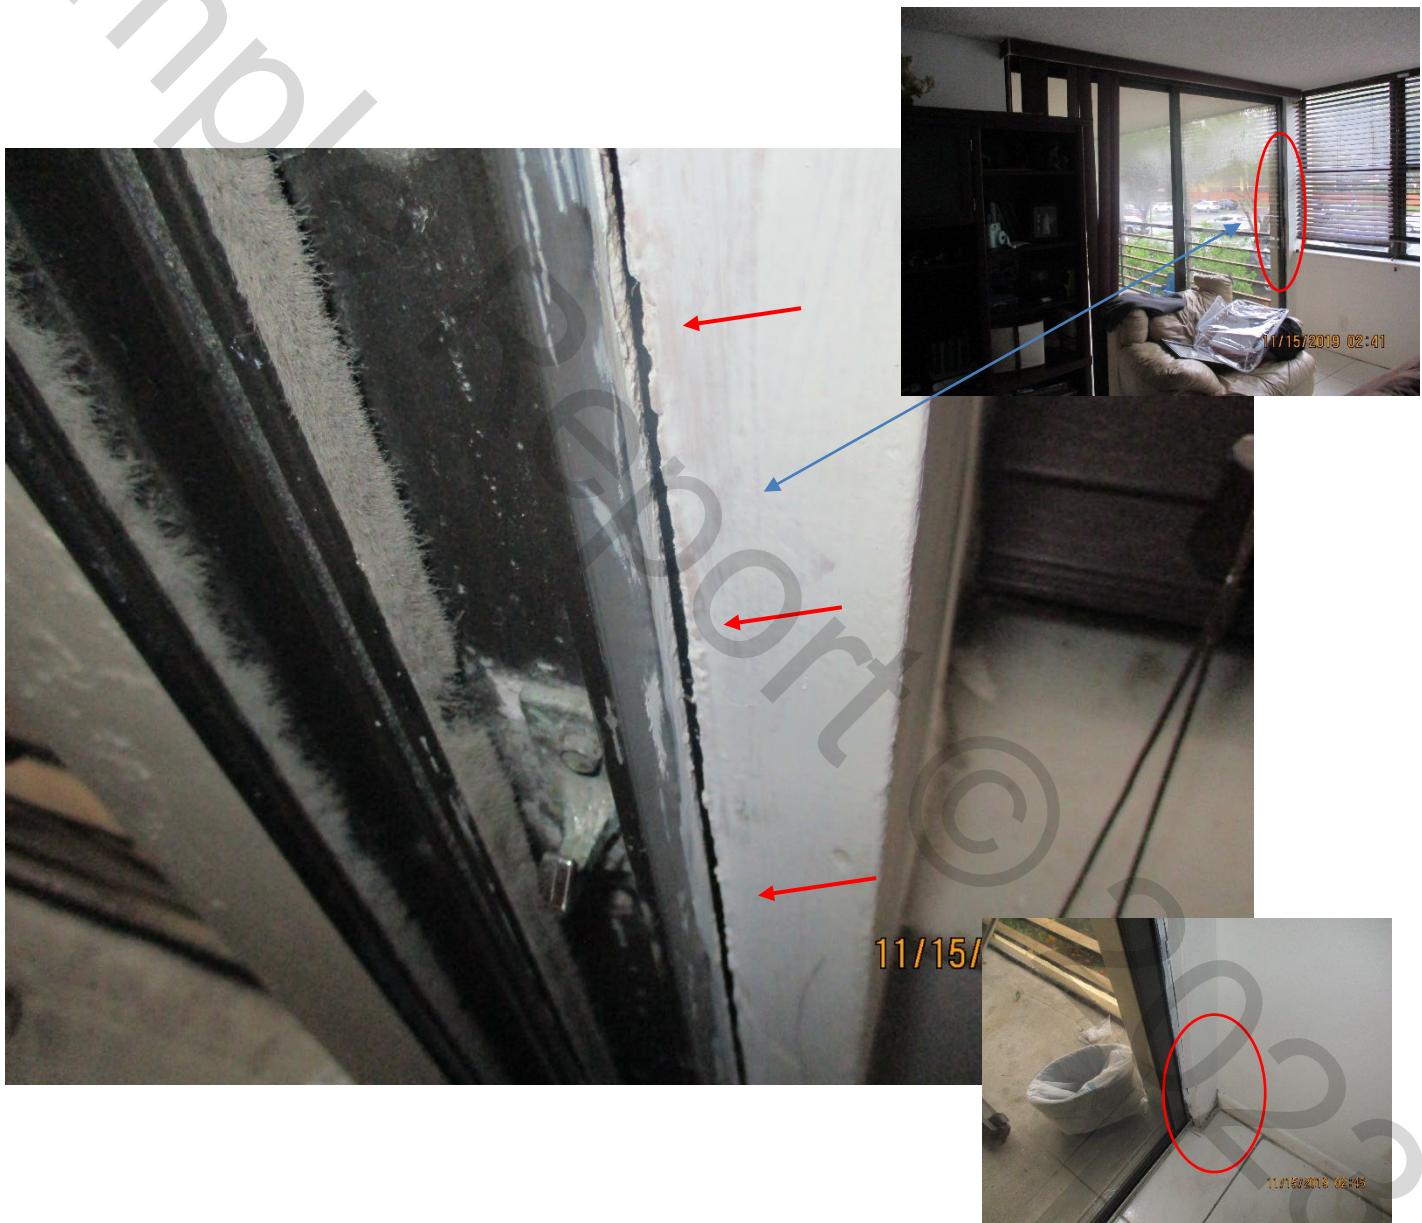
Picture #12

AN INTERIOR PHOTO SHOWN AT THE RIGHT JAMB OF A TWO PANEL SLIDING GLASS DOOR SYSTEM DISPLAYING EVIDENCE OF SYSTEM FRAME MOVEMENT WITH SUBSEQUENT MOISTURE DAMAGE. - BLDG B – UNIT B-2D – LIVING ROOM

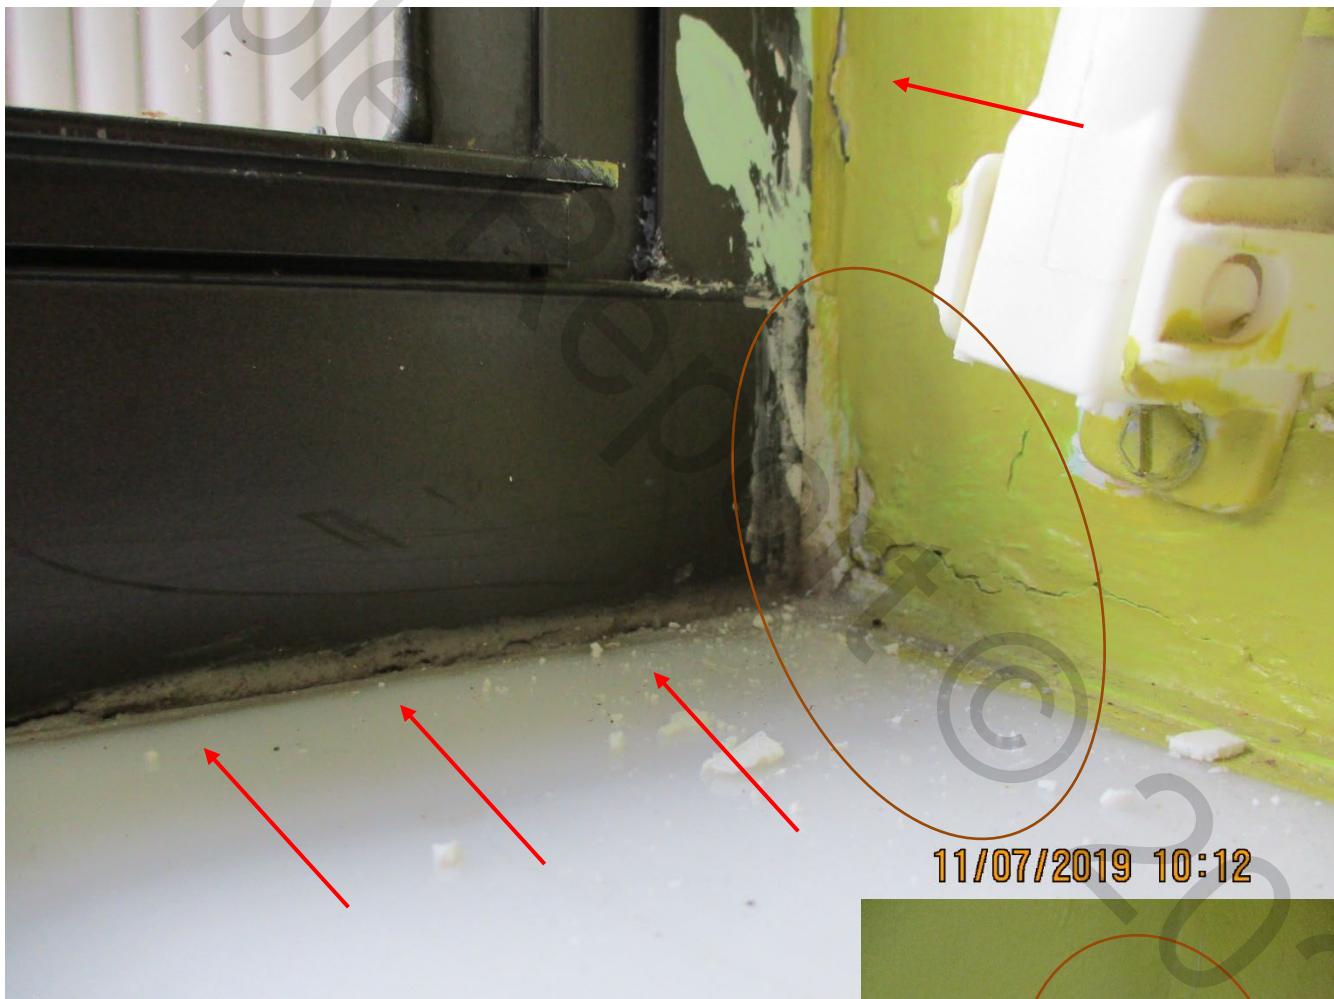
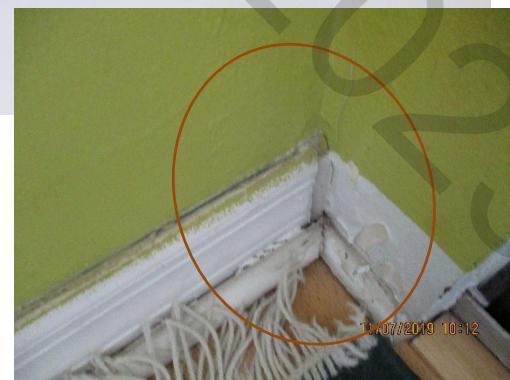
Picture #13

AN INTERIOR CASCADING DAMAGE PROFILE SHOWN AT THE RIGHT JAMB TO SILL CONNECTION POINT OF A QUAD MULLED SINGLE HUNG WINDOW SYSTEM DISPLAYING EVIDENCE OF SYSTEM MOVEMENT WITH SUBSEQUENT INTERIOR FINISH DISTRESS. ADDITIONAL PHYSICAL DAMAGES ALSO WITNESSED ON THIS SPECIMEN INCLUDES SILL MOVEMENT AND MOISTURE PENETRATION. - BLDG A – UNIT A-2R – LIVING ROOM

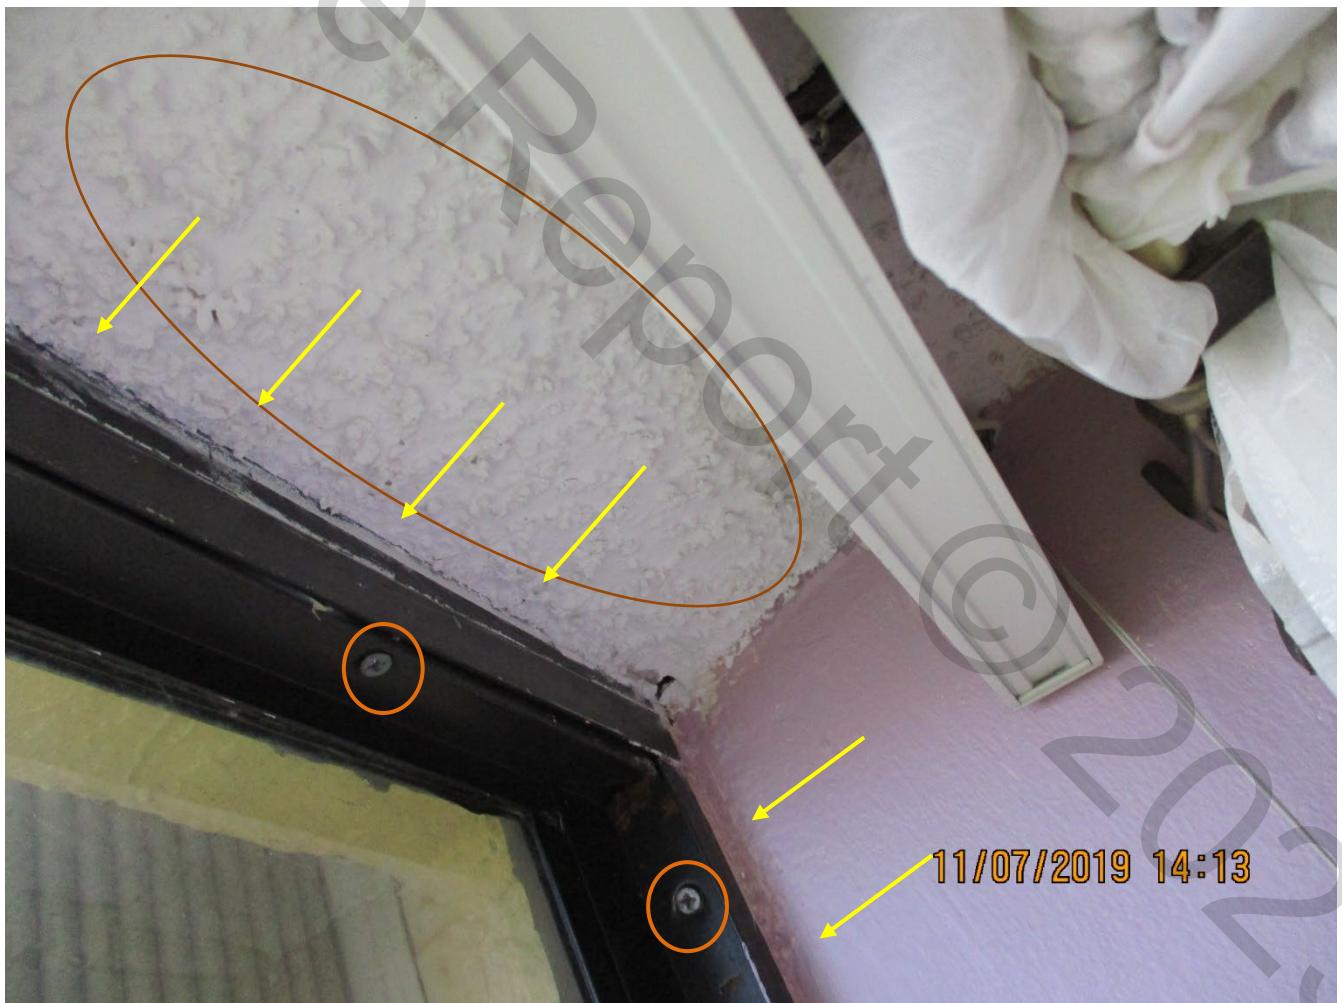
Picture #14

A CASCADING DAMAGE PROFILE SHOWN AT THE HEADER TO RIGHT JAMB CONNECTION POINT OF A QUAD MULLED SINGLE HUNG WINDOW SYSTEM DISPLAYING EVIDENCE OF SYSTEM MOVEMENT WITH SUBSEQUENT INTERIOR FINISH DISTRESS. ADDITIONAL PHYSICAL DAMAGES ALSO WITNESSED ON THIS SPECIMEN INCLUDES 1. MOISTURE PENETRATION AND FASTENER DISTRESS - BLDG A – UNIT A-3C – LIVING ROOM
