Mrs. [REDACTED] [REDACTED] Residence  
[REDACTED] Beach, Florida  
Installation Verification Inspection  
FINAL – 3-25-22

**Re: Installation Verification and Testing Structural Glazing Assessment**

TSSA Project # [REDACTED] - Installation Verification/Testing [REDACTED]  
[REDACTED] Beach - 2022-2-23

Final Report Version – 3/25/2022

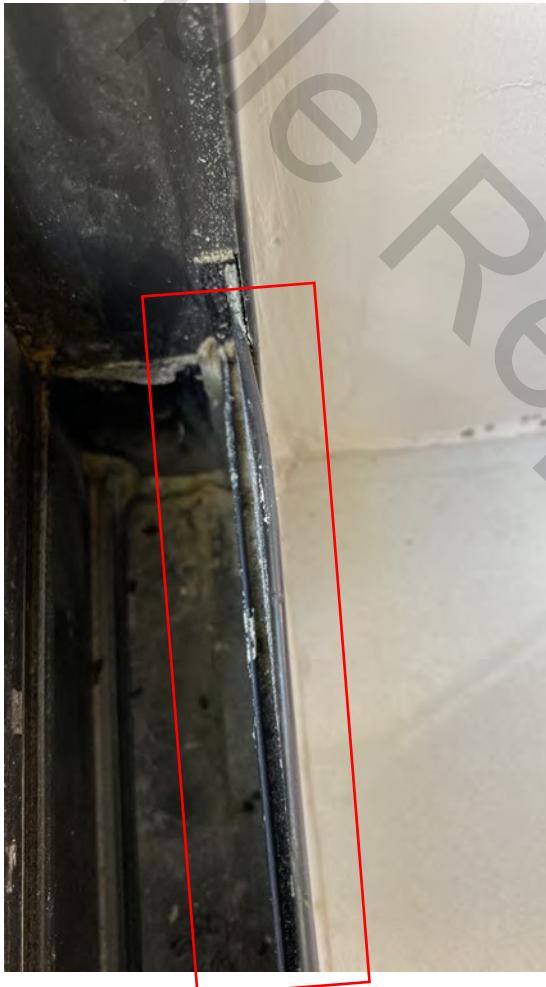
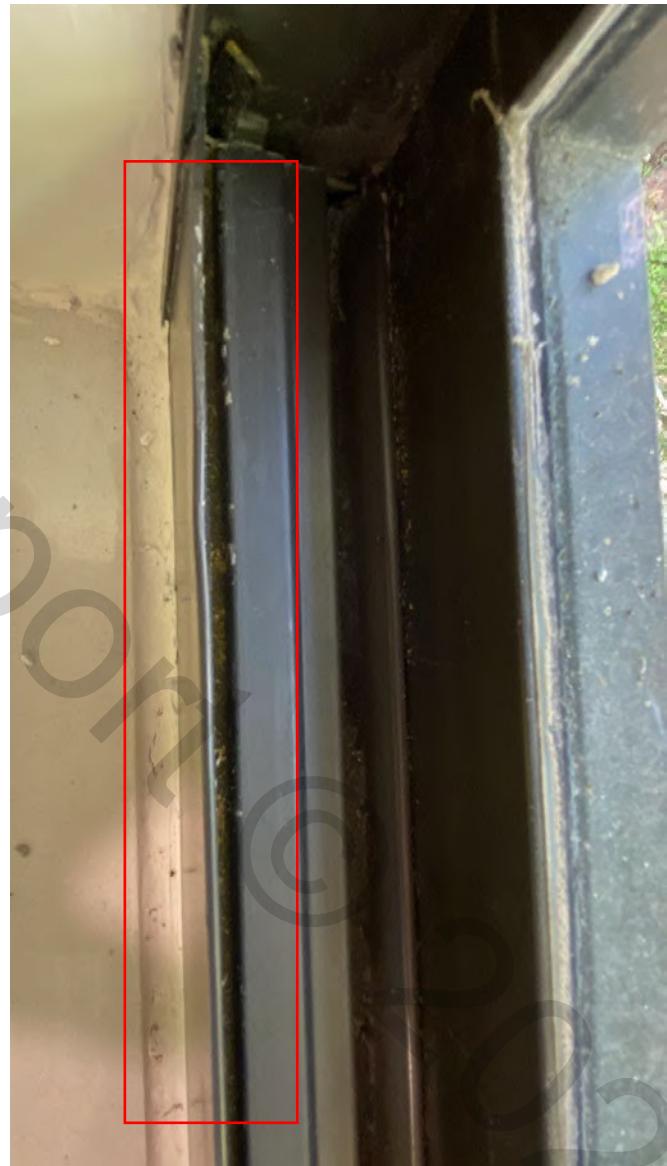
Sill Riser is bent and separated from its installed positions.

Sill Riser is bent and shows signs of being hammered back into position. This damage is due to manipulating the frame into position during the installation.

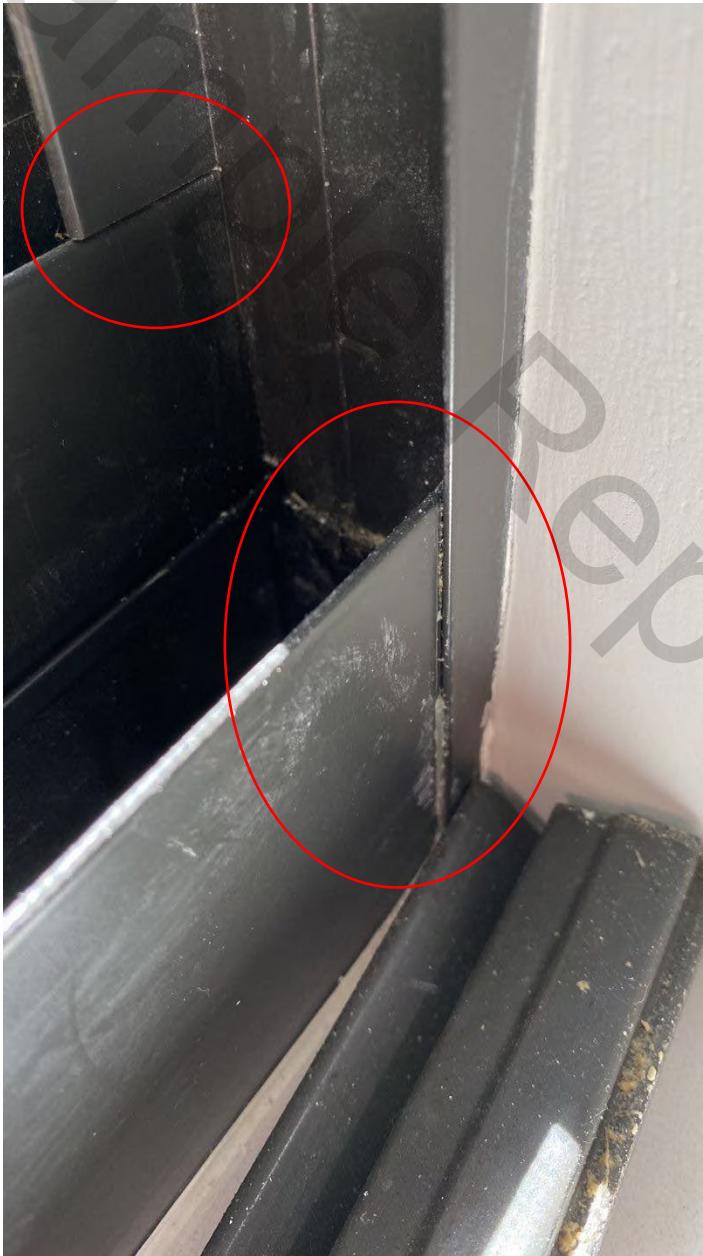
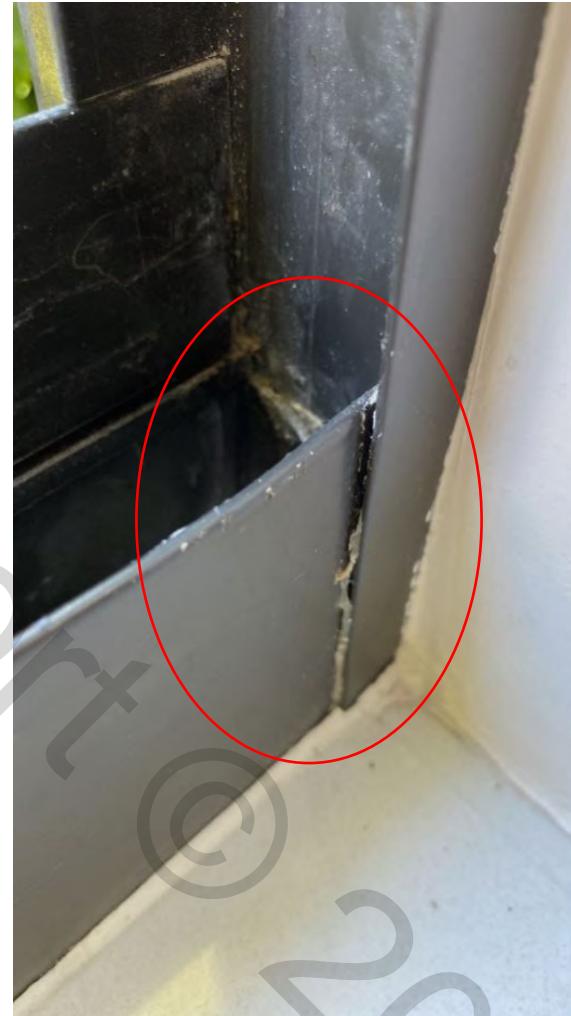
Frame Bending and Sealant Disruption is witnessed at the sill riser to jamb connection point and Glazing Style.

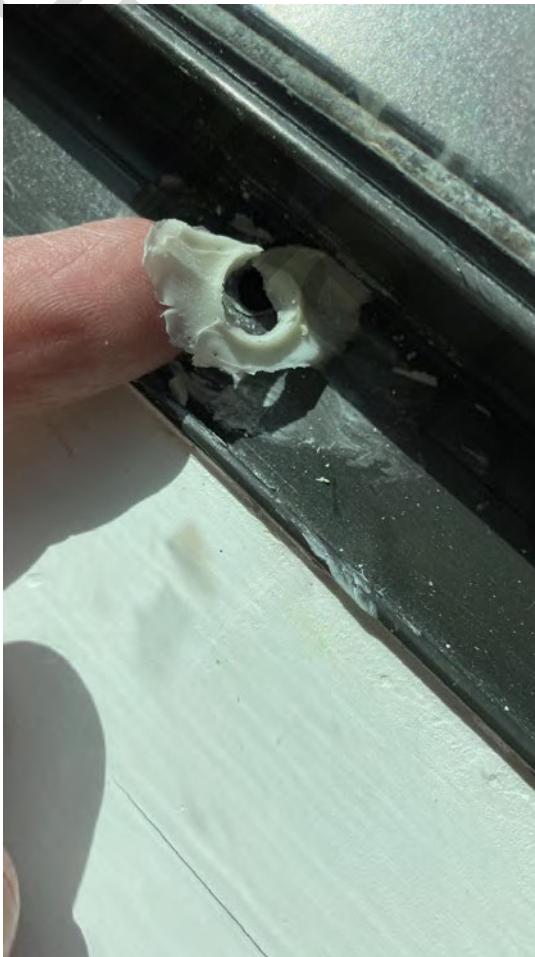
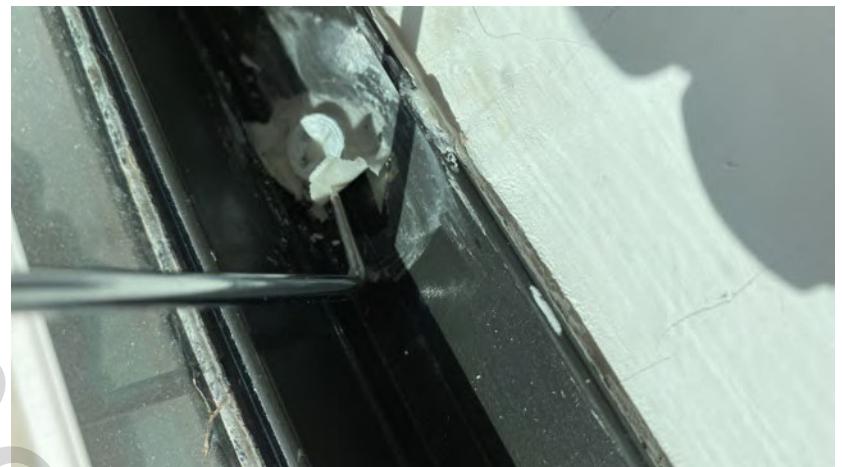
Sill Fastener Head appears to be covered with a hard, dense plastic material, not specified sealant as per best practices.

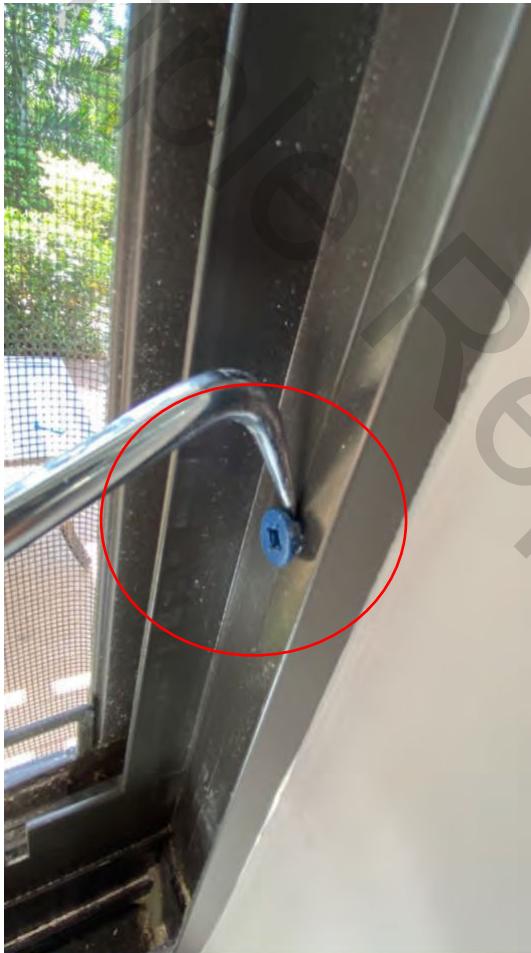
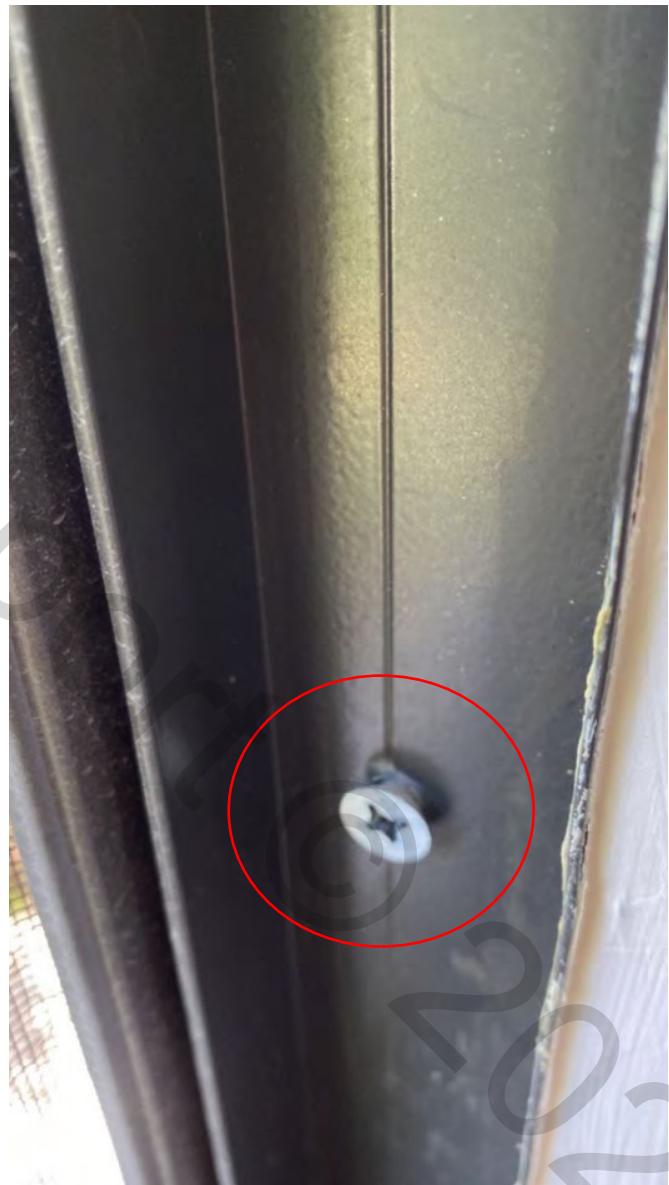
System Frame Fastener Hole does not have a conical to receive the fastener head.

Fasteners not seated within Conical.

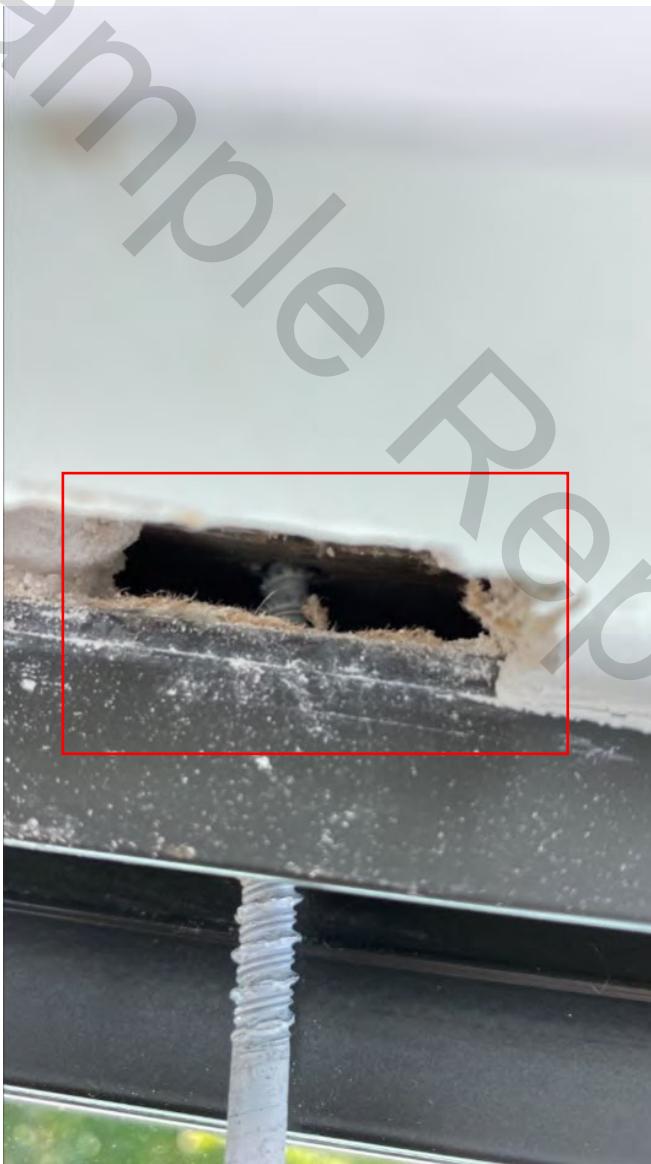
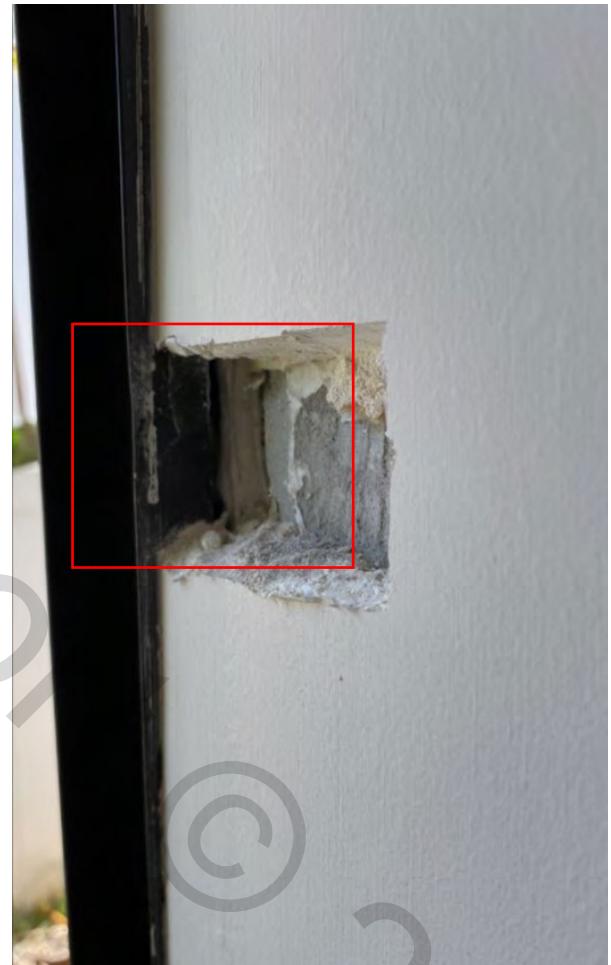
Frame is not completely supported.

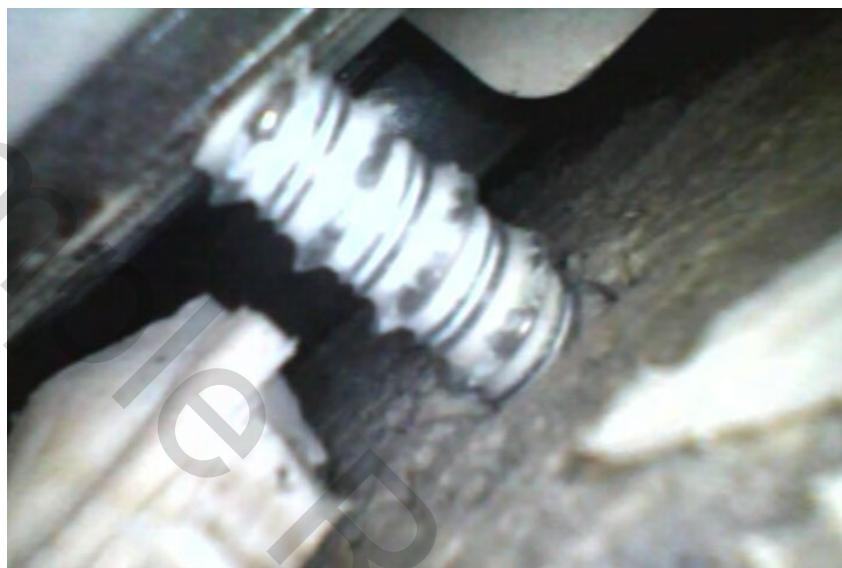
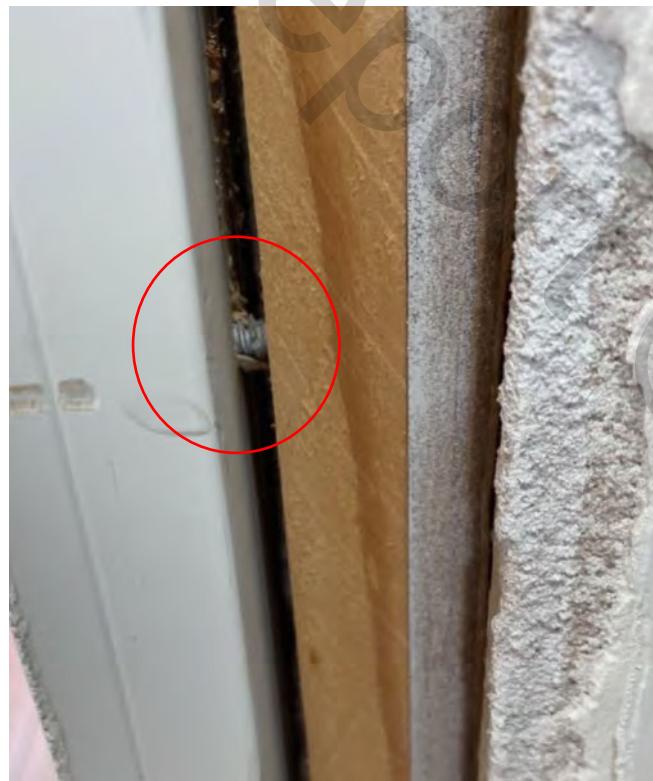
No Shims were used during installation.

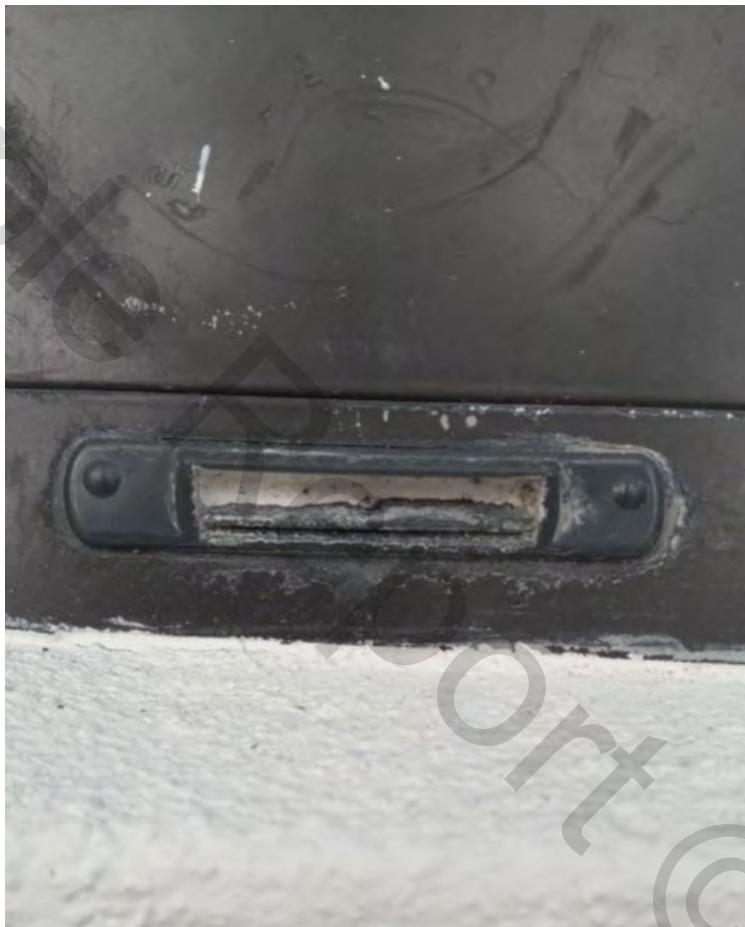
Weeping system was rendered un-functional from the interior of the sill track with Cementous material.

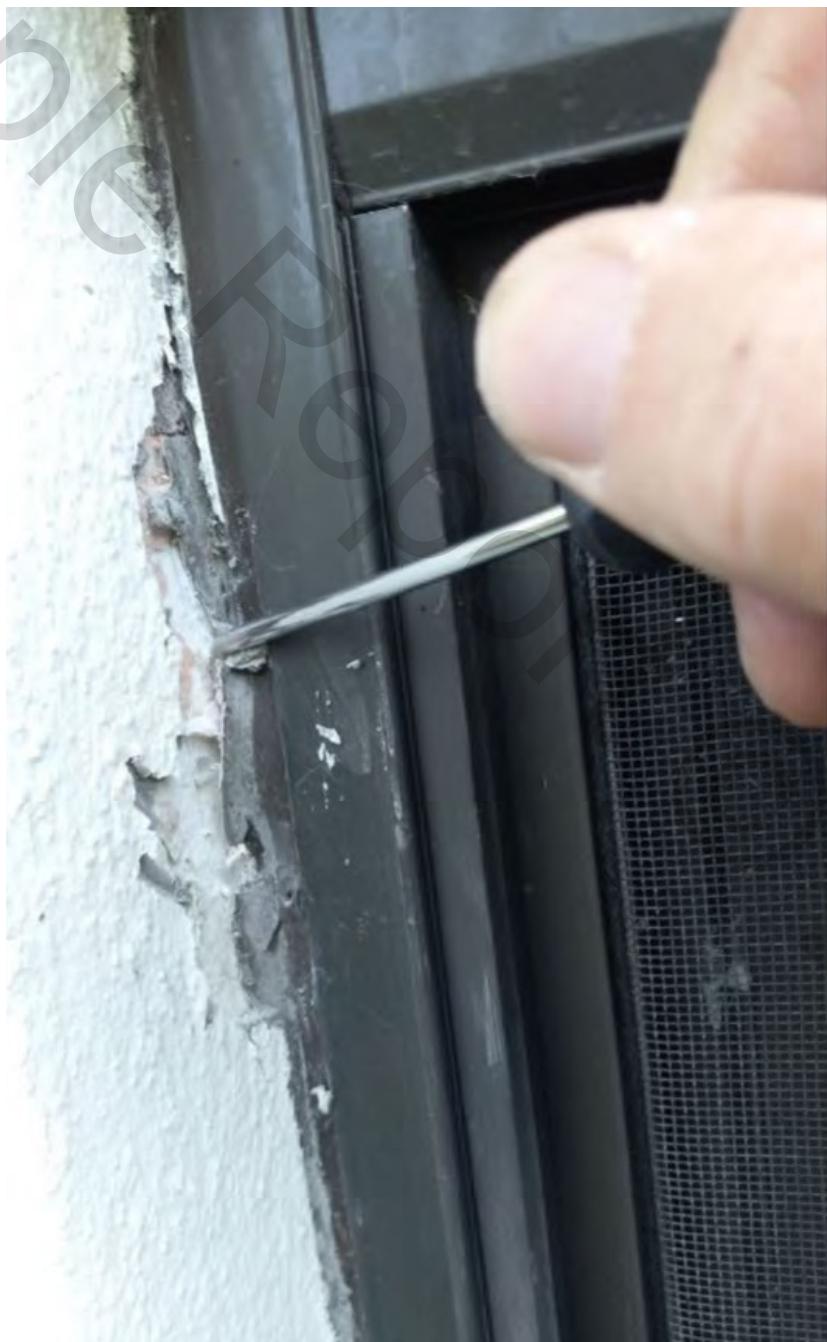
Window was installed over old stucco, and new stucco was installed after window was installed. As a result, the primary seal between the window and the old stucco was not adhering upon inspection.

Sealant Adhesion Failure on both the Exterior Stucco and the aluminum frame.

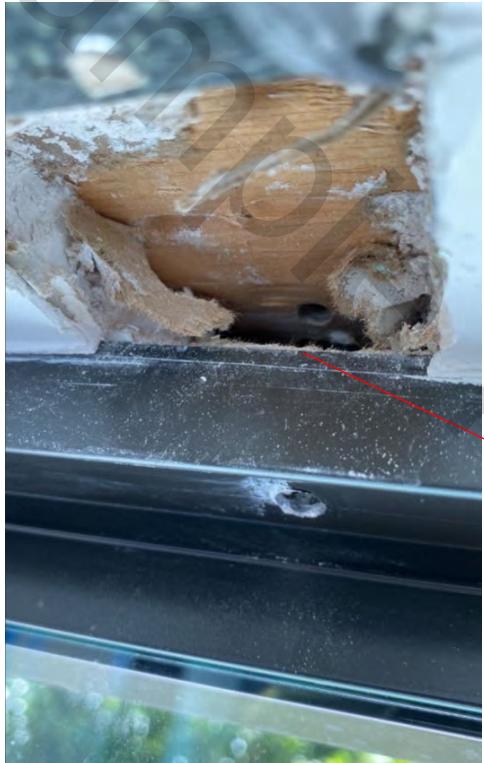
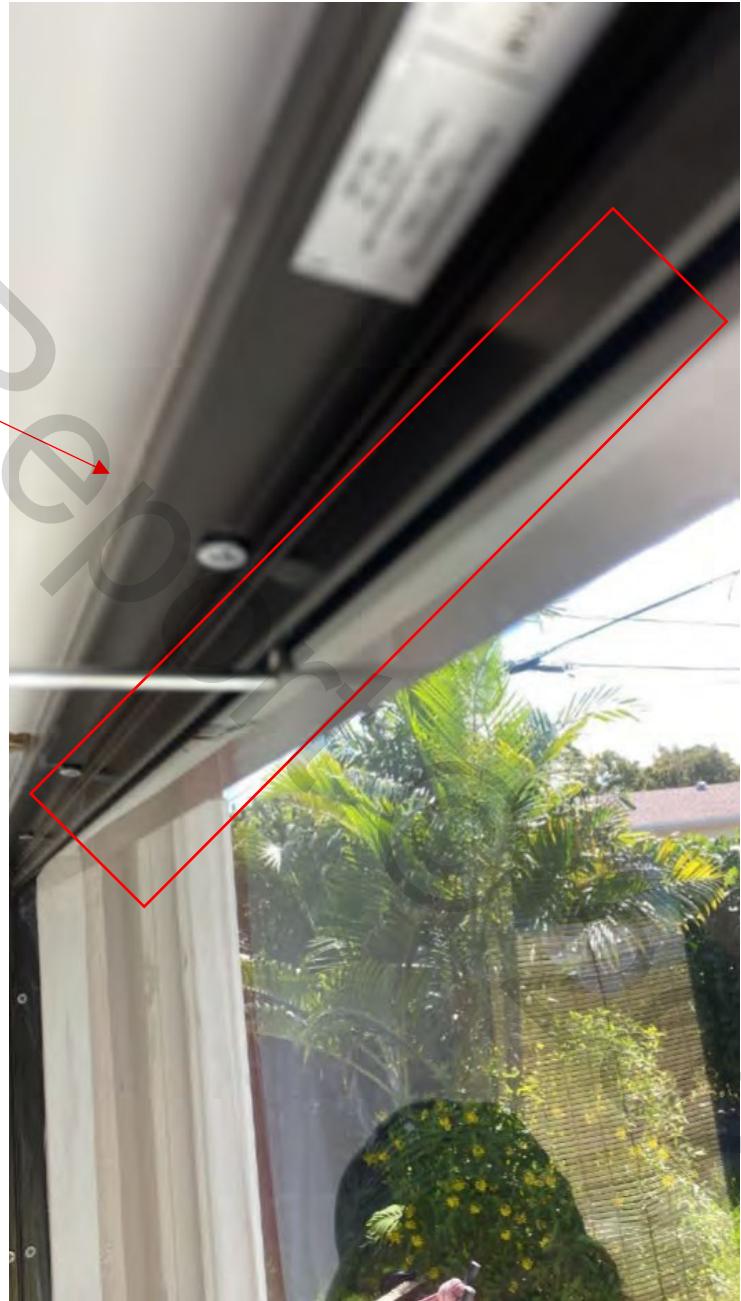
The frame was Torqued due to no Shims being used to the point of affecting the glazing leg pulling the frame member away from the installed glass lite.

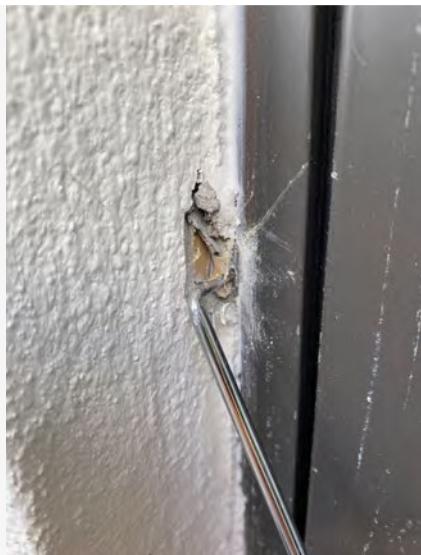
3

Window was installed over old stucco and new stucco was installed after window was installed. Primary seal between the window and the old stucco was not adhering upon inspection

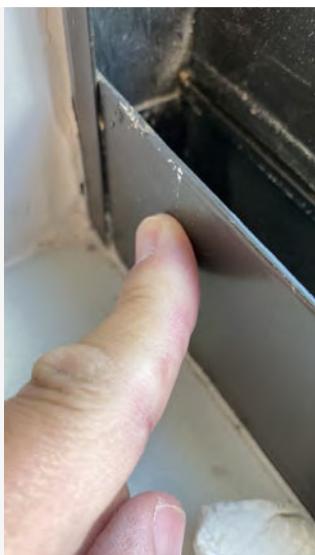
30

Sill Riser is bent and shows signs of being hammered back into position. This damage is due to manipulating the frame into position during the installation

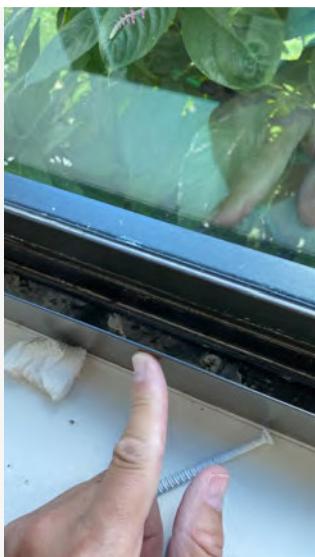
33

Sill Riser is bent and shows signs of being hammered back into position. This damage is due to manipulating the frame into position during the installation

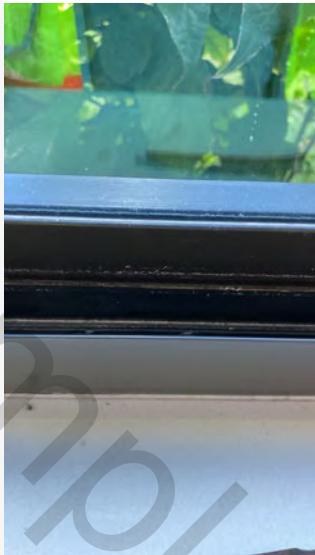
34

Sill Riser is bent and shows signs of being hammered back into position. This damage is due to manipulating the frame into position during the installation

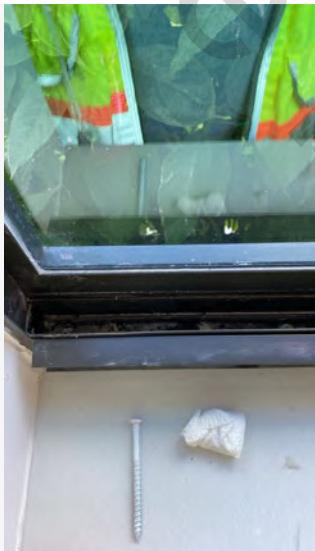
35

Straight Edge placed against Sill Riser to demonstrate the degree of bending the Sill Riser has been subjected to during the Installation Process

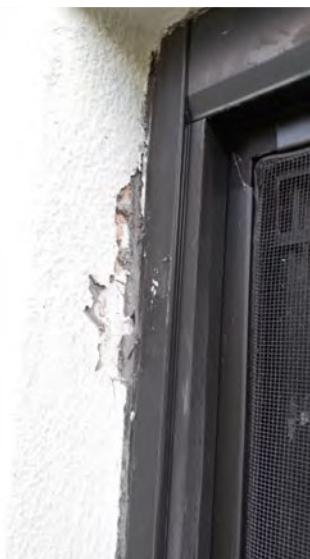
3

Window was installed over old stucco and new stucco was installed after window was installed. Primary seal between the window and the old stucco was not adhering upon inspection  
Sealant Adhesion Failure on both the Exterior Stucco as well as the aluminum frame

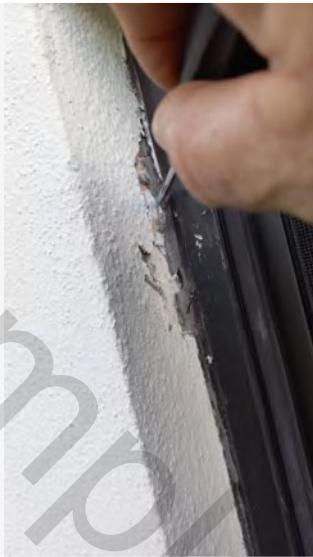
4

Window was installed over old stucco and new stucco was installed after window was installed. Primary seal between the window and the old stucco was not adhering upon inspection

Sealant Adhesion Failure on both the Exterior Stucco as well as the aluminum frame

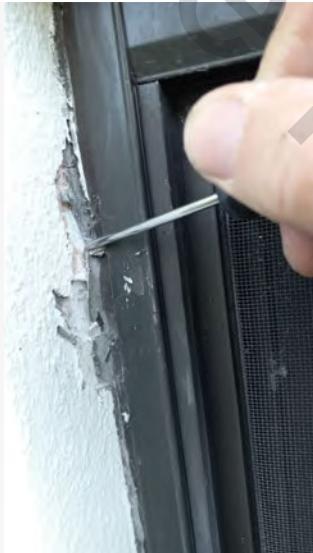
5

Window was installed over old stucco and new stucco was installed after window was installed. Primary seal between the window and the old stucco was not adhering upon inspection

Sealant Adhesion Failure on both the Exterior Stucco as well as the aluminum frame

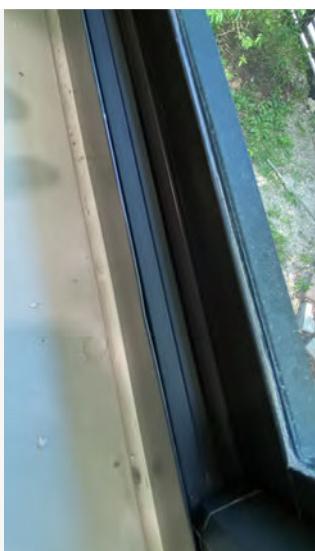
33

Sill Riser is bent and shows signs of being hammered back into position. This damage is due to manipulating the frame into position during the installation

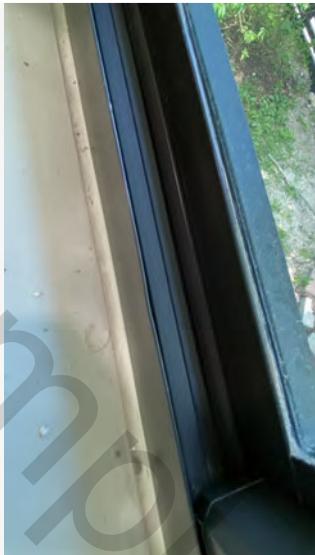
34

Sill Riser is bent and shows signs of being hammered back into position. This damage is due to manipulating the frame into position during the installation

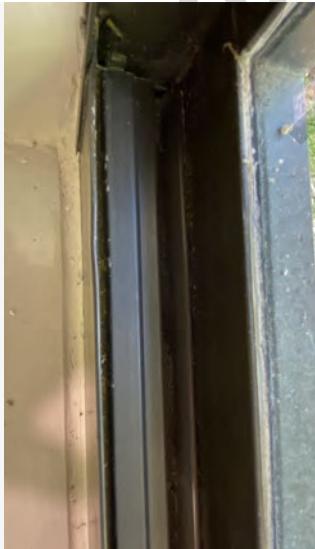
35

Sill Riser is bent and shows signs of being hammered back into position. This damage is due to manipulating the frame into position during the installation

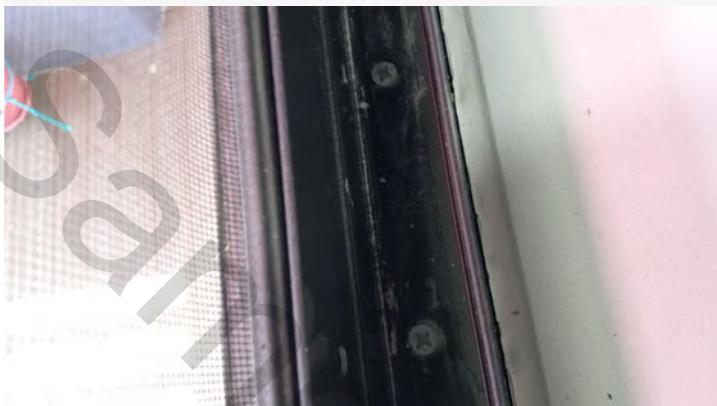
10

Sill Fastener Head appears to be covered with a hard dense plastic material not specified sealant as per best practices

Weeping system was rendered un-functional from the interior of the sill track with Cementous material

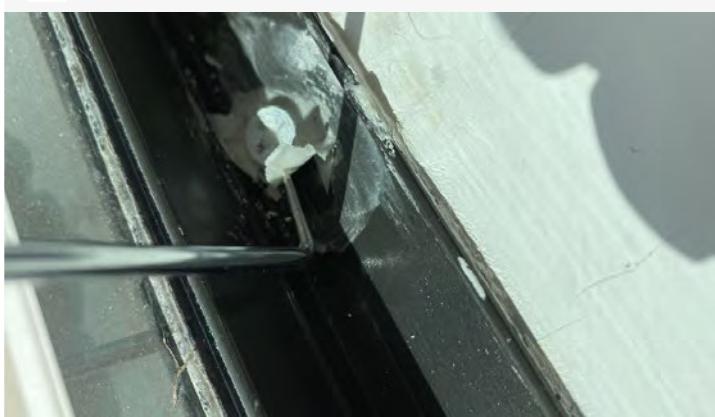
6

Sill Fastener Head appears to be covered with a hard dense plastic material not specified sealant as per best practices

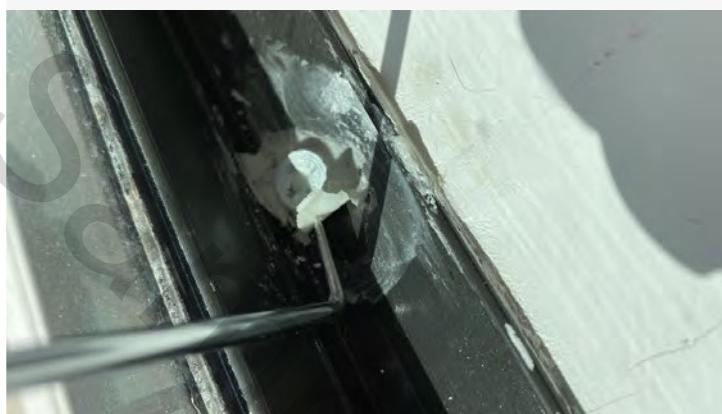
7

Sill Fastener Head appears to be covered with a hard dense plastic material not specified sealant as per best practices

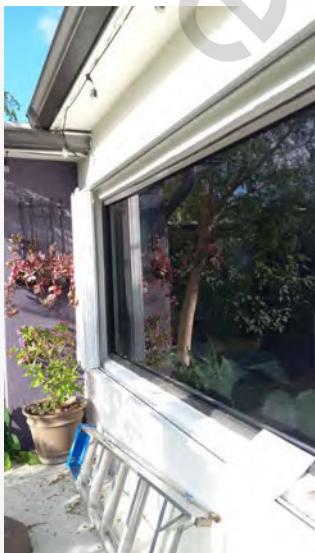
2

Frame was Torqued due to no Shims being used to the point of effecting the glazing leg pulling the frame member away from the installed glass lite.  
Frame Bowing visually evident.  
Glass stop disruption caused be frame bowing

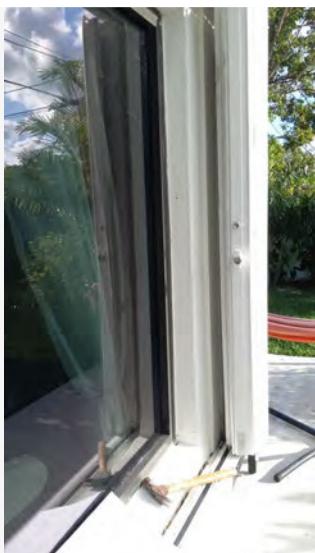
3

Re-bucking over Poured Column  
Stucco applied over the installation

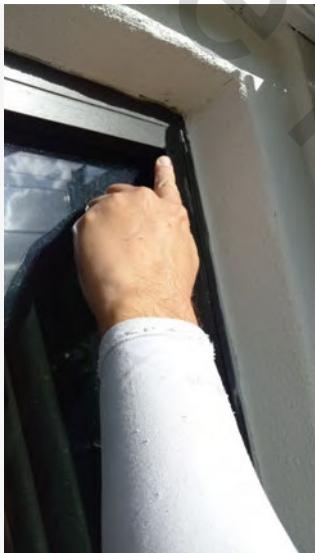
5

Frame was Torqued due to no Shims being used to the point of effecting the glazing leg pulling the frame member away from the installed glass lite.

Frame Bowing visually evident.

Glass stop disruption caused be frame bowing

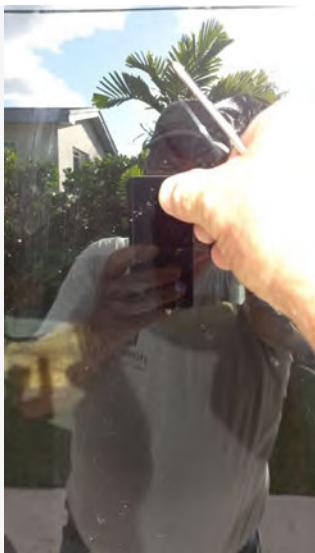
6

chips in glass

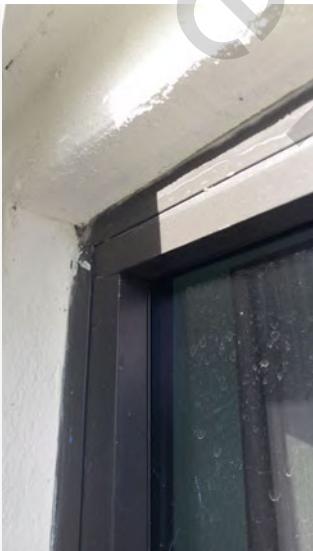
8

Frame was Torqued due to no Shims being used to the point of effecting the glazing leg pulling the frame member away from the installed glass lite.

Frame Bowing visually evident.

Glass stop disruption caused be frame bowing

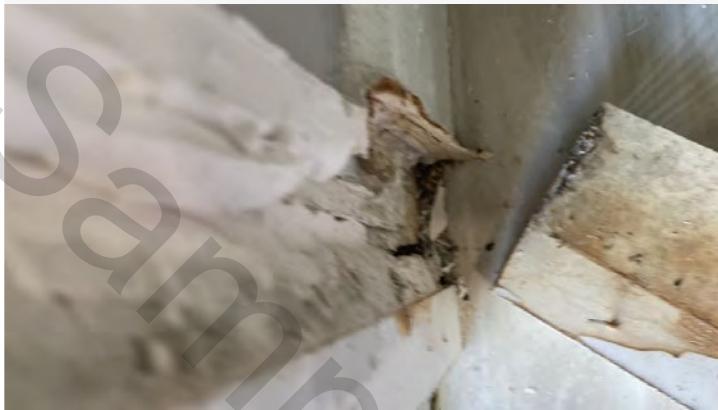
10

Water Staining Evident  
Active Water Leaks Visible

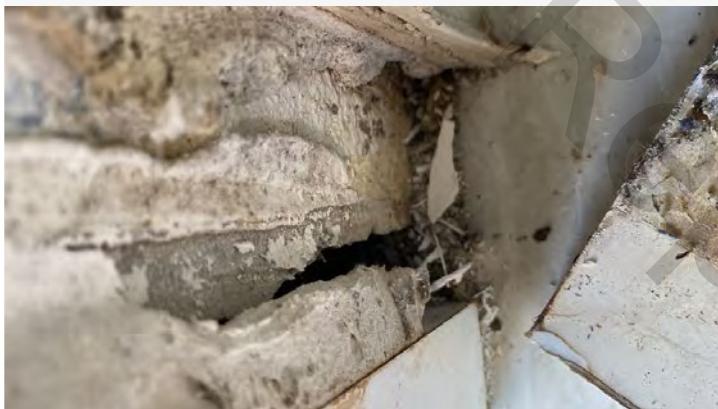
11

Water Staining Evident  
Active Water Leaks Visible

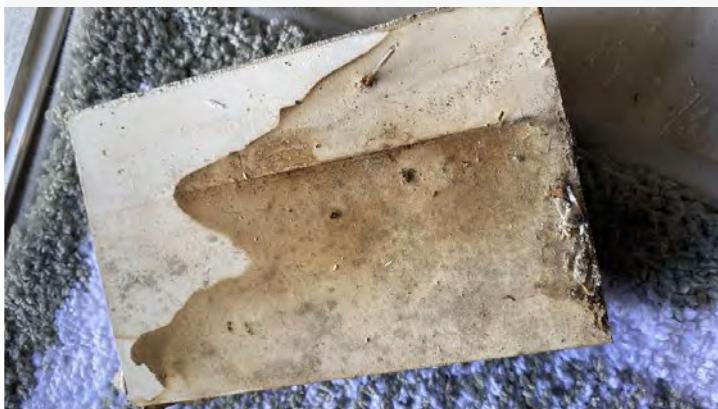
12

Water Staining Evident  
Active Water Leaks Visible

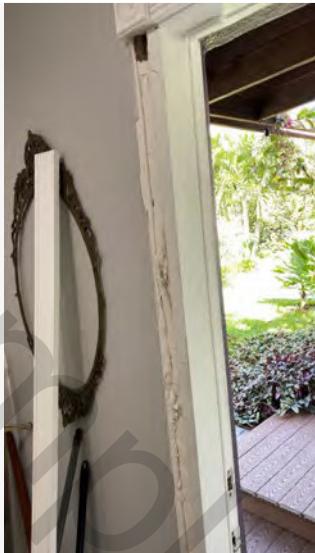
13

Water Staining Evident  
Active Water Leaks Visible

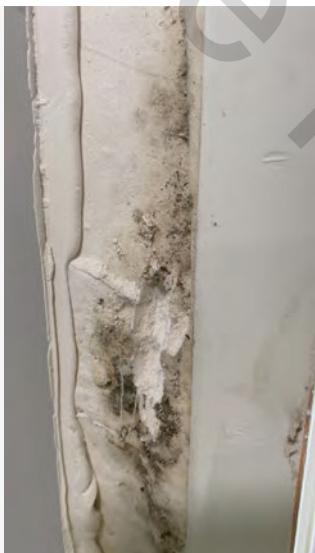
14

Water Staining Evident  
Active Water Leaks Visible

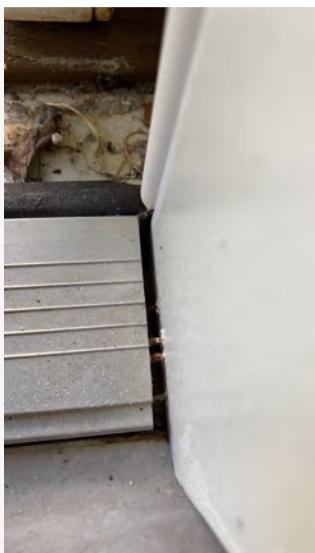
15

Water Staining Evident  
Active Water Leaks Visible  
Door out of Plumb, Level and Square

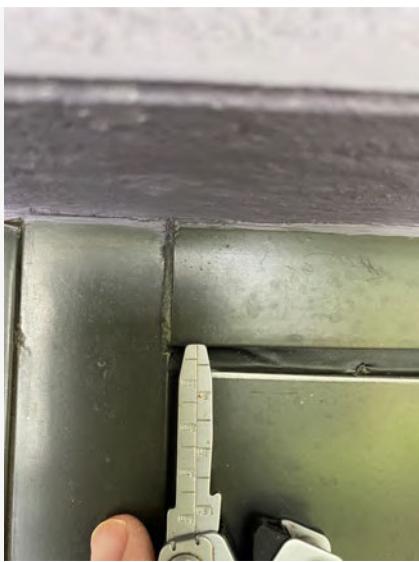
18

Door out of Plum, Level and True

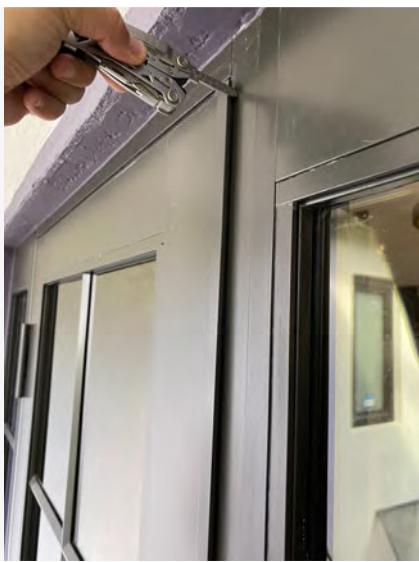
21

Door out of Plum, Level and True

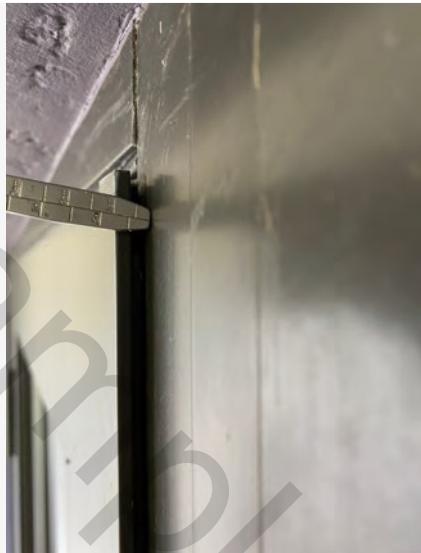
22

Door out of Plum, Level and True
