# STORM SAFE

Glazing Damage Assessment

## **Re: Storm Related Structural Glazing Assessment**

TSSA Project # [REDACTED] - [REDACTED] - 2021-10-9

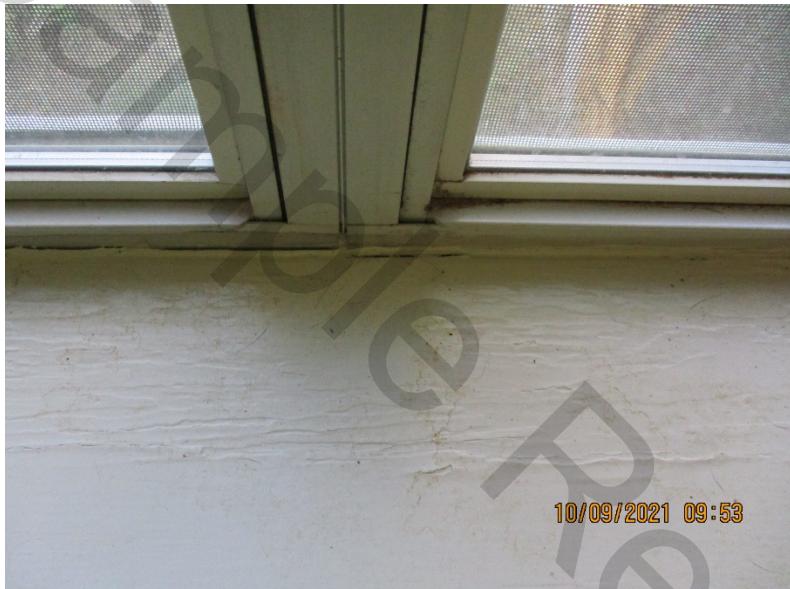
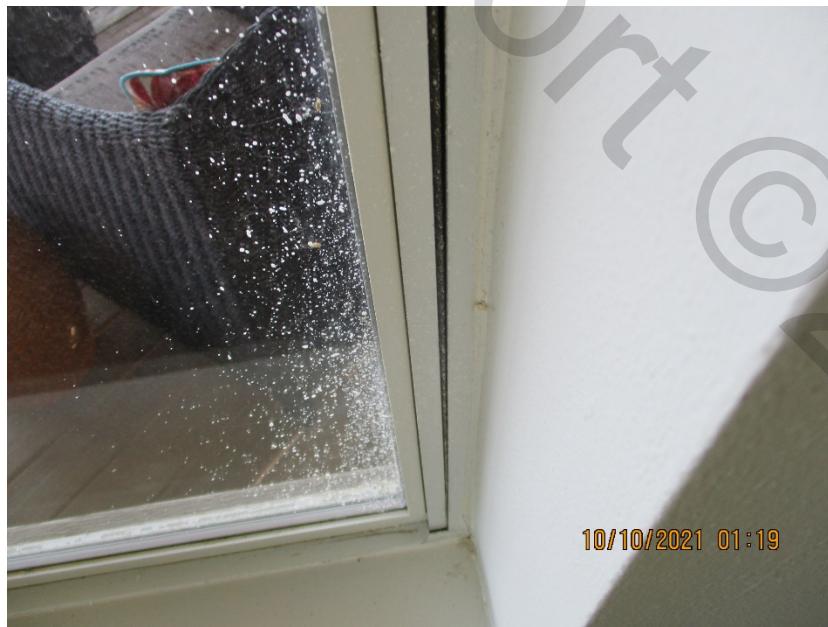
### Frames Out of Alignment

During our investigation of the [REDACTED] Residence TSSA Storm Safe DAC Inc. inspectors witnessed misaligned frames, and entry door panels. Window and Door components move out of alignment when they are acted upon by high wind created buffeting and pressure. The window and door components are forced to move within their locked position creating stress on the hinges and locking mechanisms causing these operational components to become misaligned within their installed position. This physical damage creates binding and difficulty during operation, but more importantly create separate between adjoining frame members causing a diminishment of the system's capacity to keep a congruent envelope of protection. The systems currently sit in a diminished state and are susceptible to moisture intrusion between the opened joints.

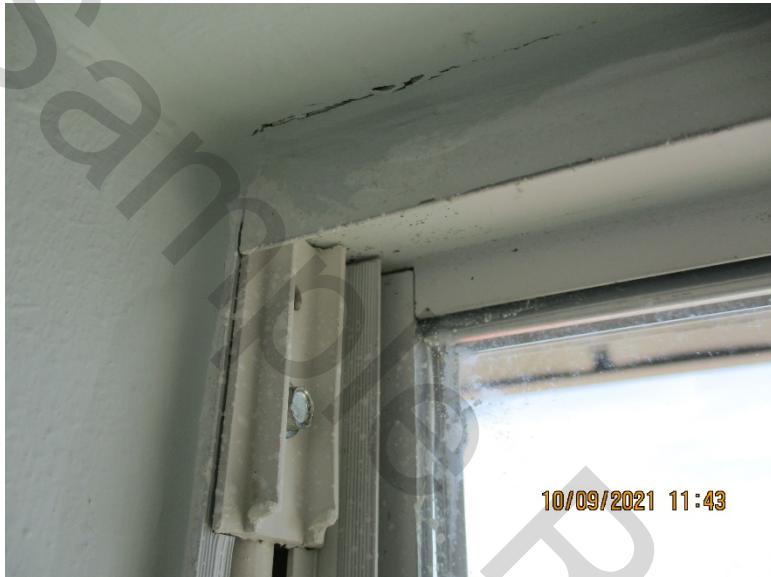
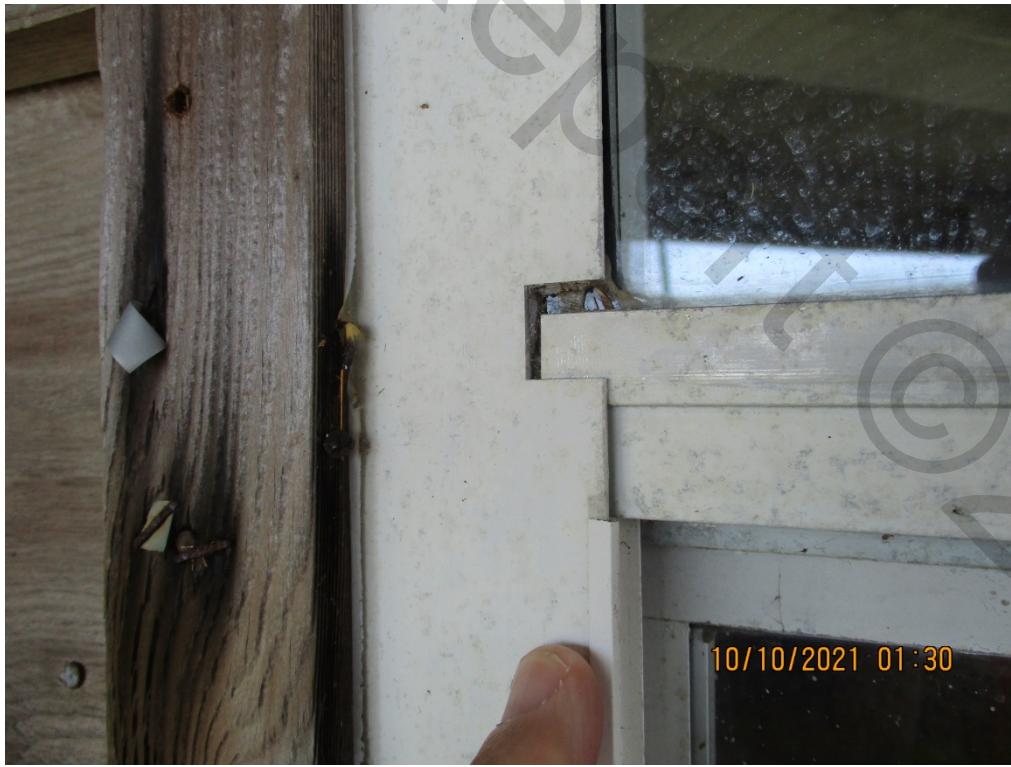
## Frame Separation

During our investigation of the [REDACTED] Residence, TSSA Storm Safe DAC Inc. inspectors witnessed frame separation seen at adjoined framing components of the installed Single Hung Window Systems. High wind created buffeting of the glazed systems and adverse framing system movement allowed the assembly systems to separate between adjoining frame members causing a diminishment of the window's capacity to keep a congruent envelope of protection. The glazed systems currently sit in a diminished state and are susceptible to moisture intrusion between the opened joints.

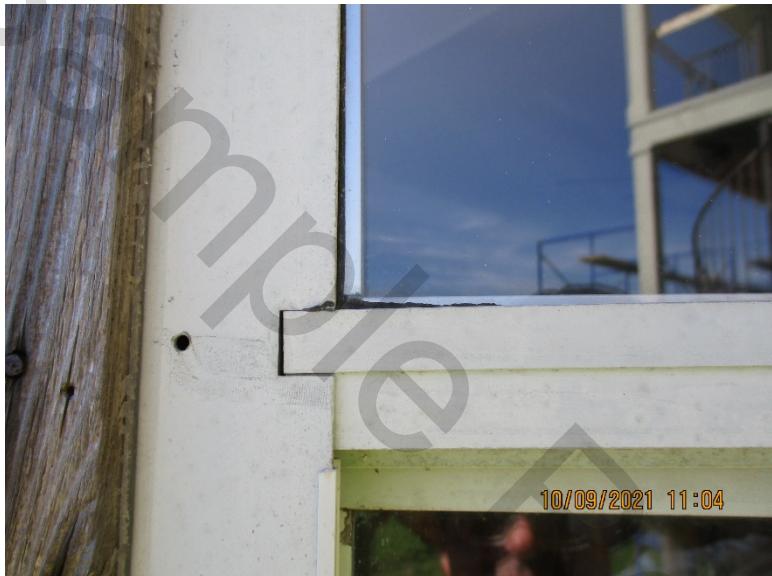
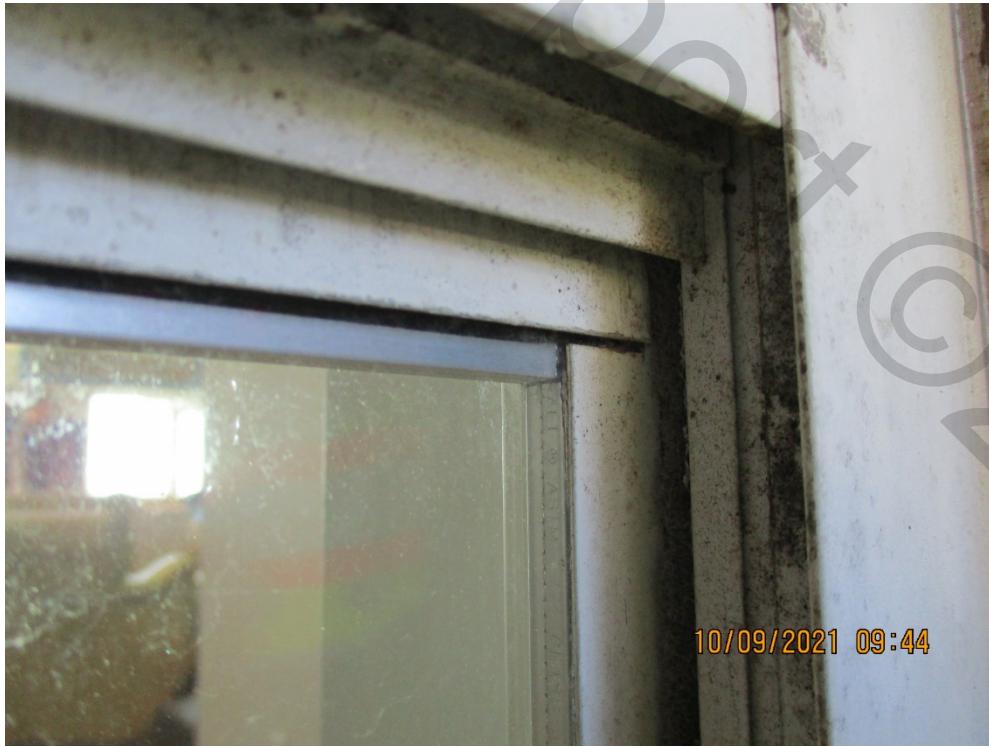
## Frame Rotation

During our investigation of the █ Residence, TSSA Storm Safe DAC Inc. inspectors witnessed frame rotation seen at adjoined framing components of the installed Single Hung Window Systems. High wind created buffeting of the glazed systems and adverse framing system movement allowed the assembly systems to separate between adjoining frame members causing a diminishment of the window's capacity to keep a congruent envelope of protection. The glazed systems currently sit in a diminished state and are susceptible to moisture intrusion between the opened joints.

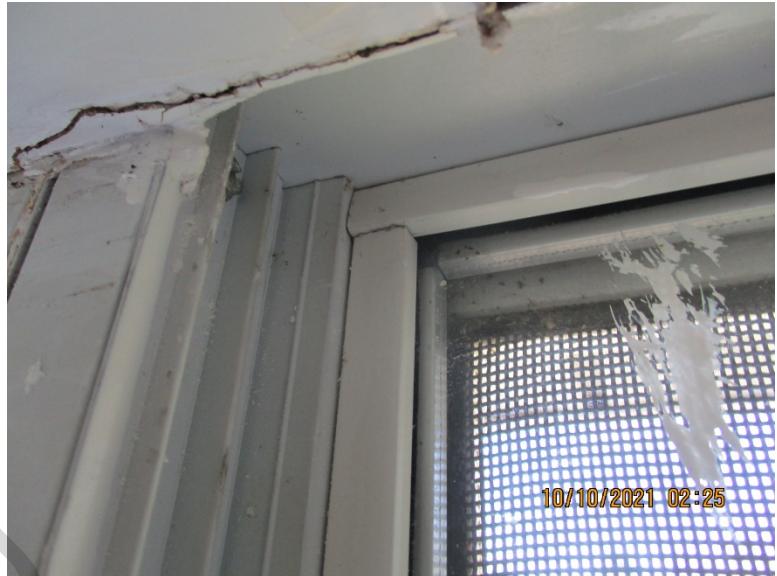
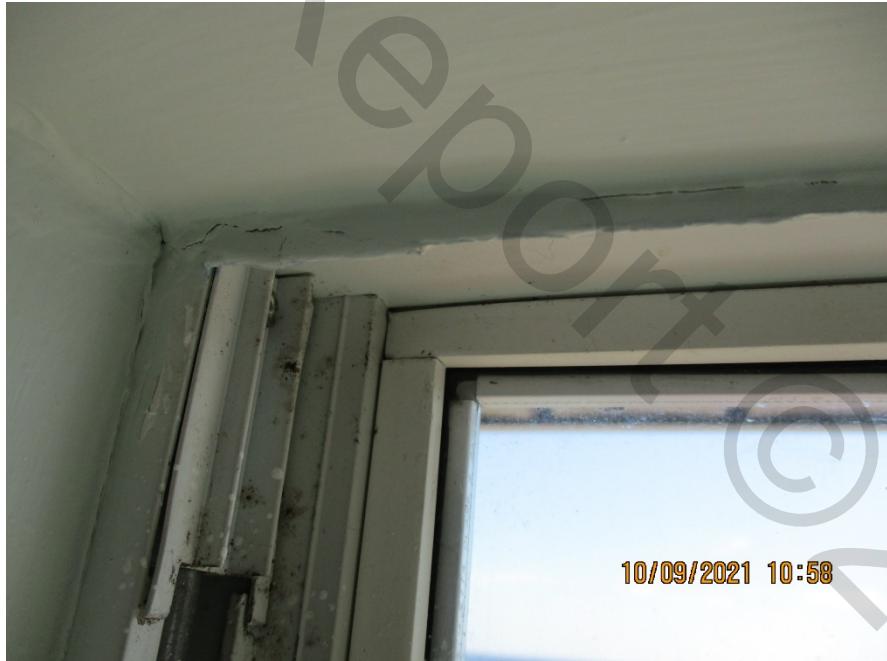
## INTERIOR FINISH DISTRESS

Throughout the TSSA Storm Safe Inc. Glazing Damage Assessment of the [REDACTED] Residence, our inspectors witnessed interior finish. The buffeting of the systems during a high wind event allowed the glazed systems to vibrate and move within their installed position. This movement affected the installation fastening system and created system movement which disrupted the interior finish between the systems framing and its interior finish reveal.

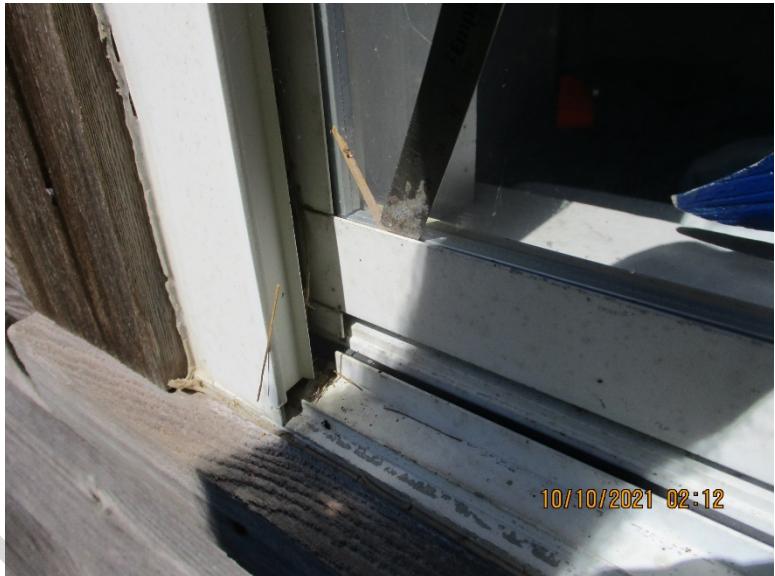
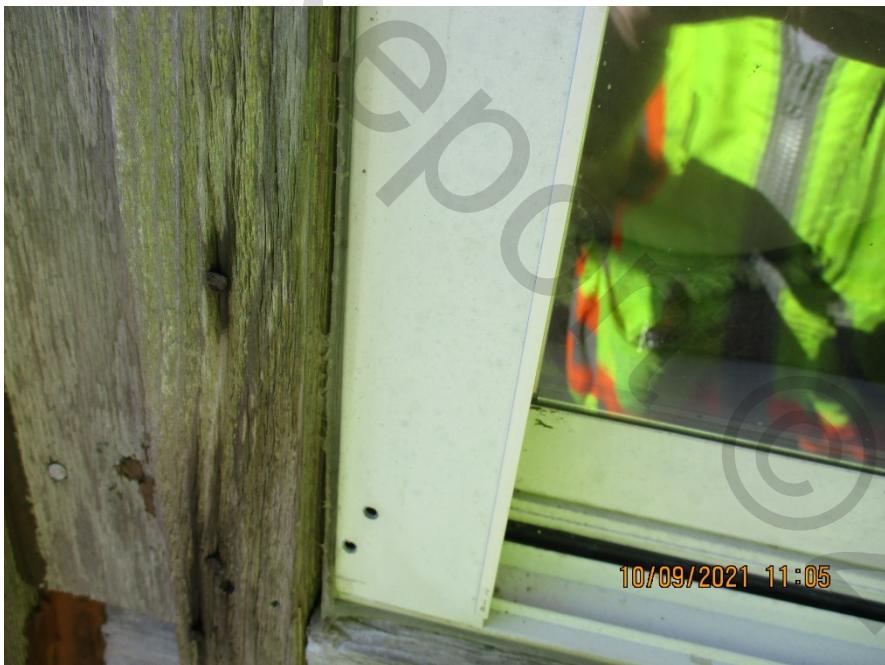
## EXTERIOR FINISH DISTRESS

Throughout the TSSA Storm Safe Inc. Glazing Damage Assessment of the [REDACTED] Residence, our inspectors witnessed exterior finish. The buffeting of the systems during a high wind event allowed the glazed systems to vibrate and move within their installed position. This movement affected the installation fastening system and created system movement which disrupted the exterior finish between the systems framing and its exterior finish.

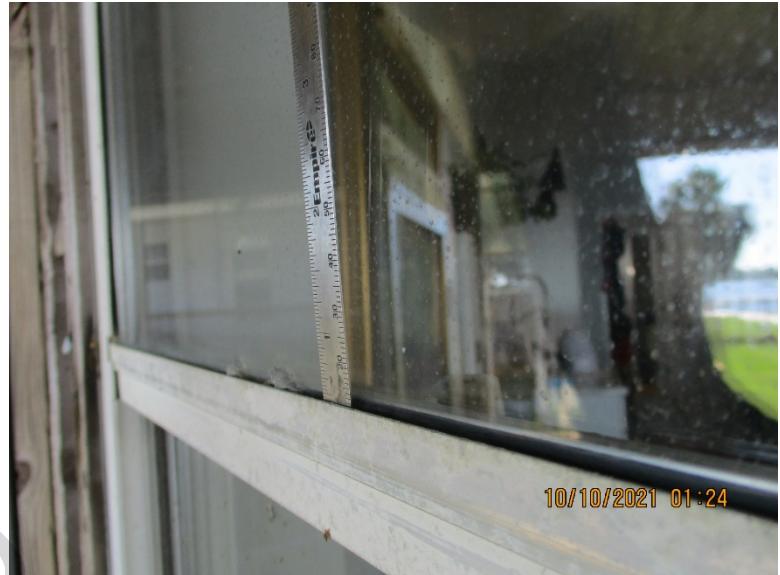
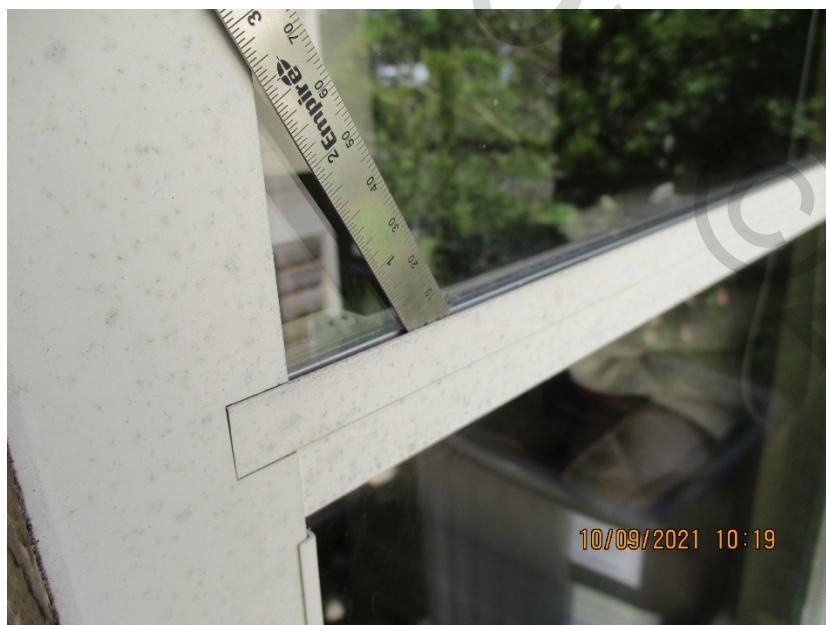
## Deglazing

Throughout the TSSA Storm Safe Inc. Glazing Damage Assessment of the [REDACTED] Residence, our inspectors witnessed widespread deglazing observed between the glazing channel and glass panes of the installed window systems. The sealant edge between the framing system and the glass pane was used to set the primary glazing seal in the same manner the primary seal is set around the installation flange of the window framing system. When a window system's glass pane is acted upon by cyclical movement such as during an interaction with a high wind event, the glass pane moves violently within the glazing channel severely weakening if not completely separating its adherence to the framing system. This is a dangerous combination which leaves the envelope of protection in a state that is no longer performing its function to protect the interior living space from the exterior elements.

(NOTE – the depth gauge is used only to show the deglazed panel and is not depicting a depth of penetration between the glazing stile and glass lite.)

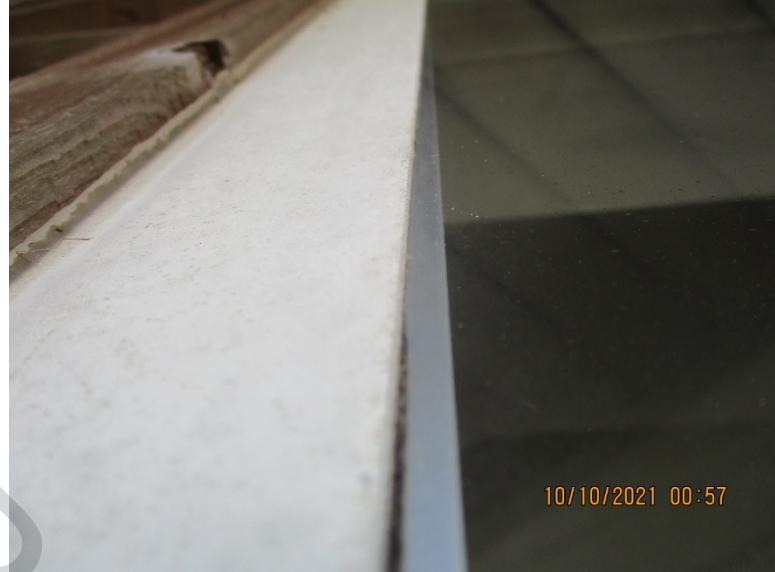
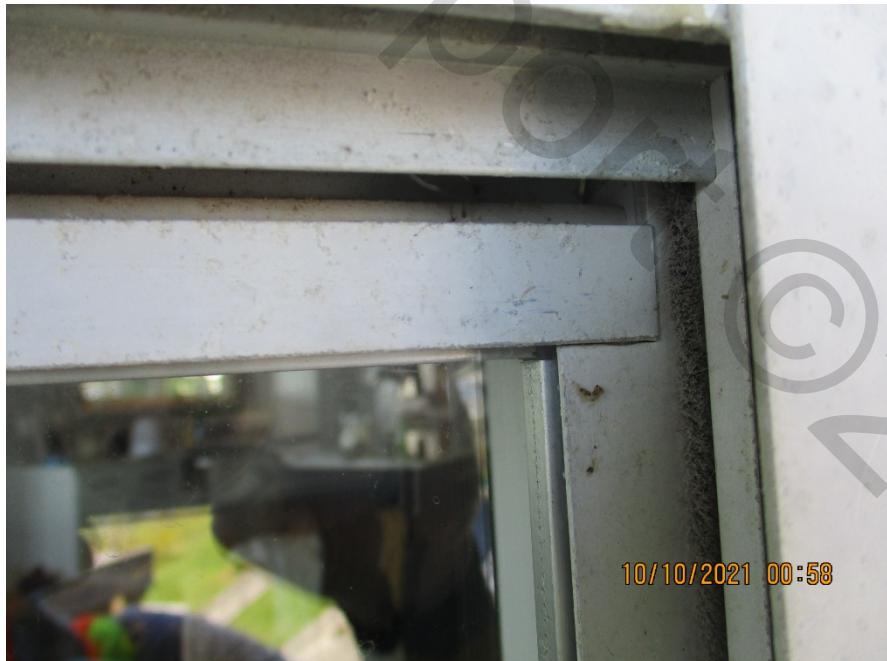
## Spacer Damage

During our investigation of the [REDACTED] Residence our inspectors witnessed disruption of the Spacer found within the Insulating Glazing Units installed on site. Wind Buffeting and Pressure created during a high wind event effects the IGU Air Space, as well as the adherence of the IGU within its glazing pocket. Spacer Migration, Spacer Sealant Disruption, and Deglazing are all indicative of IGU glass movement and damage created during a high wind event.

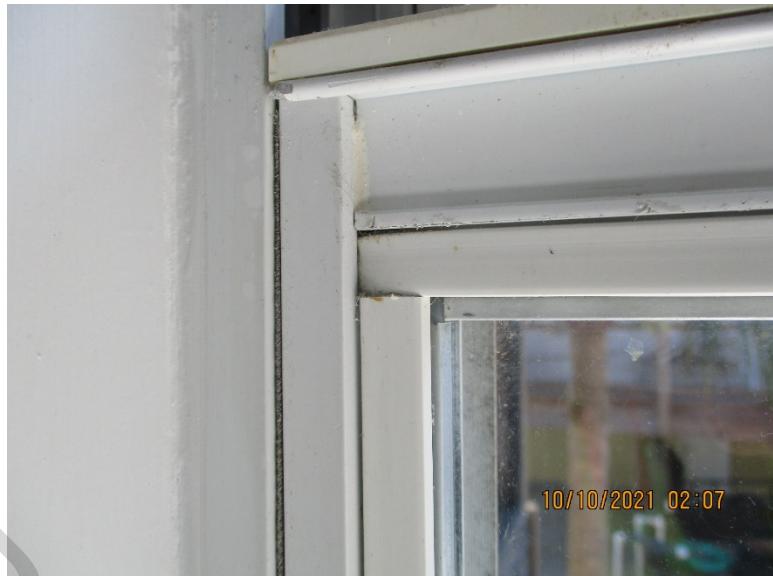
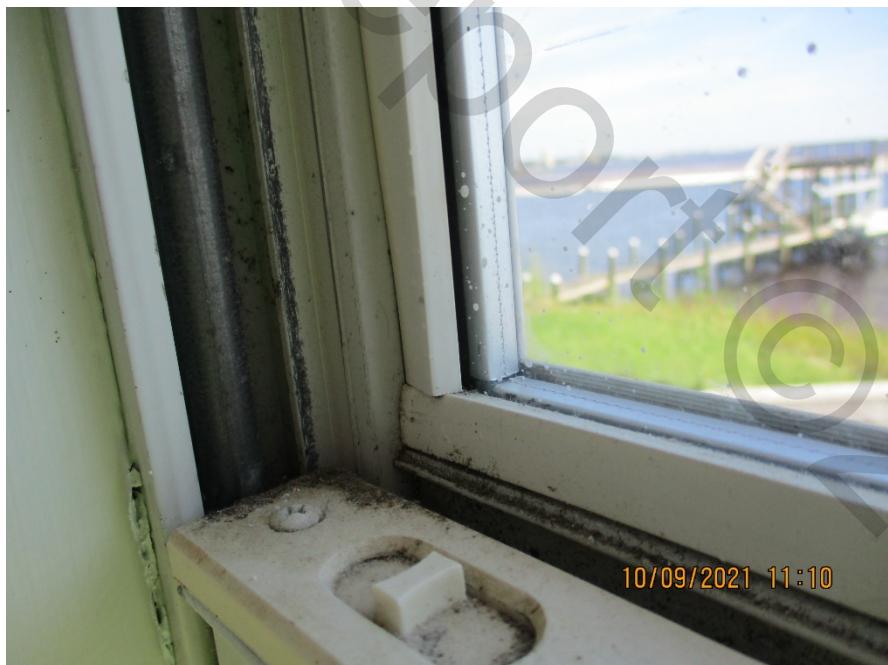
## Glass Stop Damage

During our investigation of the [REDACTED] Residence our inspectors witnessed disruption of the exterior Glass Stop system components. A Glass Stop a molding used to hold glazing infills in position. When high wind created buffeting vibrates a glass infill within its installed position, the exterior glass stops become avulsed from their installed position and are no longer protecting the glazing channel and glass lite from the exterior elements. This damage will eventually lead to deglazing and moisture damage leaving the exterior envelope in a diminished and compromised state.

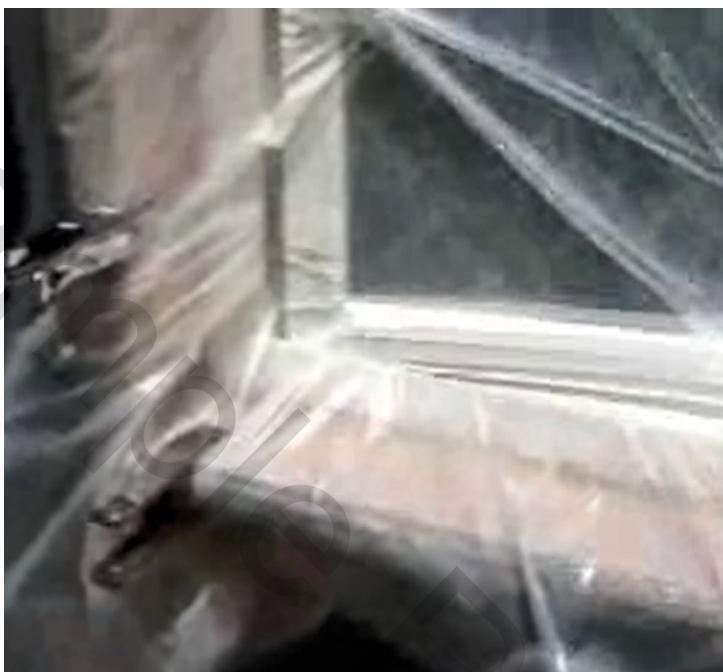
This photograph was taken during a cyclic pressure test of a single hung window system. This photograph demonstrates how high wind speed, pressure, and buffeting force affects glazed systems during a High Wind Event with extensive wind created buffeting. The rapid positive and negative cyclic movement and high wind buffeting create separations and disruptions in a window system framing joints, installation fasteners, and glazing system causing failure in the components allowing water to penetrate through the exterior building envelope into the interior living space.
