Inspection Report for Mike Hill

Property Address: 7809 Bell Tower Lane Fairburn Ga 30213

1 Report Information

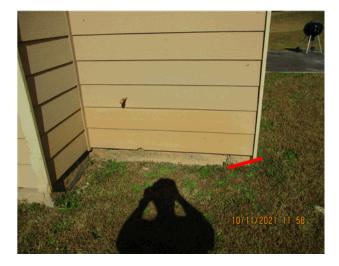
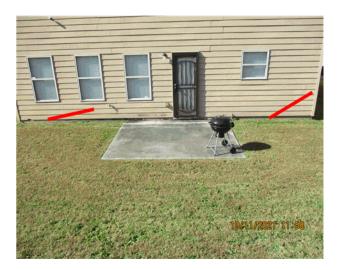
2) Grading Conditions

Grading of the soil near the foundation appears to be in serviceable condition.

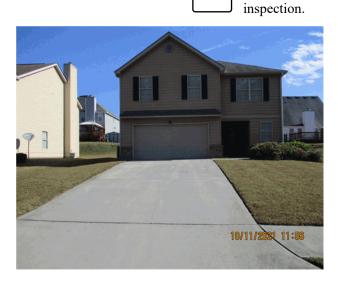
- 3) Driveway Conditions
- AS The driveway appeared to be in serviceable condition at the time of the

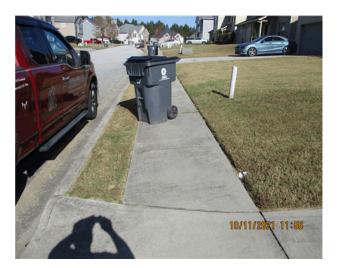
4) Sidewalk Conditions

The visible areas of the sidewalk appeared to be in serviceable condition at the time of the inspection.

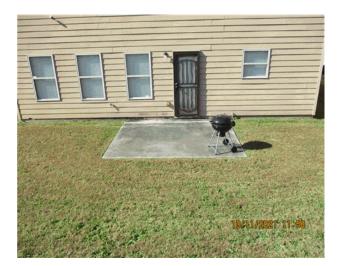
7) Back Entrance Conditions

The visible portions of the patio appeared to be in serviceable condition at the time of the inspection.

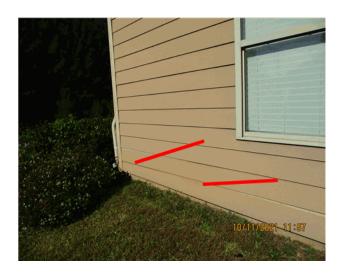
8) Exterior Wall

Damaged siding was observed at. Due to conditions observed, further evidence may exist in areas not readily visible or accessible. Water penetration may have occurred.

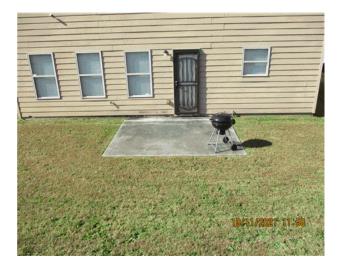
10) Exterior Door Conditions

The door(s) appeared to be in serviceable condition at the time of the inspection.

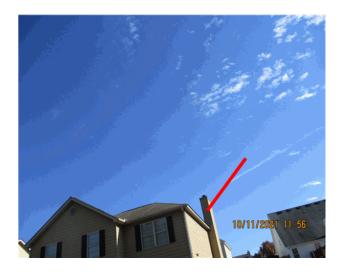
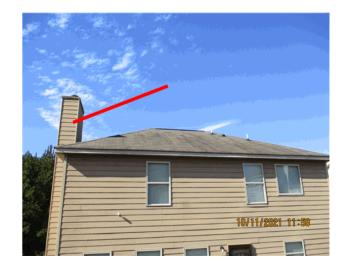
12) Chimney Conditions

The visible and accessible portions of the chimney(s) appeared to be in serviceable condition at the time of the inspection.

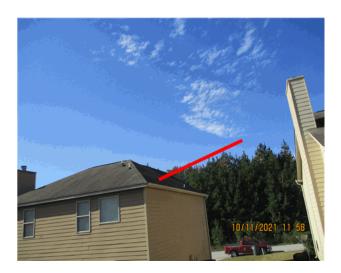
covering shows normal wear for its age and appeared to be in serviceable condition at the time of the inspection.

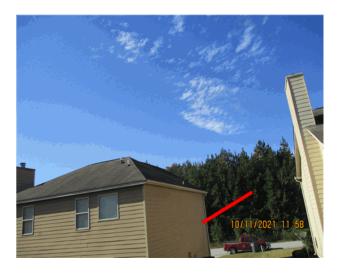
15) Gutter & Downspout Conditions

The gutter system appeared to be in serviceable condition at the time of the inspection.

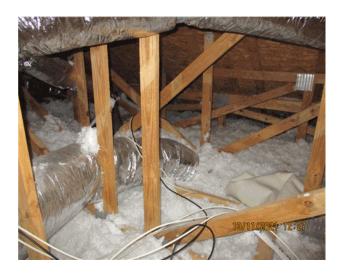
Attic Access	Hallway
Method of Inspection	Entered attic area.
Roof Frame Type	The roof framing is constructed with rafter framing.
16) Attic Conditions	AS The visible and accessible portions of the attic appeared to be in serviceable condition at the time of the inspection.

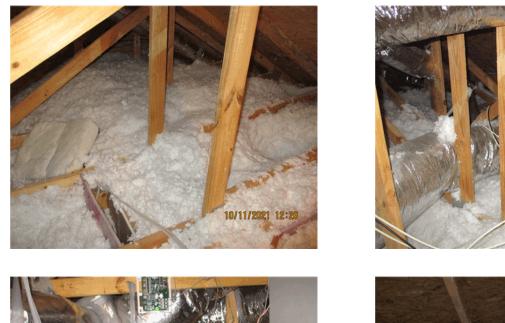
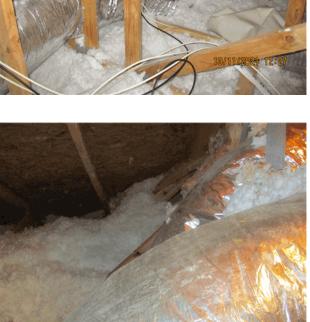
17) Attic Insulation Conditions Soffit vents

The attic has fiberglass batt insulation. The approximate depth of the insulation is 8 to 10 inches. This appears adequate.

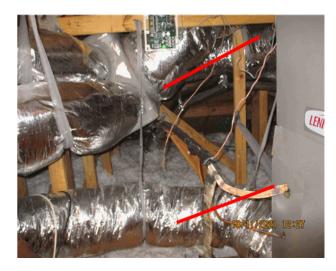
21) Ventilation Conditions

The visible and accessible portion of the venting flue appeared to be in serviceable condition at the time of the inspection.

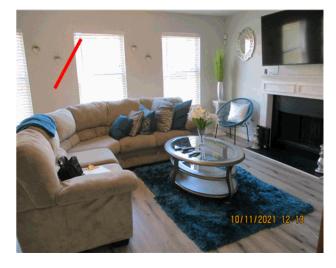
34) Wall Conditions

The general condition of the walls appeared to be in serviceable condition at the time of the inspection.

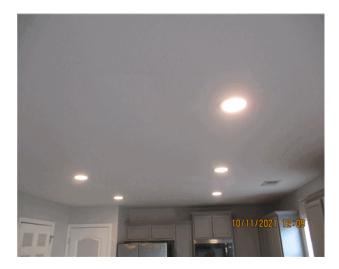
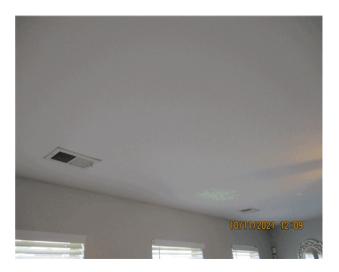
35) Ceiling Conditions

The general condition of the ceilings appeared to be in serviceable condition at the time of the inspection.

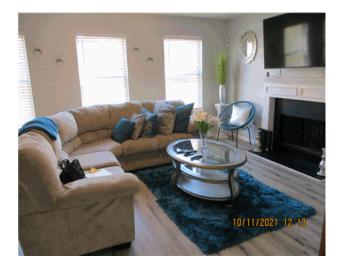
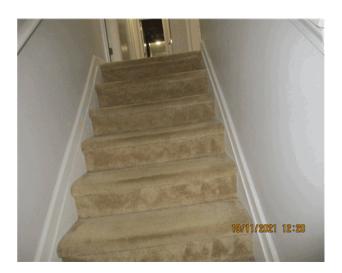
36) Floor Conditions

The general condition of the visible and accessible portions of the floors appeared to be in serviceable condition at the time of the inspection.

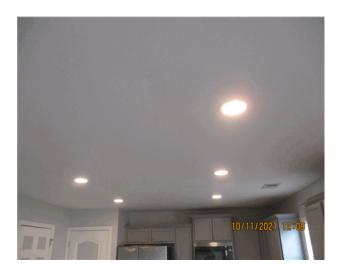
37) Heat Source Conditions

All the home register appears serviceable at the time of inspection.

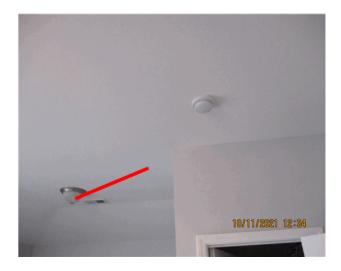
41) Lighting Conditions

Light(s) were out or inoperative at. Dismantling and testing of all light fixtures is not performed as part of this inspection. Recommend all lights be operable prior to close.

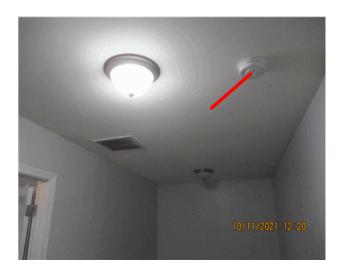
43) Smoke Detector Conditions

The home smoke detector appear serviceable at the time of inspection.

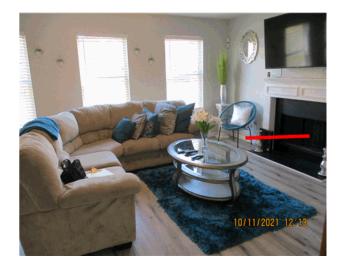
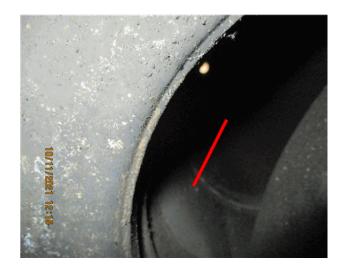
44) Fireplace Conditions

A fireplace is located at the family room.

The fireplace is gas fired and was operable at the time of inspection. Client is advised to obtain information from the manufacturer regarding use, maintenance, and carbon monoxide risks if any.

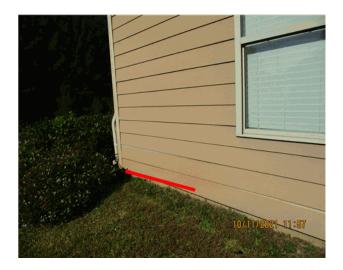
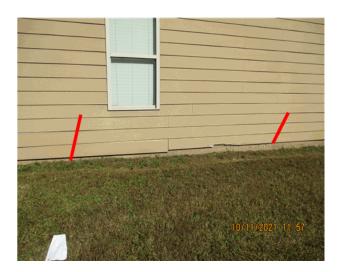
96) Foundation Conditions Slab on grade

The home foundation appears serviceable at the time of inspection.

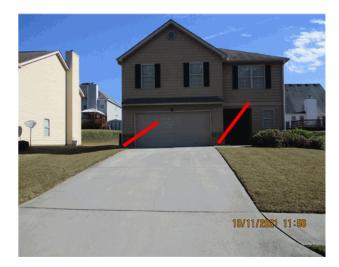
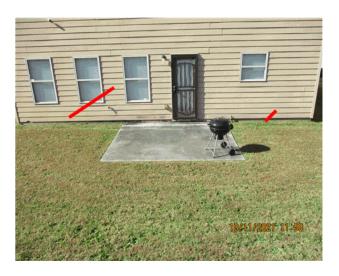
97) Flooring Support Conditions

The visible and accessible areas of the wood framing system appeared to be in serviceable condition at the time of the inspection.
