Service Bulletin No. 453D
(Supersedes Service Bulletin No. 453C)
Engineering Aspects are
FAA Approved

SUBJECT: Aluminum Push Rods P/N 73806 on O-235 Series Engines

MODELS AFFECTED: All O-235 series engines with serial numbers L-12500-15 thru L-20676-15; except the following: L-15619-15, L-16333-15, L-17291-15, L-17644-15, L-18054-15, L-18055-15, L-18073-15, L-18074-15, L-18141-15, L-18142-15, L-18207-15, L-18208-15, L-18502-15, L-18503-15, L-18601-15, L-18948-15 thru L-18951-15, L-19028-15 thru L-19031-15, L-19145-15 thru L-19149-15, L-19766-15 thru L-19768-15, L-19990-15 thru L-19998-15, L-20155-15 thru L-20158-15, L-20172-15 thru L-20176-15, L-20242-15 thru L-20246-15, L-20323-15 thru L-20327-15, L-20384-15 thru L-20389-15, L-20428-15 thru L-20432-15, L-20460-15 thru L-20464-15, L-20523-15 thru L-20527-15, L-20609-15 thru L-20612-15. All remanufactured O-235 series engines shipped between December 10, 1976 and November 8, 1979. All O-235 series engines that had push rods replaced between December 10, 1976 and November 24, 1980.

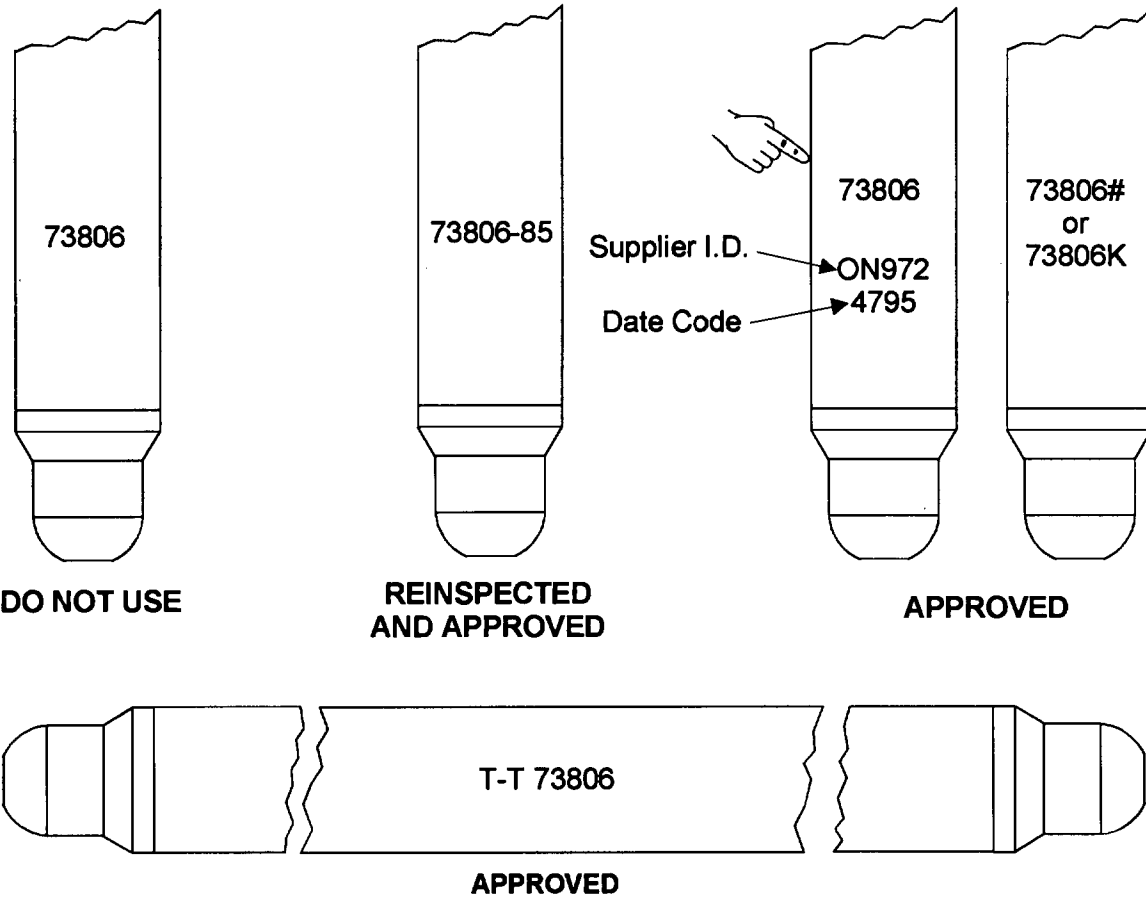
Use only push rods that are reinspected and marked with suffix -85; new push rods marked with a suffix # or K and subsequent, new push rods marked with supplier identification and date code, and push rods with a prefix T-T. See the accompanying illustration.

Push rods with the part number stamped in the center of the part and with the letters T-T as a prefix can be reinstalled.
