**MANDATORY****SERVICE BULLETIN**

DATE: December 1, 1997 Service Bulletin No. 505B (Supersedes  
Service Bulletin No. 505A) Engineering  
Aspects are FAA Approved

SUBJECT: Inspection of Crankshaft I.D. for Corrosion

MODELS AFFECTED: The following Textron Lycoming four cylinder engines which utilize fixed pitch propellers except those installed in rotary wing aircraft or new engines shipped after February 15, 1997:

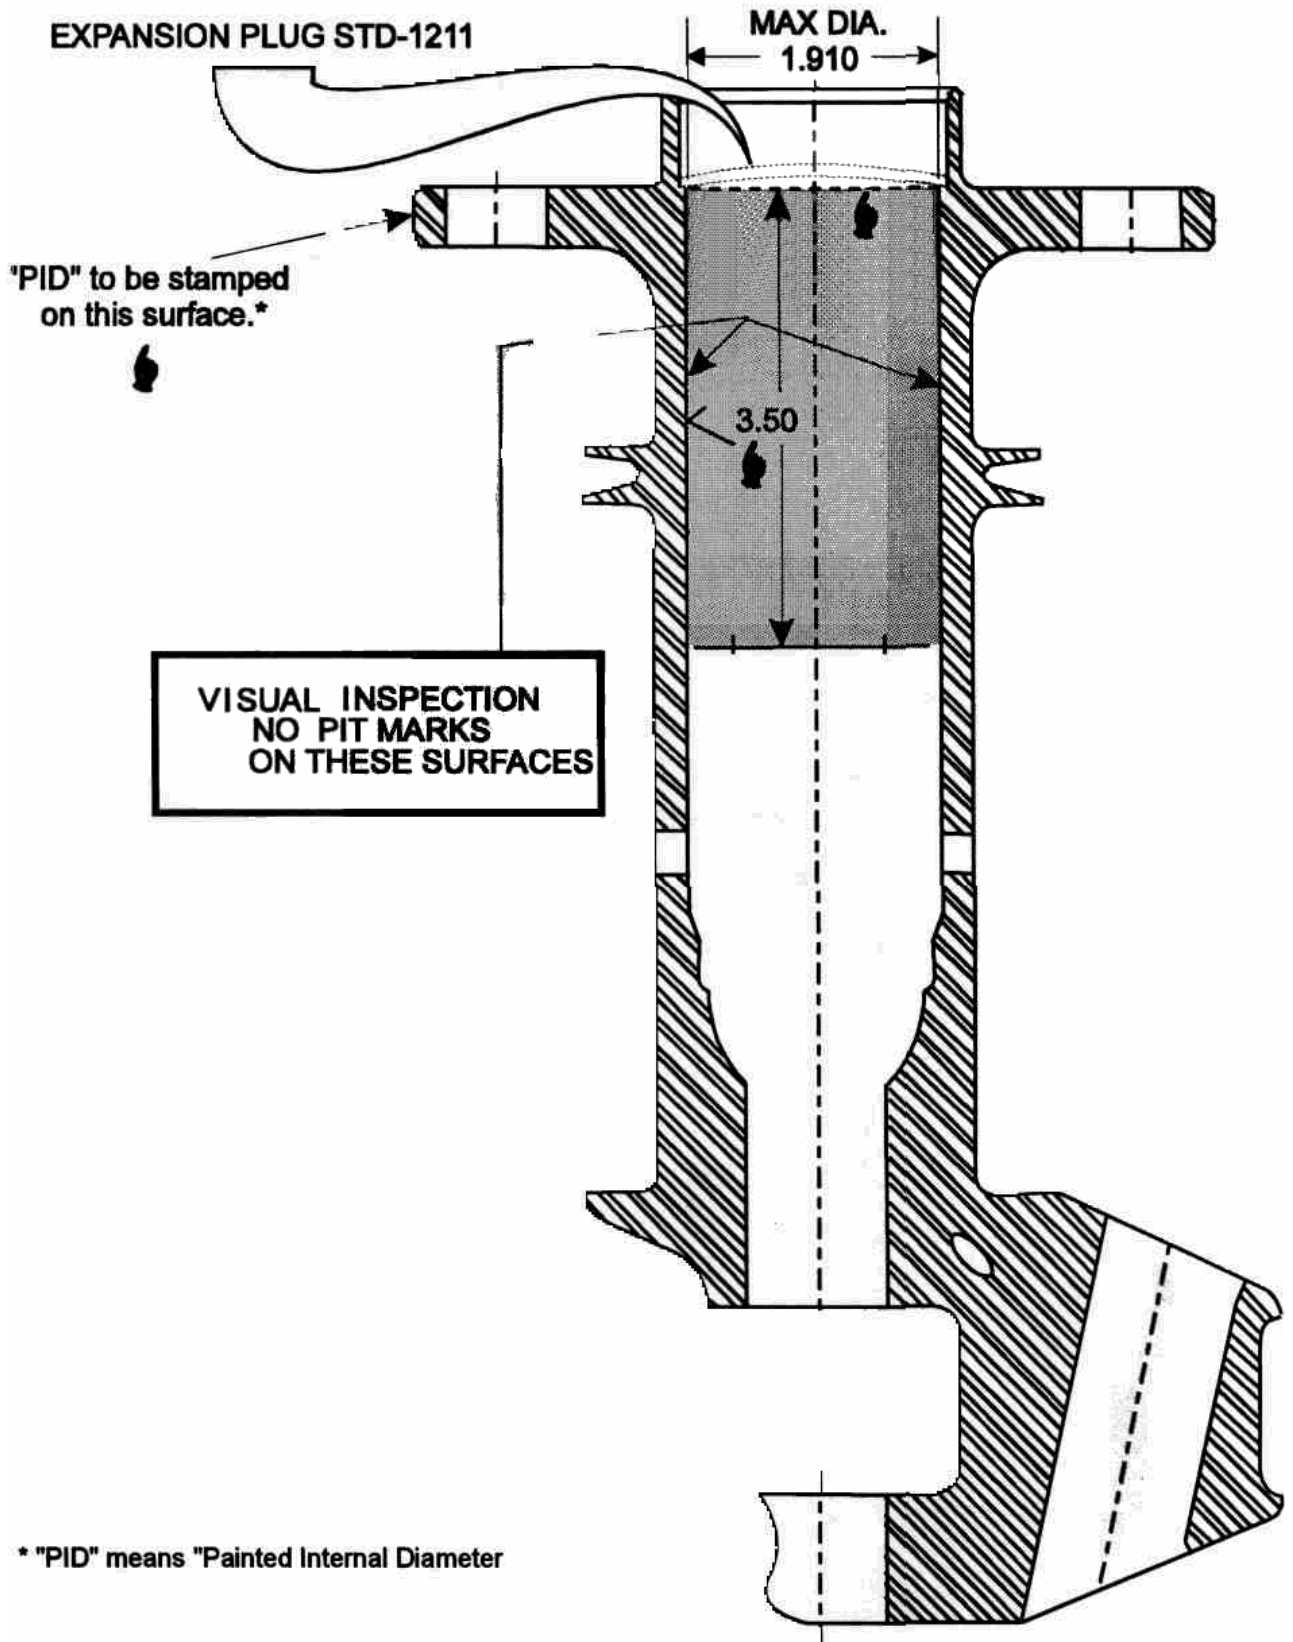
Figure 1. Area to be Inspected

TIME OF COMPLIANCE: **Uncoated Crankshafts (no "PID" stamped on flange OD, see Figure 1)**

- a. Remove the propeller in accordance with the manufacturer's instructions.
- b. Remove expansion plug (P/N STD-1211) (if installed) from end of crankshaft by piercing a 1/8" to 3/16" hole in center of plug.
- c. Measuring in from the crankshaft end, clean the first 3.50 inches of the inside crankshaft wall behind the expansion plug seat.
- d. Remove surface corrosion using a suitable tool which will follow the existing contour of the I.D. and fine abrasive cloth (see Figure 1). Prior to removing the corrosion, precaution must be taken to ensure that the material removed cannot contaminate the engine.

- e. Make a visual inspection from the crankshaft flange inward using a flashlight and magnifying glass (power 4x). A small, right angle, dental examination mirror might be helpful. The above defined area should be clear of pit marks and corrosion.
- f. If during visual inspection any pitting resulting from corrosion is found, the crankshaft must be removed from service immediately or subjected to FPI according to Section II of this Service Bulletin on page 3. Removal of corrosion results in a clean surface that may have an irregular appearance indicated by slight wavi-ness. This condition is deemed acceptable provided the maximum allowable diameter has not be exceeded. Pitting is characterized by holes or fissures of indeterminate depth and direction.

**CAUTION**  
DO NOT ATTEMPT TO REMOVE PITS FROM THE SHAFT BY REMOVING MATERIAL IN LOCAL AREAS. THIS MAY CAUSE STRESS RISERS AND PROMOTE BREAKAGE. APPLYING A PROTECTIVE COATING OVER THE PITTING CONDITION WILL NOT IMPROVE THE STRUCTURAL INTEGRITY OF THE PART NOR ARREST THE PITTING GROWTH.
