MANDATORY SERVICE BULLETIN

DATE: March 14, 2012 Service Bulletin No. 599
Engineering Aspects are
FAA Approved

SUBJECT: Compliance with Hartzell Engine Technologies, LLC (Previously Kelly Aerospace) Service Bulletin No. 045, 201F Fuel Pump Inspection and Recall

**201F Fuel Pump
 Inspection & Recall**

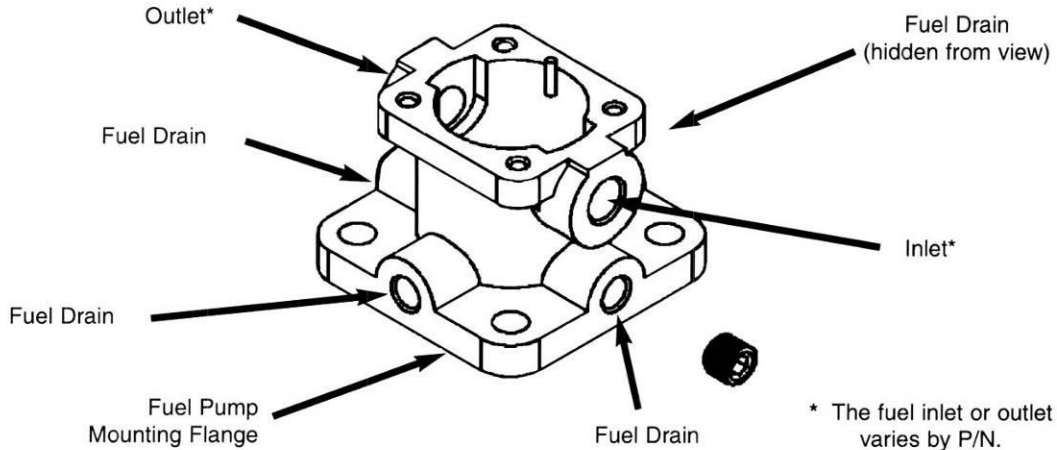
Figure 1 - 201F Inlet / Outlet & Drains (Typical)

- (3) A damaged shaft seal may result in a fuel leak which may lead to a loss of engine power and it may pose a fire hazard. Fuel will be routed to drain ports in the pump mounting flange where an airframe provided drain may be attached.

- (1) Inspect for fuel leakage from the fuel pump overboard drain. As some aircraft may put several drains together, leakage indication may not be caused by the fuel pump. To confirm that the fuel pump has a leak, the following must be accomplished:

- (c) Observe the overboard drain for fuel leakage. If leaking, turn off immediately.
 - (d) Most fuel pump overboard drains are located on the bottom cowl near the firewall. However, check with the specific AFM, POH, or maintenance manual for the aircraft for proper location.
