SERVICE INSTRUCTION

Service Instruction No. 1011N
(Supersedes Service Instruction No. 1011M)
Engineering Aspects are
FAA Approved

SUBJECT: Tappets and Lifters

MODELS AFFECTED: All Lycoming engines

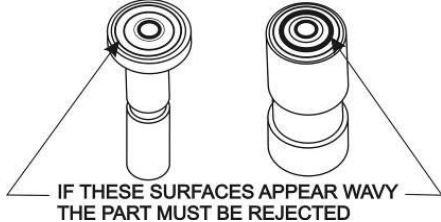
<p>Figure 10 Unacceptable Surfaces</p>

3. If a new camshaft is installed in the engine, replace all of the tappet bodies.		Replace all tappet bodies.
4. Look for discoloration, with circular wear and/or wavy patterns on the face of the tappet body (Figure 10).	Circular wear Wavy pattern(s) Discoloration	If circular wear and/or wavy patterns found, discard the tappet body and replace with a new tappet body. Discoloration, without wavy or circular wear patterns on the tappet face, is not sufficient reason to replace the tappet.

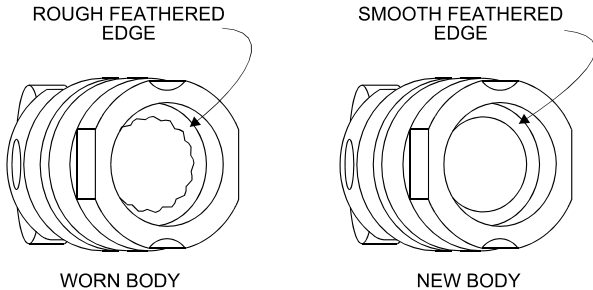
Task	Findings	Corrective Action
5. Look for damage to the lifter face.		If damage is found, discard the tappet body and replace with a new tappet body of the same part number*.
6. Examine the interior bore of the tappet body. a. Look for wear at the interior shoulder. b. Look for a feathered or chipped edge around the shoulder (Figure 11).	Wear found at the interior shoulder and/or Feathered or chipped edge around the shoulder	If wear, feathering or chipped edge found, replace with the tappet body of the same part number*.

<p style="text-align: center;">Figure 11 Comparison Between Worn and New Tappet Body</p>		
7. Record the completion of this inspection in the engine logbook.		
* If an acceptable superseding tappet part number is installed, replace all tappets with tappets of the same replaced part number. Refer to Table 4.

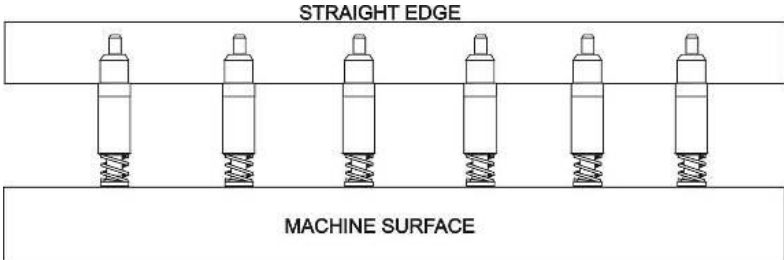
<p>Figure 13 Straight Edge Across Shoulder Surface of Plungers</p>

<p>Figure 12 Chipped Shoulder</p>		
<p>2. Examine the plungers for collapse as follows:</p> <ol style="list-style-type: none"> a. Align all of the removed hydraulic plungers side by side on a clean flat surface. b. Put a straight edge across the shoulder surface of the plungers (Figure 13). c. Measure the distance from the straight edge of any plunger that is not touching the straight edge. d. If there is any plunger that is more than 1/32 in. (0.79 mm) below the straight edge, the plunger is collapsed. 		<p>Discard and replace any collapsed plunger with a new plunger.</p>
