SERVICE LETTER

Service Letter No. L228
April 16, 1990

SUBJECT: Cracking of Cylinder-Head Exhaust Port

MODELS AFFECTED: All field-reconditioned, parallel-valve cylinder heads.

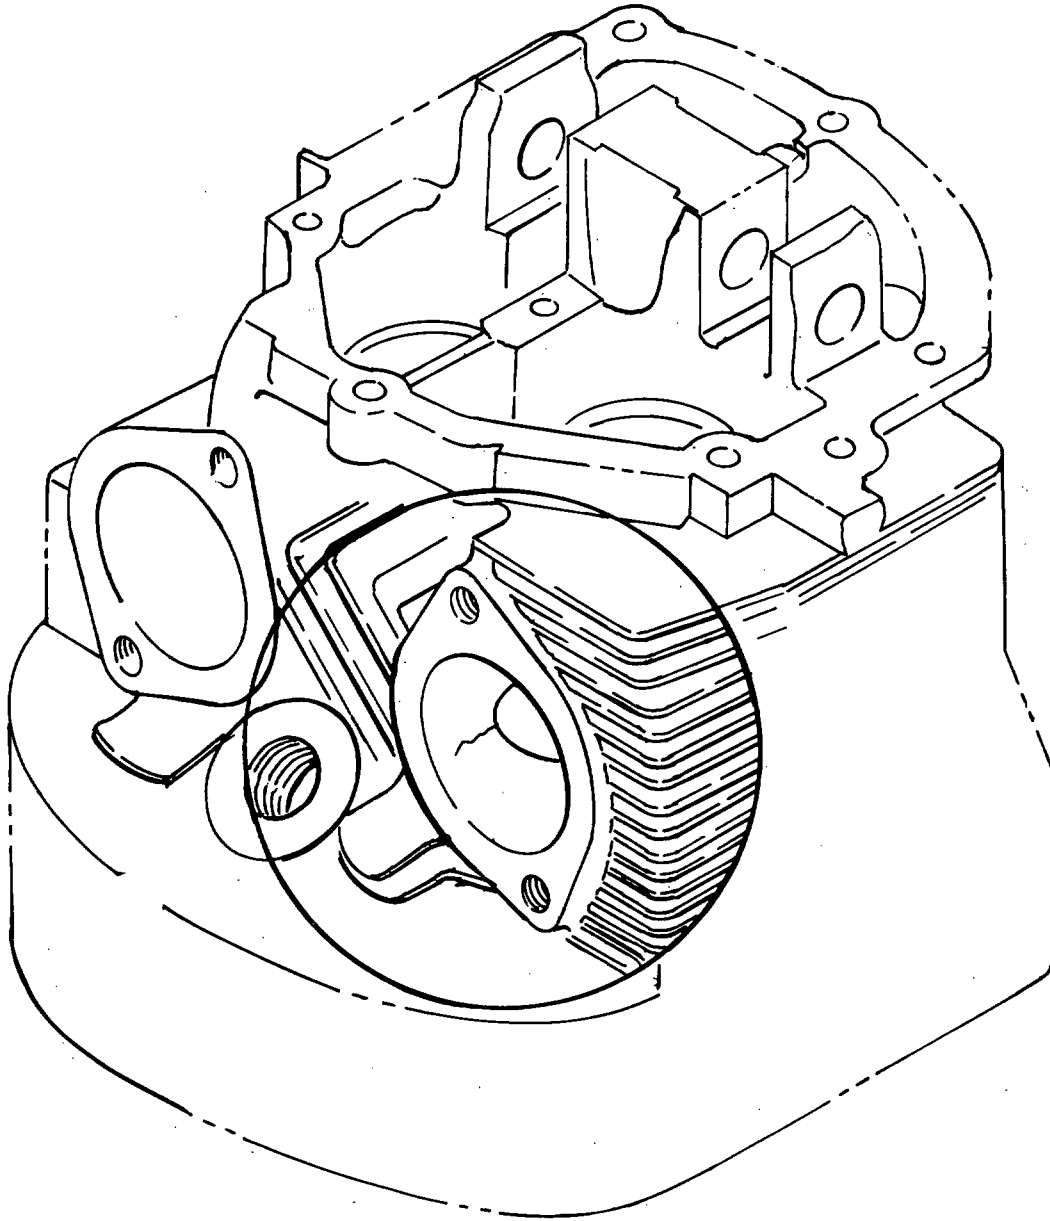
Field inspections have revealed that the cylinder-head exhaust port area on some parallel-valve cylinders reconditioned in the field may be prone to cracking. The cracking is confined to the left side of the exhaust port, next to the spark plug hole (see Figure 1).

Because the cracking may be of such a fine configuration, it can be difficult to detect visually. Therefore, a dye penetrant must be used for inspection purposes. After the dye penetrant has been applied to the left side of the exhaust port, the root areas of the fins next to the spark plug hole can then be inspected for dye seepage.

Figure 1. View of Exhaust-Port Area Prone to Cracking

Textron Lycoming advises replacement of the cylinder-head/barrel assembly, if cracking is evident.
