**TELEDYNE CONTINENTAL<sup>®</sup> AIRCRAFT ENGINE**  
**CRITICAL SERVICE BULLETIN**  
 Compliance Necessary To Maintain Safety

**CATEGORY 2**  
**CSB96-8**  
 FAA APPROVED  
 SUPERSEDES M92-16.

**SUBJECT: REPLACEMENT OF AIRMELT (NON-VAR) CRANKSHAFTS**

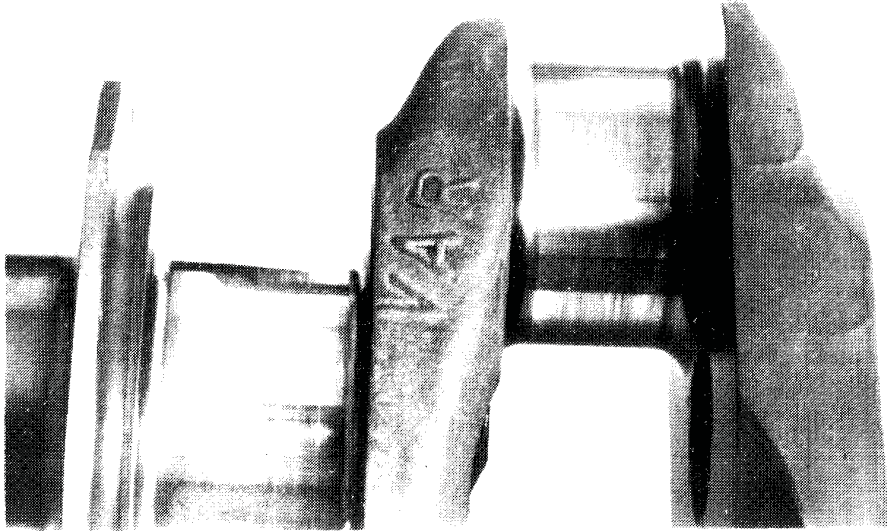
FIGURE 1

Crankshafts made from VAR process steel are identified with the raised letters VAR forged into the crankshaft. The VAR forging identification is on the number 3, 7 or 9 crankshaft cheek depending on the crankshaft part number. The VAR forging identification may have been partially removed during the balancing process. If the crankshaft is identified as VAR, vibroetch the crankshaft flange with the letter "V". This "V" should follow the serial number and heat code. Make an appropriate entry in the engine log book.

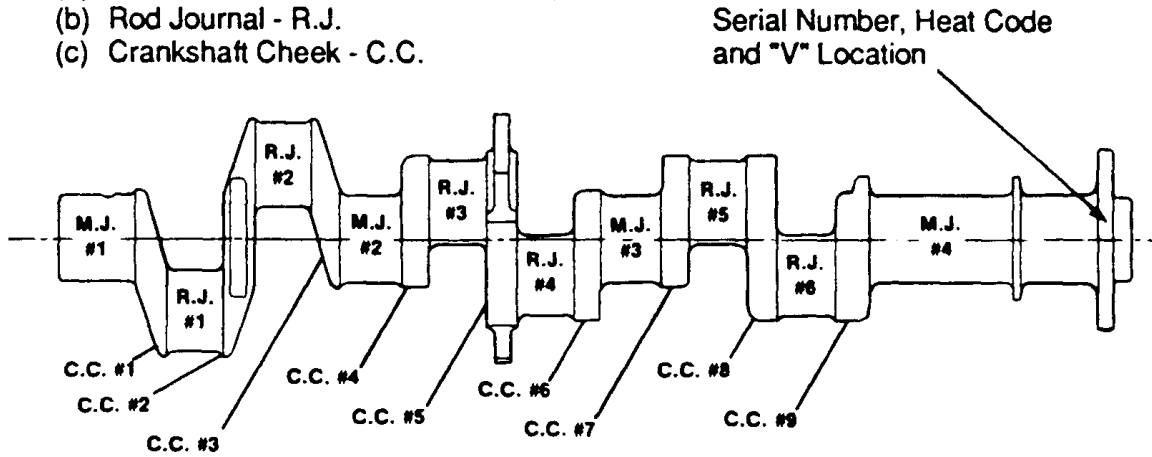
**FIGURE 3**

- (a) Main Journal - M.J.
- (b) Rod Journal - R.J.
- (c) Crankshaft Cheek - C.C.
