Hidden Lake Condominiums

CAPITAL RESERVE STUDY

Report Number: 24-10
Site Inspection Date: June 7th, 2024
Report Submittal Date: September 11th, 2024

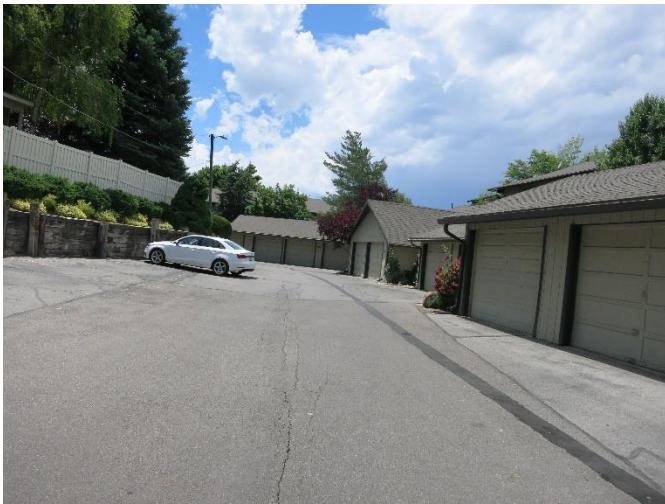
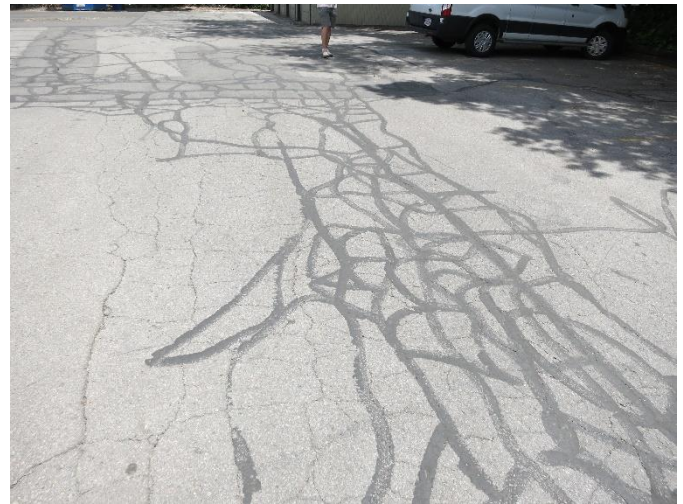
Component Name: 2" Asphalt Overlay
 Component Number: Drive Materials 1001

Component Life Expectancy: 24 years
 Age of Component: 10 years
 Remaining Component Life: 14 years

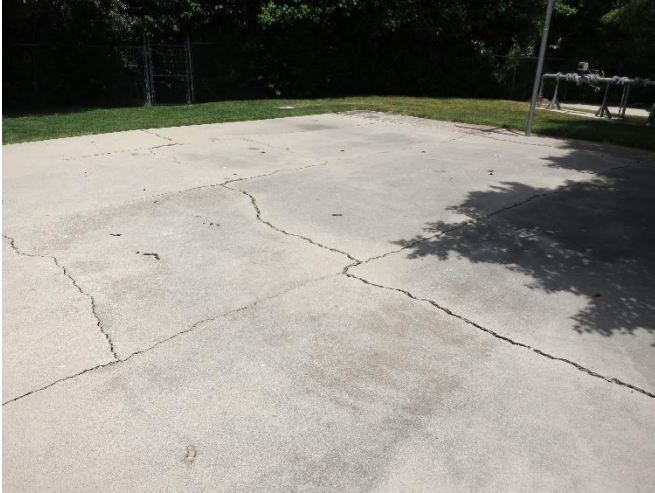
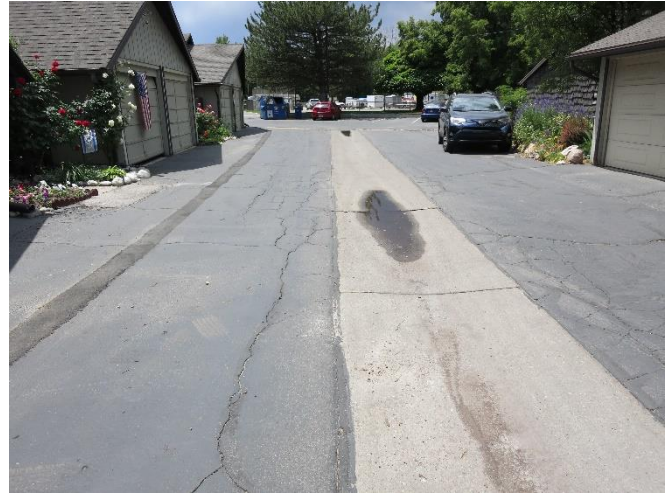
Component Name: Concrete Repair/Replace
 Component Number: Drive Materials 1003

Repair Allowance Every: 5 years
 Beginning Year: 2025

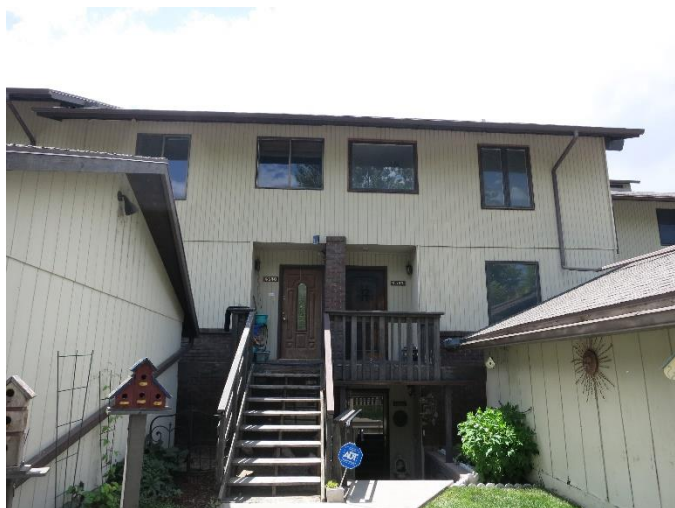
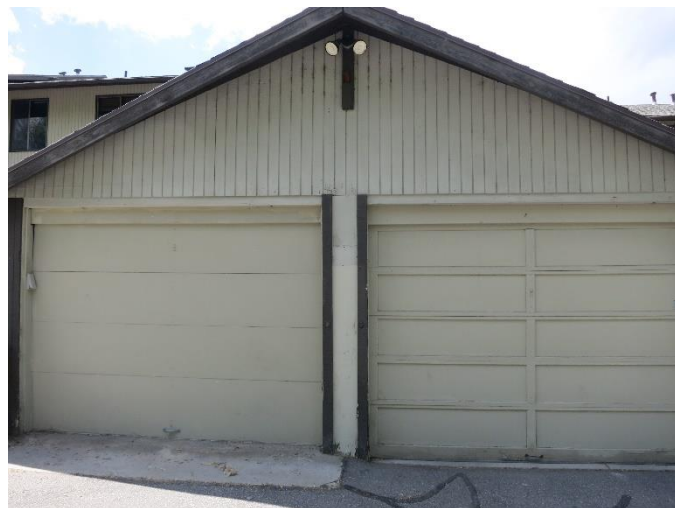
Component Name: Exterior Paint
 Component Number: Residential Building 2001

Phased Painting Every: 3 years
 Beginning Year: 2026

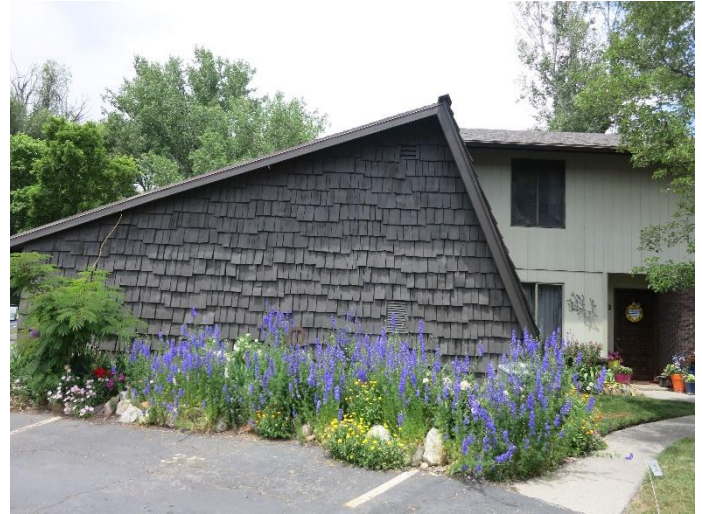
Component Name: Shake Siding
 Component Number: Residential Building 2002

Component Life Expectancy: 30 years
 Age of Component: 20 years
 Remaining Component Life: 10 years

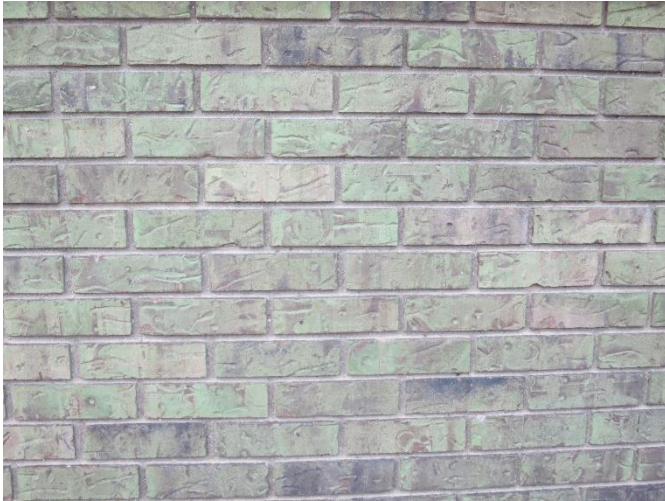
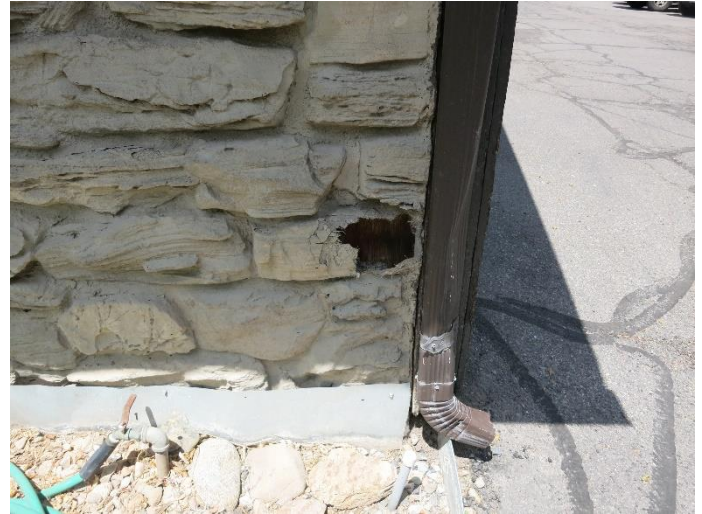
Component Name: Brick/Stone Repair
 Component Number: Residential Building 2003

Repair Allowance Every: 8 years
 Beginning Year: 2030

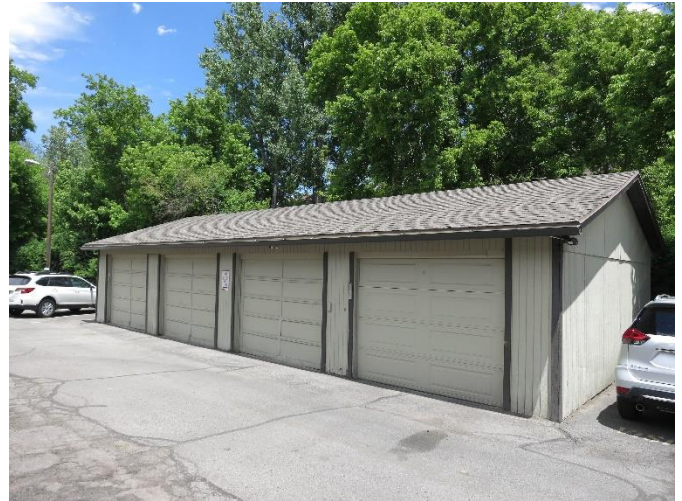
Component Name: Architectural Style Shingles
 Component Number: Residential Building 2004

Component Life Expectancy: 30 years
 Age of Component: 12 years
 Remaining Component Life: 18 years

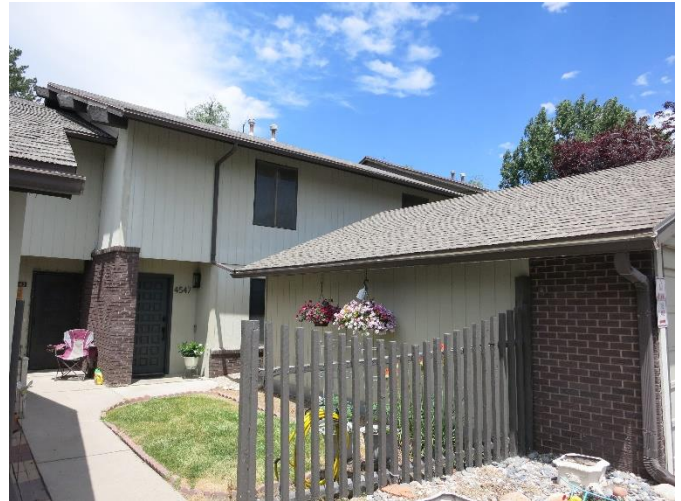
Component Name: Aluminum Roof Gutters
 Component Number: Residential Building 2005

Component Life Expectancy: 30 years
 Age of Component: 12 years
 Remaining Component Life: 18 years

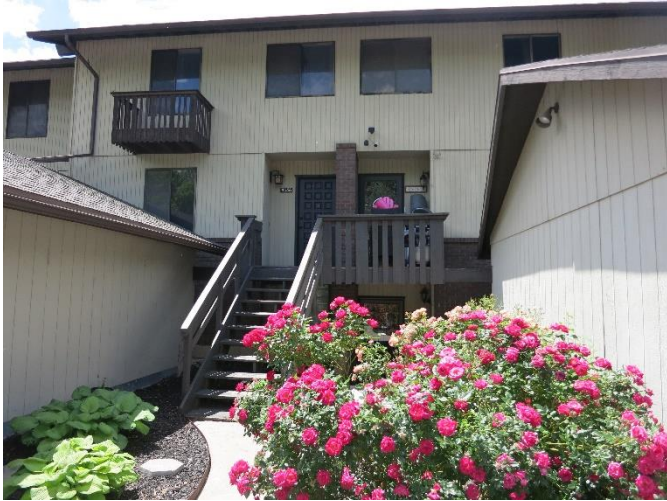
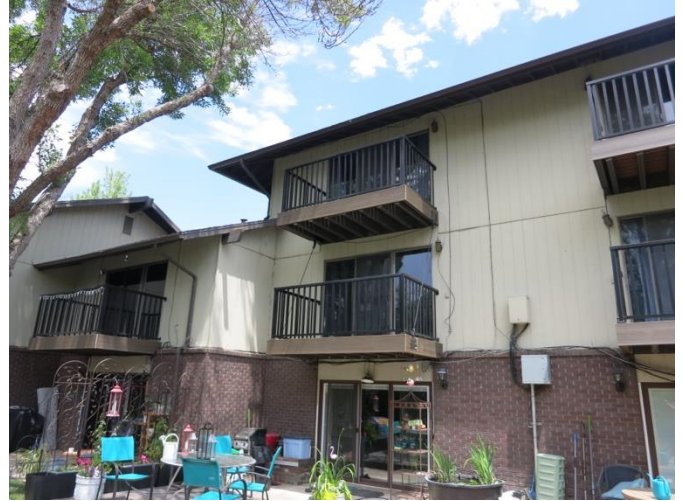
Component Name: Light Fixture Replacement
 Component Number: Residential Building 2007

Replacement Allowance Every: 5 Years
 Beginning Year: 2025

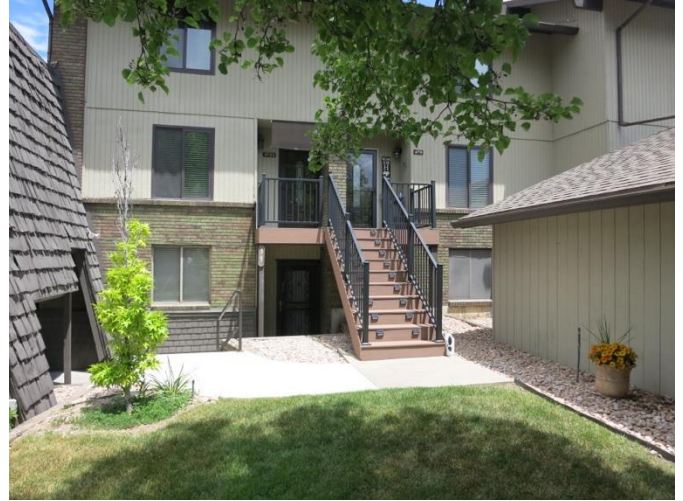
Component Name: Metal Railing Maintenance
 Component Number: Residential Building 2009

Component Life Expectancy: 10 years
 Age of Component: 0 years
 Remaining Component Life: 10 years

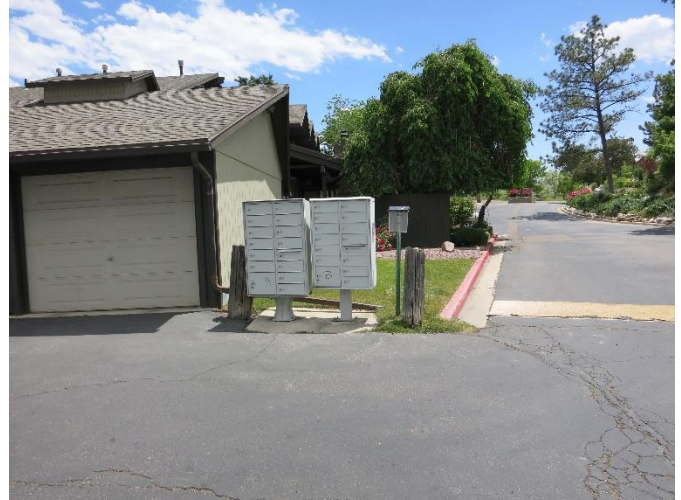
Component Name: Mailboxes
 Component Number: Common Development 3001

Component Life Expectancy: 25 years
 Age of Component: 10 years
 Remaining Component Life: 15 years

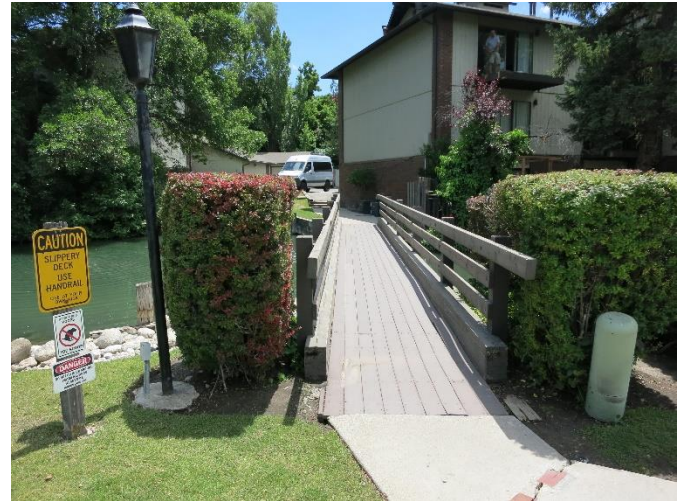
Component Name: Bridges
 Component Number: Common Development 3002

Component Life Expectancy: 30 years
 Age of Component: 0 years
 Remaining Component Life: 30 years

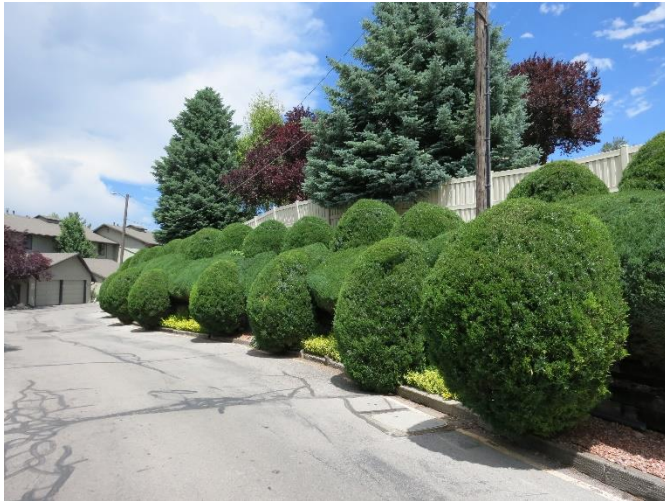
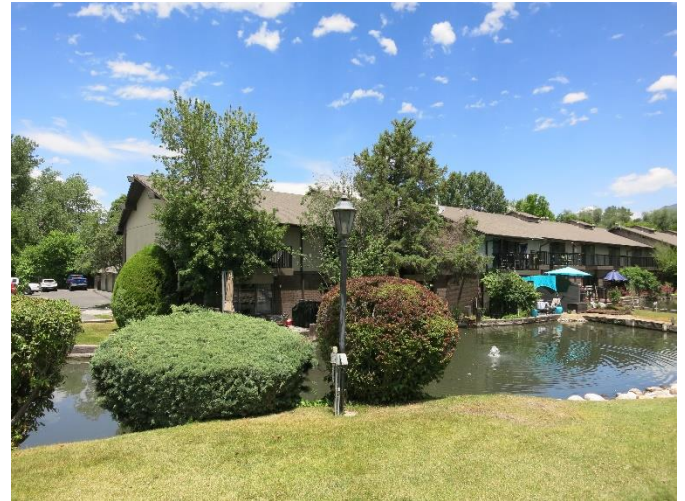
Component Name: Landscape & Irrigation
 Component Number: Common Development 3004

Repair Cycle Every: 5 Years
 Beginning Year: 2030

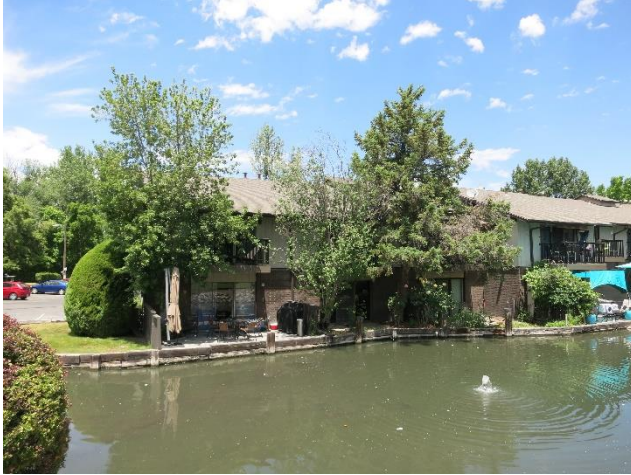
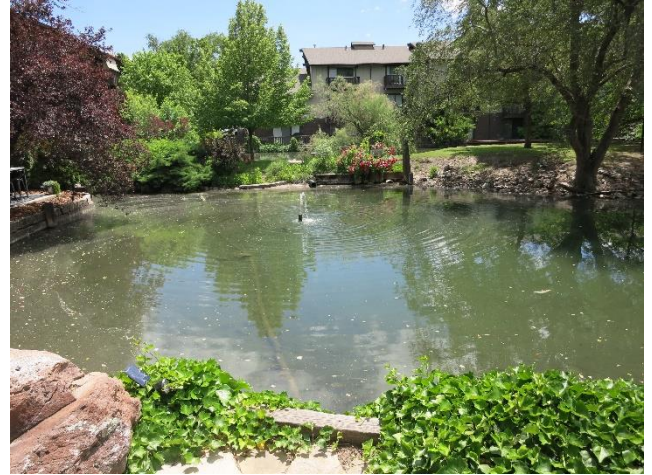
Component Name: Tree Trimming & Replacement
 Component Number: Common Development 3009

Tree Trim Allowance Every: 5 Years
 Beginning Year: 2030

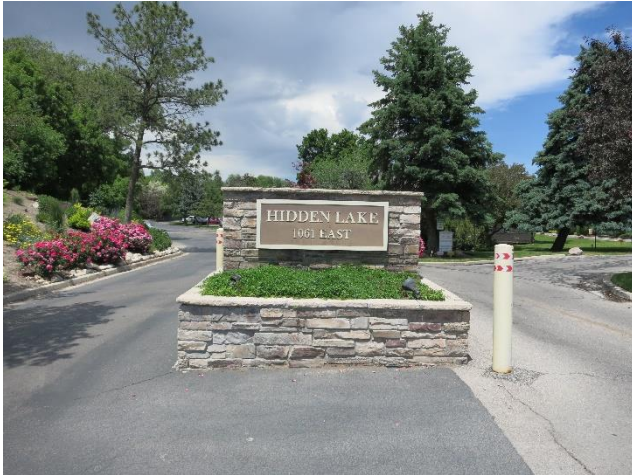
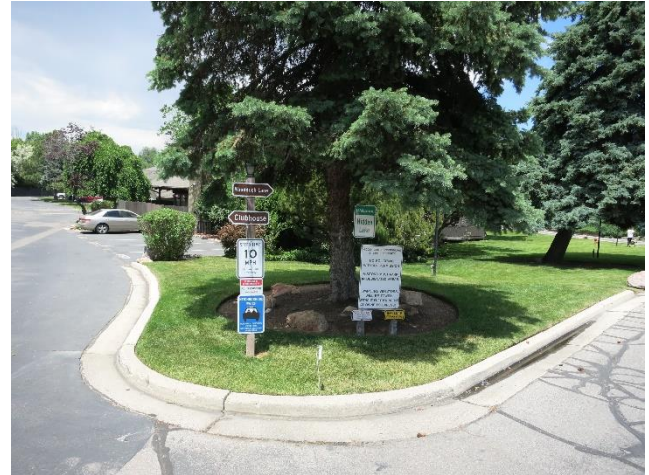
Component Name: Signs
 Component Number: Common Development 3010

Replacement Cycle Every: 5 years
 Beginning Year: 2030

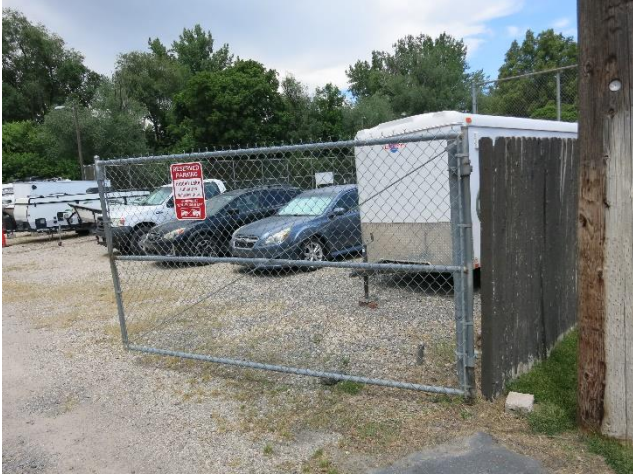
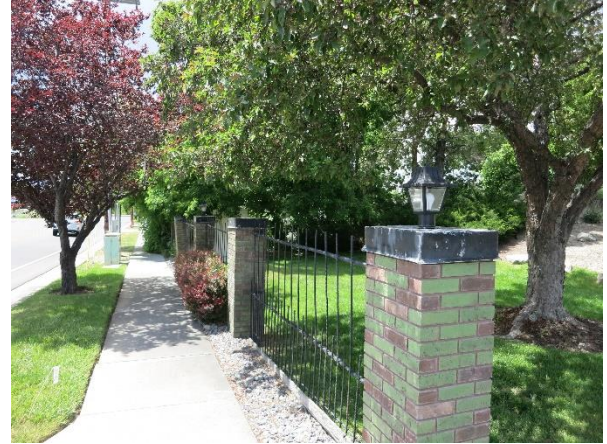
Component Name: Fence Repair & Maintenance
 Component Number: Common Development 3011

Repair Cycle Every: 8 years

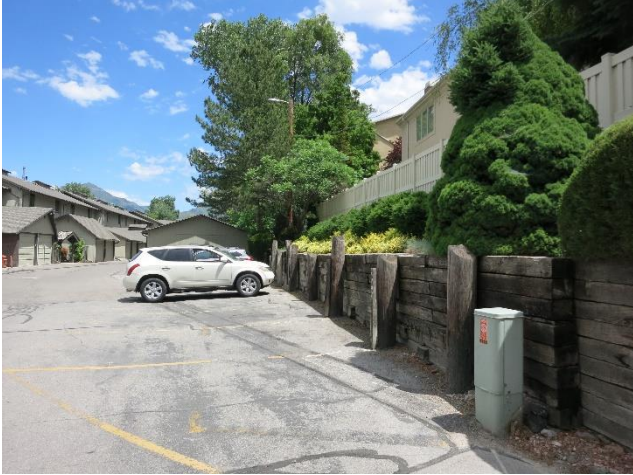
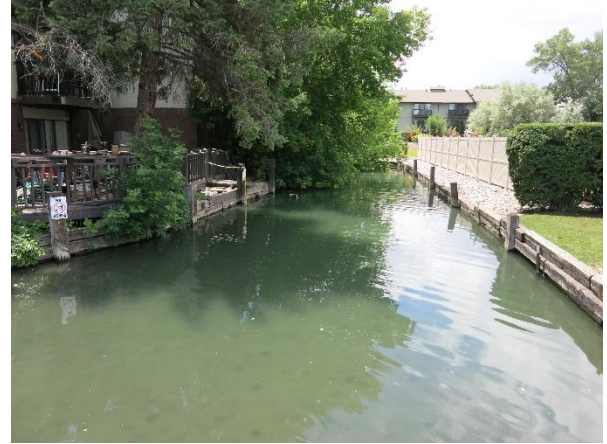
Component Name: Retaining Walls
 Component Number: Common Development 3012

Repair Cycle Every: 5 years
 Beginning Year: 2025

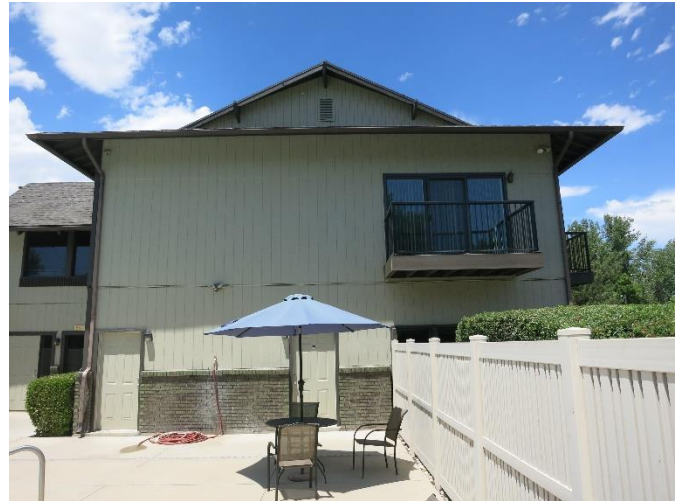
Component Name: Exterior Repaint
 Component Number: Clubhouse 4001

Component Life Expectancy: 12 years
 Age of Component: 1 years
 Remaining Component Life: 11 years

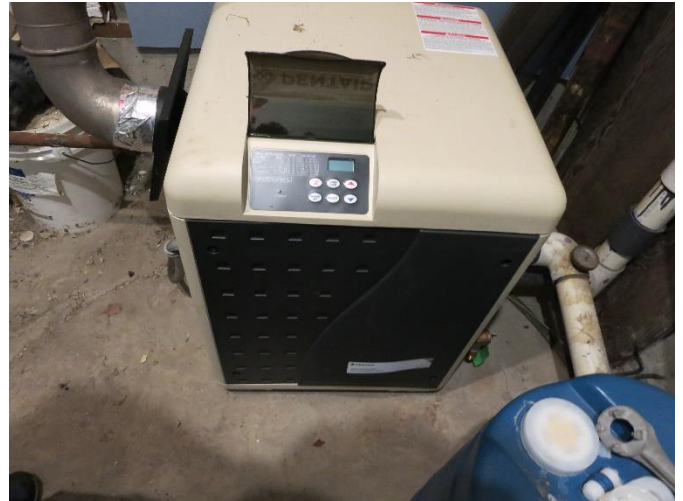
Component Name: Heater
 Component Number: Pool 5001

Component Life Expectancy: 12 years
 Age of Component: 6 years
 Remaining Component Life: 6 years
