Condominium Roof Condensation Investigation Hudson Townhome Community Prepared by Certified Roofing – Building Envelope Specialists

Report Created on March 5, 2026 9:38 PM

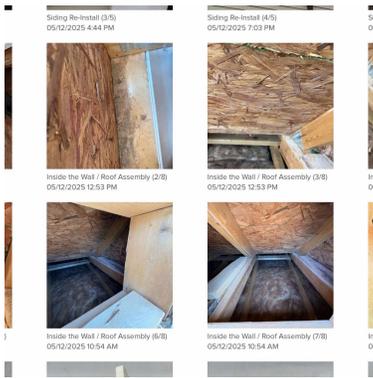
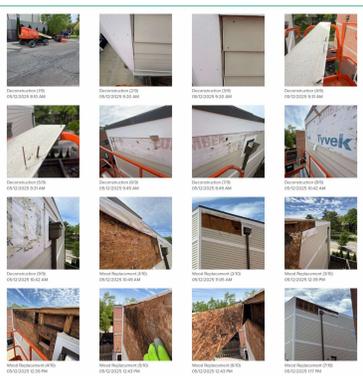
Condensation Damage Evidence
 – Unit 21 (1/2)
 03/05/2026 4:43 PM

<p>Condensation Damage Evidence – Unit 21</p>	<p>During investigative work at Unit 21, siding was removed from the parapet wall to inspect the building envelope.</p> <p>Behind the siding, the OSB wall sheathing was severely deteriorated.</p> <p>The sheathing showed:</p> <ul style="list-style-type: none"> • moisture saturation • delamination • structural degradation <p>The moisture damage originated from within the wall assembly, not from exterior water intrusion.</p>

<p>This pattern is consistent with condensation accumulation inside the roof and wall cavity.</p>
<p>Roof Assembly Investigation</p>	<p>Certified Roofing performed a roof core sample to confirm the roof assembly configuration.</p> <p>The core sample revealed the following construction:</p> <ul style="list-style-type: none">• TPO roofing membrane• ½-inch cover board• OSB roof deck• fiberglass batt insulation• drywall ceiling <p>The insulation is located below the roof deck rather than above it.</p> <p>This configuration allows the roof deck and membrane to remain very cold during winter conditions, increasing condensation potential.</p>
<p>Additional Field Observations</p>	<p>Units 35 and 37</p> <p>Certified Roofing conducted additional inspections of Unit 35 and Unit 37 during active rainfall.</p> <p>The purpose was to determine whether ceiling staining was caused by roof leaks.</p> <p>Thermal Imaging Inspection</p> <p>A thermal imaging camera was used to observe temperature patterns in ceilings and upper wall assemblies.</p> <p>Thermal imaging typically reveals cool anomalies where moisture intrusion is present.</p> <p>During the inspection:</p> <ul style="list-style-type: none">• No temperature anomalies were detected• No active roof leaks were observed• Interior finishes were dry despite rainfall <p>This confirms that the staining observed in these units is not caused by roof leakage.</p> <p>Instead, the evidence supports the conclusion that condensation occurs during extreme cold weather conditions.</p> <p>Roof Area Measurements</p> <p>Roof sections above each unit measure approximately:</p> <p>600 square feet per unit</p>
