Chainplates

All S80 owners are highly recommended to regularly check the conditions of their chainplates. There has been a few cases of them cracking and eventually breaking. For the safety of your rig, check them now!

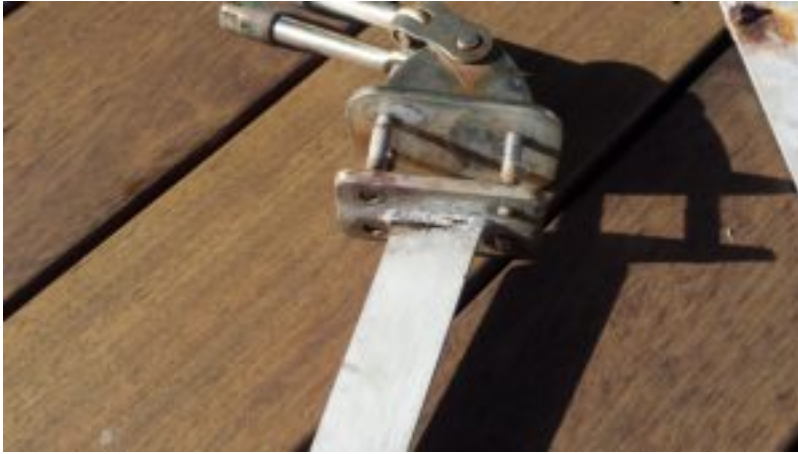
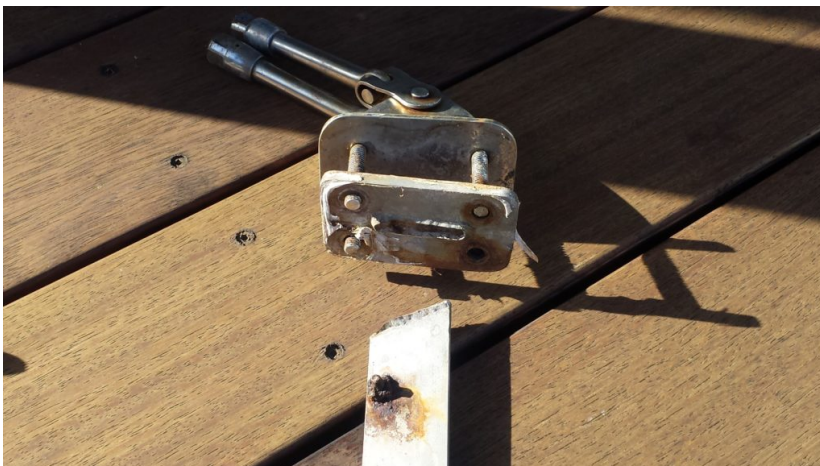
Speaking as a mechanical engineer of 55 years of experience with the last 35 years specialising in providing Expert reports for litigation, it is my opinion, based on the information apparent in the two photographs sent with your message, that the failure is likely to have resulted from one or more of the following likely causes:

1. The welding procedure possibly having being carried out by a welder who was not suitably qualified under Australian Standard AS 1554.
2. The weld being poorly carried out such that it did not comply with the relevant parts of AS 1554.
3. The heat-affected zones of the parent metal adjacent to the weld not being 'passivated' with appropriate reducing agents after the welding procedure.
4. The effects of 'stress cracking corrosion' in the welded joint.

5. A poorly-executed fillet weld being used to establish the joint when a properly-executed, full-penetration weld should have been used.

I would need to examine the failed parts to determine whether or not the failure resulted from 'metal fatigue' but it is my opinion that one or more of the above 5 likely causes of failure is/are the culprit.

It is my opinion, without having carried out any stress calculations on the weld, that had the fillet weld been properly carried out in accordance with the relevant parts of AS 1554, the joint would not have failed.

It is my opinion that all stressed welds in chain plate assemblies should be full-penetration welds which have been carried out in accordance with the appropriate parts of AS 1554.
