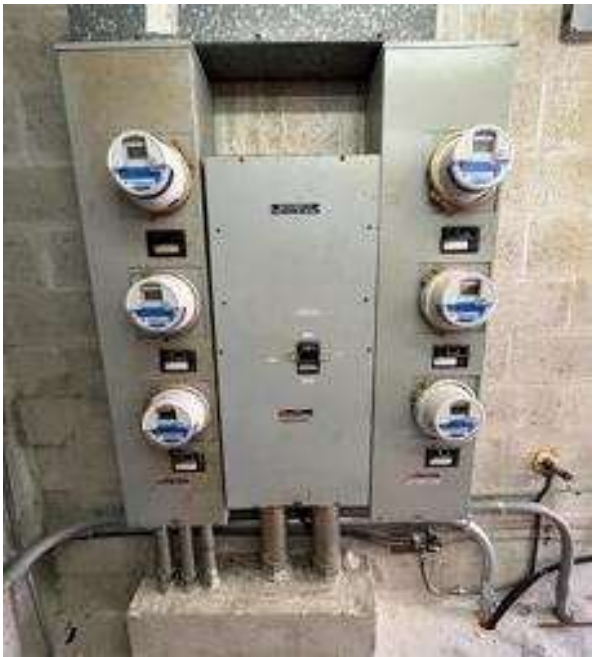
**Picture #5**

Replace main and meter center by FPE in main electric room. See picture #46 for replacement.

**Picture # 46**

The existing FPE main and meter center located in the main electrical room has been replaced with new.

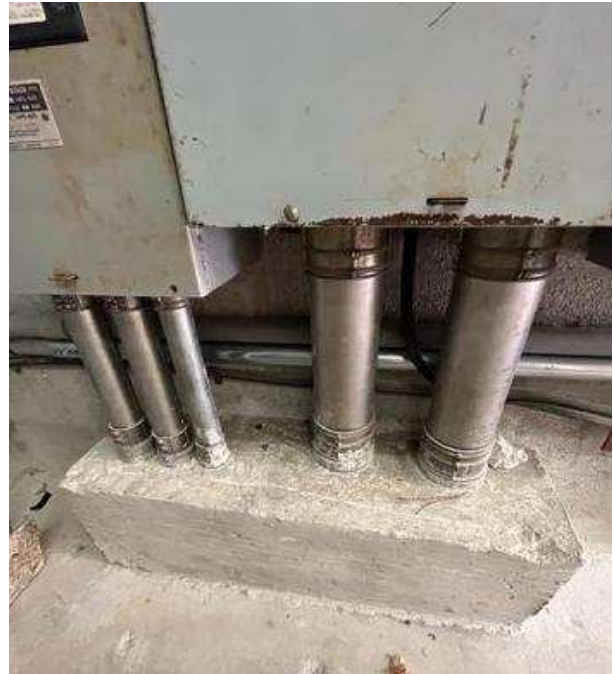
**Picture #6**

Service and Feeder conduits are in good condition.

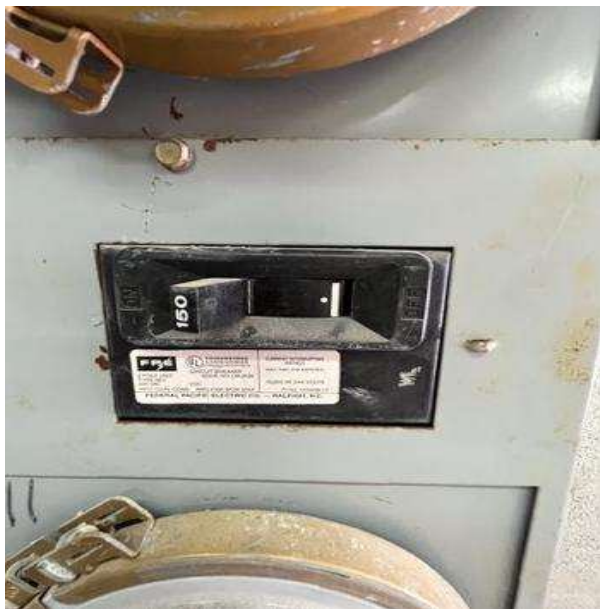
**Picture #7**

Replace main and meter center by FPE in main electric room. Equipment has been ordered; it arrives in July 2024. See picture #46 for replacement.

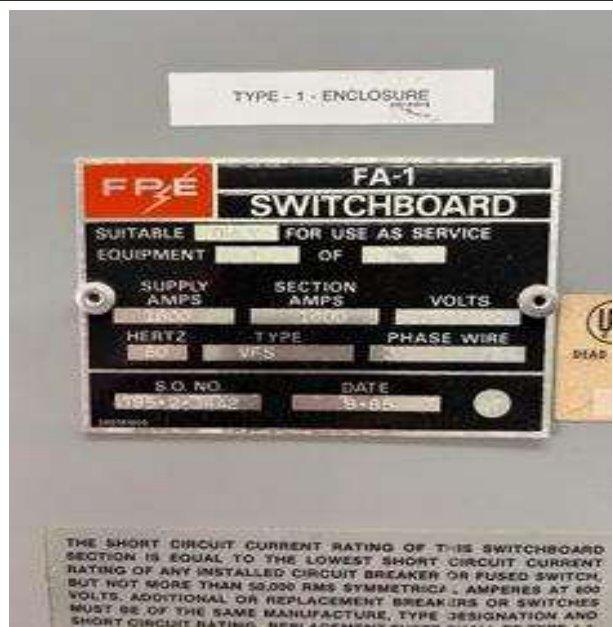
**Picture #8**

Upon reinspection this is a fusible switch board and is suitable to remain.

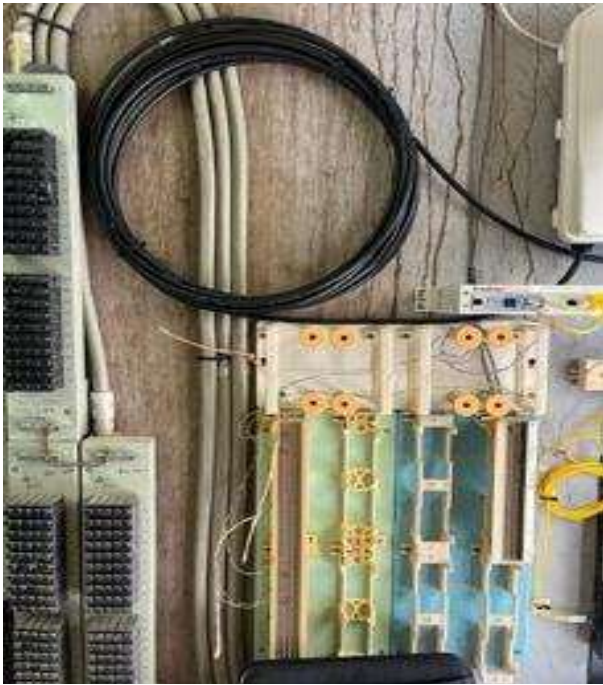
**Picture #9**

L.V./other wiring is good.

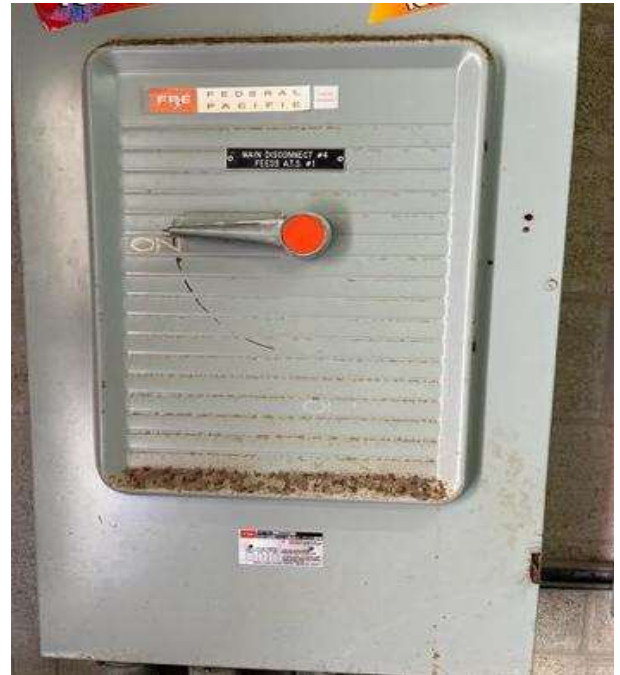
**Picture #10**

MAIN Disc. #4 is Fusible and may remain.

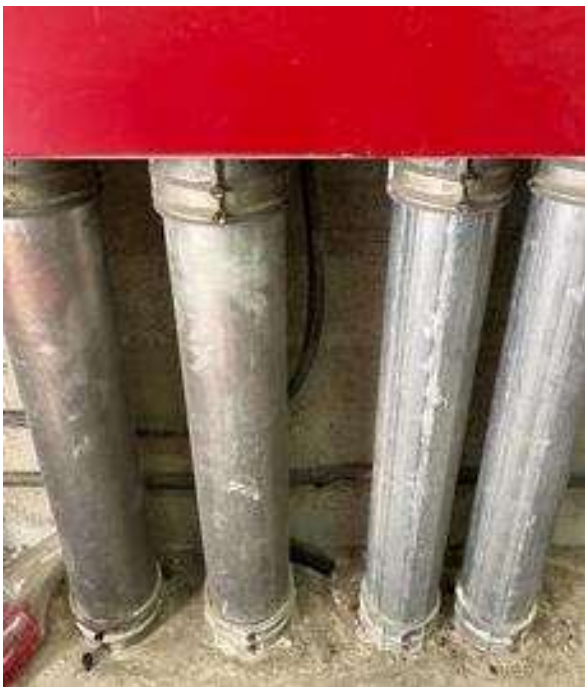
**Picture #11**

Service/feeder conduits in good condition.

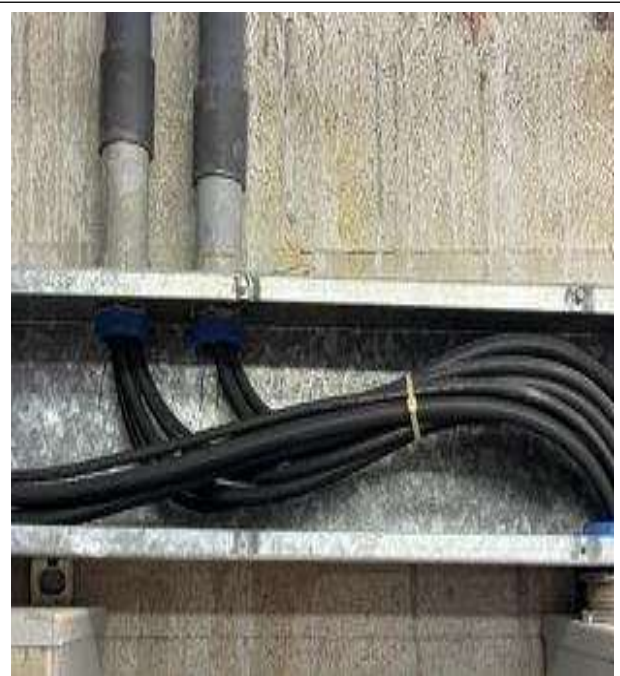
**Picture #12**

Gutter in main electric room tap and fill is good.

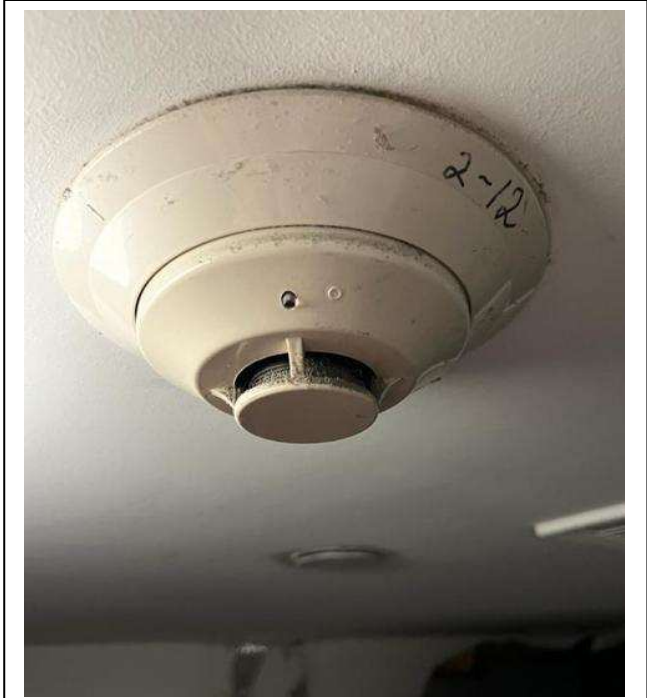
**Picture #13**

Smoke detectors are good throughout.

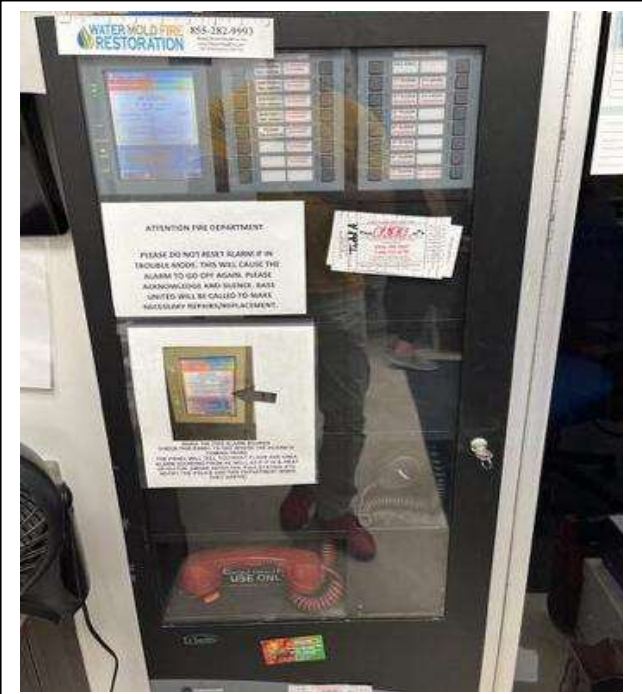
**Picture #14**

Fire alarm system is functioning properly.

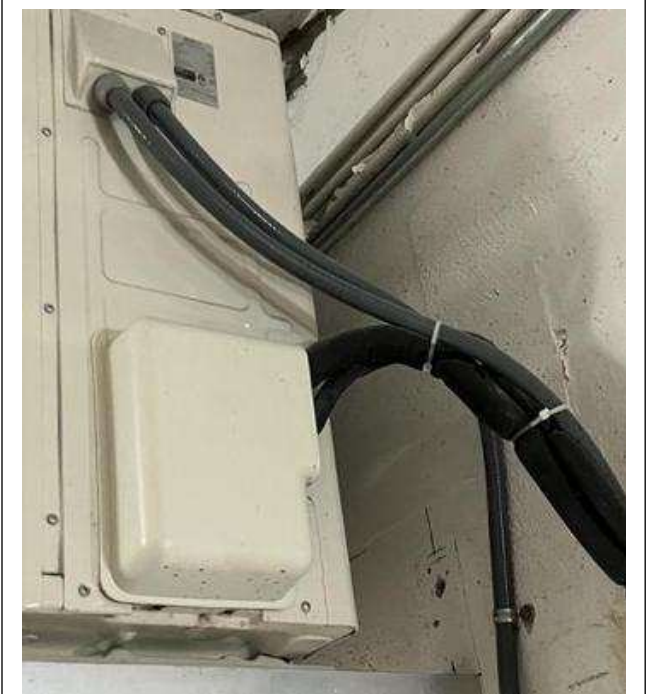
**Picture #15**

Electric connection to mechanical equipment is good.

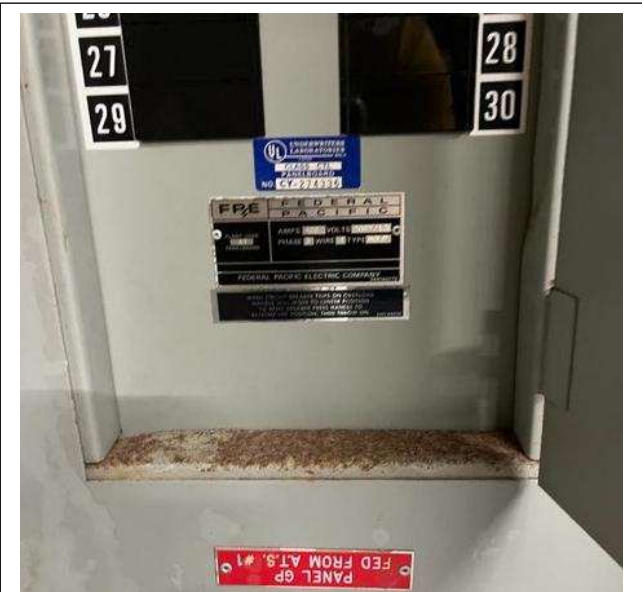
**Picture #16**

Replace FPE panel "GP" is an FPE panel, however, the CBs are not "STAB-LOK" type. Replacement is optional. Upon reinspection, the Panel "GP" is good to remain.

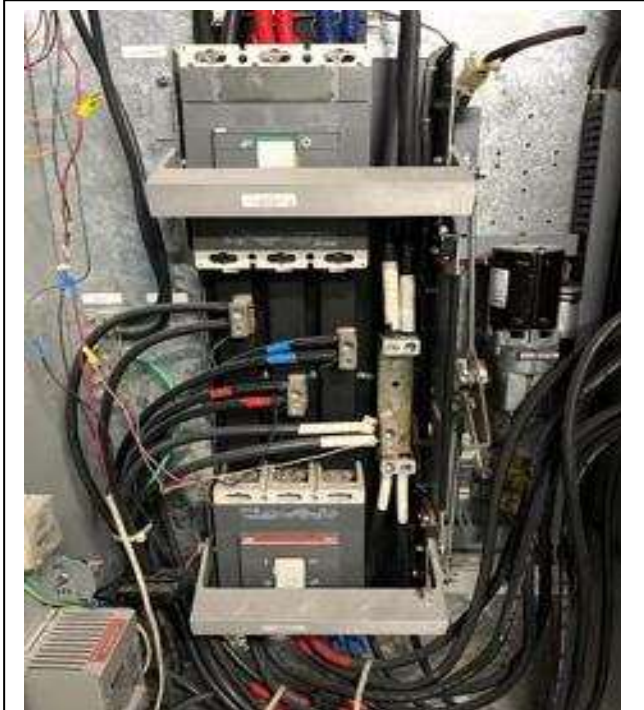
**Picture #17**

Internal wiring in panels, good condition.

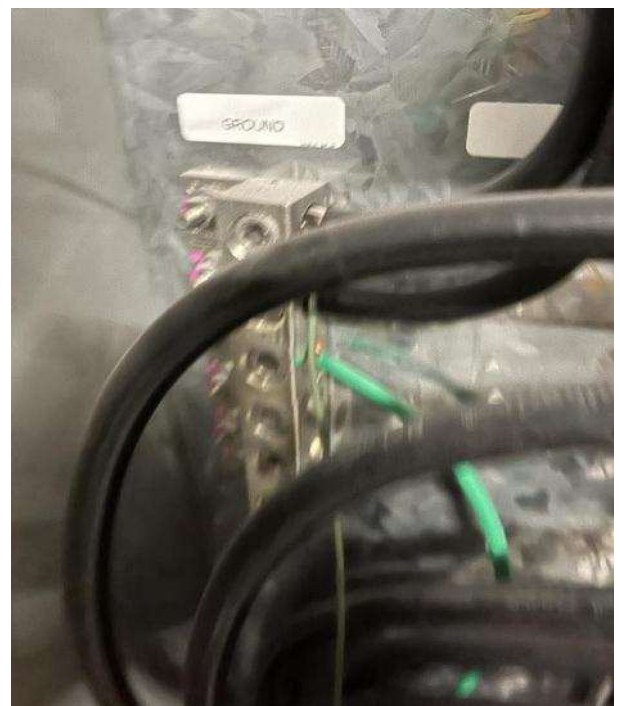
**Picture #18**

Equipment grounding is good.

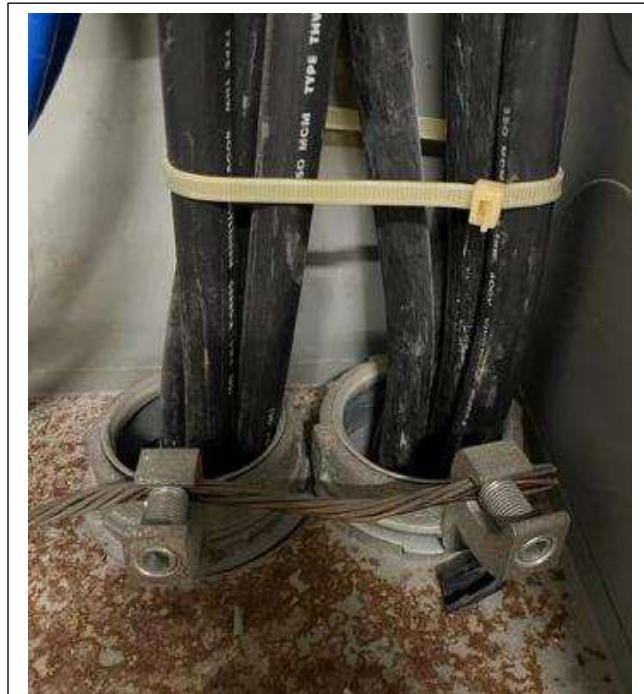
**Picture #19**

Bonding is good.

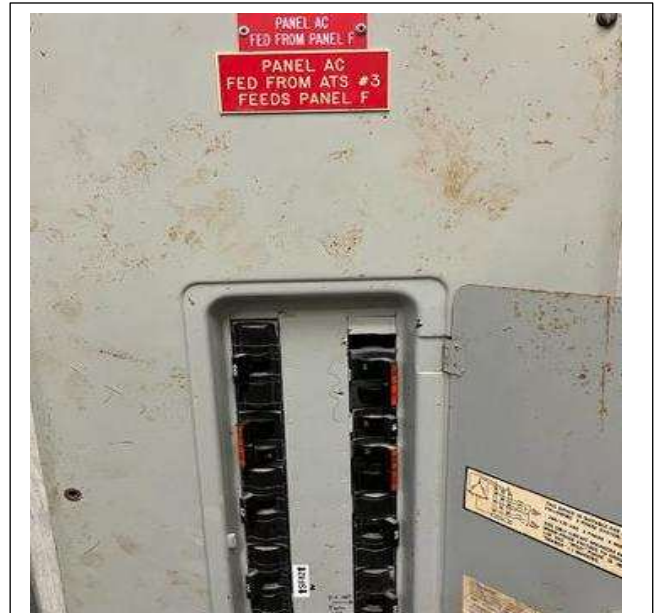
**Picture #20**

Replace FPE panel "AC" with new. See Picture #47 for repair.

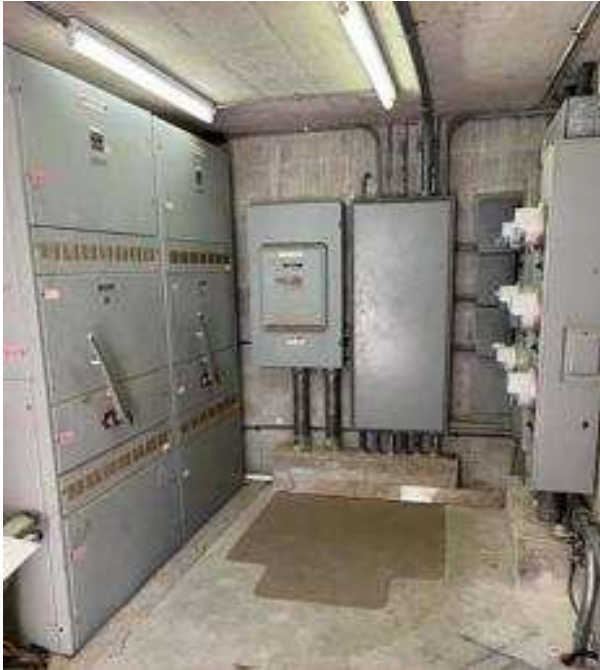
**Picture #21**

Main electrical room clearance is good.

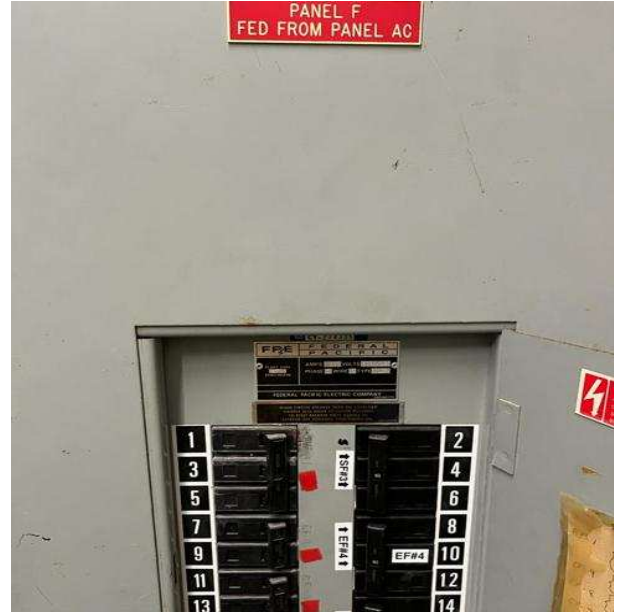
**Picture #22**

Panel "F" is an FPE Panel, however, the CB's are not "STAB-LOK" type. Upon reinspection, the "F" Panel is good to remain.

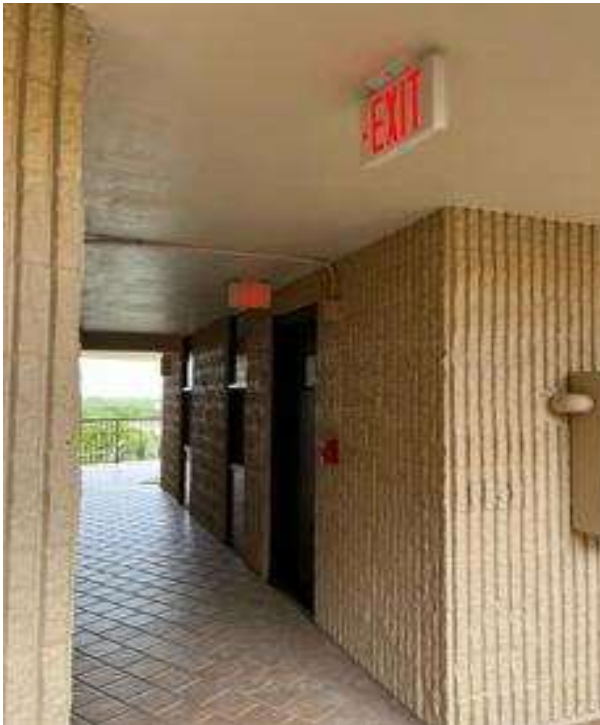
**Picture #23**

Egress path/exit illumination is good.

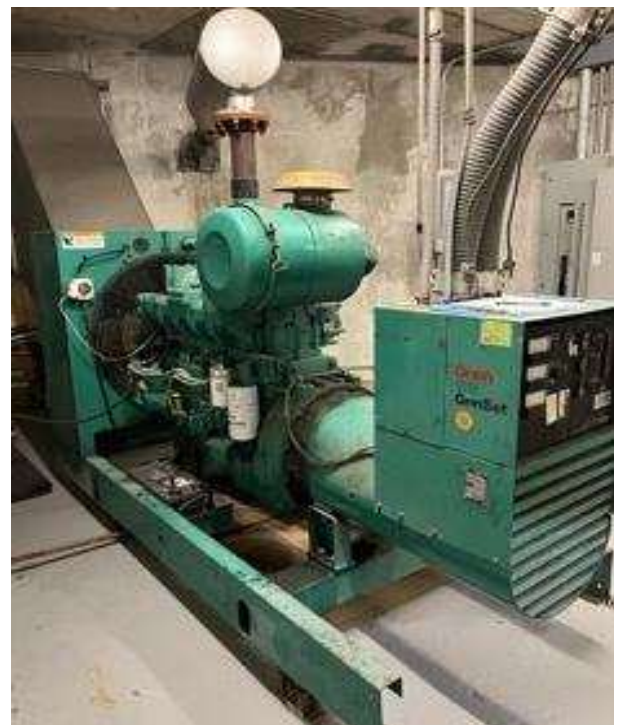
**Picture #24**

Generator is in good condition.

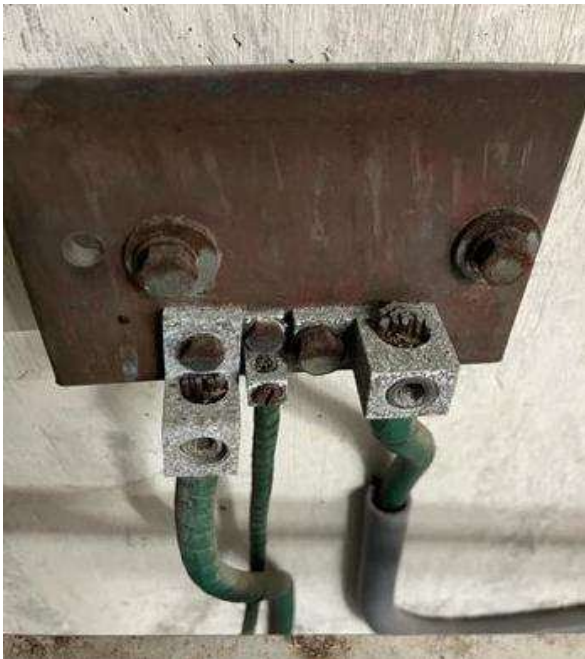
**Picture #25**  
Grounding system is good.

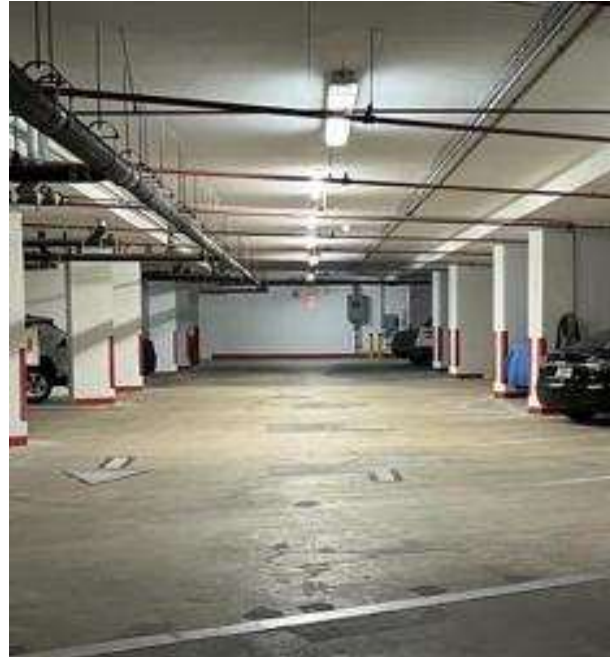
**Picture #26**  
Garage area lighting is good.

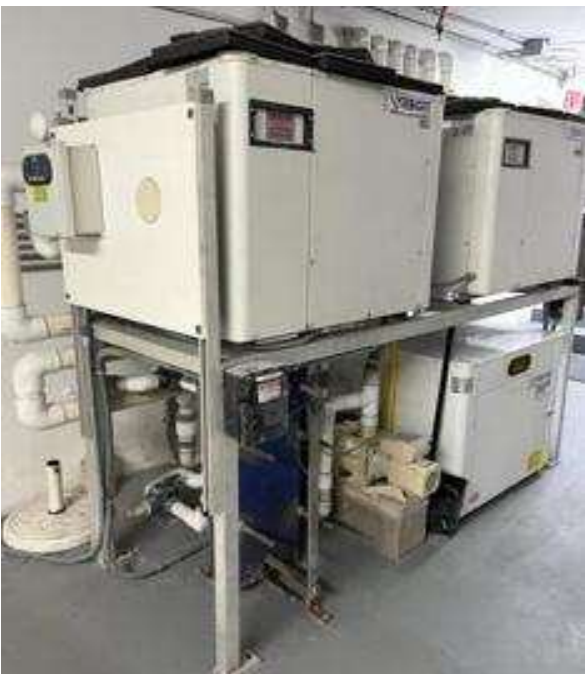
**Picture #27**  
Pool equipment and electrical connections are good.

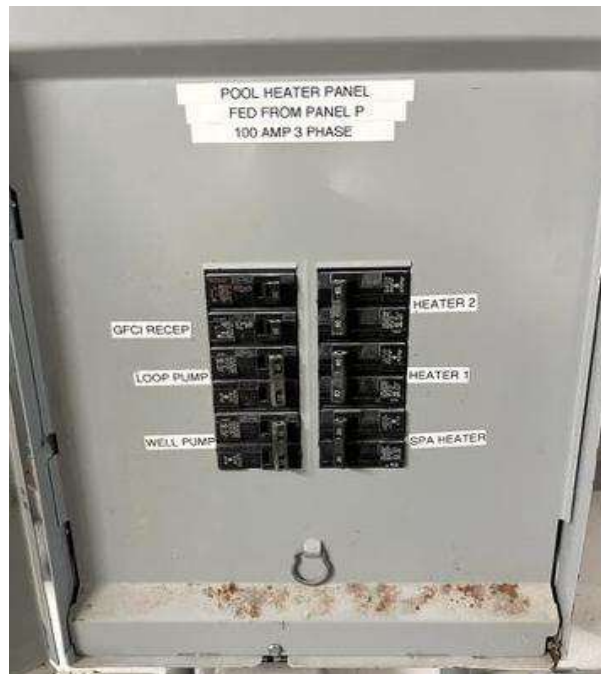
**Picture #28**  
Pool panel is in good condition.

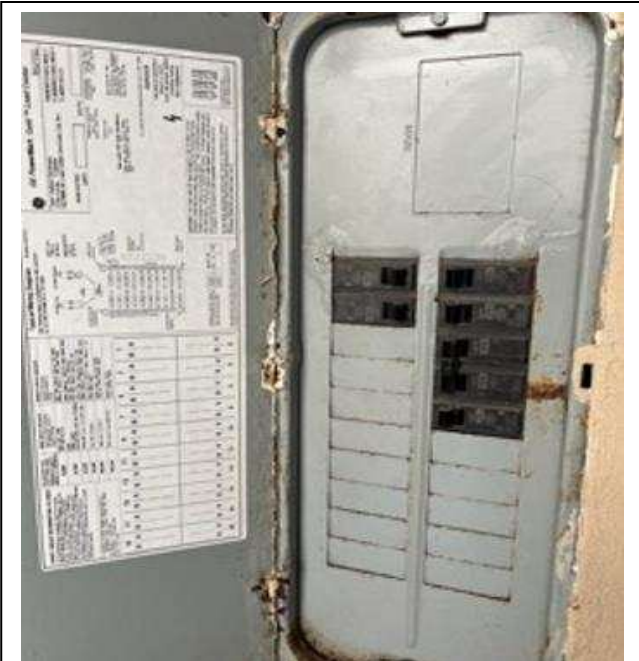
**Picture #29**

Complete panel directory at panel "P" outside by pool toilets. See picture #47 for new directory.

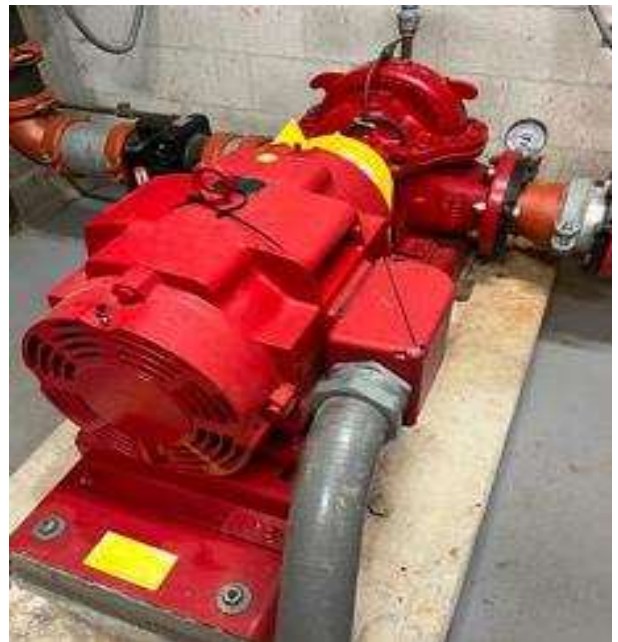
**Picture #30**

Electrical connection at fire pump is new/good condition.

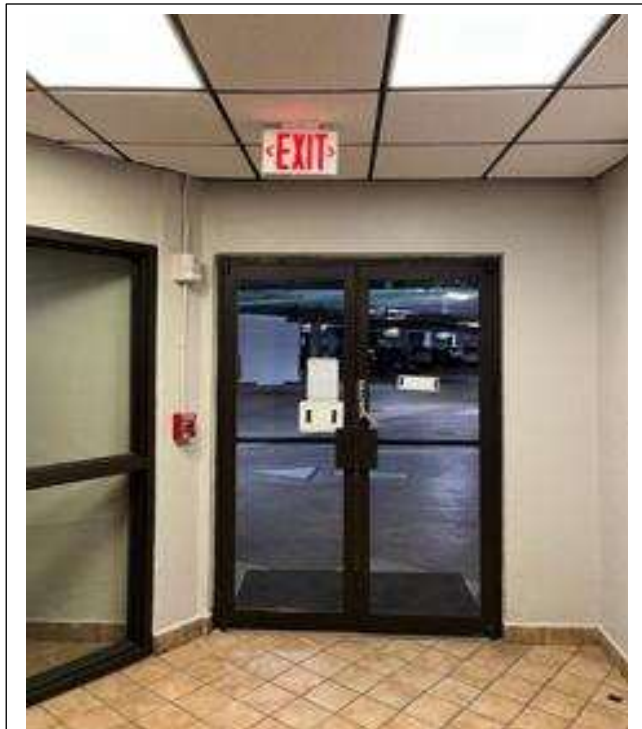
**Picture # 31**

Lobby egress illumination is in good condition.

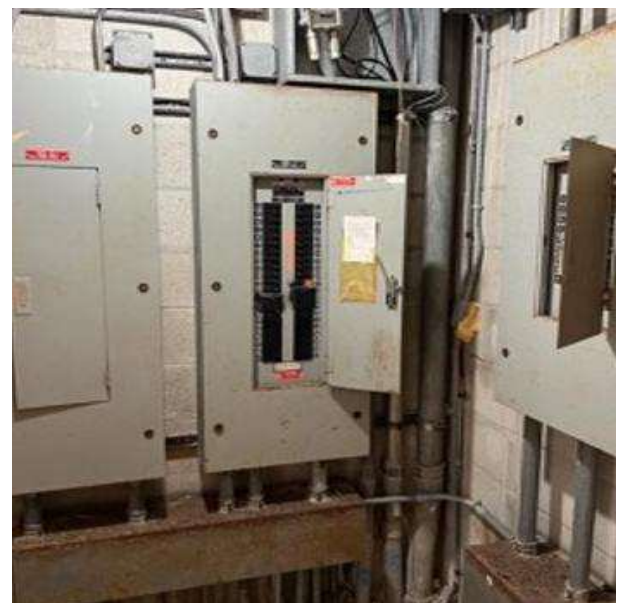
**Picture # 32**

FPE panels in this room are an FPE Panel, however, the CB's are not "STAB-LOK" type. Replacement is optional. Upon reinspection, the Panel "GB" is good to remain.

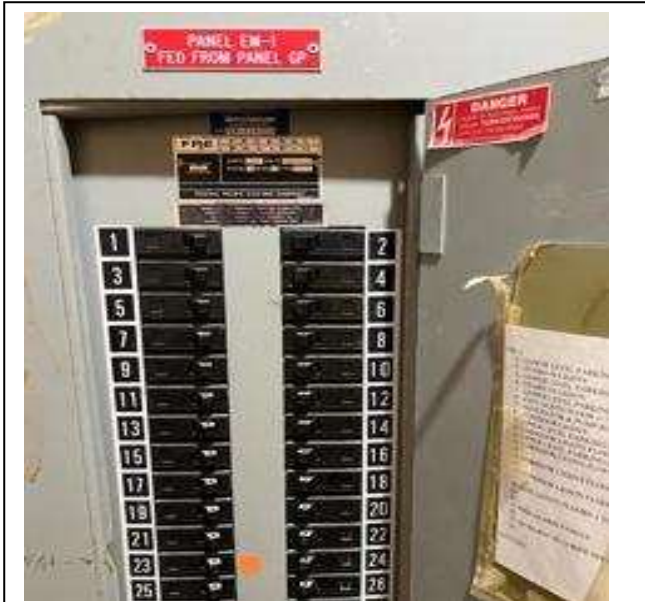
**Picture # 33**

Panel "EM1" is an FPE Panel, however, the CB's are not "STAB-LOK" type. Replacement is optional. Upon reinspection, the Panel "em1" is good to remain.

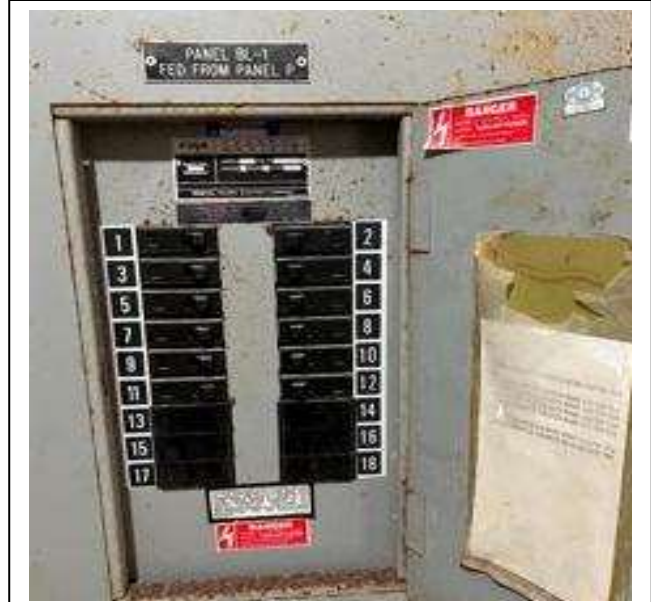
**Picture # 34**

Panel "BL1" is an FPE Panel, however, the CB's are not "STAB-LOK" type. Replacement is optional. Upon reinspection, the Panel "BL1" is good to remain.

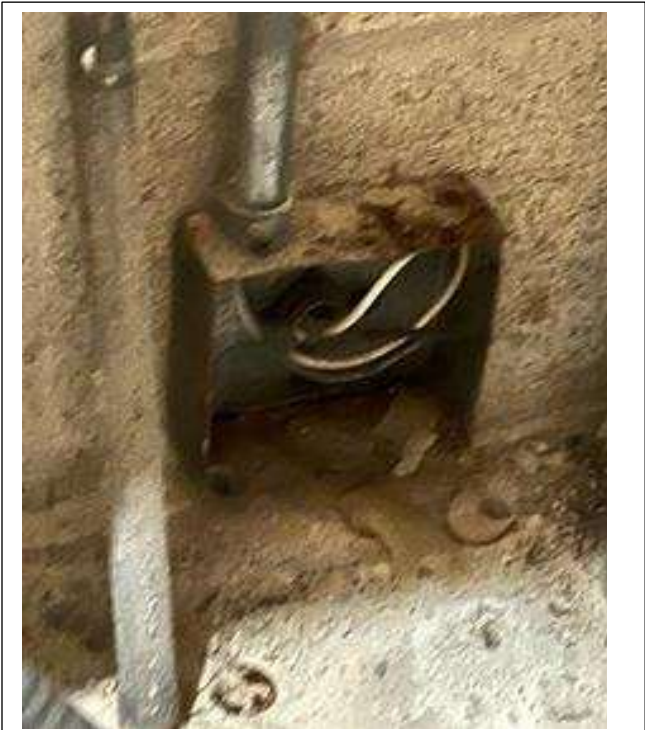
**Picture # 35**

Provide cover on open J-box at secondary electrical room. See Picture #48 for repair.

**Picture # 48**

A new cover has been provided on the open J-box at secondary electrical room.

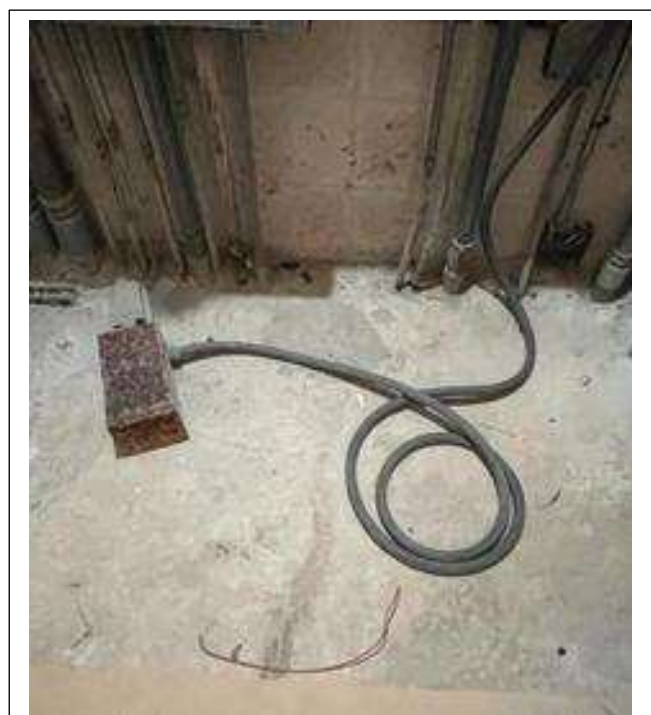
**Picture # 36**

Remove temporary power box and cable and make safe. Upon reinspection, this cable was removed.

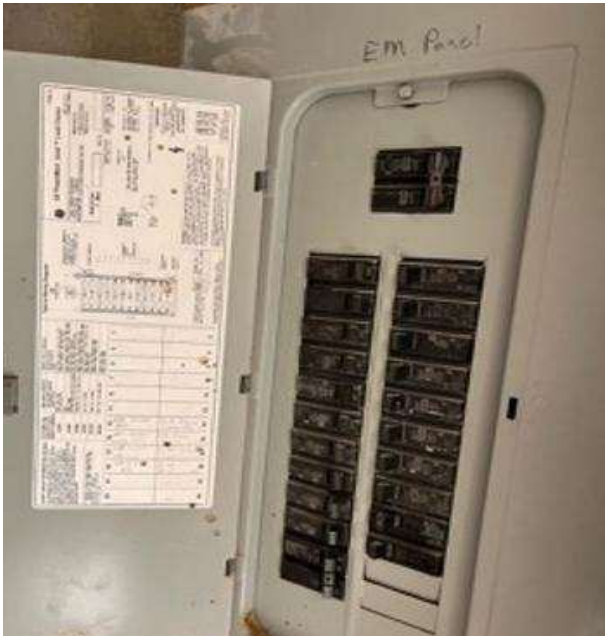
**Picture # 37**

Provide complete directory of circuits for panel "EM".

**Picture # 51**

Panel "EM" Has been replaced with new panel F1 and a complete directory.

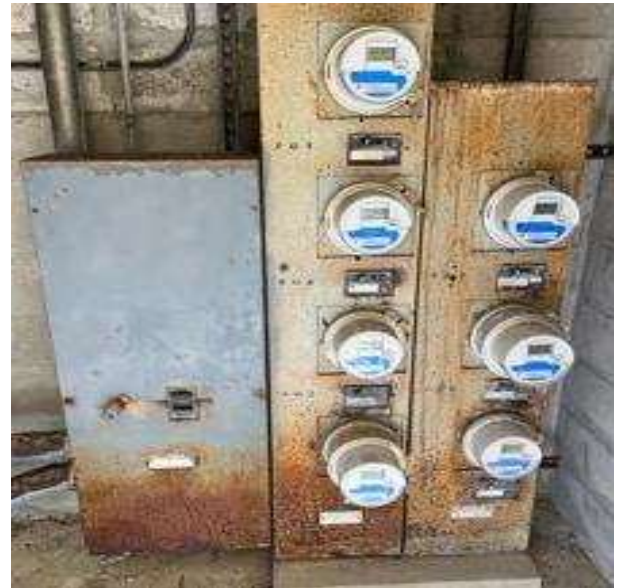
**Picture # 38**

Future replacement of all meters and mains in all secondary electrical rooms is recommended, due to corrosion. All mains/meter like this one was infrared tested and passed the test.

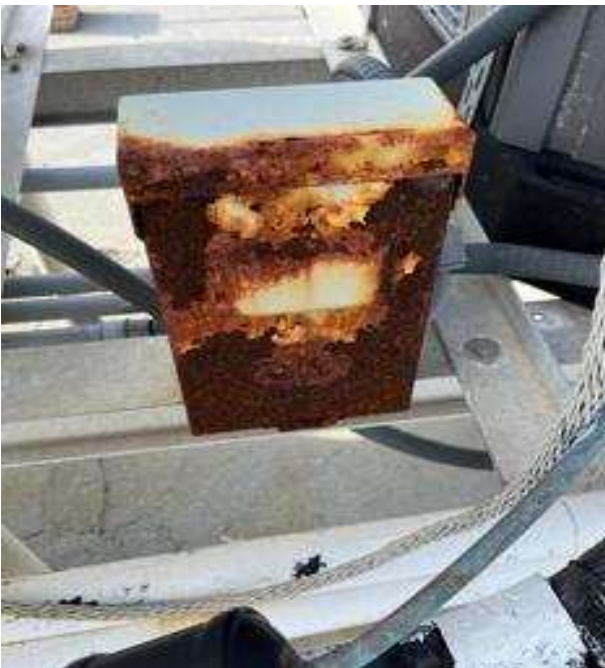
**Picture # 39**

Replace all rooftop AC disconnect switches in poor condition with new. See picture #50 for replacement.

**Picture # 50**

All rooftop AC disconnect switches in poor condition have been replaced with new.

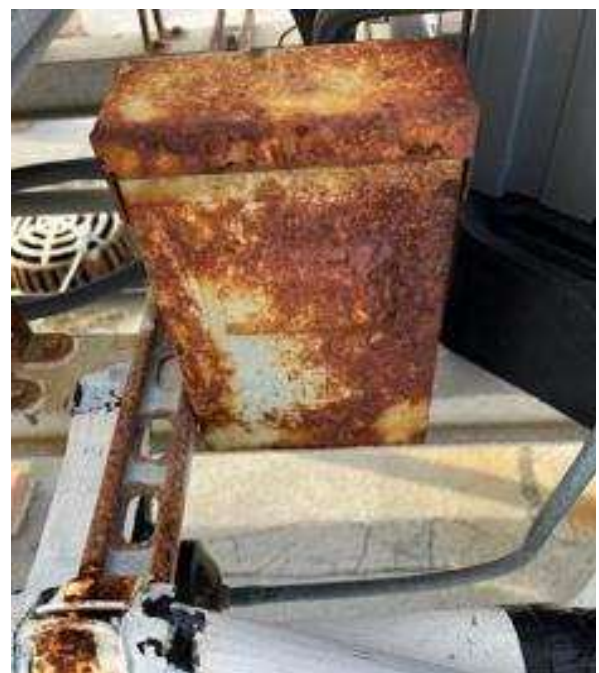
**Picture # 40**

Replace all rooftop AC disconnect switches in poor condition with new. See picture #50 for replacement.

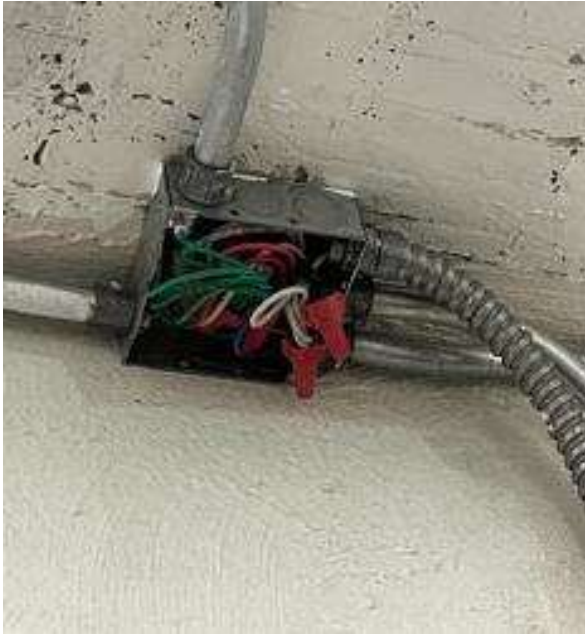
**Picture # 41**

Provide J-box with cover at rooftop elev. room.  
See picture #49 for repair.

**Picture # 49**

A new cover has been provided on the open J-box at the rooftop elev. room

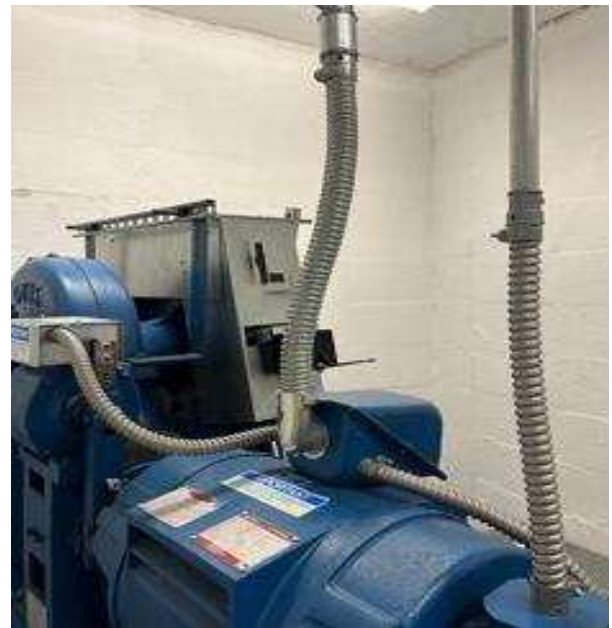
**Picture # 42**

Connections to mechanical equipment/elevator  
motor in good condition.

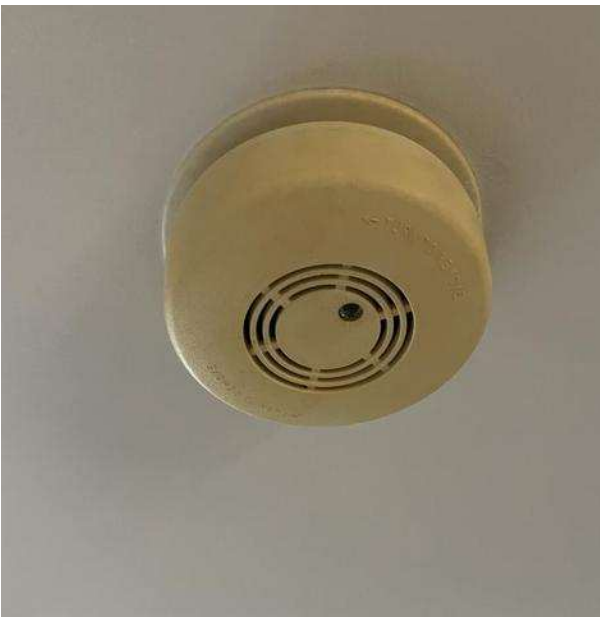
**Picture # 43**

Residential/dwelling unit smoke detectors in good  
condition.

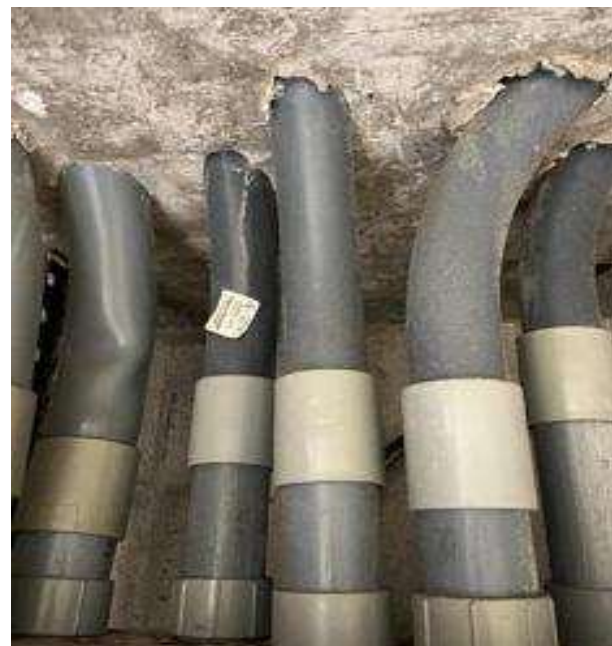
**Picture # 44**

Feeder conduits, (PVC), in good condition.

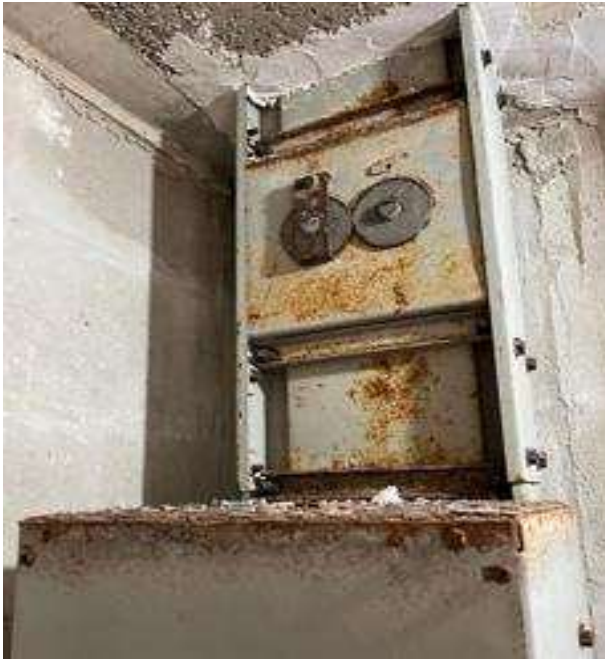
**Picture # 45**

Upon reinspection, the busducts are good to remain.
