Cause and Prevention of Microkeratome Jamming Related to Lid Squeezing

Mark E Johnston MD FRCSC
nebraskaeye.com

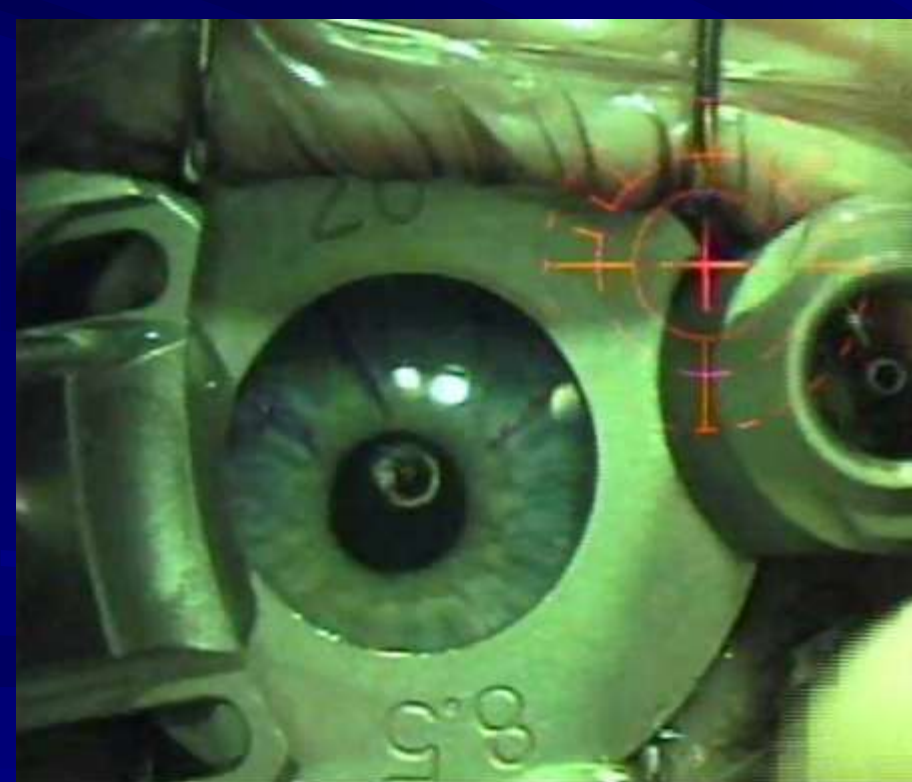
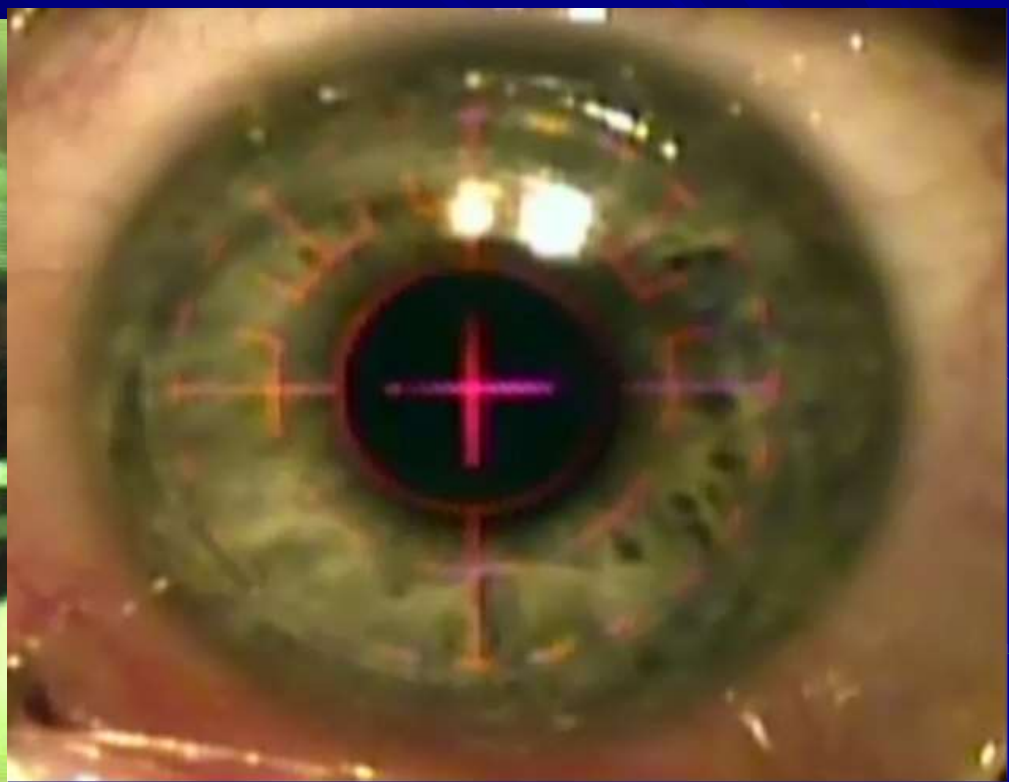
Three cases of jamming of the Technolas Zyoptix XP® microkeratome related to patient squeezing resulted in partial flap formation, all in the first eye attempted and in males with deep set eyes and strong lids.

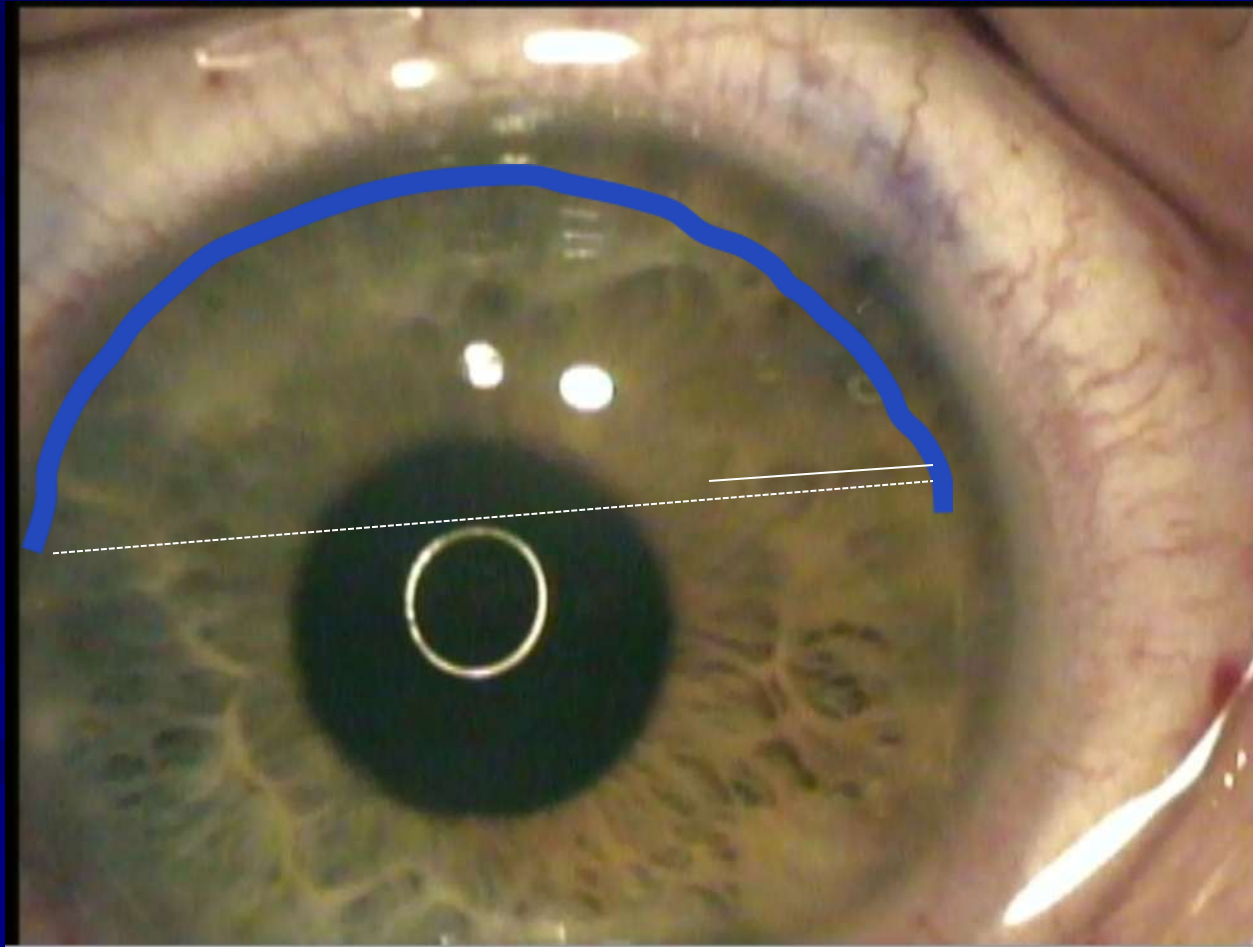
In the third case the microkeratome could not be reversed. The assembled suction ring-microkeratome was removed after suction was released, resulting in a partial flap with a partial flap tear.

Contact in place with flap repositioned

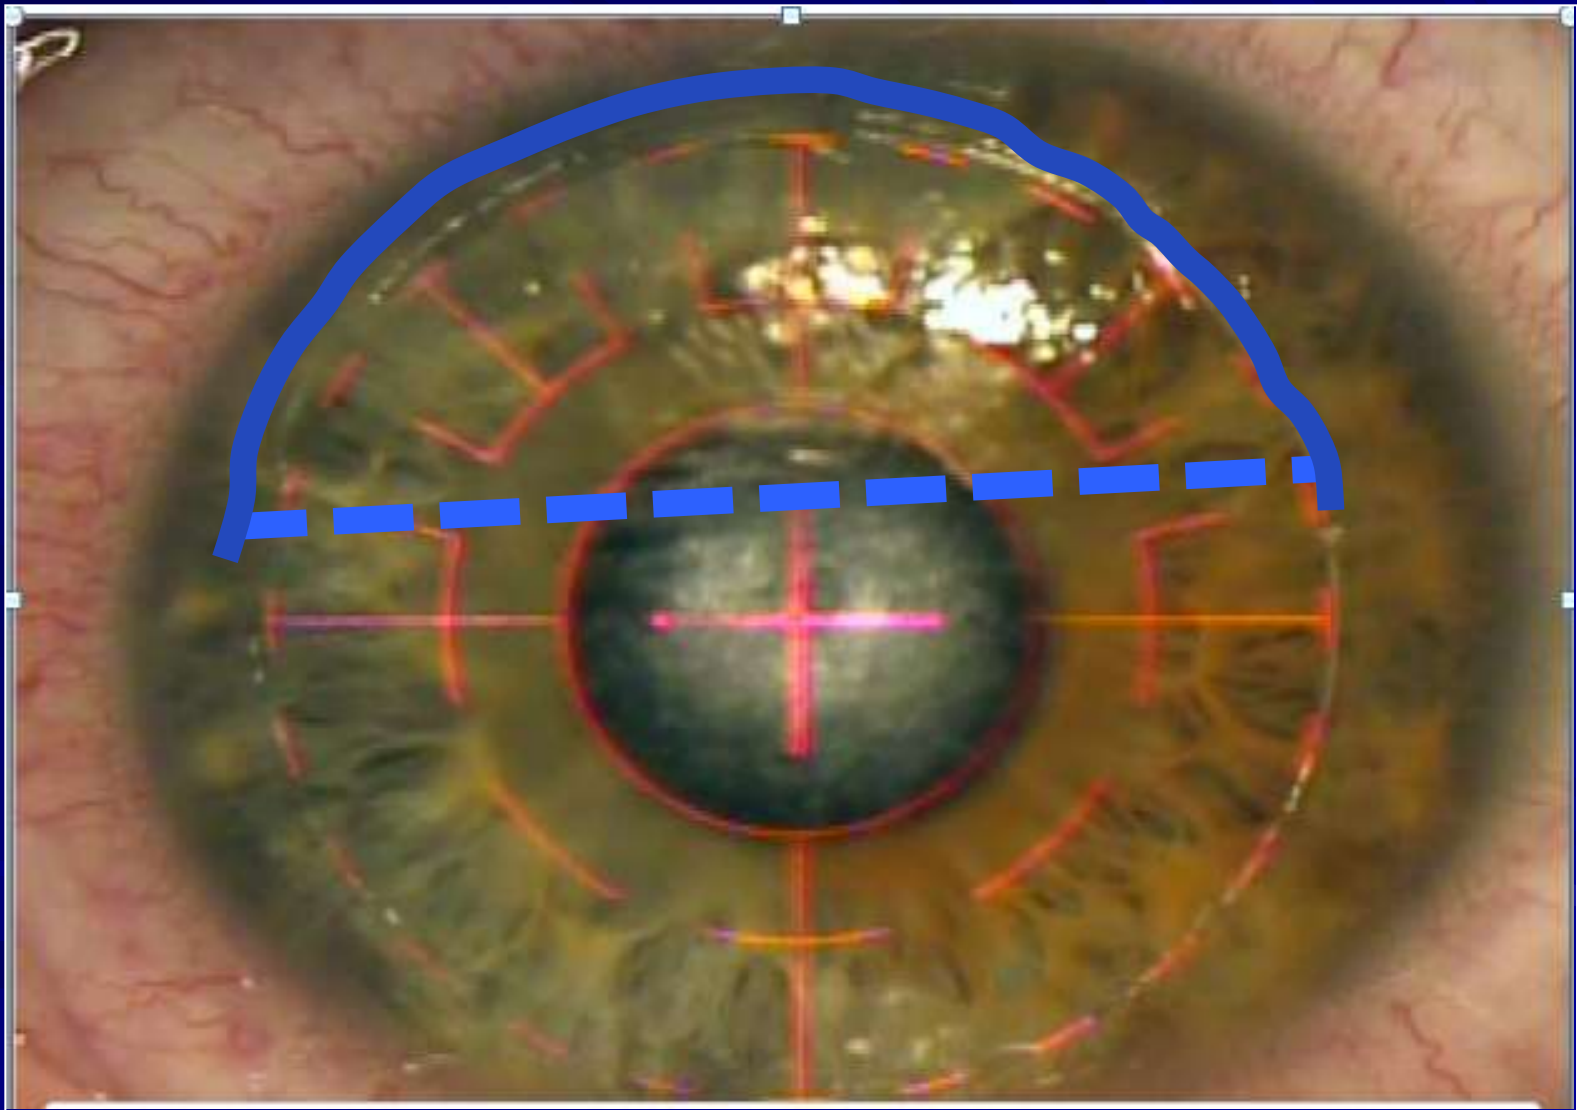
All patients had successful photorefractive keratectomy
at a later date.

PRK with alcohol over previous partial flap (40%)

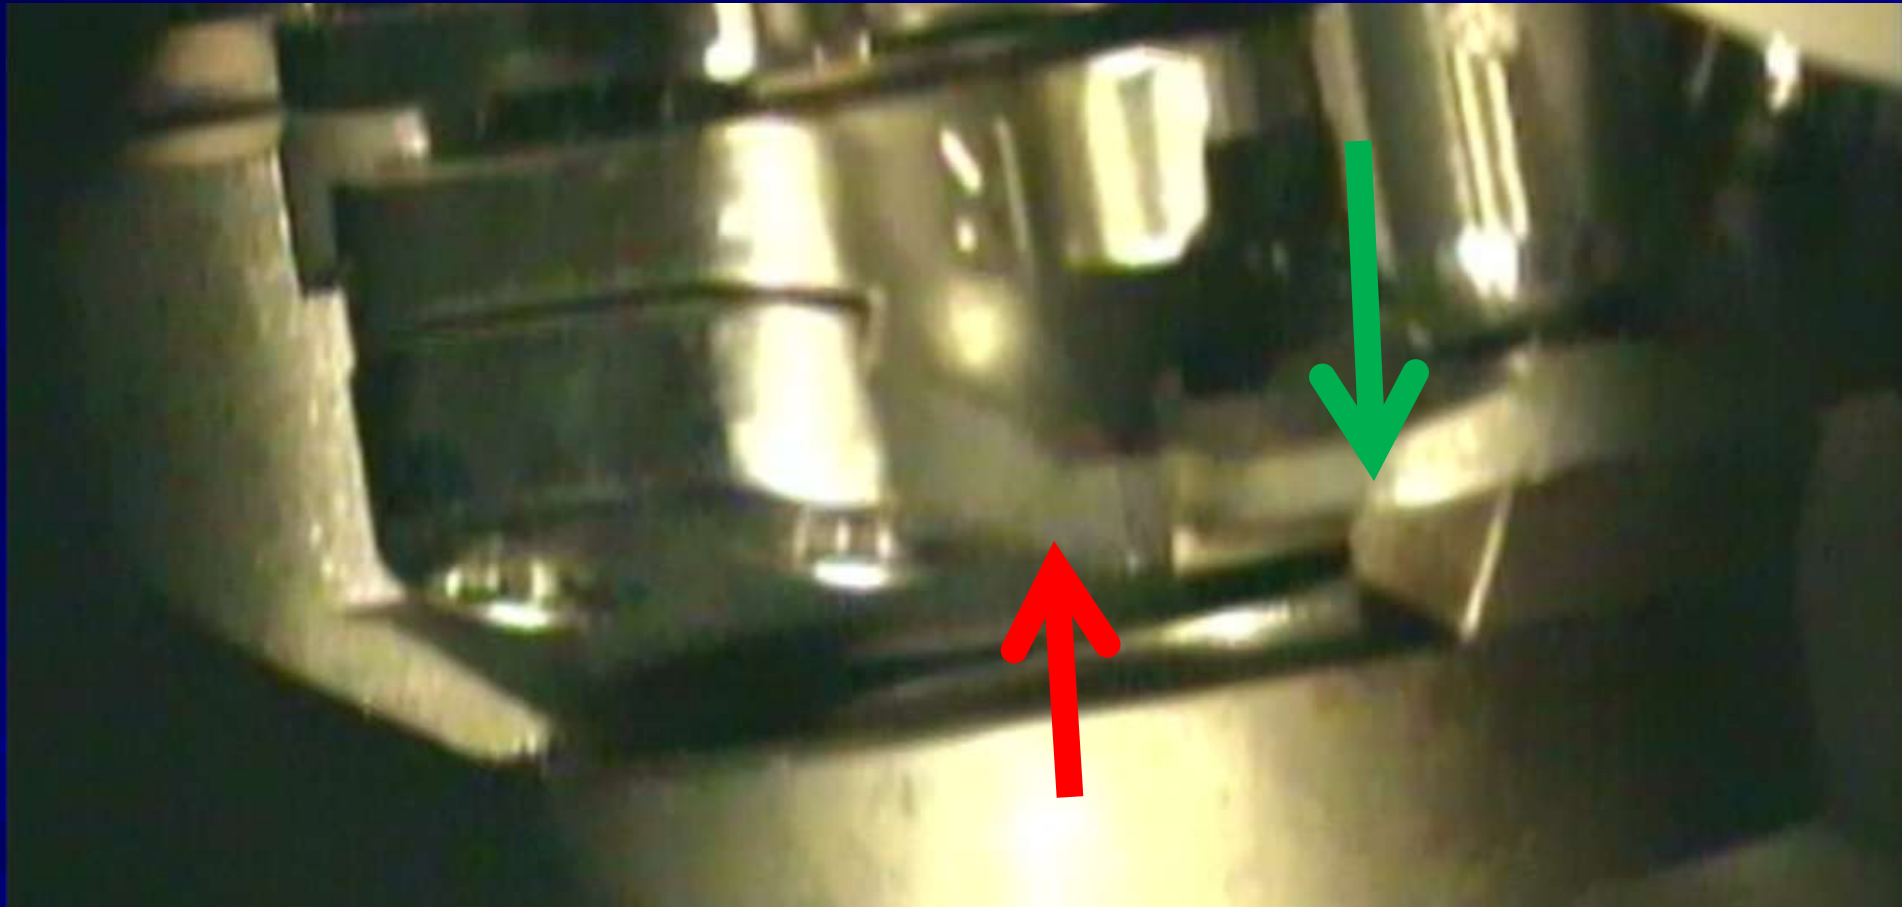
The jammed microkeratome from the third case showed that the guide on the microkeratome head which normally slides under the overhang of the microkeratome ring had instead advanced against this overhang and jammed.

Glide (red) is jammed into the ring overhang (green)

Since the mechanism of this jamming has been understood, extra care is taken, especially in squeezers, to assure that the microkeratome head guide is properly seated and lower than the ring overhang before advancing the head

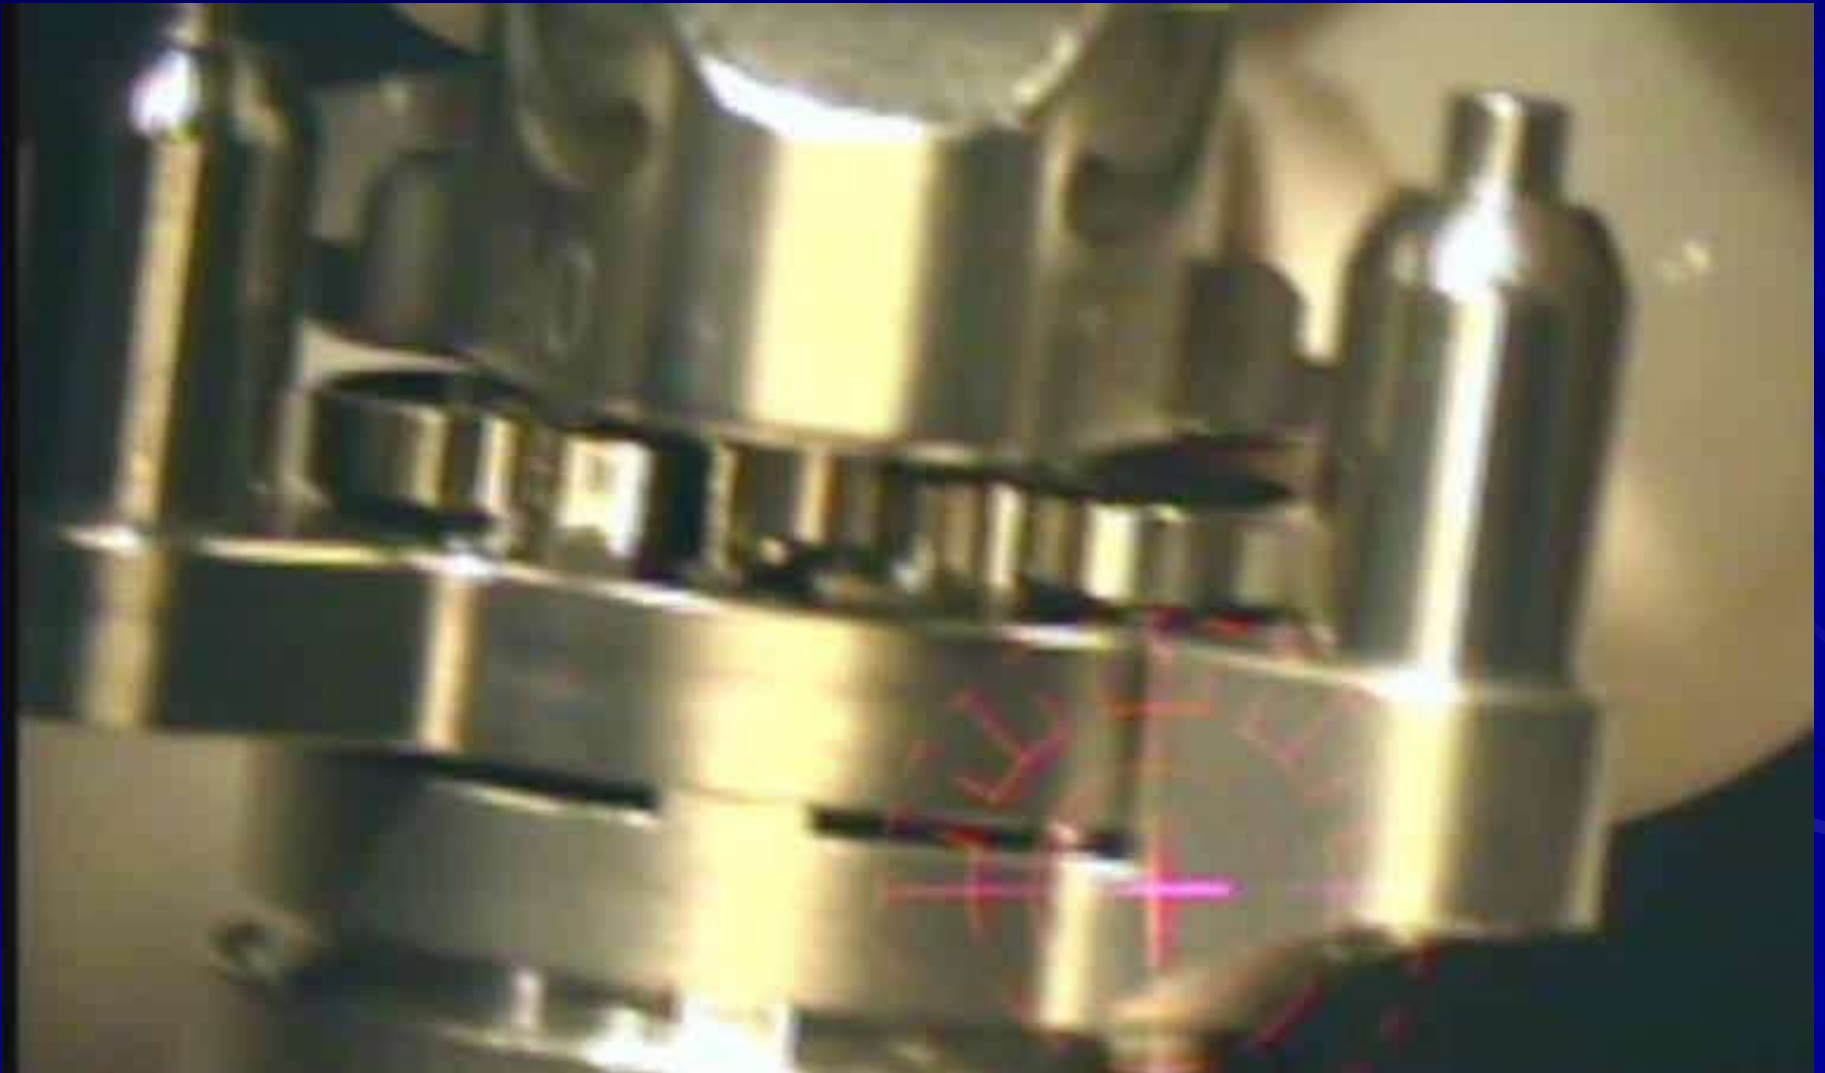
This jam can only be reproduced if the microkeratome head is first knocked slightly off angle and then advanced with the head not fully seated down into the microkeratome ring.

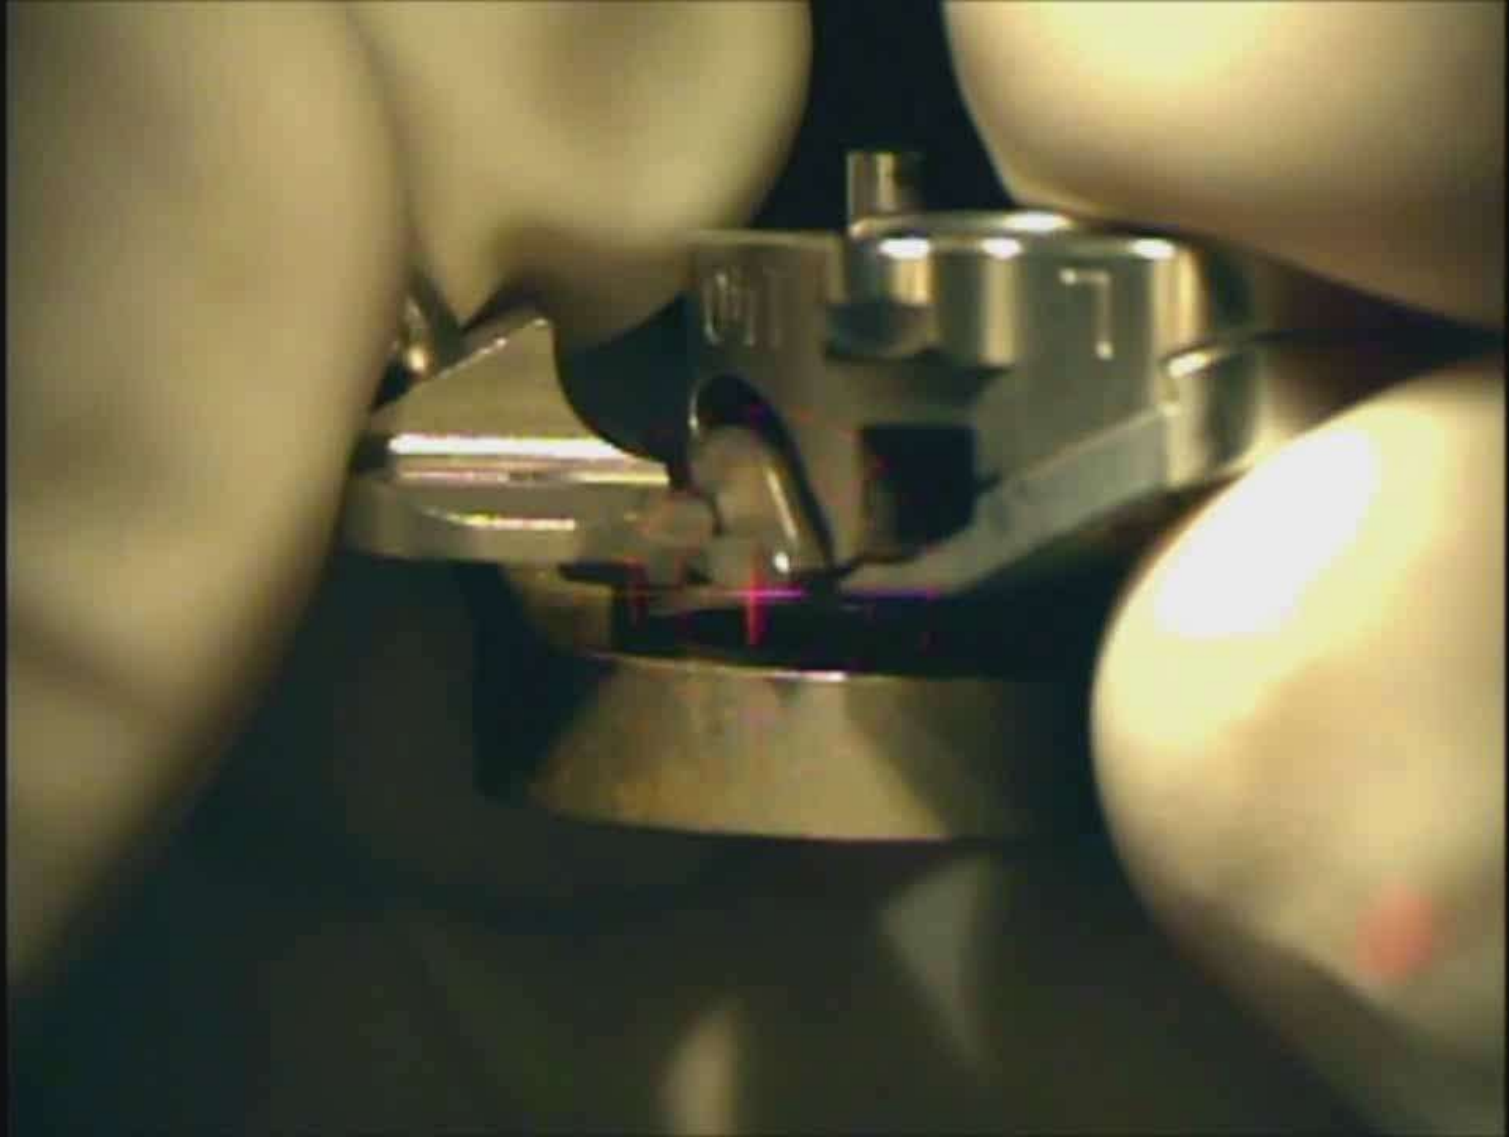
The off-angle head can then advance such that the microkeratome head guide is on the same plane as the overhang on the microkeratome ring and will jam at 40% excursion

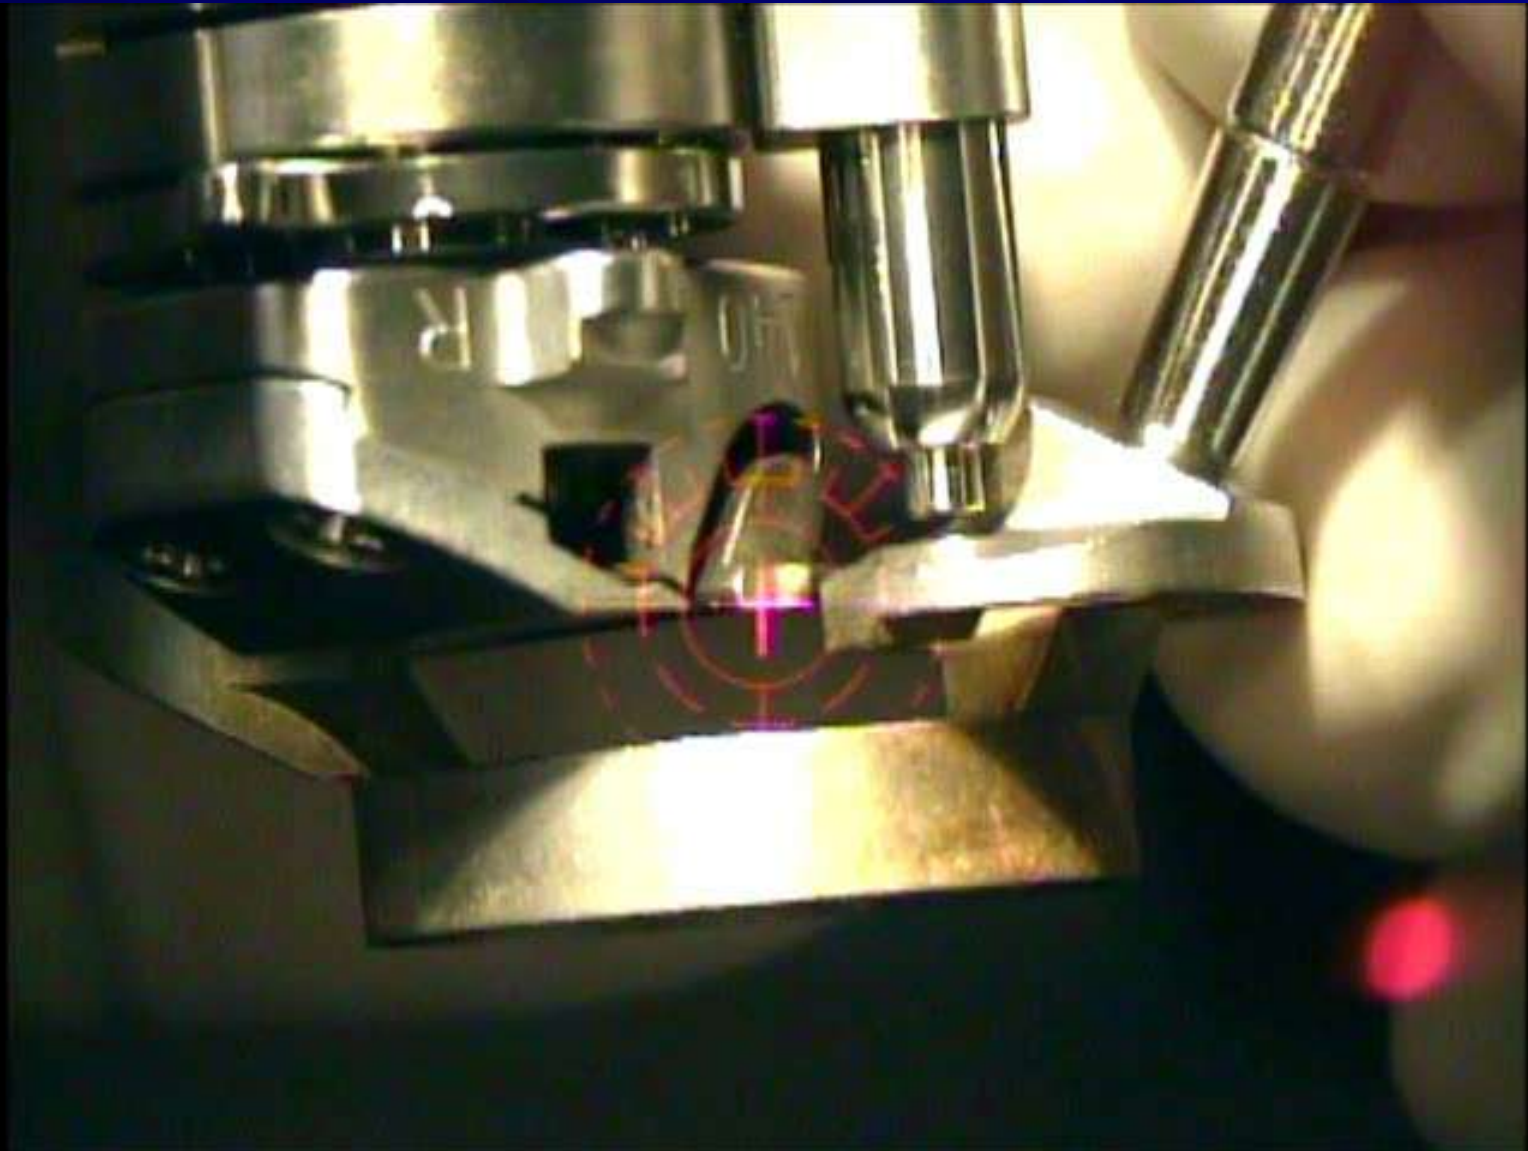
Demonstration: jamming

Caution: It may be difficult to unjam the keratome

Upper guide displacement makes the keratome difficult to unjam
