Big Bear Home Inspectors

Property Inspection Report

1111 Sample Avenue, "Lower Moonridge", Big Bear Lake, CA 92315
Inspection prepared for: Sample Sample
Real Estate Agent: Default AAA -

Date of Inspection: 7/29/2018 Time: 10:00am
Age of Home: Built in 1947 71 Years Size: A,B,C=1,330 SqFt
Weather: Clear & Warm
There will be 3 Reports Made A B C. This is Report For Building A
Inspection Report was Paid For In Full at the Time Of The Inspection. 7-29-2018
Chk#124
****PLEASURE DOING BUSINESS WITH YOU****

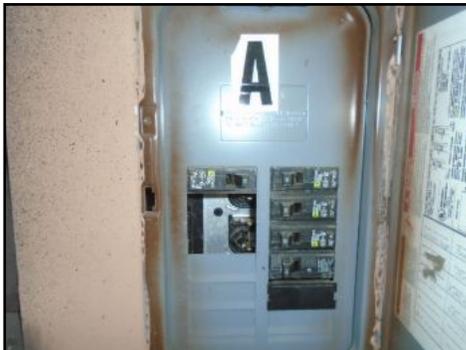
| Page 23 Item: 1 | Electrical Panel | <ul style="list-style-type: none"> • Sub-Panel: • Sub-Panel "A" Knockouts need snap-in caps inside panel box. Should be installed to keep mice out of panel box and to avoid potential electrocution hazard. |

Sub Panel for Building "A"

Sub Panel For "A" has 2 open spots.

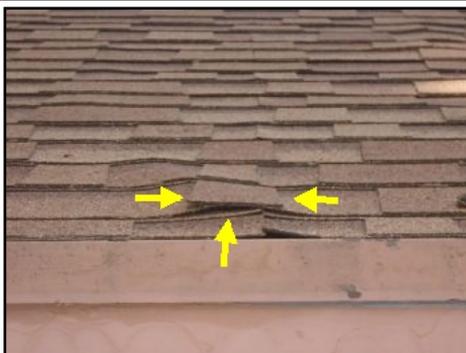
| Page 25 Item: 1 | Roof Condition | • Nail Pop Up Happening in a few spots around the roof |

Nail pop Up in a few places

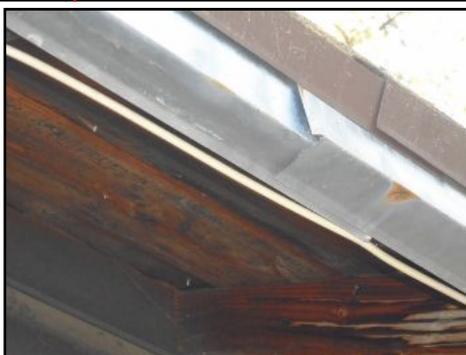
Page 25 Item: 2

• Roof Flashing, **Drip edge** needs to be secured in a few places.

Flashing is separating. Recommend sealing,

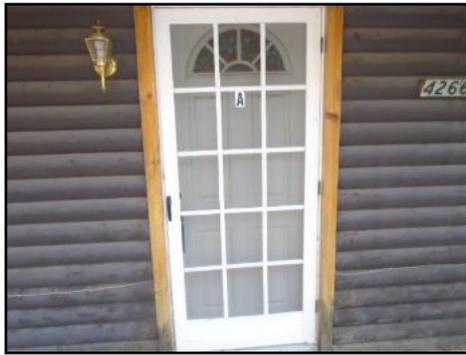
Page 26 Item: 1

• Exterior door(s) are getting weathered, may need a new coat of Paint Stain Etc.

Door Trim Water damage

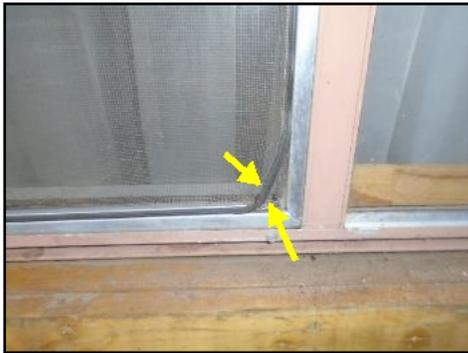
- Damaged screens observed. Rubber Window Seal Coming out of Frame. Recommend further Evaluation by a Handyman
- Peeling paint observed, suggest scraping and painting as necessary.

Screen damage

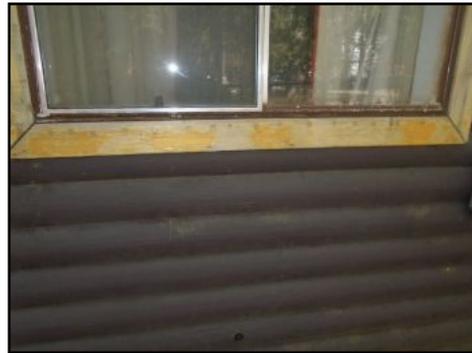
Wood Needs refinished

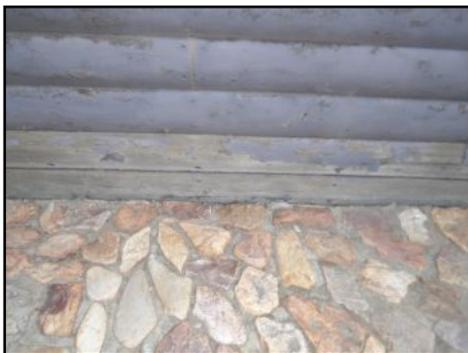
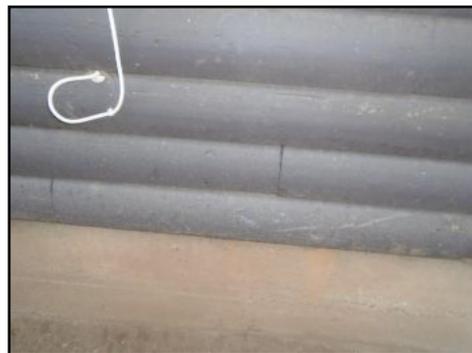
Page 27 Item: 3

- Some siding deterioration noted. Have repaired as necessary.

Seal & Fill All Gaps & Cracks

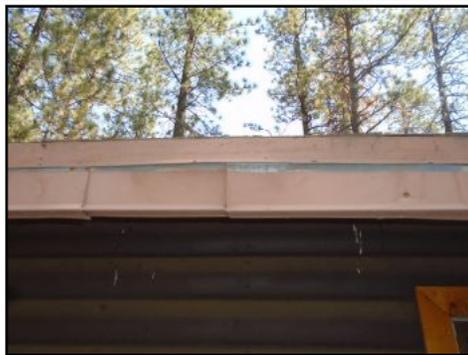
Page 27 Item: 4

- Moisture damage, wood rot, observed. Recommend review for repair as necessary.
- Split Caulking and peeling paint noted.
- Peeling paint observed, suggest scraping and painting as necessary.

Materials coming apart

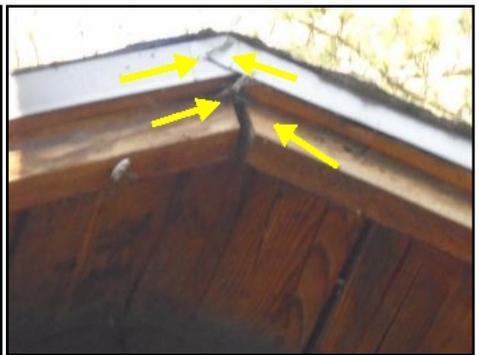
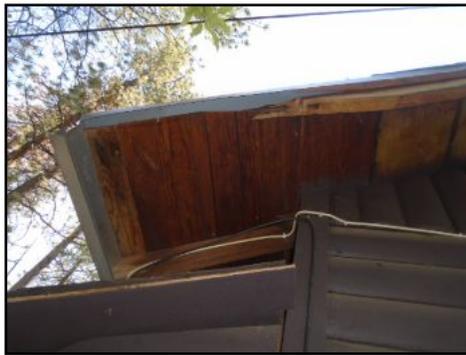
Broken Fascia Board

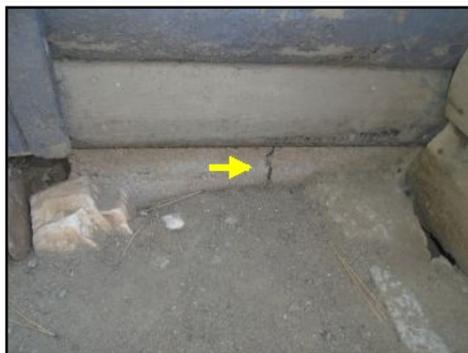
| Page 28 Item: 1 | Foundation Walls | <ul style="list-style-type: none"> • Cracks and deterioration observed. • Cracks / Holes (1/4" or less) present in: foundation / floor / ext. wall. Consider sealing them to prevent water infiltration. Generally speaking, cracks that are less than 1/4" are not commonly regarded as being structurally significant. |

Crack in Wall

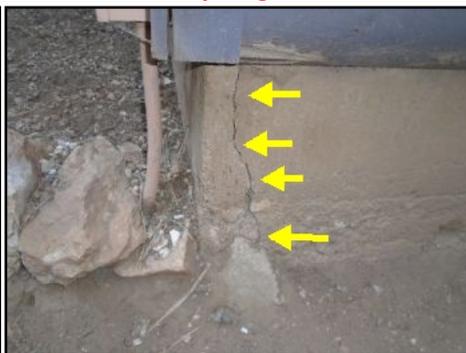
Crack in Foundation Wall

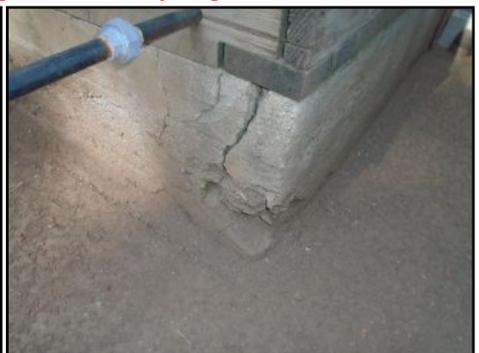
Crack In Foundation wall

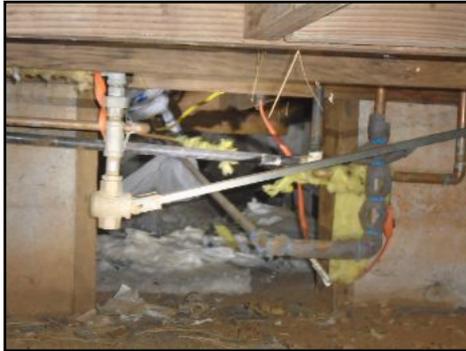
| Page 29 Item: 5 | Access Panel | <ul style="list-style-type: none"> • The exterior crawlspace access was missing a cover. We recommend installing a cover with a screen to assist in ventilating the space. • Could not access the crawlspace, there was limited space for entry. |

Entrance to the Crawlspace has been almost completely blocked with plumbing. Could not Access

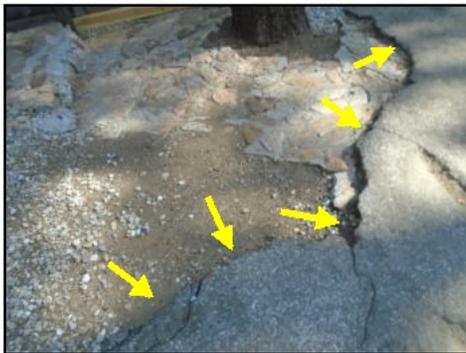
| Page 30 Item: 2 | Driveway and Walkway Condition | <ul style="list-style-type: none"> • Uneven Asphalt at the driveway. This is a Tripping Hazard |

Possible Tripping Hazard

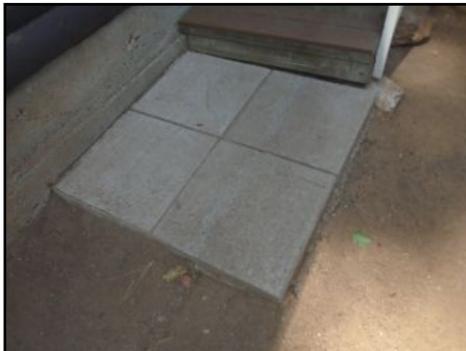
| Page 32 Item: 8 | Stairs & Handrail | <ul style="list-style-type: none"> • Landing at The Bottom Of the Back Deck is more than 3/4 inch off the ground becoming a possible Tripping Hazard |

Landing at the Back deck. Could be a Tripping Hazard

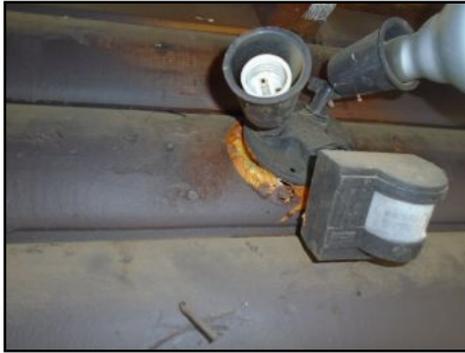
| Page 33 Item: 9 | Grounds Electrical | <ul style="list-style-type: none"> • FIXTURES: • Back Porch Light Fixture was not properly installed and Sealed. Recommend further evaluation by a Handyman |

Not the proper way to install & Seal a Light Fixture

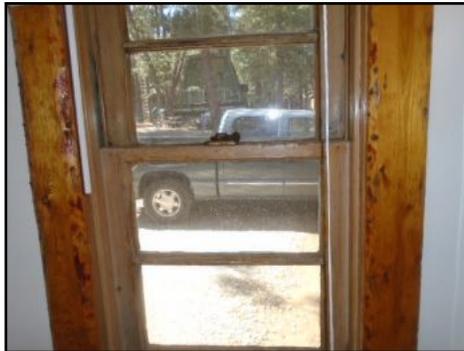
- Operated windows appeared functional, at time of inspection
- Deterioration of wooden frames noted. While basic maintenance may prolong the life of these window frames, replacement may be necessary at some point.

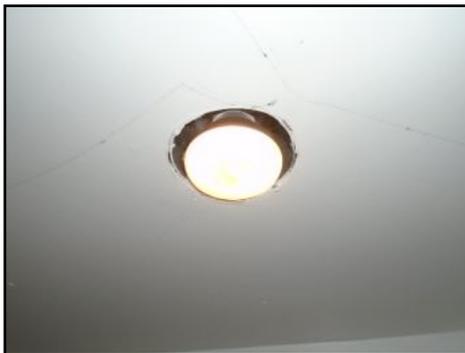
Ceiling needs to be sealed around the Light fixture.

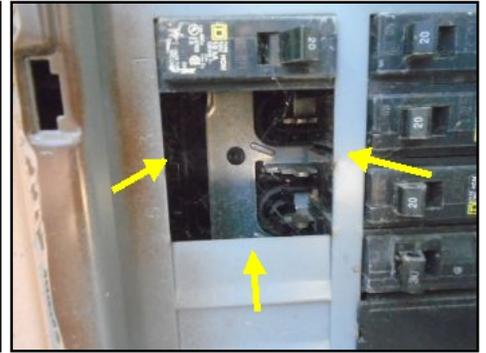
- **Sub-Panel "A" Knockouts need snap-in caps inside panel box. Should be installed to keep mice out of panel box and to avoid potential electrocution hazard.**

Sub Panel For "A" has 2 open spots.

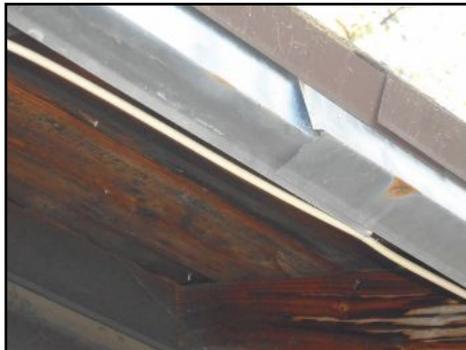
- Roof Flashing, Drip edge needs to be secured in a few places.

Flashing is separating. Recommend sealing,

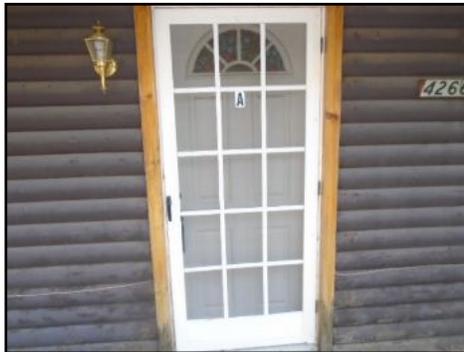
- Appeared in functional and in satisfactory condition, at time of inspection.
- **Exterior door(s) are getting weathered, may need a new coat of Paint Stain Etc.**

Door Trim Water damage

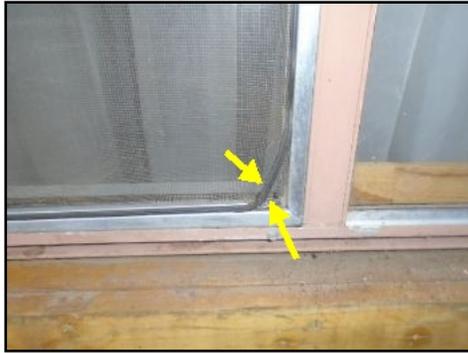
- Suggest sealing/caulking as part of routine maintenance to prevent further deterioration.
- **Damaged screens observed. Rubber Window Seal Coming out of Frame. Recommend further Evaluation by a Handyman**
- **Peeling paint observed, suggest scraping and painting as necessary.**

Screen damage

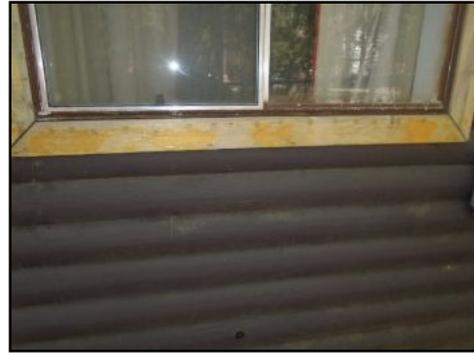
Wood Needs refinished

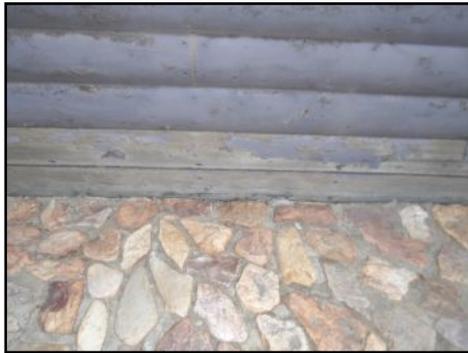
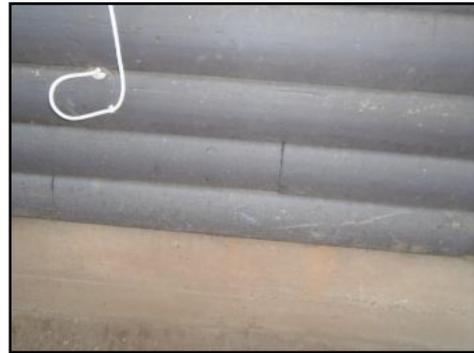
- Caulk and seal all gaps, cracks and openings.
- **Some siding deterioration noted. Have repaired as necessary.**

Seal & Fill All Gaps & Cracks

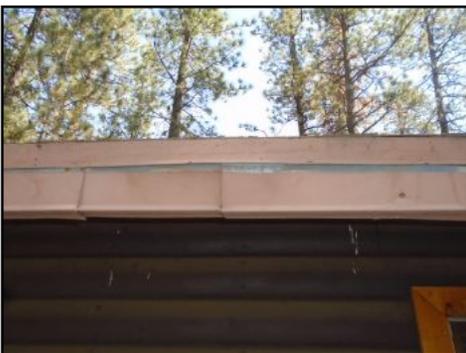
- **Moisture damage, wood rot, observed. Recommend review for repair as necessary.**
- **Split Caulking and peeling paint noted.**
- **Peeling paint observed, suggest scraping and painting as necessary.**

Materials coming apart

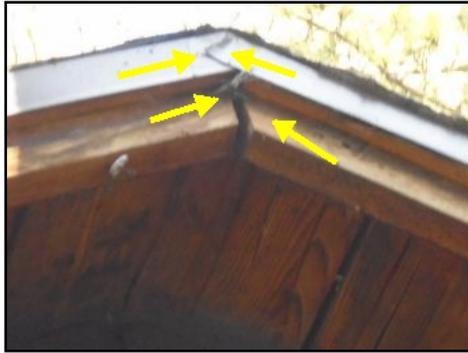
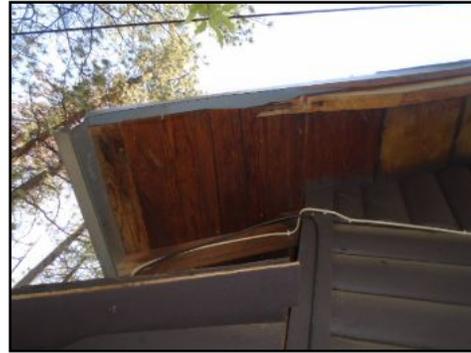
Broken Fascia Board

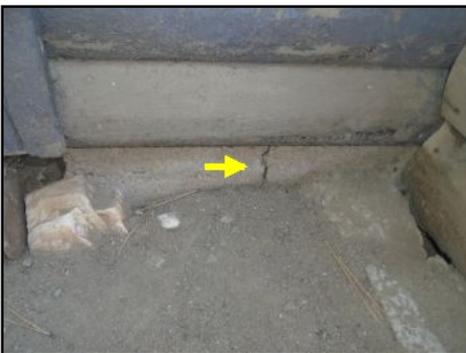
- Normal settlement.
- Cracks and deterioration observed.
- Cracks / Holes (1/4" or less) present in: foundation / floor / ext. wall. Consider sealing them to prevent water infiltration. Generally speaking, cracks that are less than 1/4" are not commonly regarded as being structurally significant.

Crack in Wall

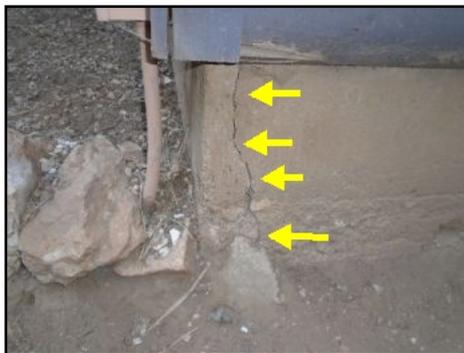
Crack in Foundation Wall

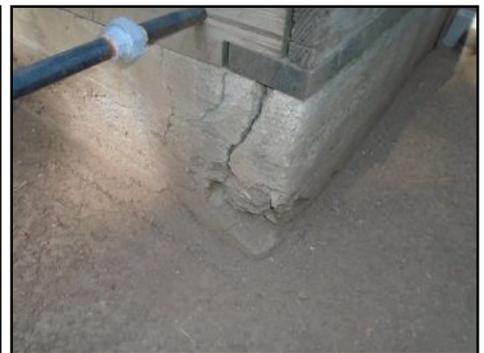
Crack In Foundation wall

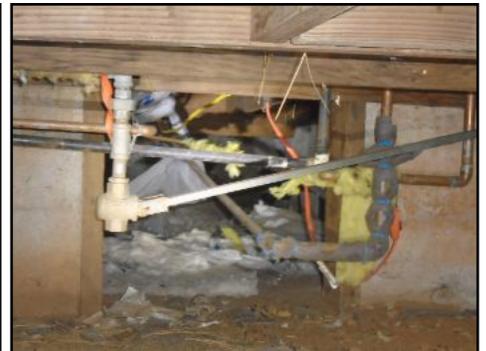
Observations:
 • The foundation access panel installed and functional during the inspection.
 • Limited inspection from the access area only.
 • Recommend at least 18 inches of clear access to gain entry.
 • The exterior crawlspace access was missing a cover. We recommend installing a cover with a screen to assist in ventilating the space.
 • Could not access the crawlspace, there was limited space for entry.

Entrance to the Crawlspace has been almost completely blocked with plumbing. Could not Access

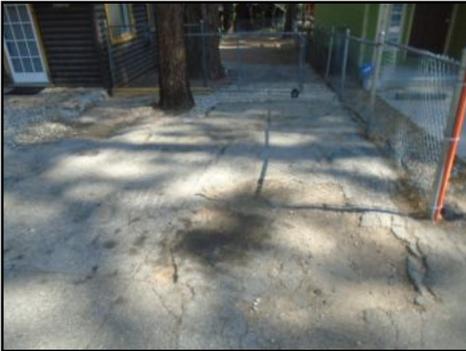
- Driveway in good shape for age and wear. Some oil staining. Clean and seal to extend life.
- Gravel driveways need ongoing maintenance. Repair as needed.
- **Uneven Asphalt at the driveway. This is a Tripping Hazard**

Possible Tripping Hazard

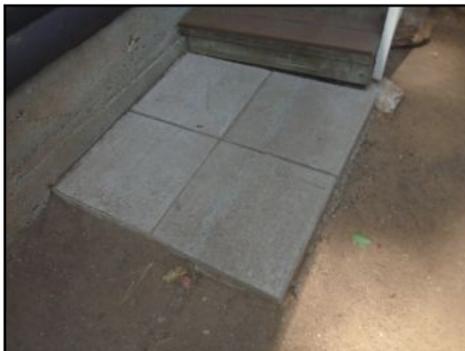
- Landing at The Bottom Of the Back Deck is more than 3/4 inch off the ground becoming a possible Tripping Hazard

Landing at the Back deck. Could be a Tripping Hazard

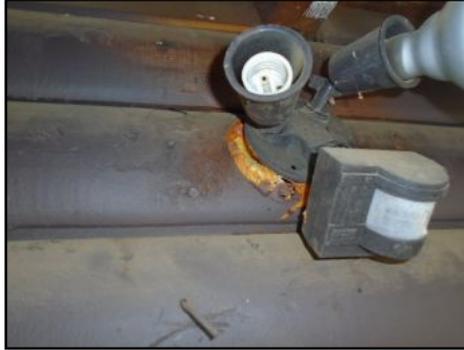
- **FIXTURES:**
- **Back Porch Light Fixture was not properly installed and Sealed. Recommend further evaluation by a Handyman**

Not the proper way to install & Seal a Light Fixture
